Remediation New Zealand Ltd

Uruti composting facility

Monitoring Programme

Technical Report 2023-05

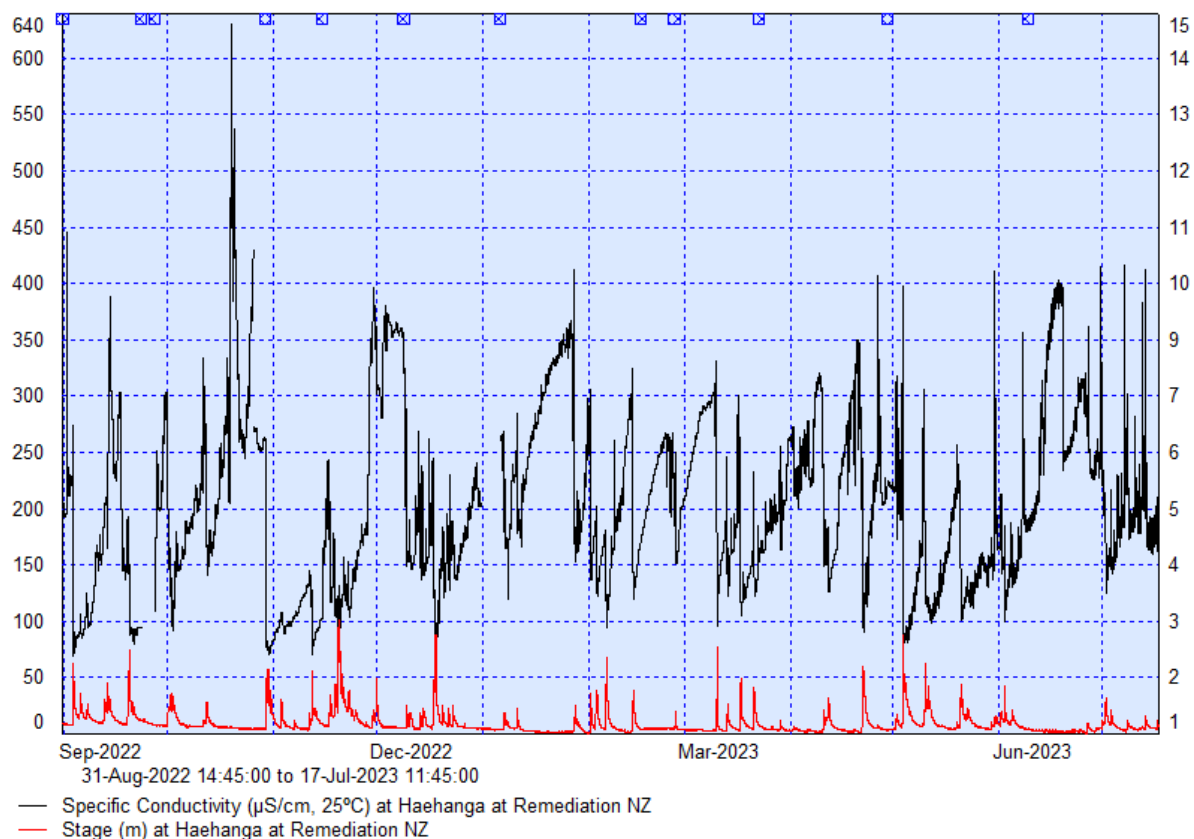
Figure 4 Continuous readings of conductivity in the lower Haehanga Stream 31 August 2022-17 July 2023

The graph above (Figure 4) presents the data from the conductivity sensor and flow height recorder since its installation and calibration. Hydrological officers have found that the probes are frequently fouled by debris within the stream, which would result in readings displaced from the actual conductivity in the main current of the stream. However, the overall patterns are clear. During dry periods (low stream flows), the conductivity gradually increases. This is a natural pattern, as deeper groundwaters have higher conductivity (due to concentrations of dissolved minerals following long exposure between minerals and groundwater) than rainfall runoff or shallow near-stream soil moisture. However, in the graph above, spikes of increasing conductivity can be observed superimposed on the natural pattern (eg the most obvious being around 19-20 October, but recurring throughout the year). These sharp peaks represent specific discharges of highly saline waters, which would be consistent with discharges from the wetland treatment system and/or irrigation direct deposition/runoff. In addition, the sustained trends of increasing conductivity above 250 $\mu\text{S}/\text{cm}$ evident in early December and again in mid to late January and in early April suggest a significant compounding effect from irrigation runoff and/or infiltration throughout this period.

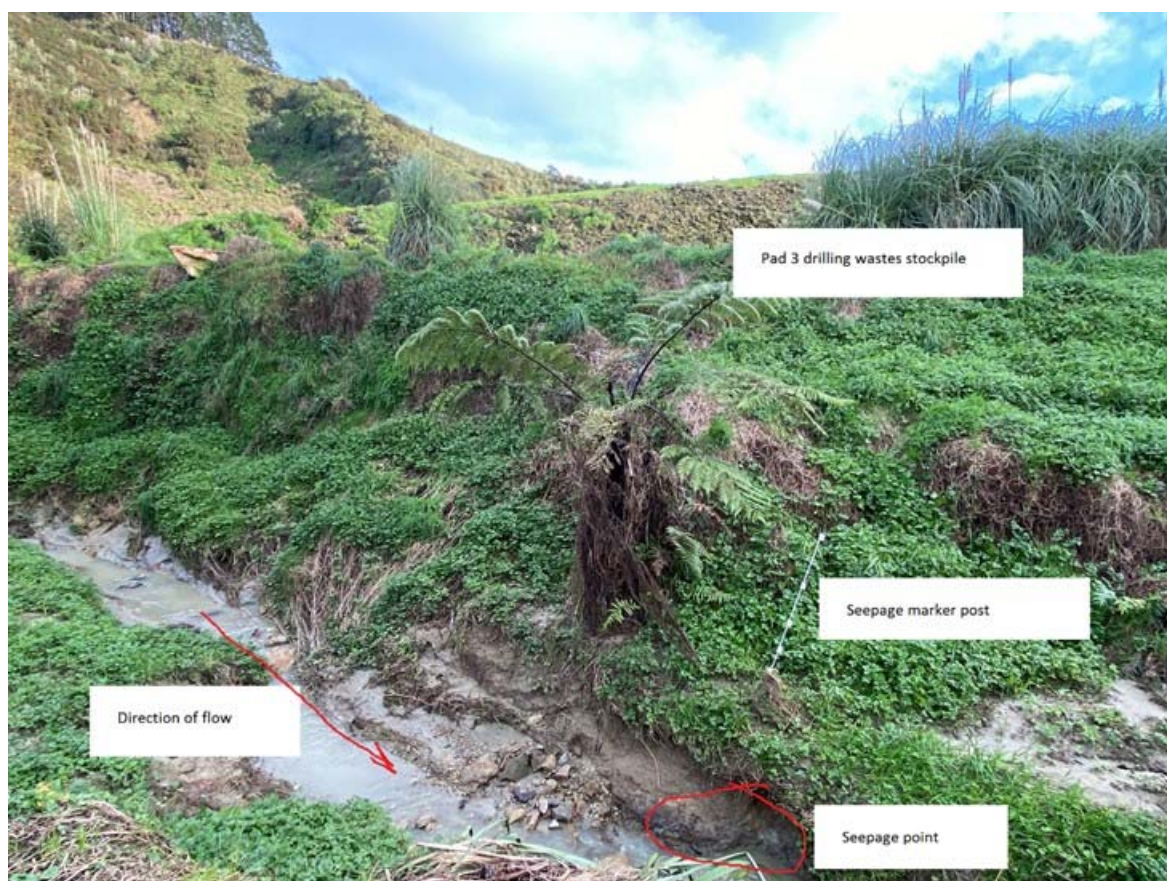
A routine monthly scheduled survey of the physico-chemical quality across the Haehanga catchment had been undertaken by the Council on 11 March 2022. Of particular significance were the anomalous results found in this survey at site HHG000106. HHG000106 is a sampling site in a small tributary that runs between, and is downslope of, Pad 1, the truckwash pond, the former Pad 3 raw wastes reception pit, and Pad 3 and the blended drilling wastes stockpile. By comparison with data for upstream sites in other tributaries or the main stem of the Haehanga Stream, markers such as total alkalinity, hardness, conductivity, chloride, and total ammoniacal nitrogen were elevated many times over. The Council considered the source(s) to likely to be from the stockpile, the holding pond previously used to receive wastes destined for Pad 3, and/or the truck-wash and irrigation ponds, as these have received run-off and leachate from Pad 3 and its dumping pond.

The point of seepage was to the east of the drilling wastes stockpile and several metres below it downslope. The point of seepage is shown below in Photo 1, by the white plastic standard.

Photo 1 Seepage into tributary of the Haehanga Stream

Remediation works have subsequently been implemented. A Council inspection on 28 April 2023 noted that an interception trench had been excavated across the southern area between the pad and the tributary, and was being backfilled with papa rock in order to create a barrier to further flow. Surface stormwater drains were being re-configured to abate overland flow in the same direction.

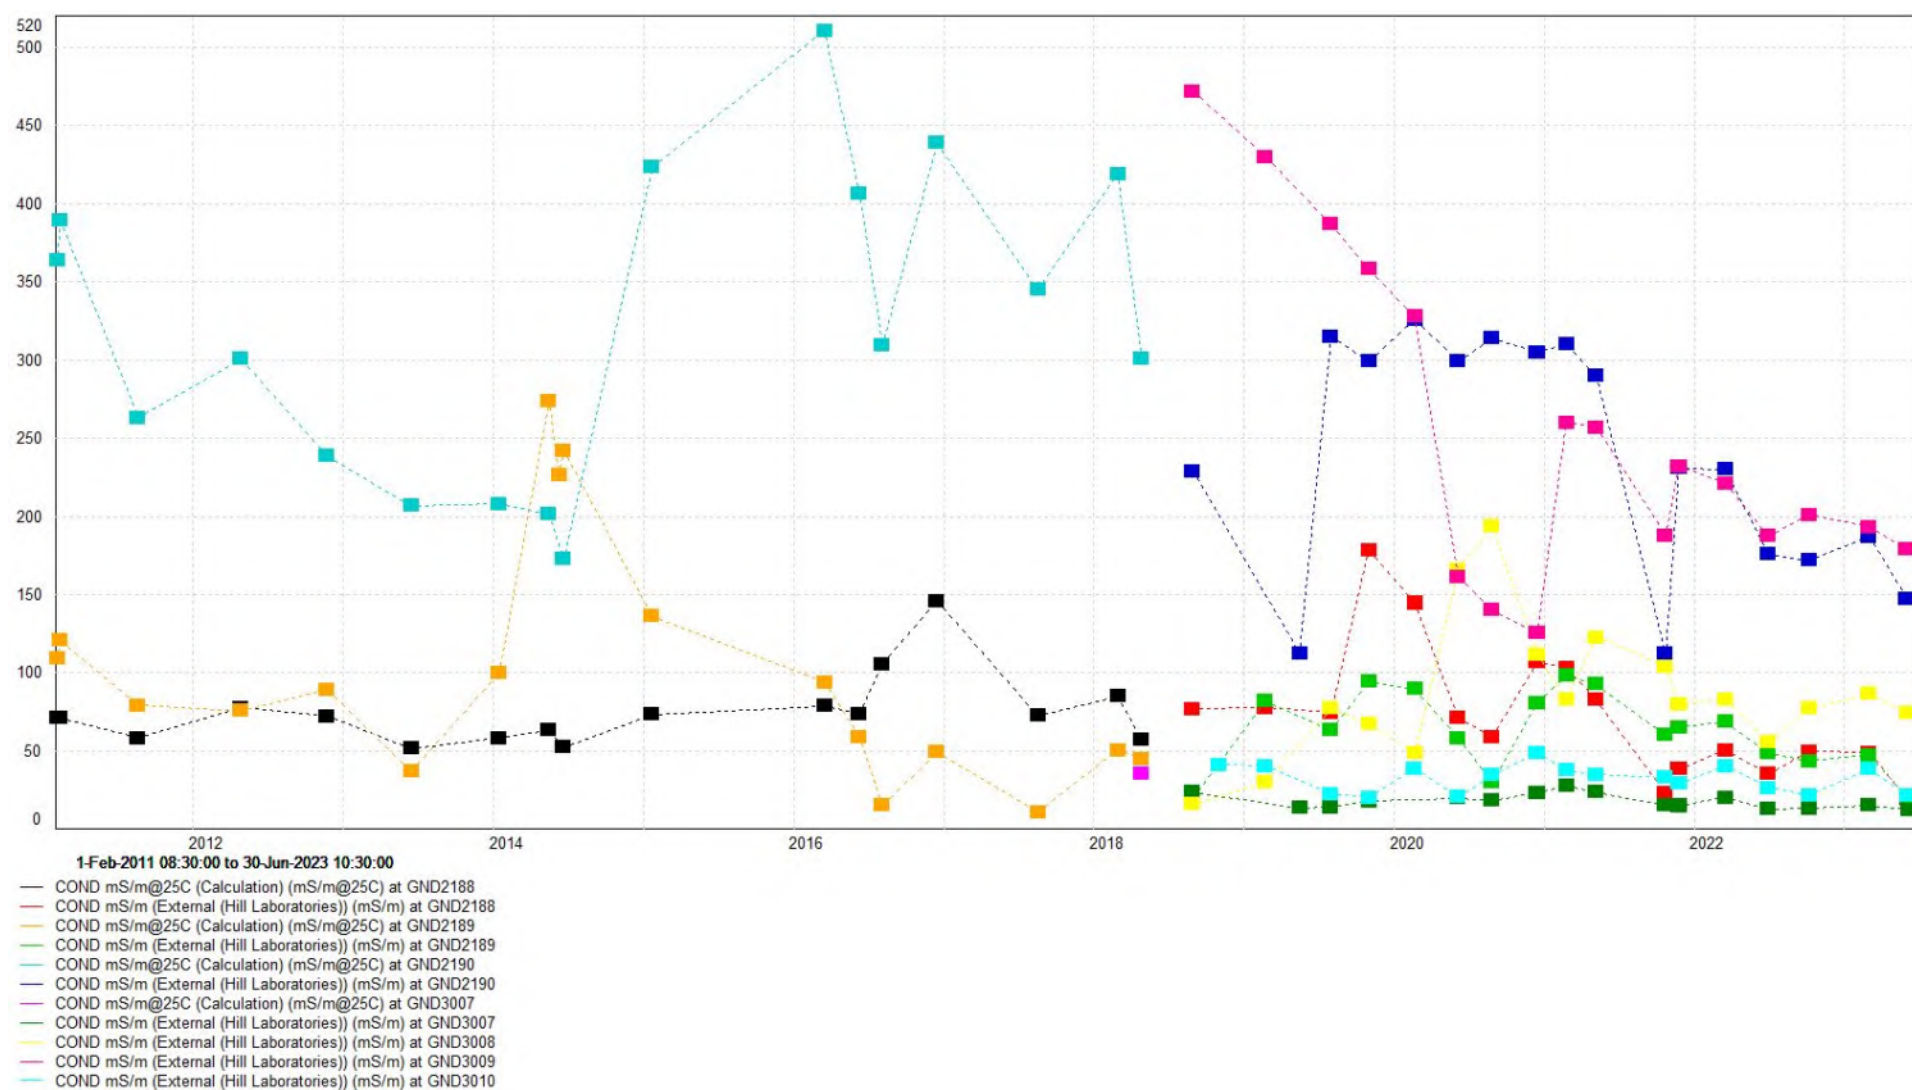
The conductivity graph is displaying an overall general decrease in concentration across all bores from 2011–2022. Bores GND3008 and GND3009 appeared to increase slightly during 2020 to late 2021, but appear to be reducing slowly since then.

For conductivity, the highest readings have been in bores GND2190 (irrigation area L2), GND3008, and GND3009. Readings in all these bores have been reducing over the past 4 years. In the 2022-2023 year, bore GND 3009 had by far the highest readings. Readings of conductivity in groundwater under the upper irrigation areas are relatively low, although still double or more the conductivity found in GND3007, the roadside bore.

Figure 13 Total conductivity concentrations in groundwater 2011–2023

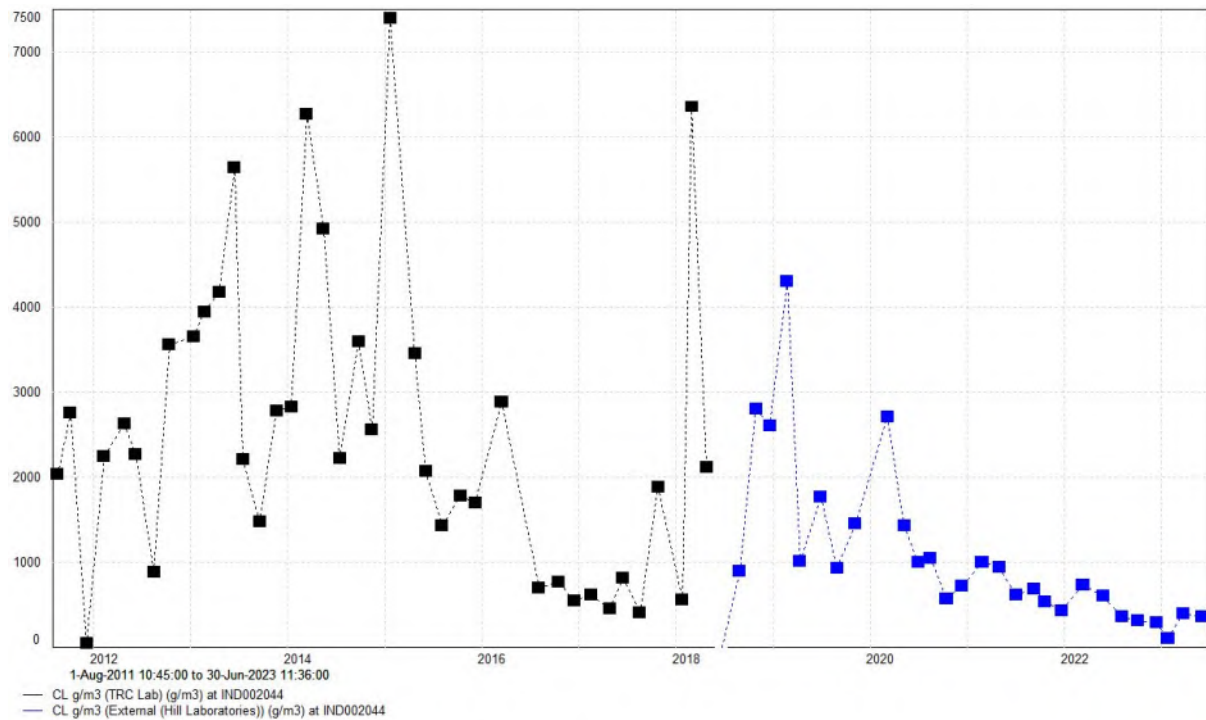
Figure 15 Chloride levels in the irrigation retention pond 2011-2023

Figure 15 above shows the trends in the concentration of chloride in the irrigation pond since 2011. RNZ committed to ending the acceptance of drilling wastes in or about December 2020. The data shows a substantial reduction in the concentration of chloride entering the irrigation holding pond since that date, while noting a pattern of overall reducing chloride leachate prior to that decision, particularly in 2017. The trend of declining transport of chloride from Pads 1 and 3 has continued into the 2022-2023 year.

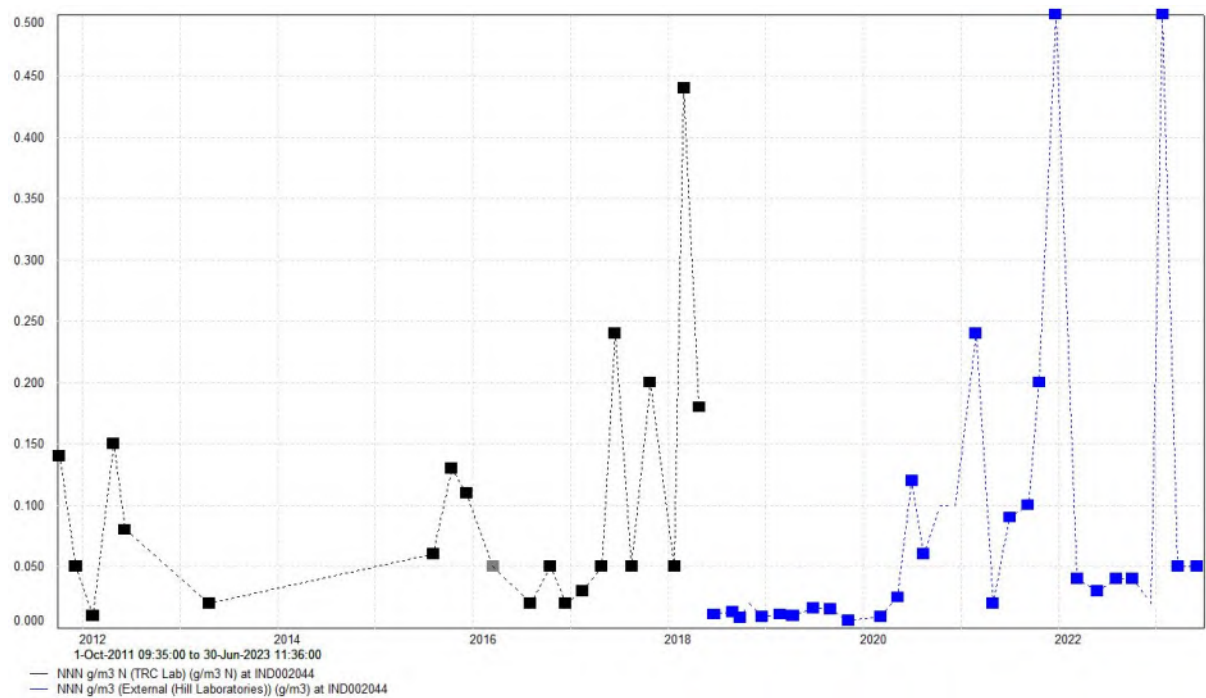
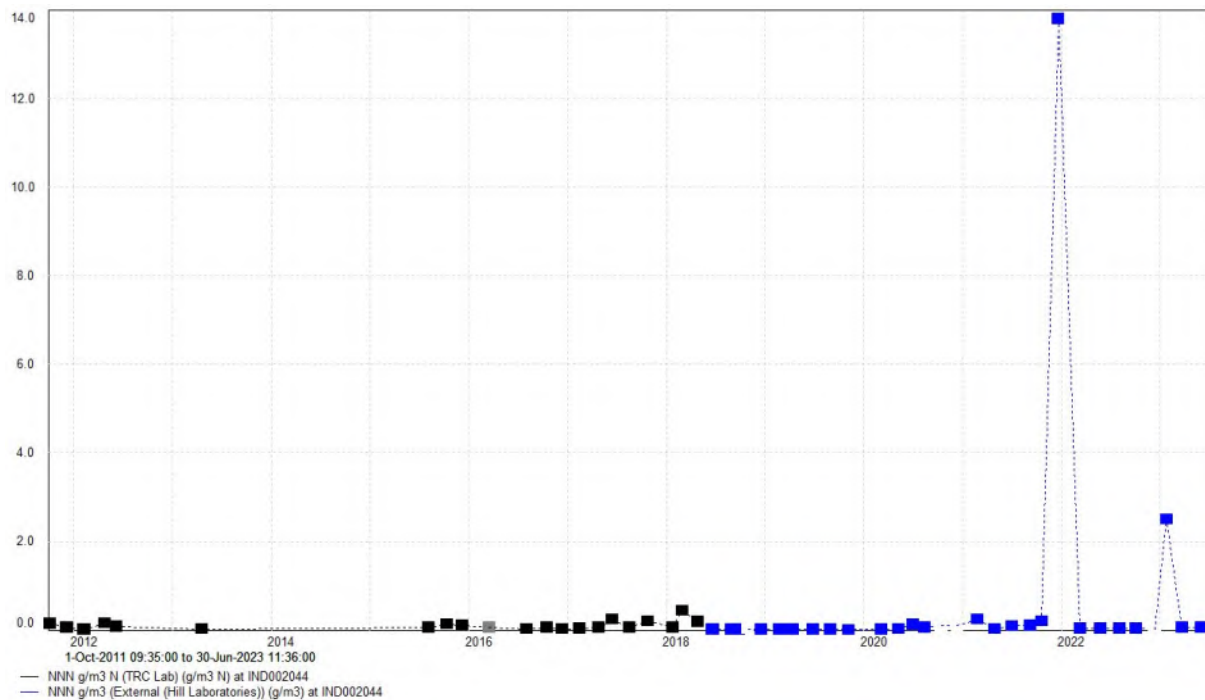
Figure 16 Oxidized nitrogen (nitrate+nitrite) concentrations in the irrigation retention pond 2011-2023 (excluding peak result in December 2022)

Figure 17 Oxidized nitrogen (nitrate+nitrite) concentrations in the irrigation retention pond 2011-2023 (including peak results in December 2021 and December 2022)

Figure 16 and Figure 17 above show the trends in the concentration of nitrate-nitrogen in the irrigation pond since 2011. The data show considerable variation in the concentration of nitrate within the irrigation holding pond over that period, with peaks in 2018, December 2021, and December 2022. The data suggests that at times, the composting process is creating highly stable compost (shown by increases and peaks in oxidised nitrogen), while at other times ammonia rather than nitrate is being leached from Pad 1 (see Figure 18 below). It should be noted that RNZ implemented greater aeration of the irrigation storage pond in late 2022, and the benefits in respect of the oxidation of ammonia to the oxidised forms of nitrogen (nitrate+nitrite) can be seen in the recent results in Figure 16 and corresponding dips in ammonia (see next figure).

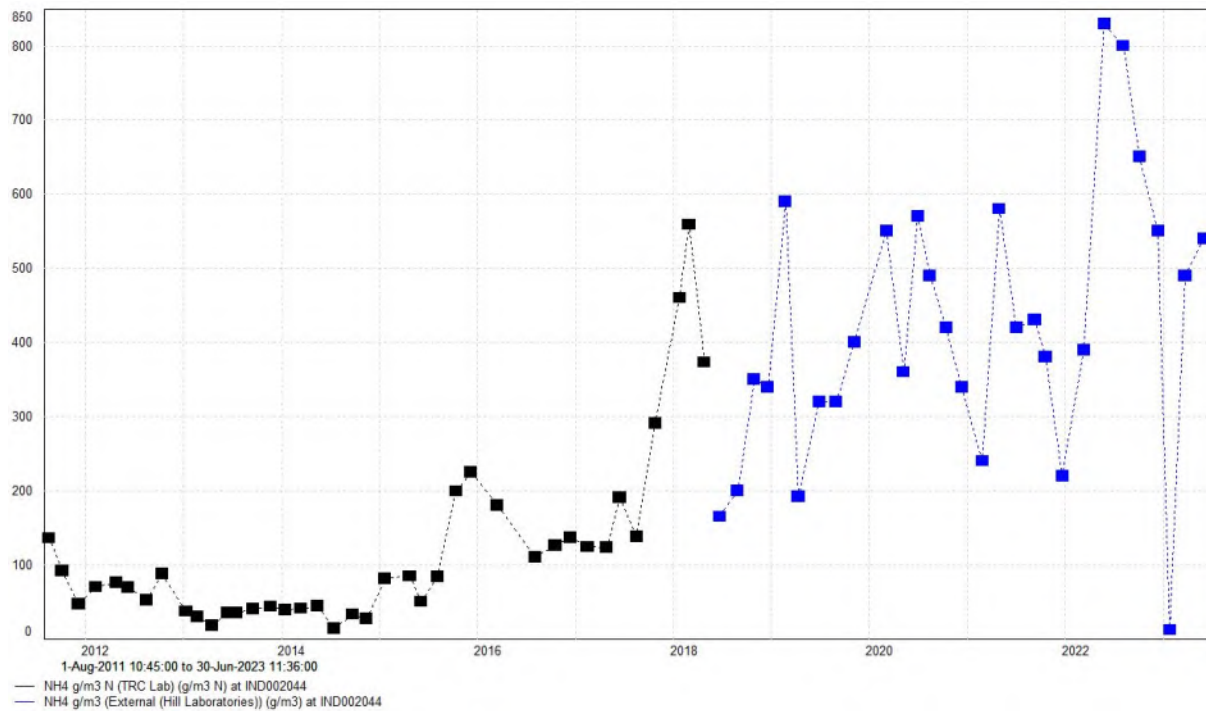
Figure 18 Total ammoniacal nitrogen concentrations in the irrigation retention pond 2011-2023

Figure 18 above shows the trends in the concentration of ammoniacal nitrogen in the irrigation pond since 2011. The data show a substantial overall increase in the concentration of ammonia entering the irrigation holding pond since around 2018, and a sharp and high peak in May 2022 that was more than a third higher than any previous result. In the year under review, concentrations of total ammoniacal nitrogen in the storage pond have remained very high (the anomalous result shown in Figure 12 for December 2022 is regarded as having been mistakenly sampled from the wrong location, and should be disregarded). The significance of increased ammoniacal or total nitrogen for the nitrogen loading on the pasture in the irrigation fields is discussed in Section 3.1.

The pattern of much higher leaching of ammonia in recent years is suggestive of much greater volumes of organic wastes being processed, and/or poorer covering of the materials during the composting process, leading to greater leaching and loss rates of soluble nutrients.

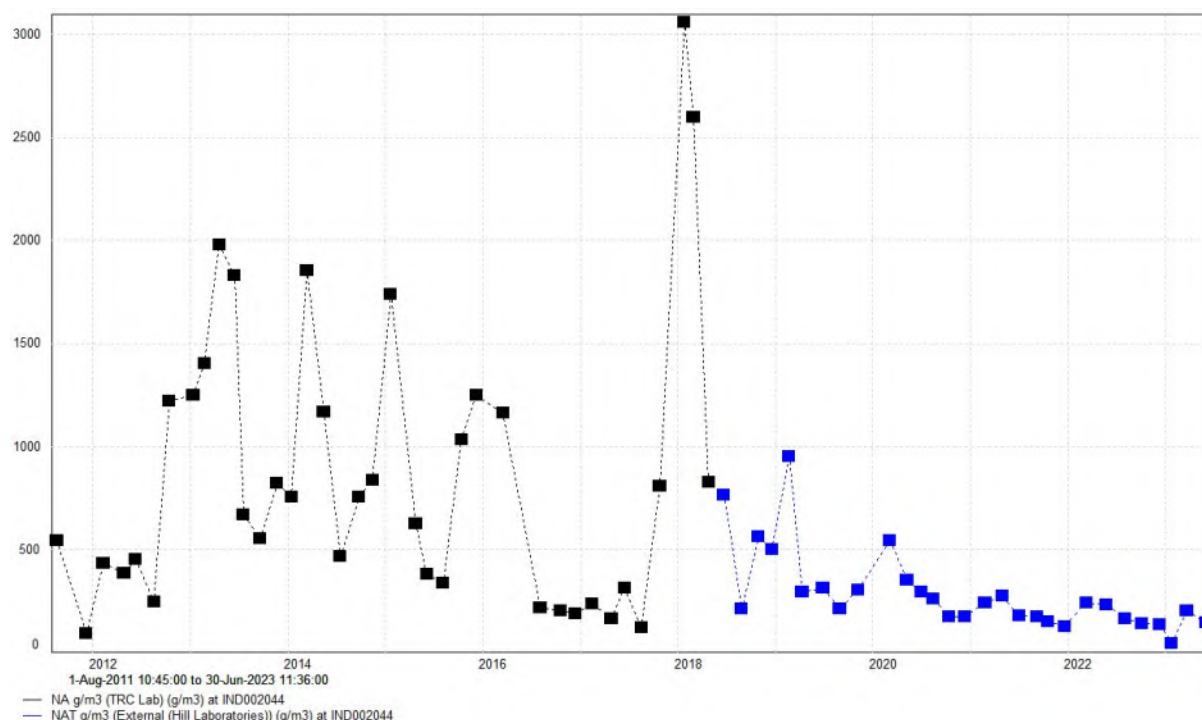
Figure 19 Ionised sodium concentrations in the irrigation retention pond 2011-2023

Figure 19 above presents the data for the concentration of sodium in the irrigation wastewaters since 2011. The application of excessive quantities of ionic sodium to soil causes degradation of soil structure, leading to loss of productivity and increased erosion. The pattern of reducing sodium concentrations is encouraging. It is noted that RNZ committed to eliminating the reception of drilling wastes from December 2020, and this appears to have had clear benefits, while noting that sodium concentrations were overall reducing prior to this time in any case (but with considerable variability and wide ranges in results). The reduction in sodium concentrations (and by implication, in total sodium loadings on irrigation soils) parallels the reduction in chloride noted above.
