# Remediation New Zealand Ltd

Uruti and Waitara Road  
Monitoring Programme  
Annual Report  
2019-2020

Technical Report 2020-84

ISSN: 1178-1467 (Online)  
Document: 2481806 (Word)  
Document: 2618686 (Pdf)  
July 2021

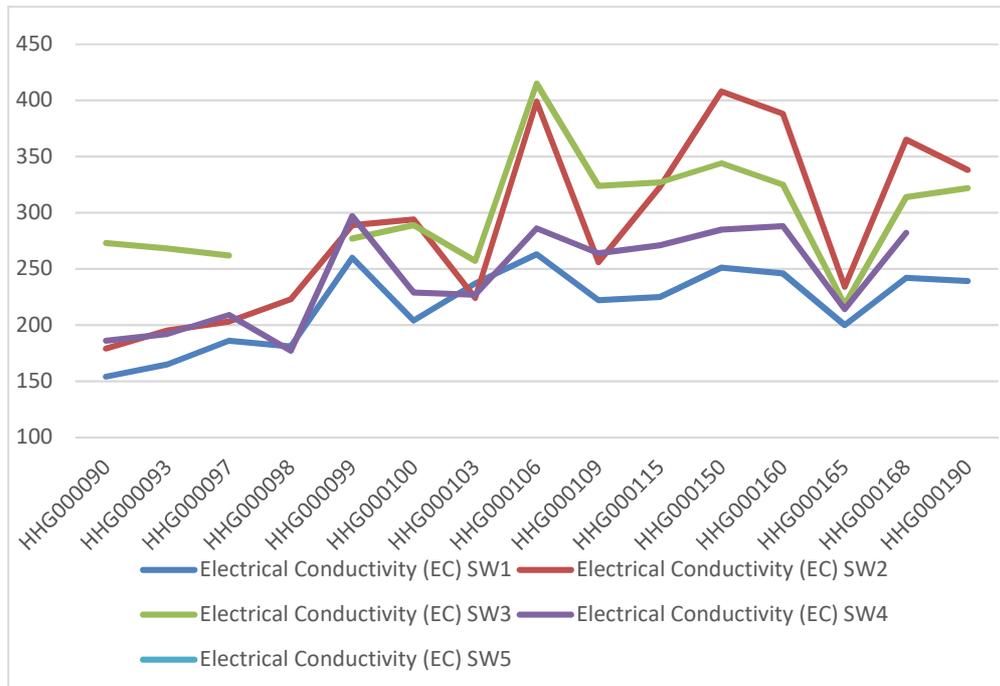
Figure 6 Conductivity uS/cm by site Haehanga Stream 2019-2020

In terms of the Haehanga Stream and the 2019-2020 monitoring, there were incremental increases in chloride and ammonia down through the length of the Haehanga Stream. It is further noted that these increases were within consent conditions. Figure 6 demonstrates the increase in conductivity within the surface water as a result of the consent holders operations. Similar increases in chloride were also recorded (Figure 7).

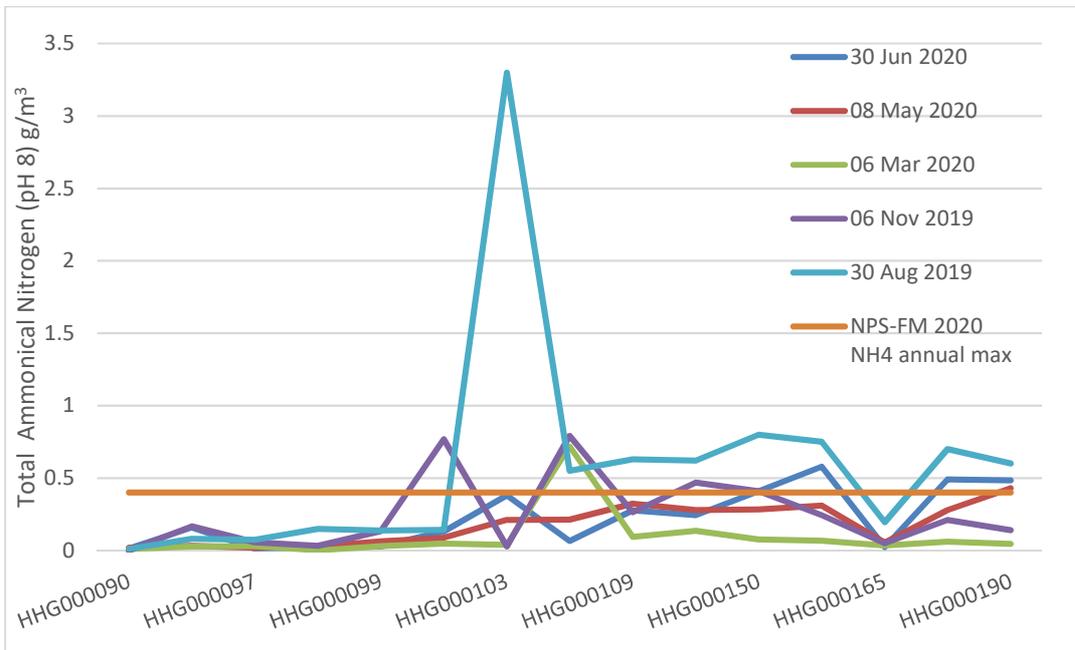
Figure 8 Total ammoniacal nitrogen (adjusted pH 8) g/m<sup>3</sup> by site Haehanga Stream 2019-2020

In terms of ammonia throughout the catchment, Figure 8 demonstrates the ammonia concentrations at sites throughout the catchment, please note these results have been adjusted to a pH 8 as required by the NPS-FM 2020 guidelines for comparison with the guidelines. Note that the elevated result at HHG000103, relates to monitoring below the WTS. This peak was compliant with the consent condition in regard to un-ionised ammonia (Section 2.2.2).

However, what is apparent is the increase in ammonia concentration down through the catchment. The increase is particularly apparent when the influence of HHG000165 is taken into account. Please note that HHG00165 is a monitoring location on an unnamed tributary of the Haehanga Stream which flows from an undeveloped area of site, located to the east of the main gate. The corresponding low ammonia

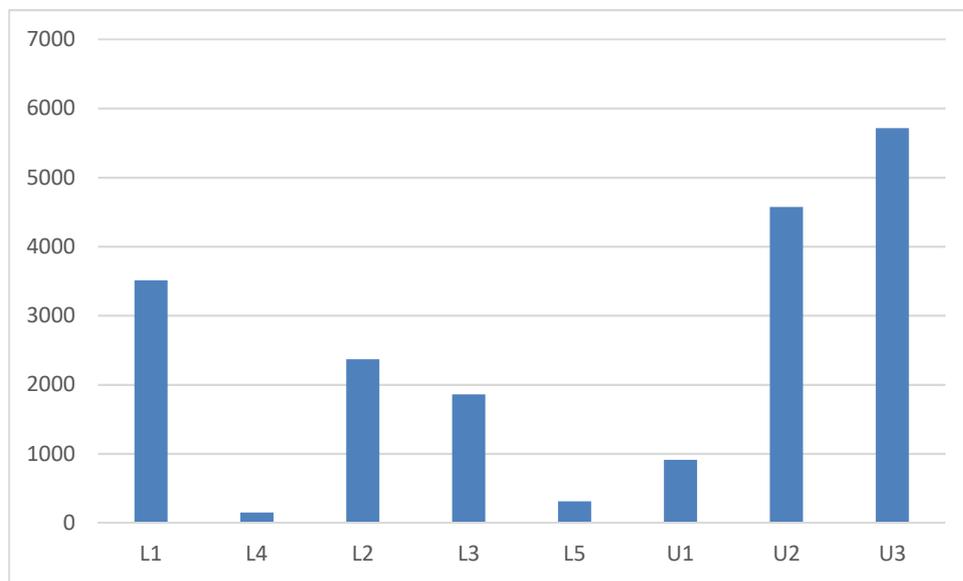
Figure 10 2019-2020 irrigation fluid discharge quantity (m<sup>3</sup>) by area

In this monitoring period area U3 received the highest application of fluid, with an annual discharge volume of 5,715 m<sup>3</sup>, this was followed by area U2 with 4,575 m<sup>3</sup>.

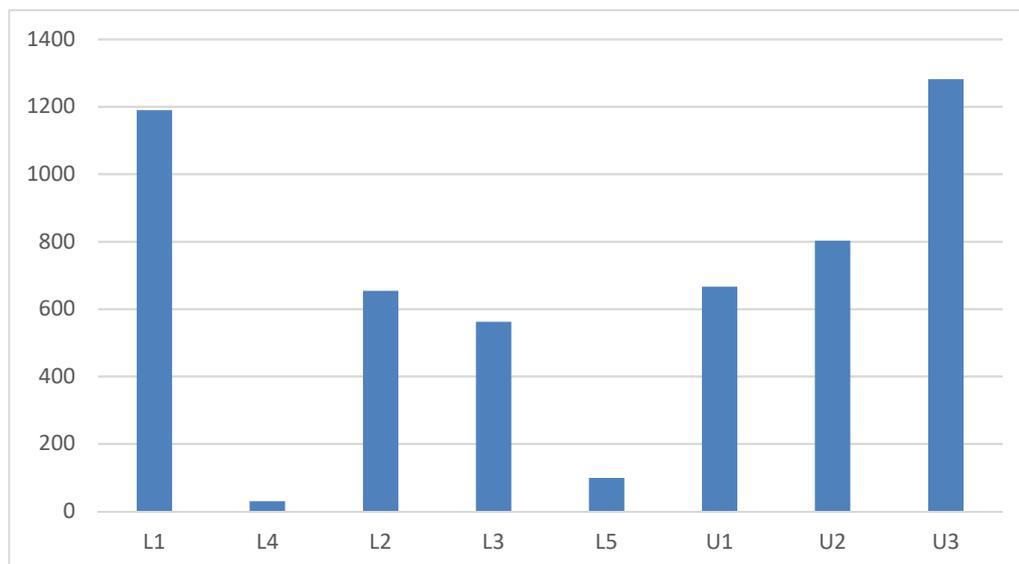
Figure 11 Estimated total nitrogen in kg per ha by irrigation area 2019-2020

The estimated results demonstrate that an exceedingly high concentration of nitrogen has been put to land across the irrigation areas in the 2019-2020 monitoring period. Three irrigation areas received equal to or in excess of 800 kg/ N/ ha, these were L1, U1, U2 and U3. In the case of L1 and U3, the estimated loading was close to (in the case of L1) 1,200 kg N/ha. In the case of U3, in excess of 1,200 kg N/ha.

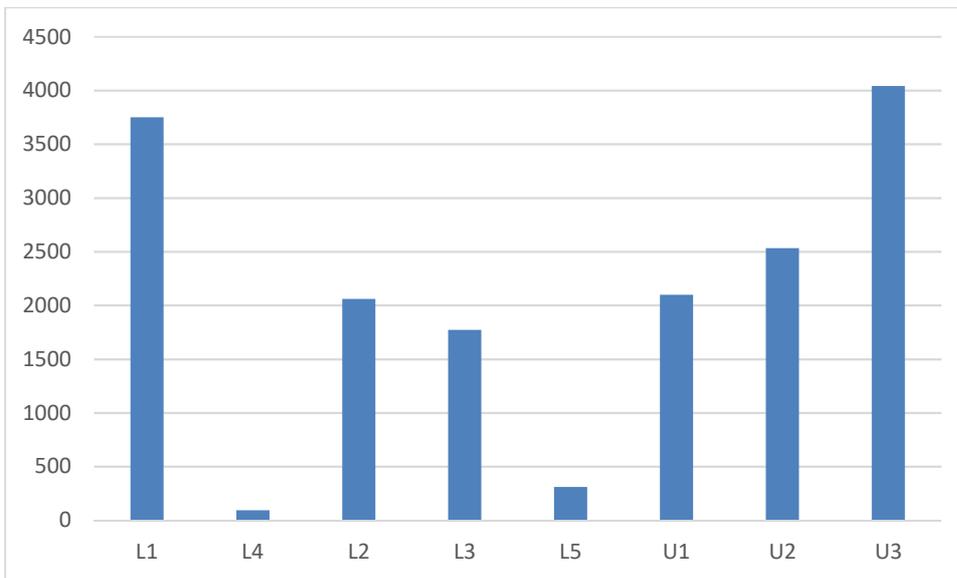
Figure 12 Estimated chloride applications in kg per ha by area 2019-2020

In terms of chloride loading applications (Figure 12), six irrigation areas (L1 – L3 and U1 – U3) received in excess of 1,500 kg of chloride per Ha. In the case of L1 (3,700 kg Cl/ha) and U3 (4,000 kg Cl/ha), the applications were high.

Considering the total irrigation area is now 13.18 ha. The estimated average chloride concentrations throughout the monitoring year was estimated at 1,498 g/m<sup>3</sup>. When divided by the total area, the applicant could discharge a total of 2,206 kg/ha, which is still high if each area had an equal quantity discharged.

Drilling mud and produced water is the main source of the elevated chloride within the irrigation fluid. The consent holder will cease the acceptance of any drilling waste related material on the 31 December 2020. This is proposed to reduce the chloride loading in the long term.

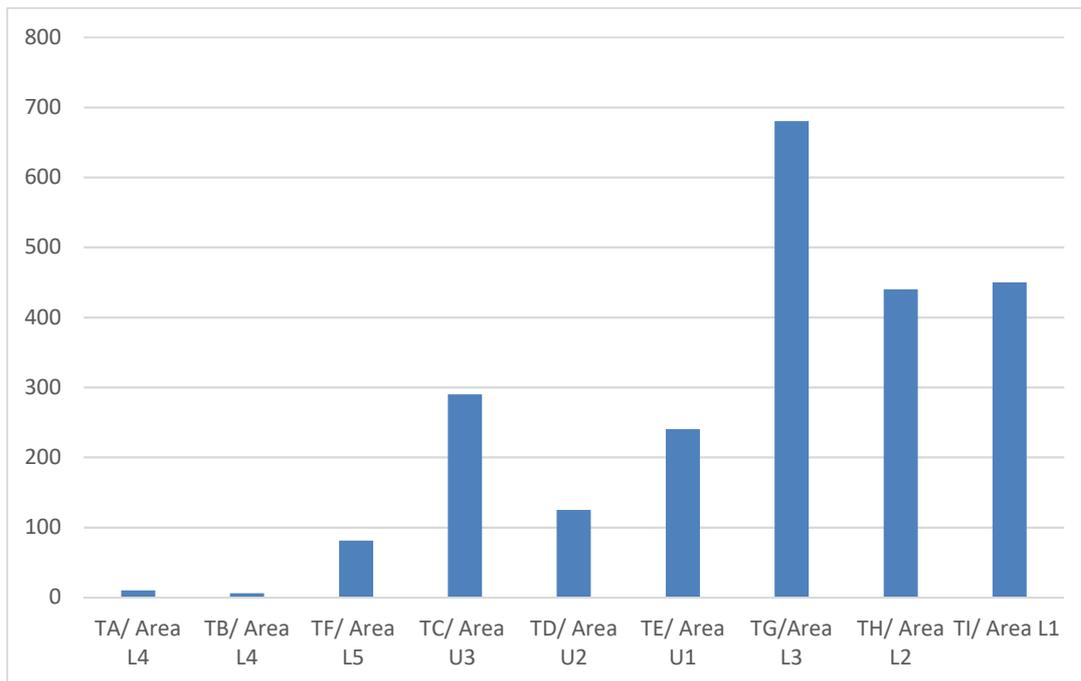
Figure 13 Irrigation area soil chloride results (mg/kg)

- In terms of C<sub>7</sub>-C<sub>36</sub>, two transects recorded results, transect G/area L3 (300 mg/kg) and transect H/area L2 (189 mg/kg).
- In terms of soil chloride concentrations (Figure 13), significant variation existed across the irrigation areas. Area L3 held the most elevated result with a high concentration of 680 mg/kg, followed by area L1 (450 mg/kg) and area L2 (440 mg/kg).

- The remaining areas held concentrations below 300 mg/kg. Of note is the impact from the irrigation in this figure, as the baseline soil transects of area L4, which have yet to be utilised for irrigation, recorded trace values (very low concentrations) 6-10 mg/kg.

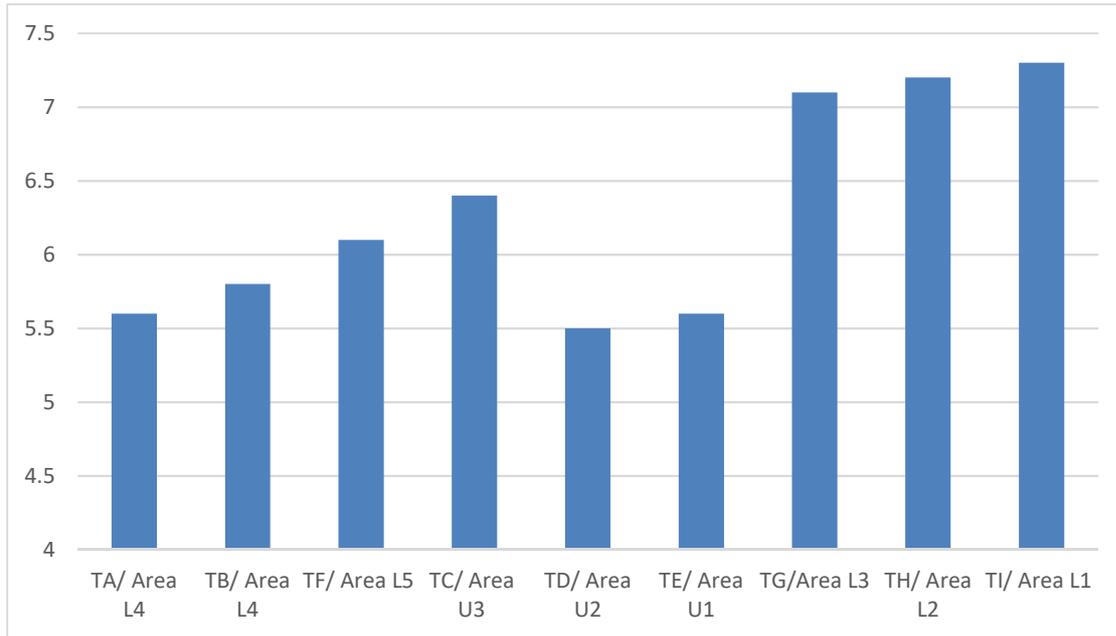
Figure 14 Soil pH results by irrigation area

- Soil pH results ranged 5.5-7.3 pH. The majority of the soil pH results were slightly acidic however, the irrigation areas (L1-L3) to the north of the duckpond all held pH results above 7 pH, Figure 14.

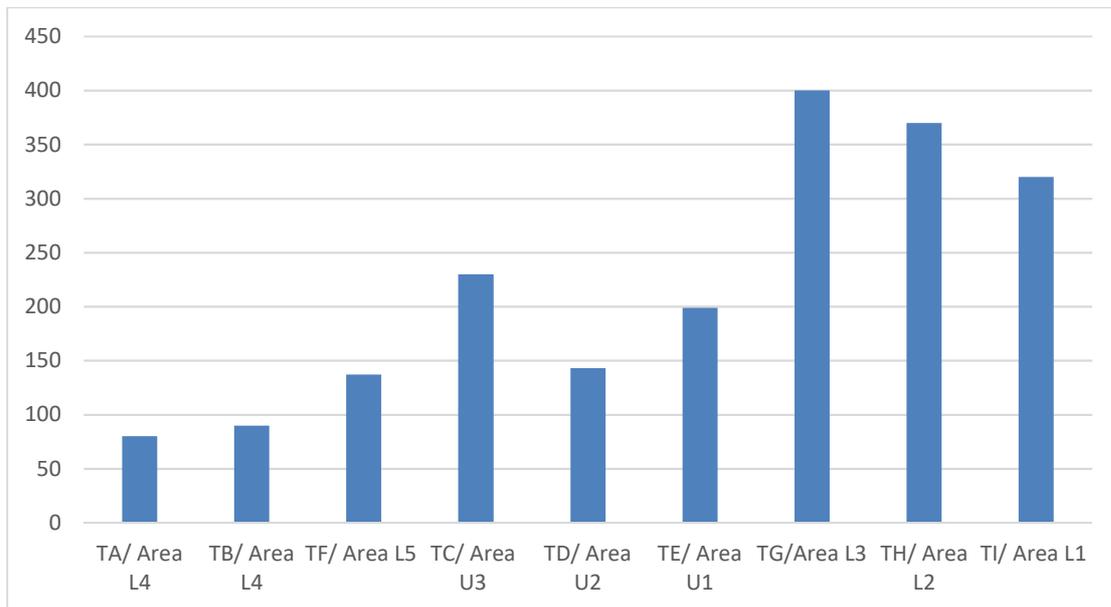
Figure 15 Soil sodium results by irrigation area

- Soil sodium results were found to be elevated within the high application rate (U1-U3 inclusive) and long-term irrigation areas (L1-L3 inclusive), Figure 15.

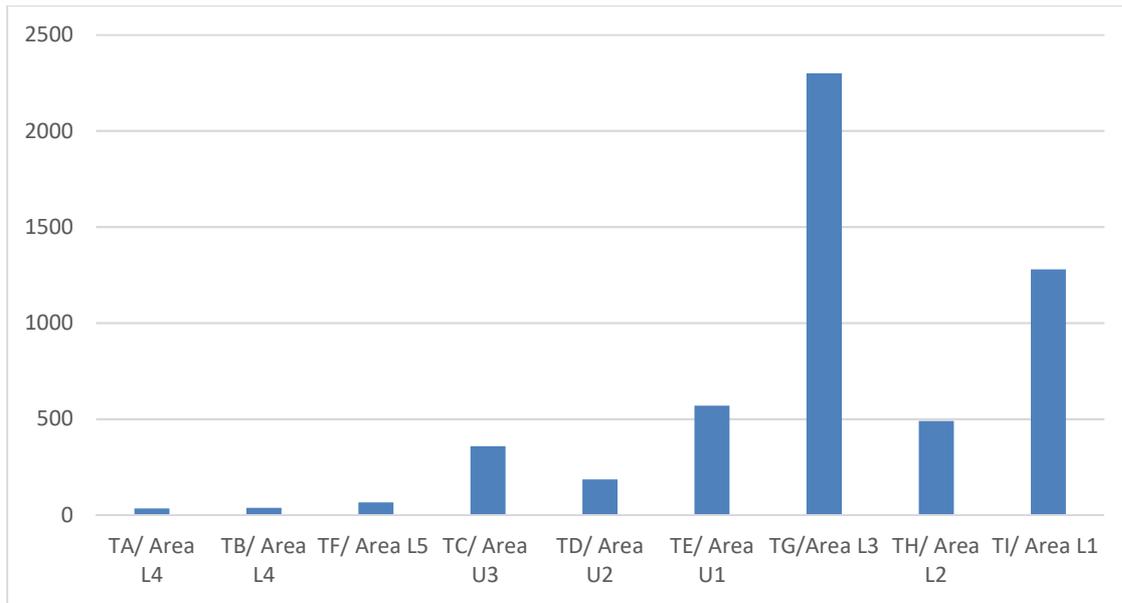
Figure 16 Soil barium results by irrigation area

- Sodium absorption ratio (SAR) results were of low concentration, the most elevated result of the data set was at area U2 with a value of 3.5 SAR.
- Total recoverable barium results demonstrate the result of irrigating drilling mud constituents to land (Figure 16). In this monitoring period the elevated result was recorded at area L3, with a concentration of 2,300 mg/kg. Please note that area L3 is one of the long term irrigation areas.

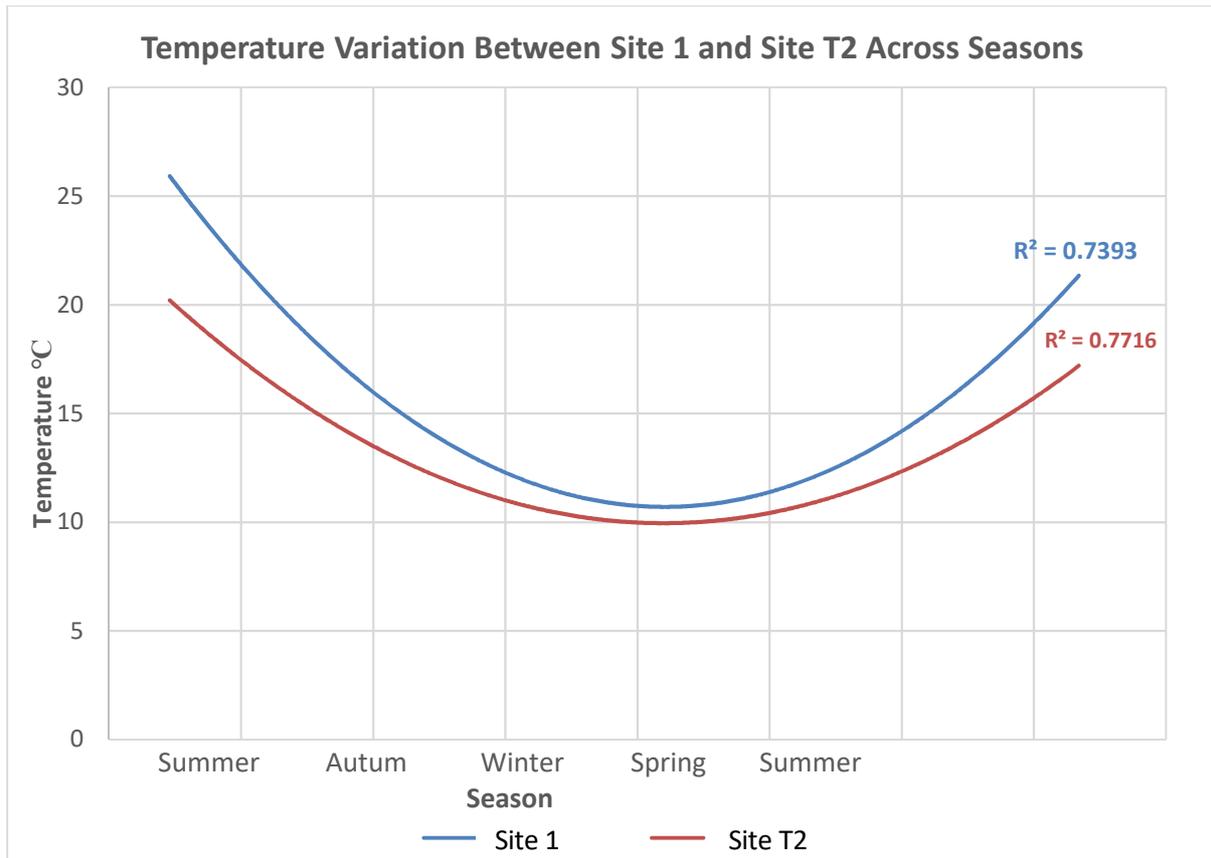
Figure 20 Seasonal temperature comparison between site 1 and site T2 (2010-2019)

All sites in the main stem Haehanga lack bed shading during most of the day. This causes water temperature to rise up to 28°C in the summer, which is outside the thermal preference and, in some cases, tolerance of many stream dwelling species. Unshaded streambeds also promote algal and periphyton growths which were reported as abundant in the previous survey. Site T2 in the unnamed tributary historically has the highest macroinvertebrate health scores and has a mostly shaded bed with much lower temperatures in the Spring, Summer, and Autumn months compared to site 1 (Figure 19). The increased temperature and increased algal growth reported in previous reports is likely contributing to the negative trend in the macroinvertebrate community over the past few surveys.
