Remediation New Zealand Ltd

Uruti composting facility

Monitoring Programme

Technical Report 2021-81

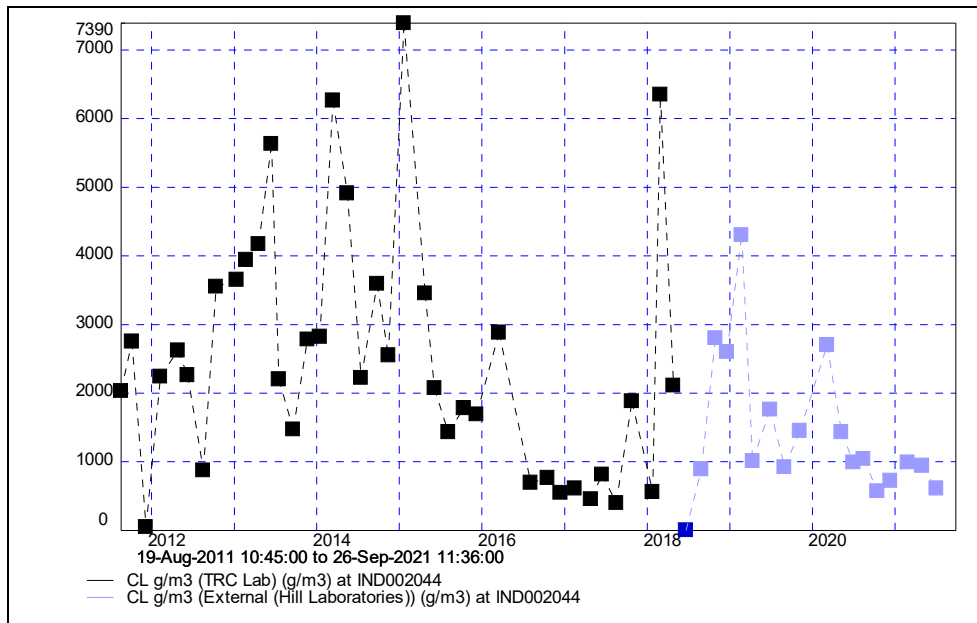
Figure 6 Long term chloride monitoring irrigation pond August 2011- September 2021

- Electrical conductivity (EC) ranged 540-802 mS/m @ 25°C.
- Chloride concentration ranged 570-1,040 g/m³. Of note is the gradual reduction in chloride concentration within the irrigation pond over time (Figure 6).

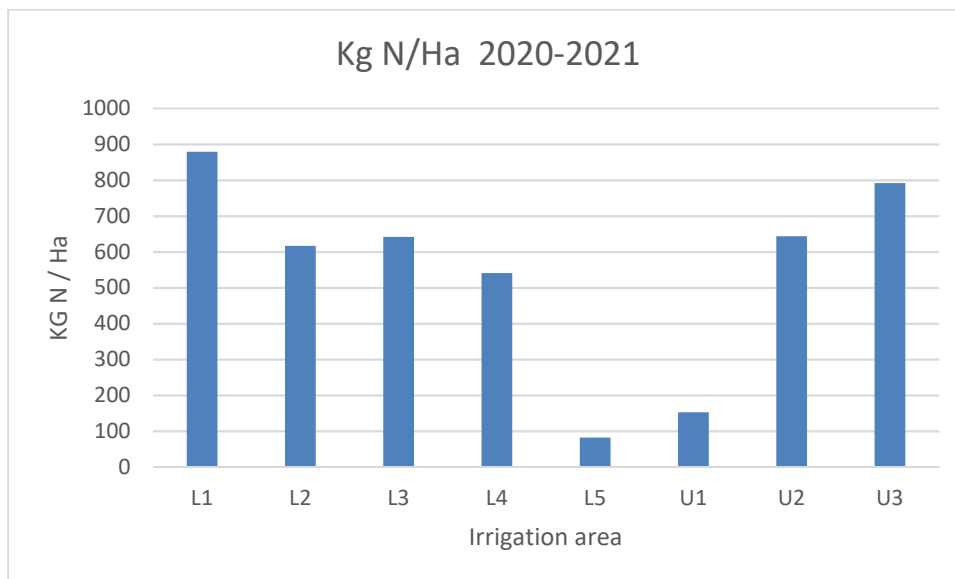
Figure 8 Estimated nitrogen loading rate KG N / Ha by irrigation area

Based on the estimated loadings (Figure 8), it can be determined that six of eight irrigation areas received in excess of 500 kg N/ha Pa. Of the six, five areas (L1, L2, L3, U2, and U3) received over 600 kg N/ha Pa. Of the five, two areas (L1 and U3) received over 700 kg N/ha Pa. One area (L1) received over 800 kg N/ha Pa.

Other industries have set nitrogen caps, which limit the total amount of nitrogen which can be put to land in a monitoring year. In some cases these caps are set between 250-400 kg N/ha, with the higher end of the

loading allowed for cut and carry operations. This is a means of removing excess nitrogen from the system. The strict loading rates are undertaken to prevent elevated nitrogen from affecting the groundwater and or surface water, which has been observed in some parts of the region. Noting the council is required to give effect to the National Policy Statement for Freshwater Management, balancing the applications to land with what can be sustainable sequestered will be vital for the Company moving forward.

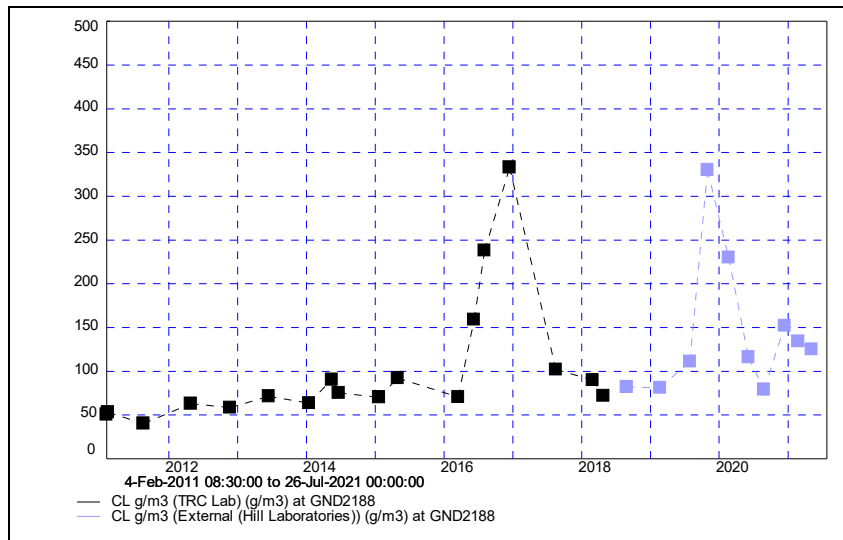
Figure 10 Long term chloride monitoring GND2188 2011-2021

- Acid soluble barium ranged from below the LOD (<0.11 g/m³) through to 0.18 g/m³.
- Chloride results ranged 79-152 g/m³, increased during the summer months. Long term monitoring of this analyte has indicated a slow and steady increase over time (since 2011, Figure 10).

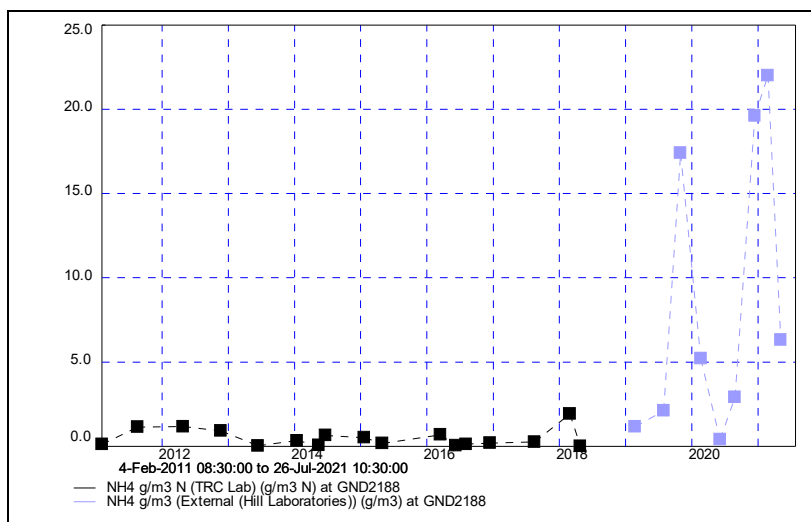
Figure 11 Long term ammoniacal nitrogen monitoring GND2188 2011-2021

Ammoniacal nitrogen ranged 2.9-22 g/m³. Note that 22 g/m³ NH₄ is the most elevated concentration in this data set to date. The data from the previous monitoring years indicates an increase in this analyte more recently than in the previous eight years (Figure 11).

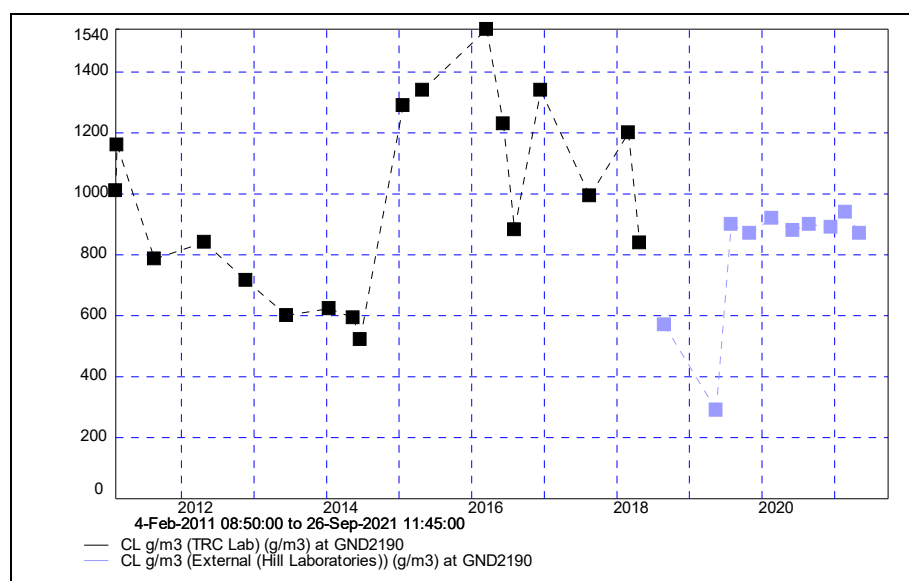
Figure 14 Chloride monitoring GND2190 February 2011 - September 2021

- Chloride remained elevated within this monitoring well, fluctuating either side of 900 g/m³ (Figure 14). It is noted that the consent holder's tiered management plan dictates that concentrations over this limit (900 g/m³) should trigger a reduction in irrigation to this area.

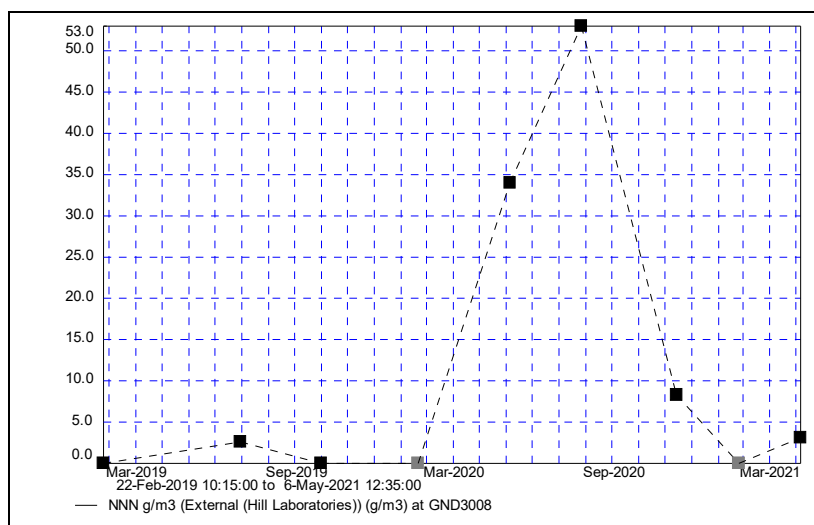
Figure 17 Nitrate nitrite (NNN) monitoring GND3008 May 2019- May 2021

- Ammoniacal nitrogen fluctuated above 1 g/m³ this monitoring period, ranging 1.01-3.3 g/m³.
- Nitrate/ nitrite nitrogen recorded a significant increase (53 g/m³) in this analyte during the initial sampling round of the year (August 2021), prior to reducing in subsequent monitoring events (Figure 17).

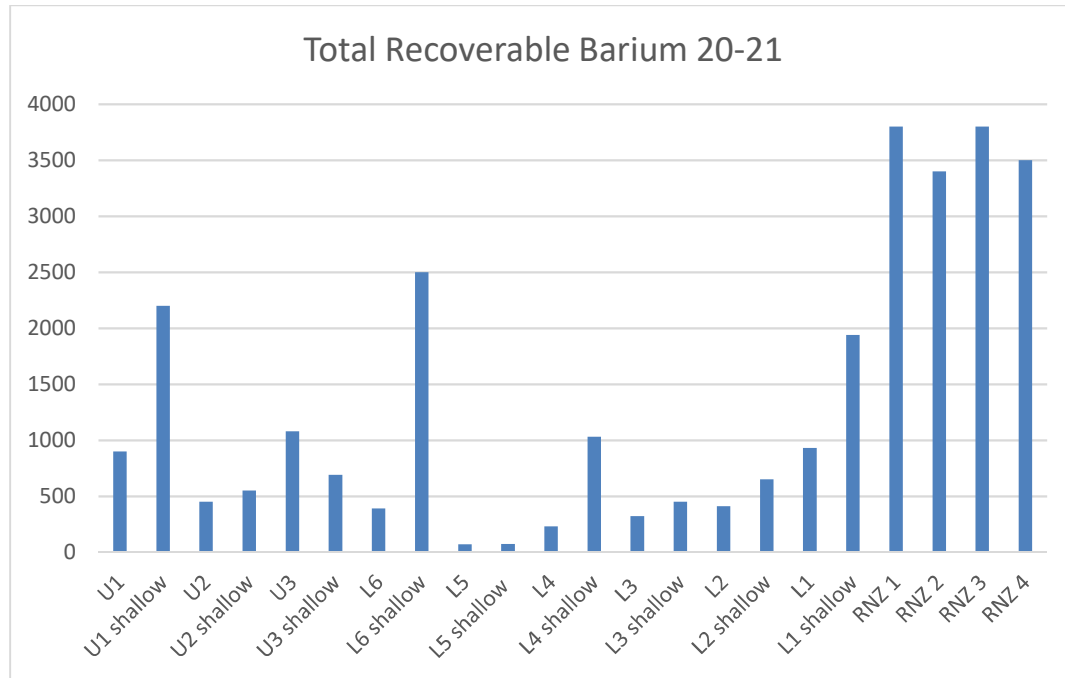
Figure 21 Total recoverable barium 2020-2021 soil analysis

Noted are the shallow samples from areas U1 and L1. U1 is a long term irrigation area, while area L1 was constructed of partially composted drilling mud pad material. Hence the basis for the elevated concentrations of barium.

Area L6 shallow however, had not been irrigated upon. This suggests that partially composted drilling mud material was utilised. The Council considers this is a breach of consent, as the discharge of drilling mud material to land is not allowed under the Regional Freshwater Plan for Taranaki unless covered by a consent.

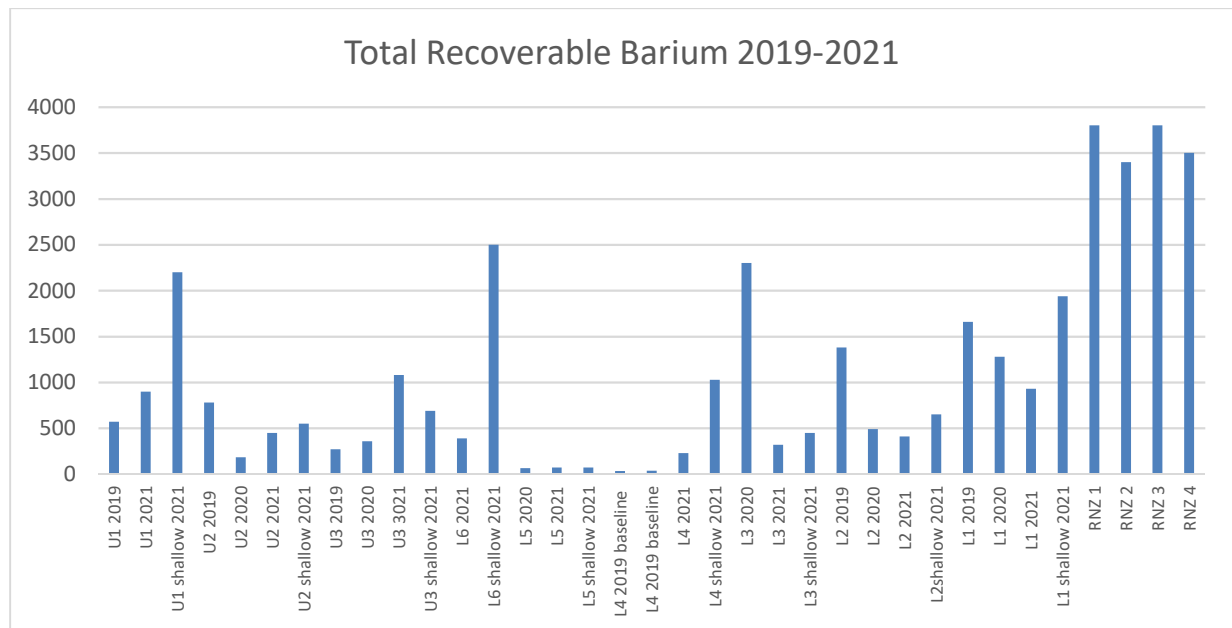
Figure 22 2019-2021 soil analysis total recoverable barium by irrigation area

When compared to the long term analysis (Figure 22), the concentrations held in L6 shallow exceed all previous barium tested irrigation areas. Within both figures (21 and 22), background barium concentrations can be found in area L5 and L5 shallow for comparison, they can also be observed in area L4 2019 baseline. Figure 22 encapsulates the effects of the irrigation fluid on the soil within the Company site over time.

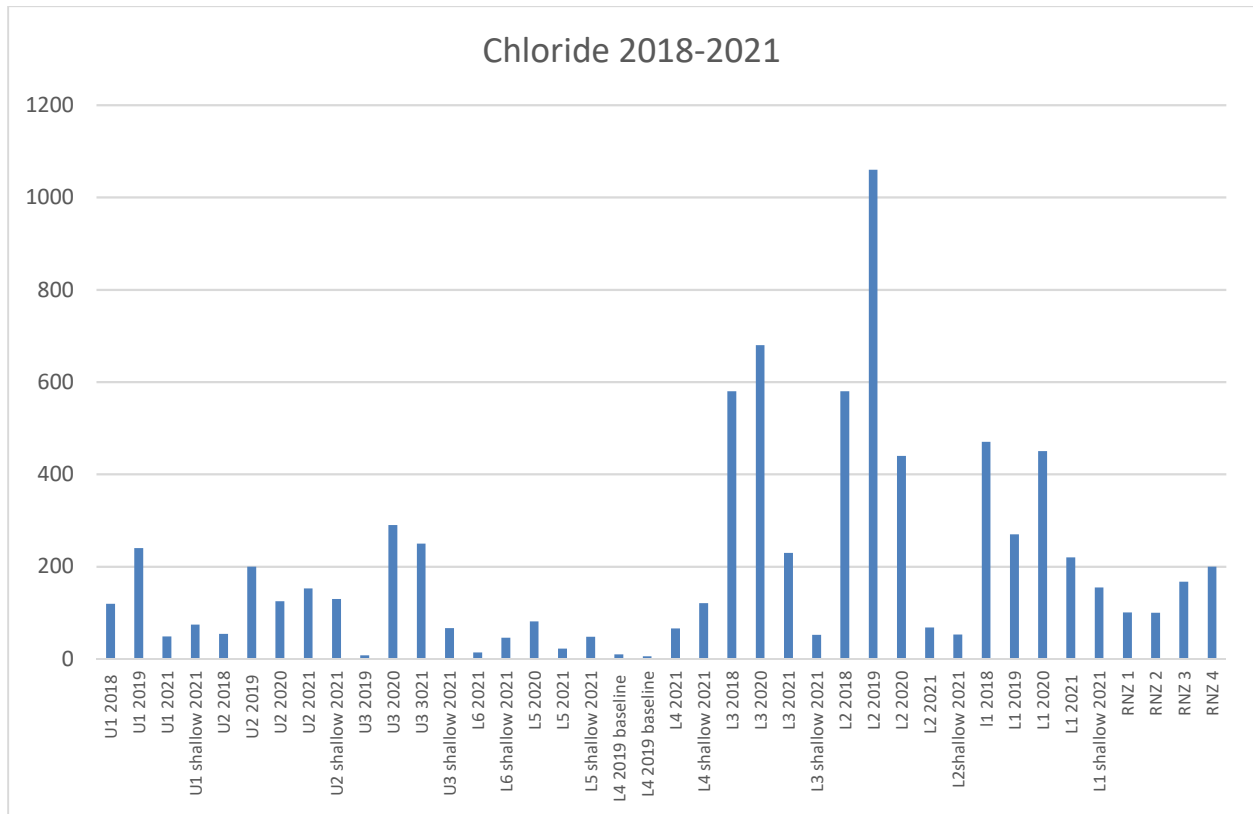
Figure 23 Soil chloride concentrations by irrigation area 2018-2021

Chloride analysis over time has observed some significant decreases in soil chloride concentrations (Figure 23). In the 2018 and 2019 monitoring periods, the concentrations of chloride in the irrigation areas L1, 2 and 3 were trending up. More recent analysis has determined that these areas appear to be trending down in chloride concentrations.

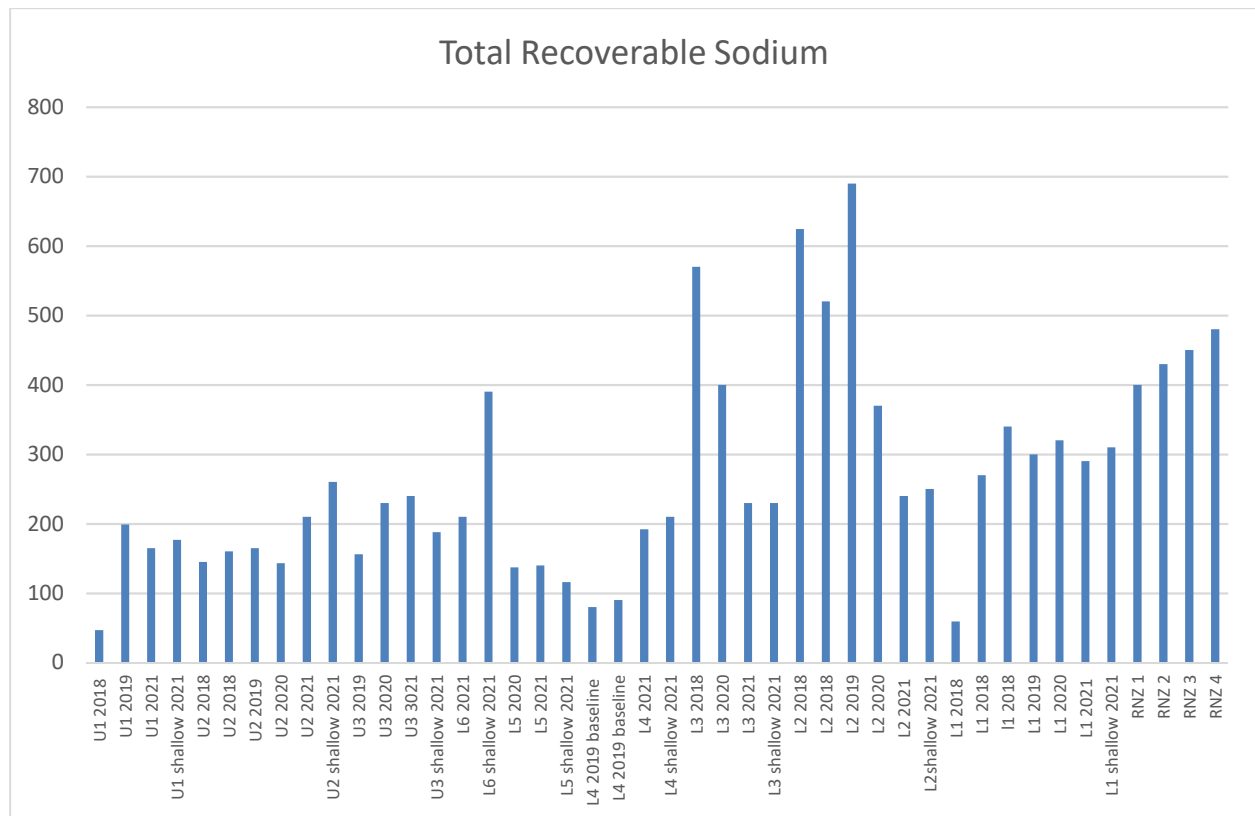
Figure 24 Total recoverable sodium results 2018-2021 by irrigation area

Soil sodium results (Figure 24), in similarity to the chloride, have also recorded a reduction in concentration over time. This was observed in area L2 and to a certain extent L3, which recorded a significant reduction in soil sodium since 2018. Though noted in the case of L6 shallow 2021, this area held the most elevated concentration in the 2021 data set, which was close to the concentrations recorded in the drilling mud spot samples (RNZ1-4).

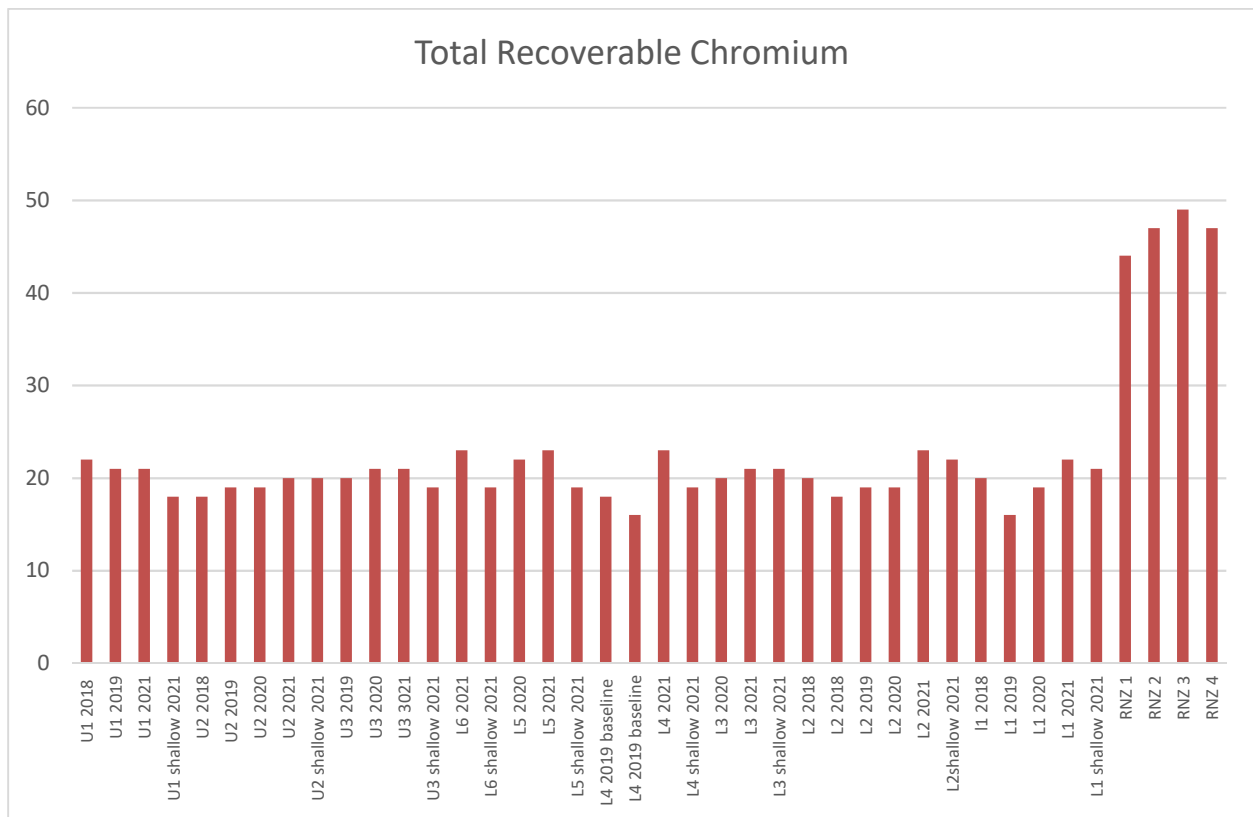
Figure 26 Total recoverable chromium 2018-2021

For chromium in soils (Figure 26), all samples were above the predicted medium background (10.44 mg/kg), but below the 95% percentile (62 mg/kg).

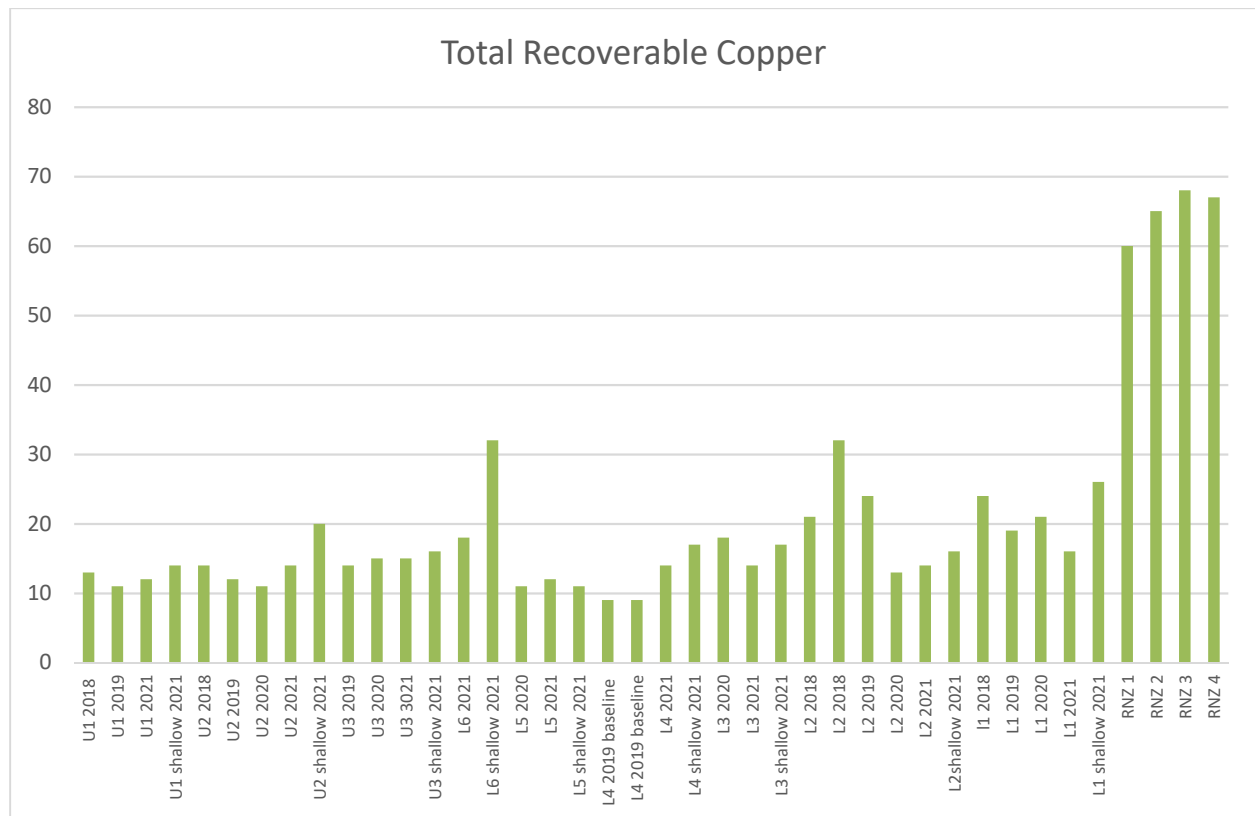
Figure 27 Total recoverable copper 2018-2021

For copper (Figure 27), the majority of irrigation areas were below the medium predicted background concentration (14 mg/kg). However, U2 shallow 2021 (20 mg/kg), L1 shallow 2021 (26 mg/kg) and L6 shallow 2021 (32 mg/kg) exceeded the predicted median background. Noting that area L4 baseline 2019 analysis, recorded a concentration of 9 mg/kg and this should be considered a background for the site

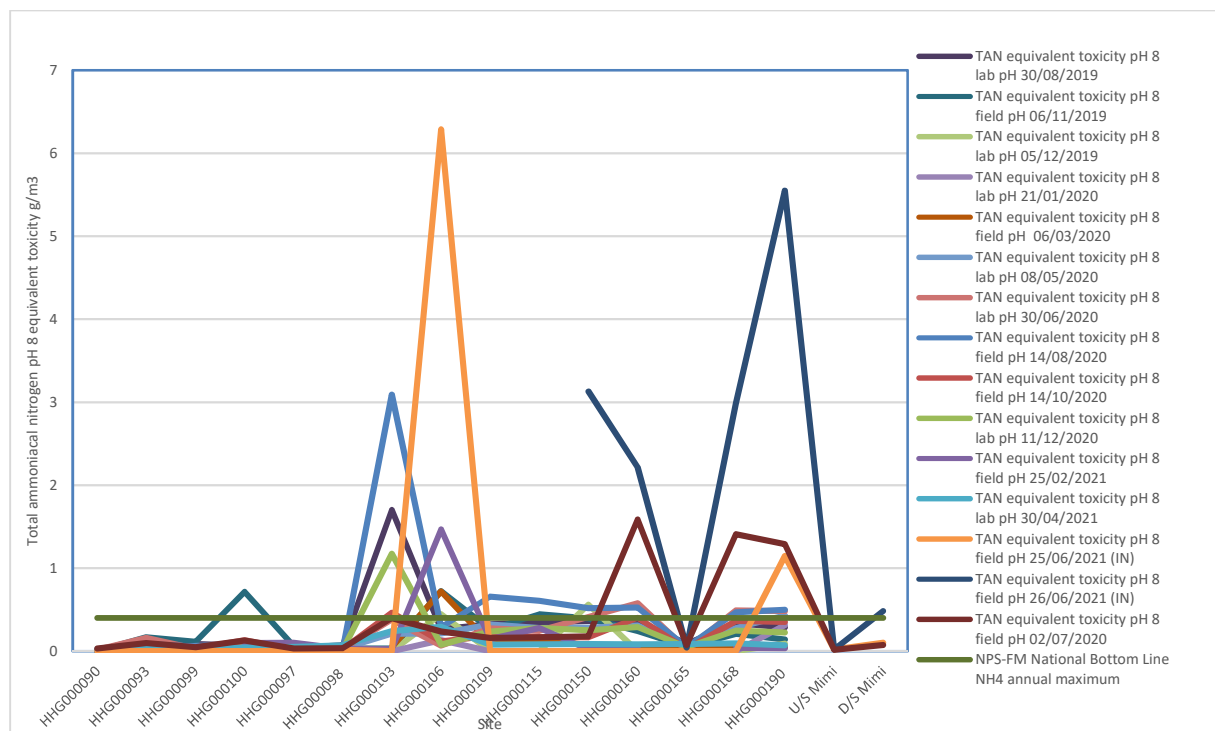
Figure 34 Total ammoniacal nitrogen (at pH 8 for equivalent toxicity, with lab or field pH) water monitoring Haehanga Stream 19-21

The context of the nitrogen impacts to the Haehanga Stream are clearly demonstrated in the following Figure 34. This figure contains surface water data since 2019. Of note are the baseline ammoniacal nitrogen results, defined by sites HHG00090, 97 and 165. These are unaffected by the site operations. In the case of HHG000165, this is from the new lower irrigation area, L6. This has yet to be utilised for irrigation. If current site practices continue it would be expected that the downstream sites (HHG000168 and HHG000190) and the Mimitangiatua River would be further impacted by an increase in ammoniacal nitrogen from the utilisation of L6.
