Value Timber Limited  
Monitoring Programme  
Annual Report  
2014-2015

Technical Report 2015-73

February 2016

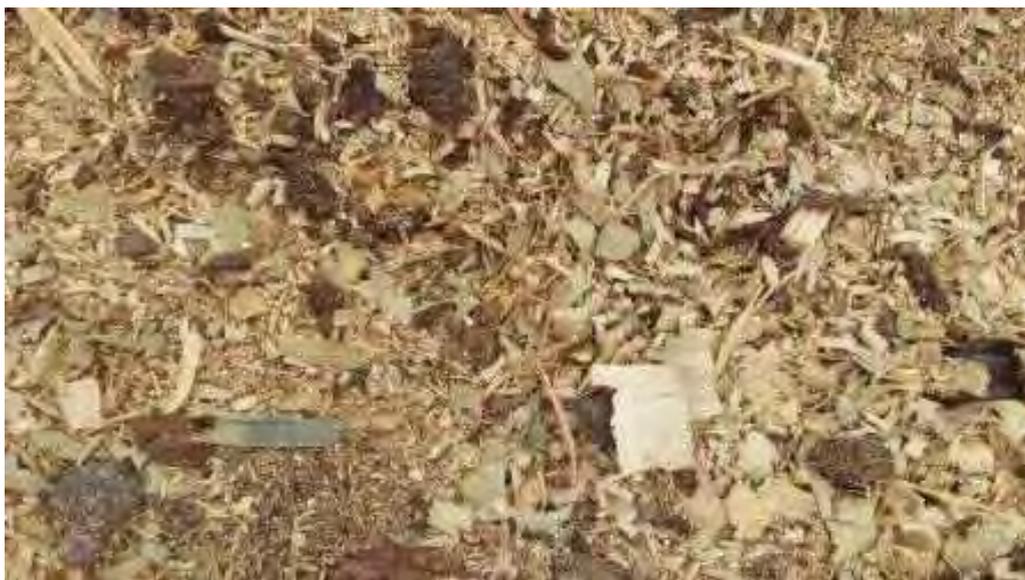
The site was visited in overcast conditions to undertake a routine compliance monitoring inspection and take a sample of the wood waste. It was found that the previously filled and stabilised area looked good. There was wood waste present on site that had been discharged over the tip face since the last inspection. Some of the shavings had a greenish tinge. Photographs and samples were taken.

**Photo 1** Treated wood waste in recently discharged load

An onsite meeting was held with the Company to discuss the results of the wood waste sample results and identify the actions required. The results received earlier that day showed that the wood waste sample collected on 9 December 2014 (sample number TRC1412238) contained treated timber. A copy of the result was provided to the Company. Council staff outlined that the consent permits the discharge of untreated wood waste only.

The area in which the treated shavings were located was viewed with the Company. The inspecting officer was informed that staff at the mill site had placed cleanings from the planar area in the incorrect bin, resulting in them coming to this site, rather than being disposed of via the normal channels for the CCA treated wood waste. The

The results showed that there was CCA treated wood waste in the fill, and this was logged on Council's incidents register. An onsite meeting was held, and the Company was instructed to remove the material. A follow up inspection confirmed that this had been done.

Company agreed to remove as much of the treated shavings as practicable, and it was agreed that this was to be done by 10 January 2015. A re-inspection would be undertaken after this date, and the Company was advised that an abatement notice may be issued if the works had not been completed.

- Remove the treated timber.

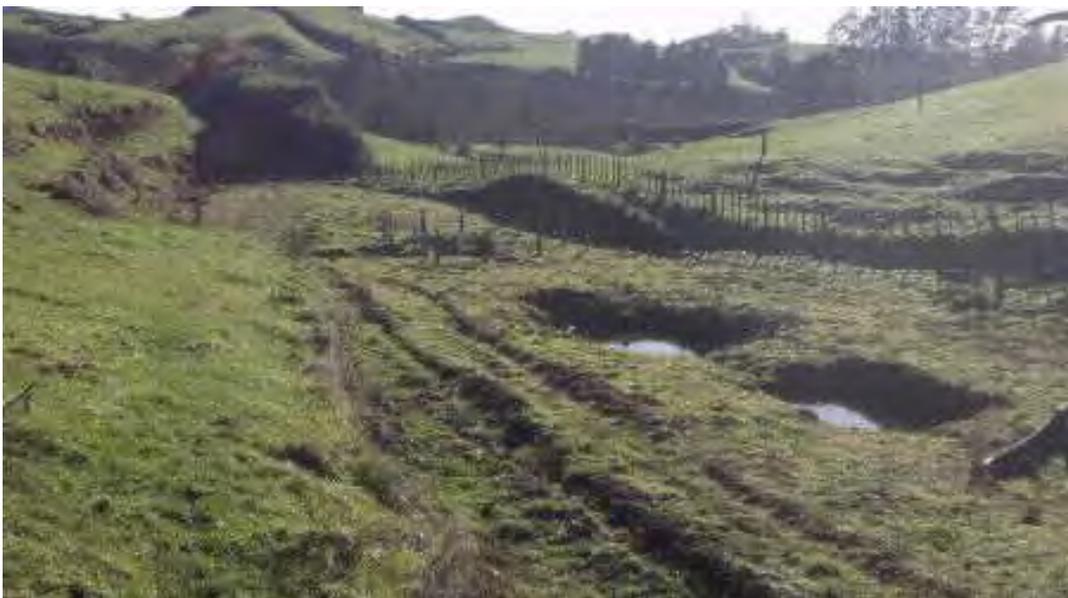
The site was inspected in fine and sunny conditions. The landowner met up with the inspecting officers at the site, but did not join Council staff for the inspection. It was found that reasonable progress had been made with regard to the length of the filled area since the last inspection on 22 December 2014. There was no visible evidence of treated timber or other unacceptable wastes present. The pre-fill area had re-grassed reasonably well, and as a result, there was a lot less exposed soil present. The two silt ponds treating surface water flow were not discharging. The tributary was flowing clear over heavy iron oxide deposits, and a sample was collected. The Company was advised that the silt fence above the boundary should ideally be extended bank to bank, and be dug into the creek bed. However, it was also noted that with the current improved vegetative cover up gradient, and treatment ponds in a satisfactory condition, there did not appear to be a significant increase in sedimentation in the channel upstream of the site boundary at the time of inspection.

**Photo 2** Silt ponds and vegetative cover establishing at lower end of stage 2 basin
