NPDC Colson Road Landfill  
Monitoring Programme  
Annual Report  
2017-2018

Technical Report 2018-76

Taranaki Regional Council  
Private Bag 713  
STRATFORD  
March 2019

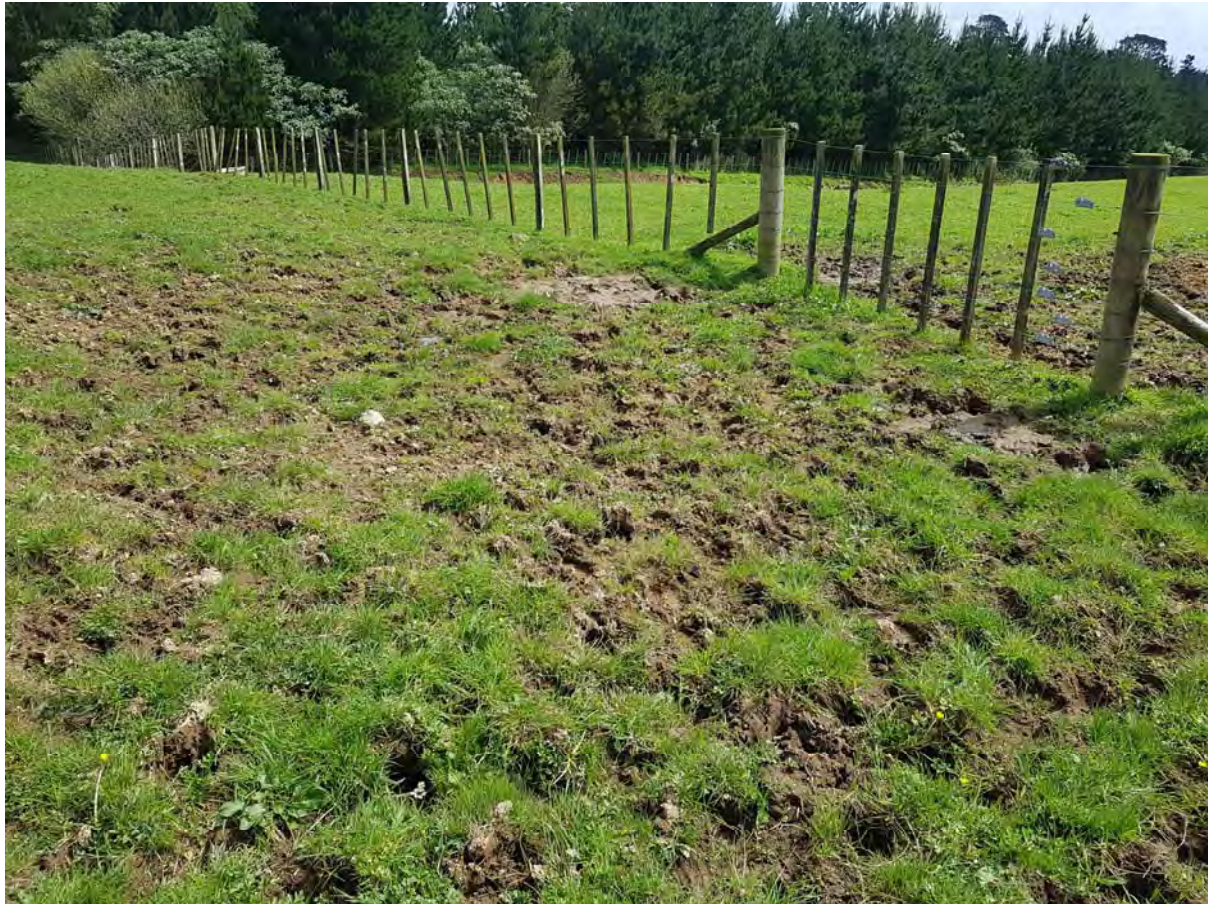
At the time of the November inspection it was found that remediation works had been undertaken on the cap following advice from the previous inspection. Additional cover material had been applied to low-lying areas, and recontouring was underway prior to maize cropping.

Photo 4 Stage 2 cap condition at inspection on 4 October 2018

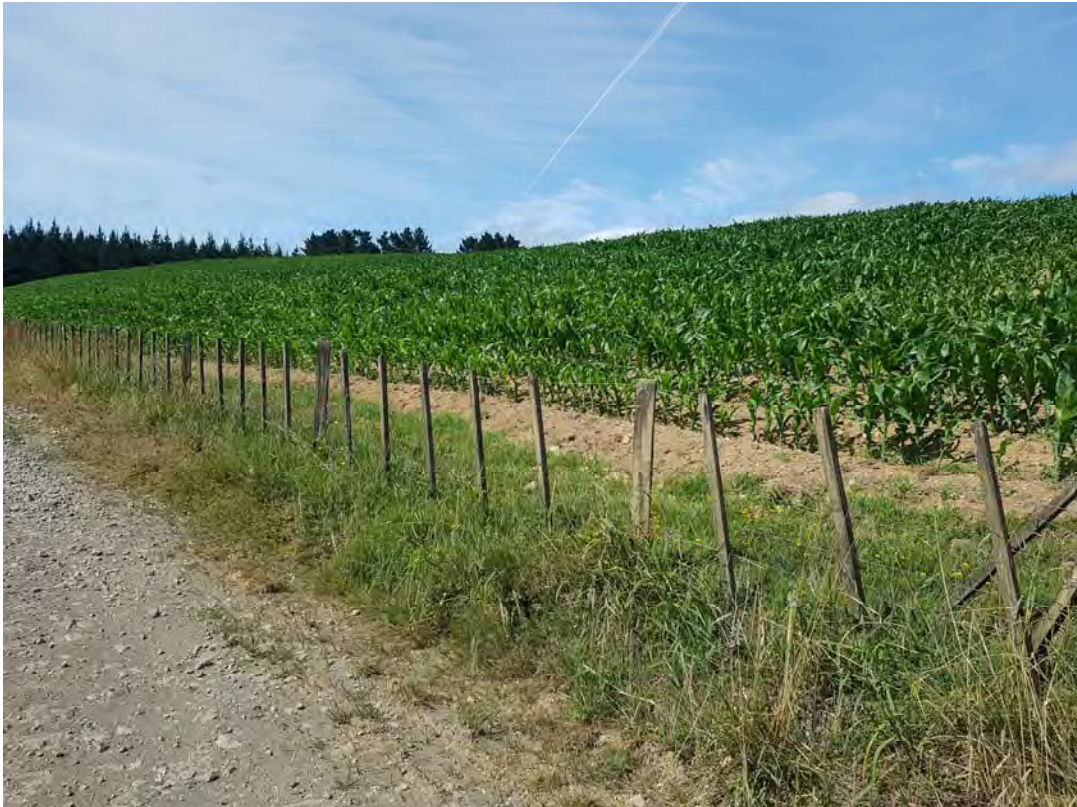
At the time of the inspection on 20 December 2017 it was found that the cap had been revegetated with maize (Photo 5), which was found to still be present at the inspections on 19 February and 6 March 2018. On 28 March 2018 grass was found to be re-establishing after the maize harvest (Photo 6).

Photo 5 Re-vegetated Stage 2 cap at inspection on 20 December 2017

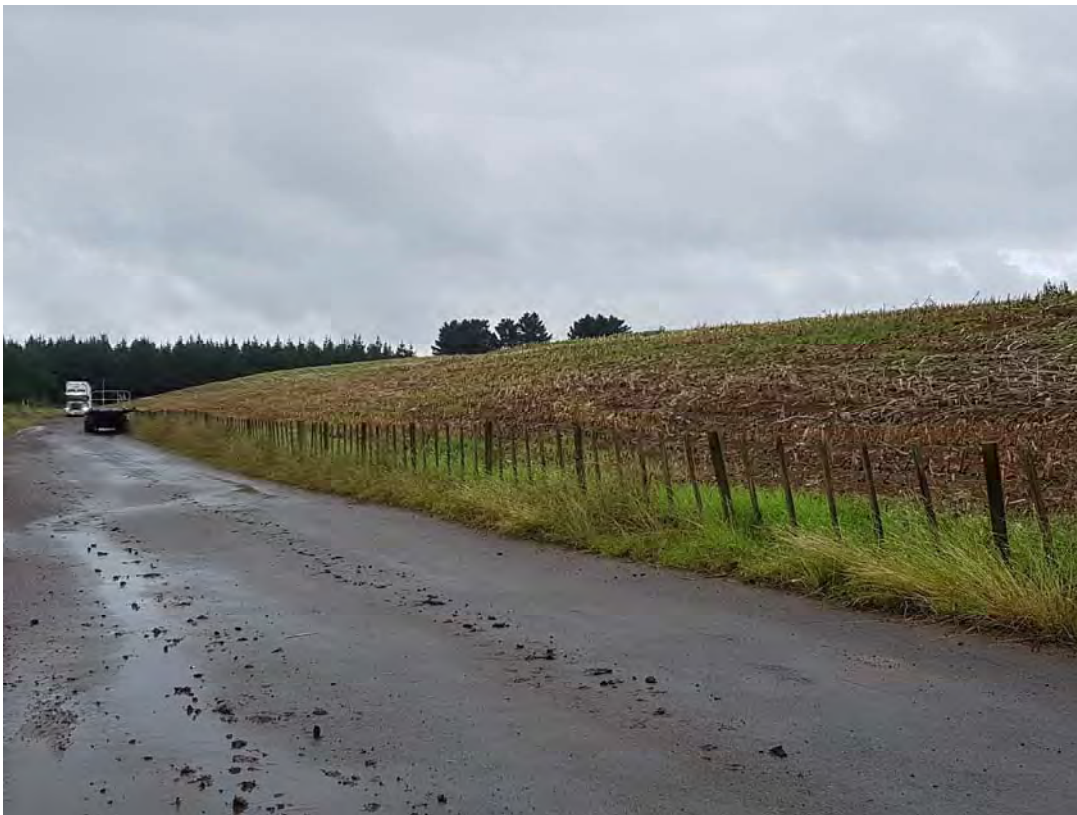
Photo 6 Grass establishing after maize harvest, 28 March 2018

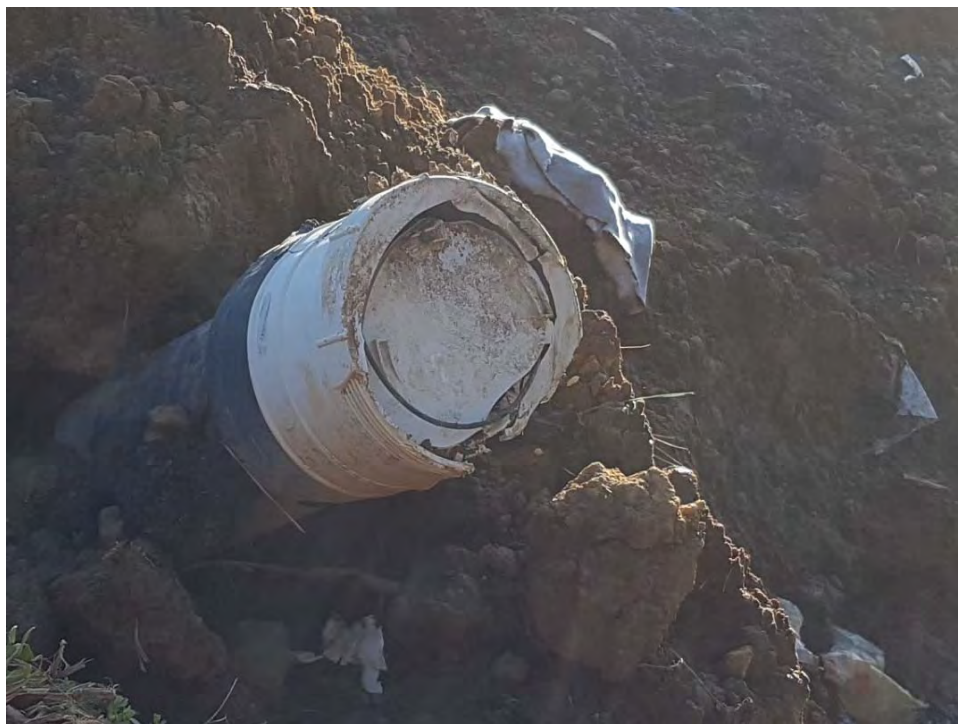
During a routine compliance monitoring inspection it was found that there were landfill gas emissions from a broken cap on one of the leachate lines (Photo 7) and fugitive landfill gas emissions from areas of leachate breakout on the eastern side and from the ponded area (Photo 8) on the western side of the special waste pit level. As the cap had been repaired by the time of the following inspection (30 August 2017), and no significant off site effects were found, no further enforcement action was considered necessary.

Photo 7 Broken leachate line cap, 11 July 2017

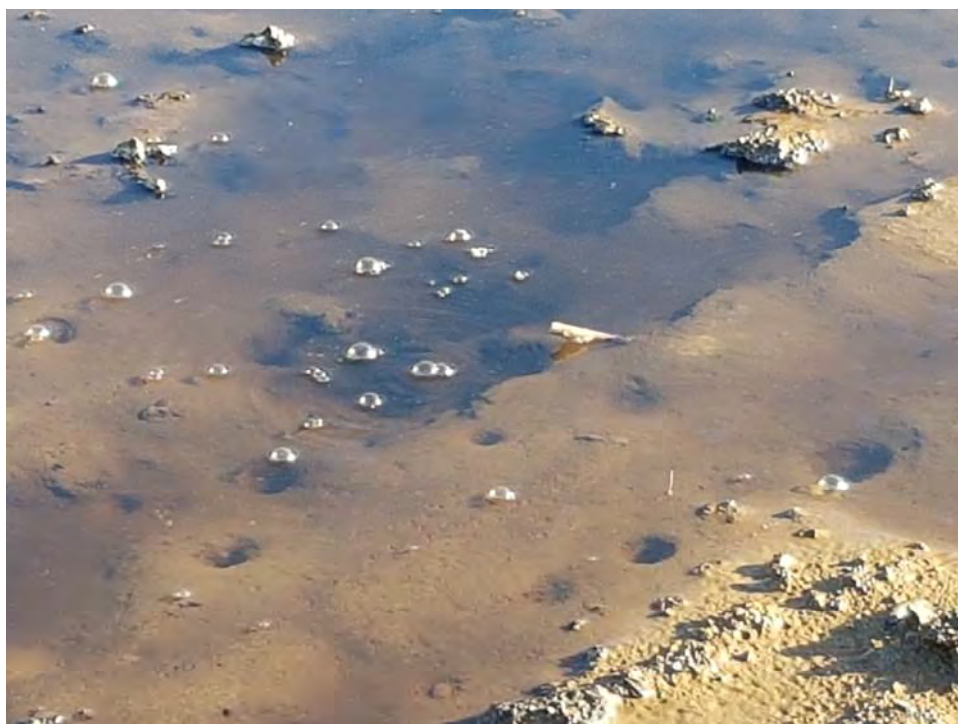
Photo 8 Fugitive landfill gas emissions, 11 July 2018

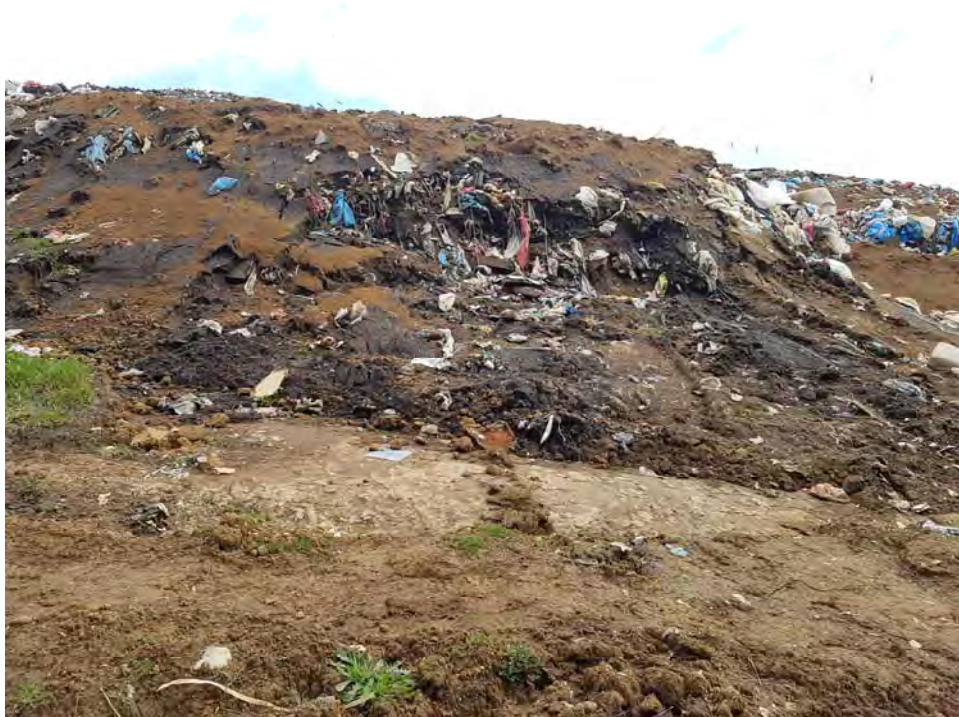
At a routine compliance monitoring inspection it was found that there was insufficient cover on the landfill (Photo 9, Photo 10 and Photo 11), in contravention of the resource consent condition that requires the cover to be within the management plan specifications. At the time of inspection staff were instructed to improve the cover to comply with the management plan requirements. It is noted that the site is the subject of an abatement notice (EAC-20881), also requiring that cover is in compliance with the management plan.

Photo 9 Cover slumping, 4 October 2017

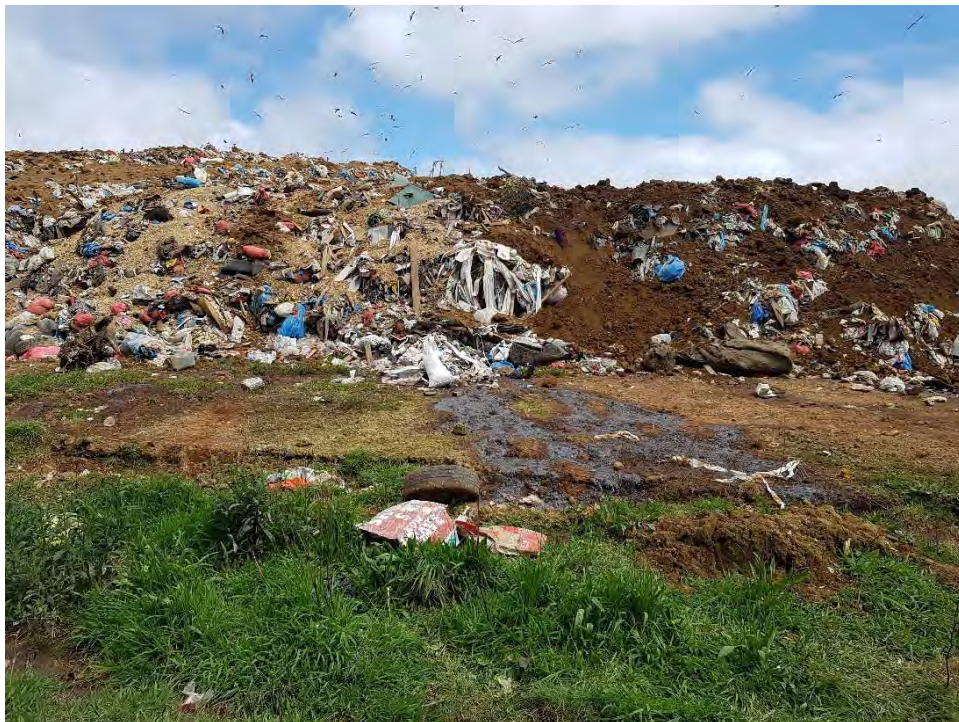
Photo 10 Insufficient cover, 4 October 2017

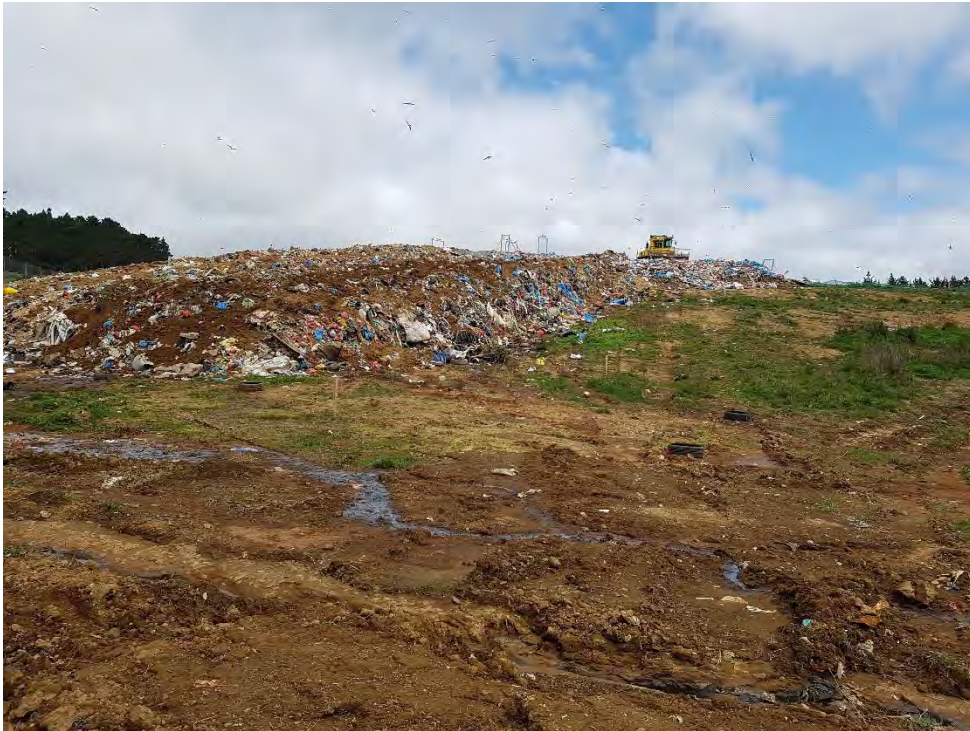
Photo 11 Insufficient cover, 4 October 2017

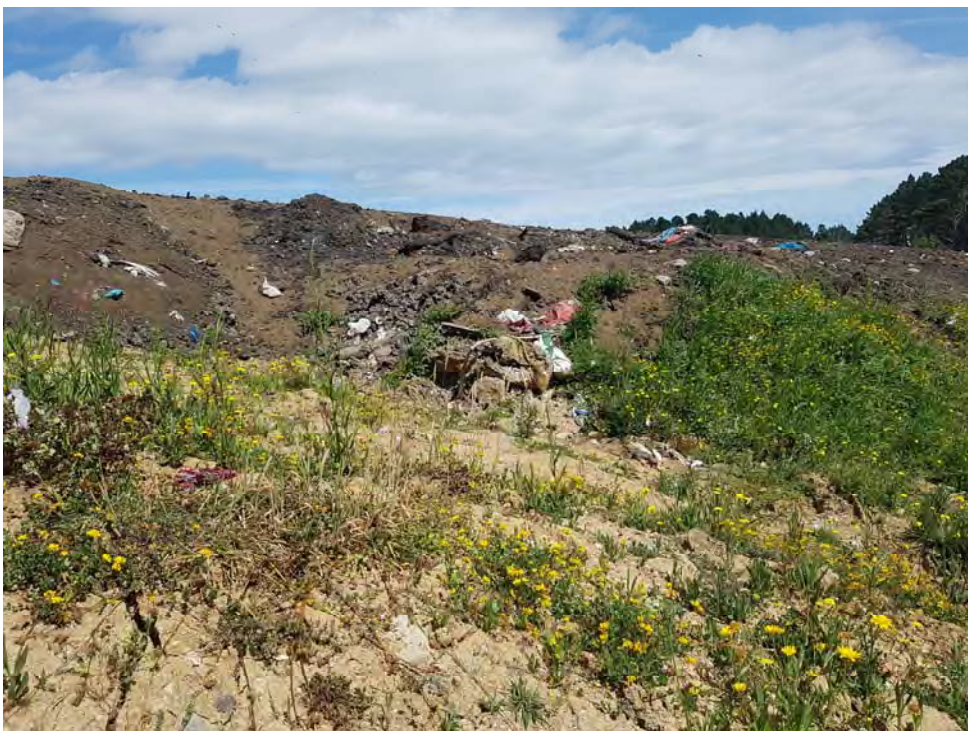
The matter had not been fully resolved by the time of the November or December (Photo 12) inspections, but was at the time of the February inspection.

Photo 12 Insufficient cover, 20 December 2017

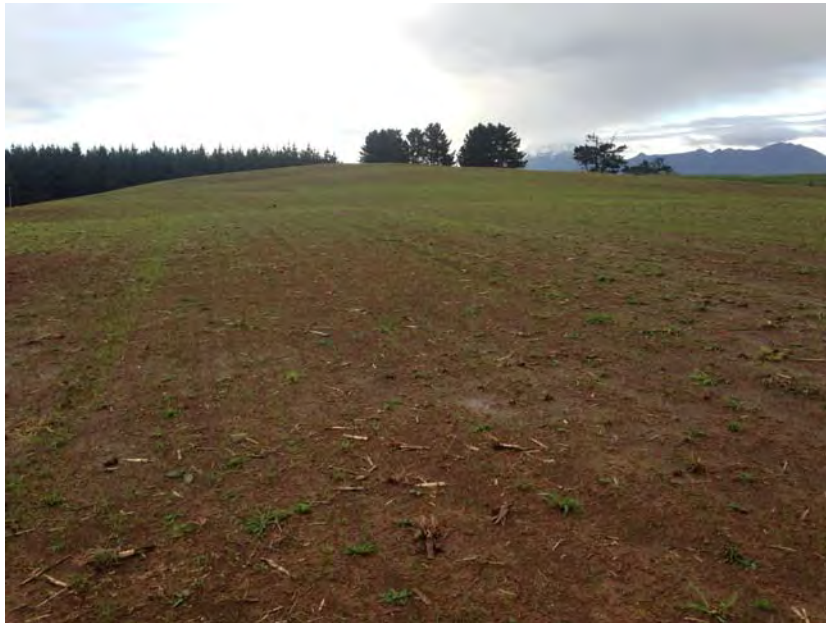
At a routine compliance monitoring inspection it was found that although grass was beginning to establish on the Stage 2 cap, the cap was non-compliant with conditions 2, 8 and 10 of consent 2370. These conditions require that the activity is undertaken as per the information submitted with application (condition 2), that there is an adequate capping barrier and vegetative cover (condition 8), and that the contouring is maintained in order to minimise ponding (condition 10). It was found that there were areas of inadequate vegetative cover (Photo 13) and ponding (Photo 14). An area of rilling was also found (Photo 15), indicating that the vegetative cover and compaction was not sufficient. In light of the ponding, rilling and conversation with the contractor on the previous inspection where he stated that the cap was relatively thin in places (Section 2.1.1, 3 May 2018), NPDC advised that the ground contour, capping depth and compaction needed to be assessed and addressed as necessary to ensure compliance with the conditions of this consent

Photo 13 Areas of poor grass strike, 23 May 2018

This remained non-compliant through to the end of the year under review with NPDC agreeing to undertake investigations to ensure that the cap depth, contouring and re-establishment of vegetative cover was undertaken prior to the return of wet weather.

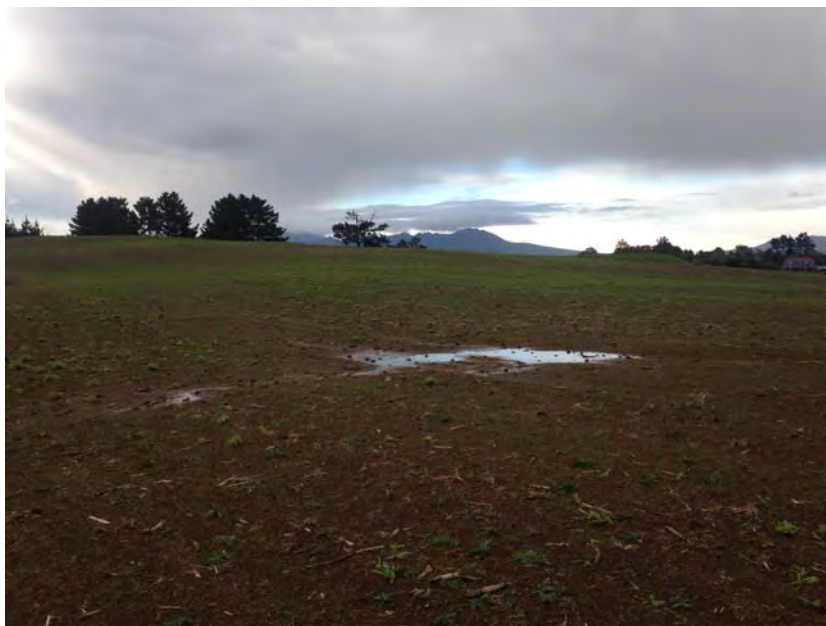
Photo 14 Depression where some ponding remains, 23 May 2018

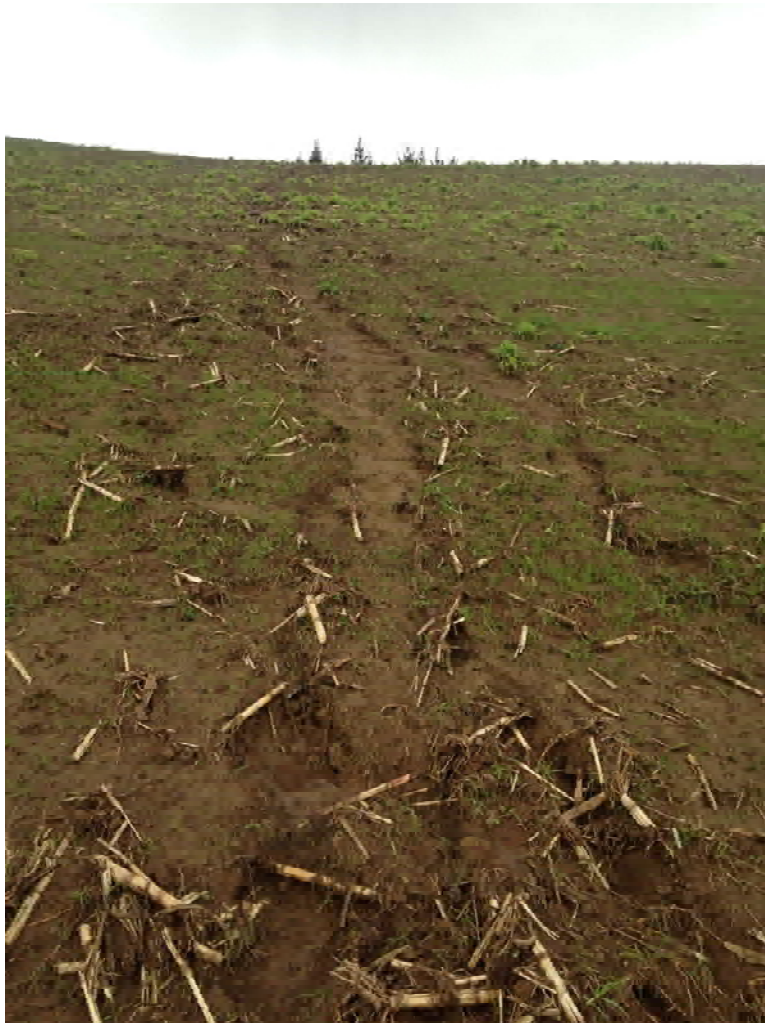
Photo 15 Area of riling, 23 May 2018

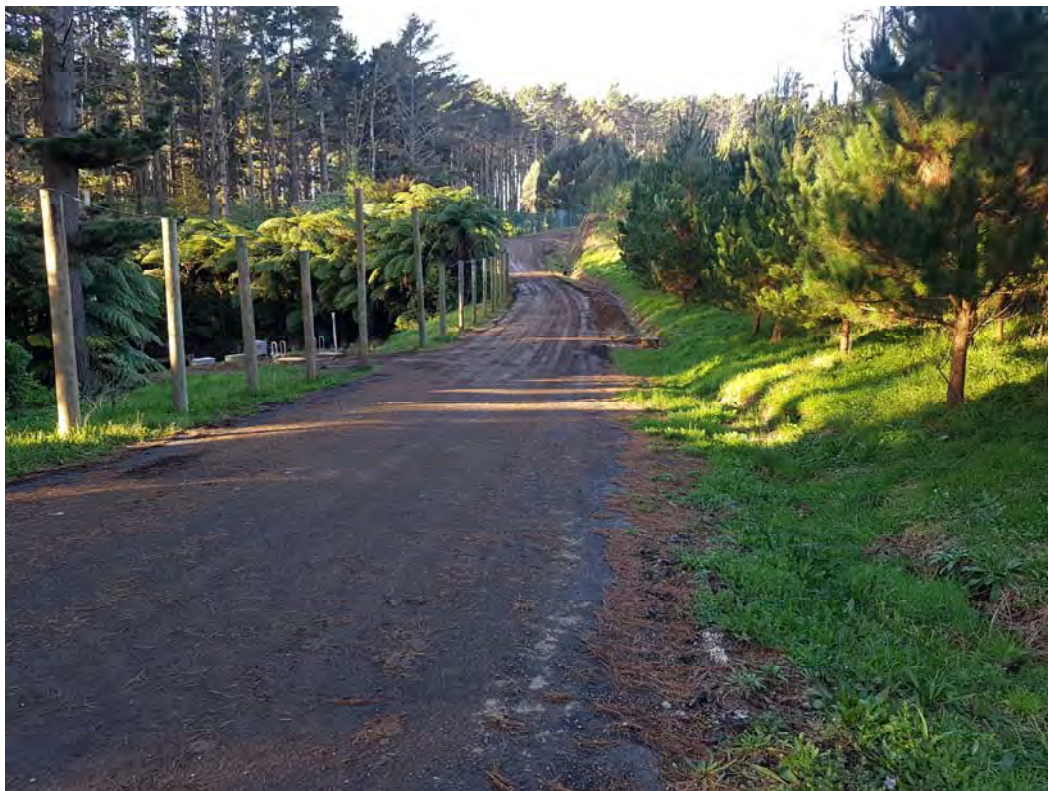
However, this has caused some on site issues with sediment control. At a number of inspections it was found that there was a lot of silt on the access roads, and that the sediment ponds required de-silting. The need for better compaction of the intermediate cover and/or improvements to silt controls or the maintenance thereof. It was noted that it appeared that the amount of silt in the tributaries immediately downstream of the pond discharges appeared to have increased, and that it was possible that some impoundment may be happening.

Photo 16 Silt on access road, 5 July 2017

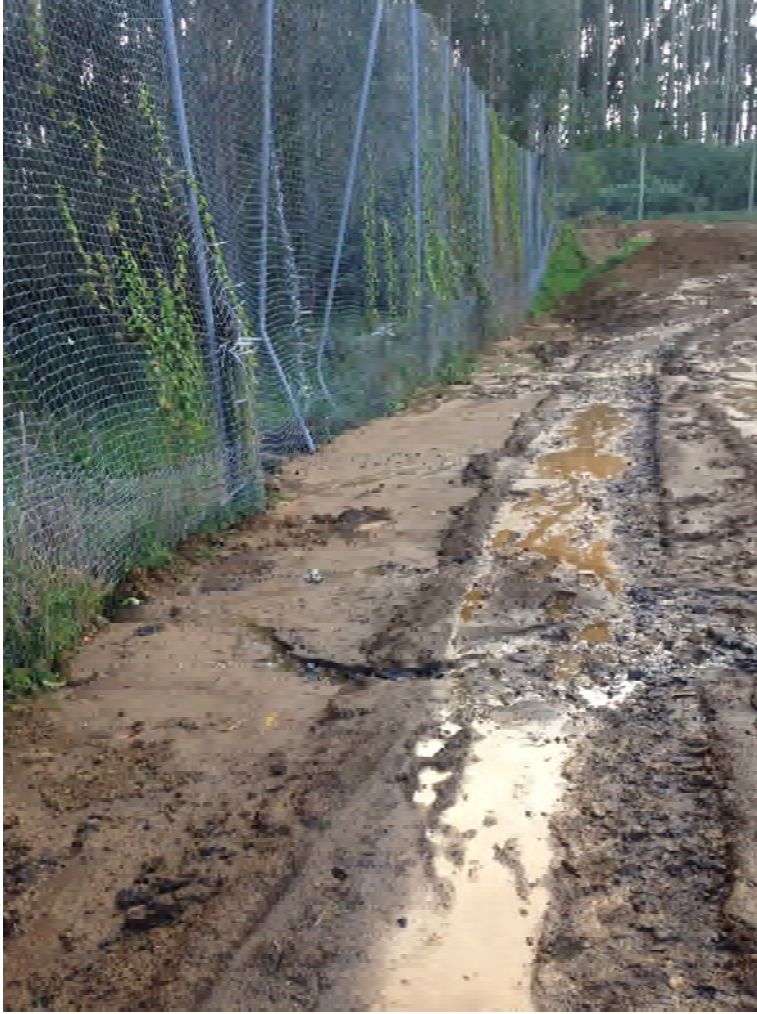
Figure 12 Silt between landfill northern batter and the leachate pond area, 23 May 2018

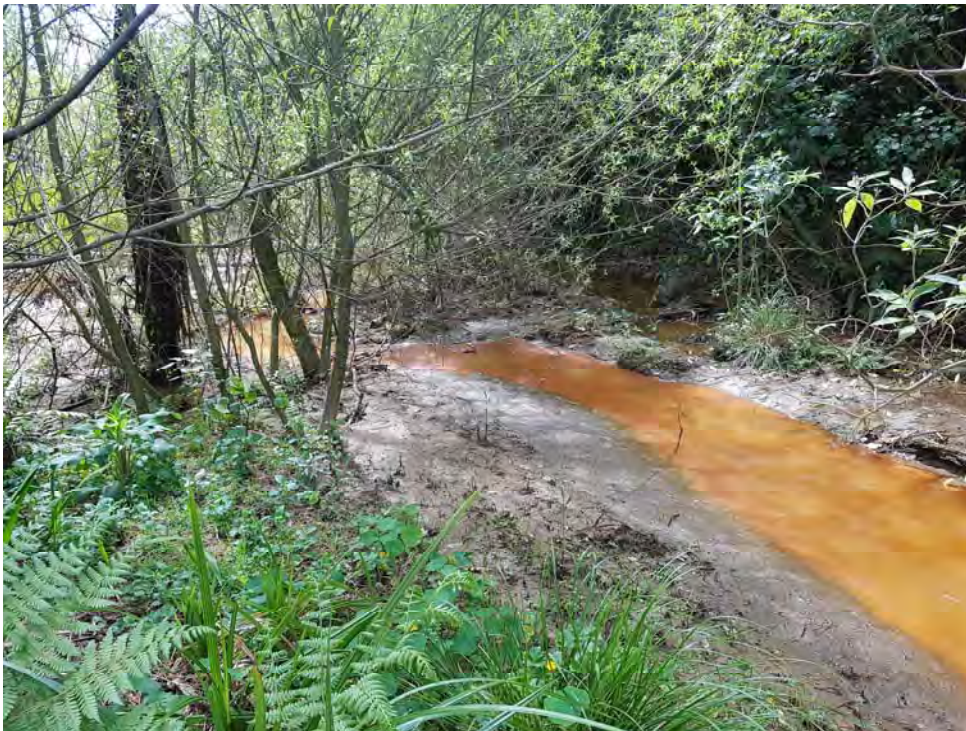
Photo 17 Silt below small silt pond, 4 October 2017

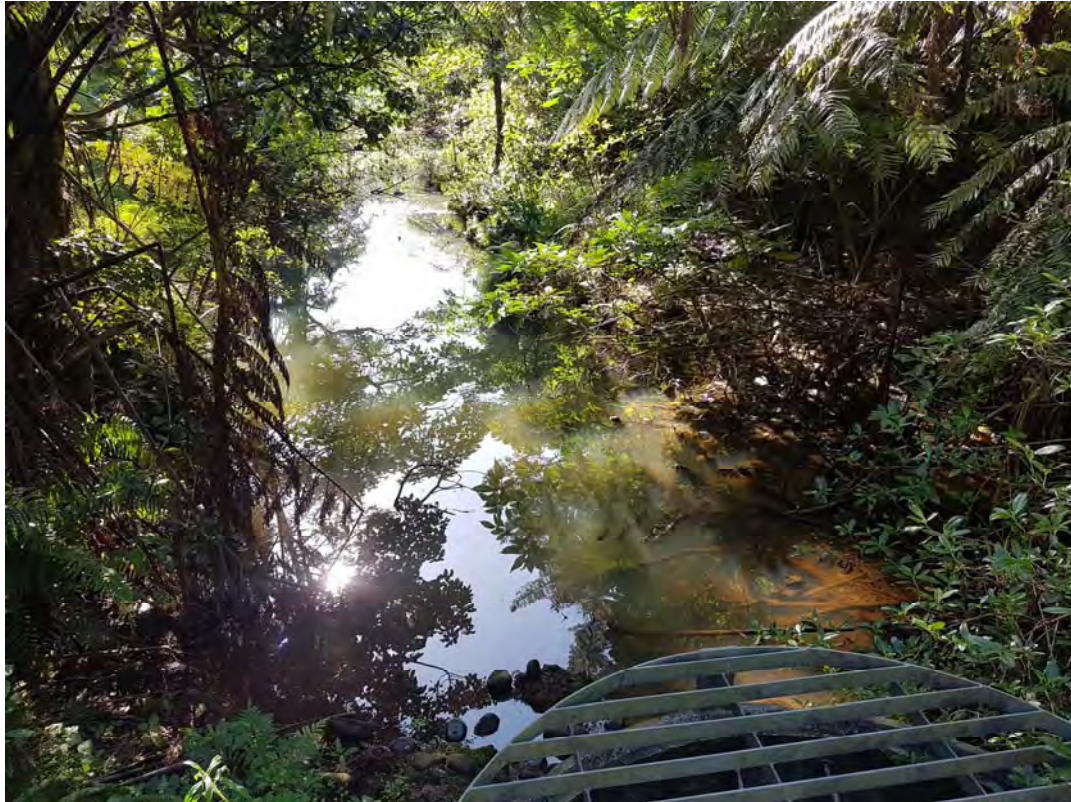
Photo 18 Tributary water level below the big silt pond, 3 May 2018

Although this is on site and within the mixing zone, there is, never the less, potential for adverse effects if not brought under control.
