NPDC Colson Road Landfill  
Monitoring Programme  
Annual Report  
2020-2021

Technical Report 2021-97

Taranaki Regional Council  
Private Bag 713  
Stratford

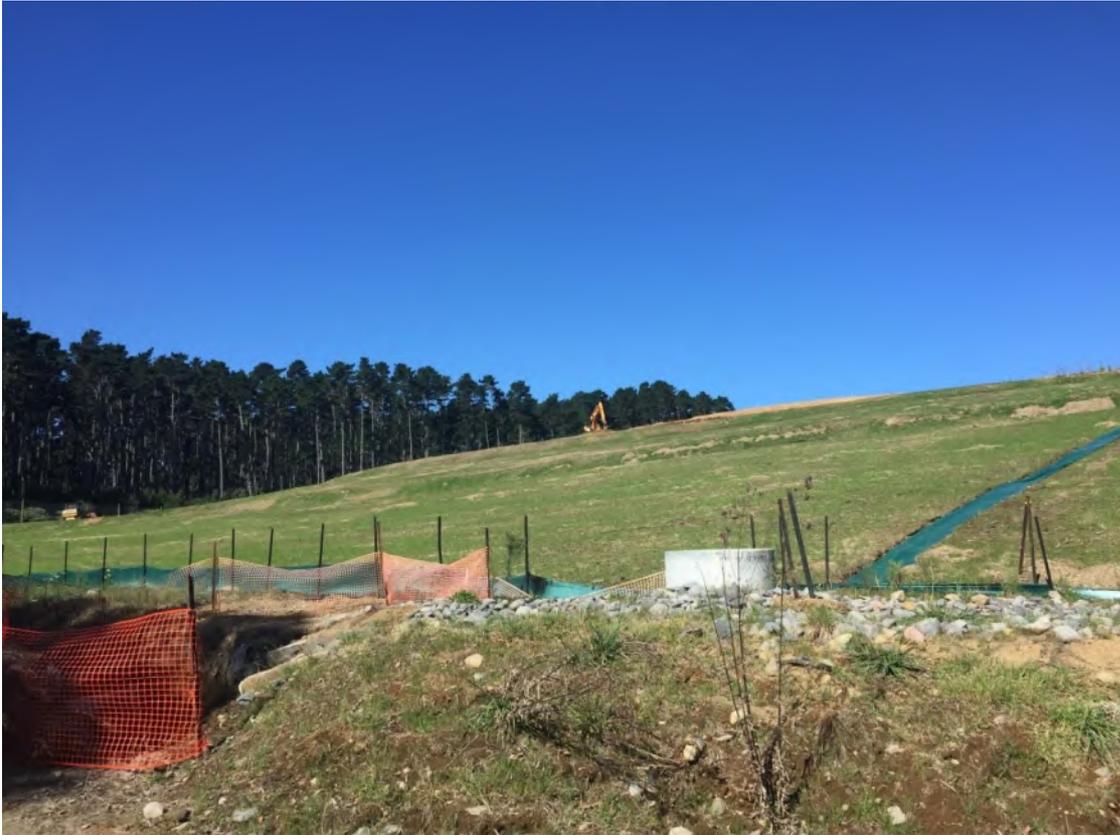
Photo 1 Finished and partially stabilised cap on the northern batter of Stage 3, April 2021

Contouring, preparation work and the application of the final cap has commenced (Photo 1 and Photo 2). A site closure plan has been prepared for NPDC that has been reviewed and accepted by Council. This is discussed further in Section 2.1.3.

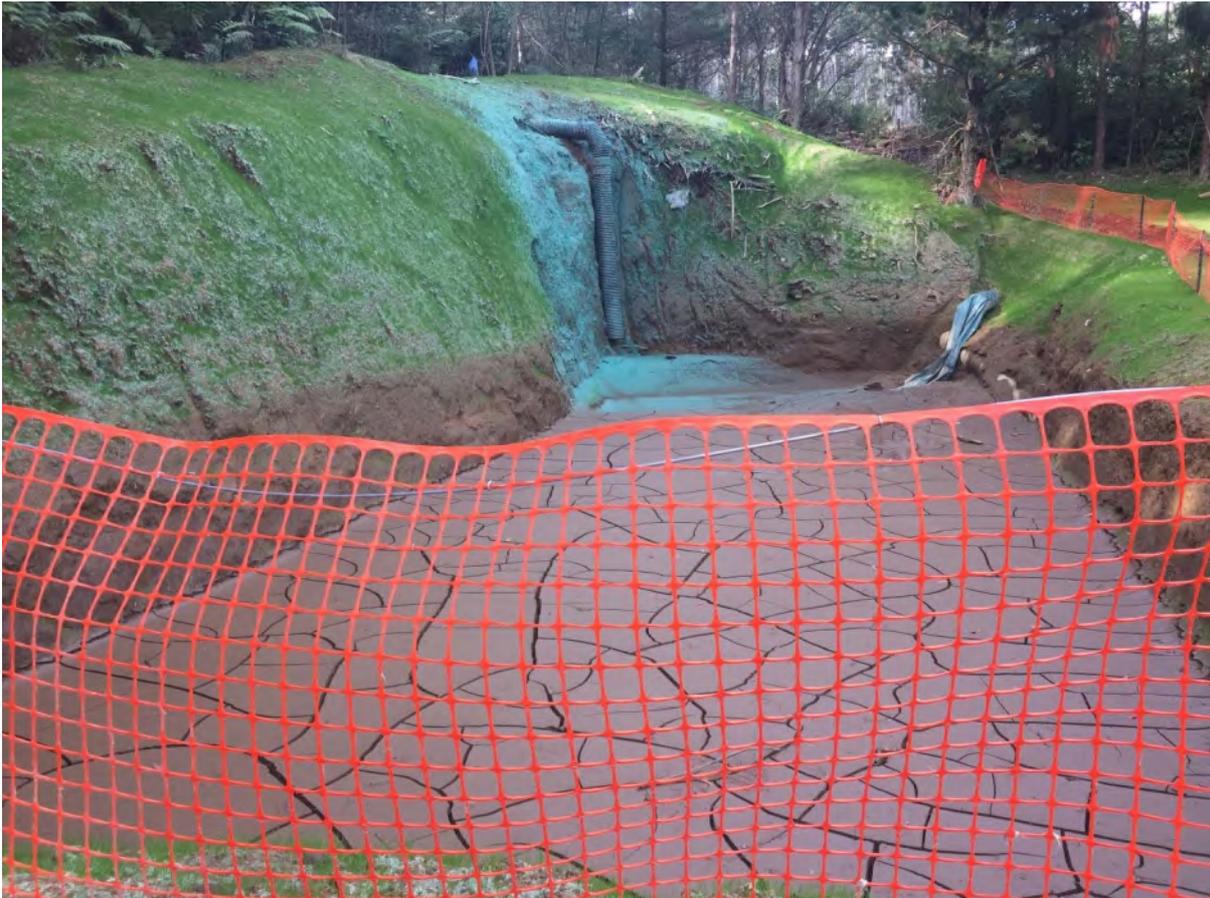
Photo 3 Pretreatment pond for large silt pond, May 2021

The sediment treatment system for Stage 3 was upgraded during the year under review. This was undertaken following an analysis of the erosion and sediment control measures in place at the site and associated recommendations. These upgrades included the addition of a pretreatment pond (Photo 3) prior to the large silt pond and floating decants in the large silt pond (Photo 12, page 35).

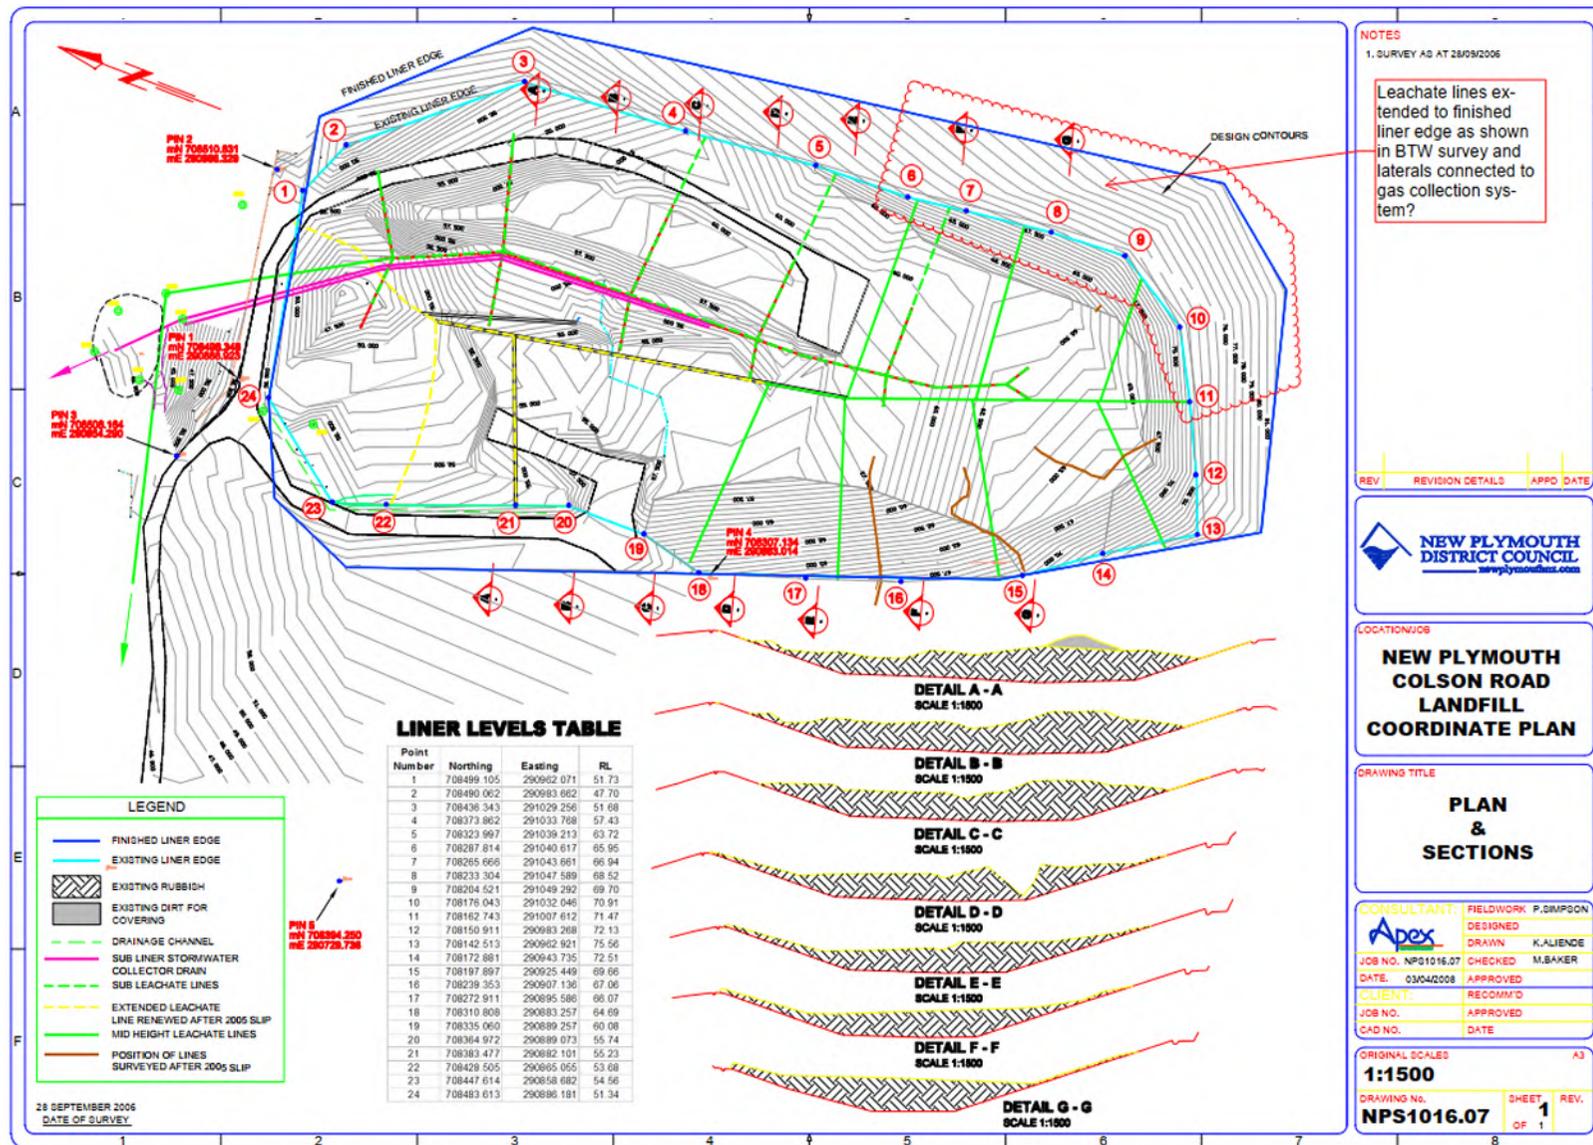
Figure 2 Location of leachate and under liner groundwater collection lines

Construction of Stage 3 began in 1999, with filling commencing in June 2002. This stage has a fully engineered liner consisting of high density polyethylene (HDPE) laid over compacted clay. Under liner drainage was also installed. This discharges to a large stormwater detention pond at the northern end of the site. Leachate is collected in porous pipes that have been put down in herring bone configuration over the polyethylene liner. On 12 July 2005, the waste at the southern end of Stage 3 slumped a distance of 8 to 10 metres, with the waste also rotating within the lined area. The slip involved 50,000 tonnes of compacted refuse. An operator on site at the time of the slip described the motion of the waste as "sloshing backwards and forwards for about 30 seconds". This resulted in a number of tears in the liner that were visible above the level of the settled refuse. All but one of the tears were considered to be due to items in the refuse puncturing and ripping the liner during the slump, with only one tear that may have been as a result of the liner tearing due to being stretched. All of the visible tears were repaired. With the 300 mm clay cover over acting to protect the liner in the lower area of the landfill, it was considered reasonable to assume that damage under the waste lower down may have been less severe. It was agreed that 18 months of monitoring of the water quality in the under liner drainage would occur prior to attempting to remove the waste to visually inspect the liner. This monitoring did not detect any changes that would indicate contaminants escaping the landfill through the liner. Therefore removal of the waste and a visual inspection was not considered necessary at that time, but that monitoring of the under liner groundwater quality would continue. In terms of the leachate collection system, it was found that movement of the refuse resulted in issues with the integrity of the leachate system. Although the leachate line was in good condition up to 130 m from the northern end of the landfill, under the north eastern segment, beyond that it was compromised. These factors resulted in wet conditions developing in two areas within the landfill footprint. Bentonite matting was utilised and a secondary leachate drainage system was constructed on top of the clay cover over the slumped refuse in the southern end of the landfill. The layout of the leachate drains, as surveyed in September 2006, are shown in Figure 2.

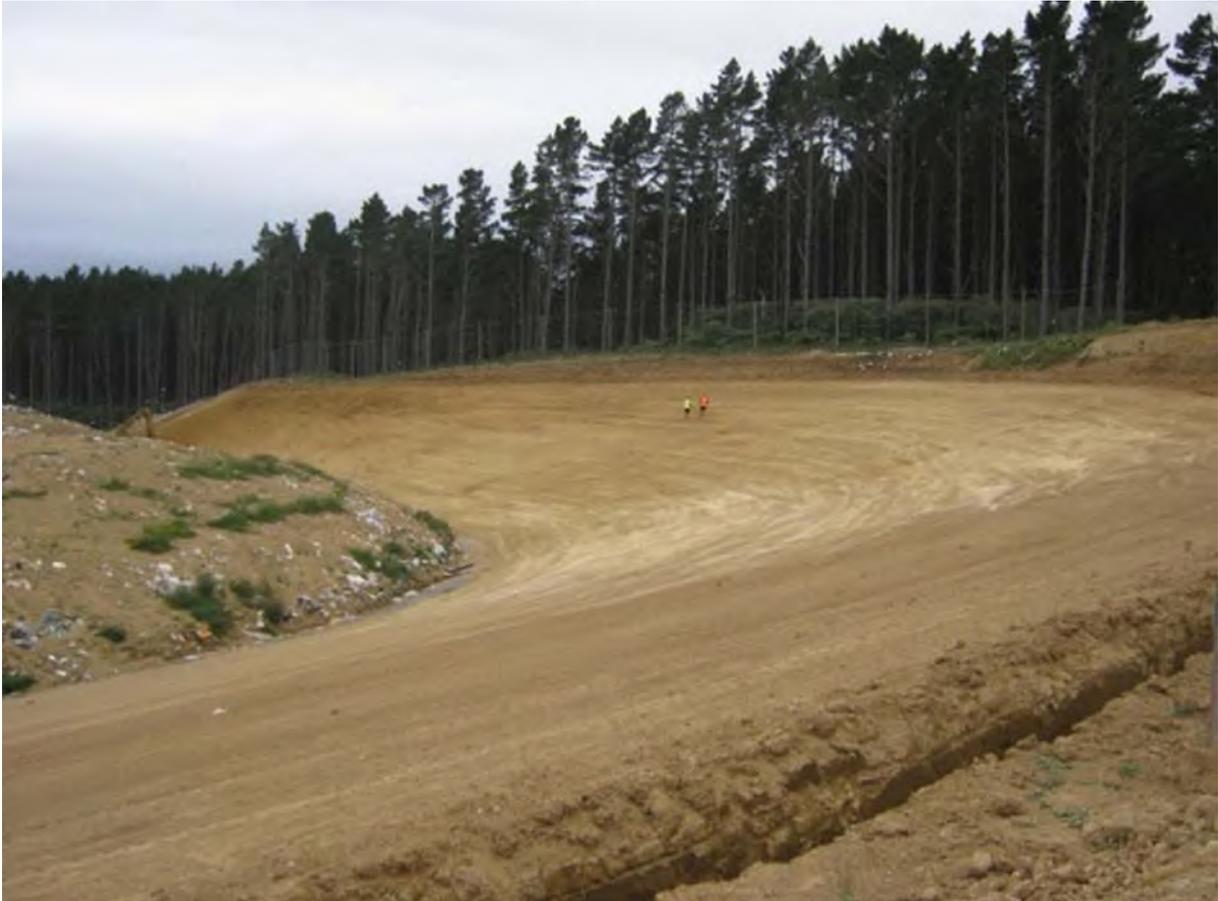
Photo 4 Stage 3 extension works, February 2011

During the 2013-2014 year, the lining of Stage 3 was completed so that the liner covered Stage 3's entire footprint (Photo 4). From this point on, there was an increase in the amount of potentially contaminated stormwater generated due to the increase in the lined and filled area, and this was therefore directed to the leachate collection system for discharge via the New Plymouth wastewater treatment plant. From this point in time, the volumes of leachate/contaminated stormwater generated exceeded the instantaneous capacity of the pipe to the waste water treatment plant on occasion. Therefore the flow from Stage 3 to the leachate system was controlled via a shut off valve to prevent overflows to the Puremu Stream tributaries, when required. Under these circumstances excess leachate/contaminated stormwater is stored within Stage 3 of the landfill.

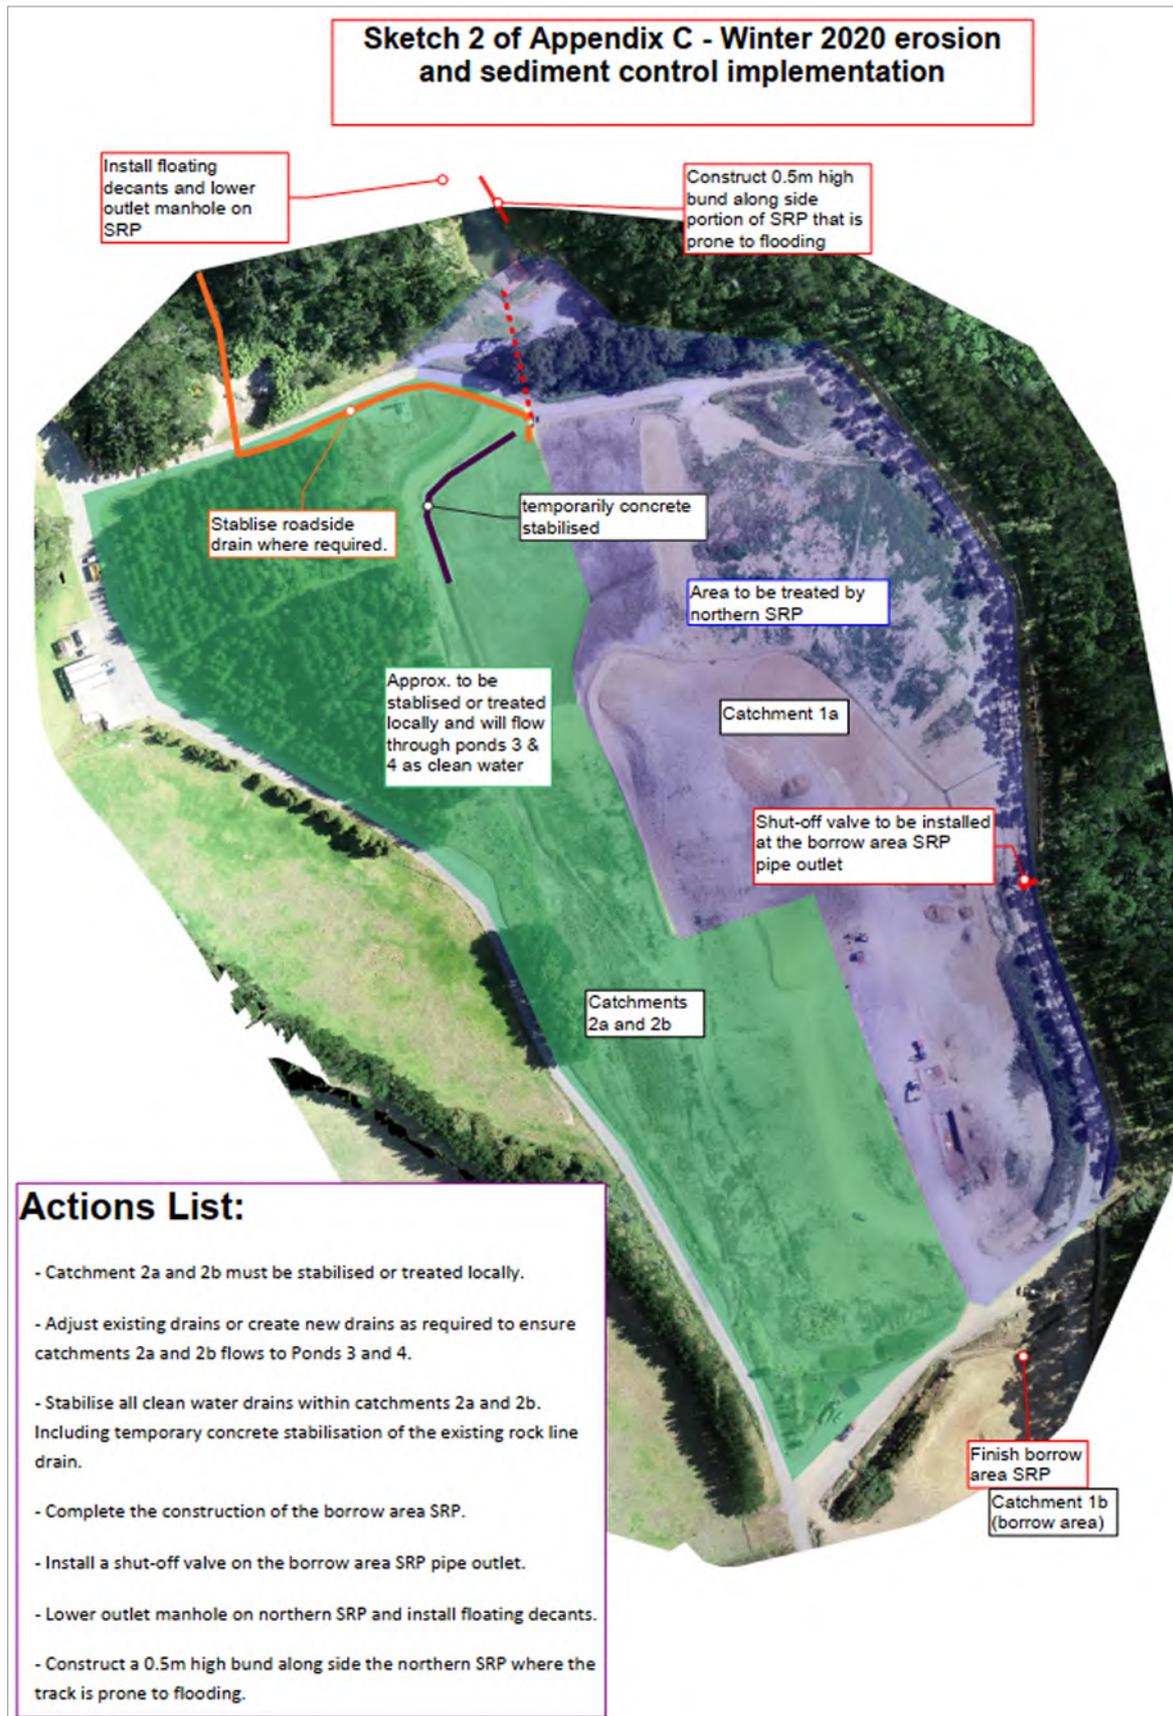
Figure 7 Summary of winter 2020 erosion and sediment control recommendations

A number of recommendations were made that would ensure that adequate erosion and sediment controls were in place for the winter of 2020. These are summarised in Figure 7.

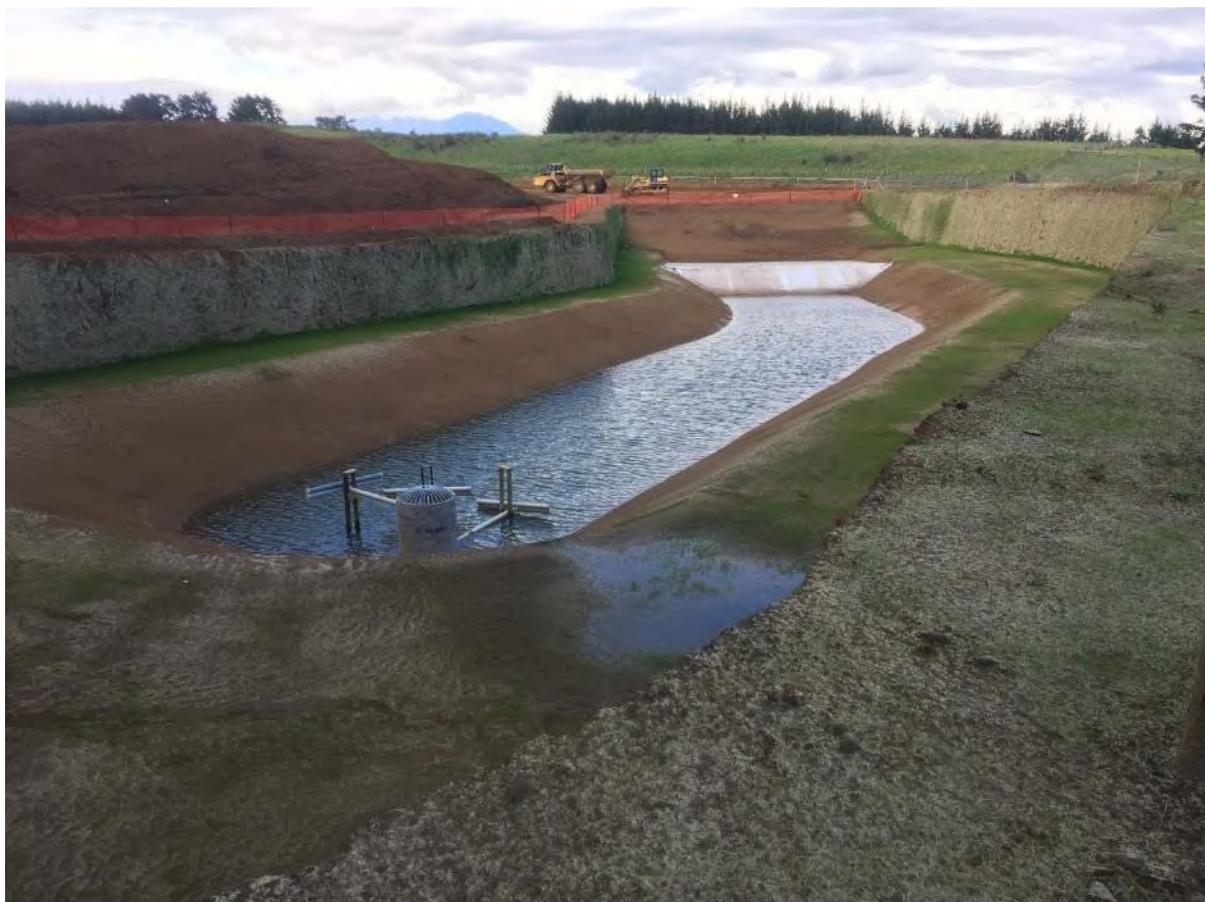
Photo 7 Borrow area sediment pond, November 2020

and was looking good (Photo 7). No discharge was occurring from the old compost ponds and there was no flow observed in the drain along the north-eastern side.

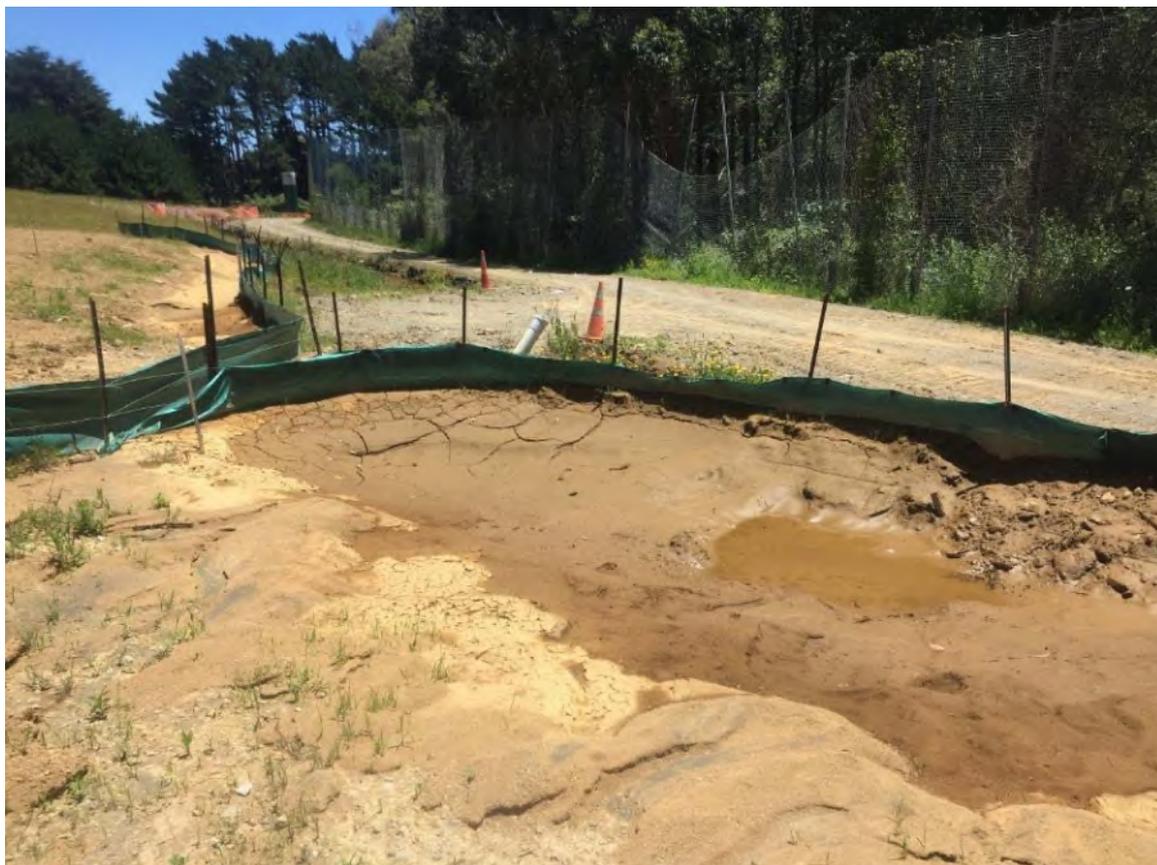
Photo 8 Silt fence, December 2020

There was some ponded water in the bunds and drains along the north side of the landfill, however they were not discharging. All the retained water was clear. The silt fences were quite full in some places, but there was no evidence that they had not functioned adequately during the recent rainfall events, that is, all silt appeared to have been contained.

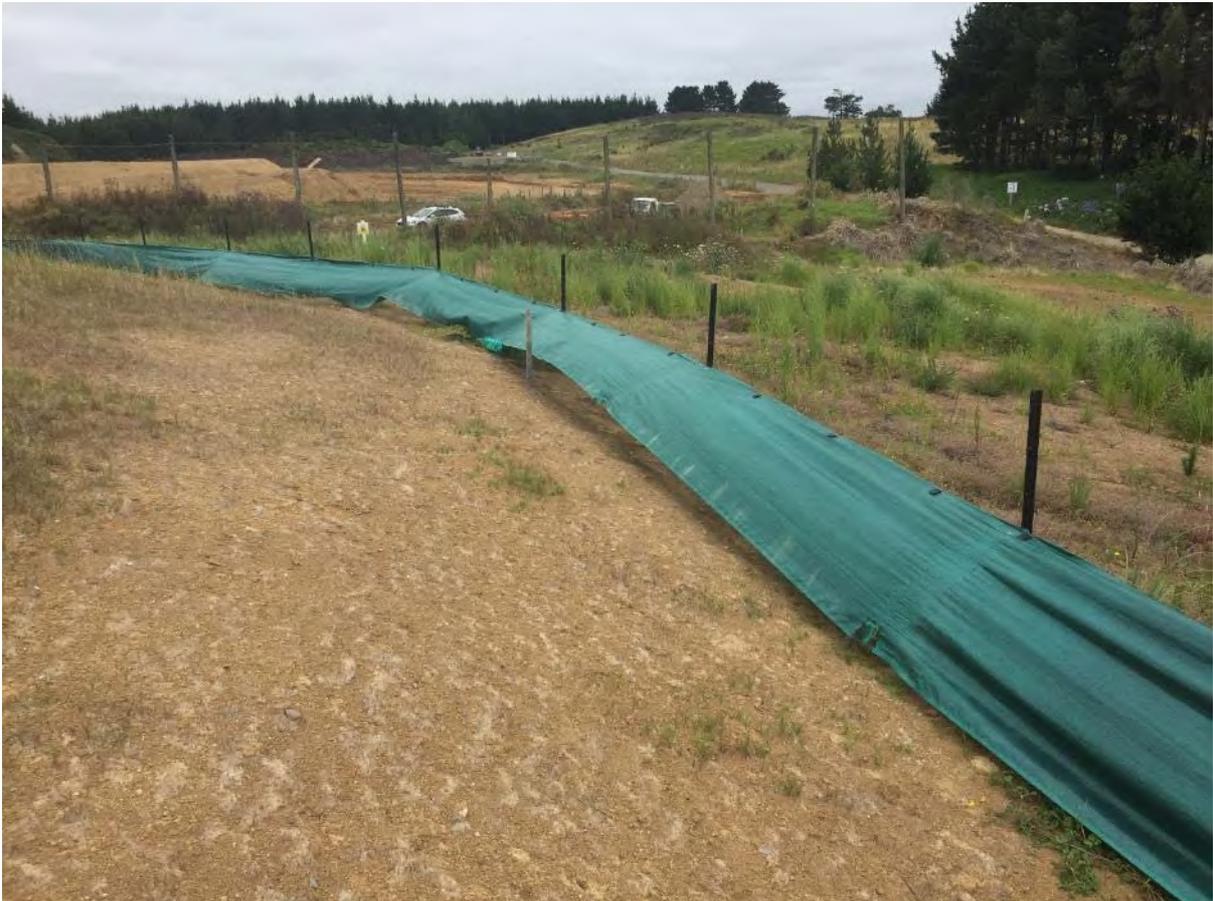
[Photo 9](#) Example of incorrectly installed silt fence 27 January 2021

It was noted that silt fences along the top western side were upside down in places, most were not dug in and some were freely flapping in the wind (Photo 9).

- Continue to work towards complying with abatement notice EAC-22506.
- Continue to ensure that silt detention devices are maintained to ensure their on-going effectiveness.

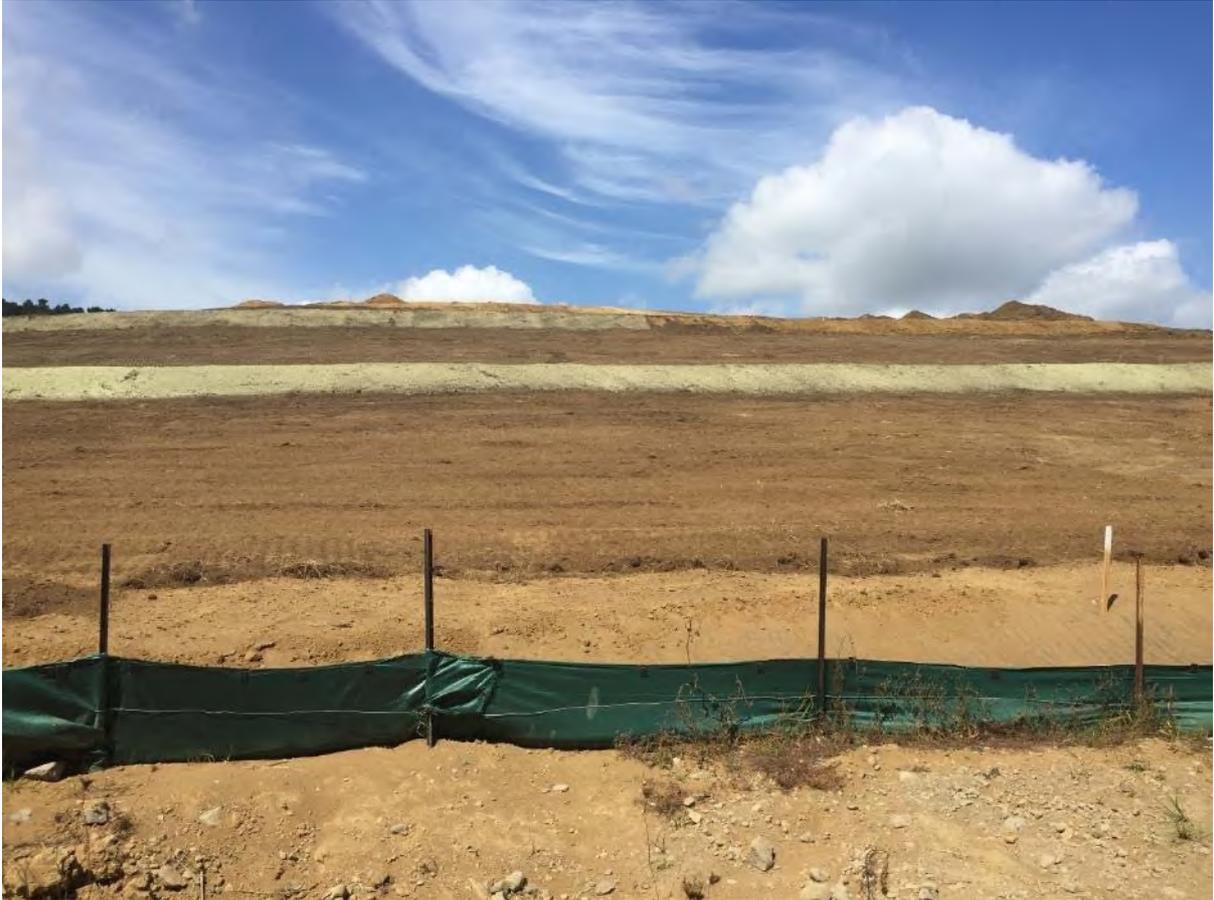
Photo 10 Hydroseeded bunds on northern face of the landfill, February 2021

Machinery was active over the north and eastern parts of the landfill area. Two bunds had been constructed across the north face and it appeared that these had been hydroseeded (Photo 10).

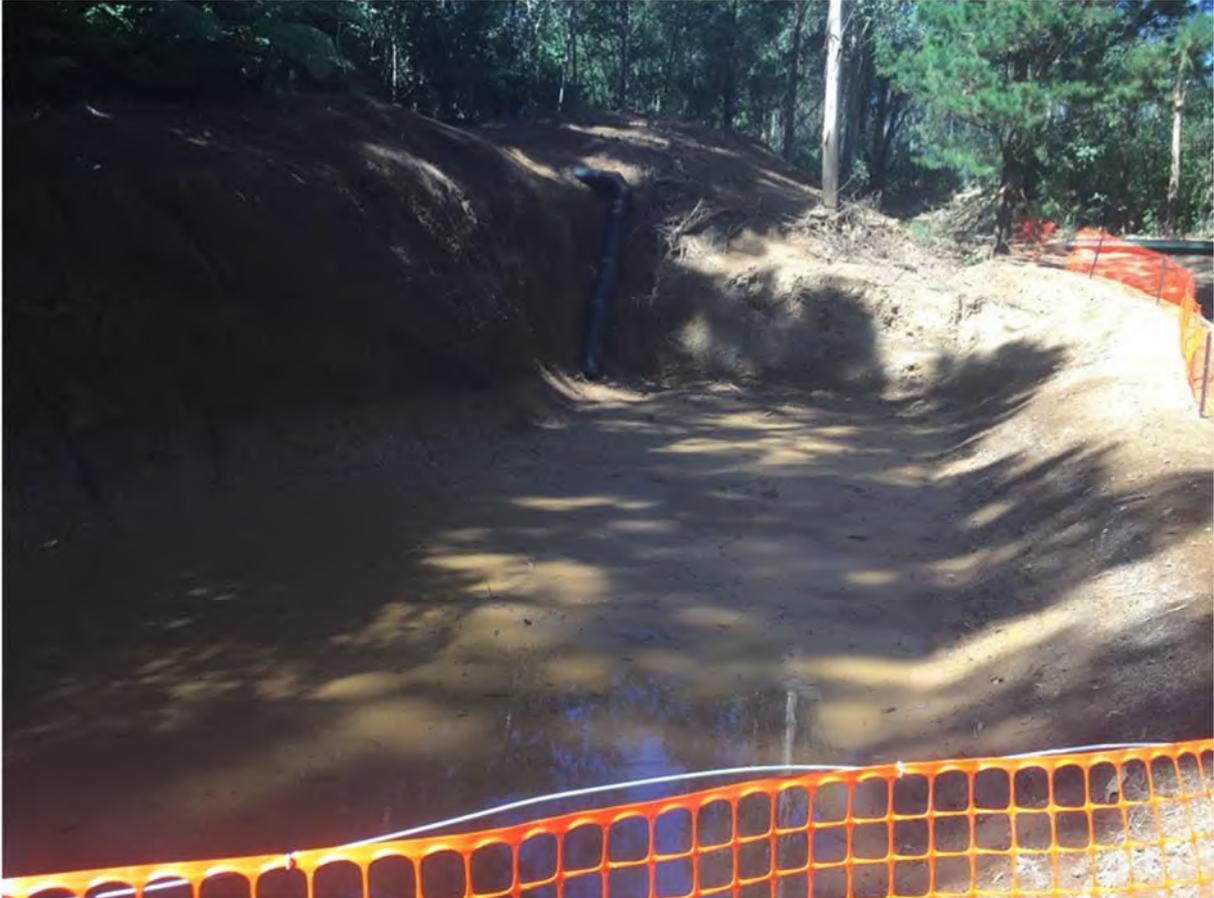
Figure 8 Completed fore bay to large silt pond, March 2021

The pre-treatment pond for the large silt pond had been completed (Figure 8). The large silt pond was a turbid brown colour with a very low level. A floating decant had been installed at the outlet (Photo 12). There was a small amount of outflow to the wetland/stream area below. The area below the outfall was discoloured a greenish/brown. There were no sheens, scums or other visible effects observed immediately below the outlet. No odours were noted in the area.

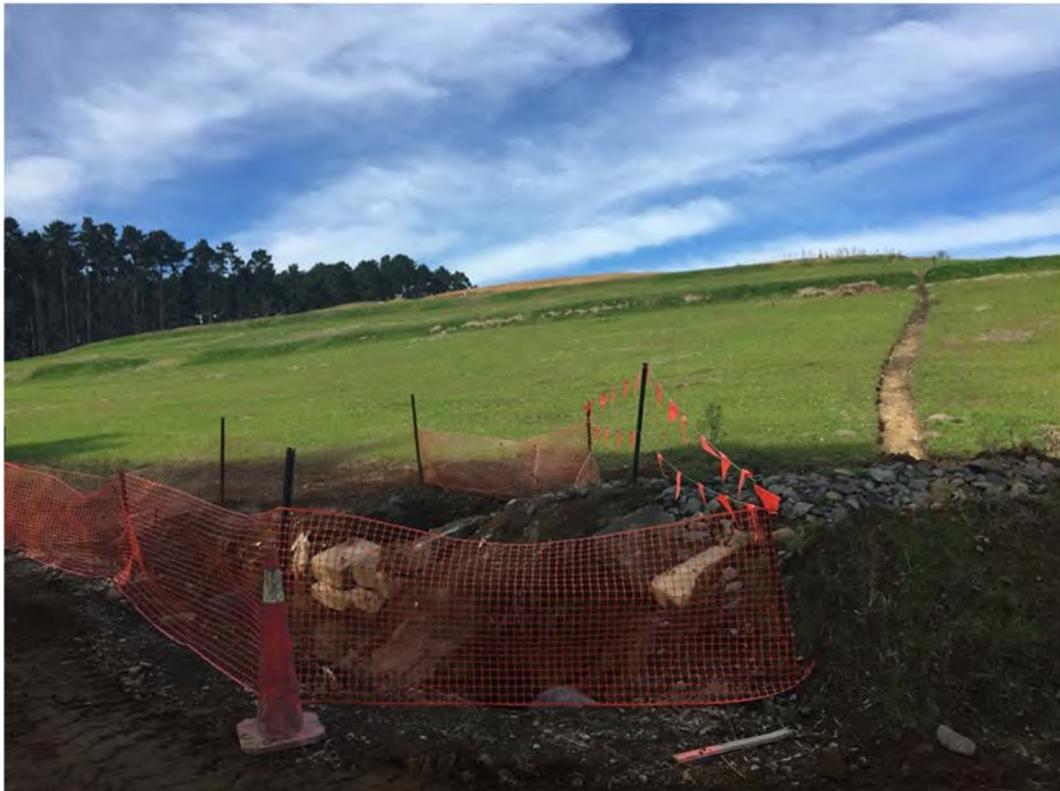
Photo 14 Northern face of the landfill, May 2021

There was good grass growth on the north and north-western parts of the old landfill area (Photo 14). There was some ponded water in the bunds along the bottom of the north side. All the water was clear. Silt fences along the bottom of the northern face had been removed. A digger was working to fill in the drain and contour the area along the northern toe of the landfill.

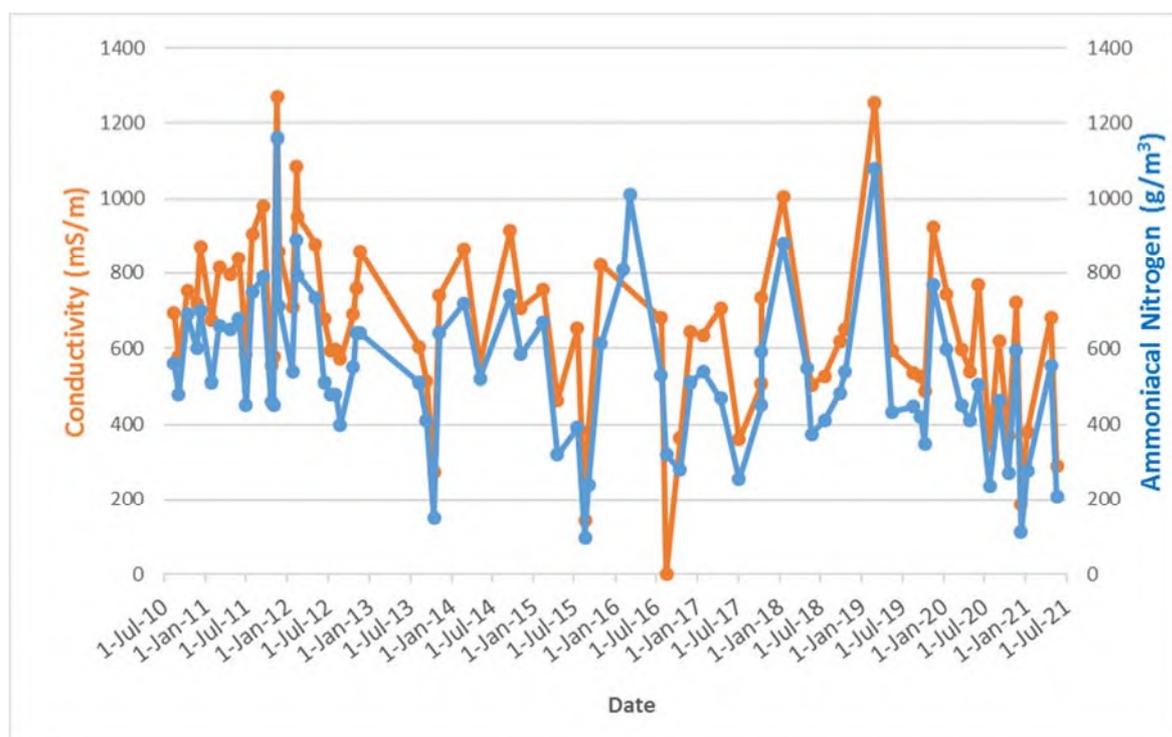
Figure 9 Leachate conductivity and ammoniacal nitrogen, July 2010 to date

The results gathered by NPDC during the year under review reflect typical leachate quality. There are no obvious trends in the indicator leachate constituents measured emerging at this stage (for example, the concentration variations within each parameter are likely to reflect seasonal variations in leachate quality and the dilution afforded by the contaminated stormwater that is diverted through this system).

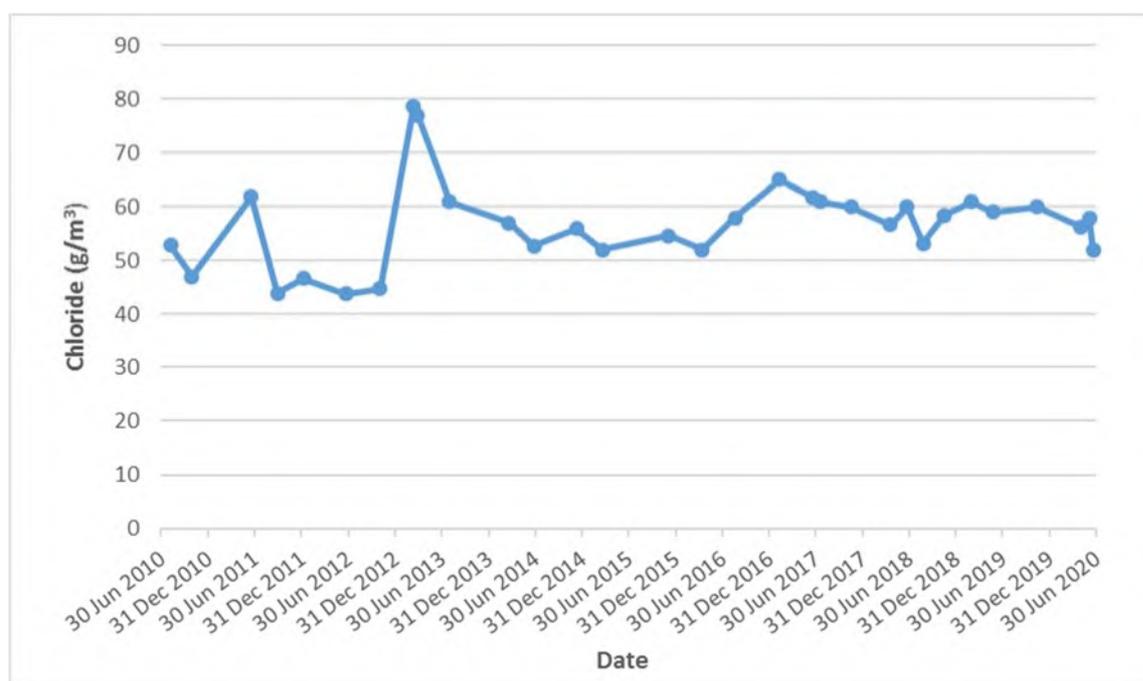
Figure 10 Chloride concentration in the under liner drainage, June 2010 to June 2020

On the basis of this review, it was concluded that, although the level of key indicator species such as zinc and chloride (Figure 10) appeared to have been relatively stable over the last several years, there may have been an emerging trend of very slight increasing contaminants. In particular, the results for the 2017-2020 years indicated that some contaminant concentrations such as ammoniacal nitrogen had increased more noticeably.

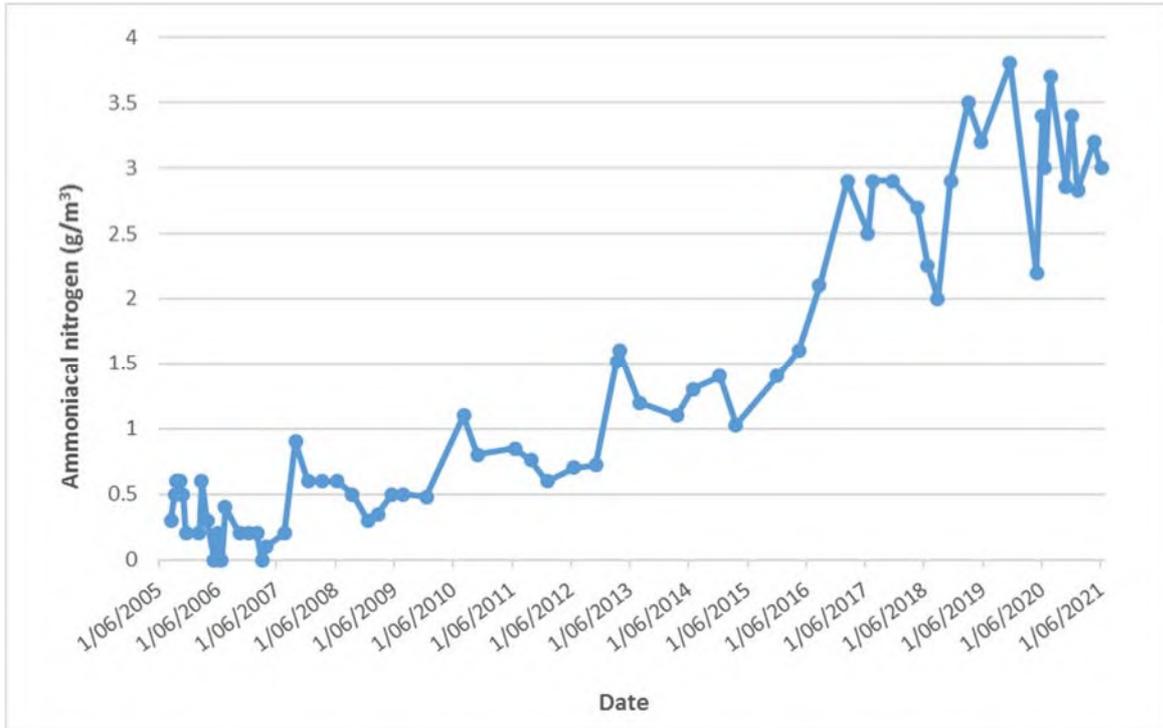
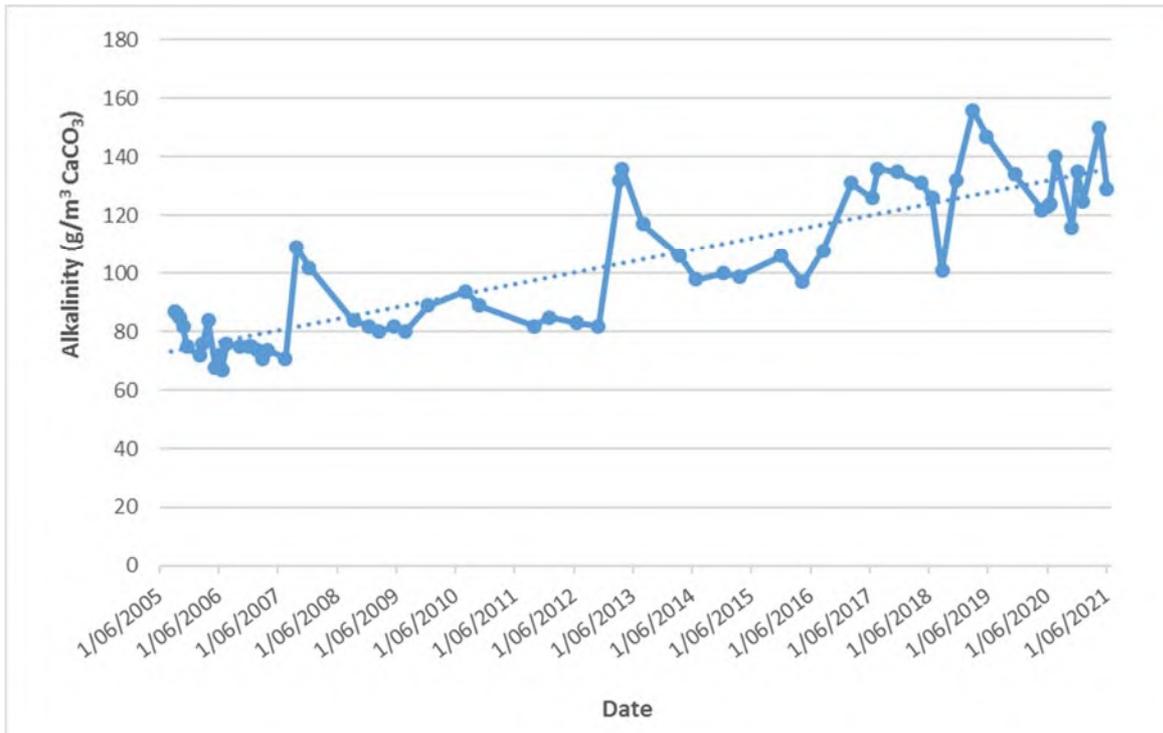
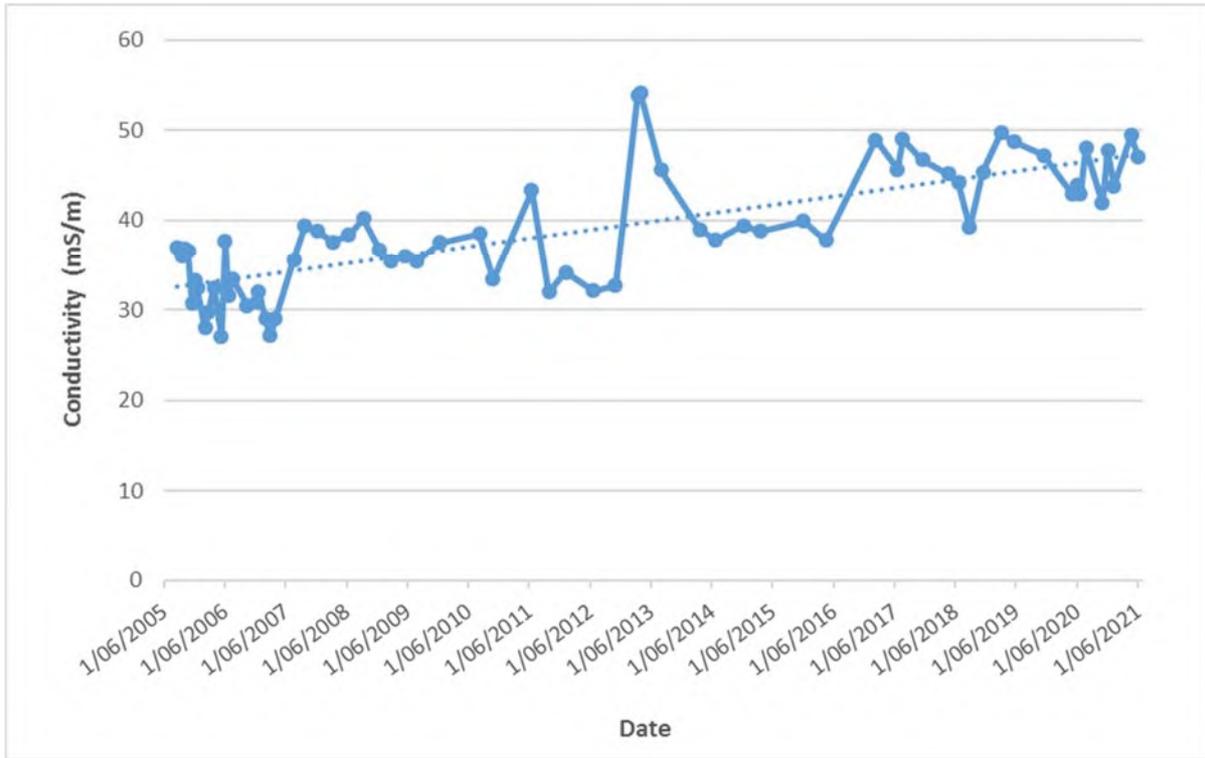
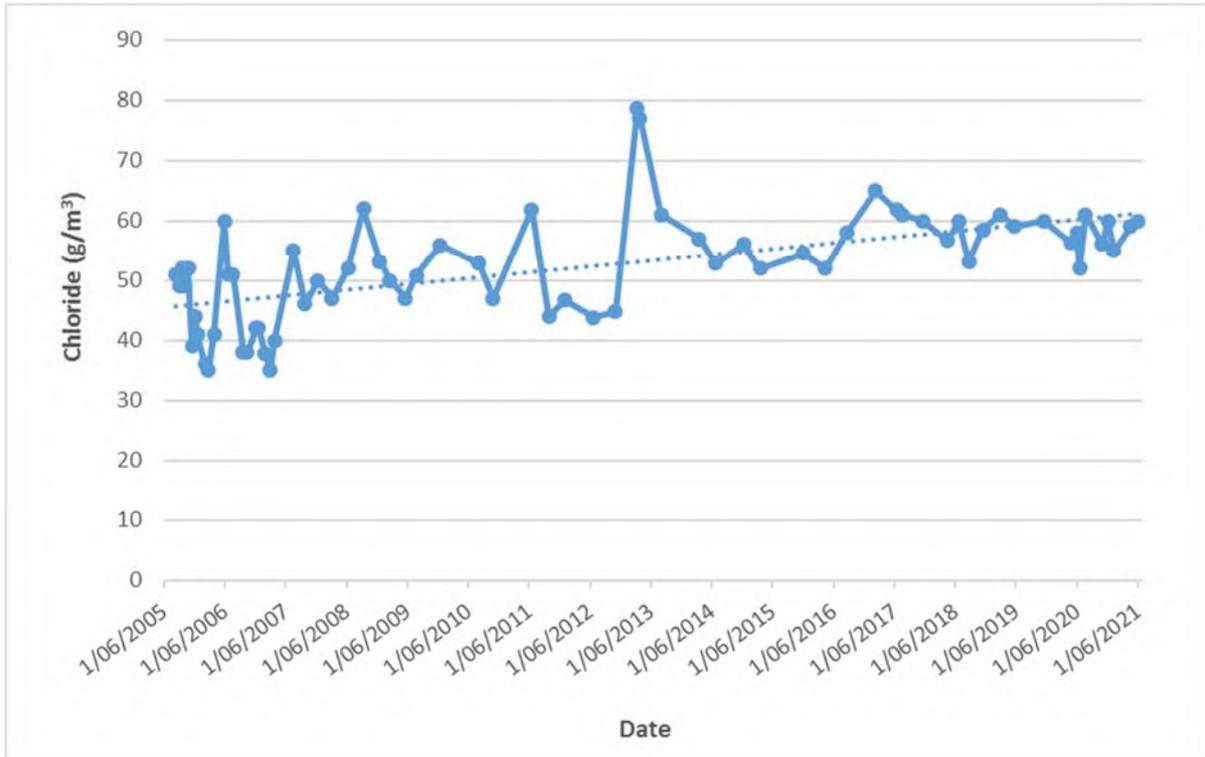
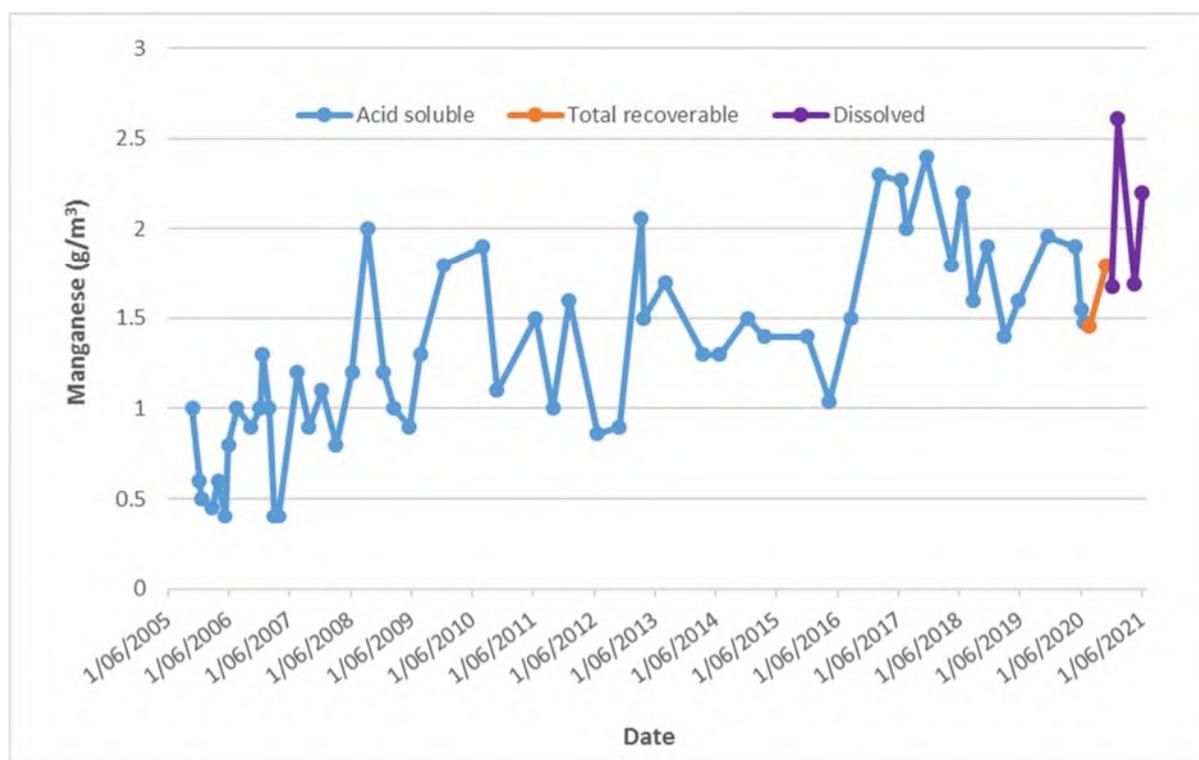
A review of the expanded time series data indicates that the trend of increasing levels of parameters may have started soon after the July 2005 slip as shown in Figure 11, Figure 12, Figure 13, Figure 14, and Figure 15.

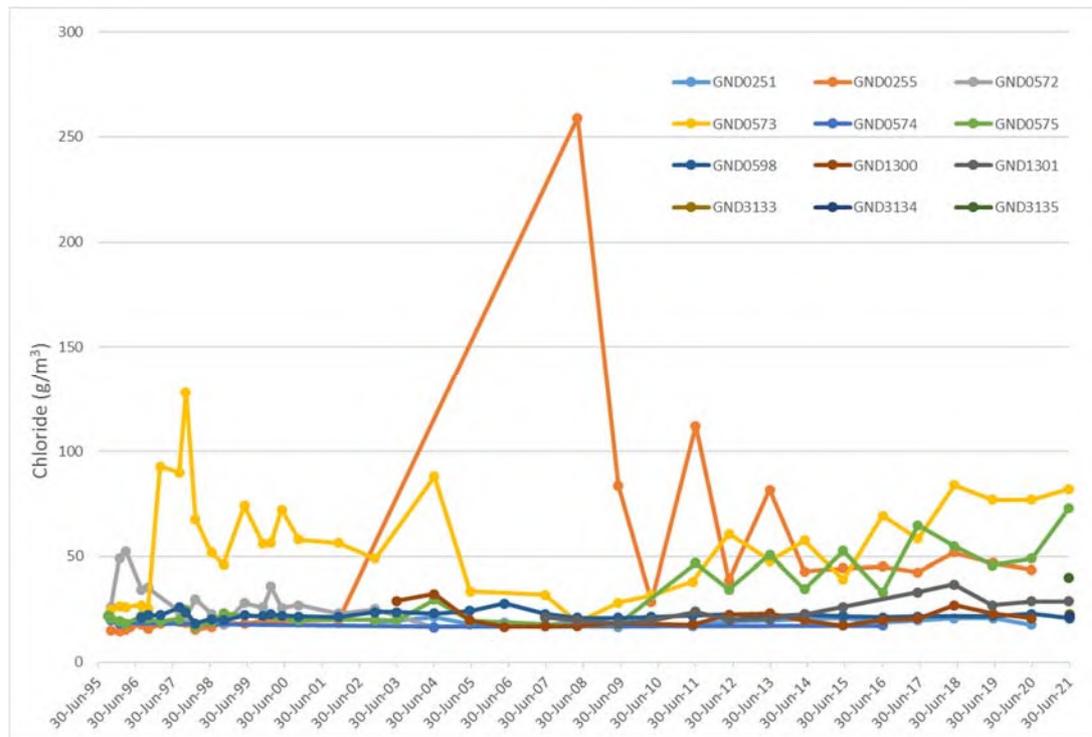
Figure 18 Chloride concentrations in the Colson Road groundwater bores

Although the NPDC subsurface drainage samples (Table 4, Section 2.3.1.2) is showing slight contamination from the impact of leachate for some parameters, on the whole, the groundwater results show little evidence of leachate contamination. During the year under review, all parameters measured for all the bores, were well within the ranges expected in Taranaki groundwater. However, there are some small changes in recent years, particularly in the chloride, conductivity and nitrate/nitrite nitrogen concentrations, that may be indicative of newly emerging trends.
