NPDC Colson Road Landfill  
Monitoring Programme  
Annual Report  
2020-2021

Technical Report 2021-97

Taranaki Regional Council  
Private Bag 713  
Stratford

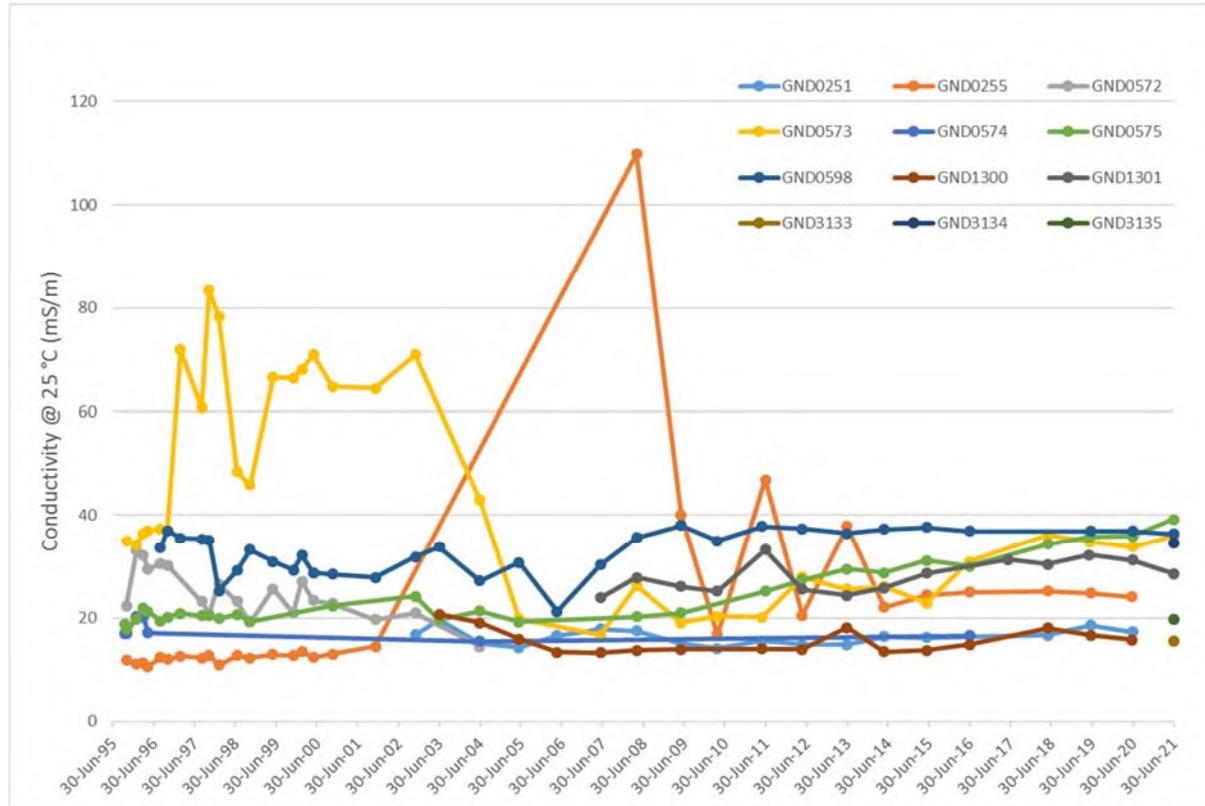
Figure 19 Conductivity in the Colson Road groundwater bores

In bores GND0573 (down gradient of Stages 1 and 2) and GND0575 (down gradient of Stage 3) although the changes are relatively small, it does appear that there may be an emerging trend of increasing chloride concentrations in the groundwater at these locations. This may be indicative of some minor leachate contamination. These trends are also apparent in the conductivity of the groundwater samples from these bores.

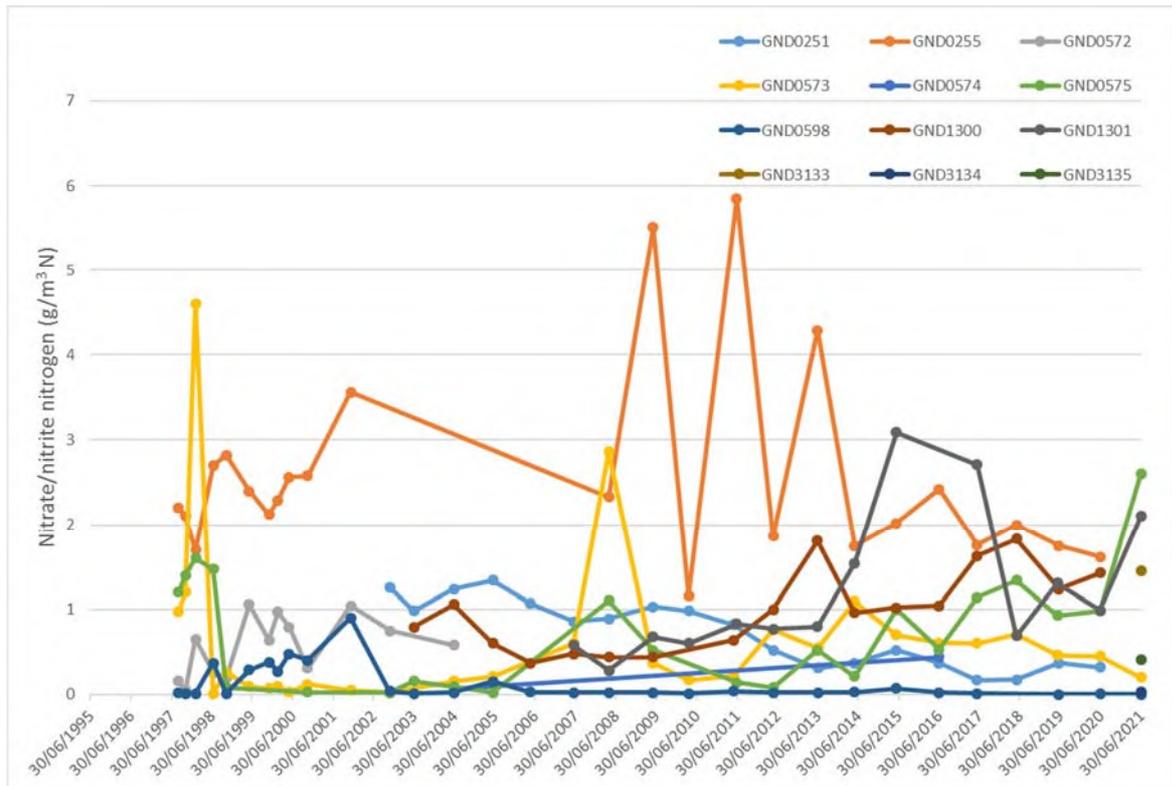
Figure 20 Nitrate/nitrite nitrogen concentrations in the Colson Road groundwater bores, June 2006 to date

Figure 20 shows that there may also be an emerging trend of increasing nitrate/nitrite nitrogen concentrations in GND0575 (north of Stage 3). This finding is consistent with emerging trend of increasing ammoniacal nitrogen in the under liner drainage results provided by NPDC (2.3.1.2, Figure 11). Nitrate/nitrite nitrogen is not currently determined in the under liner drainage monitoring undertaken by NPDC. The nitrate/nitrite nitrogen concentration obtained at GND1301 (further east of the landfill than GND0575) during the year under review was again elevated above the historical median for this monitoring location, and was the third highest on record for this site. In contrast there is a trend of decreasing nitrate/nitrite concentration at GND0251.

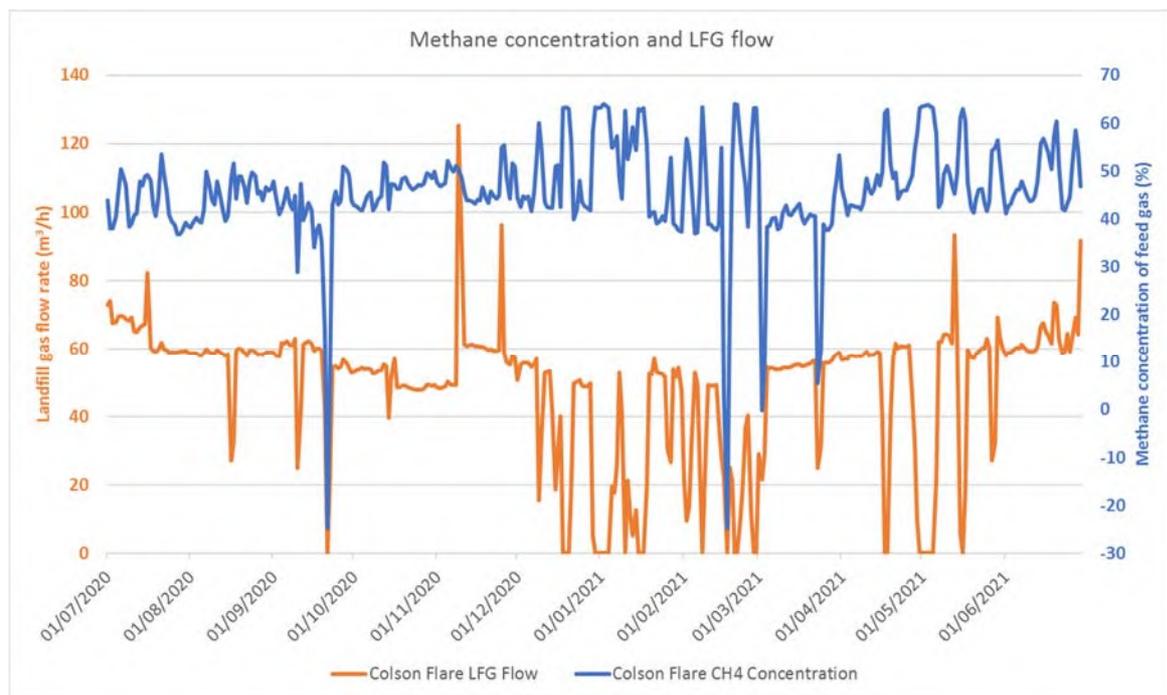
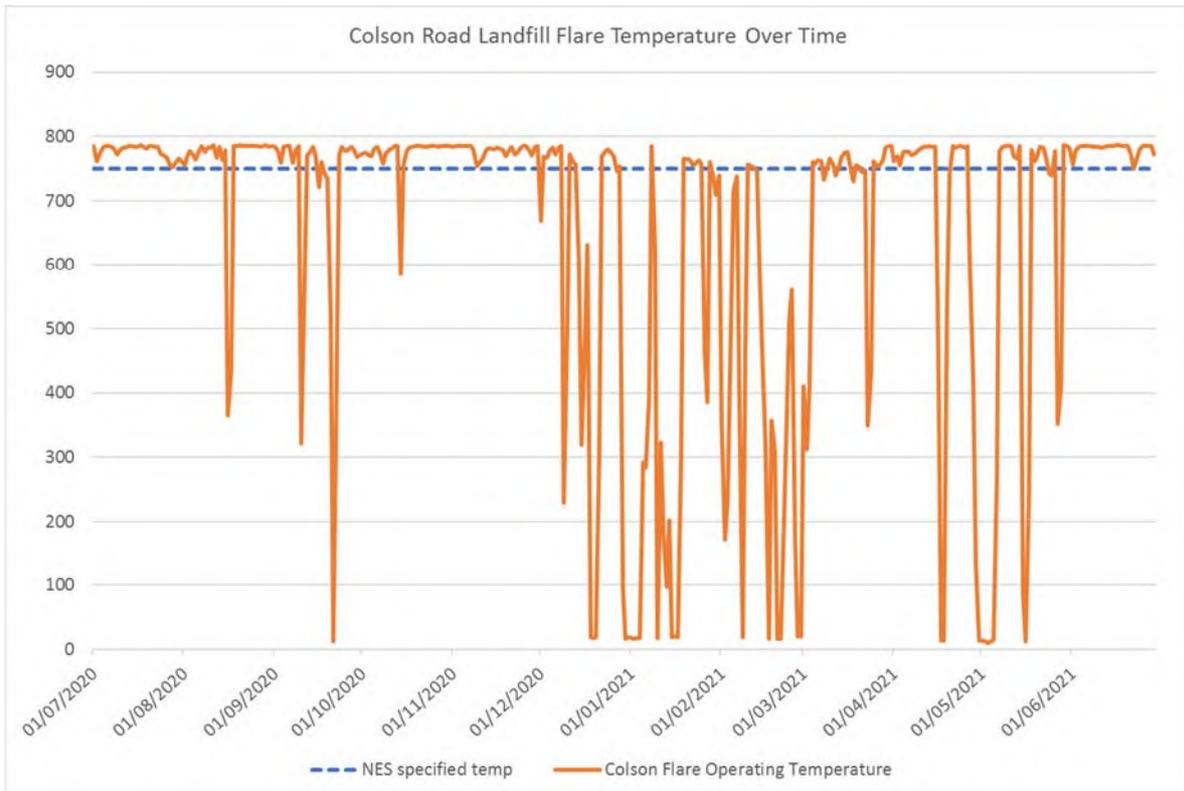
Updated annual information on the feed gas and temperature was provided upon request in the form of graphed gas flow, methane concentration in the feed gas and temperature data from the continuous (1 minute) data collected by the monitoring system that is integrated into the flare system (Figure 21 and Figure 22).

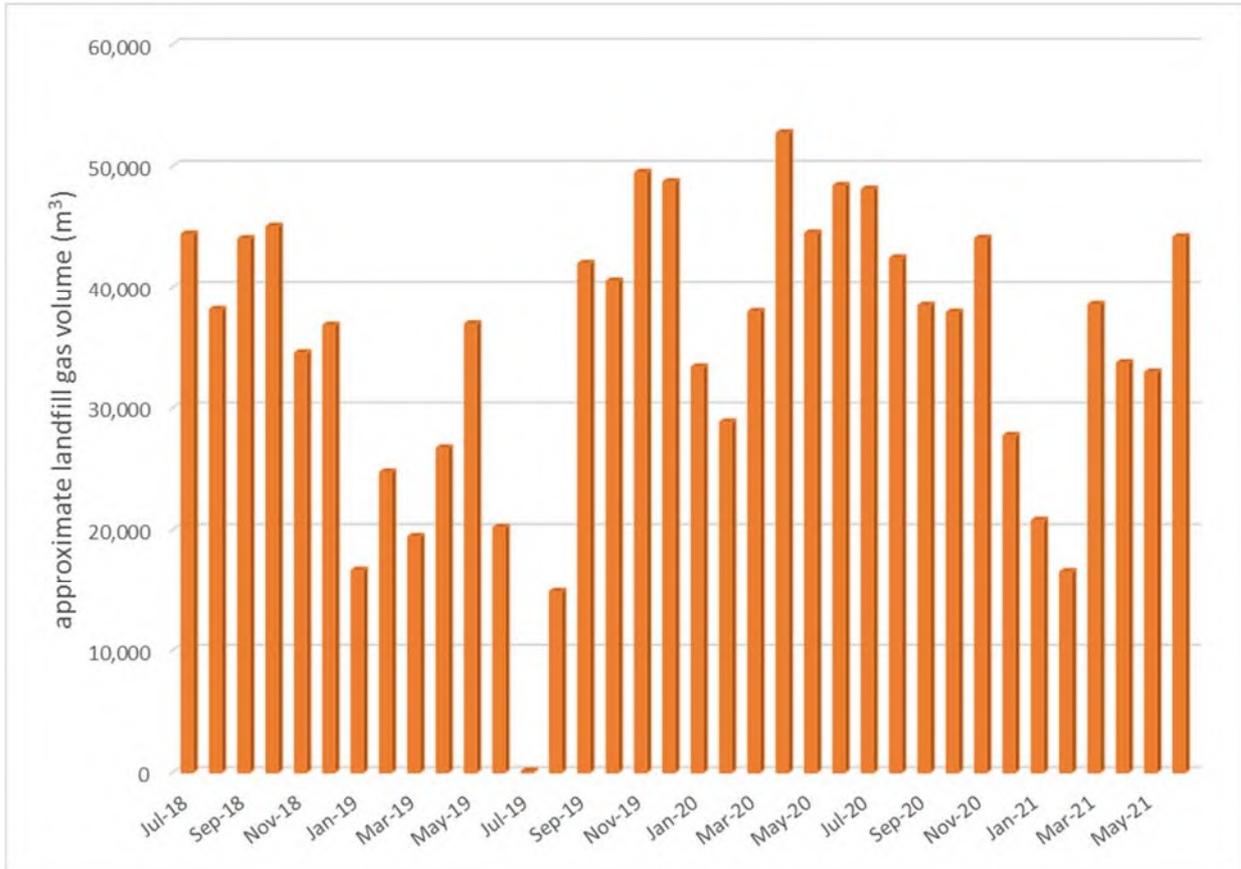
Figure 23 Monthly landfill gas flow volumes flared, July 2018 to date

The total landfill gas volume treated by the flare during the year under review was 425,383 m<sup>3</sup> calculated from daily average landfill gas flow in m<sup>3</sup>/h. This is 3% lower than the total of 440,758 m<sup>3</sup> for the 2019-2020 year. The approximate monthly landfill gas volumes are shown in Figure 23.

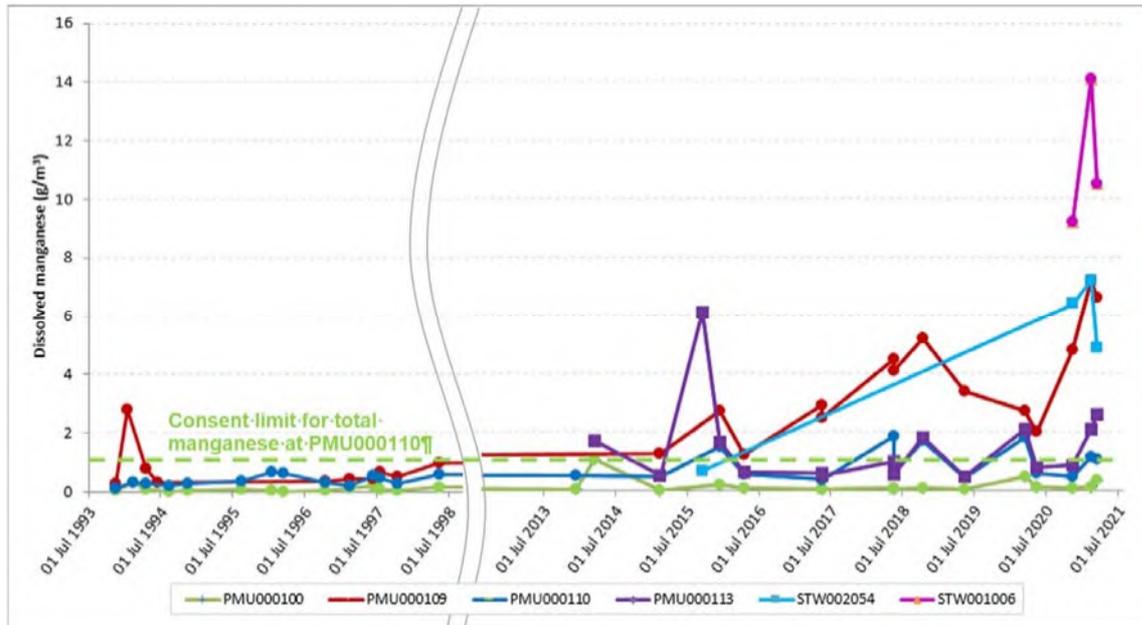
Figure 25 Dissolved manganese concentrations in the wetland polishing area and Puremu Stream

therefore not a compliance issue. It may however suggest that NPDC may want to investigate this further to ensure continued consent compliance at site PMU000113. In order to assist data interpretation monitoring of the manganese concentration in the discharges from the stormwater ponds commenced during the year under review.
