**Waste Remediation Services (WRS) Ltd**

**Symes Manawapou Landfarm**

Monitoring Programme

Technical Report 2022-27

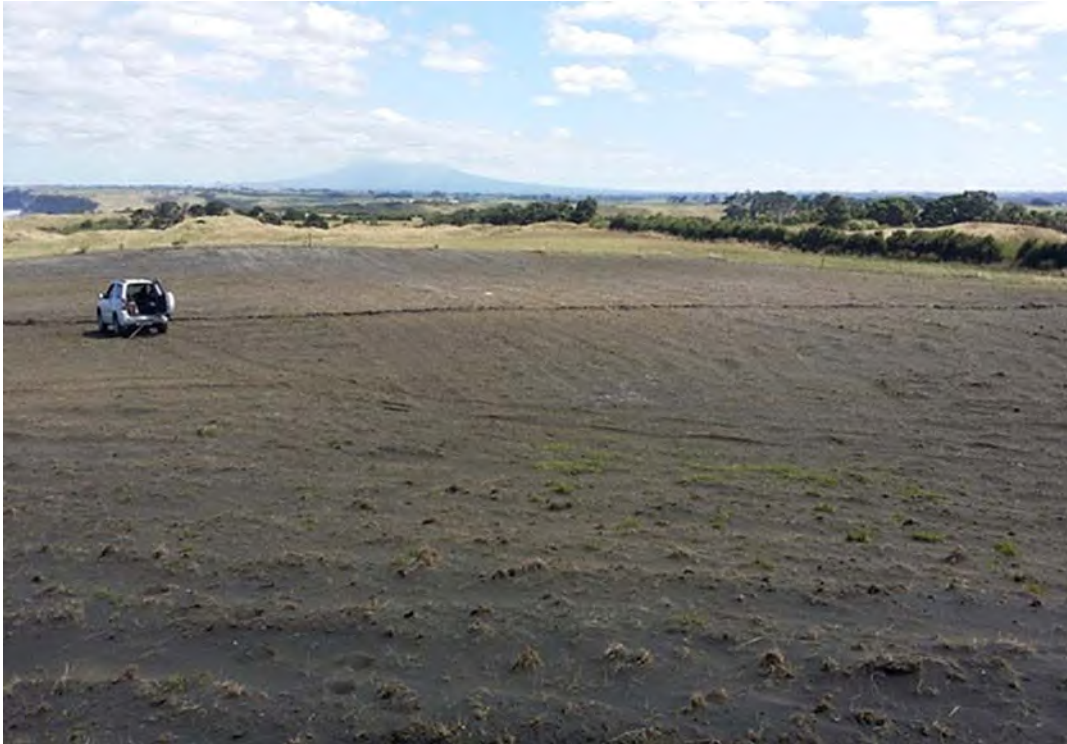
Photo 1 WRS Symes Manawapou Landfarm post discharge and reinstatement pre-seeding 2014

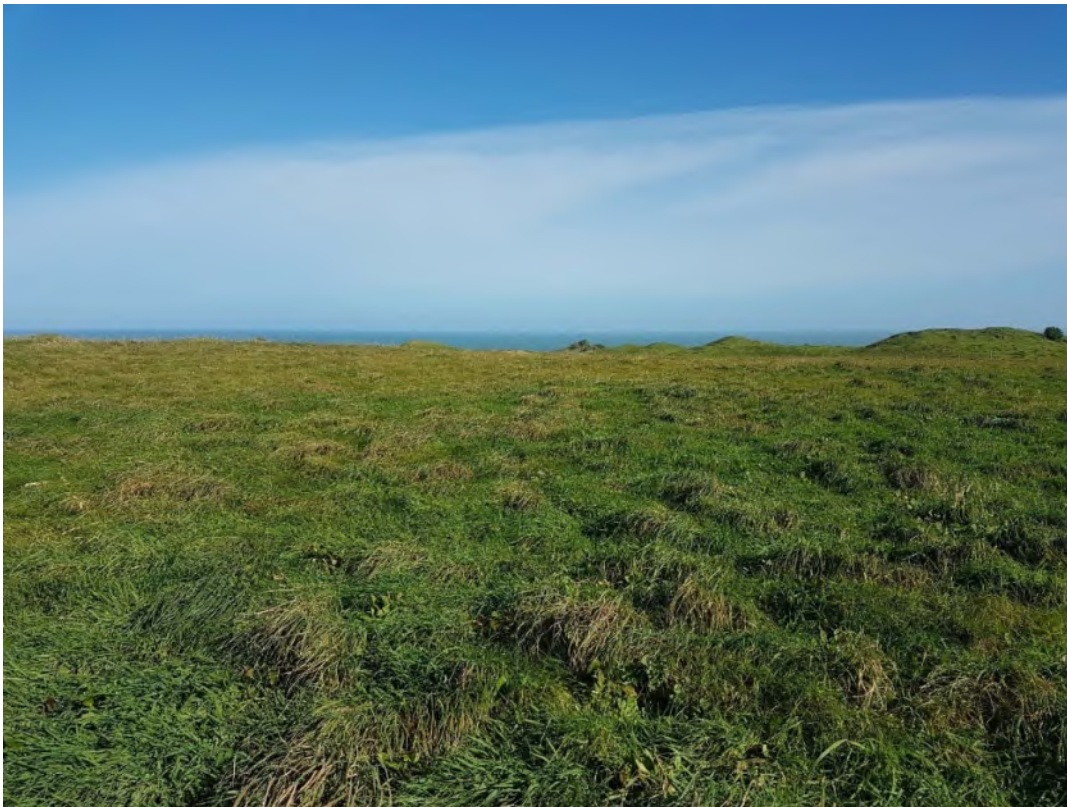
Photo 2 WRS Symes Manawapou Landfarm post surrender sampling 2018

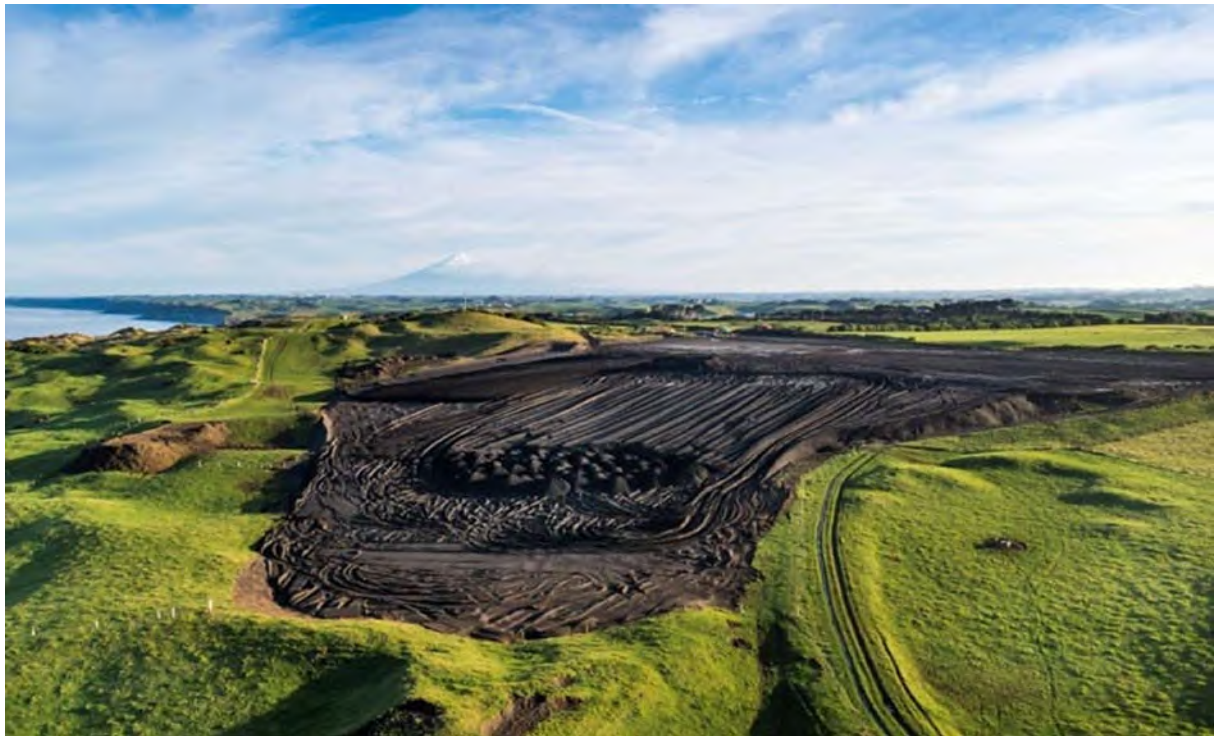
Photo 3 Landfarming area M2110 2021 (image provided by WRS)

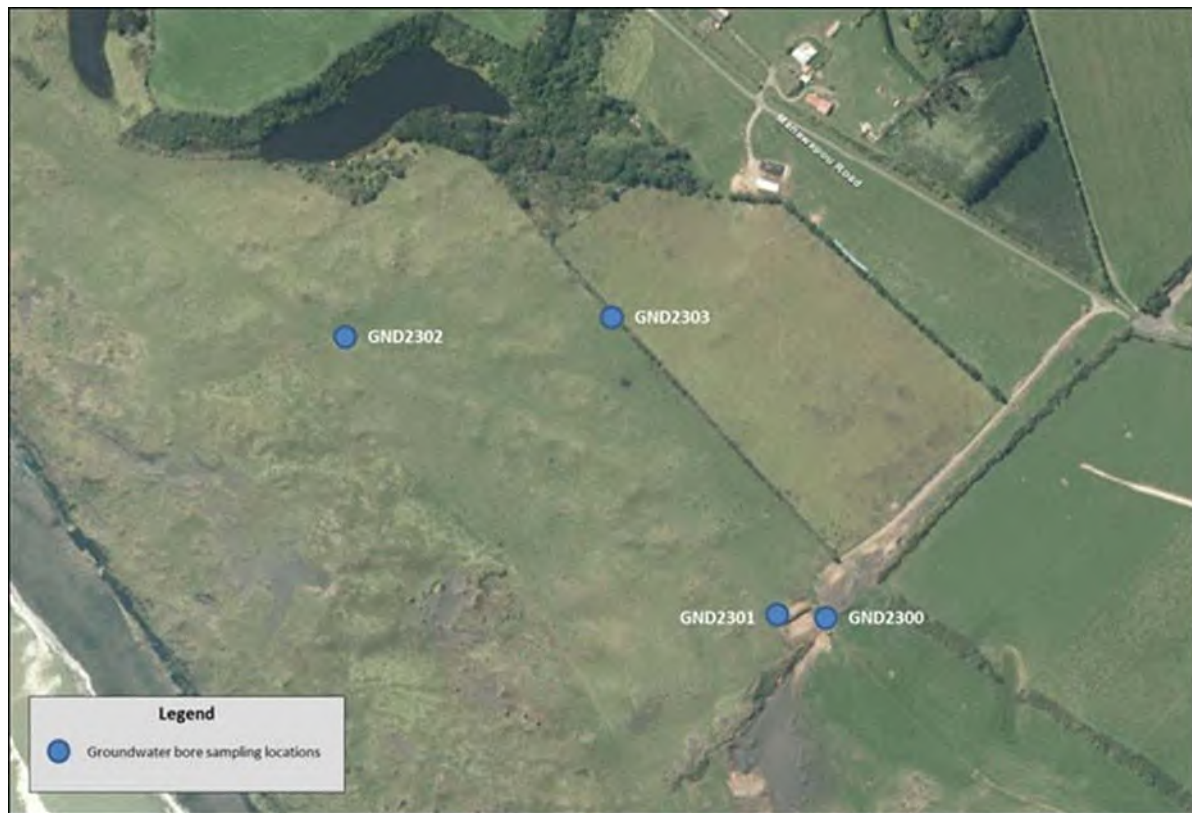
The Symes Manawapou Landfarm contains four groundwater monitoring bores (Figure 2). The bores were installed as part of the consent and have been monitored since October 2012. They were installed to assess the quality of the groundwater; in close proximity to the storage cells in the case of GND2300 and 2301, and the landfarming exercise, in the case of GND2302 and 2303.

Figure 2 WRS Symes Manawapou Landfarm groundwater monitoring locations

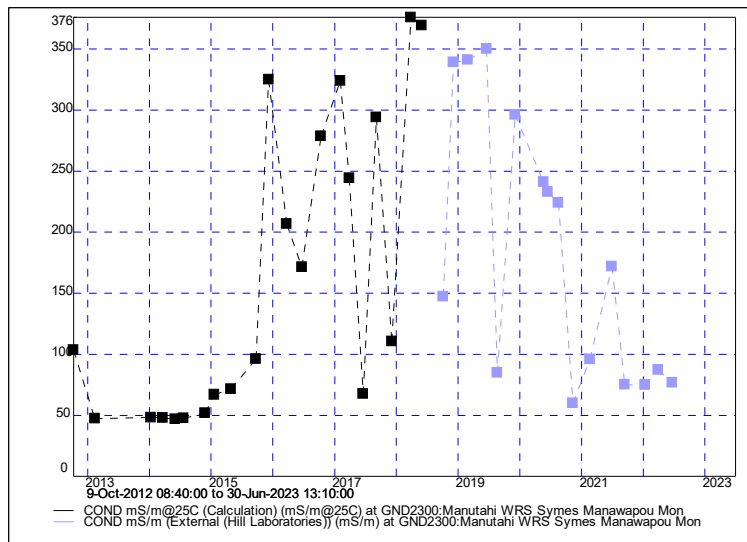
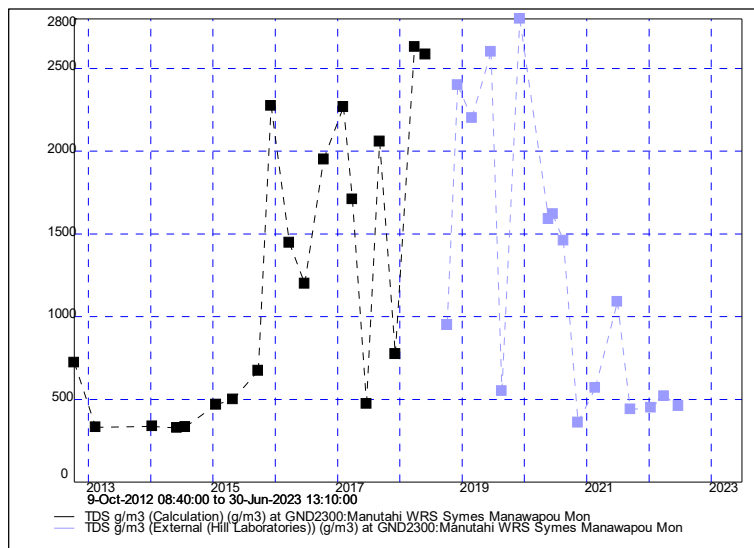
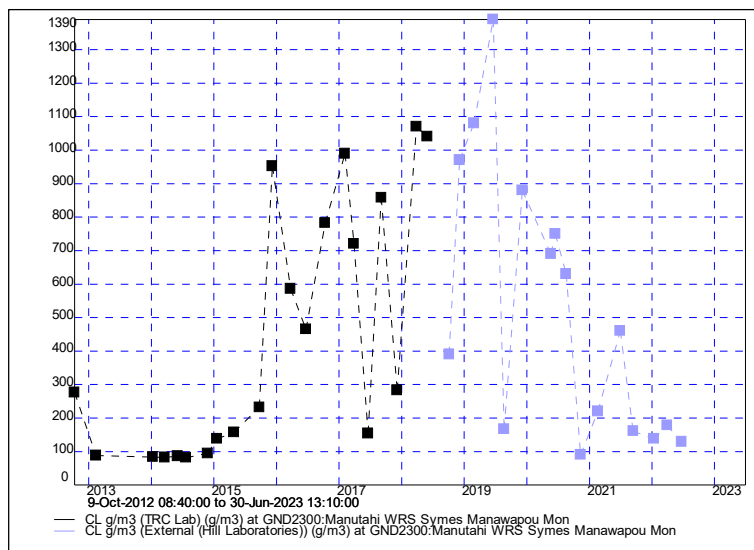
- Sodium results ranged 74-108 g/m<sup>3</sup> and showed a slight increasing trend.
- pH results remained quite stable and weakly acidic, ranging 6.2-6.5 pH.

Figure 3 Long term EC mS/m @ 25°C monitoring GND2300 2012-2022

Figure 4 Long term TDS g/m³ GND2300 2012-2022

Figure 5 Long term chloride g/m³ results GND2300 2012-2022

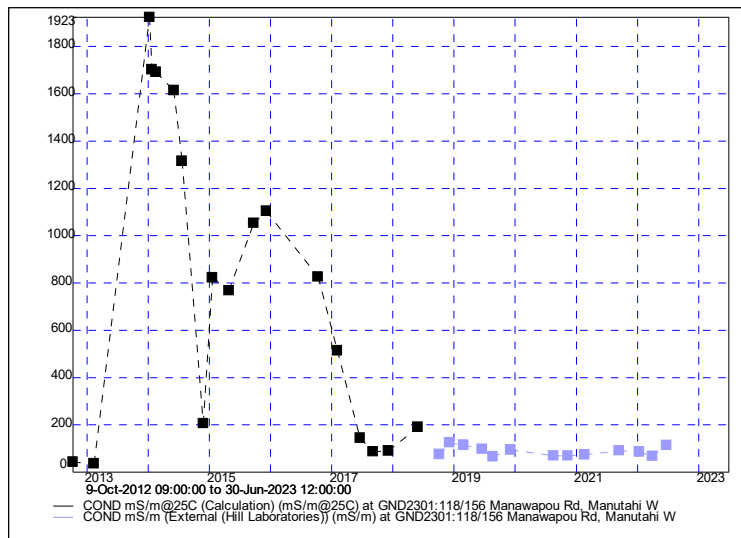
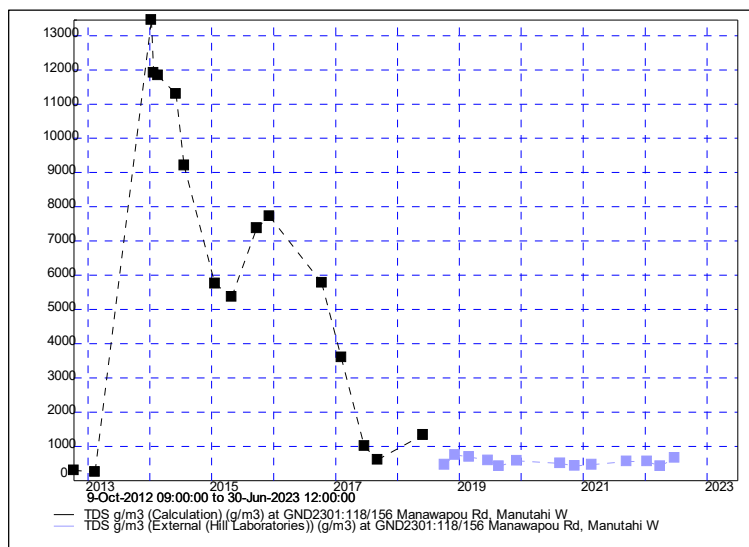
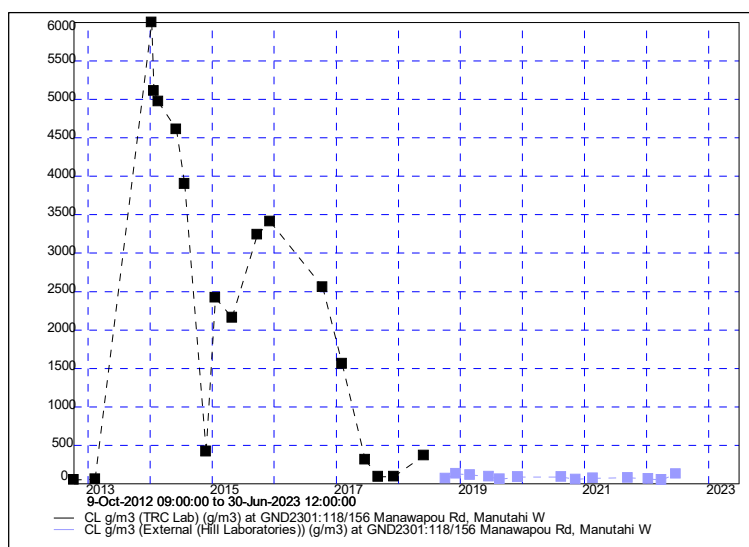
- Temperature remained relatively stable, ranging 15.1-17.1 °C.
- EC results started off high, then dropped in March before increasing again in June, ranging 67.4-113.7 mS/m.
- TDS also remained stable, ranging 420-660 g/m<sup>3</sup>, with a marginal rise in June.
- Acid soluble and dissolved barium remained relatively stable and of low concentrations across the four monitoring rounds.
- Chloride ranged 50-129 g/m<sup>3</sup>, starting fairly stable then rising slightly in June.
- Sodium remained stable, ranging 46-55 g/m<sup>3</sup>.
- pH remained weakly acidic, ranging 6.5-6.7 pH.
- Traces of toluene was recorded at 0.027 g/m<sup>3</sup> in June 2022, but for the majority of the monitoring period TPH and BTEX were not recorded above the LOD.

Figure 6 Long term EC mS/m @ 25°C monitoring GND2301 2012-2022

Figure 7 Long term TDS g/m³ GND2301 2012-2022

Figure 8 Long term chloride g/m³ results GND2301 2012-2022

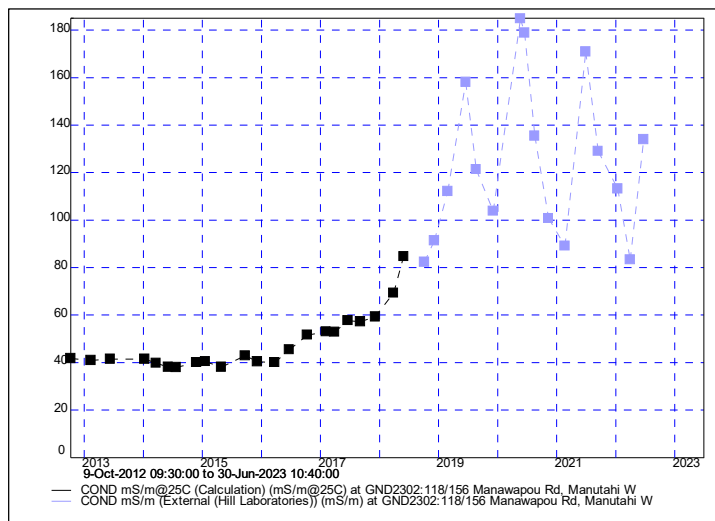
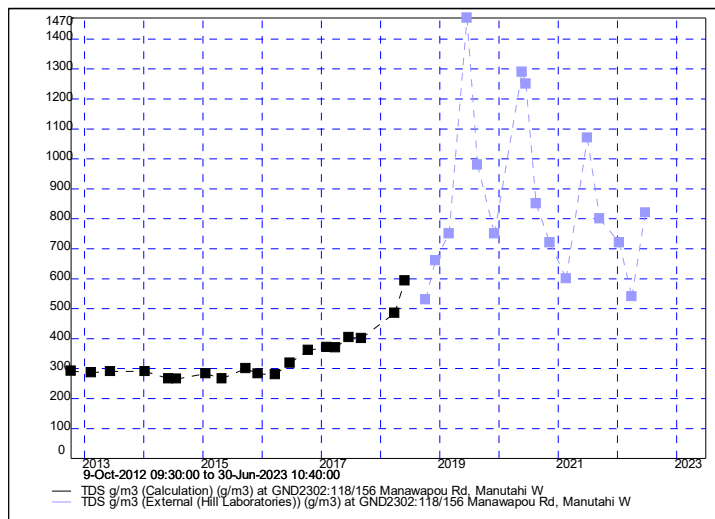
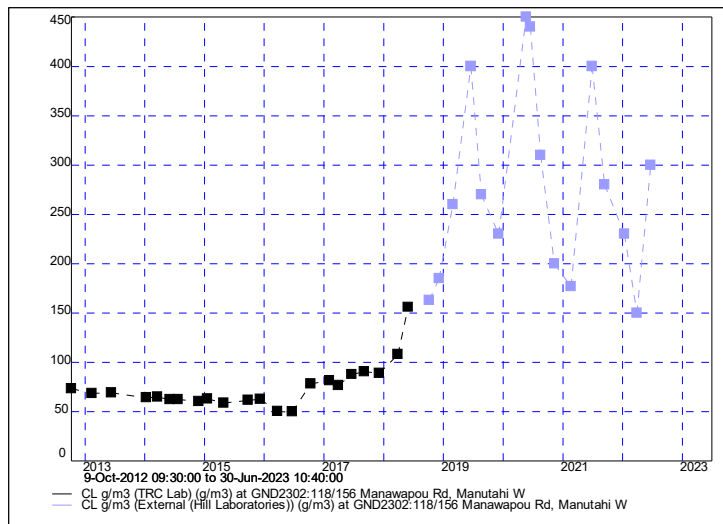
- TDS followed a similar trend to EC, with a lower concentration during March, prior to an increase in the final monitoring round, with a range 540-820 g/m<sup>3</sup>. The long term record (Figure 10) suggests a steady increase in this parameter. However, TDS has recorded a reducing peak concentration since June 2019. The results do not exceed the consent condition 22, which allows up to 2,500 g/m<sup>3</sup> of this analyte. Further monitoring will assess this location over time.

- Dissolved barium remained of low concentrations, ranging 0.030-0.058 g/m<sup>3</sup>.
- Chloride monitoring, had a similar trend to EC and TDS, ranging 150-300 mg/kg. The long term record indicates a steady increase over time (Figure 11). The annual peak in concentration (300 g/m<sup>3</sup>, June 2022) was of lesser concentration than in the previous monitoring period (400 g/m<sup>3</sup>, June 2021). This may suggest that peak concentrations have been reached in this well, however, further monitoring will assess for this over time.
- Sodium ranged 65-90 g/m<sup>3</sup>.
- pH remained relatively stable and weakly acidic, ranging 6.3-6.6 pH.
- No TPH or BTEX were recorded above the LOD in any of the four monitoring rounds this monitoring period.

Figure 9 Long term EC mS/m @ 25°C monitoring GND2302 2012-2022

Figure 10 Long term TDS g/m<sup>3</sup> monitoring GND2302 2012-2022

Figure 11 Long term chloride g/m<sup>3</sup> monitoring GND2302 2012-2022

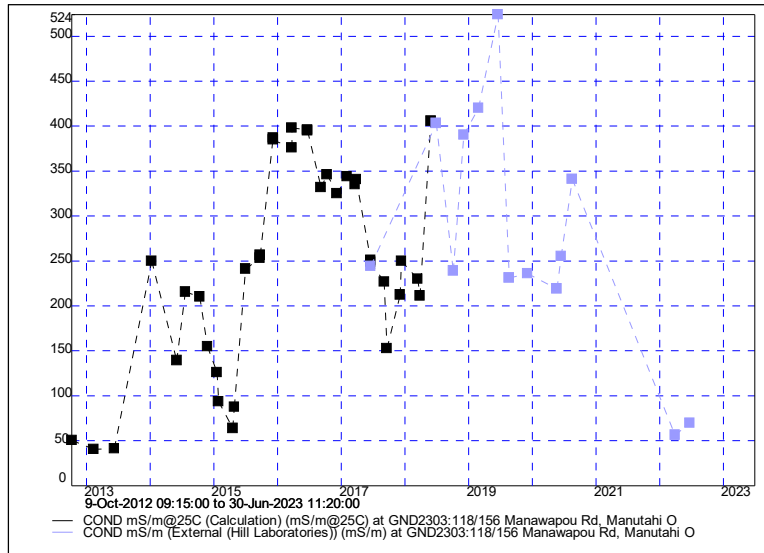
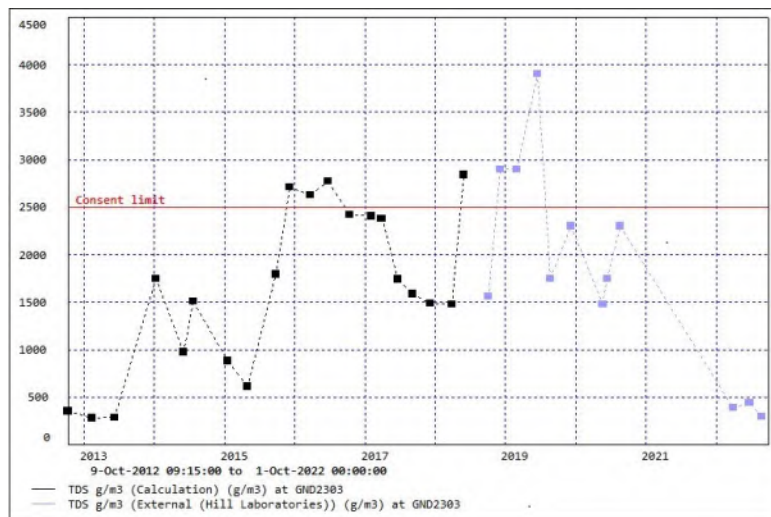
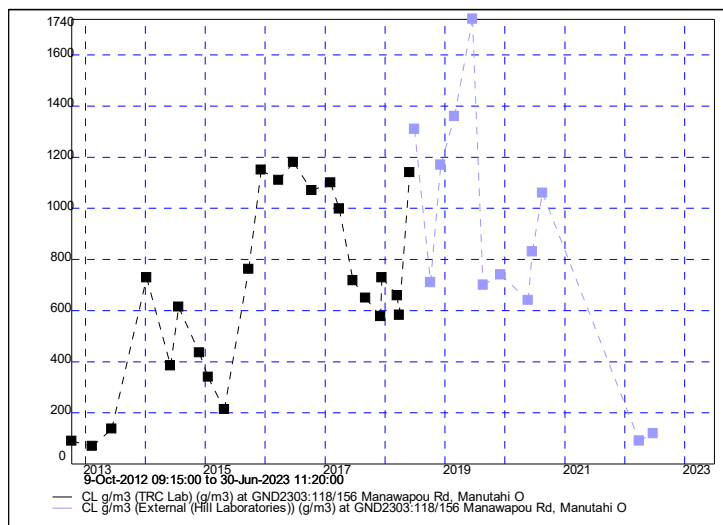
This monitoring well has recorded some elevated saline impacts to groundwater over the past ten years (Figures 12-14). TDS in particular (Figure 13) has been found to be in breach of consent 7795-1.1, condition 22 on seven occasions since 2015 (peaking at 3,900 g/m<sup>3</sup> in June 2019). However, the previous seven monitoring rounds had been below this limit.

The increase noted in EC, TDS and chloride appear to correspond loosely with landfarming dates undertaken by the Company over time. Area M1408 was finalised in at the end of August 2014, with elevation in these parameters noted to occur throughout 2015. Area M1610 was landfarmed in October 2016, while area M1810 was initiated in June 2017 through to October 2018.

- Temperature ranged 14.6-17.6°C.
- EC ranged 56.3-69.6 mS/m
- TDS ranged 390-440 g/m<sup>3</sup>
- Acid soluble barium was recorded at 0.61 g/m<sup>3</sup> in March 2022 and below the LOD in June.
- Dissolved barium remained stable and of low concentrations, ranging 0.043-0.047 g/m<sup>3</sup>.
- Chloride monitoring remained stable with a slight increase in the last round, ranging 90-119 g/m<sup>3</sup>. This concentration level is much lower than that recorded in the previous period which was 1060 g/m<sup>3</sup>.
- Sodium ranged 64-76 g/m<sup>3</sup>, which is also lower than the previous period
- pH remained relatively stable and weakly acidic, ranging 6.5-6.7 pH.
- Traces of C7-C9 were recorded at 0.32 g/m<sup>3</sup> in March 2022. No other TPH or BTEX were recorded above the LOD.

Figure 12 Long term EC mS/m @25°C monitoring GND2303 2012-2022

Figure 13 Long term TDS g/m³ monitoring GND2303 2012-2022

Figure 14 Long term chloride g/m³ monitoring GND2303 2012-2022

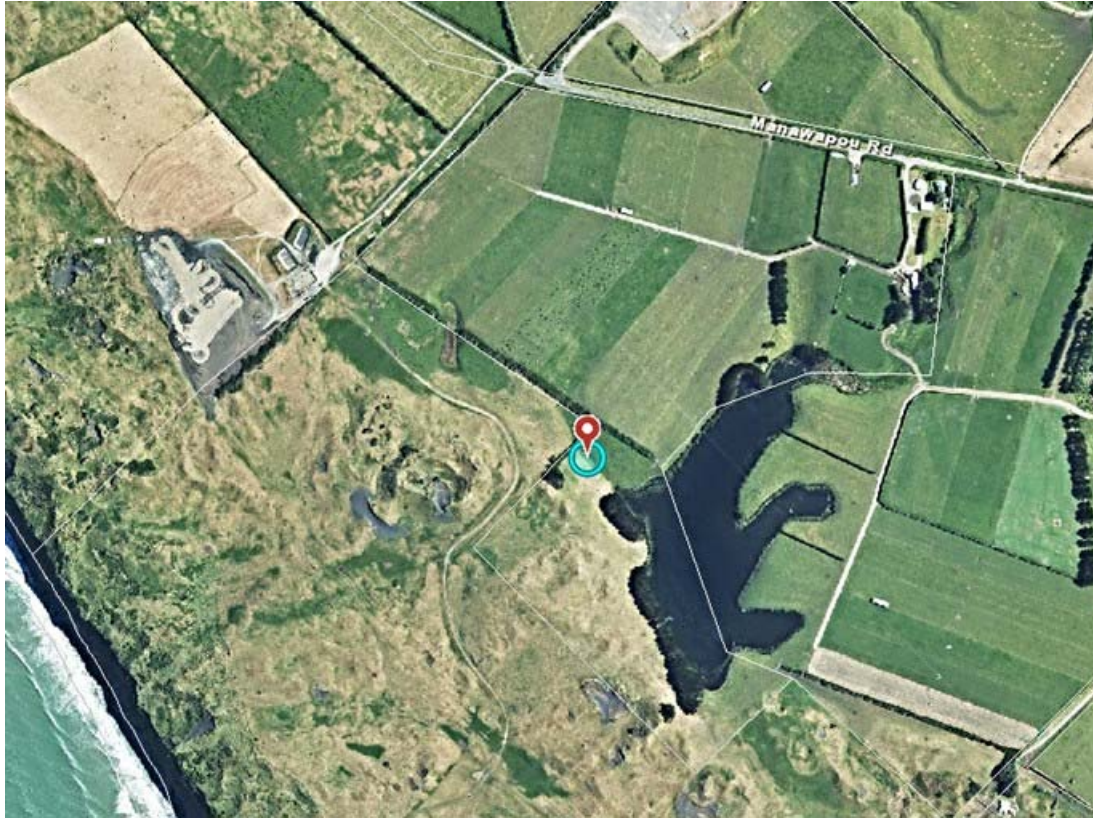
A surface water sample (Table 6) was collected from Lake Taumaha (Figure 15) this monitoring period.

Figure 15 Sample location Lake Taumaha

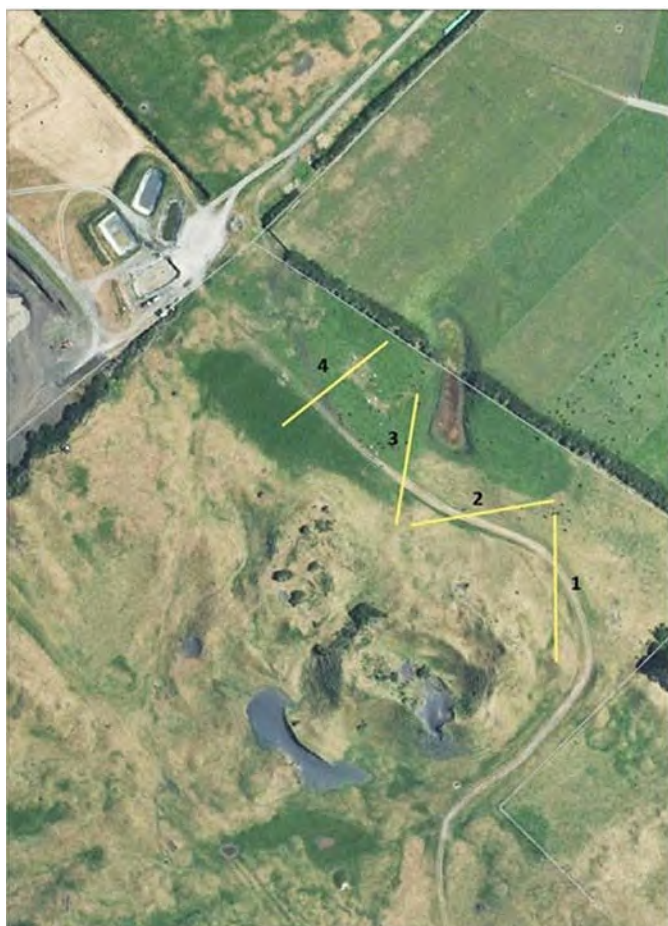
Figure 16 Location of soil transects in relation to WRS Symes Manawapou Landfarm for 2021-2022

- Area M2110 due to concentrations of TPH C<sub>10</sub>-C<sub>14</sub> & C<sub>15</sub>-C<sub>36</sub> being above consent criteria of surrender will need further monitoring.

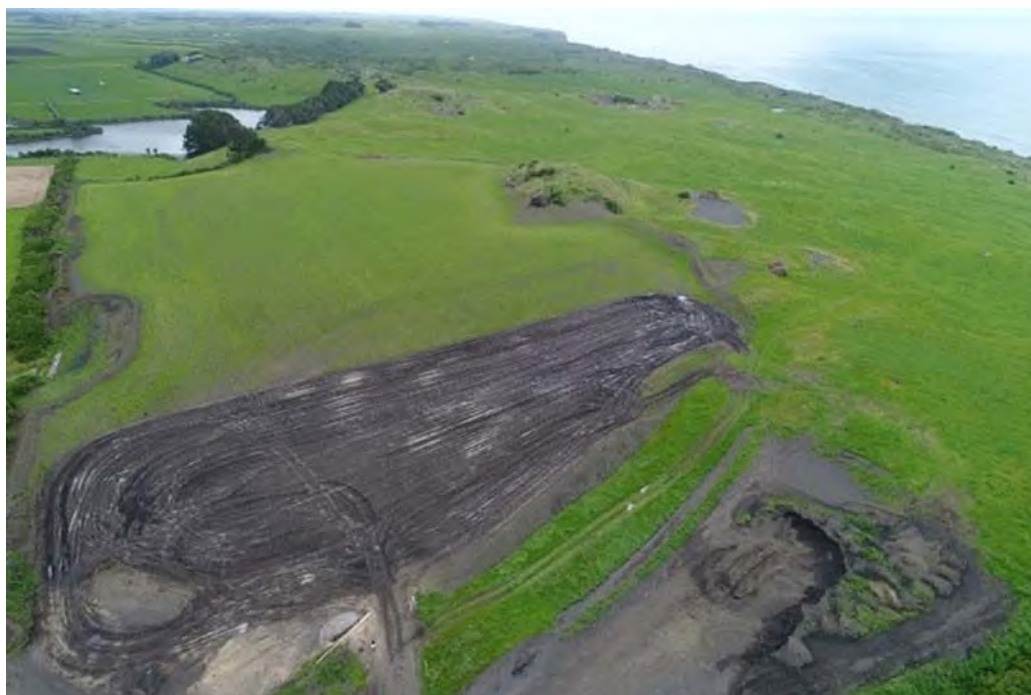
During 2021-2022 there has been a high level of activity. Preparation of a new spreading area in Stage 2 seaward westward of site M2110 was undertaken; the continuum of waste receipt, spreading and remediation continued during this monitoring period. (Photo 4)

Photo 4 Ground preparation westward of M2110 (looking south via drone) (Image supplied by WRS)

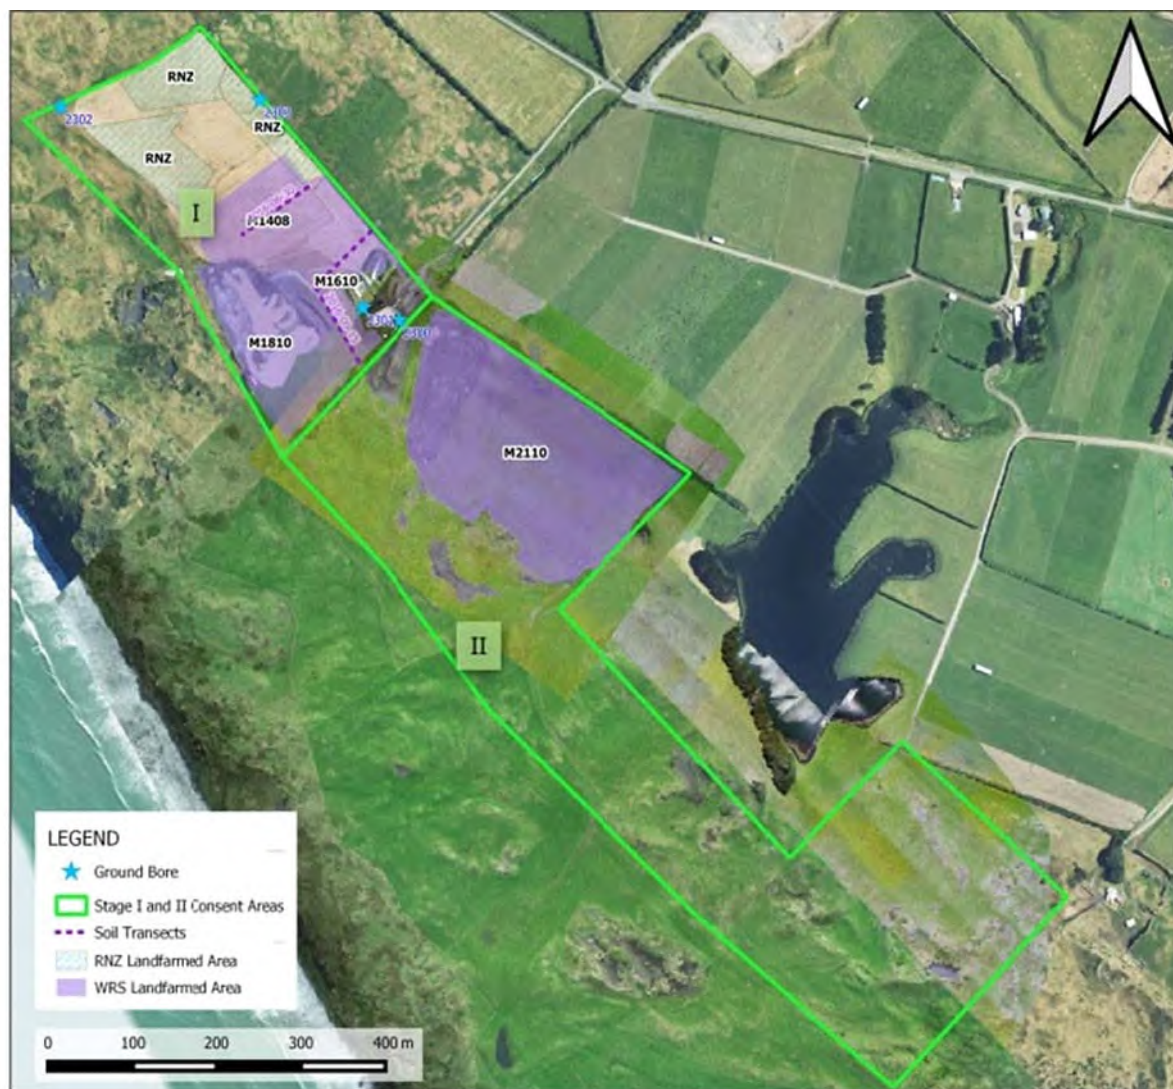
The Company provided the Council with an annual report, as required by condition 13, of consent 7795-1.1. A copy of the Company report is attached in Appendix II. Table 8 contains the delivery record for material accepted by the landfarm during this monitoring period. Figure 17, also provided by the Company, is a map of the previous and current landfarming operations.

Figure 17 WRS provided map of landfarmed areas

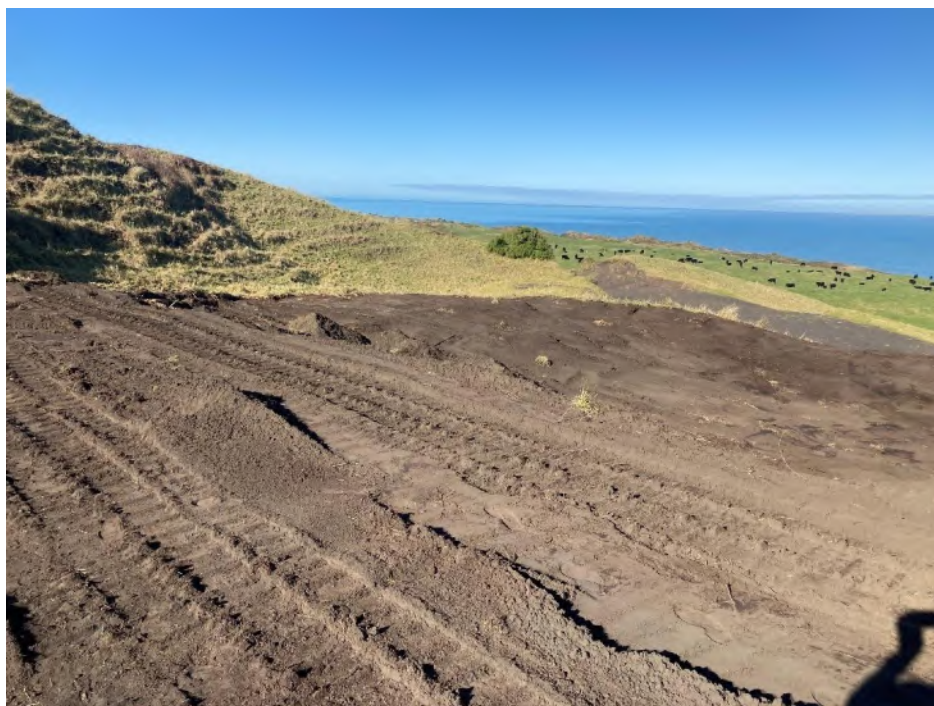
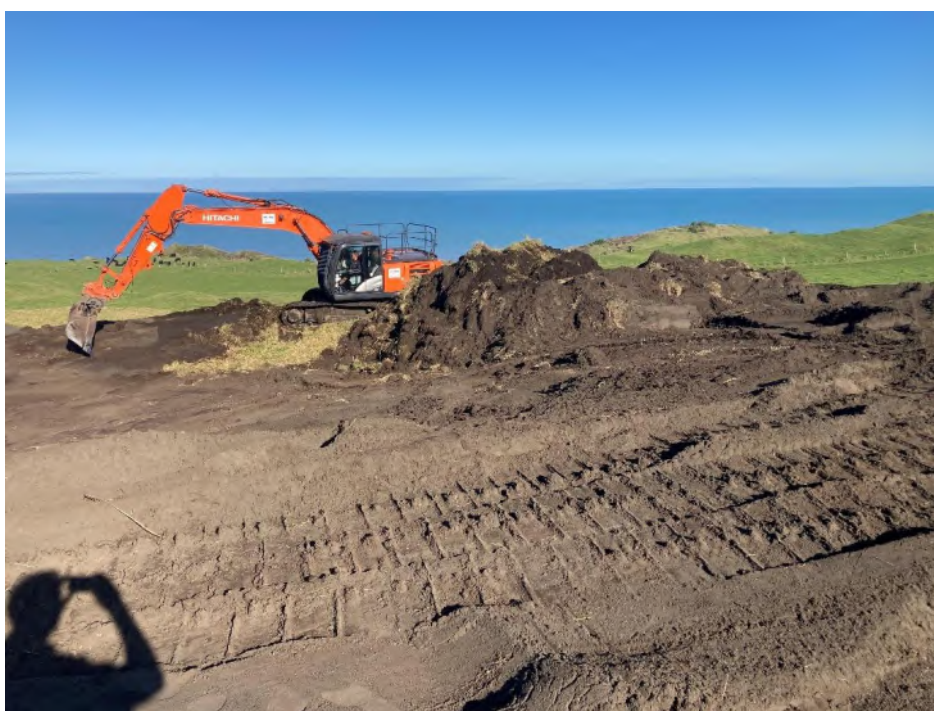
Ground Preparation Westward of M2110 (looking SW)

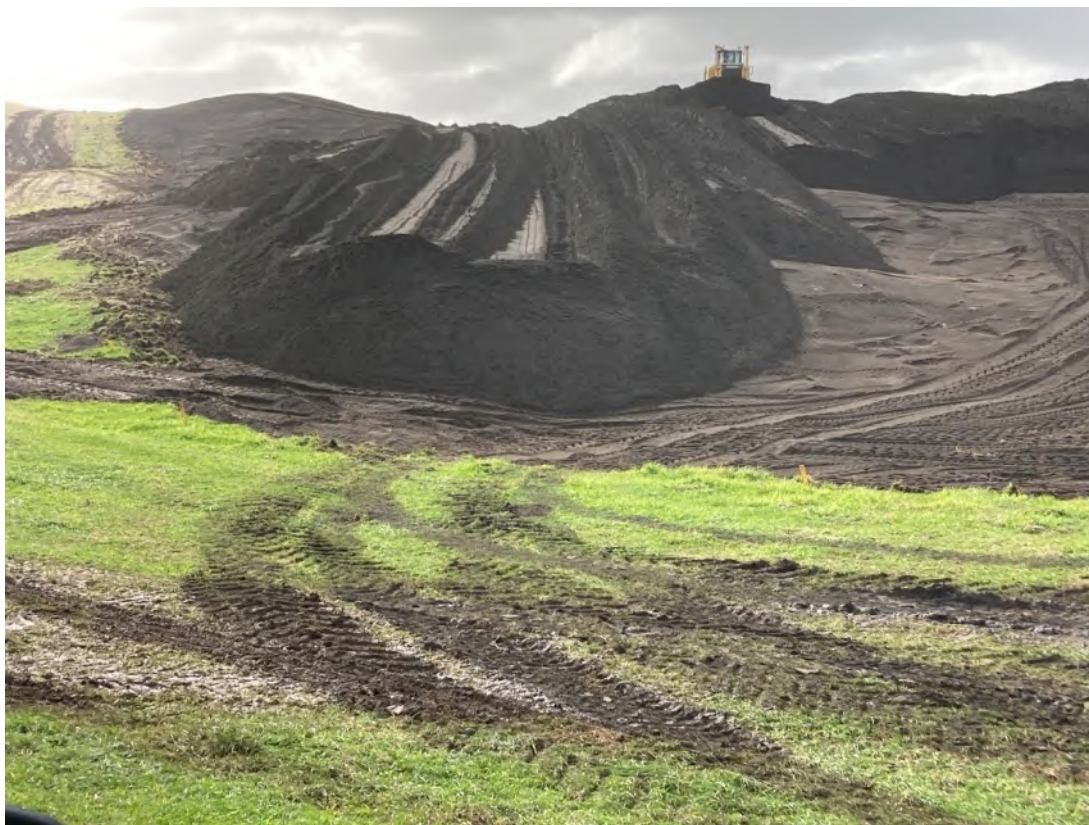
Ground Preparation Westward of M2110 (Looking NW)

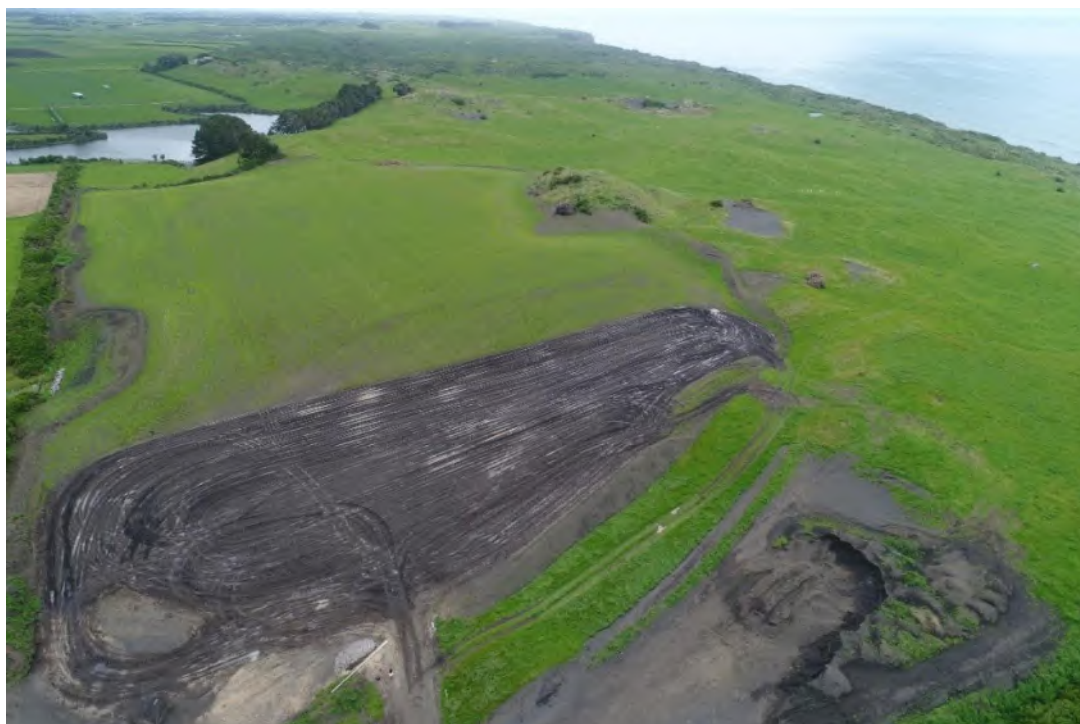
Ground Preparation Westward of M2110 (Looking S via Drone)

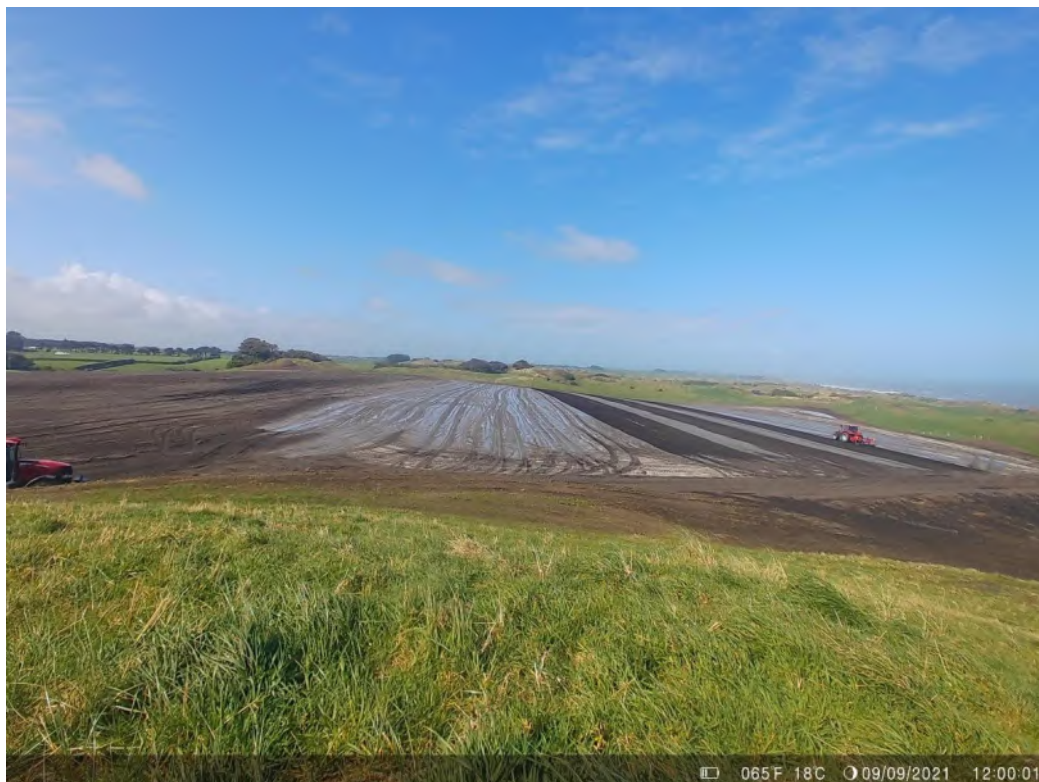
Spreading/Deep Ripping Incorporation into Sands

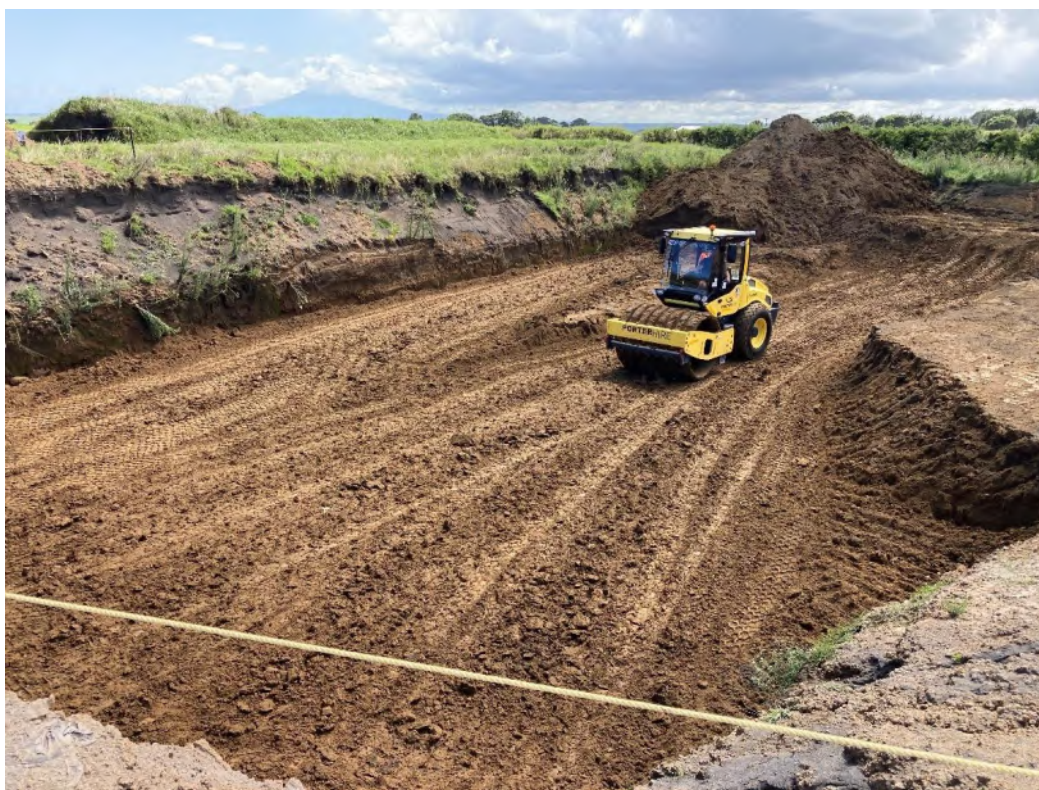
Pit floor Construction/Compaction.

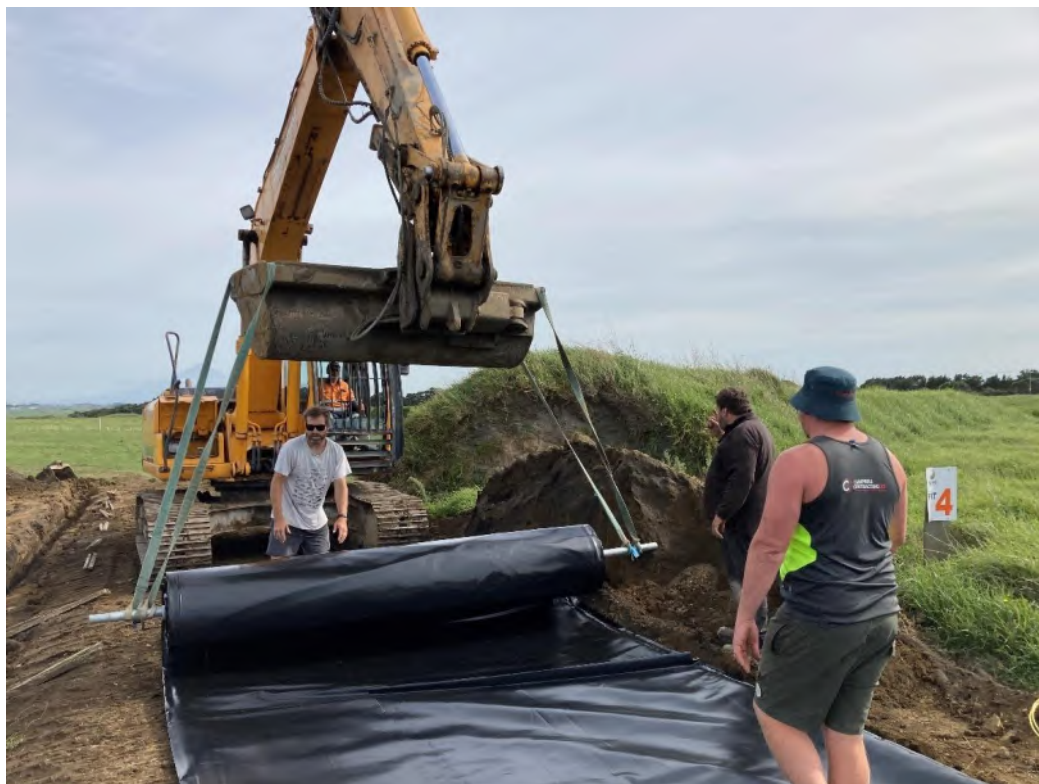
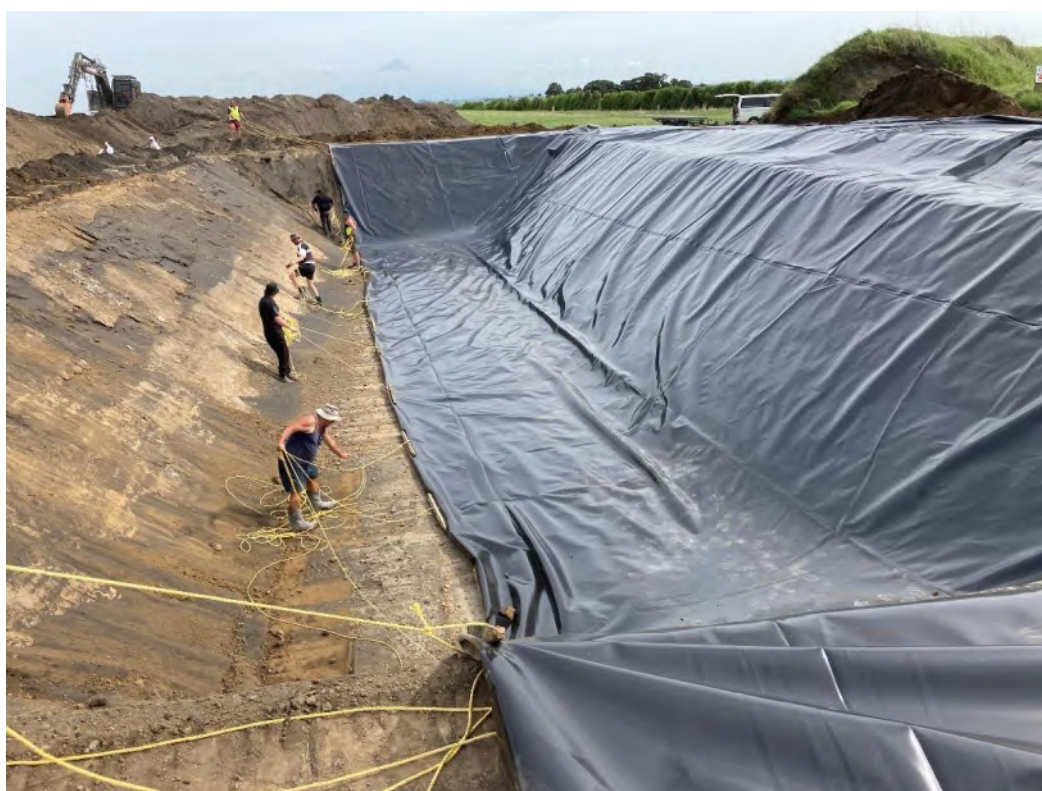
Pit 2 Liner installation.
