STDC Coastal Structures  
Monitoring Programme  
Monitoring Report  
2007-2008

Technical Report 2008–43

Taranaki Regional Council  
Private Bag 713  
STRATFORD

November 2008

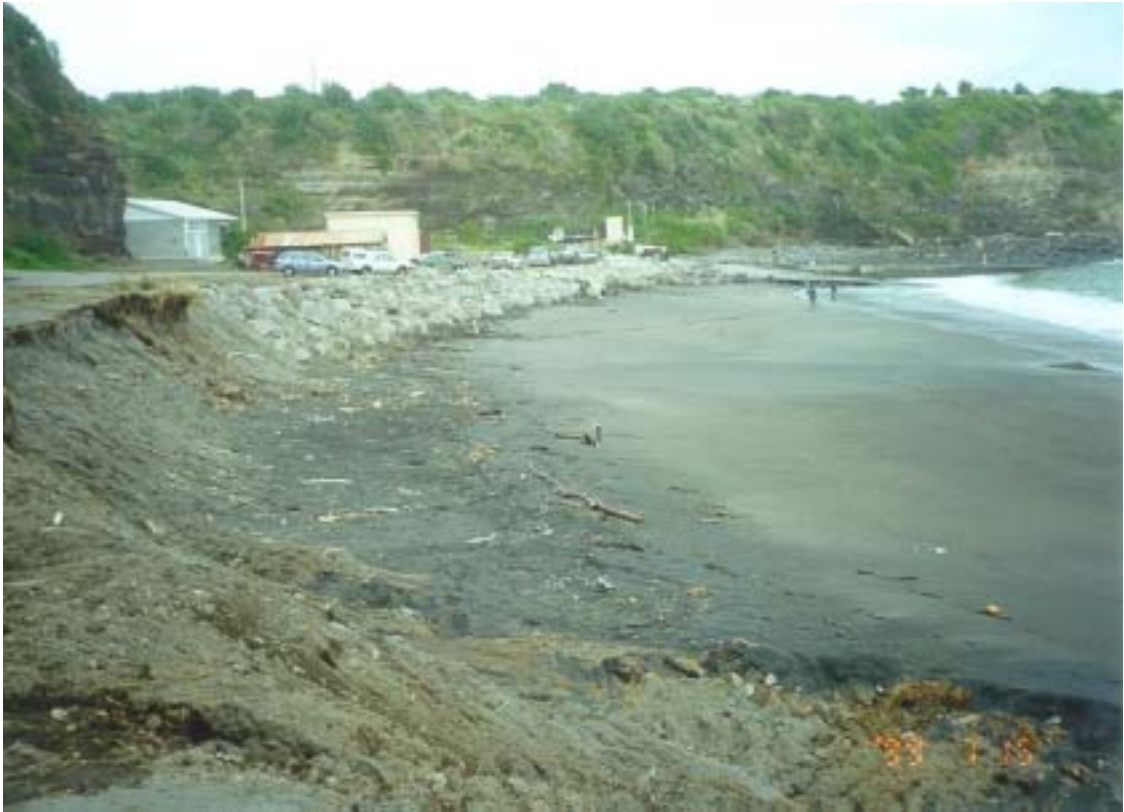
**Photograph 1** Construction of rip rap seawall, Middleton Bay July 1999

Subsequently, STDC applied to reconstruct, and maintain a boulder rip rap seawall on the foreshore at the southeast end of Middleton Bay for coastal erosion protection purposes (Photograph 1). This application was granted as coastal permit 5504.

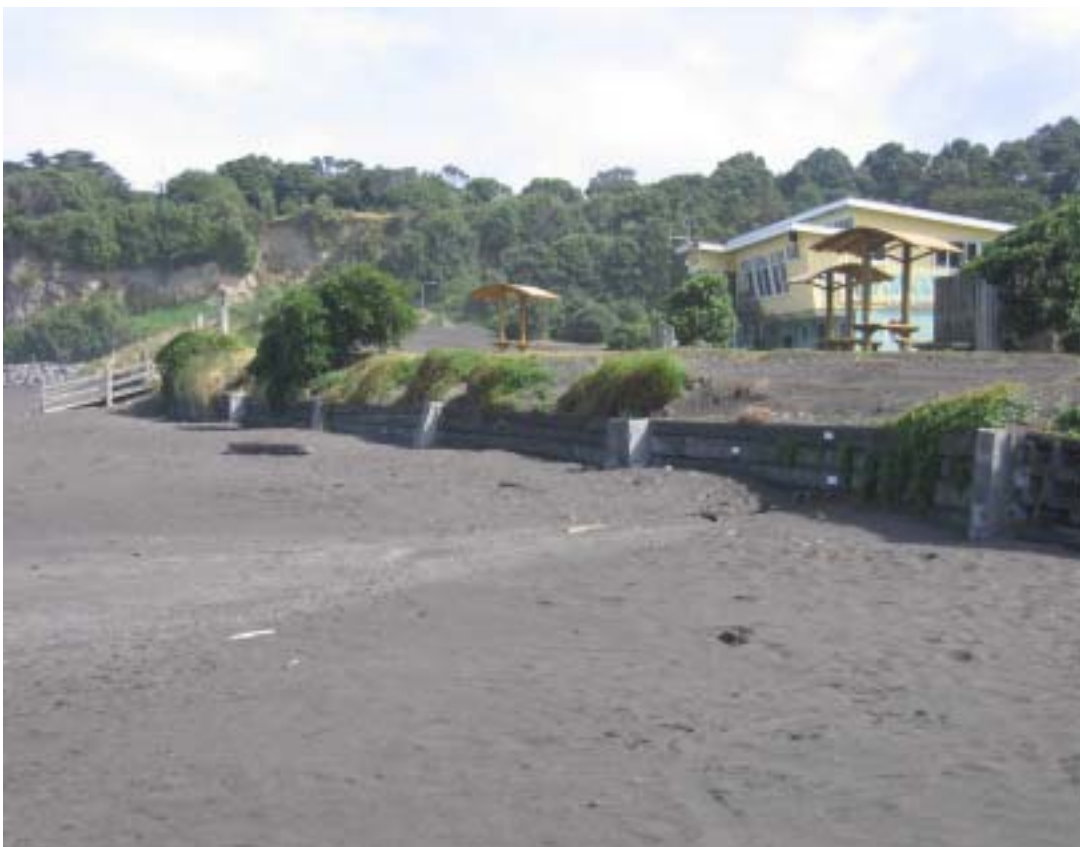
**Photograph 2** A section of the Opunake Beach retaining wall

The structure covered by this permit consists of a low retaining wall which stretches the length of Opunake Beach. Breaks and ramps in the wall provide pedestrian, vehicular and inflatable rescue boat access to the beach. The structure was constructed in stages, some of which are many years old. The structure was constructed in order to stabilise the natural accretion which has occurred on the beach and to protect and enhance the recreational facilities which exist immediately landward of the beach.

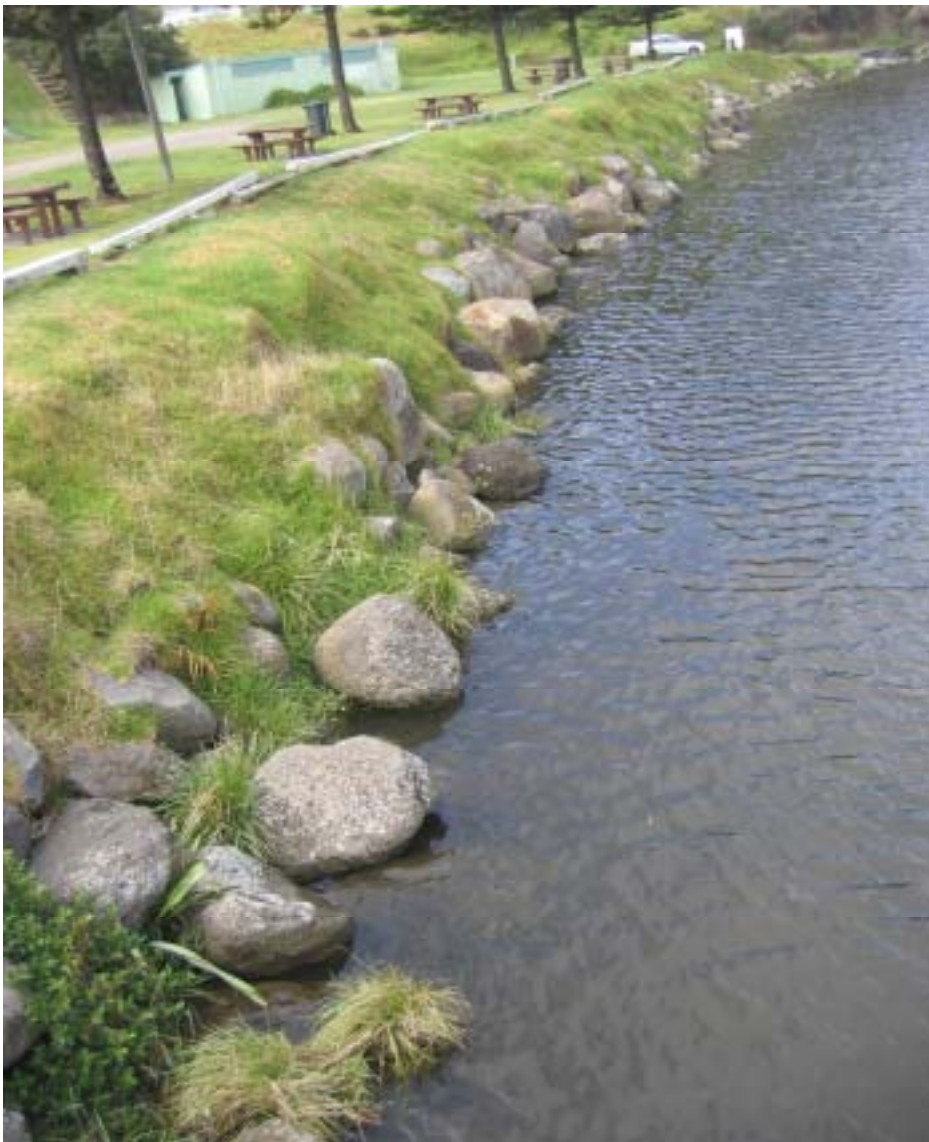
**Photograph 3** Looking upstream along rock protection works in the Kaupokonui Stream

Following receipt of a complaint regarding works in the Kaupokonui Stream in 2002, investigation by Council officers discovered that substantial boulder rock rip rap had been placed on the true left bank of the Kaupokonui Stream (Photograph 3).

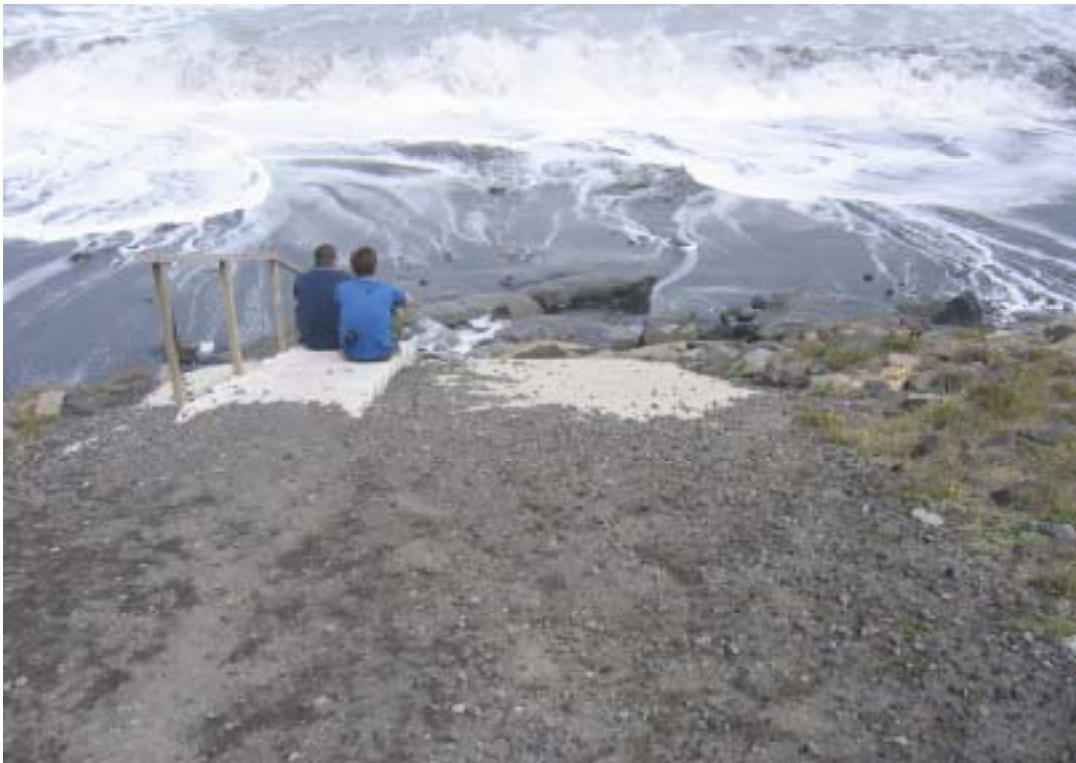
**Photograph 4** Accessway to Waihi Beach, Hawera

The gabion mattress measured 6m x 2m x 0.23m in size and was placed on existing rocks. Surrounding the rocks a geo textile fabric was used to prevent the scouring of sand and to increase the longevity of the structure.

Once completed, the structure was covered in concrete to further aid pedestrian access.

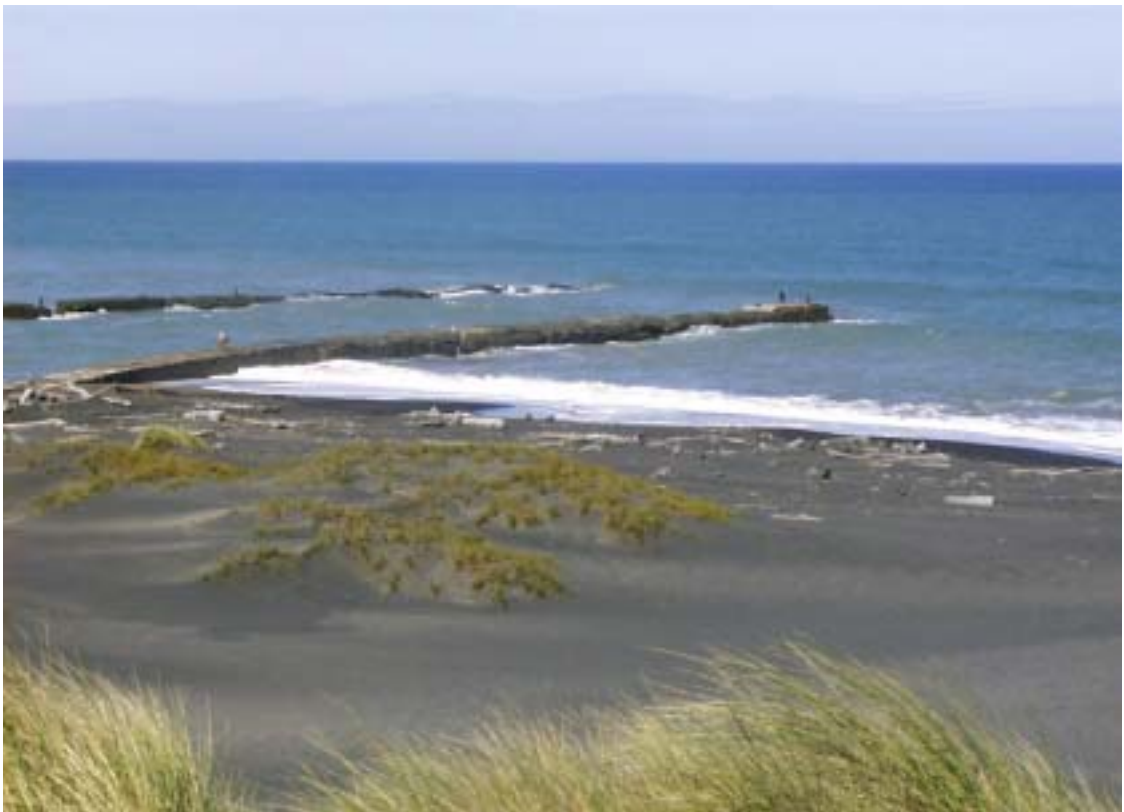
**Photograph 5** Patea River groynes

Significant levels of erosion have occurred along this coastline during the past 50 years which has led to the river moles becoming seriously degraded. Studies undertaken by consultants (Duffill Watts & King, 2006) have shown that with the current condition of the moles and rate of shoreline change, the river moles could decay, threatening the overall stability of the river entrance. If the stability of the river entrance was changed, it could mean the passage between the river and sea is no longer navigable.

From the studies undertaken by Duffill Watts & King in 2006, it was found that without some intervention process the Patea River will break through behind the southeast mole within 20 to 25 years which would prevent navigable access to the sea. It was proposed that the most effective method to maintain a navigable river entrance for small seagoing craft was to reconstruct the southeast seawall. Consent **6839** was granted, with the works aimed to constrain the river channel to its existing alignment and prevent it from breaking through behind the left mole.

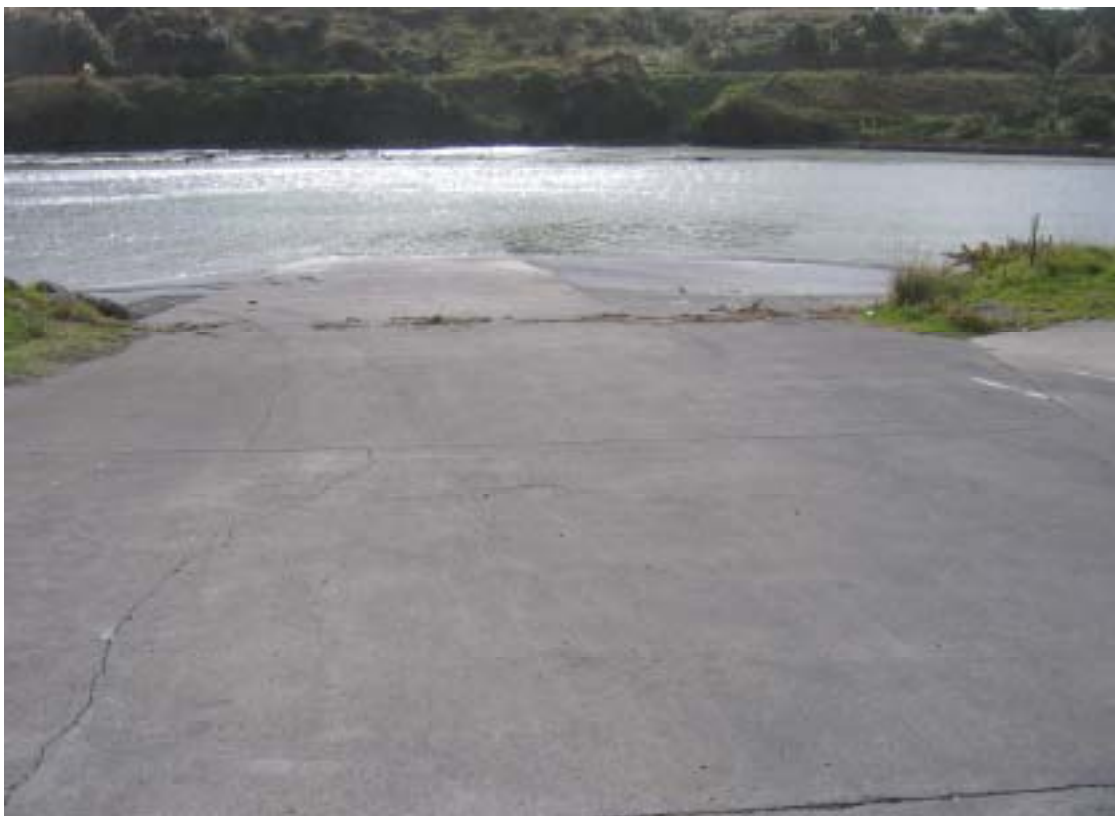
**Photograph 6** Patea boat ramp

The boat ramp at Patea has been in existence for many years, providing one of the few good, effective and safe boat launching facilities on the South Taranaki coast (Photograph 6). The facilities experience extensive use and are considered to be one of Patea's more important recreational facilities.

The launching ramp was an undular concrete pad which extended from the end of the formed roadway of Turi Street, down to approximately the low tide level of the river. Upon granting of coastal permit 4566, the STDC strengthened the existing boat launching ramp by placing a concrete strengthening overlay over the existing ramp. The overlay is seven metres wide and extends a further three metres down into the river than the previous ramp, improving the launching facility.

The overlay was contoured so it is more consistent with natural beach profiles than the previous ramp and is therefore expected to have less effect on riverbed/beach processes than the previous ramp. In association with expanding and strengthening the ramp, the STDC reinstated and rock protected the eroding riverbank both immediately upstream and downstream of the ramp. The bank protection was wrapped smoothly into the existing bank and aligned in a manner which is compatible with wave refraction/diffraction patterns and which will not adversely affect natural river processes.

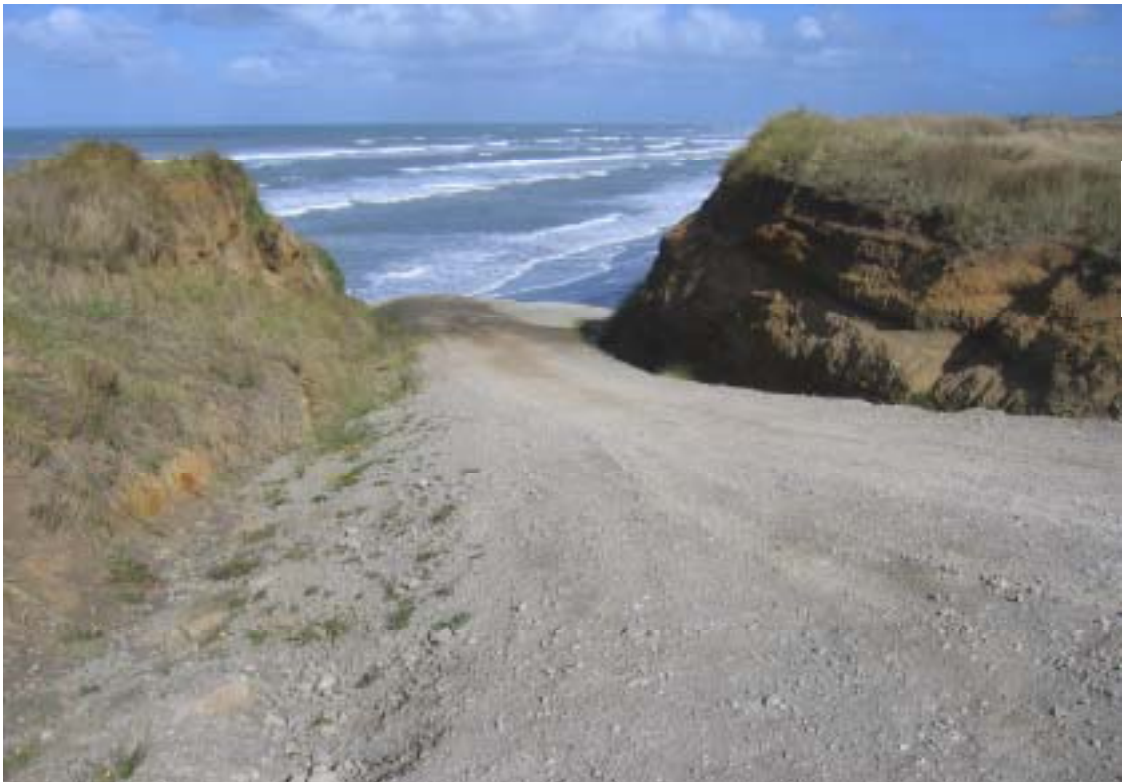
**Photograph 7** Accessway to Waverley Beach

The accessway covered by consent 4567 has been in existence for many years (Photograph 7). It was originally formed in order to provide access to the beach down the steep coastal cliffs present in the area. The accessway is basically a bulldozed track which traverses down the mudstone cliffs. The accessway relieves access pressure from the fragile vegetated sand dunes which separate the beach from the Waverley Beach settlement, and as such has a role in protecting the environment.

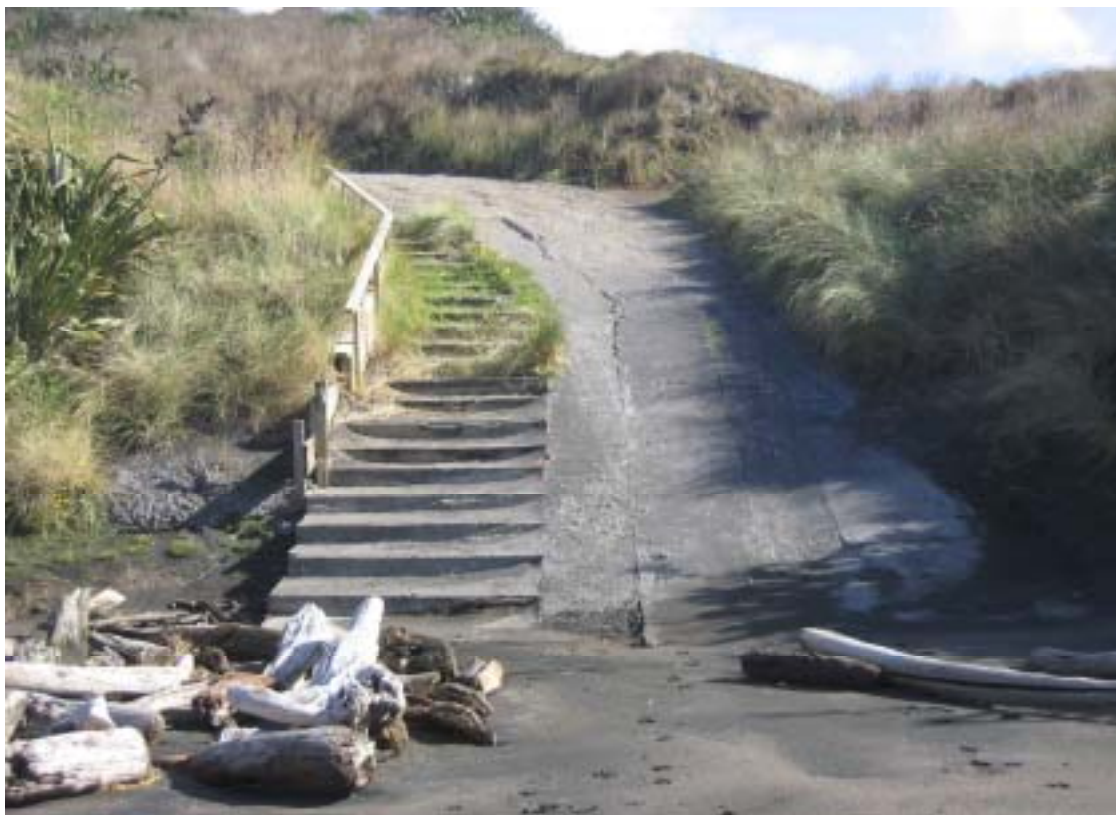
**Photograph 8** Access ramp and steps, Caves Beach Waverley

The structure covered by consent 4579 consists of a concrete public access ramp way, 20 metres in length and 3 metres in width with an associated 2 metre wide by 16 metre long concrete step-way down the western edge of the ramp (Photograph 8). The ramp

extends down to the beach sands from the upper ground level of the mudstone coastal bluffs, providing access to the coastal Caves Beach area for the cave and beach viewers/visitors, again reducing pedestrian damage of the fragile sand dunes.

The access steps and ramp down to Caves Beach were satisfactory. It was noted that erosion to the north of the steps may effect access to the structure in the future.

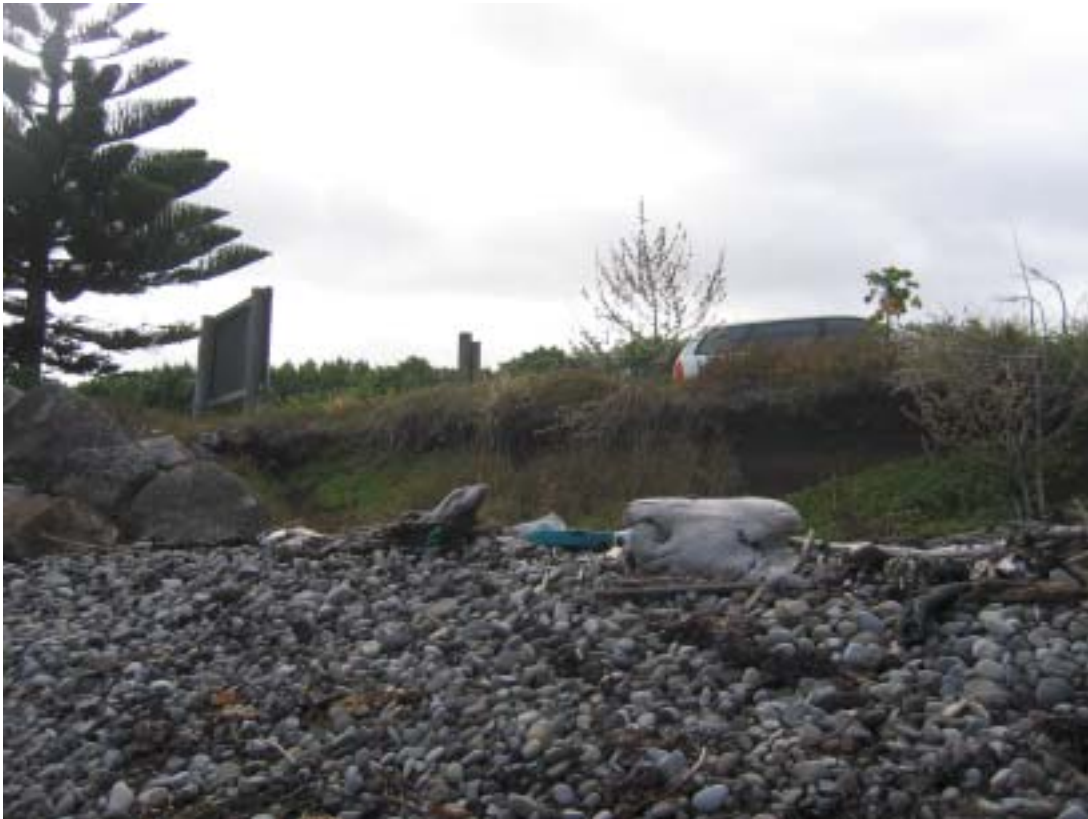
**Photograph 9** Erosion at the end of the Bayly Road seawall, Cape Egmont

An inspection of the Bayly Road seawall was undertaken on 25 February 2008. The northern part of the wall was satisfactory. Erosion of the wall had occurred for a distance of approximately 50 metres just below the power pole at the end of Bayly Road (Photograph 9). It was recommended that this length of wall should be re-instated to comply with the consent and to prevent further erosion.

The seawall at the end of Bayly Road, Cape Egmont is eroding at the southern end and it was recommended that this length of wall should be re-instated to comply with the consent and to prevent further erosion.

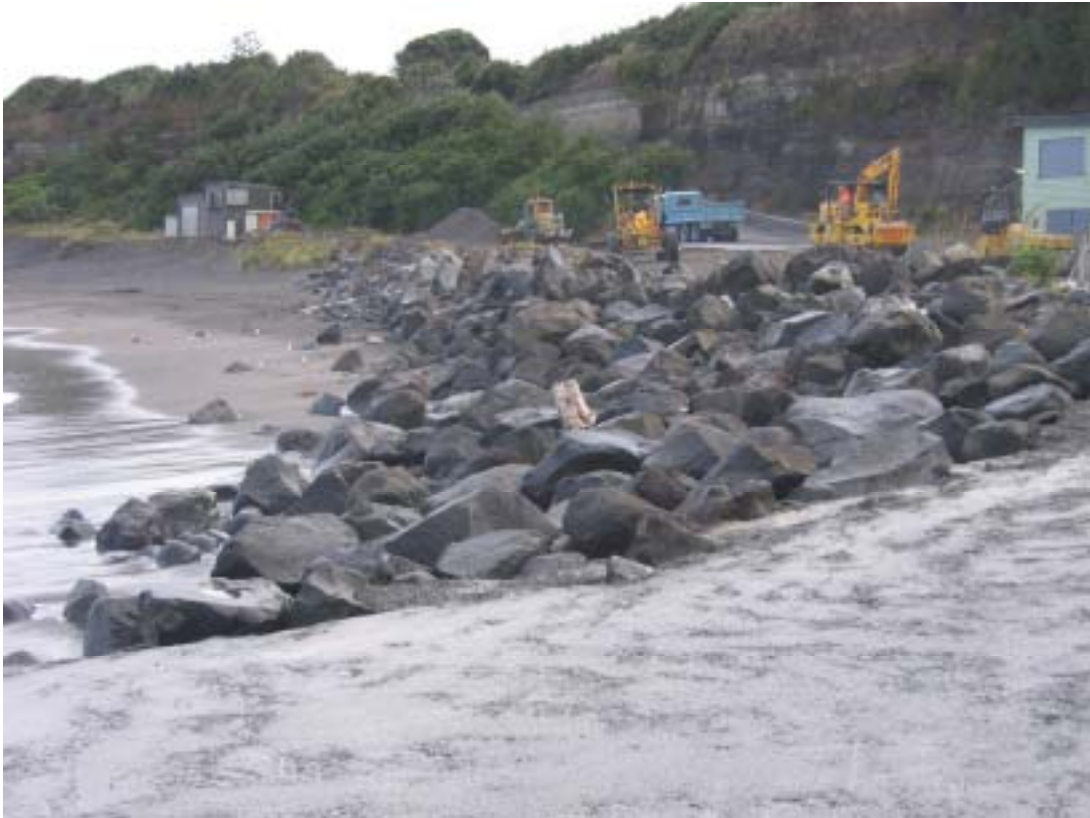
**Photograph 10** Middleton Bay seawall

An inspection of the Middleton Bay seawall (Photograph 10) was undertaken on 25 February 2008. The wall appeared to be a similar length as consented for, however boulders had been dislodged and were strewn across the beach. It was noted on the inspection notice that it would be the best interests of STDC (though not strictly required by TRC at this stage) to re-form the revetment in order to maintain a sandy beach and reduce the risk of storm surges cutting into the land behind the wall.
