Wai-iti Motor Camp
Monitoring Programme
Annual Report
2009-2010
Technical Report 2010–06

Taranaki Regional Council
Private Bag 713
STRATFORD

July 2010

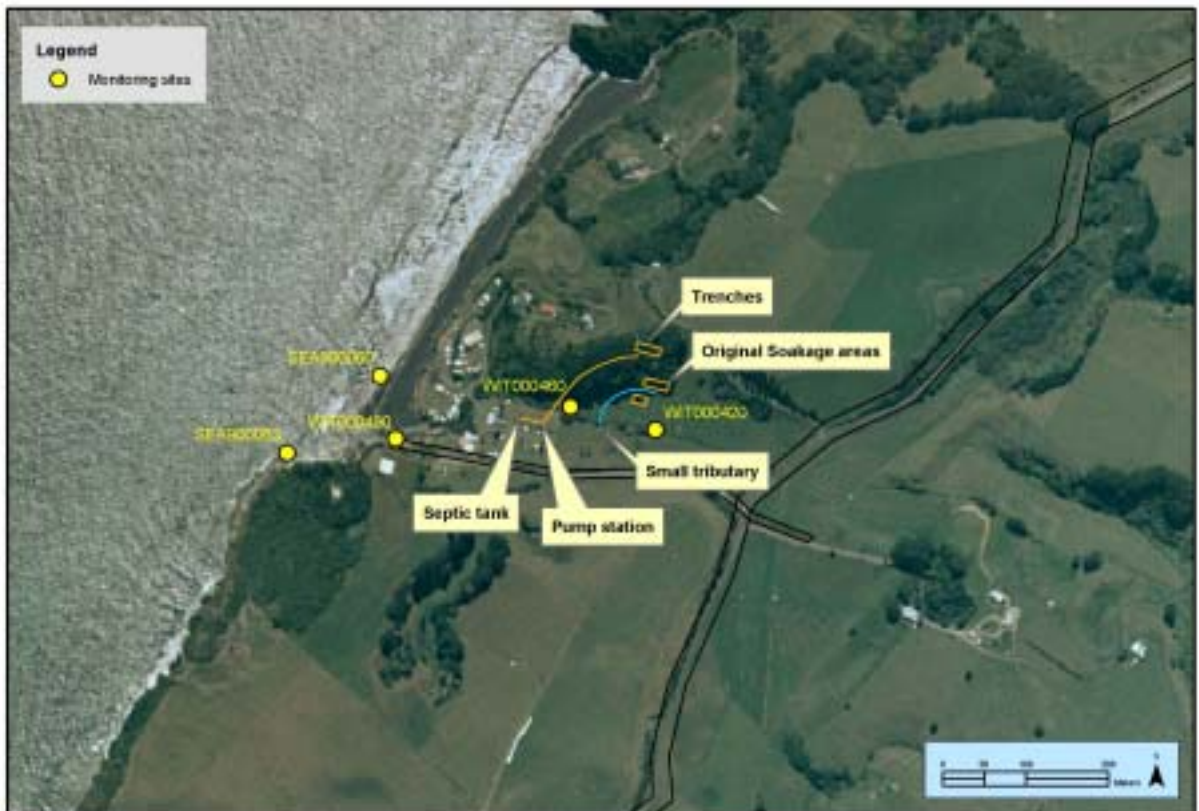
All wastewaters from the camping ground enter a septic tank of 143 cubic metre capacity. The effluent is then pumped via a 50 mm alkathene pipe across the Wai-iti Stream and into soakage trenches situated on a wooded hillside approximately 30 metres from the stream.

Figure 1 Location of sewage treatment system and sampling sites at the Wai-iti Motor Camp

Samples are collected at five sites; three in the Wai-iti Stream, and two coastal sites either side of the stream mouth (Photograph 2). Site locations are detailed in Table 1 and illustrated in Figure 1.

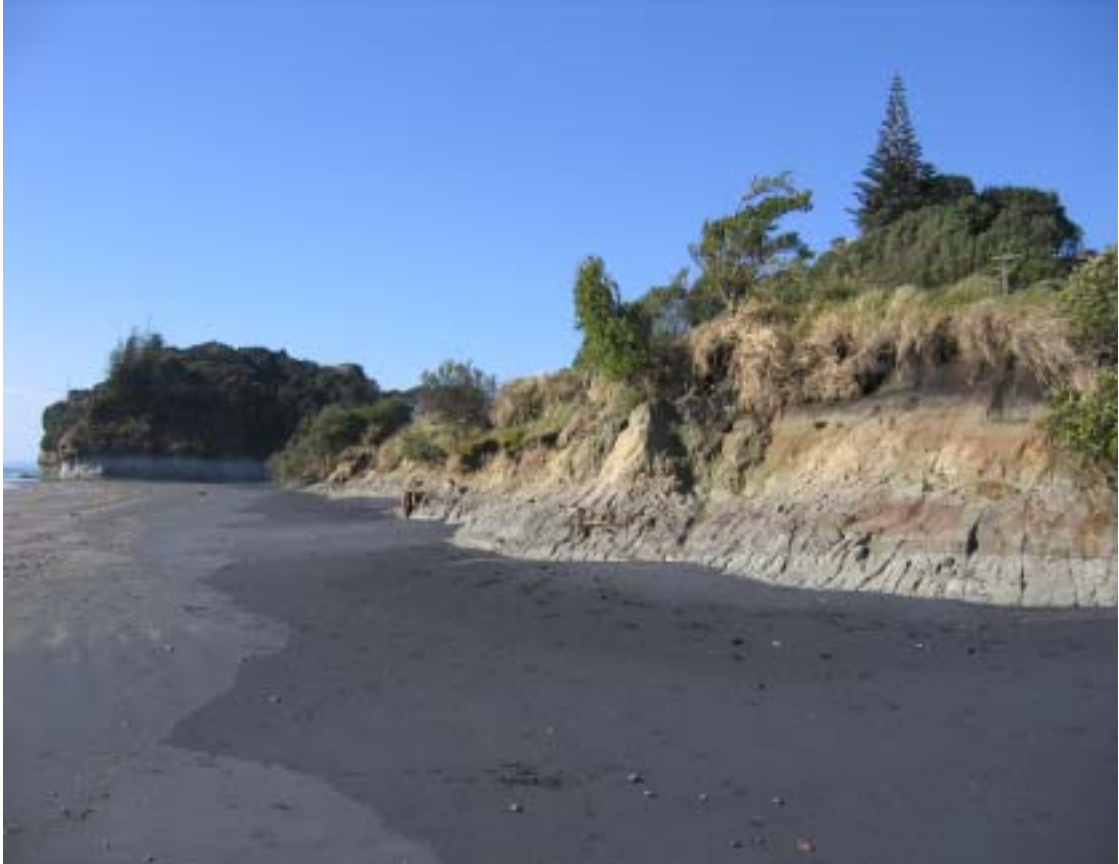
Over the summer and autumn months of 2004, rough seas combined with high tides reached the beach toe of the coastal banks and sand dunes that front Wai-iti Motor Camp. Fresh erosion scarps were cut into these banks for nearly the full beach frontage where no system of protection exists (photograph 1).

Photograph 1 Erosion on Wai-iti foreshore prior to construction of the rock rip rap seawall

In 2005 an application was received for a resource consent to provide boulder rip rap protection over a total distance of 293 metres from the stream at the south end of Wai-iti Beach to an area of existing large boulder protection in the north. This consent was granted in July 2005. To mitigate any possible end affects, the area between the public entrance and the river was also protected using the boulder rip rap method.

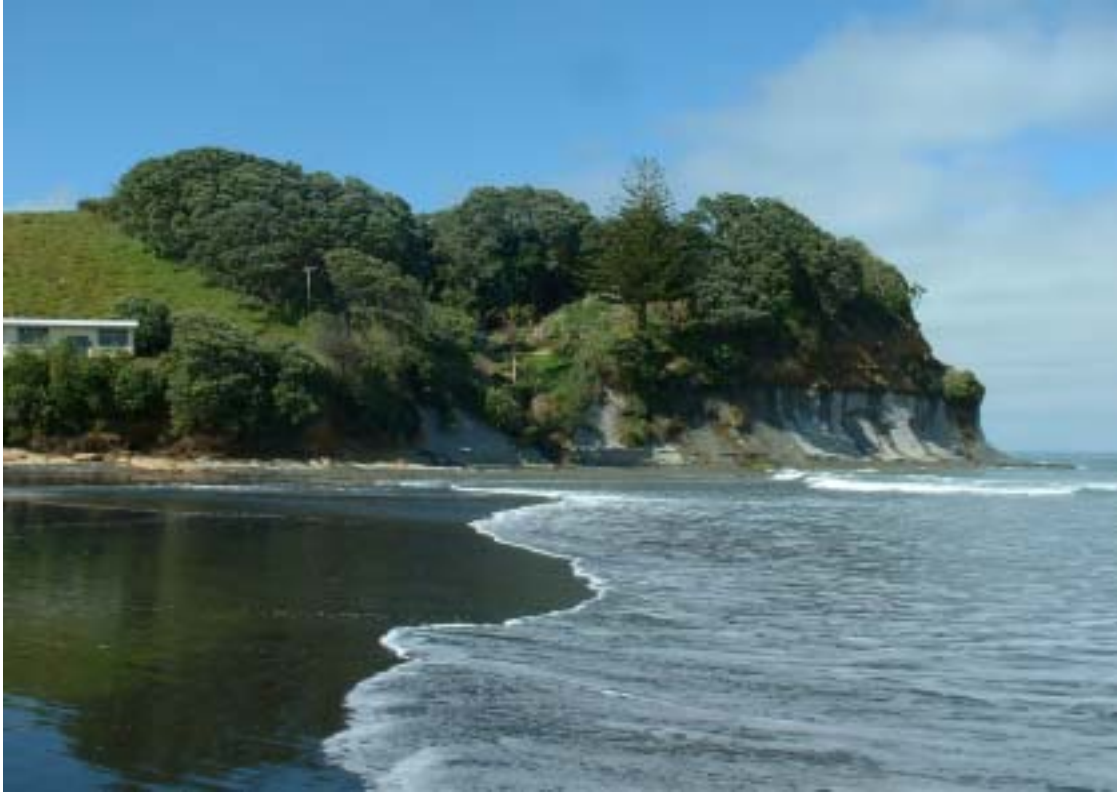
Photograph 2 Photograph taken at site 4, looking towards site 5, with the Wai-iti Stream entering from centre left

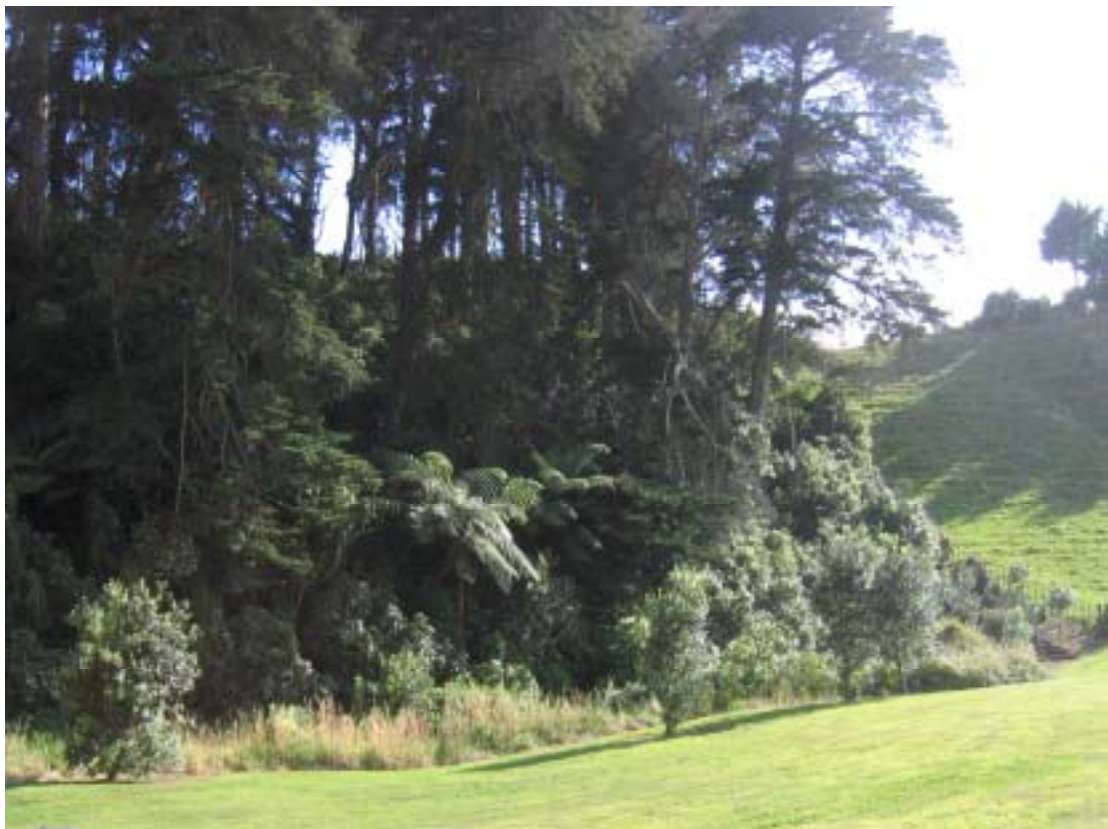
The first inspection was performed on 15 December 2009, prior to the period of peak usage. There were no odours present in the vicinity of the septic tank or trenches (Photograph 3). The camp site was looking very clean and tidy.

Photograph 3 Wai-iti Beach camp trenches on hillside covered with trees

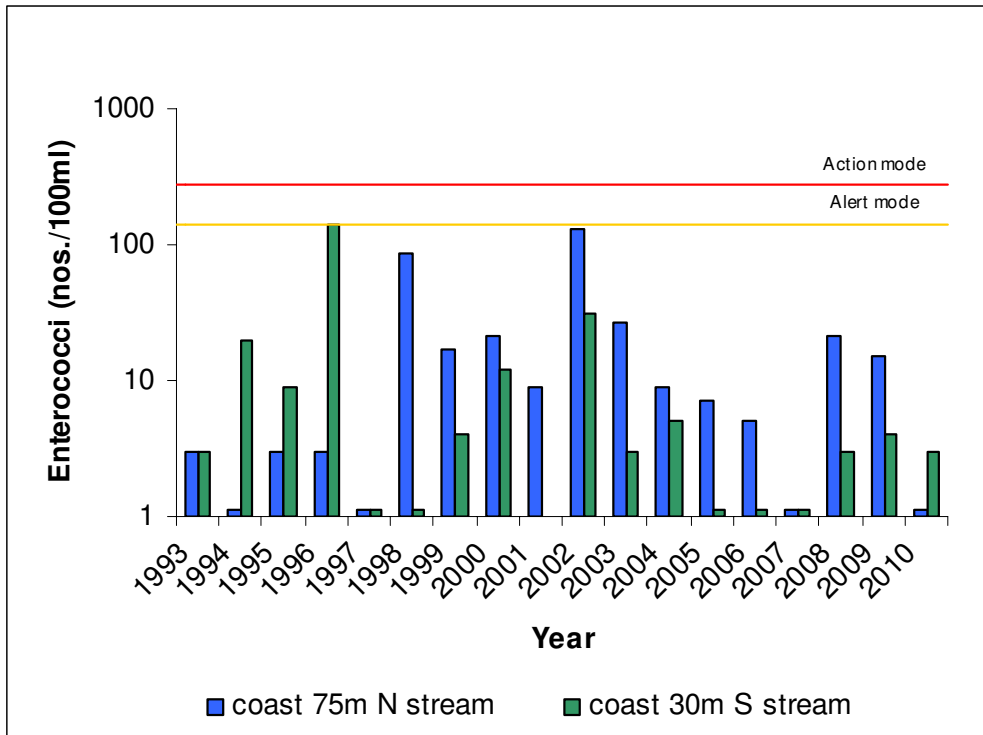
At 1 (75m north) and 3 (30m south) cfu/100ml, enterococci in samples collected at the coastal sites were well below the guidelines set out by MfE for recreational contact use. Figure 2 below presents results obtained from 1993 to the present monitoring period. The graph shows that no samples have exceeded either 'Alert' or 'Action' modes, indicating that the water is suitable for recreational bathing at the two coastal sites.

Figure 2 Enterococci (nos/100 ml) results at the two coastal sites since 1993
