South Taranaki District Council
Eltham Wastewater Treatment Plant
Monitoring Programme
Annual Report 2008-2009

Technical Report 2009-42

October 2009

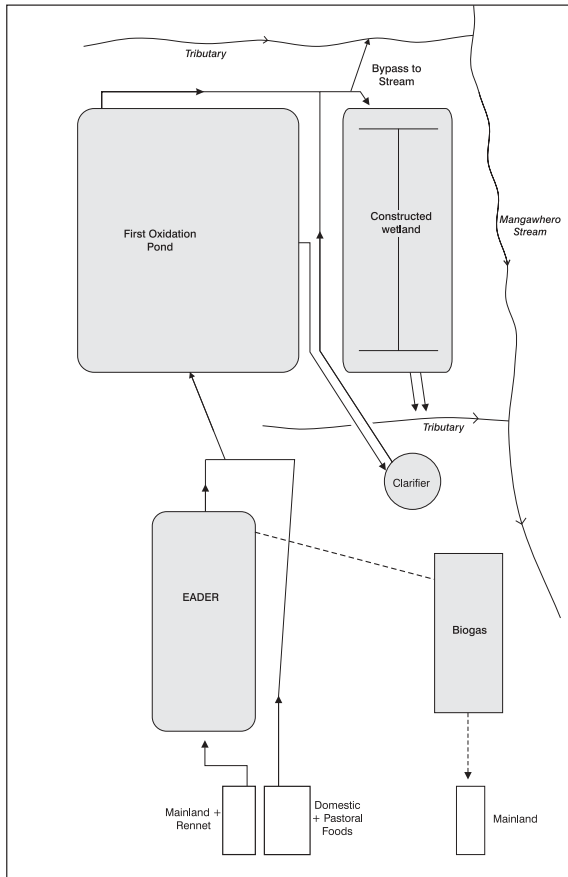
Figure 1 Schematic layout of Eltham wastewater treatment plant as at 30 June 2009

No alterations to the layout of the wastewater plant occurred during the year under review. At the end of the 2008-2009 monitoring period the layout remained as illustrated in Figure 1, with wetlands vegetation remaining stable, while the wastewater levels were generally maintained at a suitable depth to provide for plant development. No use of the clarification component of the system was made during the period.

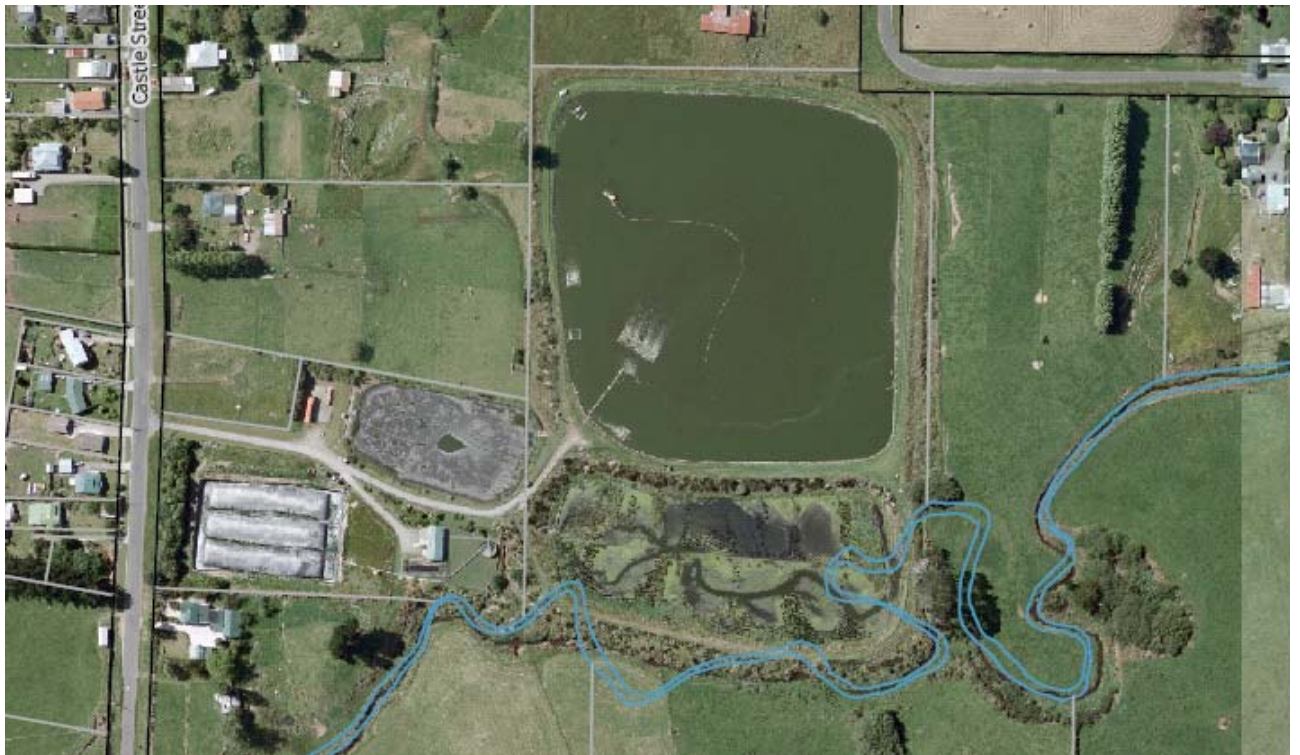
Figure 2 Aerial view of the Eltham WWTP showing the sludge geo-textile bags disposal area (lower LH corner) near the plant entrance

The primary pond was de-sludged during the 2006-2007 monitoring year with the de-watered sludge contained in geo-textile bags in an excavated, bunded area adjacent to the EADER (Figure 2). De-waterings and stormwater from this area continued to be returned to the primary pond through the clarifier during 2007-2008 and 2008-2009 and no odour problems were associated with this operation. However, STDC water treatment plant sludge was placed over the geotextile bags during 2008-2009 (Photos 1 & 2) without consultation, resulting in neighbours' concerns with respect to future sludge disposal at this site. The original intention had been to dispose of the Eltham WWTP pond sludge to the Patea landfill which, however, was subsequently closed.

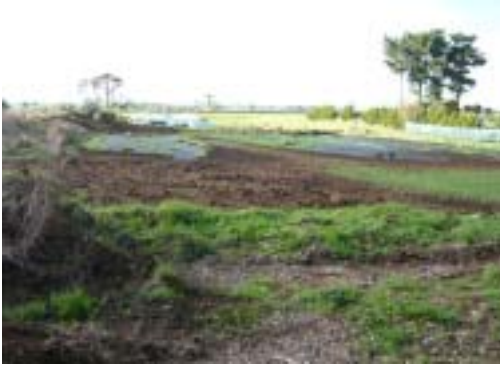
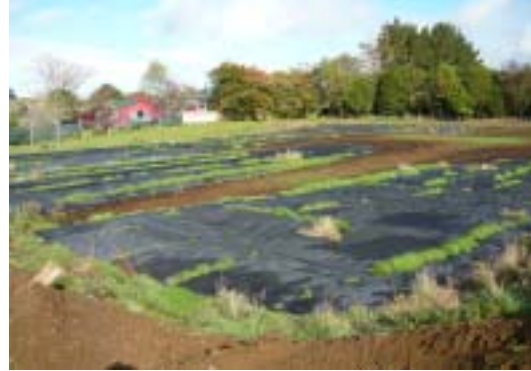
Photos 1 and 2 Water treatment plant sludge and geotextile WWTP sludge bags, May 2009

After meetings with interested parties STDC was advised that there were no specific issues preventing the consented burial of this sludge on site as chemical testing indicated that it was suitable for land disposal. Although STDC was planning to provide a sludge disposal facility at Whareroa (to take both water and wastewater treatment plant sludges), it was considered that rather than transport the Eltham sludge to that site, a one-off on-site disposal event was appropriate and could be consented. An application for such a consent is currently in preparation.

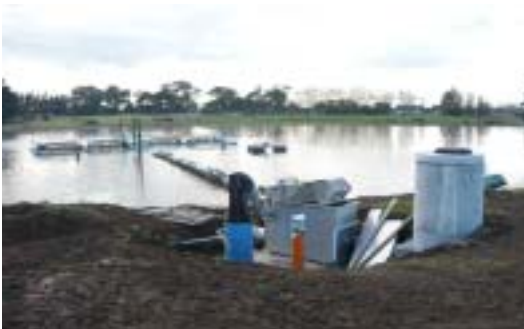
Photo 3 Step screen at new inlet to primary pond, June 2009

Work commenced on the pipeline connection to the Hawera WWTP during the latter half of the monitoring period (see Appendix III). A step screen and new inlet to the primary pond (Photo 3) were constructed on the raw wastewater reticulation and a new stormwater pipe from this area was directed to the wetland (Photo 4). The wetland will be converted to a holding pond to provide high stormwater ingress containment in excess of the pumping capacity of the new pipeline connection. This system is anticipated to overflow on one to two occasions in five years necessitating a new consent for this discharge. Improved access to the outfall site was constructed for sampling purposes (Photo 5).

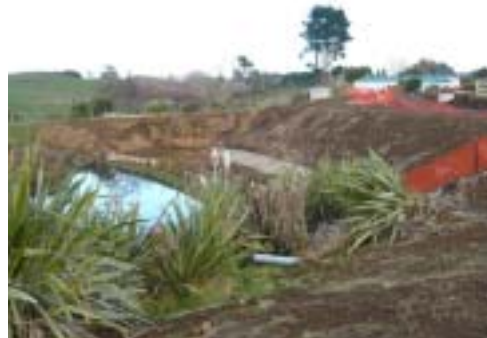
Photo 4 Future holding pond (current wetland) and outlet, June

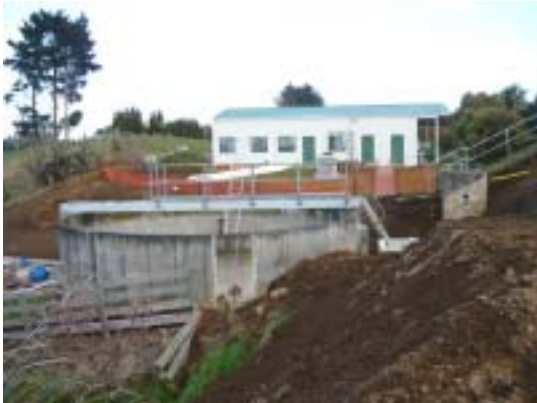
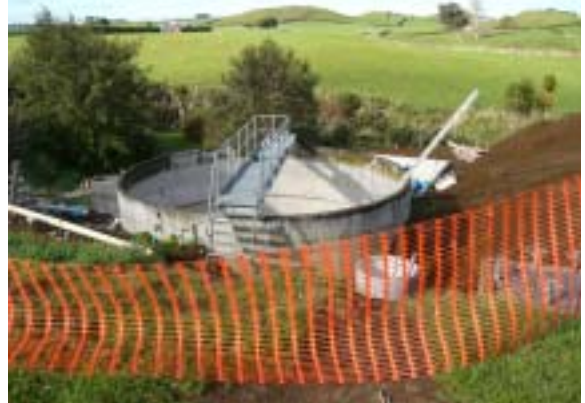
Photos 6 and 7 Pump base at rear of old clarifier, May 2009

Construction of the pump outlet from the primary pond component of the treatment system to the new pipeline was partially completed by June 2009 (Photos 6 and 7).

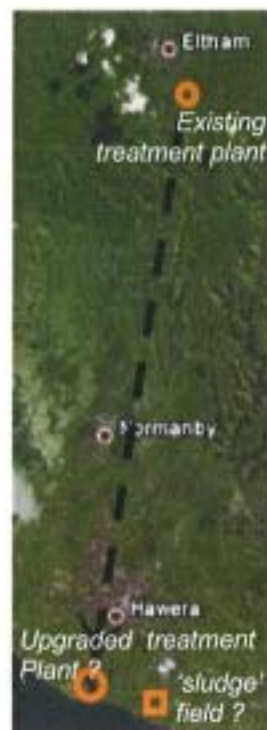
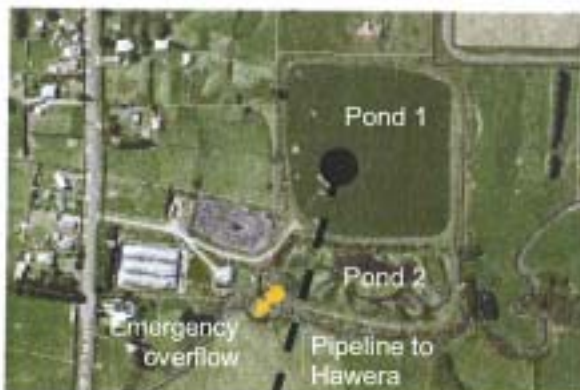
The Details: Eltham Pipeline

The new system to pump all of Eltham's wastewater to Hawera (from Pond 1 on left) is designed to handle not only all of Eltham's wastewater but nearly all of the storm water that can now get into the town's aging sewerage system.
