# Coastal Erosion Information

## Inventory and recommendations for state of environment monitoring

Taranaki Regional Council  
Private Bag 713  
STRATFORD

November 2009

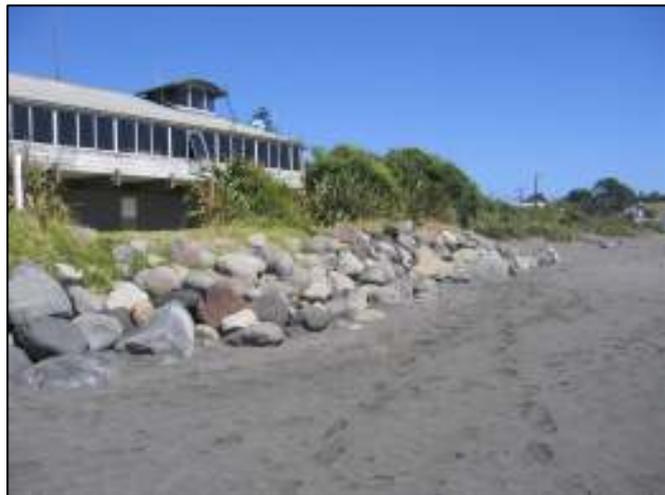
*Rock rip rap protection in front of the Oakura Surf Life Saving Clubrooms.*

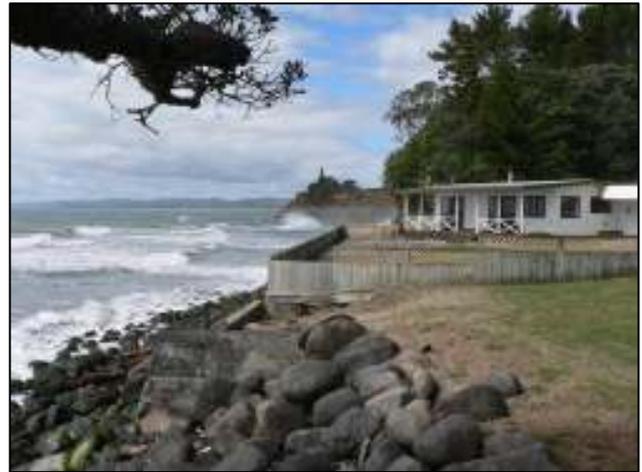
Historically at Onaero, boulders were dropped in front of receding banks (1974), concrete blocks from old building foundations dropped over cliff edge (1977), an attempt to build a retaining wall – but this was swept away (TCC, 1978). Historic ad hoc seawall measures were removed and the 220 m long boulder rock seawall was reconstructed by NPDC in the late 1990's. There is now no beach present at high tide, and limited beach at low tide.

*House and seawall at Onaero*

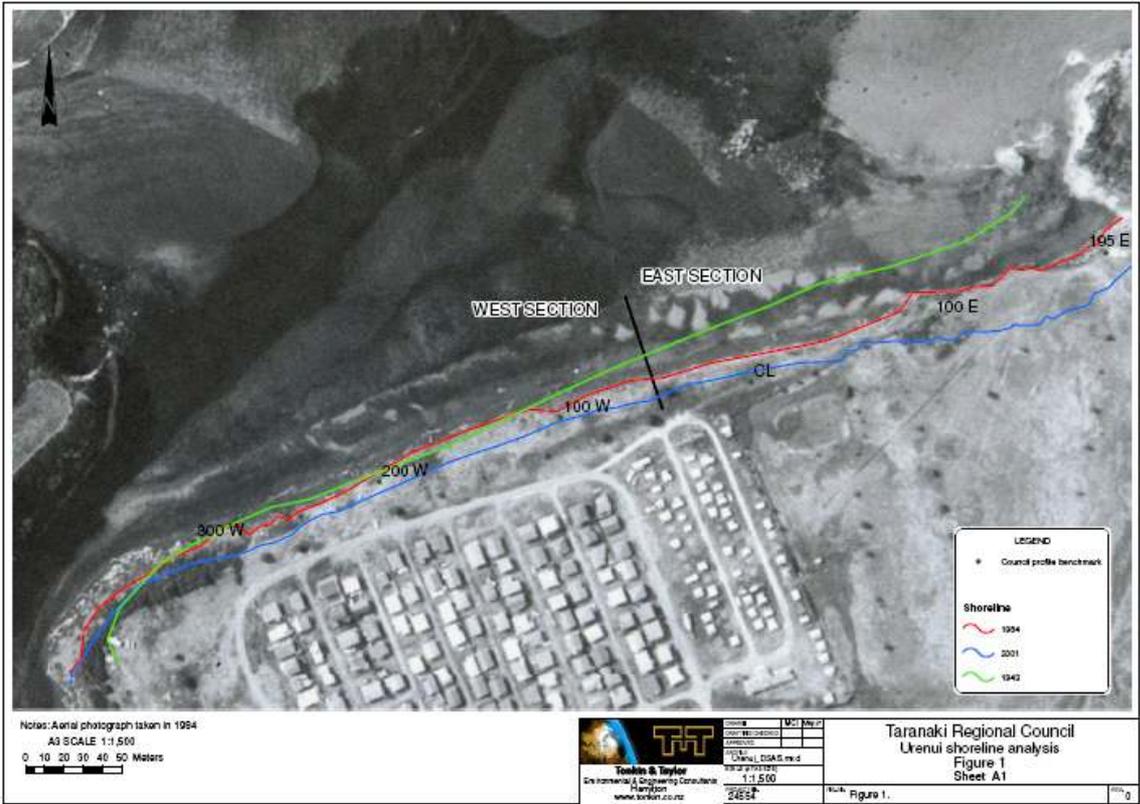
Figure 3: Urenui shoreline analysis shown on 1984 aerial photograph.

To verify the changes estimated from the aerial photographs, an assessment was also made of shoreline change from beach profiles at survey points 100W, 200W and 300W (see Figure 3) which had data from 1987 to 2003, comparable to the period 1984 to 2001 (Tonkin and Taylor, 2007 reported on in TRC, 2007). Trends from the profiling also had to be interpreted with caution due to the relatively low number of profiles and datum and origin difference. However, there appeared to be an underlying trend of erosion of around -0.2 m/year at 100W and 200W, with around -0.1 m/yr erosion at 300W.

Comparing results from these two different sources confirmed long term erosion retreat at the western end, but probably at lower rates than suggested by the aerial photograph analysis. Therefore the rate of -0.54 m/yr erosion is likely to be an upper bound rate of retreat, with a rate of around -0.2 m/yr considered more representative of a longer term trend.

The western section of Urenui Beach has a lower rate of historic erosion than the eastern section. The closest dwelling is approximately 30 metres, and the road is approximately 12 m, from the existing erosion scarp. Therefore, at a rate of retreat of around -0.2 m/yr it would have taken approximately 150 years for the erosion scarp to reach the baches, and

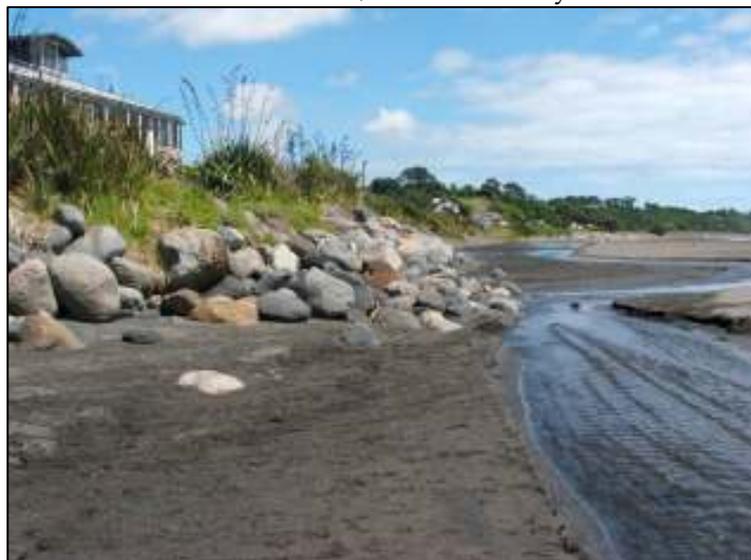
*Rock protection along Oakura Beach*

concern to house owners, and as a result various protection works ranging from car tyre seawalls to gabions were erected to reduce foreshore erosion, but that since the early 1980's the beach has recovered and most of the protective works are now buried under sand deposits. It also noted that land on which the surf club is sited did not exist in 1923, according to cadastral survey, so is reclaimed land (TCC, 1987; OCEL, 1994; and McComb et al, 2005).

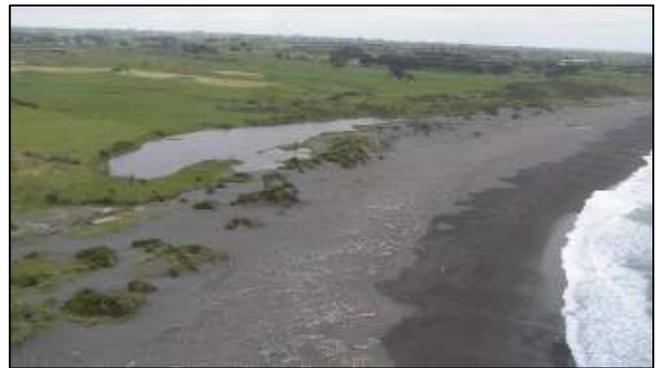
Hangatahua (Stony) River coastline, November 2008

Since the initial collapse in 1998, the adjacent coastal shoreline has experienced a continuous influx of dense 'black' titanomagnetite-rich volcanic sands from the Stony River. These sediments are being rapidly transported to the north-east by the energetic wave climate, creating upper-shore sandy beaches on what is normally a rocky boulder coast devoid of sand (Cowie et al, 2009).
