Fish Survey & Biomonitoring Report

To Nathan Crook, Scientific Officer
From Bart Jansma, Scientific Officer
Report No BJ301
Document 1924640
Date 1 September 2017

Fish Survey of the Haehanga Stream in relation to discharges from the Remediation (NZ) Limited composting site at Uruti, December 2016

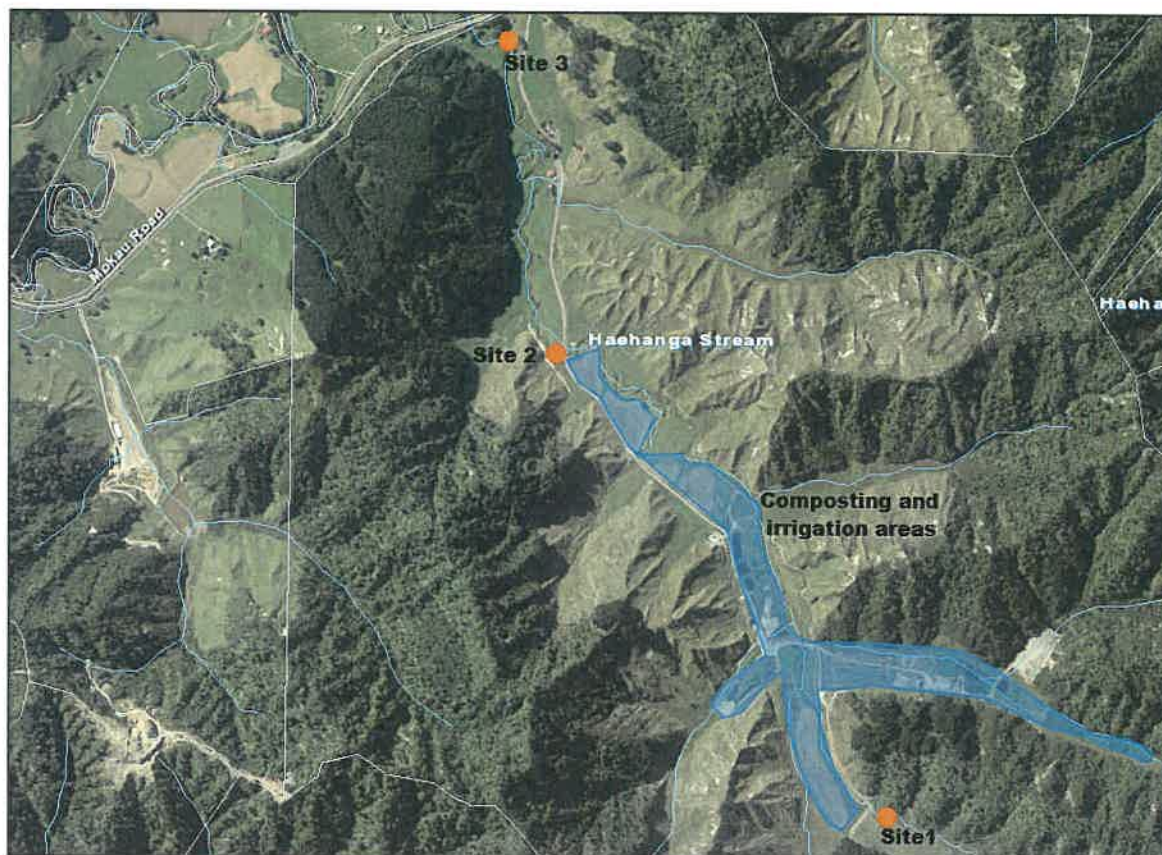
Figure 1 Location of the three sampling sites in relation to composting and waste water irrigation areas.

In this survey, three sites were surveyed in the Haehanga Stream. Site 1 was located upstream of all composting and waste disposal activities, site 2 was located immediately downstream of the lower irrigation area, while site 3 was located just upstream of State Highway 3. Details of the sites surveyed are given in Table 1 and the locations of the sites surveyed in relation to the site are shown in Figure 1.

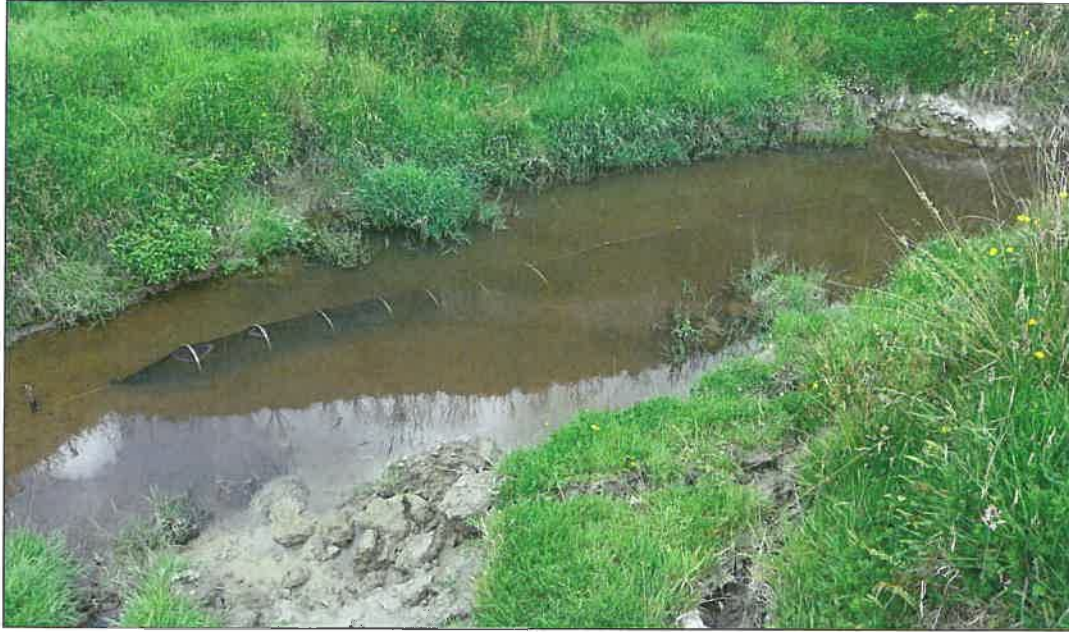
Photo 1 A fyke net, set at site 2, Haehanga Stream.

The fish populations were sampled using fyke nets (Photo 1) and gee minnow traps. At each site, five gee minnow traps were set, and baited with Marmite. They were set overnight, among macrophytes or alongside woody debris. Two fyke nets were also set at each site, a standard mesh (25mm) net and a fine mesh (13mm). The standard mesh was set downstream, in attempt to intercept any large eels moving up from downstream. Both fyke nets were baited with fish food pellets. These nets were also set overnight. All fish caught were identified, counted and measured, and any eels longer than 300mm were weighed, using electronic scales that measured to the nearest 20 grams. All nets and traps were deployed on the afternoon of 14 December 2016, and retrieved midmorning on 15 December 2016.

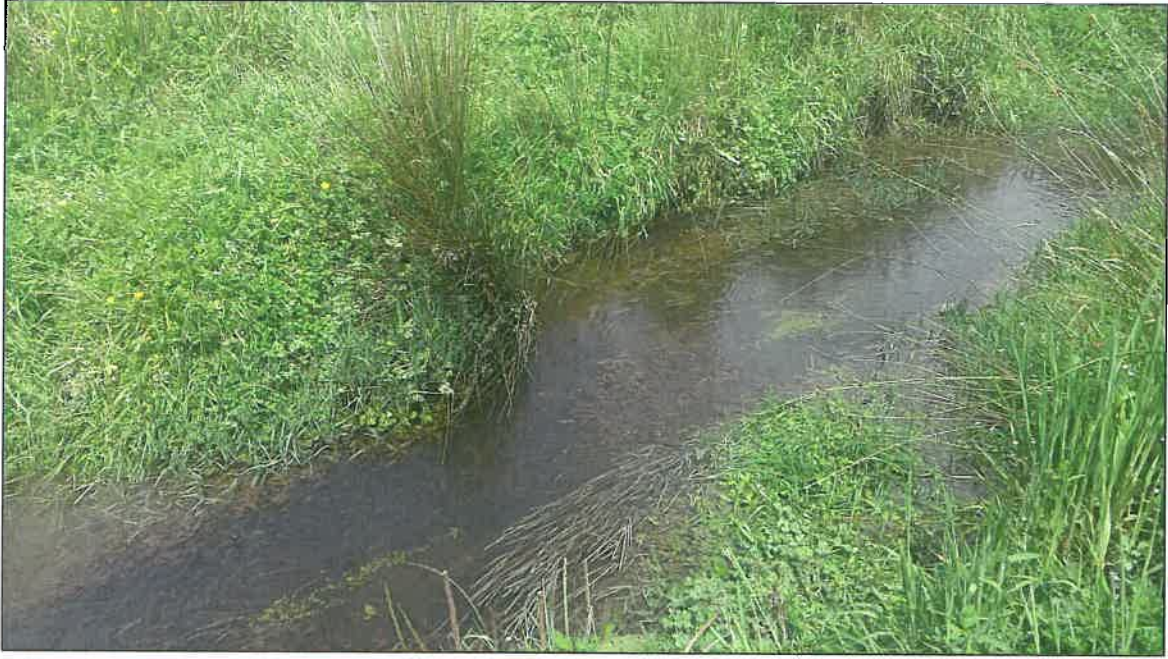
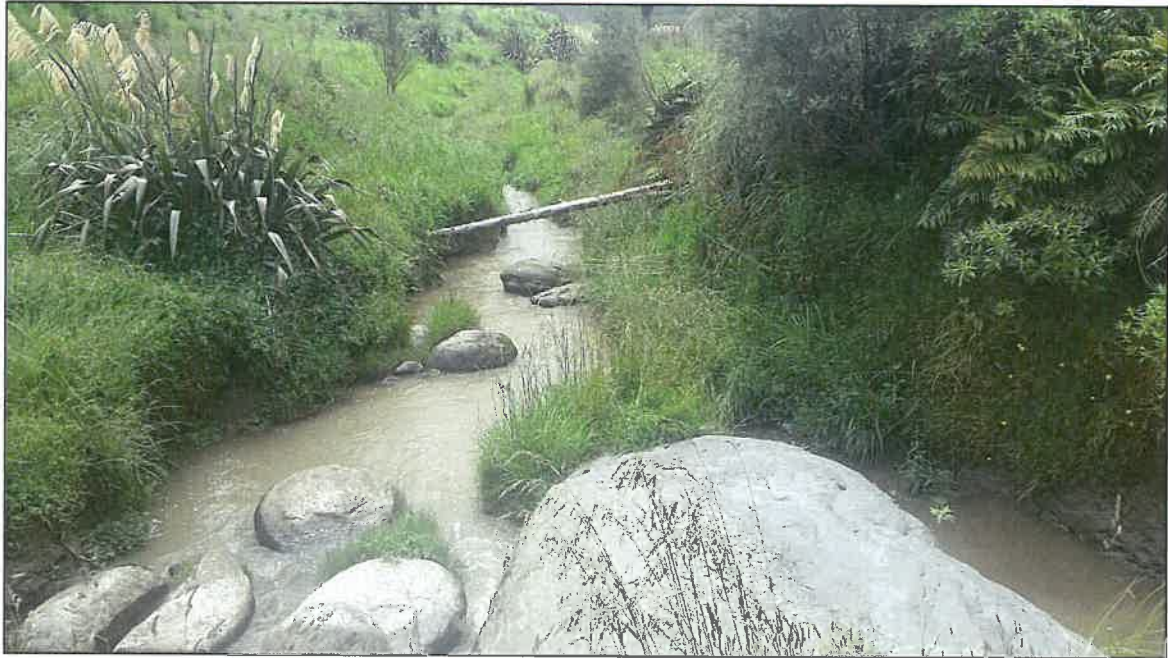
Photo 2 Water clarity at site 1 (top) and at the culvert near the composting pads (bottom). Photos taken about 30 minutes apart.

On the day that the nets were set, a localised rain event caused flows to increase in the Haehanga Stream. This also resulted in the discharge of sediment-contaminated stormwater into the Haehanga Stream, resulting in discolouration. Although discolouration is frequently noted in this catchment, the degree of discolouration at sites 2 and 3 was particularly severe, where it was described as brown and dirty. However, at site 1 (upstream of the site), which had only slightly elevated flows, there was no obvious discolouration. The change in water clarity is shown in Photo 2. All sites contained moderate fish habitat, with deep pools, and macrophyte beds, although site 2 only had macrophytes on the edge. The substrate of the surveyed pools comprised primarily of thick silt, with some large logs present at site 3. All sites had at least some undercut banks, but there was no overhanging vegetation at any site, other than long grass.

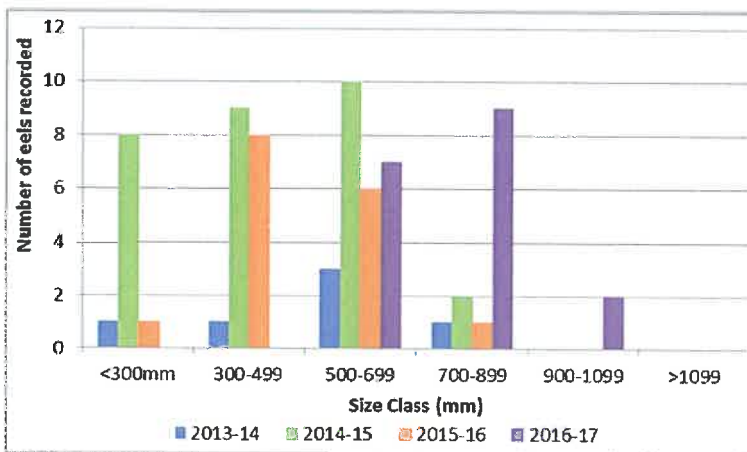
Figure 2 Size class distribution of all eels recorded at site 2 over the four surveys completed to date

Eighteen eels were captured, of which seventeen were longfin eels, one being relatively large at 1050mm and 3.425kg and two were shortfin eels. This is similar to the number of eels recorded in the previous survey, which recorded sixteen eels. However, there was a clear difference in size class distribution in the current survey, with the results dominated by larger (>700mm) eels, while earlier surveys were dominated by eels smaller than 700mm (Figure 2). Although the nets included a means of shelter for the smaller eels,

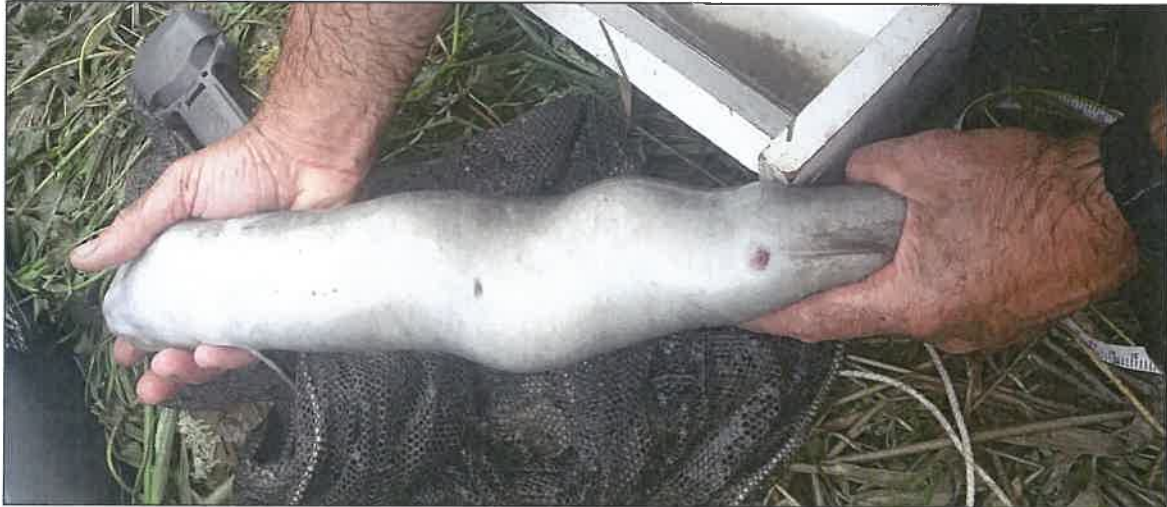
Photo 3 A large longfin eel recorded at site 2, with a consumed eel evident through the deformation of the eel's underside.

including either a tube shelter and/or an eel excluder, the number of large longfins captured increased the risk of predation. Three eels were observed to have eaten relatively large eels, as the consumed eel was discernible when handling and viewing the consuming eel (Photo 3). It is likely smaller eels were also consumed, but they were not discernible in the large eels stomach. Therefore, it is likely to the number of eels recorded at site 2 was an under-representation of the actual number of eels captured.

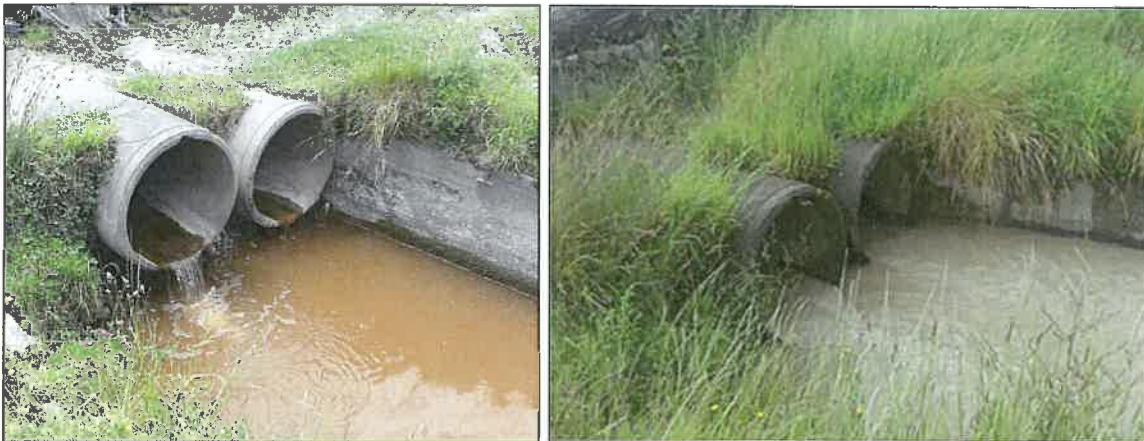
Photo 4 The access culvert immediately upstream of site 2, December 2015 (left) and December 2016 (right).

It is apparent that site 2 still had a much higher abundance than that recorded upstream at site 1. This suggests that the access culvert immediately upstream of this site may still be posing a barrier to fish passage (Photo 4). Some remedial works had been undertaken, with gravel being used to build up the bed level at the outlet of the first pool downstream of the culvert. While this is an appropriate approach, as it will lift the water level and resolve the perched nature of the culverts, the material used was too fine and had already begun scouring away (Photo 5). During the current survey, the culverts were not perched, although this may have been partly because flows were high.

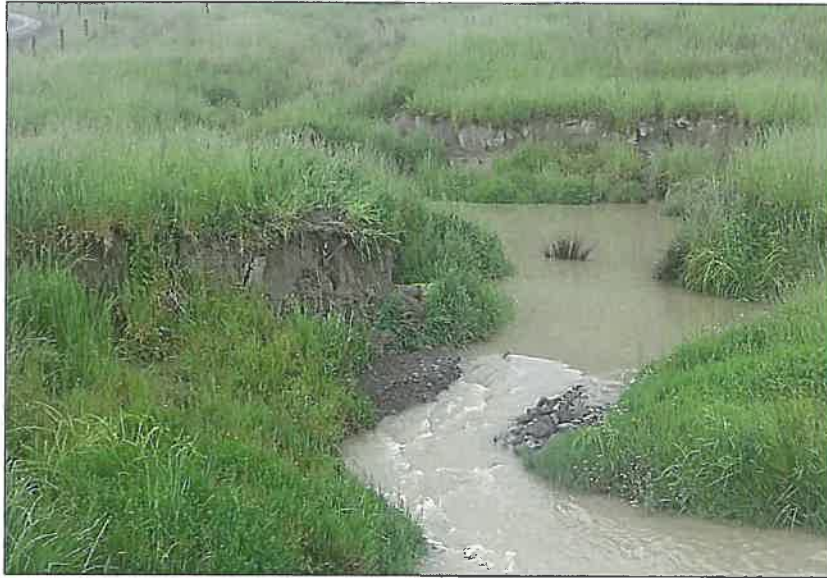
Photo 5
The outlet of the pool,
directly below the main track
access culverts, showing
deposited gravels that are
beginning to scour away

Culvert 3, a double culvert under the main access track, had experienced some remedial works since the previous survey, with the bed level built up in an effort to resolve the perched nature of the culvert. During the current survey, neither of the two culverts was perched, due to the remedial works and higher water levels caused by recent rain (Photo 4). It was noted that the remedial works were beginning to scour away, and it is likely that the culverts will again be perched once flows recede (Photo 5). This will need to be assessed during lower flows, with remedial works required should this be confirmed.

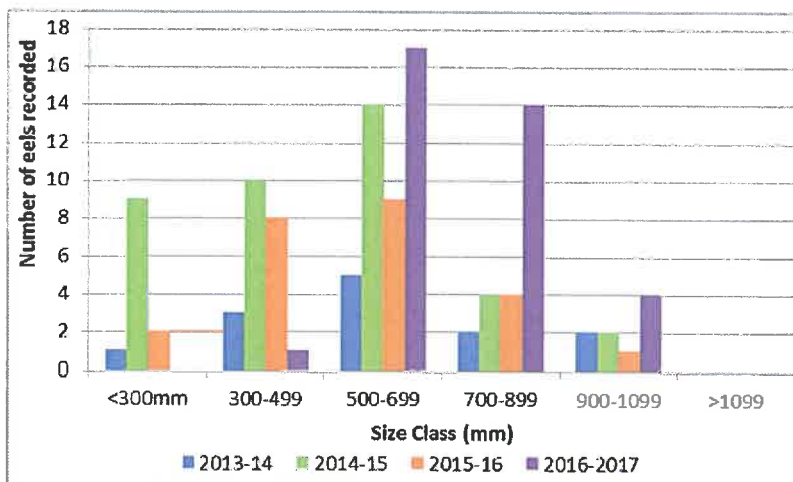
Figure 3 The size class distribution of all eels captured at all sites over the three surveys undertaken to date.

Figure 3 shows that a similar number of eels were recorded in the current survey as in the 2014-15 survey, higher than that recorded in the 2013-14 and 2015-16 surveys. The size class distribution was quite different however. In the first three surveys, the eel community was dominated by fish smaller than 700mm, while in the current survey, the community was dominated by fish larger than 500mm. However, all surveys recorded the most eels in the 500 to 700 mm size class.

This difference in size class distribution can be attributed to the improved flow conditions during the current survey. This higher flow meant that the bait scent was carried further downstream, and can have attracted fish from well downstream. The likelihood that predation occurred in the nets means that it was likely that the current size class distribution was an underrepresentation of smaller eels.

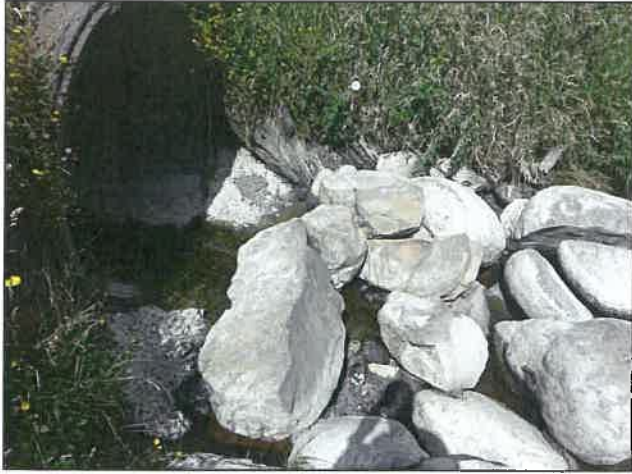
Photo 7

Culvert 1, on the Haehanga Stream near the composting pads, had a deep but swift flow (Photo 7), which would inhibit poorer swimmers such as inanga. The outlet of this culvert is usually too steep and water speeds too swift, and only suitable for climbing species. The higher flows during the current survey improved it slightly, but it is likely that passage will deteriorate as flows reduced.

Culvert 2 was perched, and not suitable for swimming species (Photo 7). However, while kokopu and eels have been recorded upstream of this culvert, these species are good climbing species and highly adept at negotiating barriers that swimming species cannot pass. This culvert will still reduce the passage of climbing species, while completely preventing the passage of swimming species. It was noted during the current survey that the lower of the two culverts might have been partially blocked.

Top left: Culvert 1 December 2015

Top Right: Culvert 1 December 2016

Bottom Left: Culvert 2 December 2015

Bottom Right: Culvert 2 December 2016

Three access culverts were assessed for fish passage during this survey, and one was found to present a barrier to fish passage at all flows, while the remaining two culverts were considered likely to restrict fish passage during lower flows. Even in the higher flows of the current survey, it is likely that all culverts severely restricted the passage of swimming species such as inanga. The culvert located immediately above site 2 had experienced some remedial works since the previous survey, but this was already being scoured away. It is likely that this culvert will still be perched during lower flows, and this would preclude the passage of a number of species, included inanga. If this is confirmed, then remedial works will be required. Remedial works are still to be undertaken on the remaining two culverts, which have been identified as a barrier for a number of years.

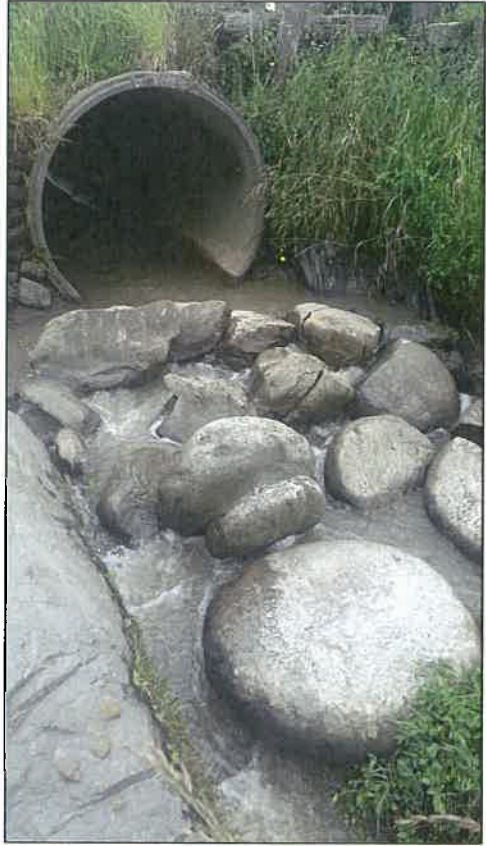
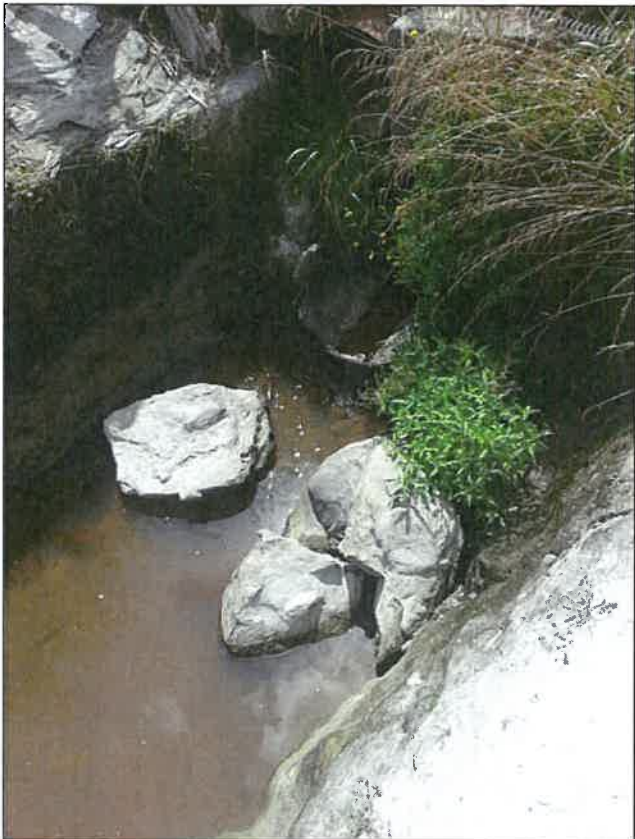
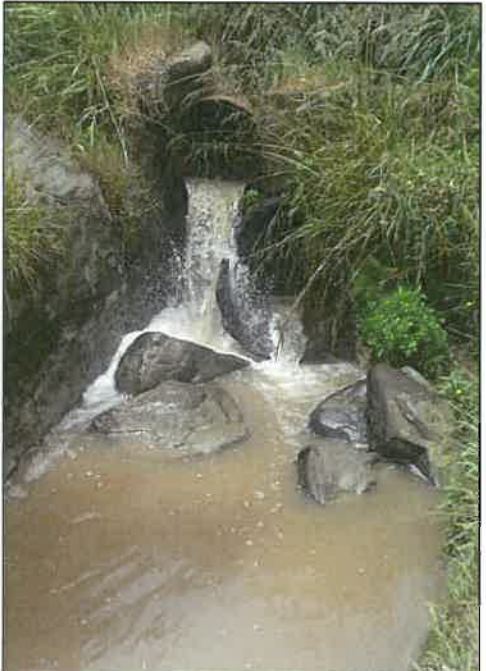
This site is intended as a control site with which to compare the downstream results. Due to the lack of fish passage, it cannot be considered a true control site. In addition, if a culvert does not provide for the passage of fish, it is non-compliant and must be remediated. Some remedial works have been undertaken since the previous survey was completed. However, further remedial work is required, so it is once again recommended that the site operator is made aware of these barriers to fish passage, which are discussed in more detail below, and required to take steps to remediate them.

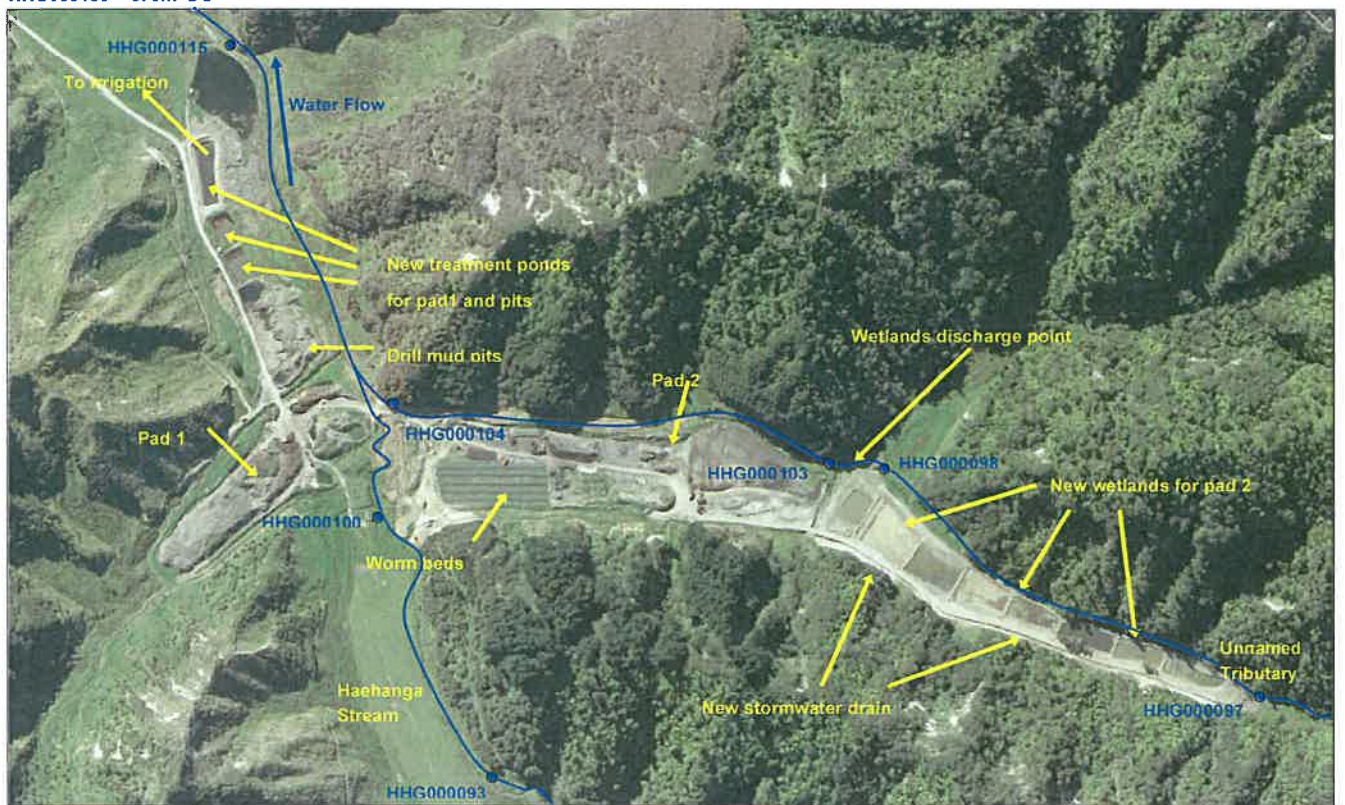
Figure 1 Location of biomonitoring sites in the Haehanga Stream catchment

A baseline survey of five sites was conducted in October 2002 in relation to the composting operation (Dunning, 2003). At the time of this earlier survey, only composting pad 1 was operational, and sites were established for both the existing and proposed composting pads. Unnamed tributaries of the Haehanga Stream flow adjacent to (and down gradient of) both composting pads and flow into the Haehanga Stream downstream of the composting areas (Figure 1). Since this baseline survey, significant changes have

HHG000190 ~1900m DS

HHG000150 ~ 675m DS

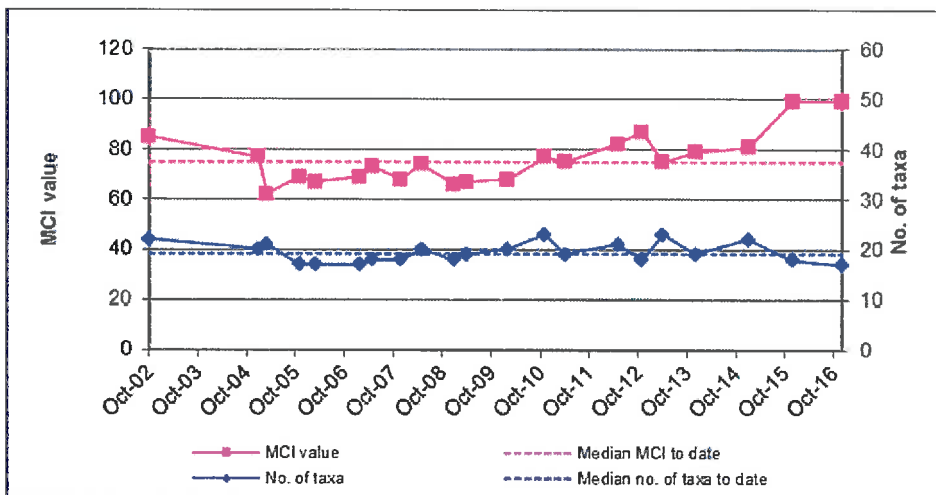
The MCI value of 99 units reflected a relatively high proportion of sensitive taxa in the community at this site (65%). This score is equal to that recorded in the previous survey, but significantly higher than the next highest score recorded at this site, and is twenty-four units higher than the median, also a statistically significant difference (Stark 1998)(Table 2, Figure 3). The SQMCI₅ value at this site (4.3) was similar to the median value, but significantly less than the previous maximum score, recorded in the previous survey. This reduction is primarily due to the reduced abundance of 'highly sensitive' *Deleatidium* mayfly.

Figure 5 Taxa numbers and MCI recorded to date at site 2
