## Haehanga Catchment Preliminary Groundwater Investigation

Remediation New Zealand

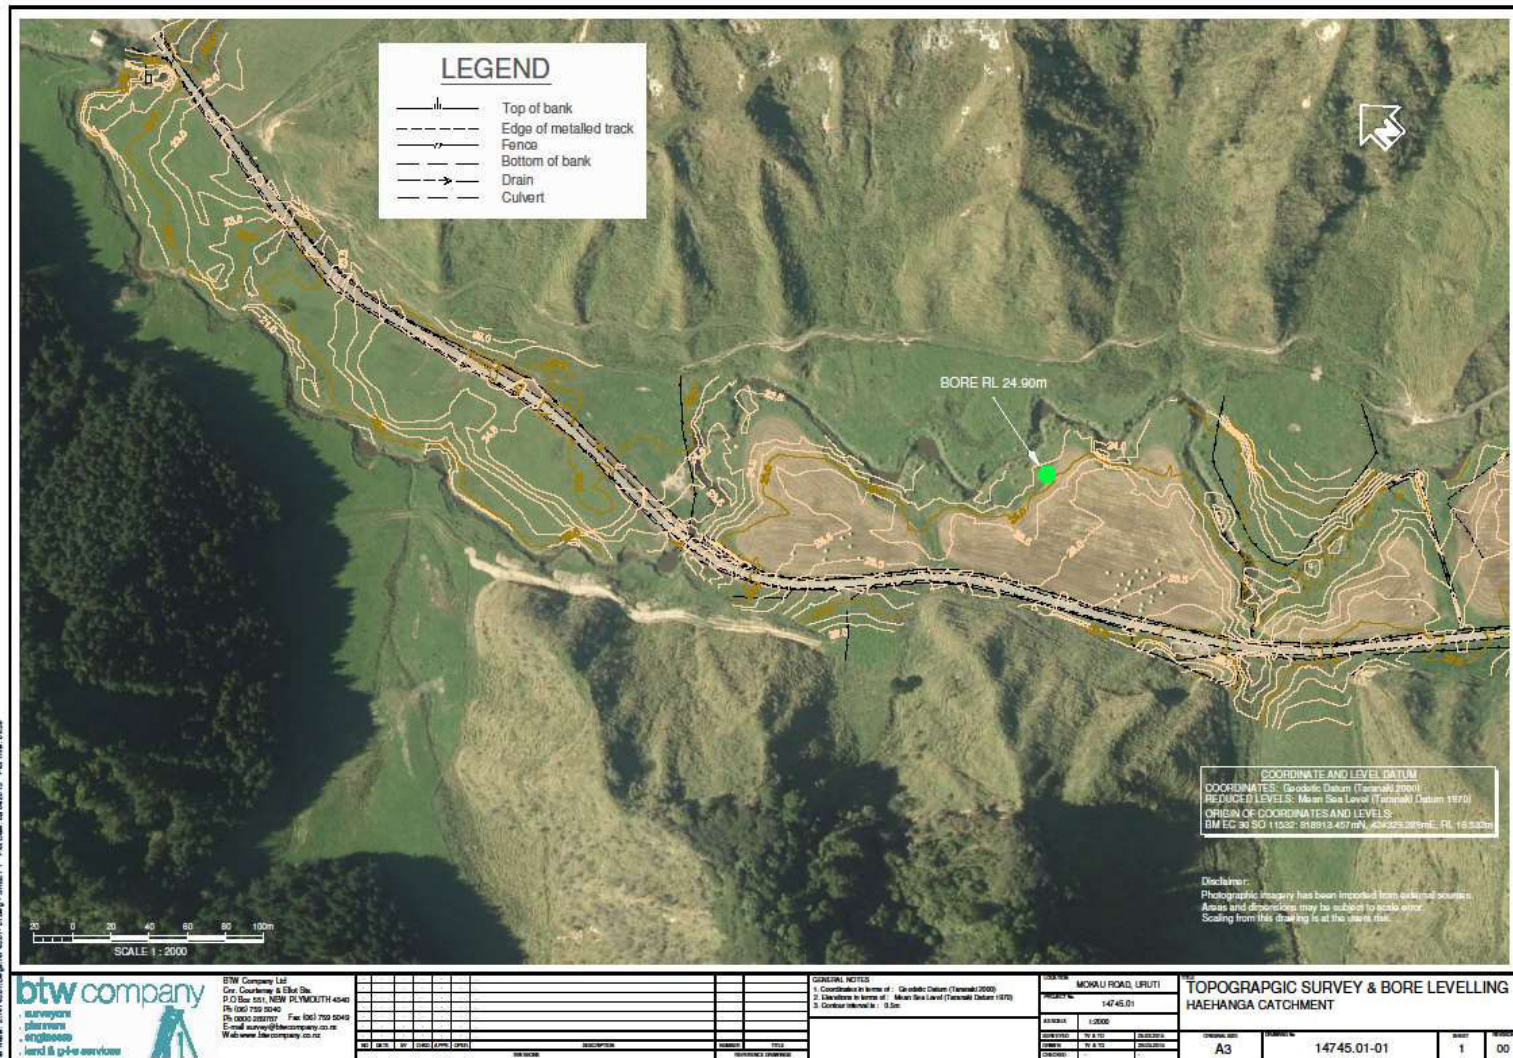
Figure 2.1:Uruti Composting Topography Survey-lower part of site. Green dot denotes GND 2190 and reduced level

Monitoring bore locations are shown on the site plan in Figure 2.1-2.3. Monitoring bore construction details are in Appendix A. Photographs of the well construction are presented in Appendix B.

Based on these parameters above, average hydraulic gradients and linear groundwater velocities have been estimated. Hydraulic gradients have been determined from the groundwater reduced levels in the monitoring bores GND 2188 to GND 2190 and distances between bores taken from the Topographic Survey (Figure 2.1-2.3).

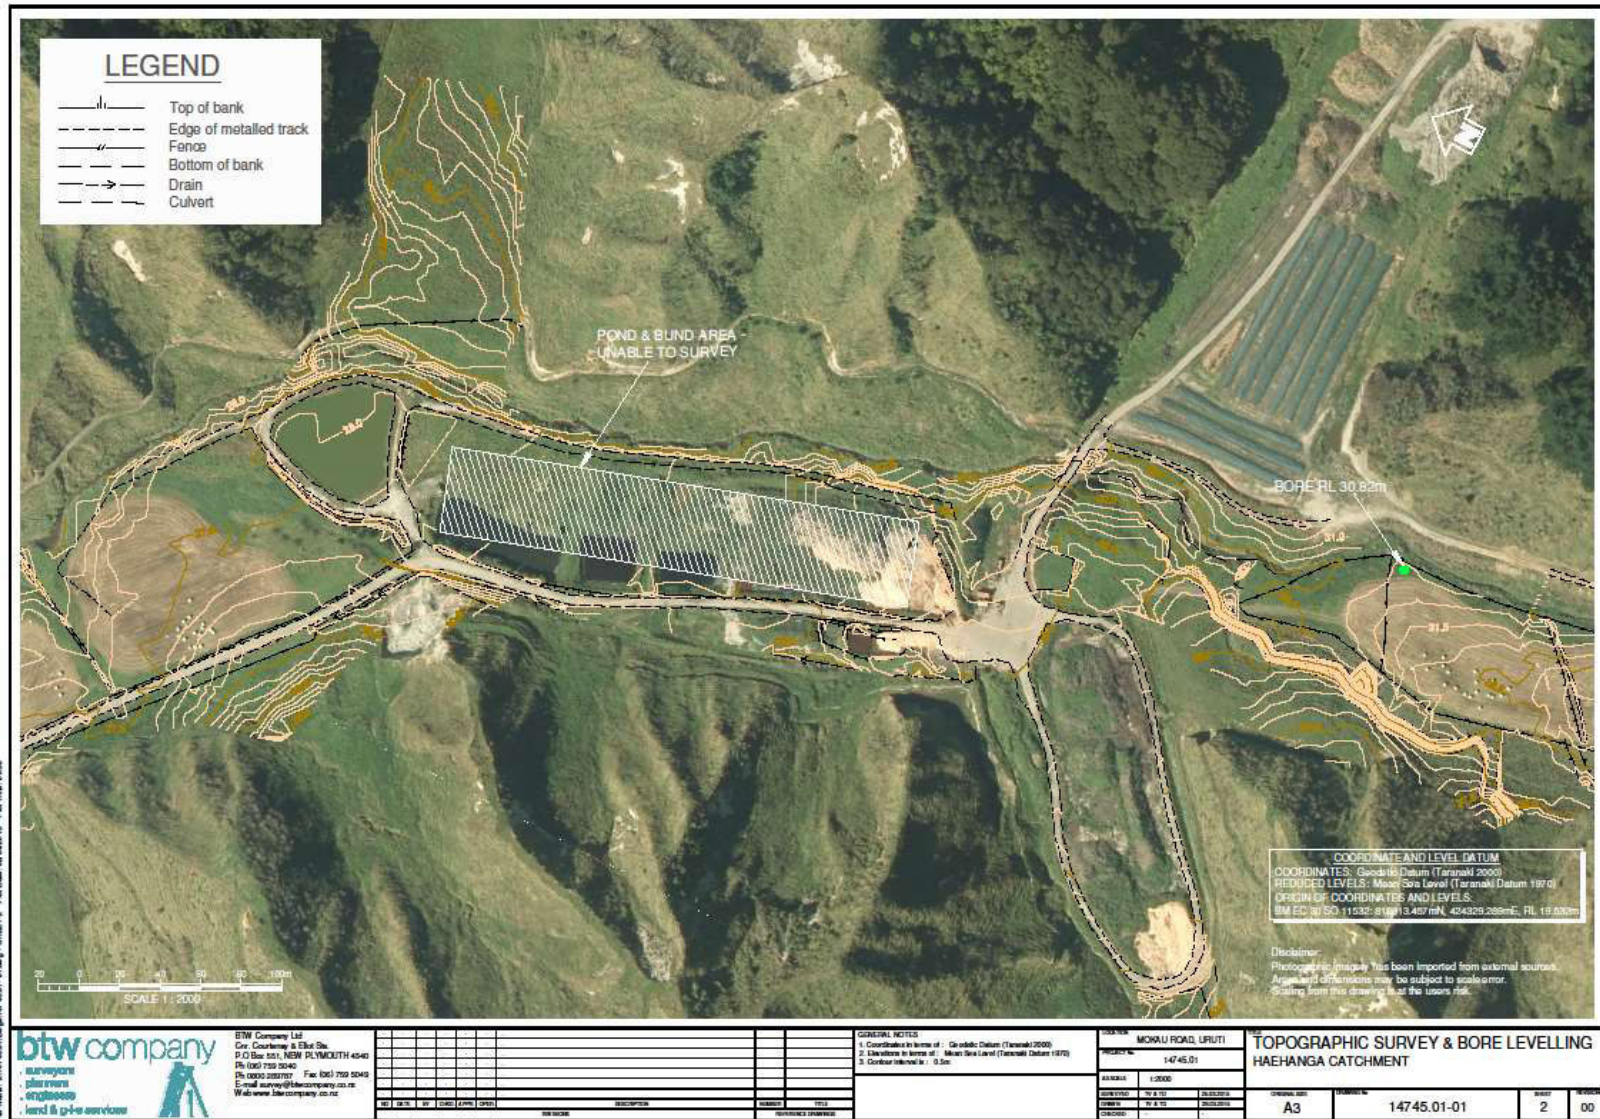
Figure 2.2:Uruti Composting Topography Survey-middle part of site. Green dot denotes GND 2189 and reduced level

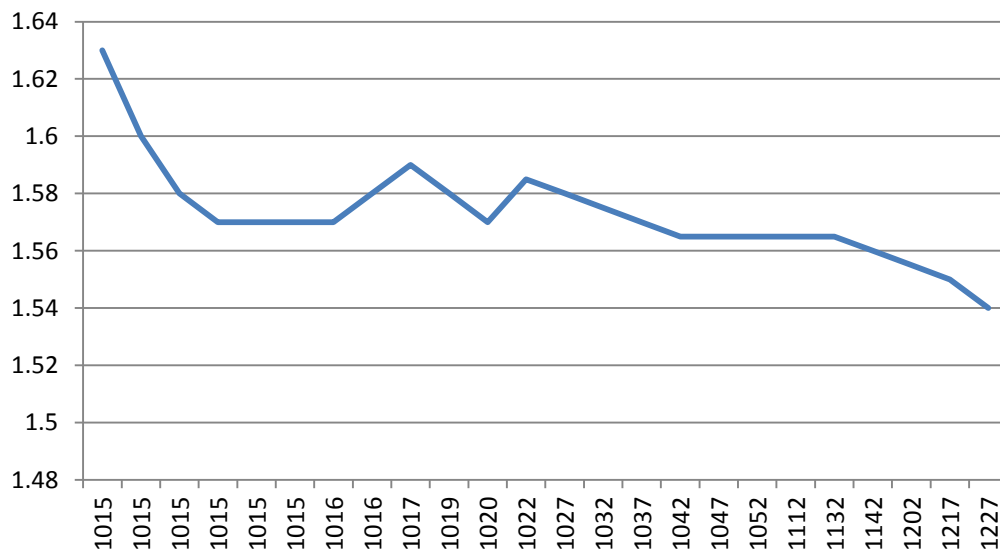
The erratic water levels in GND 2188 during recovery phase of the 'slug test' are represented in Figure 2.4.

Figure 2.4: Fluctuating water levels in GND 2188

Due to the inconsistencies recorded in GND 2188, only permeability calculations were undertaken for GND 2190. These calculations were undertaken using the Bouwer and Rice method (1976) available from free software from the USGS website (<http://pubs.usgs.gov/of/2002/ofr02197/index.html>) and the online Bouwer and Rice calculator ([http://www.groundwatersoftware.com/calculator\\_11\\_slugtest.htm](http://www.groundwatersoftware.com/calculator_11_slugtest.htm)).

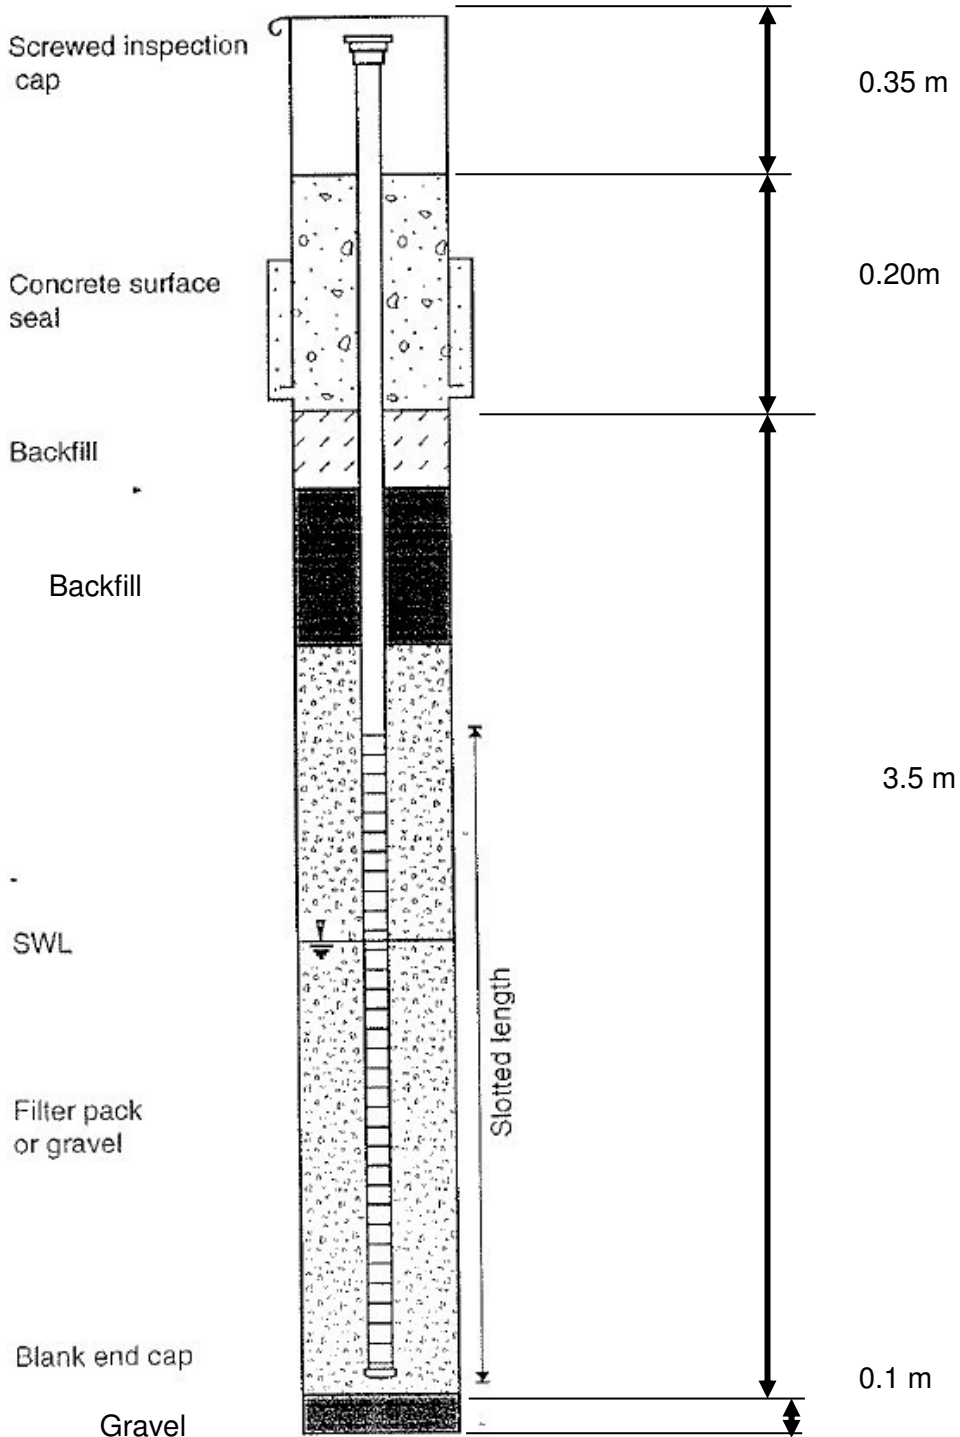
## Monitoring wells – Remediation New Zealand - Uruti

**CASING and SCREENS:**

PVC: 51.8mm (2-in) satisfactory,  
slotted screen.

- Final depths should be measured and recorded
- The slotted portion of the pipe should start 0.2m below the ground level as per the schematic. This is not the case in all the bores.
- The top of the monitoring well should be capped to prevent contaminants entering the bore
- The top of the casing should be 300 mm above the ground and sealed so that potential contaminants or small animals cannot get in.
- A 2 meters perimeter fence should be erected around the monitoring well ( i.e, 0.5 x 0.5 x0.5 x 0.5)

Well construction information is also limited but deemed critical to the analysis of slug test data, and as such several of the parameters required for the Bouwer and Rice Method (1970) were estimated from the monitoring well schematic (Appendix A). These parameters were screen length, base of aquifer and the annular fill above the screen. It is therefore highly recommended that all future monitoring bores installed onsite, accurate bore logs and lithology below 2 m be described, along with accurate bore construction information as to allow recalculation of groundwater velocities.

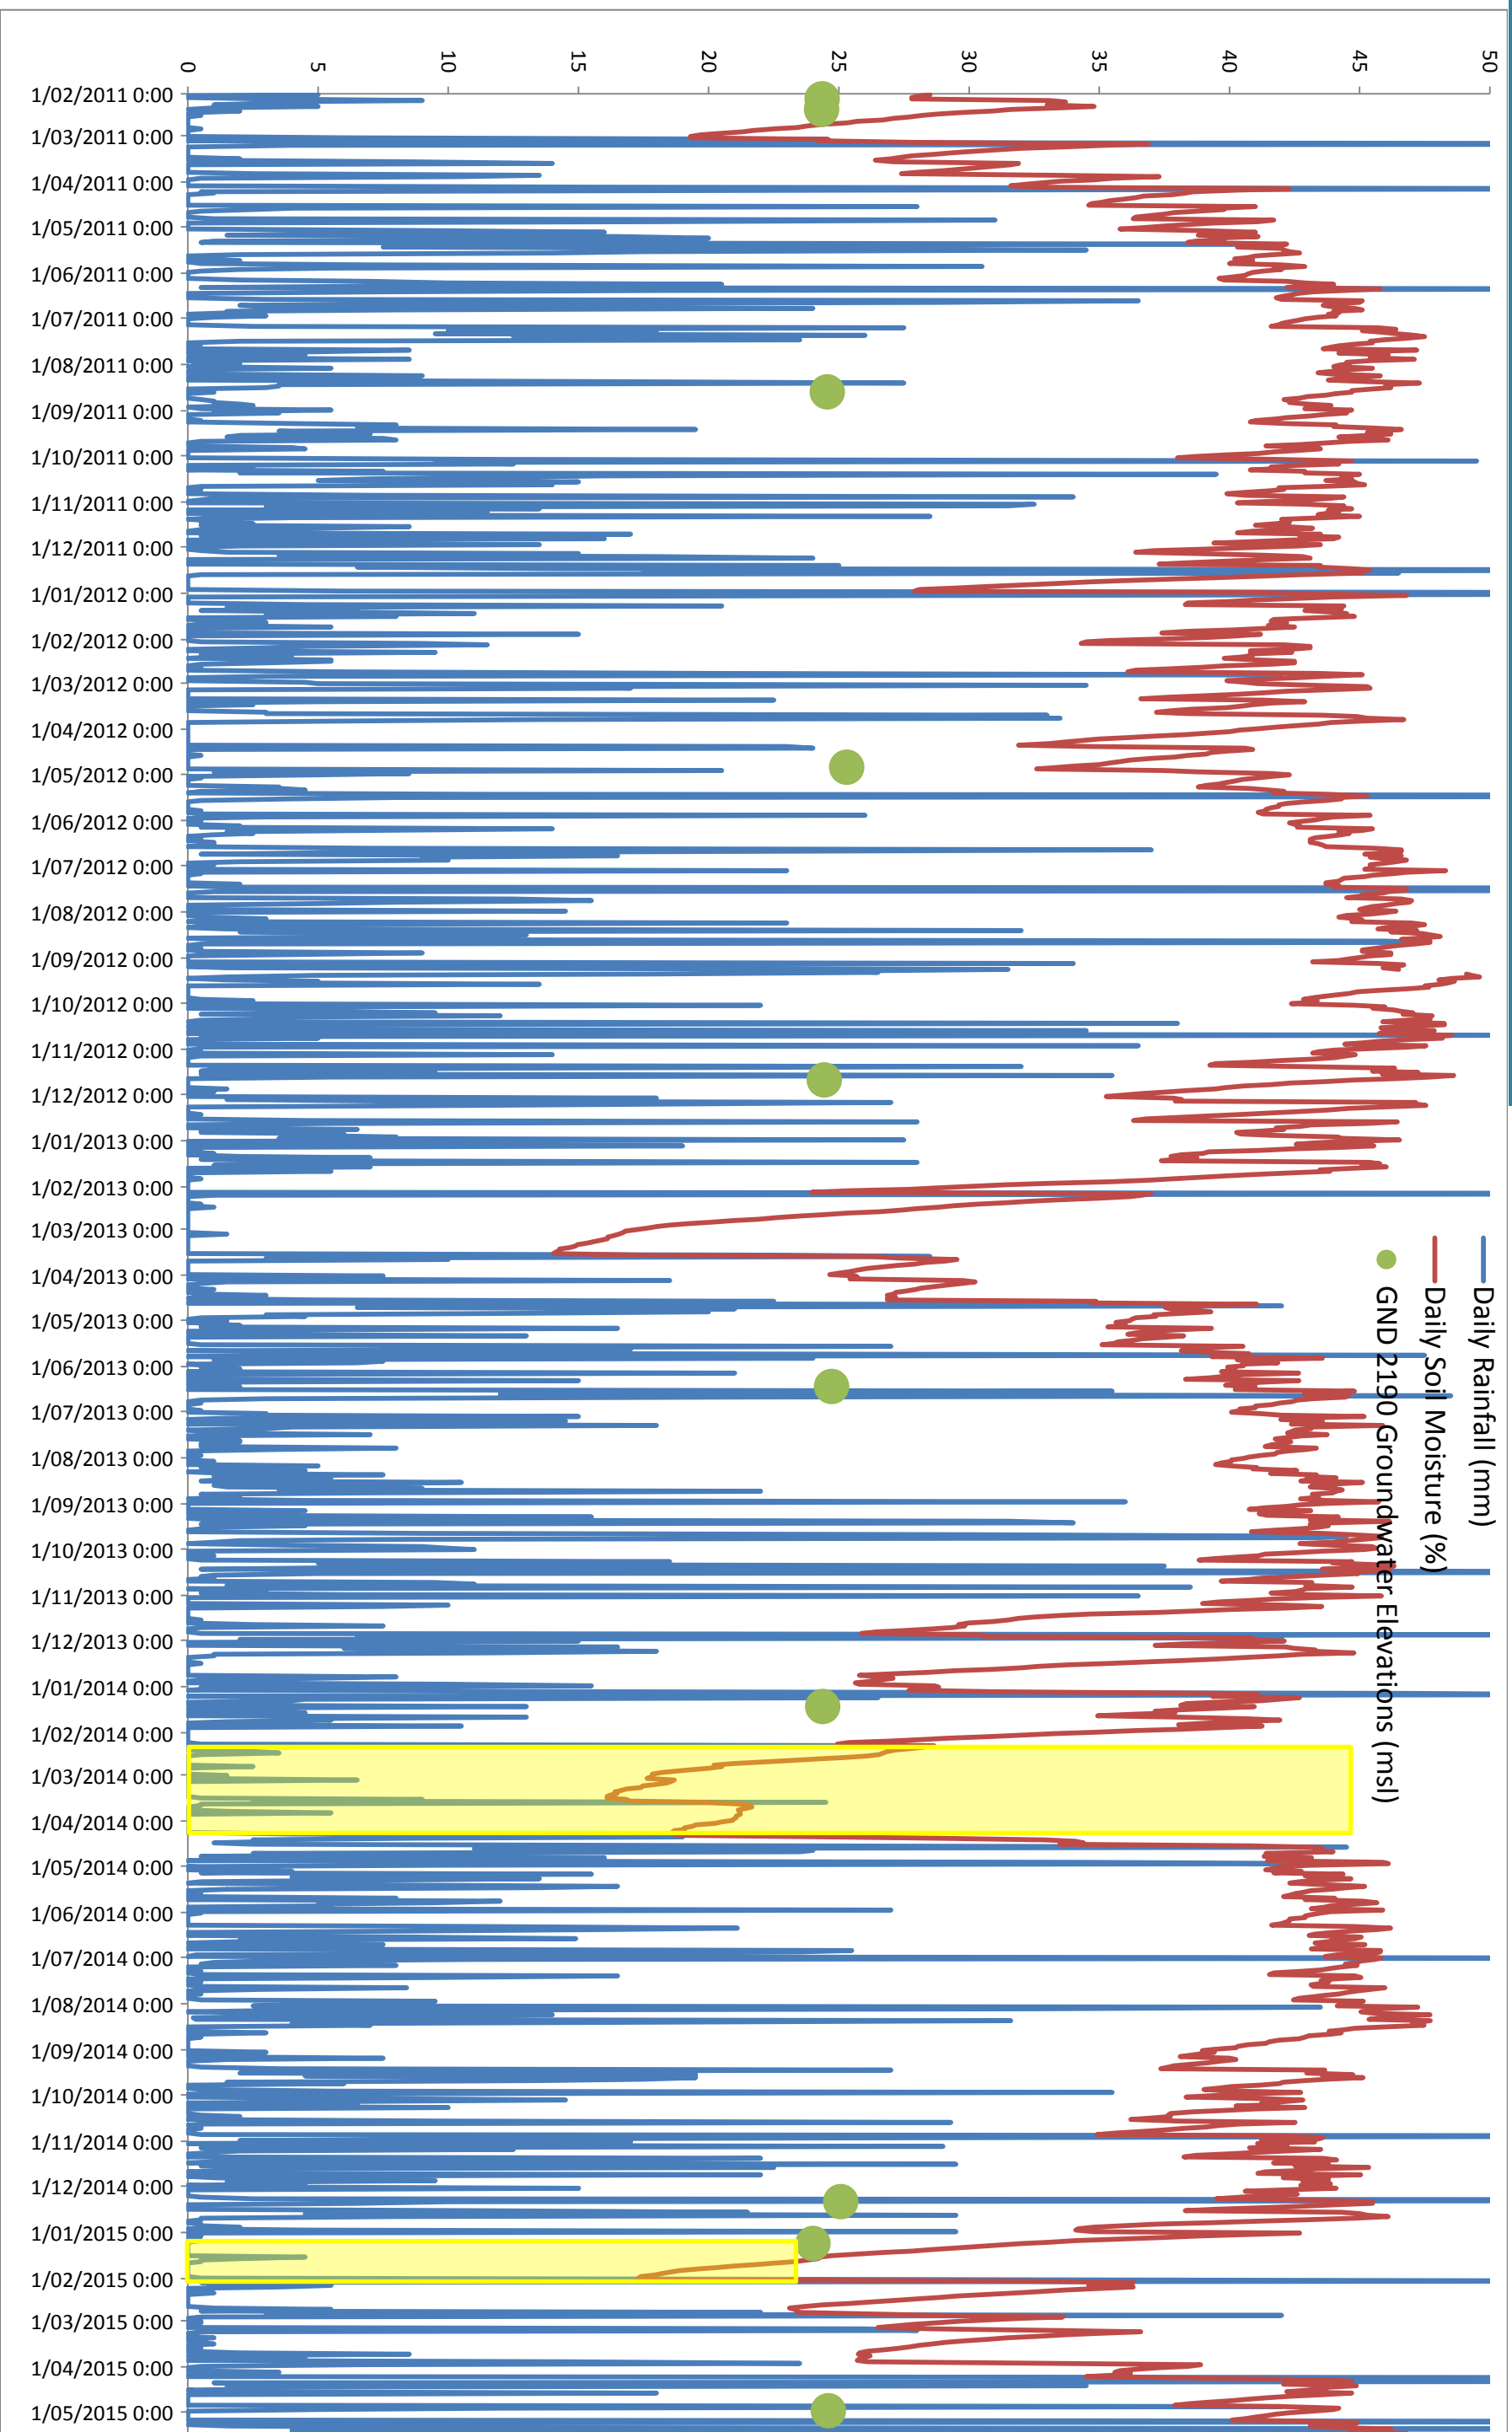
Examination of soil moistures (2003-2015), rainfall statistics, and available water chemistry data record elevated chloride within groundwater during periods of low rainfall and soil moistures (groundwater discharge to stream). During these periods groundwater levels (and most probably stream levels) are reduced (Table 2.1 & 2.2) and there is limited water within the hydrological system to attenuate the irrigated leachate. For example, the highly elevated chloride concentrations recorded in March 2014 in the Haehanga Stream and the monitoring bore GND 2190, coincided with the second lowest monthly rainfall total between 2003 and 2014, a very low soil moisture of 18% (yellow bars in figure below).

Uruti at Kaka Road Monthly Rainfall and Soil Moistures, yellow bars denote elevated Chloride concentrations in the Haehanga Stream and monitoring bore GND 2190

Appendix C goes some way to document how discharge/outflow events (i.e no rainfall, decreased soil moistures) and continued leachate irrigation results in elevated chloride concentrations in both the surface and groundwater resources. During these discharge events, where stream-flows are low over the summer months, the shallow groundwater table is most likely losing water to the Haehanga Stream. Therefore, limited water within the shallow groundwater table and the Haehanga Stream appears unable to attenuate the continued drainage losses of chloride through the soil profile as a result of continued irrigation.

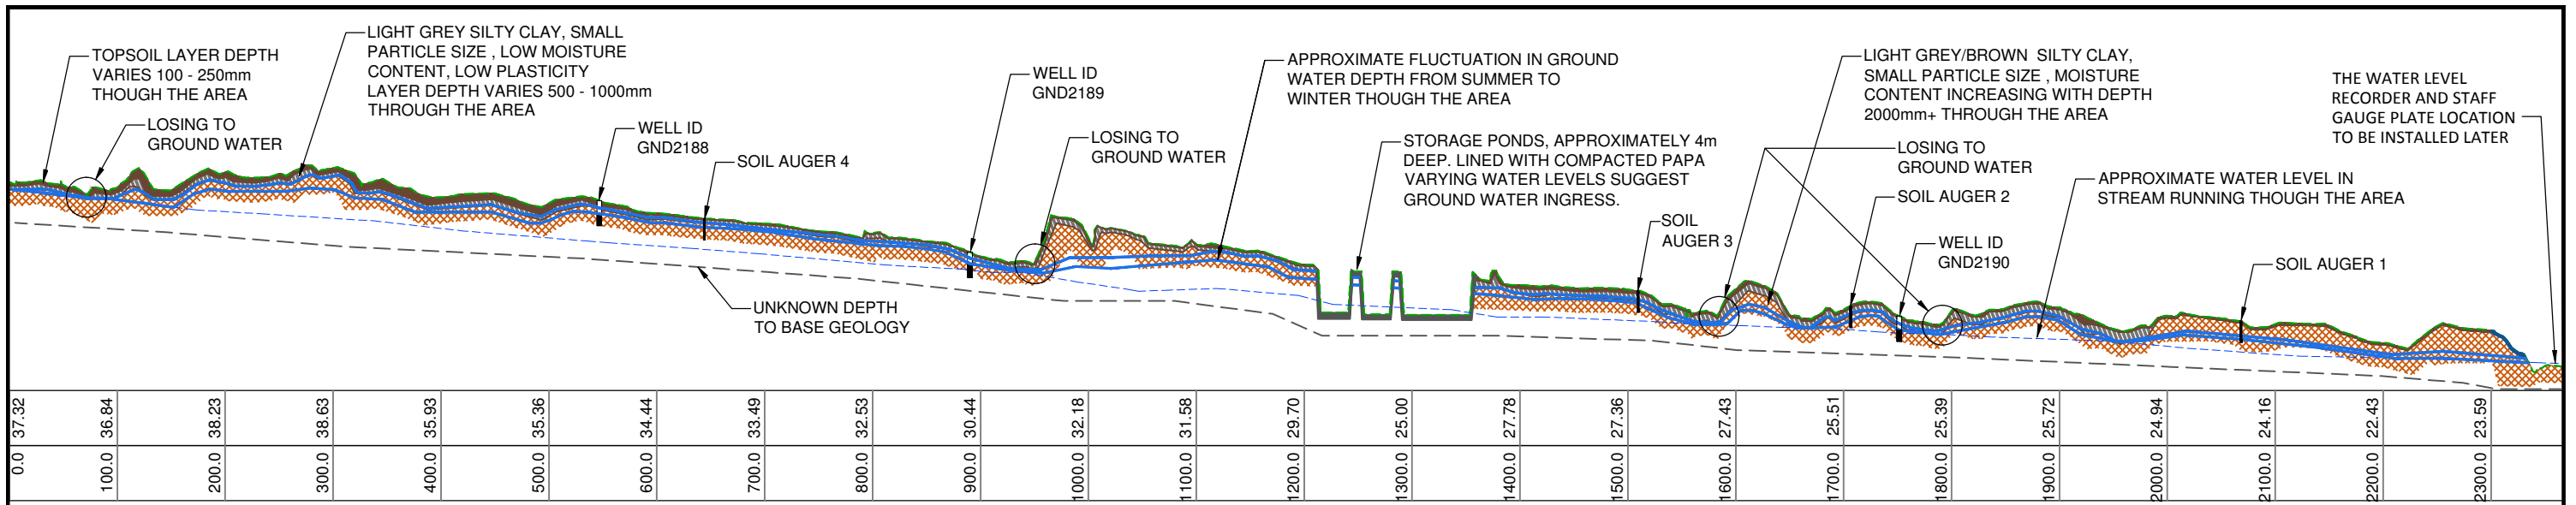
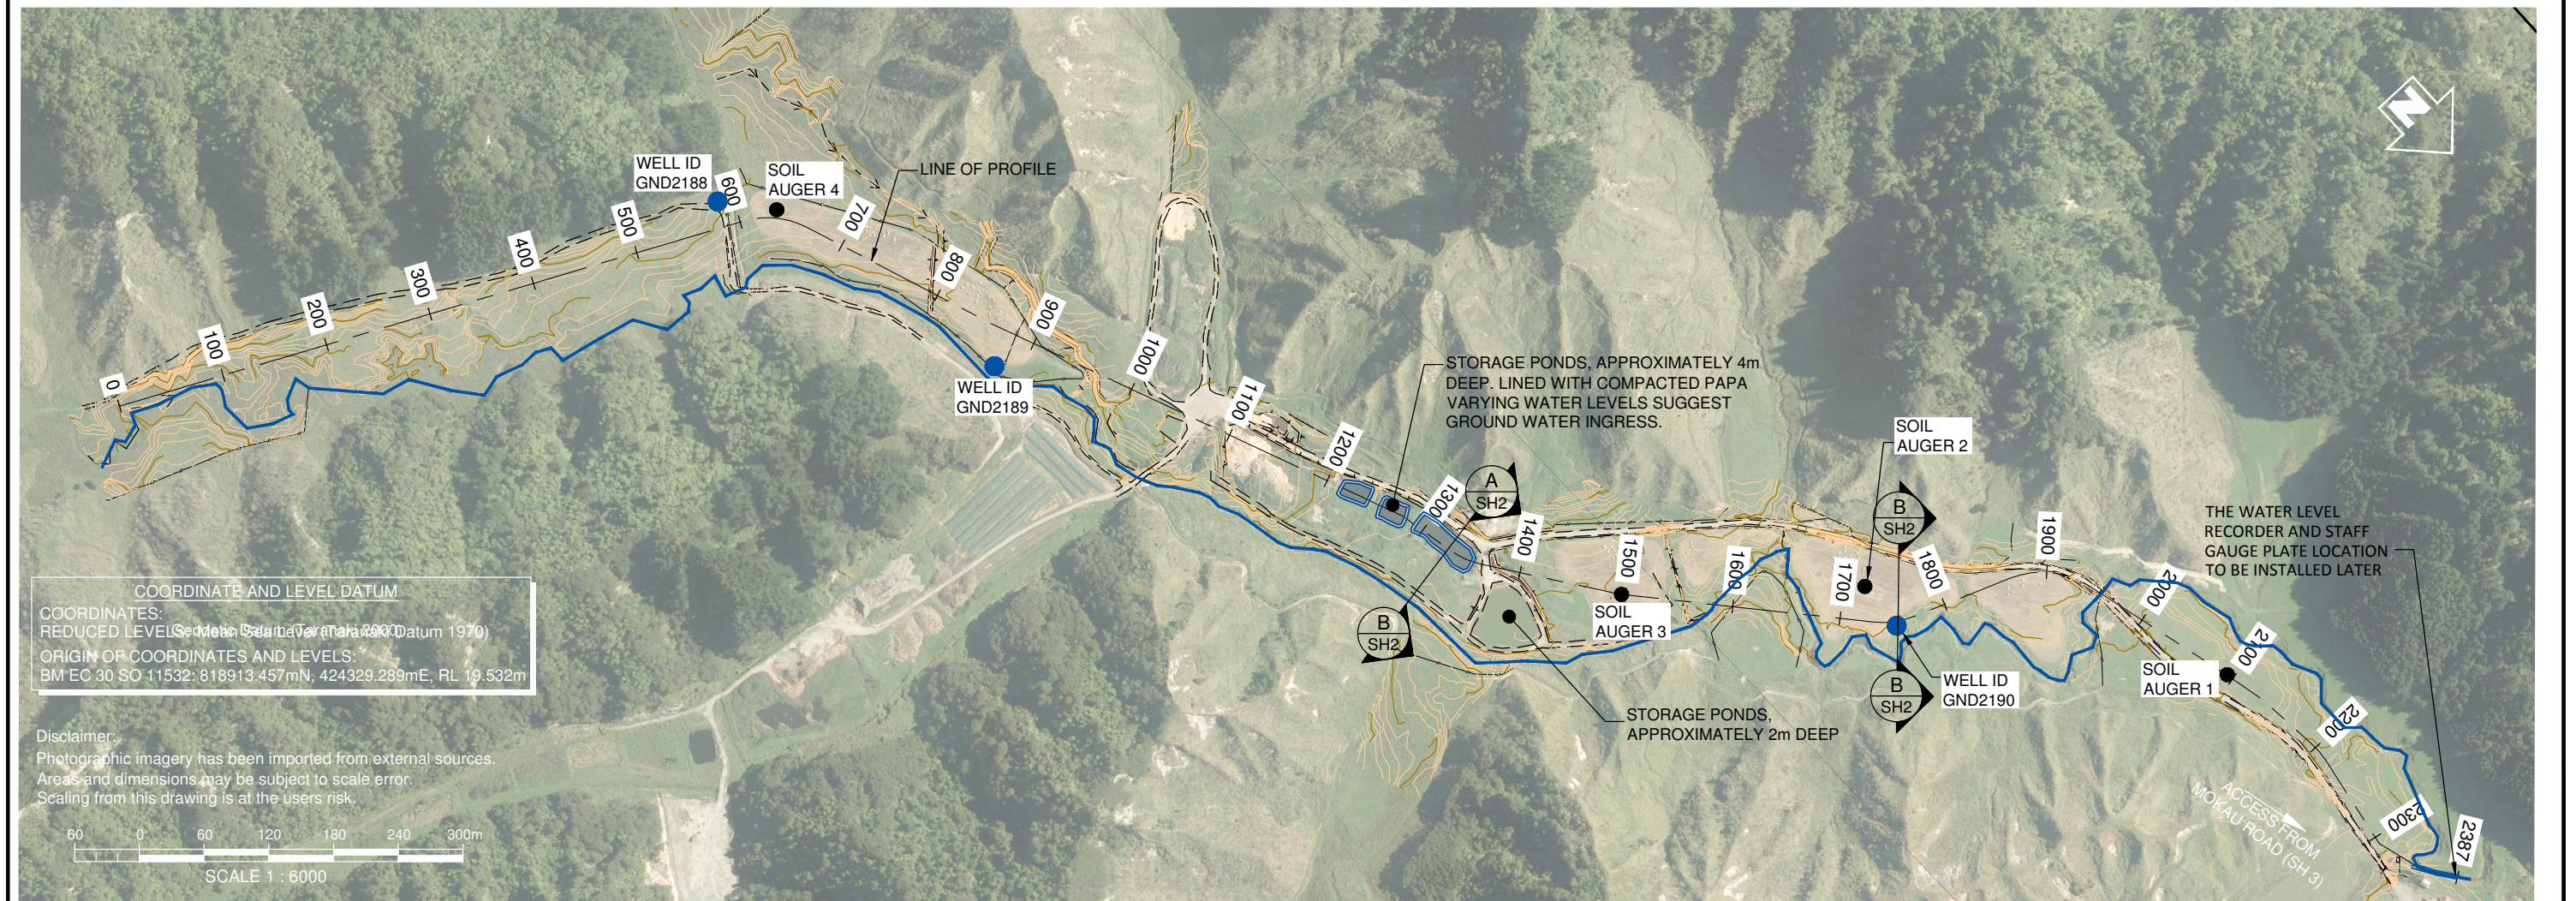
**APPENDIX D      PRELIMINARY UNCONFIRMED CONCEPTUAL SITE MODEL**

**PROFILE**  
 SCALE 1:6000 (A3) VERTICAL  
 SCALE 1:600 (A3) HORIZONTAL

**PLAN**  
 SCALE 1:6000 (A3)

The Topographic Survey formed the basis of the preliminary Conceptual Site Model (CSM) in Appendix D. The CSM was developed in Civil3E software, with all elevations in Mean Sea Level to the Taranaki 2000 Geodetic Datum. At present the CSM is unconfirmed and requires significantly more input to identify other potential contaminate sources and likely downstream receptors, both ecological and human. The preliminary CSM has however, defined the general hydrological setting in terms of hydraulic gradients down the Haehanga Stream, groundwater direction and hydrogeological interactions with the Uruti Composting Facility.

The preliminary Conceptual Site Model has been developed (Appendix D) but as yet is not confirmed. The CSM has identified potential hydrogeological 'exposure pathways' for contaminates in the Haehanga Catchment, such as the chloride loaded porous surface soils being in direct contact with the shallow water table, and the reaches of Haehanga Stream 'gaining' water from the groundwater table, adjacent GND 2190 in the lower irrigation zone. However, considerable more information is required to confirm the CSM, in particular the identification of downstream receptors for all contaminates potential leaving the site, not only chloride but also metal and hydrocarbons contaminates.

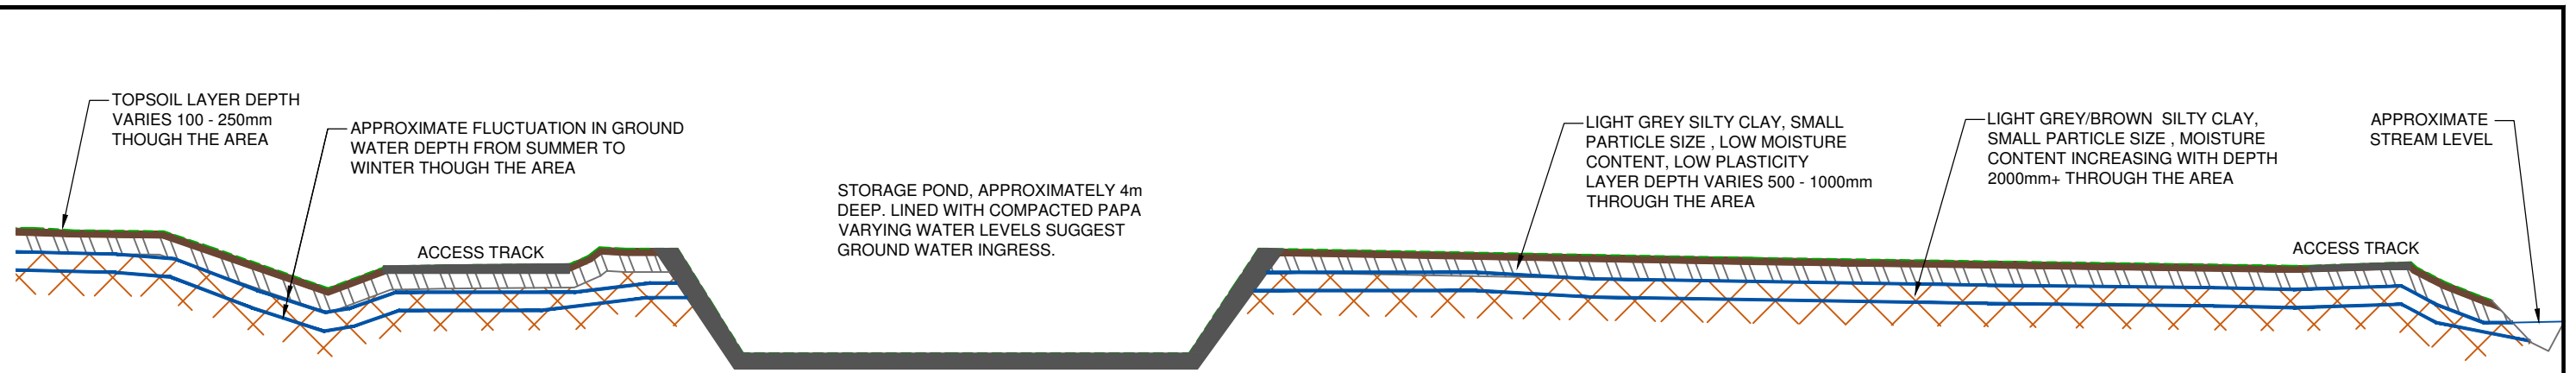
CROSS SECTION A-A  
SCALE 1:250 (A3)

UNKNOWN DEPTH  
TO BASE GEOLOGY

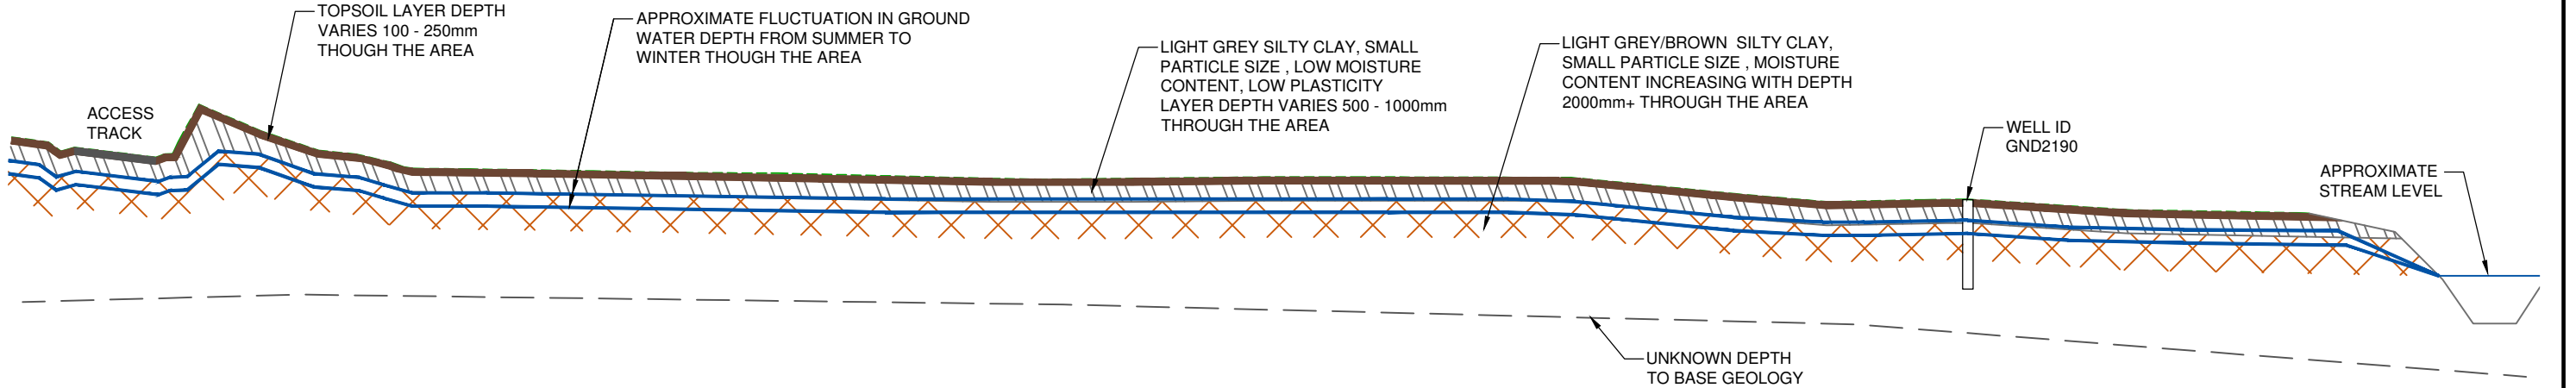
CROSS SECTION B-B  
SCALE 1:250 (A3)

UNKNOWN DEPTH  
TO BASE GEOLOGY
