Osflo Fertiliser Limited Monitoring Programme Annual Report 2019-2020

Technical Report 2020-70

Taranaki Regional Council

October 2020

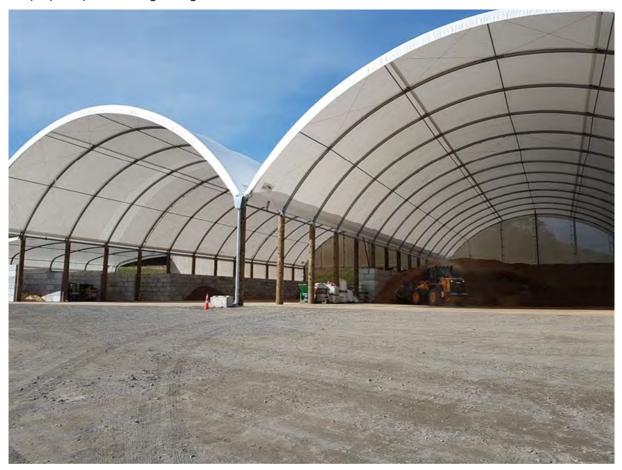
Figure 2 Osflo facility during construction both sides of the depot visible

The covered storage depot comprises two large stockpiling areas (Figure 2, note that this photograph was taken when the facility was being constructed and now the front has been closed in). The fresh litter is deposited on one side of the storage depot, where it is composted in this area with sawdust. Older more mature litter is stockpiled on the other side. In this area the more mature litter can be mixed with additional components as required, prior to being loaded for customers.

Odours at the facility are controlled with good air flow through the specially designed roof of the facility (Figure 2), this actively dries the material. During the planning stage of this establishment, a separate odour assessment of the project was undertaken by the consultant's Golder Associates. This added confidence to the proposal prior to the granting of the consents.

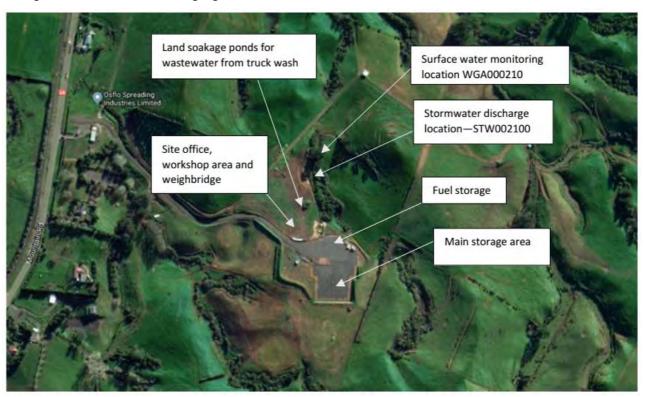
Figure 3 Aerial view of Osflo with associated labelling

Four surface water samples and one discharge sample were collected from the Company facility this monitoring period. As previously discussed, the facilities' only discharge to surface water is stormwater which is composed of the roof surfaces only at the facility. The only wastewater discharge is through ground soakage as defined in the following Figure 3.
