M A Brophy  
Compliance Monitoring Programme  
Annual Report  
2012-2013

Technical Report 2013-70

February 2014

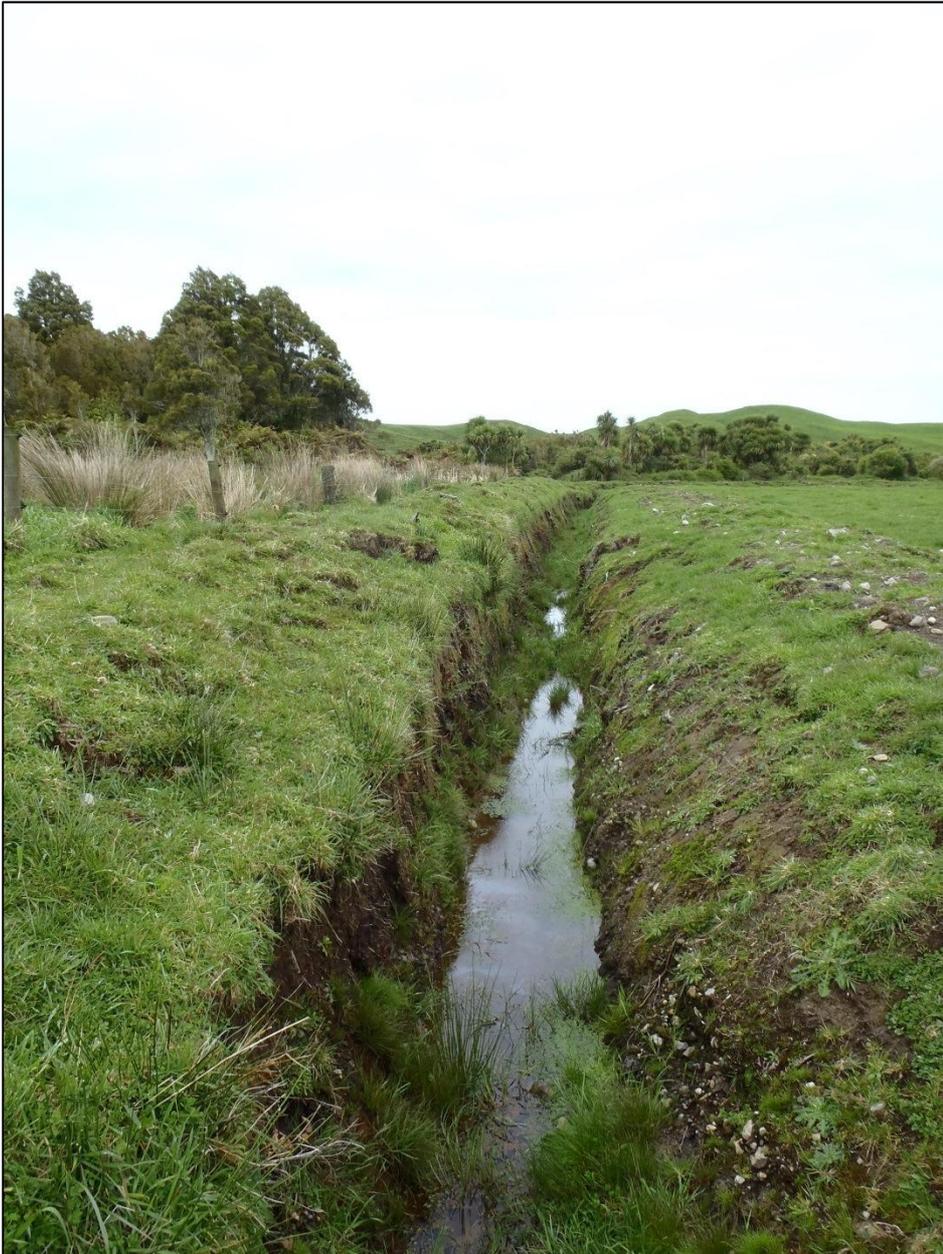
**Photo 2** Excavated outflow drain

The earth works associated with the draining and backfilling of the man-made ponds, and the excavation of the two unnamed tributaries, commenced on 12 December 2007.

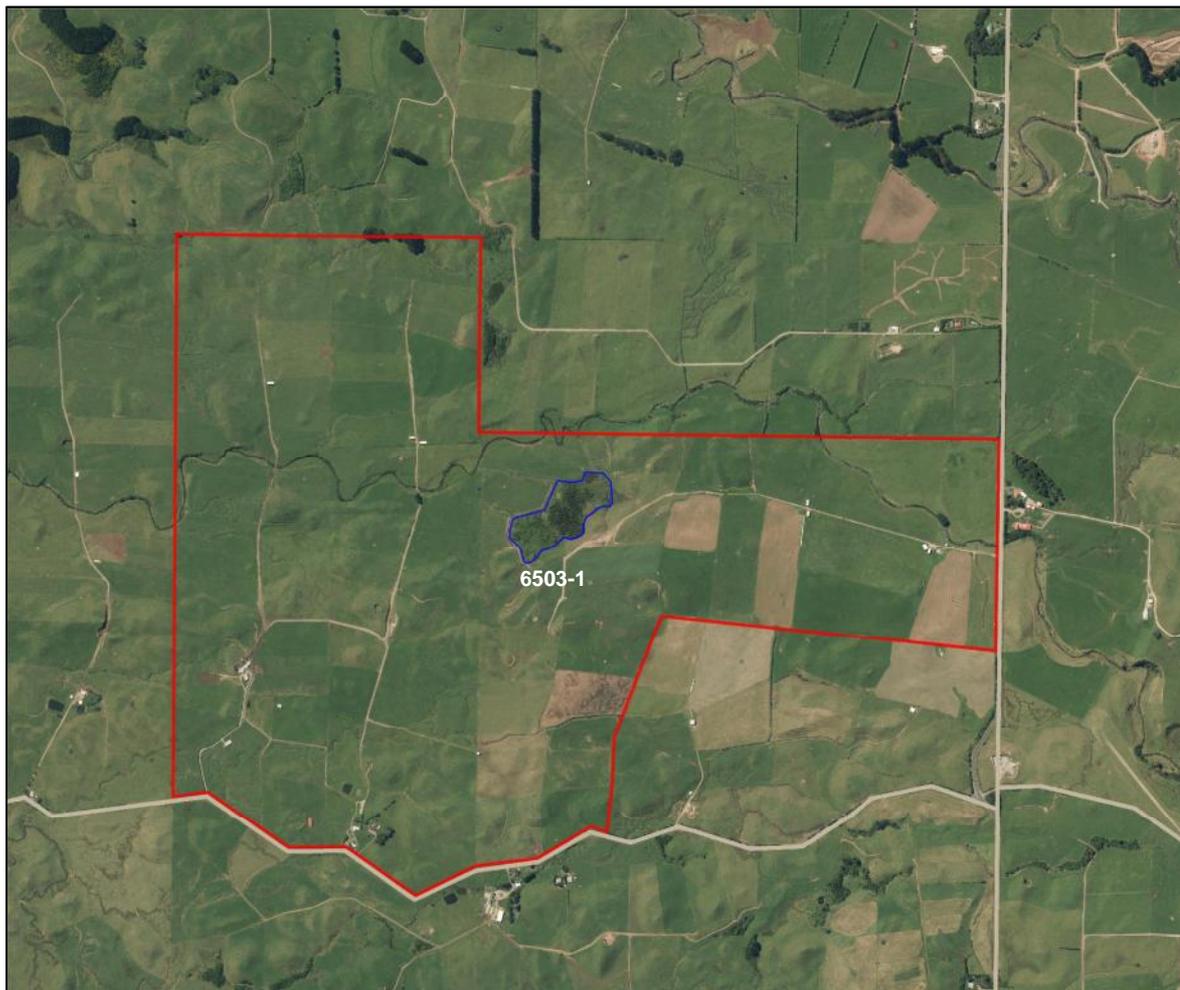
**Figure 1** Boundary of Brophy property (red) and wetland area (blue)

Figure 1 shows the location of the property at which the consent is held. A copy of the consent certificate is included in Appendix I of this report.

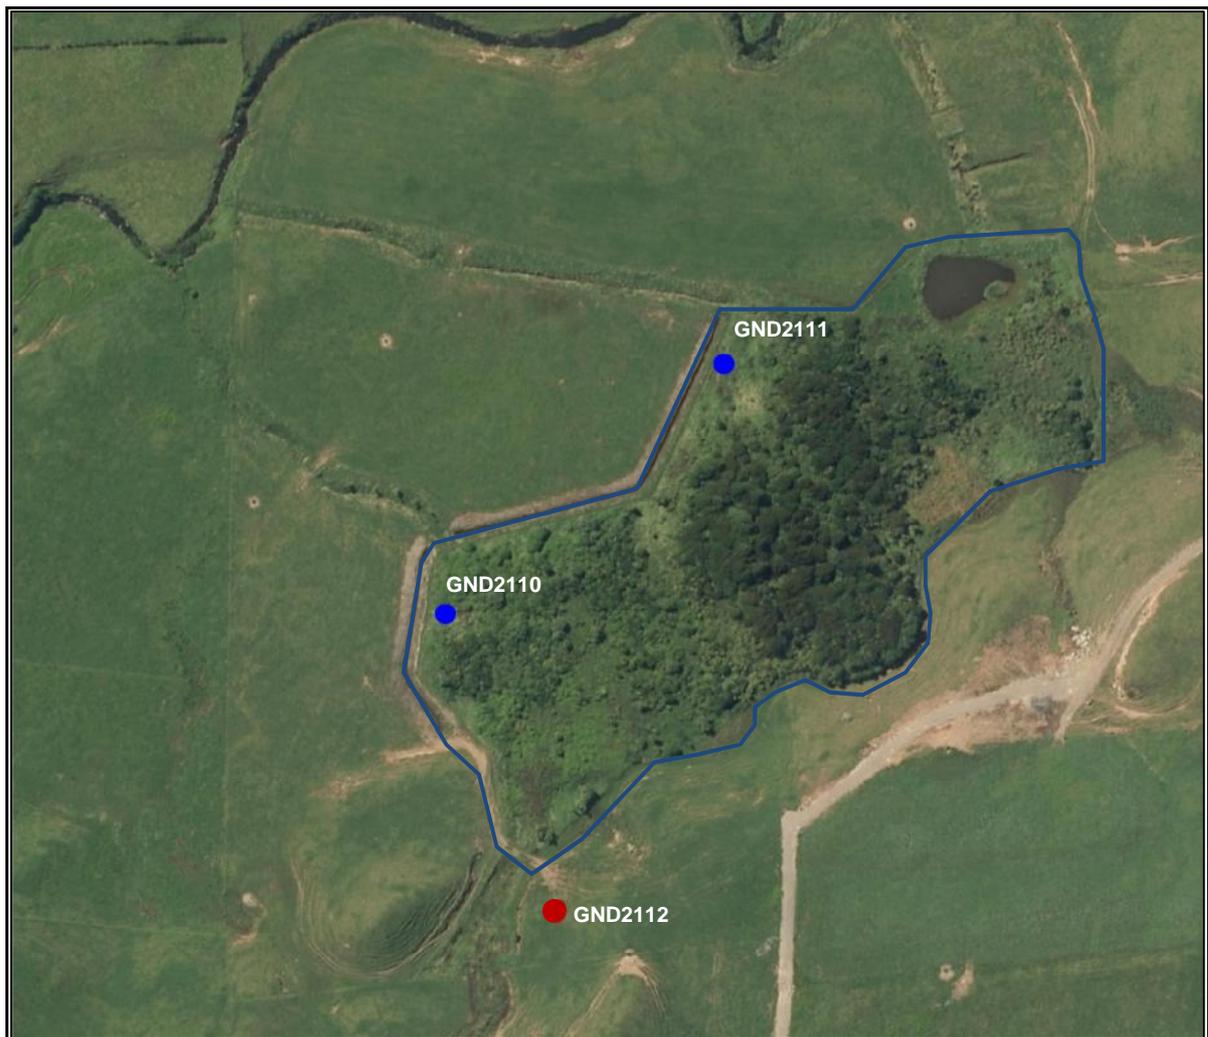
**Figure 2** Location of groundwater piezometers

During the initial site works carried out in December 2007, three piezometers were installed in order to monitor wetland water levels. Two piezometers were installed within the wetland boundary, and one outside the wetlands south-western boundary. During the site visit on 4 September 2012, only the two piezometers within the wetland area were able to be located (GND2110 and GND2111). The above ground section of the piezometer located outside the wetland area (GND2112) appears to have been destroyed by stock or farm machinery, making it impossible to locate. At this stage, there is no requirement for GND2112 to be replaced. The locations of the two accessible piezometers, and the approximate location of GND2112, are illustrated in Figure 2.

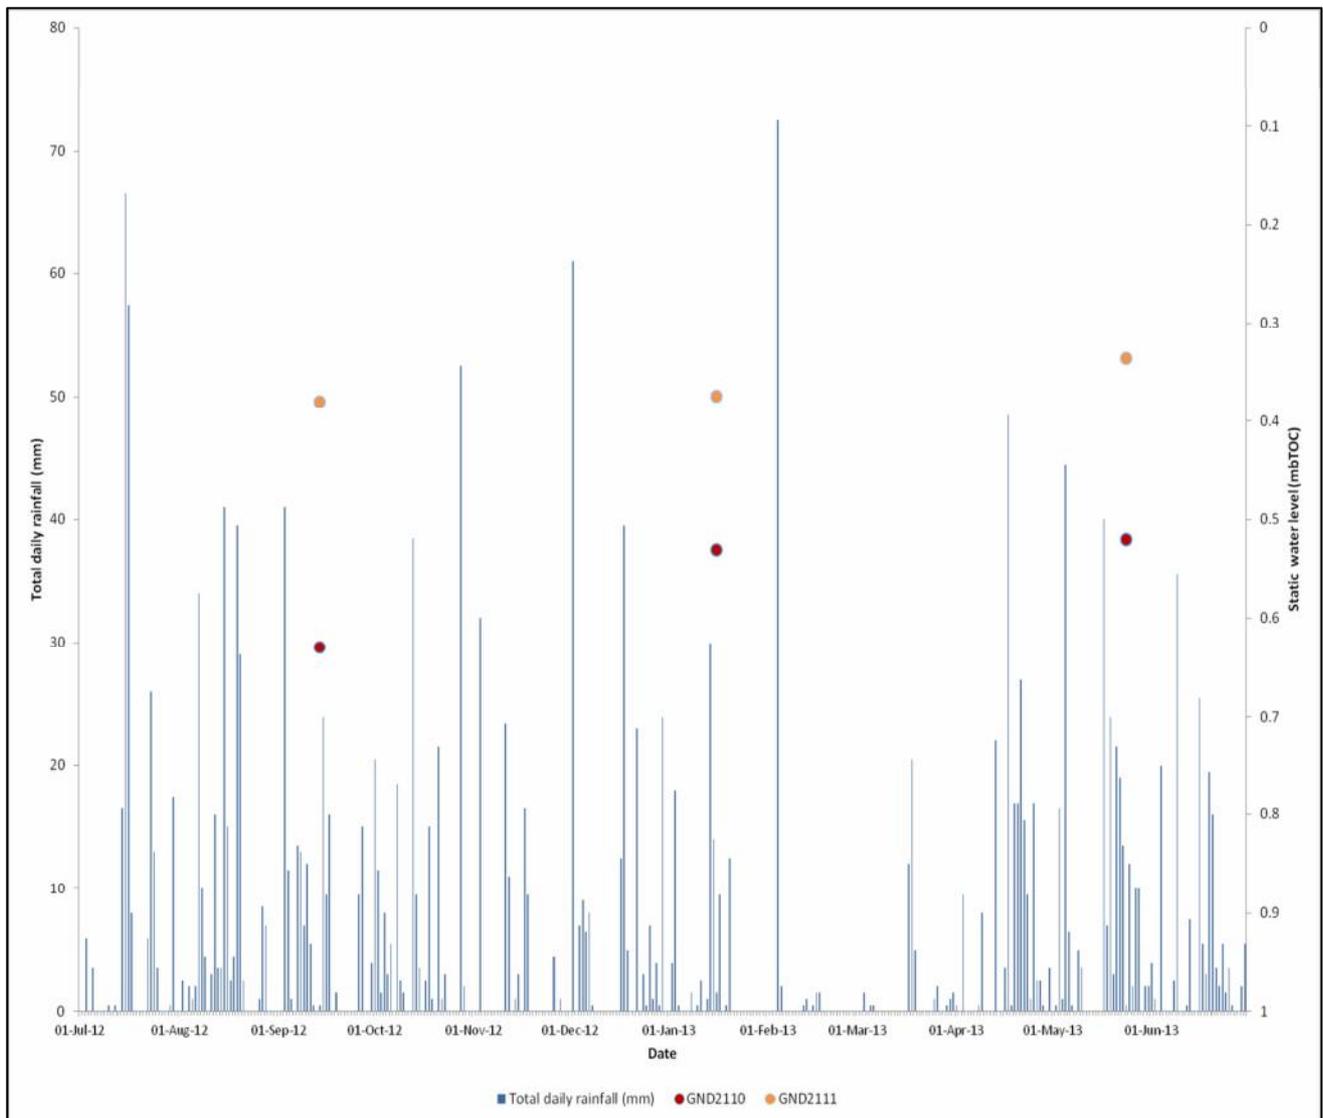
**Figure 3** Static water level measurements from piezometers and total daily rainfall values

Date	Season	GND2110 Static water level (mbTOC*)	GND2111 Static water level (mbTOC*)
14 September 2012	Spring	0.630	0.380
16 January 2013	Summer	0.530	0.374
24 May 2013	Autumn	0.520	0.336

The monitoring of water levels within the wetland does however indicate that water levels were relatively stable over the 2012-2013 monitoring period. Water levels also showed little response to seasonal variation in rainfall volumes. Wetland water levels will continue to be monitored during the forthcoming 2013-2014 period enabling more definitive trends to be identified. Regular wetland condition assessments will also be carried out for comparison against baseline results.

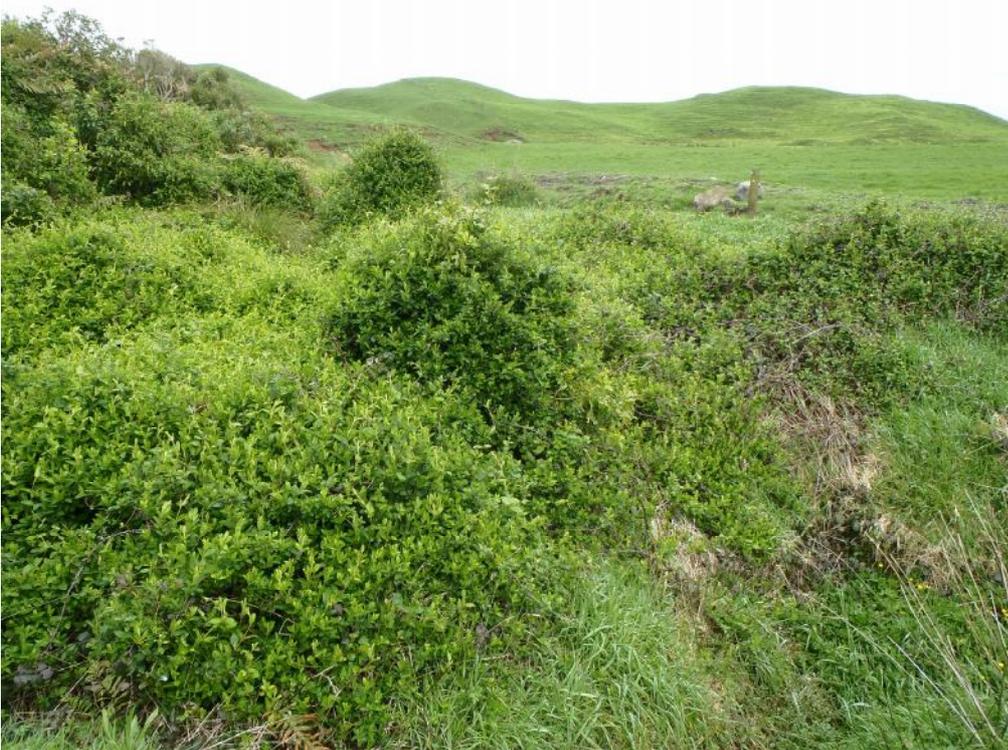
**Photopoint 1** Rank grass, blackberry and Japanese honeysuckle along boundary fence, looking SW

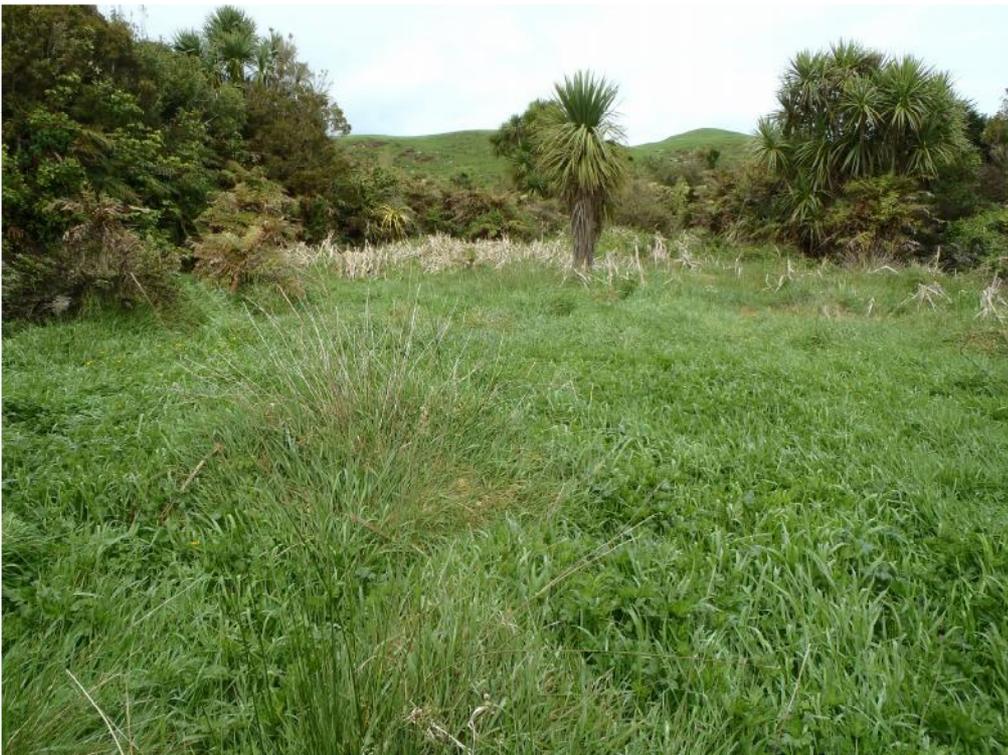
**Photopoint 2** Raupo in background & rank grass encroachment in foreground at boundary fence, looking S

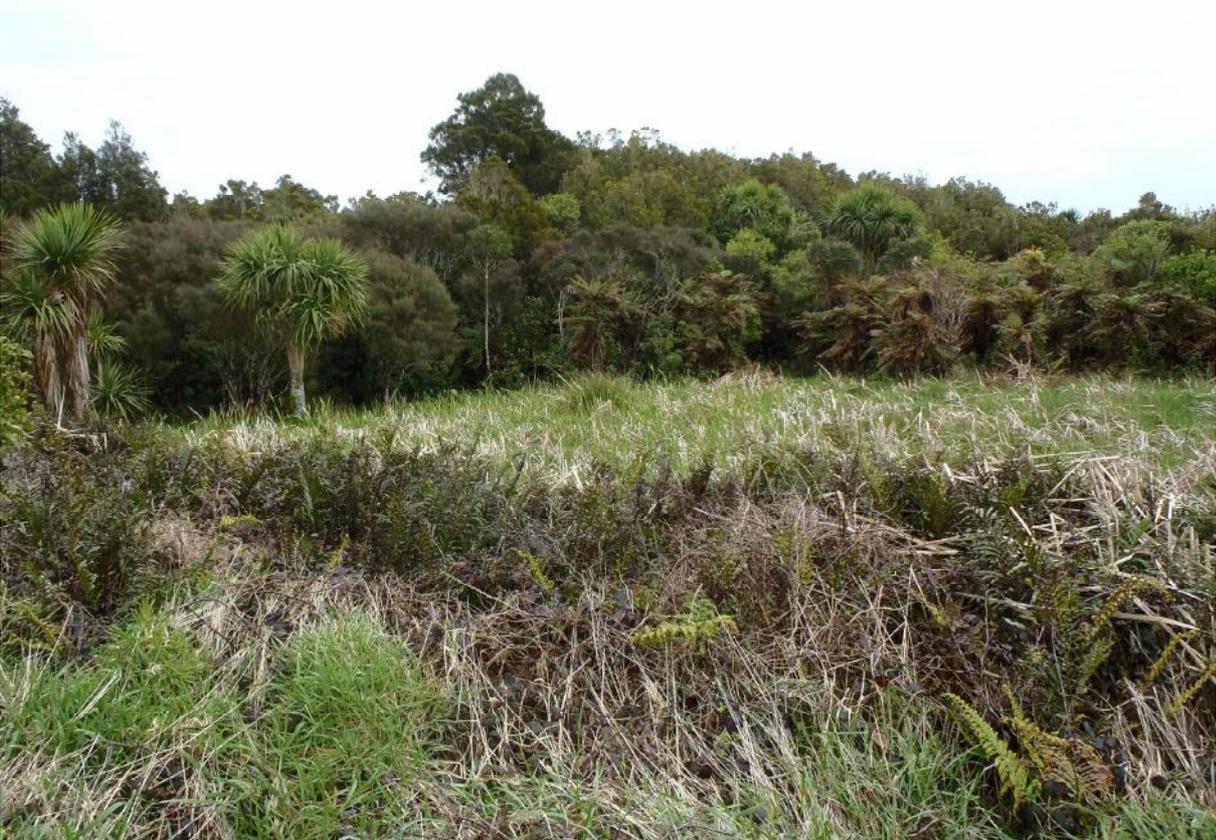
**Photopoint 3** Invasive weed encroachment in foreground, raupo in mid-ground and swamp maire canopy in background from boundary fence, looking N

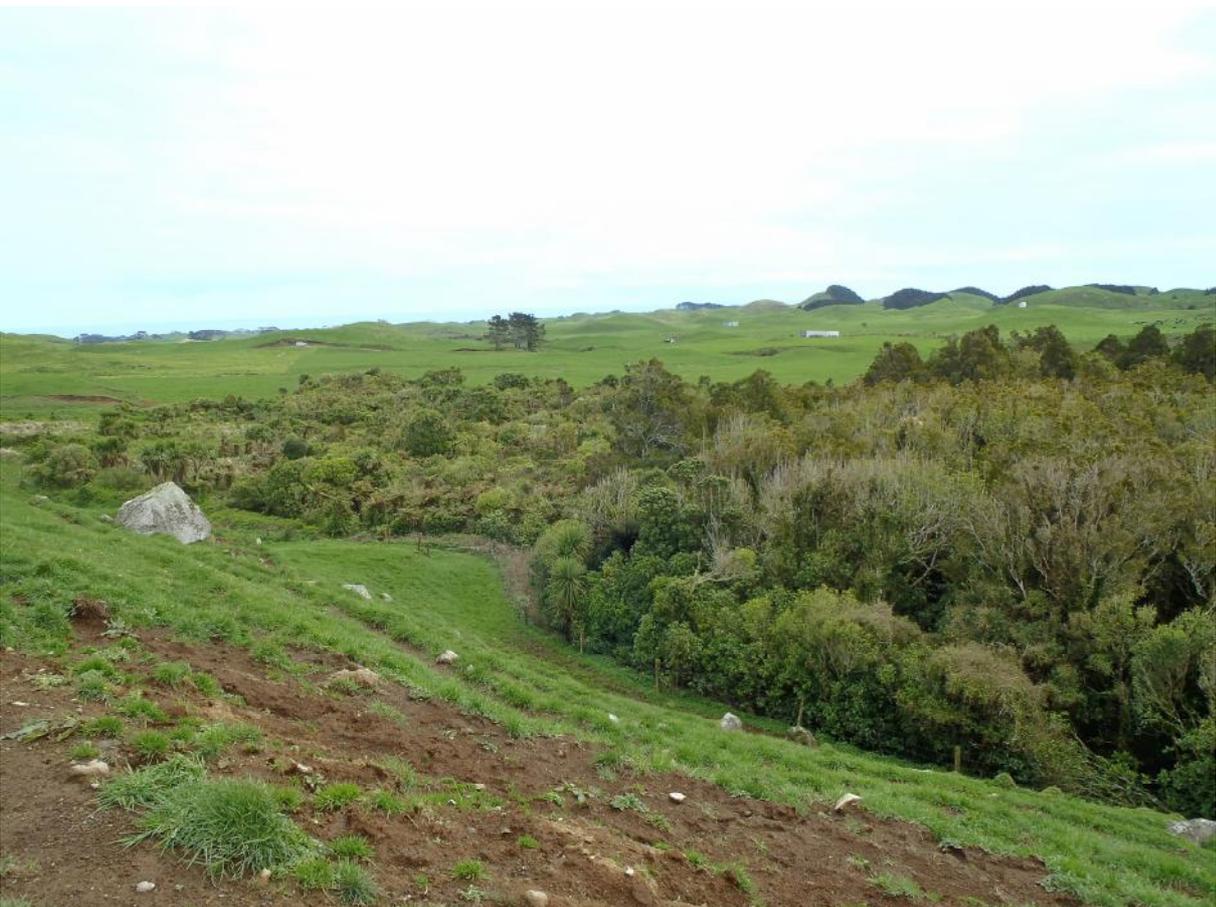
**Photopoint 4** Regionally Significant Wetland area showing raupo wetland and forest canopy, including healthy

stands of swamp maire, looking W from hilltop above wetland

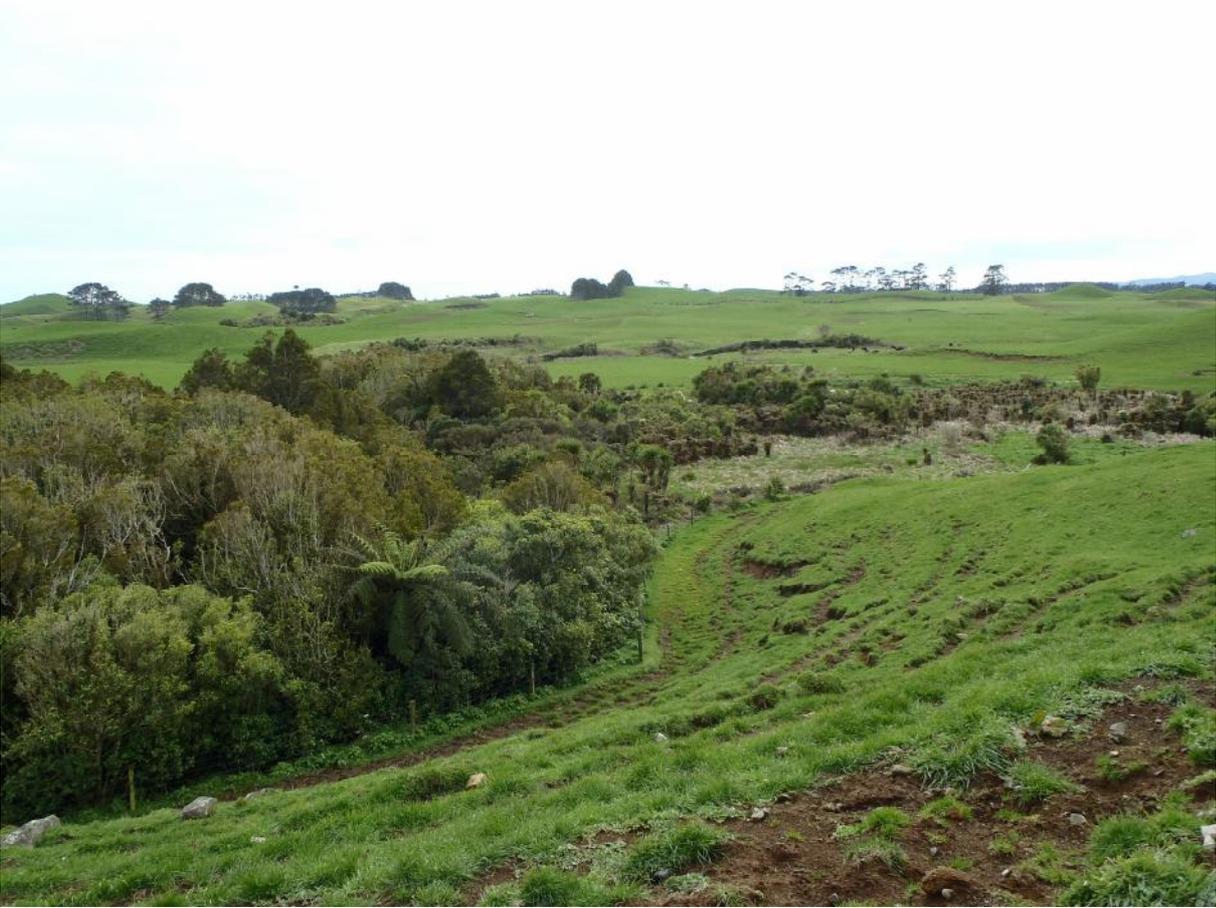
**Photopoint 4** Regionally Significant Wetland area showing raupo wetland and forest canopy, including decent sized stands of swamp maire, looking N from hilltop above wetland

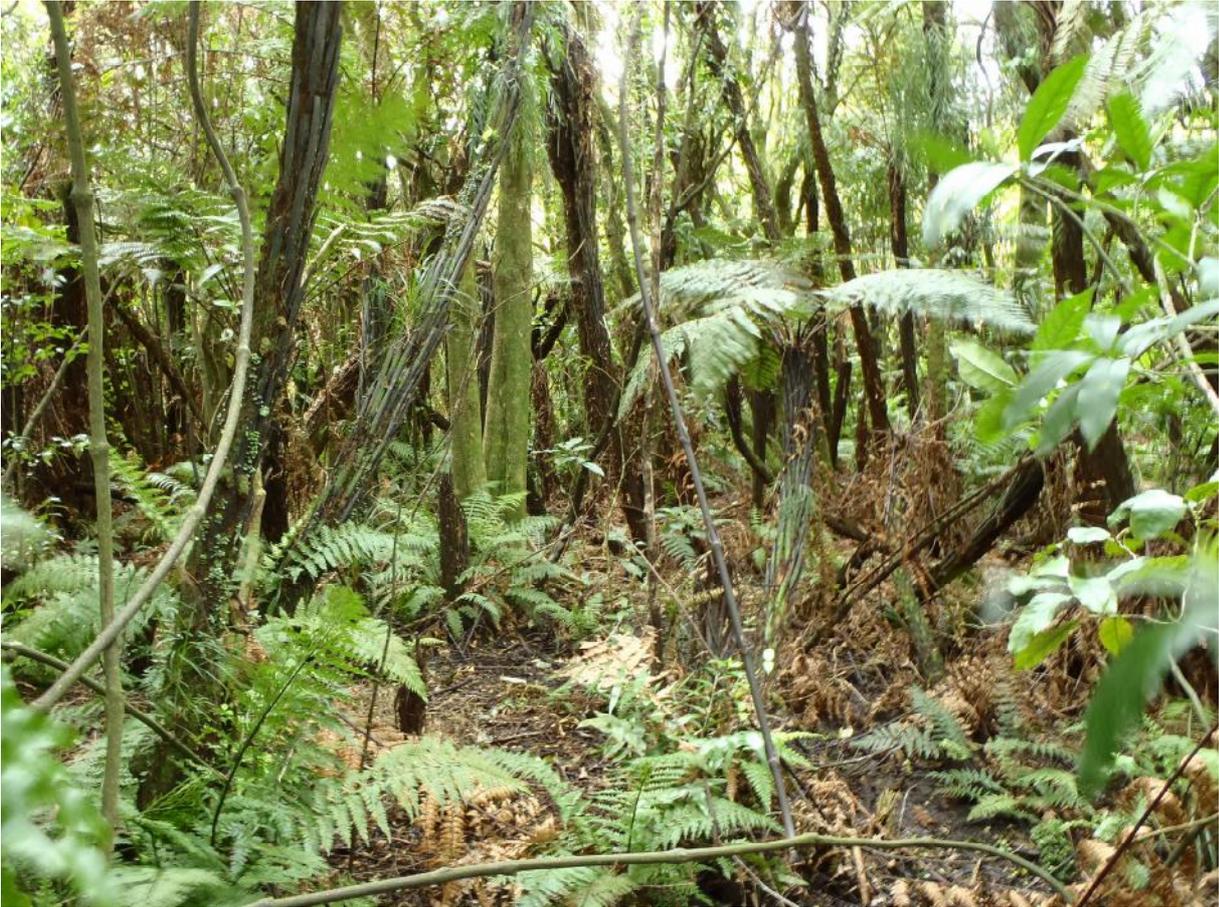
**Site photo 1** Dense understorey of palatable species and wet pools on forest floor

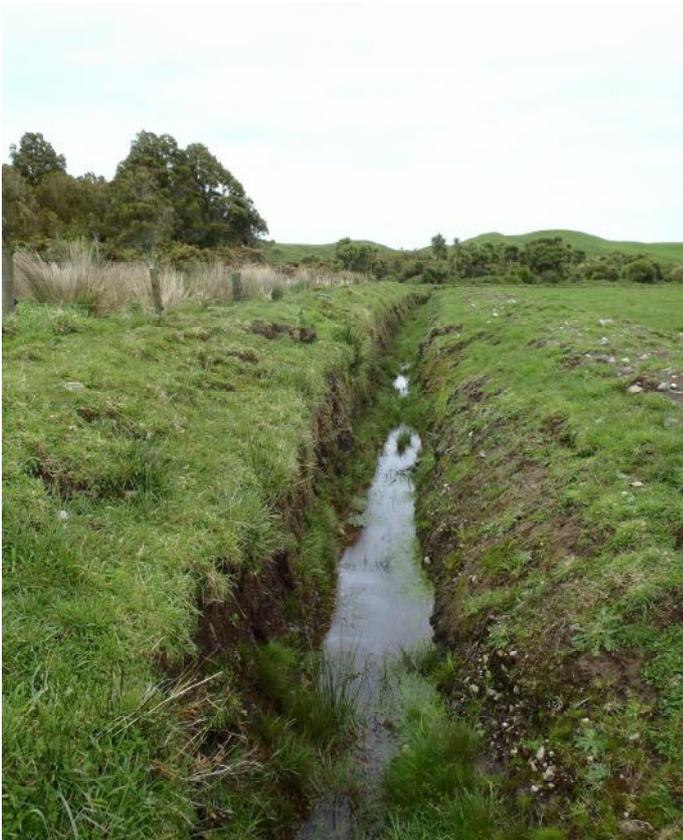
The baseline wetland condition assessment carried out during the period under review indicates that there is evidence of drying around the wetland margins. While the swamp forest area of the wetland appears to be in relatively good condition (with relatively healthy areas of swamp maire and kahikatea), the raupo and flax reedland areas around the wetland edges appear to be slowly drying out and are being replaced by invasive rank grasses, blackberry, Japanese honeysuckle and bracken.

**Site photo 2** Deep drains surrounding wetland (approx. 2m deep), causing some areas to dry out and allowing encroachment of invasive dry-land species

Management recommendations			
Action:	Priority <sup>1</sup>	Specify/comment:	
Drainage	H	Investigate the possibility of halting/remediating drainage works around wetland area and allowing wetland to revert to its natural state, with enhancement planting and weed control programmes put in place <b>only</b> if current drainage has been stopped.  Biodiversity team to investigate the possibility of including propagation and re-introduction of threatened, at risk or regionally rare species within their known range (eg. small flowered mistletoe, kirks tree daisy, mudfish etc) <b>only</b> if current drainage has been stopped.	
Legal protection	L	Legally protected with QEII covenant. No further protection required	
Fencing	L	Wetland securely fenced and stock-proof. Maintain as required.	
Planting	M	The wetland habitats will benefit from an ongoing planting programme using eco-sourced native plant species within their known natural range <b>only</b> if current drainage has been stopped. LMO to discuss suitable options with landowner and Biodiversity Team.

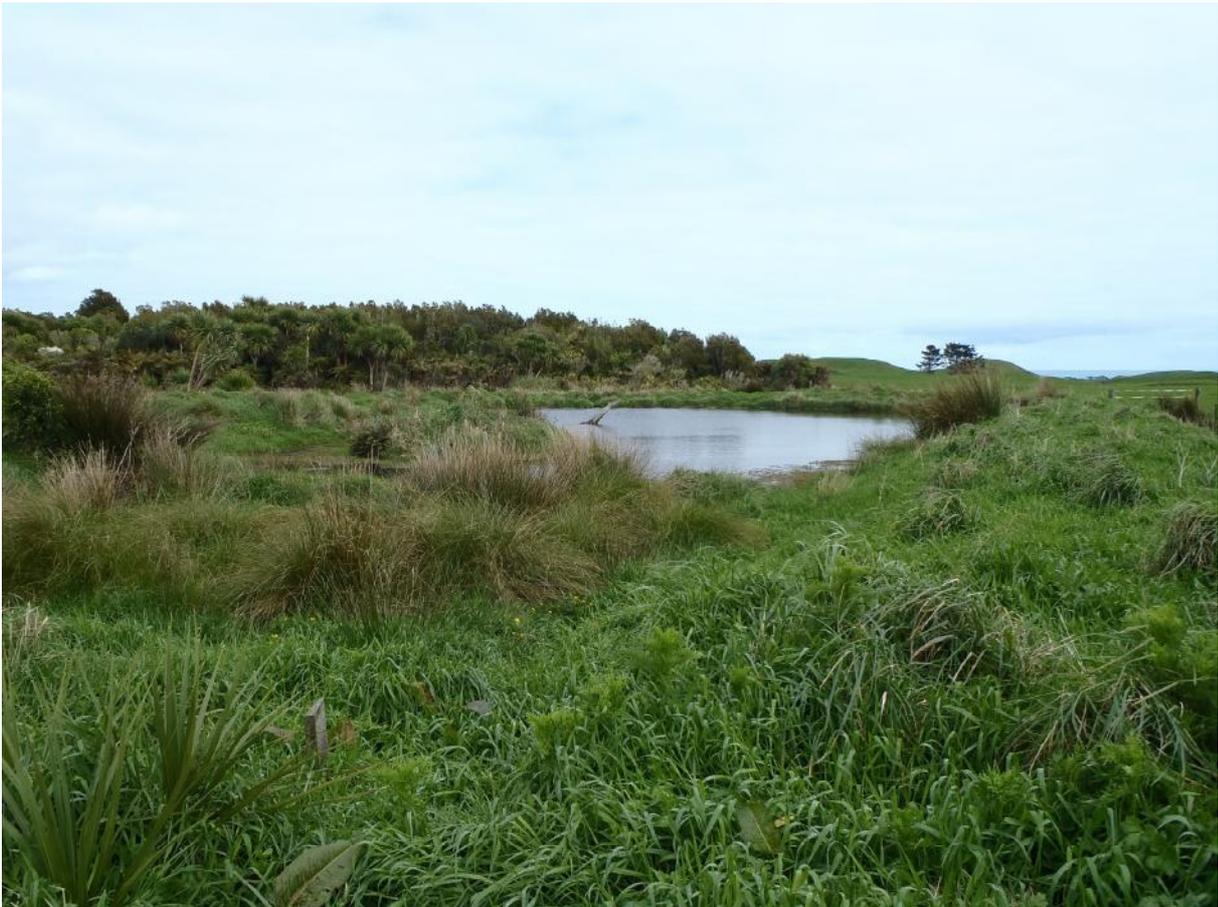
**Site photo 3** Pool created at northern end of wetland by bunding of drains (along right hand side of pond in this photo)
