Remediation NZ Ltd
Uruti and Waitara Road
Monitoring Programme
Annual Report
2018-2019

Technical Report 2019-50

February 2020

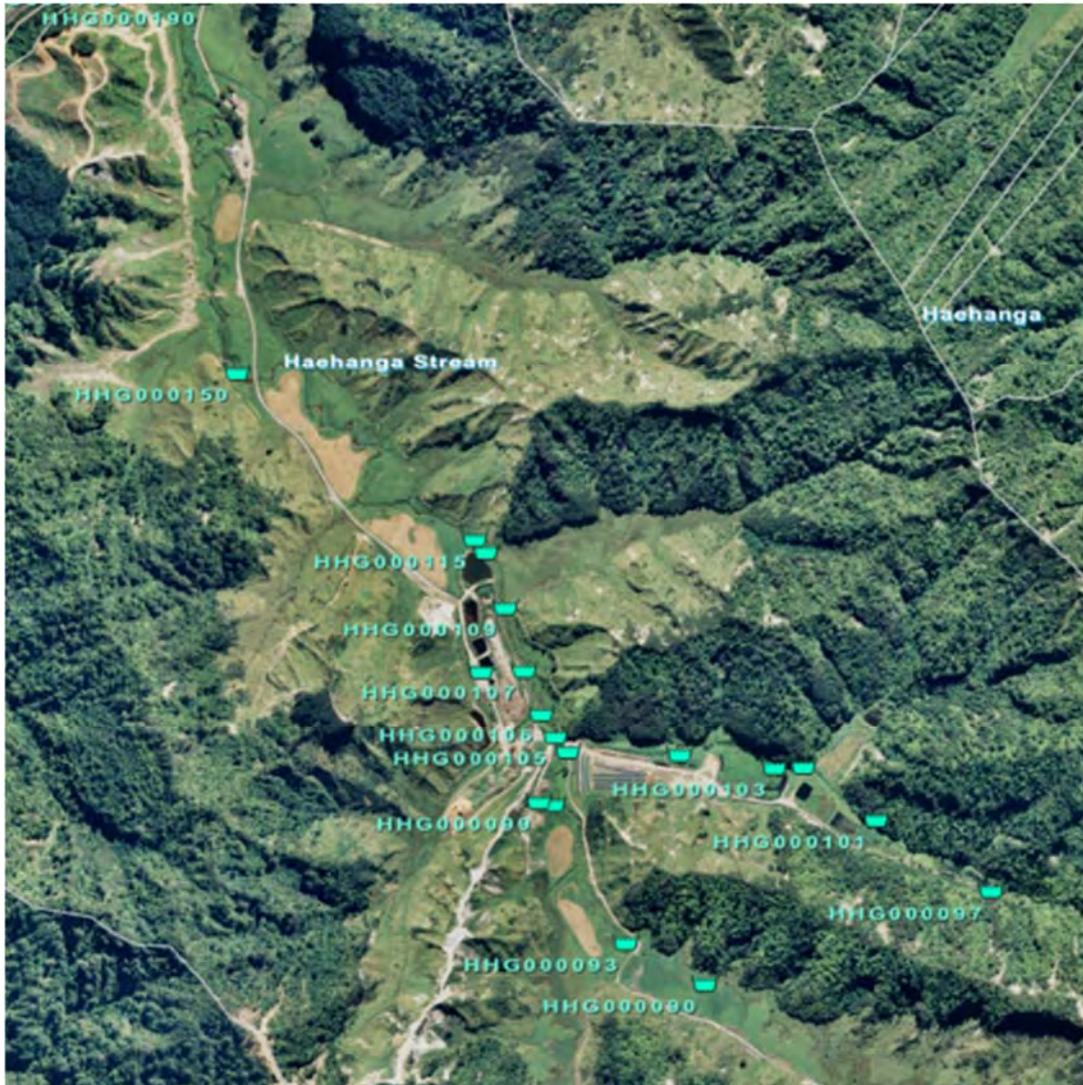
Figure 6 Surface water monitoring locations

The Haehanga Stream and its associated unnamed tributaries were monitored on a bi-monthly schedule this period. The water course was assessed at 12² locations down its length (Figure 3 and 6). The analysis of the six compliance monitoring rounds and two additional follow up assessments are provided in the following Tables 5-12.

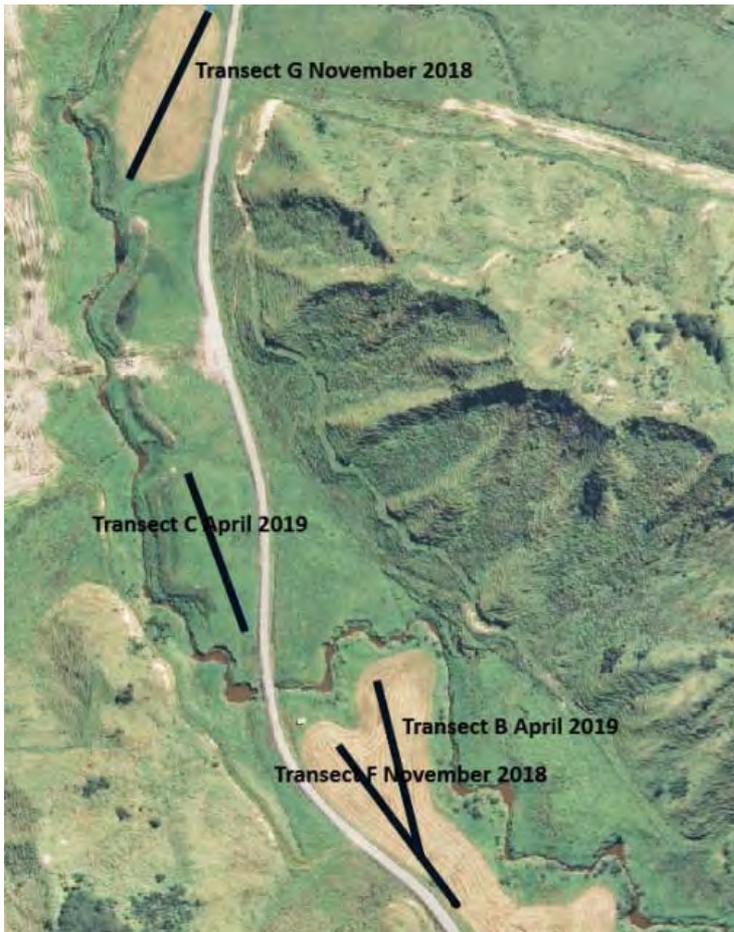
Figure 7 RNZ Uruti lower irrigation area soil transects

The analysis of the soil samples this period has identified that area J is impacted when compared to area F with elevated values for chloride, calcium, potassium, sodium, barium and soluble salts. The analysis of the newly extended irrigation area F, details the difference between a slightly utilised area in the case of area F and significantly utilised areas in the case of area J and also area E. The variation is particularly evident when soluble salts concentrations are compared across the areas. Area J contains four times the amount of soluble salts (transect B, 3,100 mg/kg) when compared to area F (700 mg/kg, transect A).

Additional soil samples will be collected from all irrigation areas in the upcoming monitoring period, with particular emphasis on area J and H as these two locations are historically the older irrigation areas. Noting that the company was intending to limit applications in these older areas to mitigate the elevated chlorides recorded in the soil.

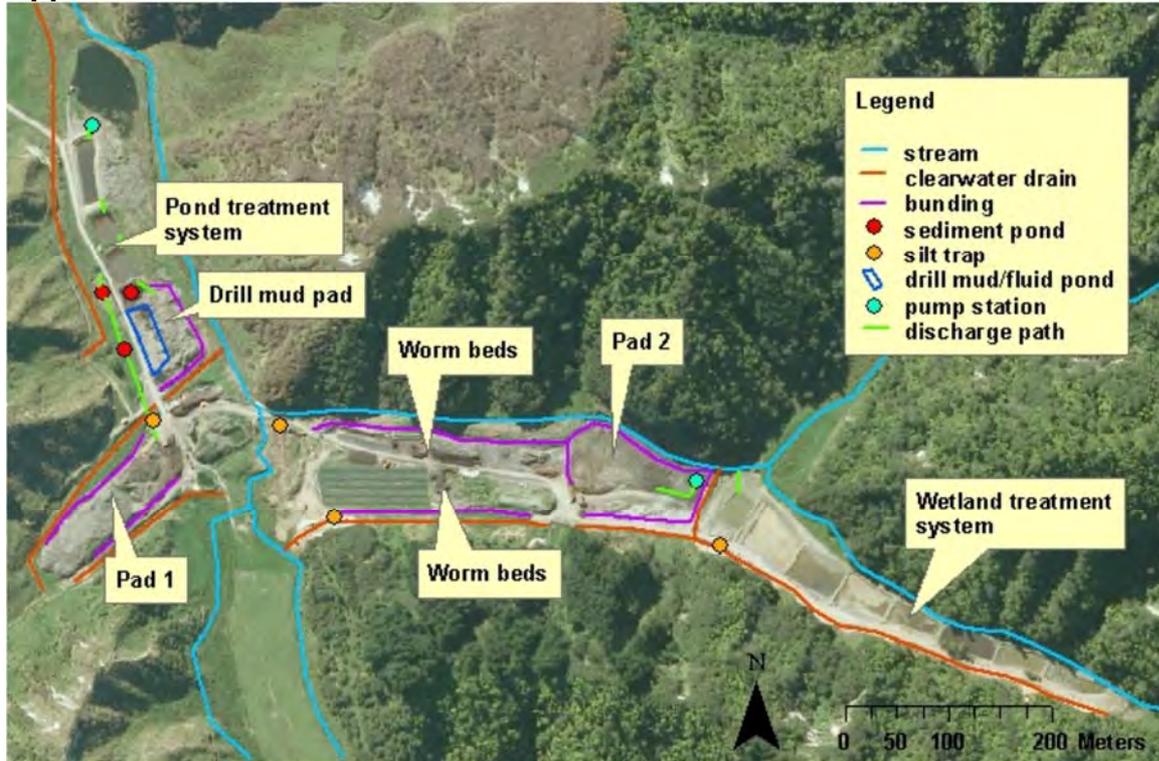
Figure 1 The location and extent of the Pond Treatment System, Wetland Treatment System, Pads 1 and 2, and the Drill Mud Pad.

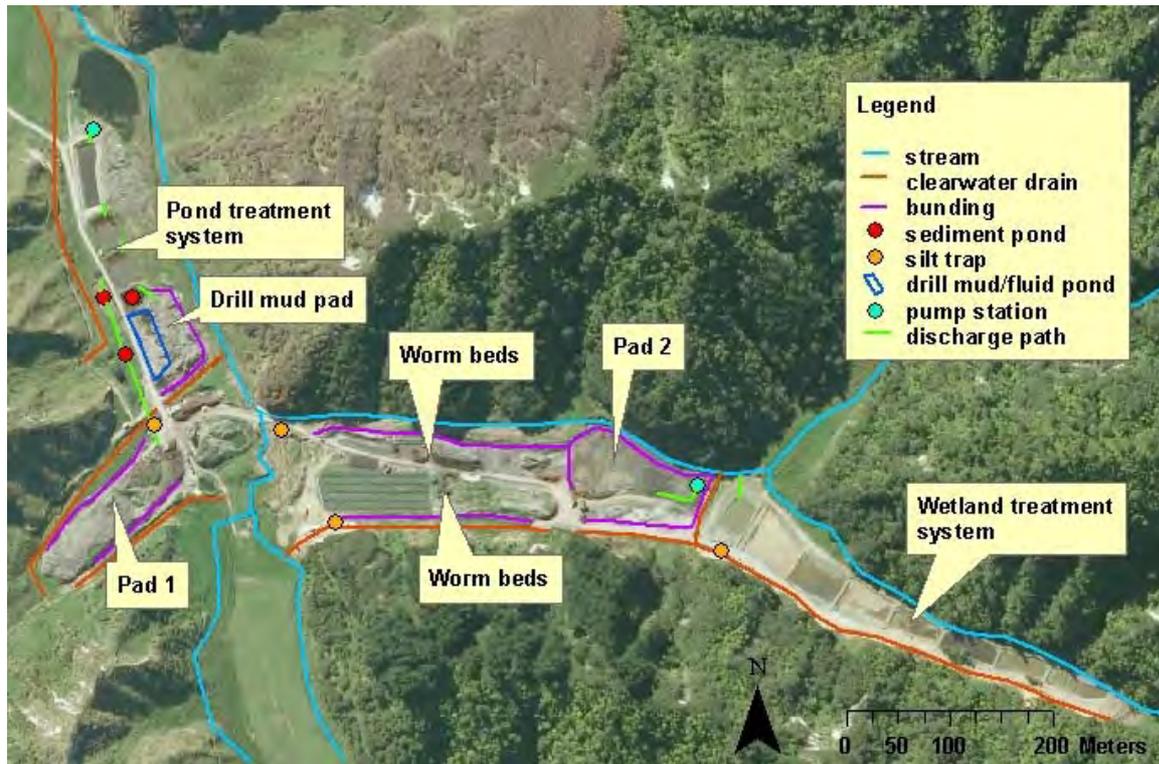
Figure 1 The location and extent of the composting operation including Pads 1 and 2.
