# Lower Waiwhakaiho Catchment

Monitoring Programme

Annual Report

Technical Report 2020-64

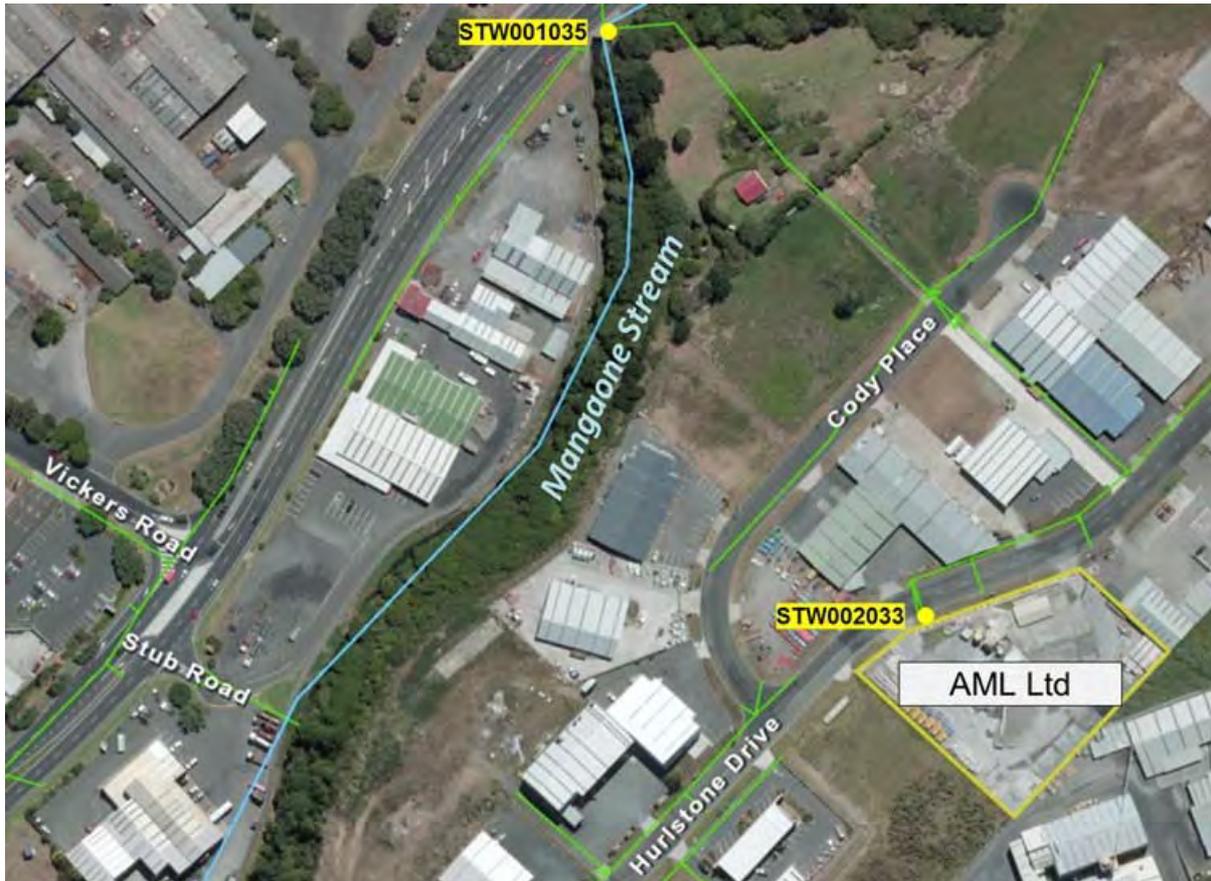
Figure 3 AML Ltd (trading as Allied Concrete) site location and stormwater drainage

Stormwater from the majority of the site drains directly to the New Plymouth District Council (NPDC) stormwater system and then to the Mangaone Stream.

The wastewater treatment system consists of a series of settlement ponds and pumps for the recycling of process water. The emptied mixing bowls of up to seven concrete trucks are washed out each day using water and a small amount of detergent. This bowl wash water is discharged into two 36 m<sup>3</sup> bins and allowed to settle for at least 18 hours before treatment through an additional series of six settlement ponds totalling approximately 360 m<sup>3</sup> in volume. Solids from the settlement process are removed from the bins and ponds as required.

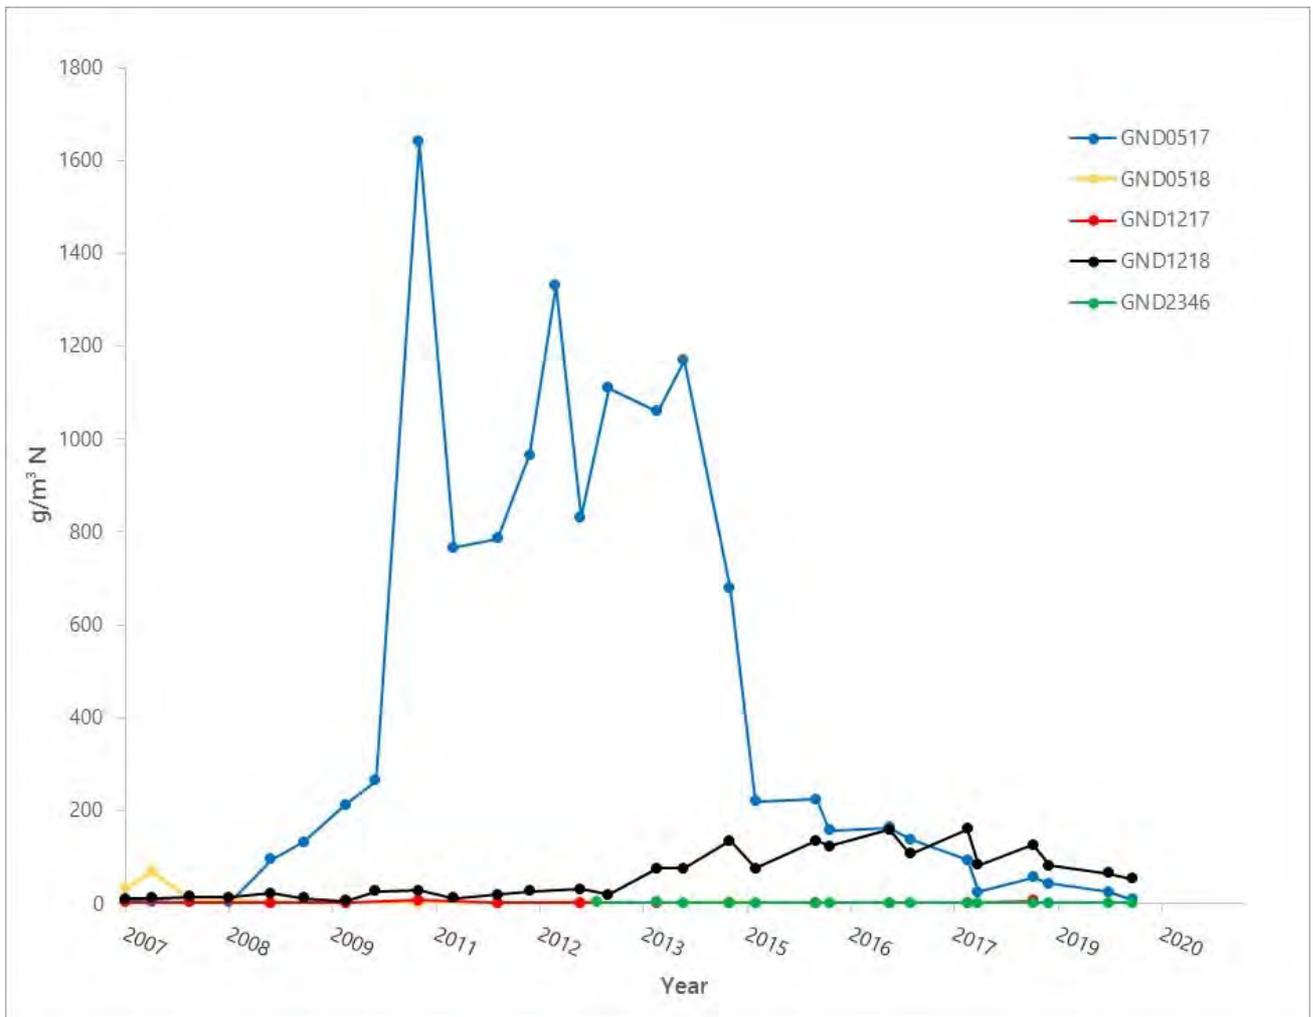
The only bore located mid-site, GND0518, had previously shown frequent short-term fluctuations in ammoniacal nitrogen concentrations. Since January 2019, these levels have shown a steady decline which is most likely attributed to decreased activities on the site, with Ravensdown operations ceasing in October 2018 and no further onsite works since.

Figure 5 Ammoniacal nitrogen concentration at all Devon 662 monitoring bores from 2006 to June 2020

Despite the elevated ammoniacal nitrogen in the vicinity of the Devon 662 site, dry weather in-stream monitoring (Section 16.1.2) showed that during the period under review, there were only slight increases in the ammoniacal nitrogen concentration in the Mangaone Stream as it flowed past the Ravensdown site. Of particular note are the results of the unionised ammonia concentration, which decreased at the downstream site compared to the upstream results. Both sites were well below the 0.025 g/m<sup>3</sup> chronic toxicity guideline for freshwater ecosystems. The dissolved reactive phosphorus concentration was found to be slightly in excess of the ANZECC trigger value of 0.010 g/m<sup>3</sup> below the site, however it should be noted that the upstream site was also in excess of this trigger value. .

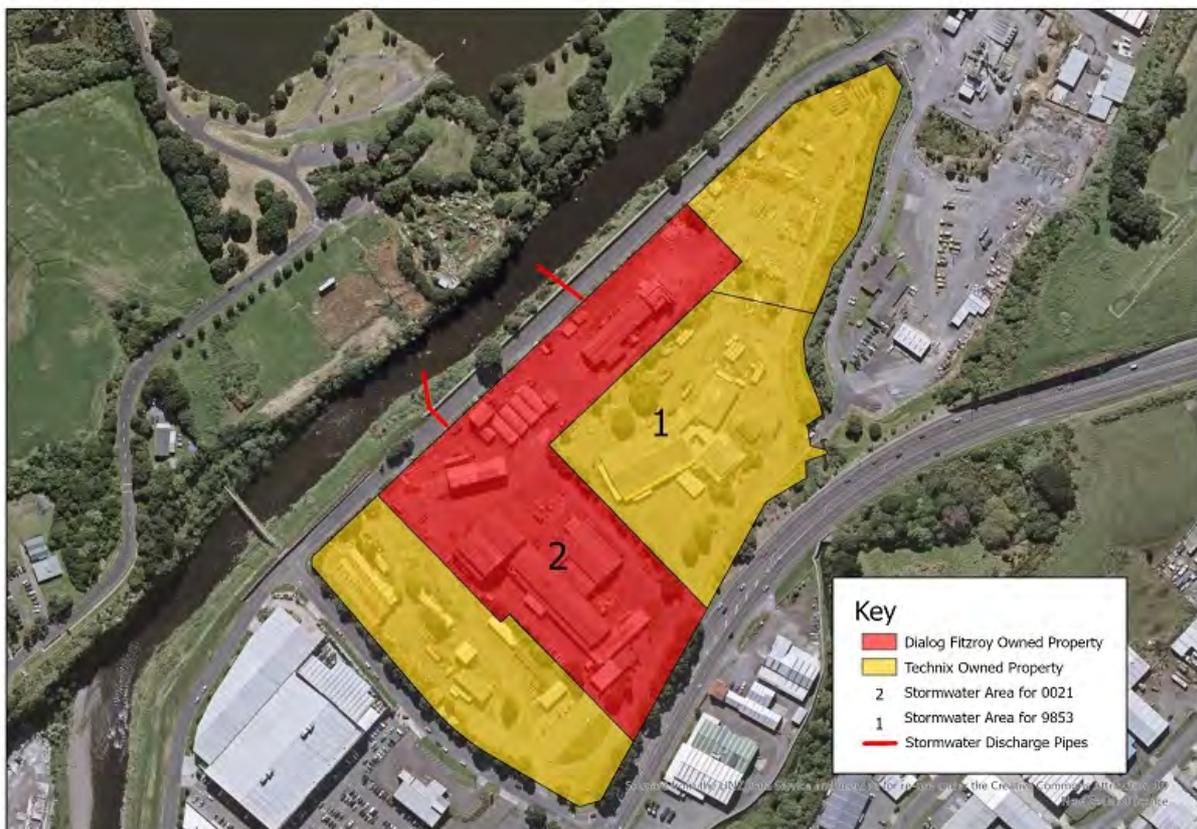
Figure 6 Aerial view of Technix Group Ltd and Dialog Fitzroy Ltd subdivided site

The site was previously leased by Dialog Fitzroy from Technix Group Ltd (Technix), and the stormwater discharges from Dialog Fitzroy's activities were covered under consents held by Technix. In 2013 Dialog Fitzroy purchased the part of the property they operate on from Technix (Figure 6). After the purchase of the property resource consent 0021-3 was transferred from Technix to Dialog Fitzroy. Resource consent 0291-3 was split into two consents as the northern area covered by this consent was now owned by FEGL. The consent number assigned to this catchment area was consent number 9853.

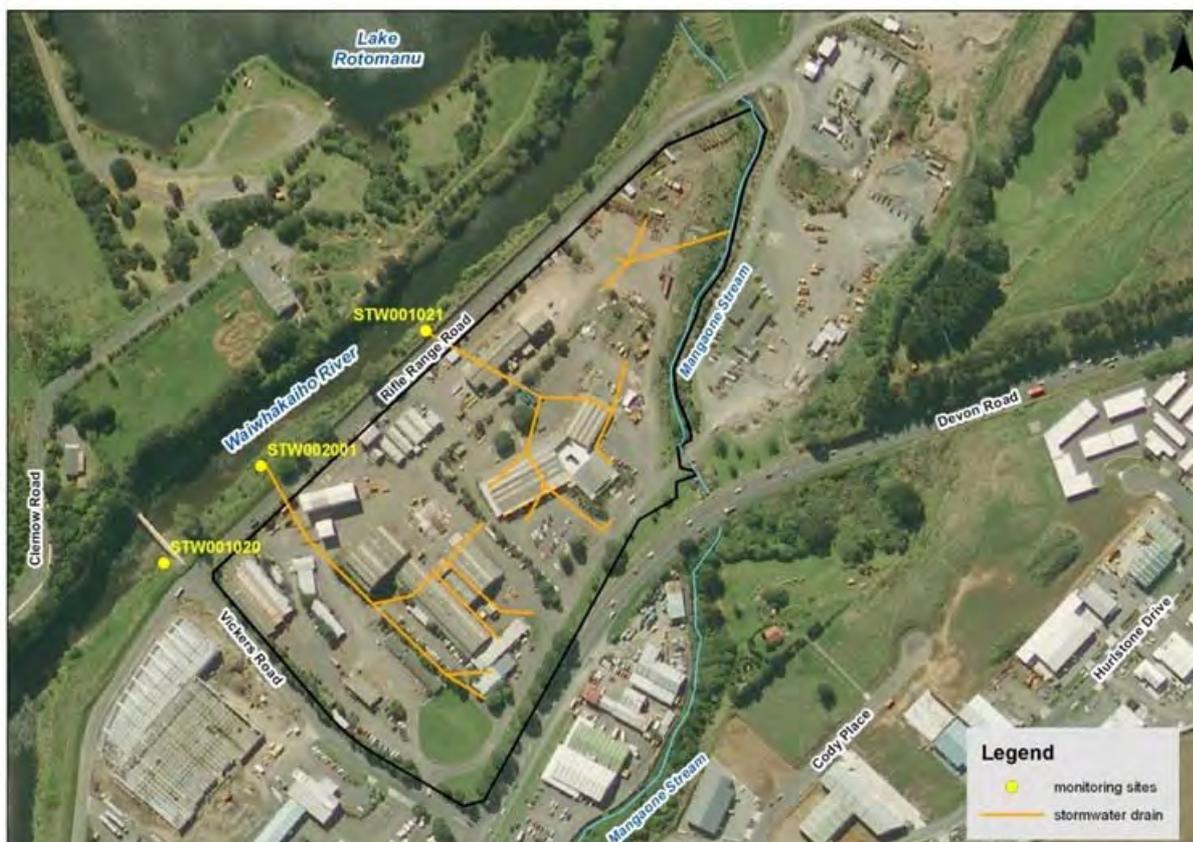
The stormwater area for consent 0021 covers the south-west section of Dialog Fitzroy's property. The stormwater drainage system runs from the south and east boundary towards the east boundary, the drainage then runs north towards the Waiwhakaiho River and discharges into the river via a stormwater drain (STW002001, Figure 7). There are multiple sumps along this system to collect stormwater.

Figure 7 Dialog Fitzroy's site and stormwater discharge points

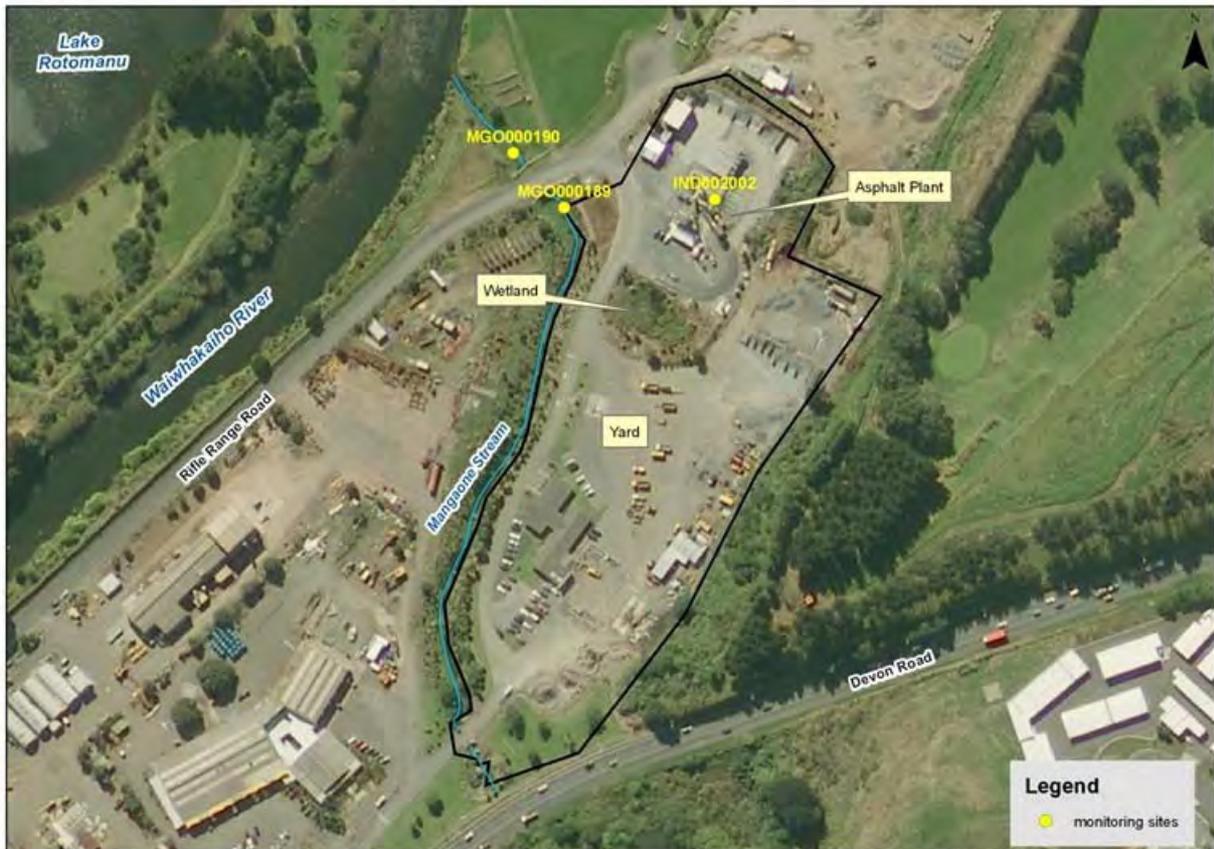
Figure 8 Aerial view of the Downer site and sampling point locations

In the manufacturing process, aggregate metal is dried by gas heating and is mixed with heated bitumen to form hot-mix bitumen. Diesel oil and/or kerosene may be added to adjust the consistency of the mix. The product is loaded onto trucks for transport. Dust and gases generated from the process are treated in a wet scrubber. Scrubber effluent is treated in four settling ponds then reused.

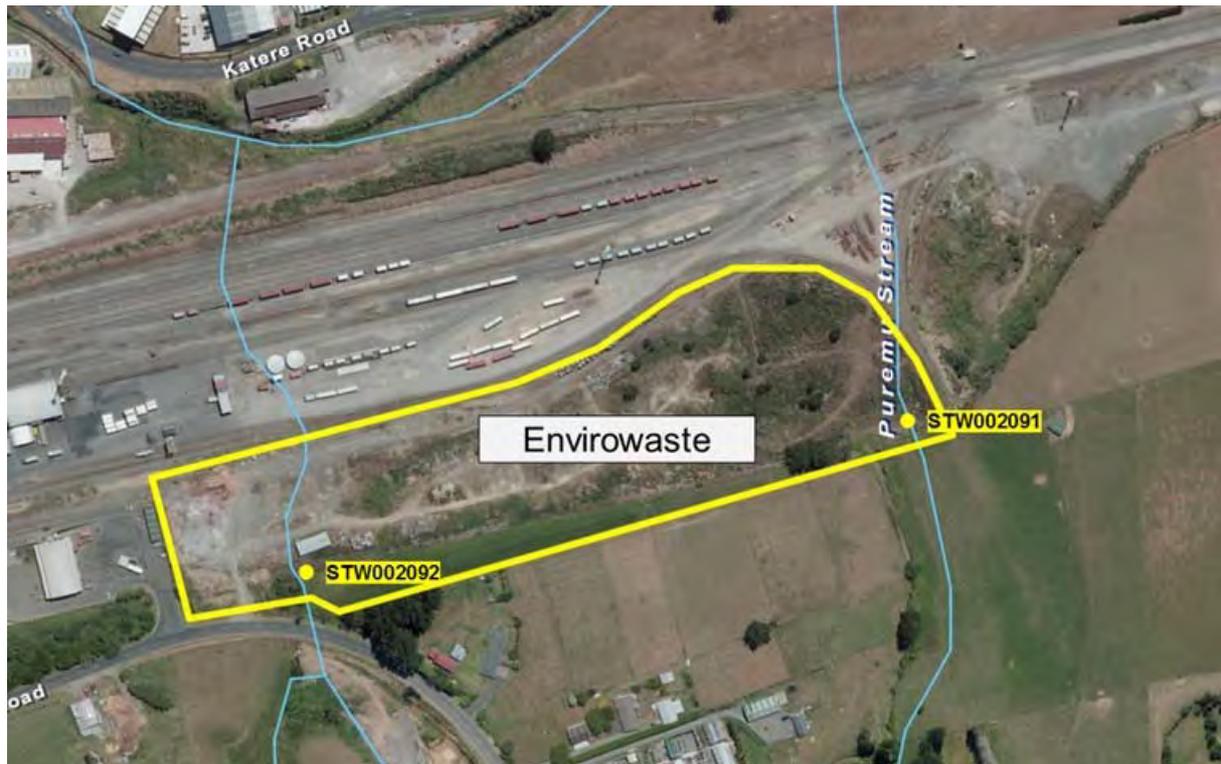
Stormwater from the site discharges via retention ponds to the Puremu and Mangamiro Streams. Prior to discharge the stormwater is treated in long sediment ponds that discharge via grates to prevent litter being carried with it.

Figure 9 Envirowaste's site and sampling locations

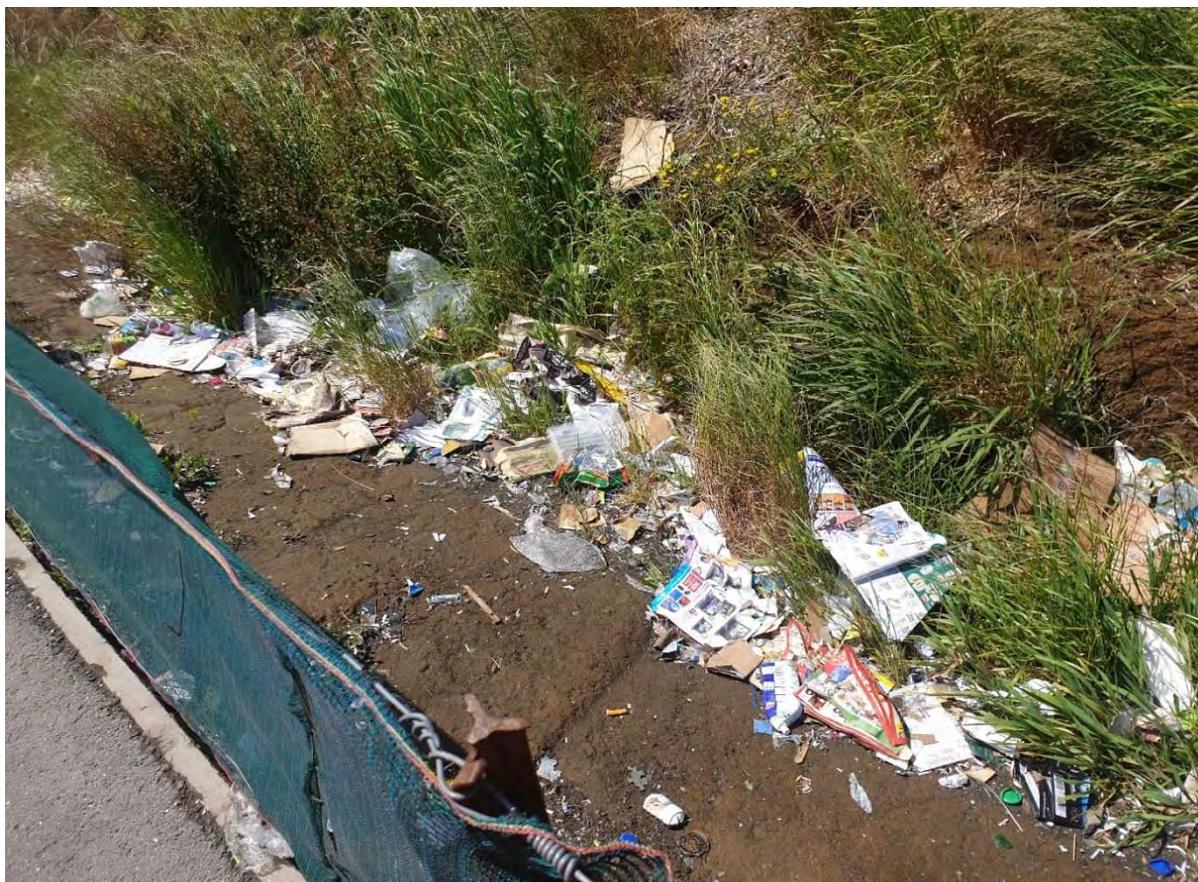
In general the site was found to be relatively clean and tidy, however, some wind-blown rubbish was noted within the swale drain and on the banks of the Mangamiro Stream (Photo 1).

Photo 1 Wind-blown litter at the Envirowaste site November 2019

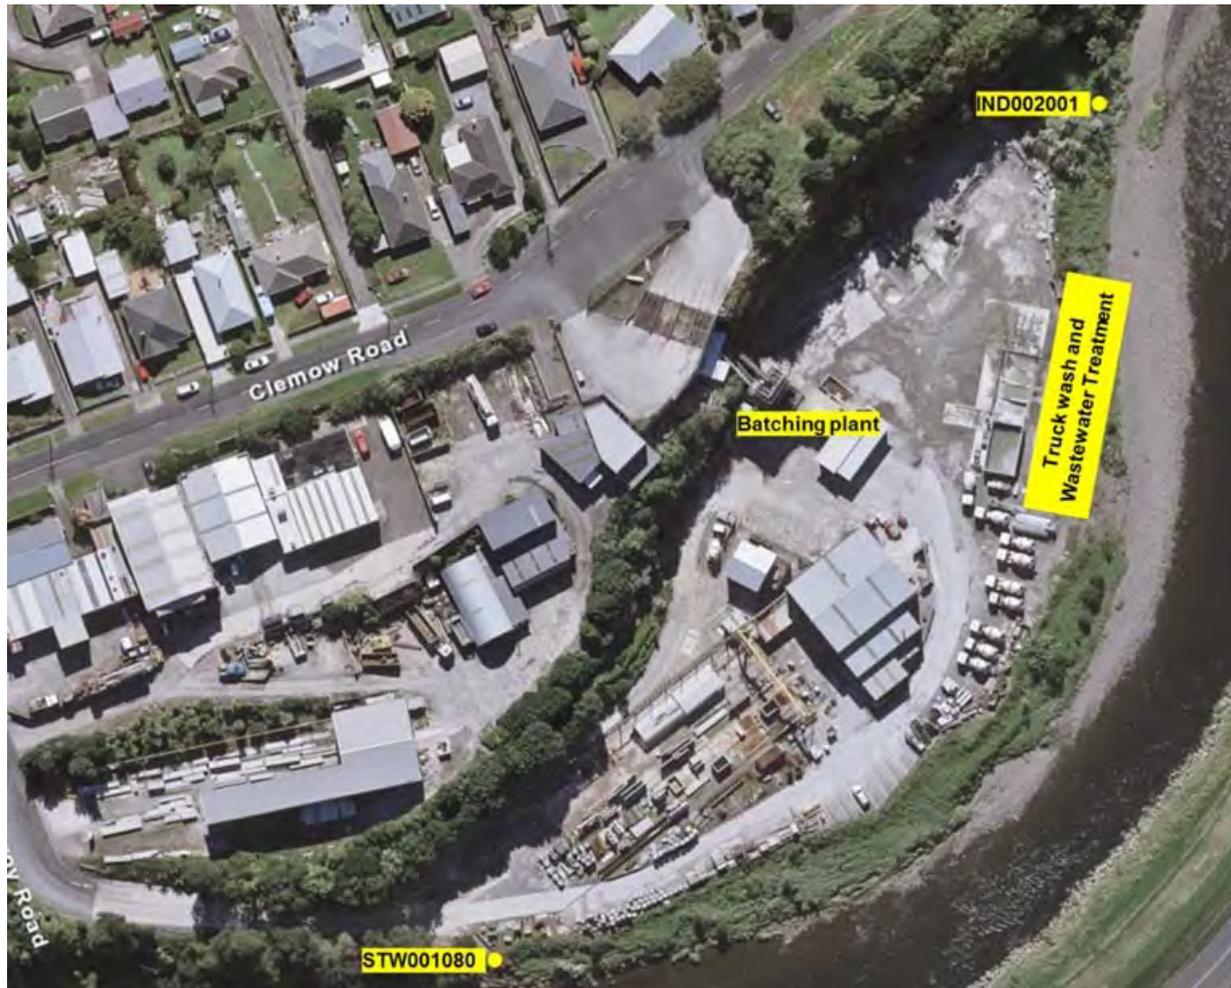
Figure 10 Firth Industries site location and discharge points

Stormwater from the lower part of the site is treated in a four-pond settling system before being pumped to the Waiwhakaiho River via an old watercourse. Wastewater from the washing of plant and concrete delivery trucks is discharged to separate wastewater treatment system which treats and recycles the wastewater.

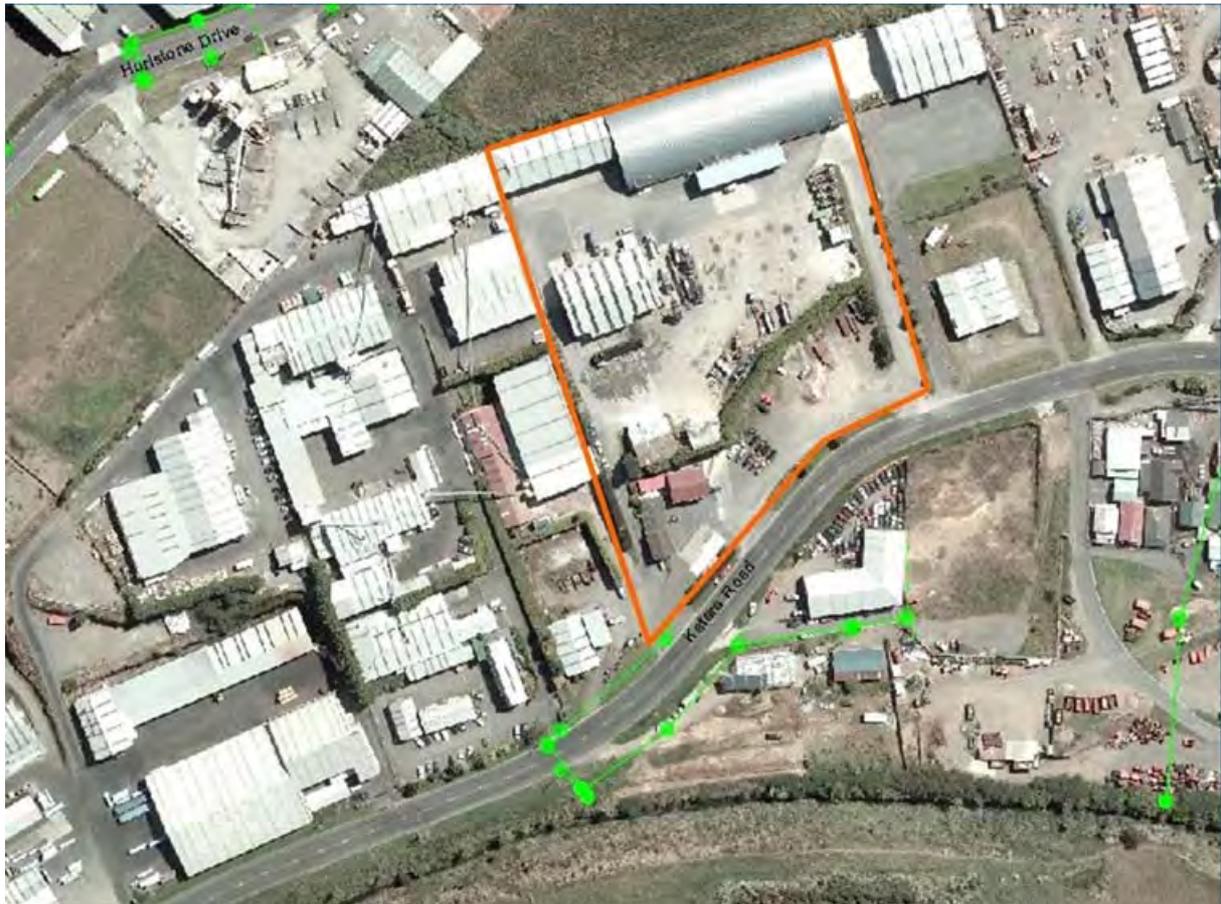
Figure 11 Location of Freight and Bulk Transport Holdings site

Freight and Bulk Transport Holdings Ltd (FBT) operate a truck depot that services the rural sector from this 1.77 ha site on Katere Road (Figure 11).

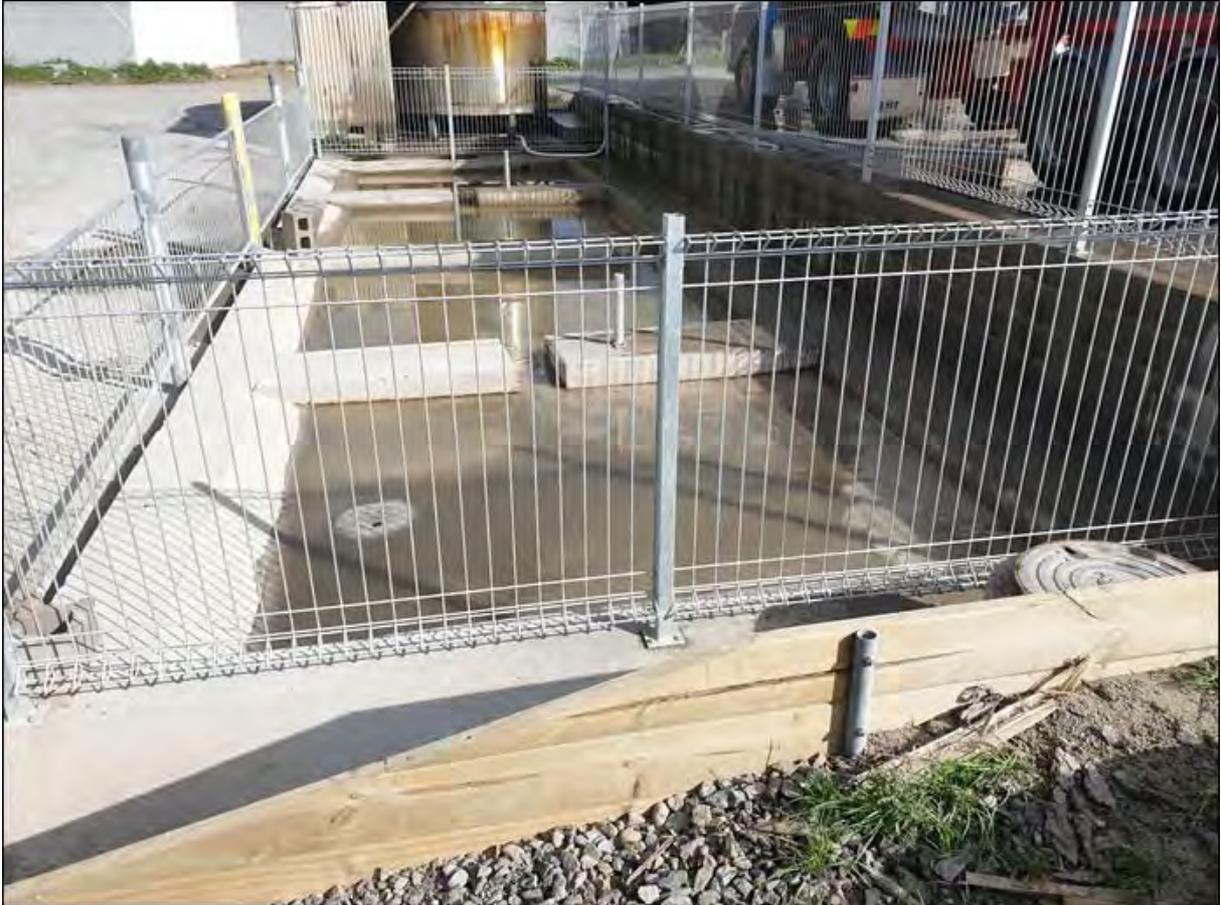
FBT stores, blends and distributes dry stock feeds such as crushed meal, palm kernel and grains. Lime, fertiliser and gravel used for farm races are also stored at the site. The lime, stock feeds and fertilisers are stored in the sheds at the northern end of the site; only the gravel is stored outside in the stormwater catchment. Trucks are washed at the site and the wash water was historically (until expiry of consent 0241) discharged to soak holes. During the 2018-2019 monitoring period a new truck wash was installed that recycles wash water and discharges contaminants to trade waste (Photo 2).

Photo 2 FBT's new truck wash treatment system.

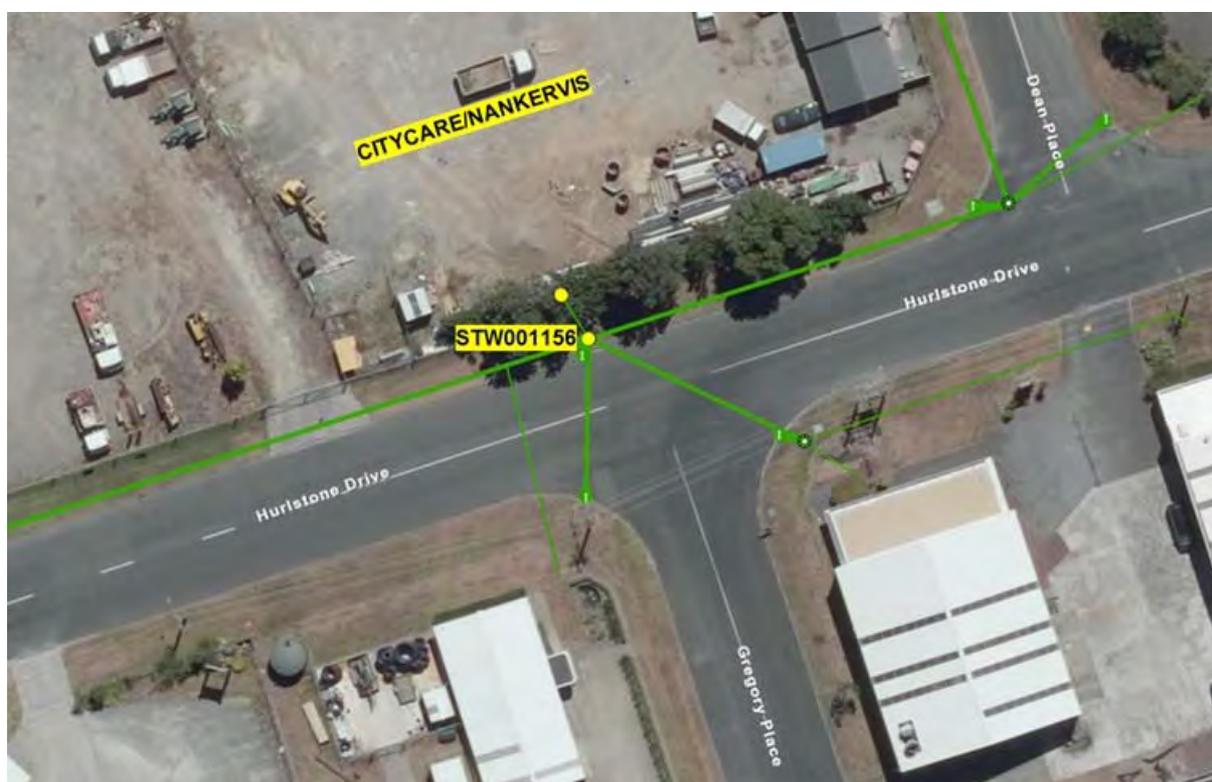
Figure 12 Nankervis Family Trust site location and discharge point

The site is located in the Fitzroy industrial area, in the defined urban catchment of New Plymouth, approximately 380 m from the closest water body, the Mangaone Stream (Figure 12).

Previously wash down water from the truck wash bay discharged to a drain which is directed to an interceptor system. This was then discharged into the NPDC's stormwater system and into the Mangaone Stream (via discharge site STW001035). During the current monitoring period the truck wash was removed from the site.

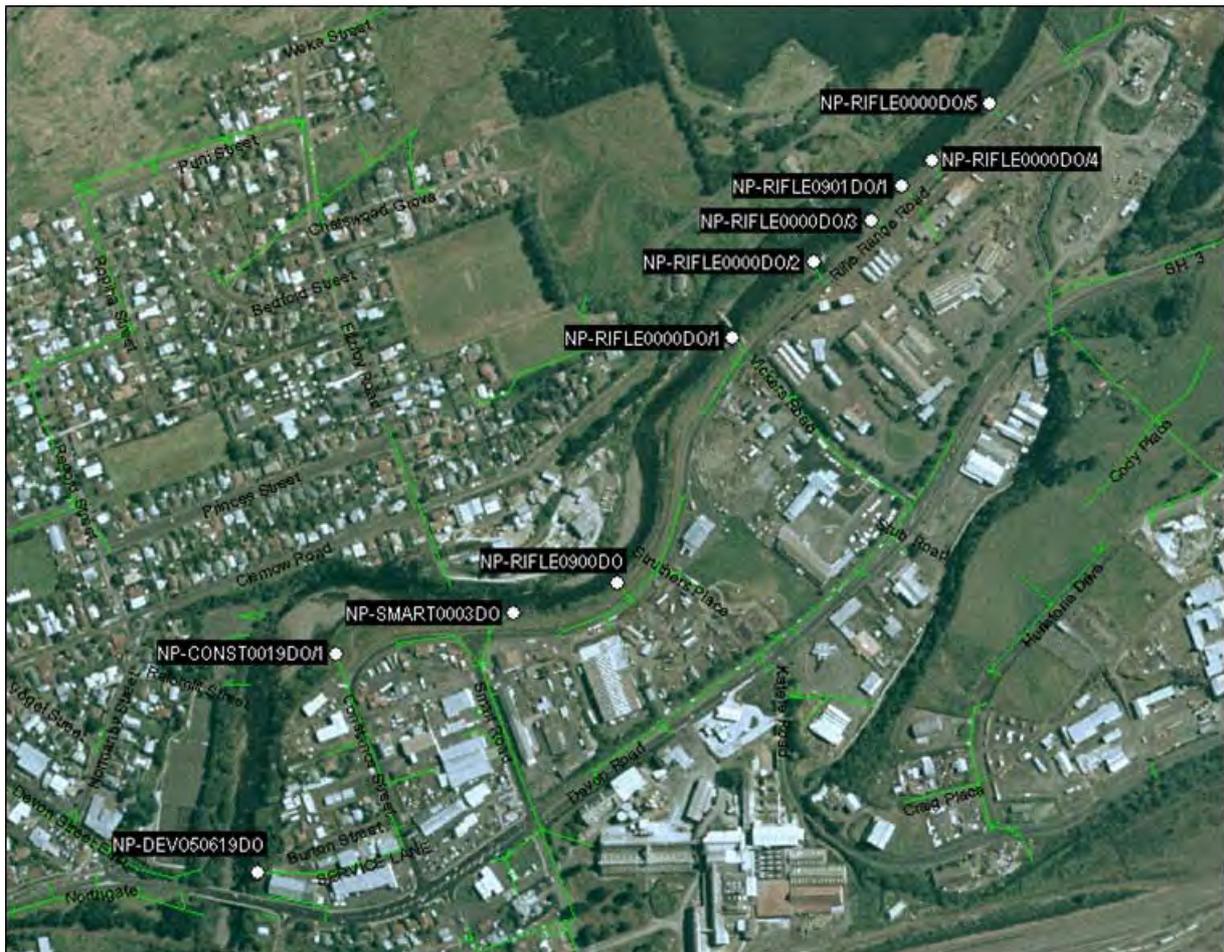
Figure 13 NPDC stormwater drainage and consented discharge points to the Waiwhakaiho River

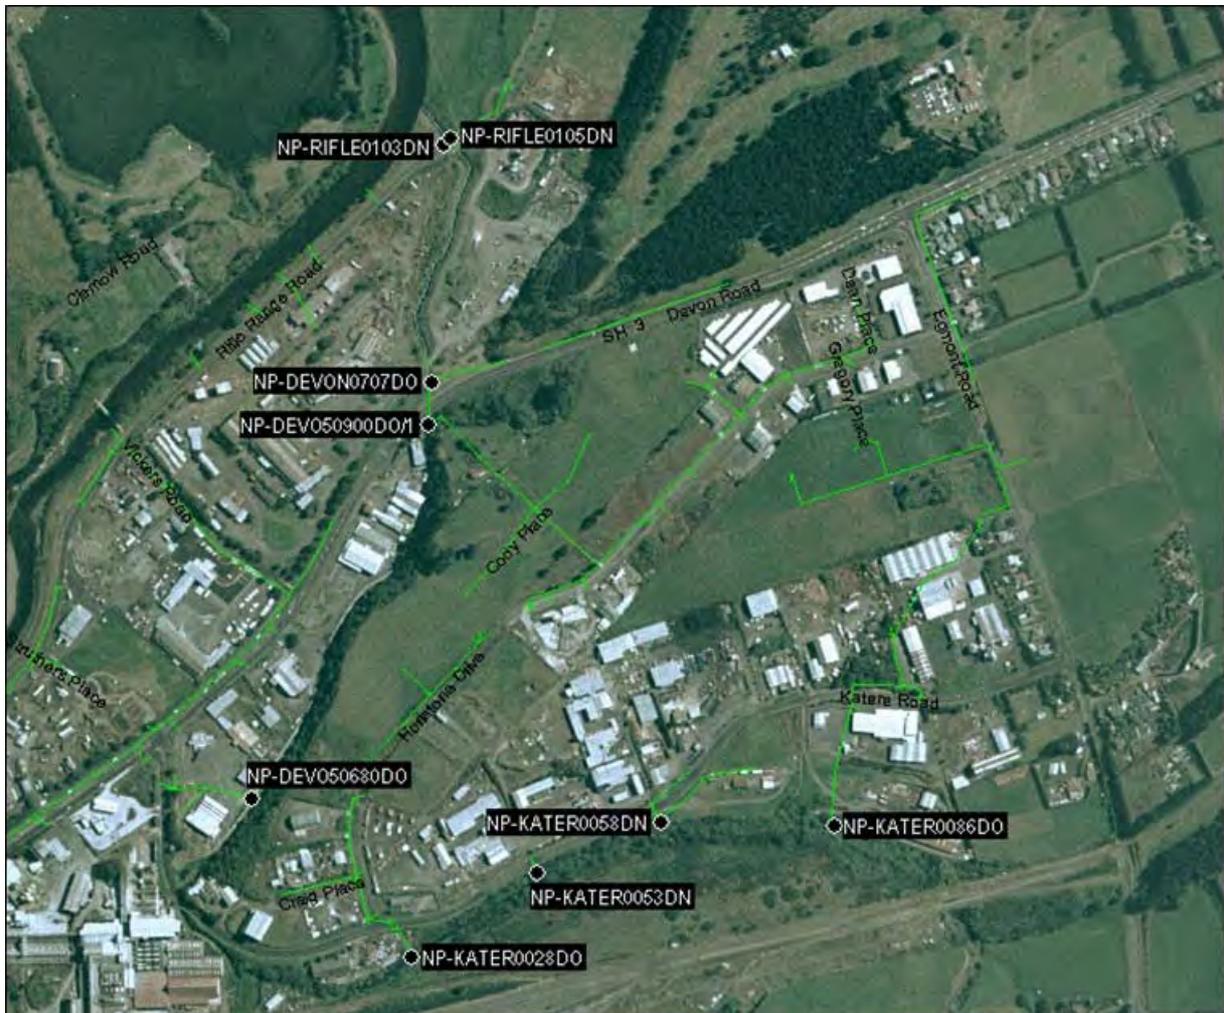
Figure 14 NPDC stormwater drainage and consented discharge points to the Mangaone Stream

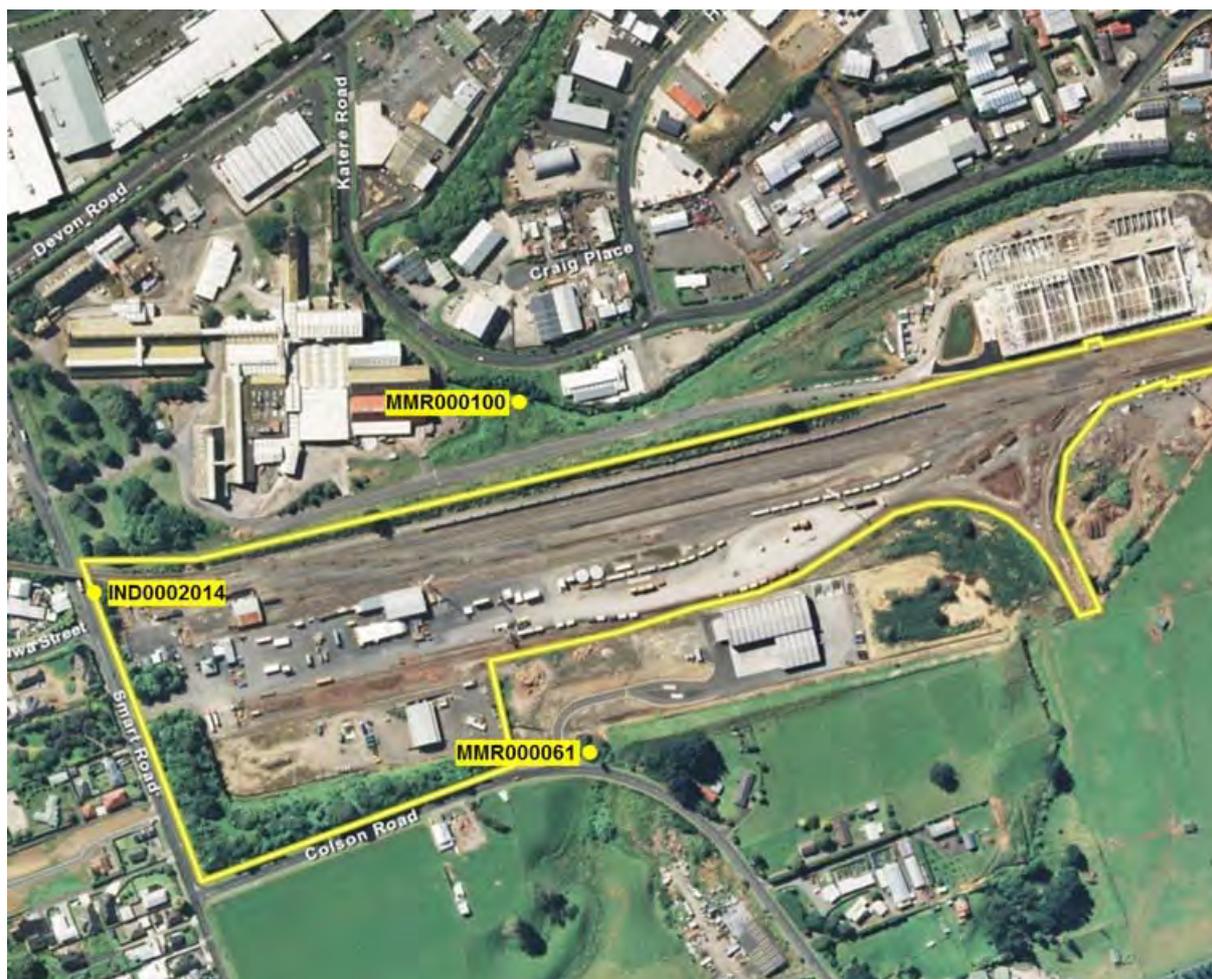
Figure 15 KiwiRail yard and sampling point locations

Drainage from the area to the west and north of the offices (i.e. the refuelling area and maintenance area) flows to the Waiwhakaiho River via McLeod's Drain, an underground pipe that also receives stormwater from Devon 662's former fertilizer depot, other industrial sites, a residential area, and a rural area. Wastewater from washing of wagons, containers and locomotives is treated in a three-stage oil separator before discharge to the river. Liquids from the repair depot and locomotive fuelling point are discharged to an underground holding tank that is emptied by a waste disposal company at two-monthly intervals. The holding tank is also connected to the oil separator via an automatic pump in case of overfilling.

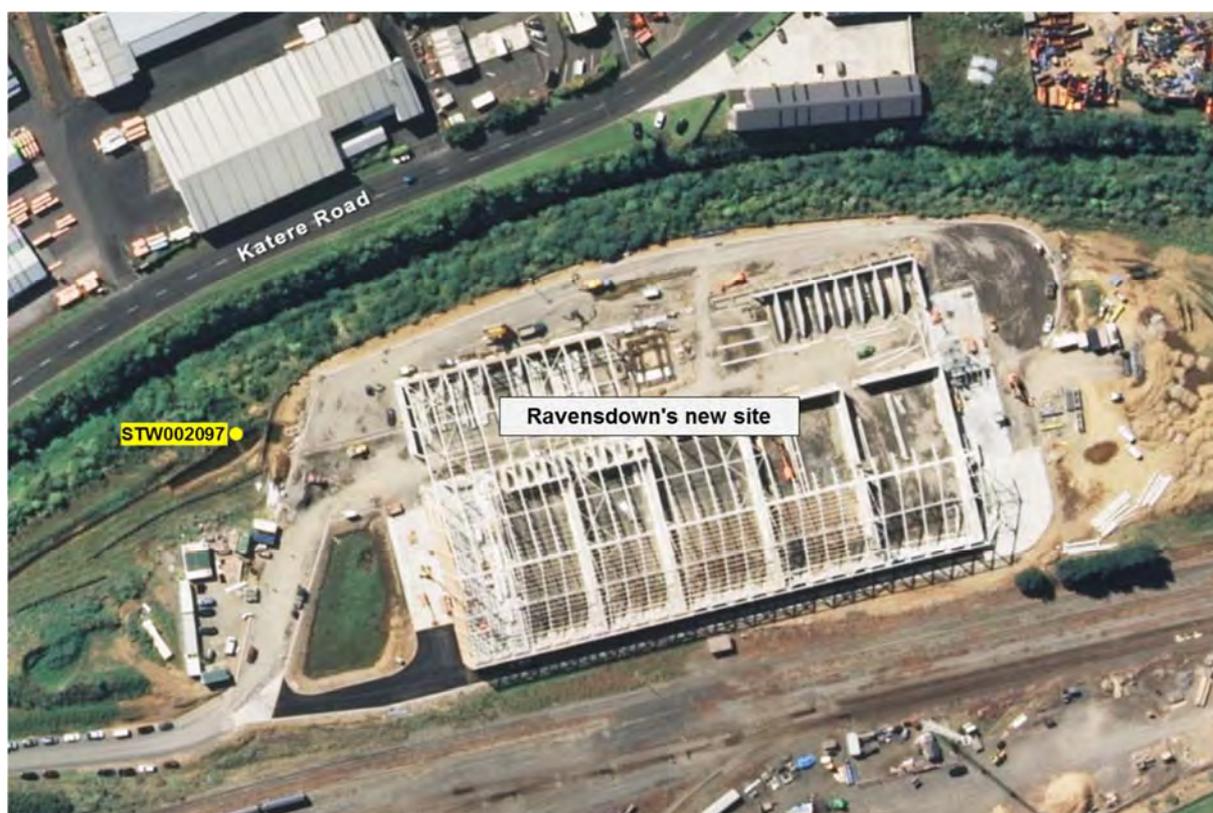
Stormwater from the roof and the area immediately surrounding the main building is directed through a planted treatment pond prior to discharge to the Mangaone Stream. Stormwater from the upper end entrance road is diverted to setting ponds and discharged to the Mangaone further downstream. Stormwater from the lower part of the access road is diverted to the Waiwhakaiho River via MacLeod's drain on Smart Road.

Figure 16 Ravensdown's new site location and discharge point

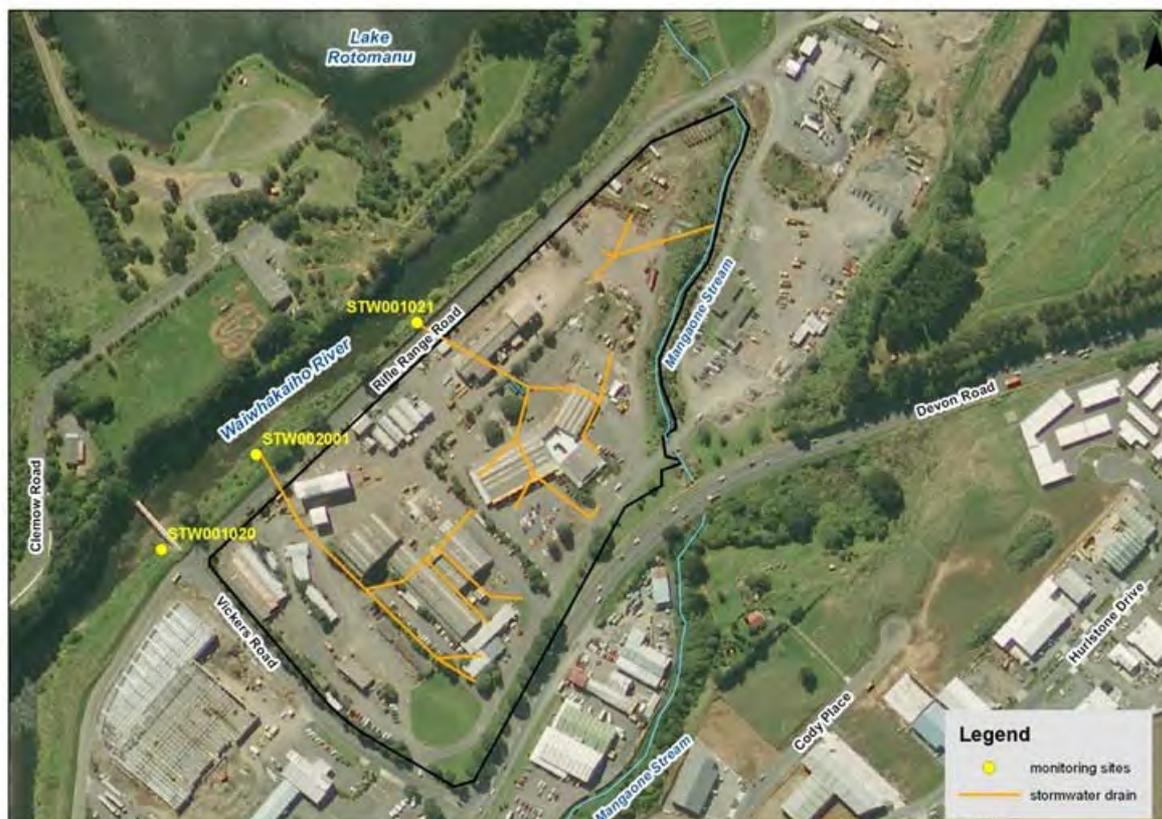
Figure 18 Technix site, drainage system and sampling point locations

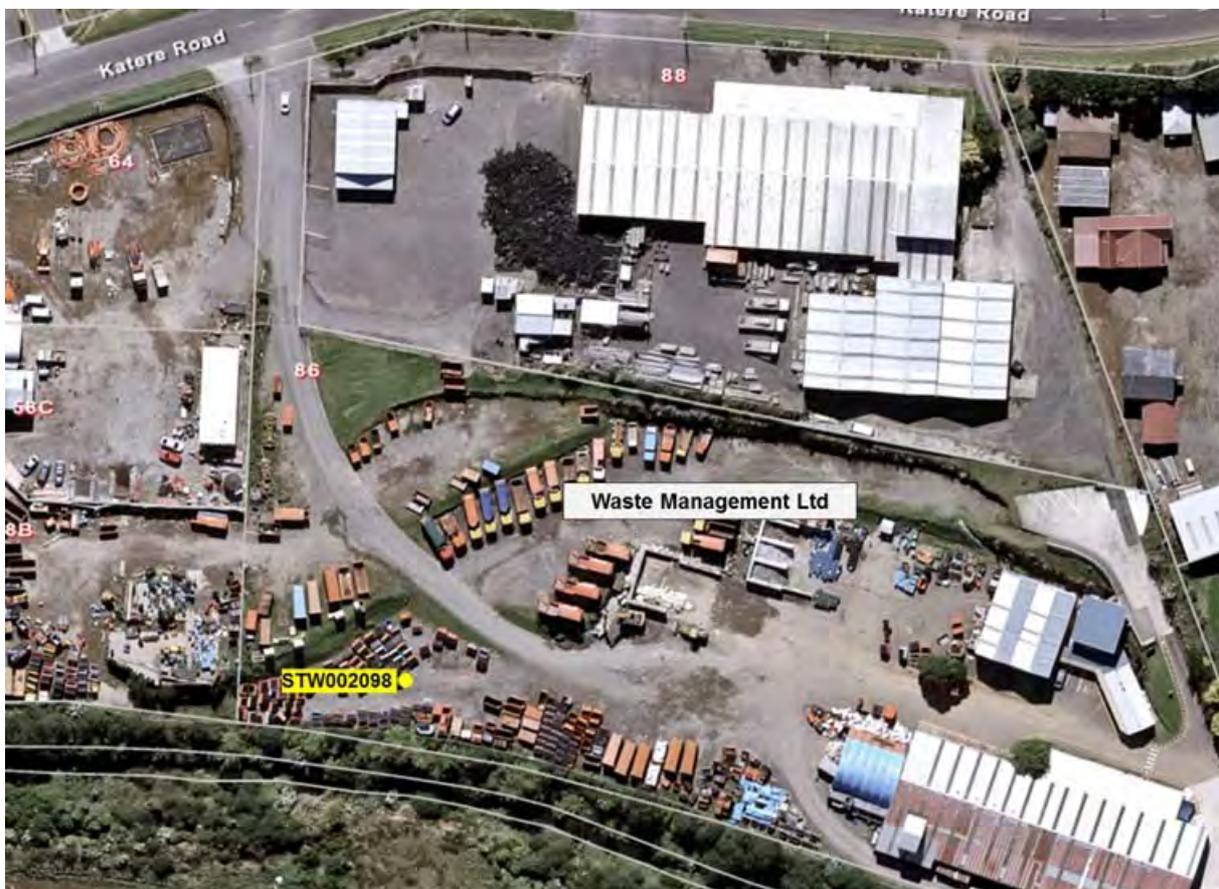
Figure 19 WML's site and discharge point

Waste Management NZ Ltd (WML) operate a refuse transfer depot on Katere Road, New Plymouth (Figure 19). Activities on the site include the receipt and temporary storage of general refuse (non-hazardous solid waste). The site does not use or store any hazardous substances. Refuse is deposited onto a transfer pad on site by truck or from smaller bins. Sorting takes place into recyclables-glass cardboard and plastic. Most refuse is loaded onto a truck and driven to a landfill near Marton.

The refuse storage area is usually cleared at the commencement of each day's activities, but on occasions there is excess refuse left within the storage area over night. This is the first refuse to be loaded the next morning. Empty used bins are stored on the wash pad which is connected to the New Plymouth District Council (NPDC) trade waste system. These bins are then washed with a water blaster and the runoff is directed to the trade waste system. Washed bins are then generally moved to the yard where they are stored until required in the future.

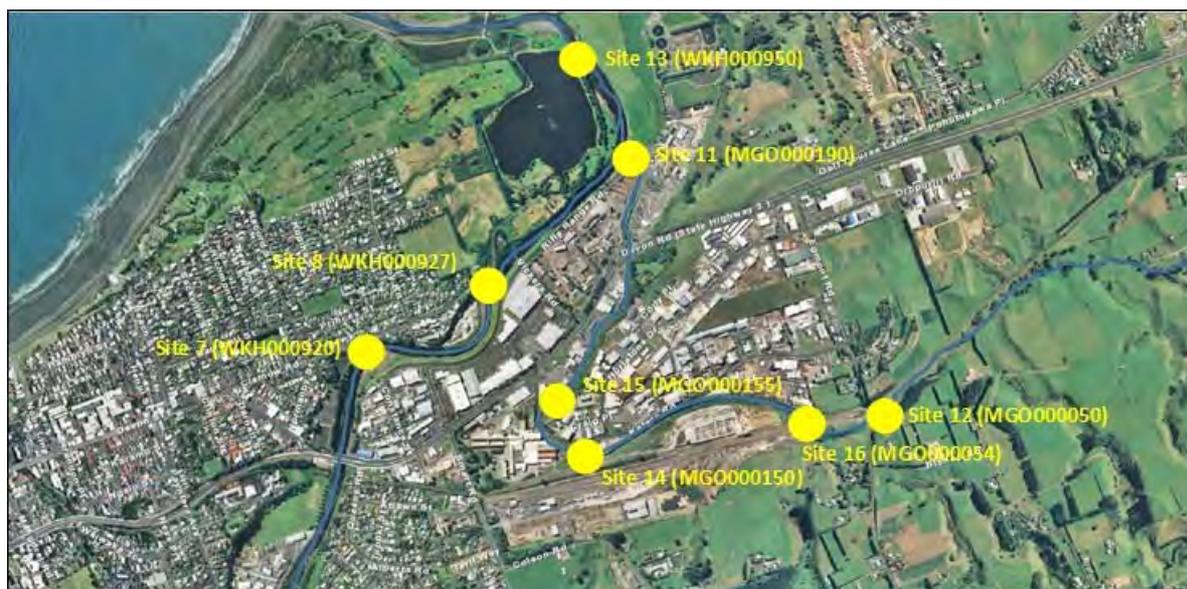
Figure 20 Biomonitoring sites in the Lower Waiwhakaiho River Catchment

Samples of streambed macroinvertebrates and algae are collected from three sampling sites in the lower Waiwhakaiho River and five sites in the Mangaone Stream on a biannual basis. During the 2019-2020 period, these surveys were conducted on 6 November 2019 and 11 February 2020. The locations of the biomonitoring sites are shown in Figure 20. A summary of the findings is discussed in section 16.2.

The Council collected streambed macroinvertebrates at five sites in the Mangaone Stream and three sites in the Waiwhakaiho River on 6 November 2019 and 11 February 2020, in order to assess whether discharges from the Lower Waiwhakaiho Industrial area had had any adverse effects on the macroinvertebrate communities of these streams (Figure 20). Macroinvertebrates were identified and the number of different types of taxa counted (taxa richness), and MCI and SQMCI scores were calculated for each site.

The reports both concluded that the results from the surveys indicate that the discharges from the Fitzroy industrial areas were not having a significant effect on the macroinvertebrate communities in the Waiwhakaiho River. However, the taxa richness and MCI scores indicate that a pollution event had likely occurred upstream of the industrial area prior to the surveys. The Mangaone Stream had a significant decline in macroinvertebrate indices between sites 16 and 14, which may be due in part to chronic pollution from historic sites but the results suggest that a more recent discharge lowering water quality has also occurred.

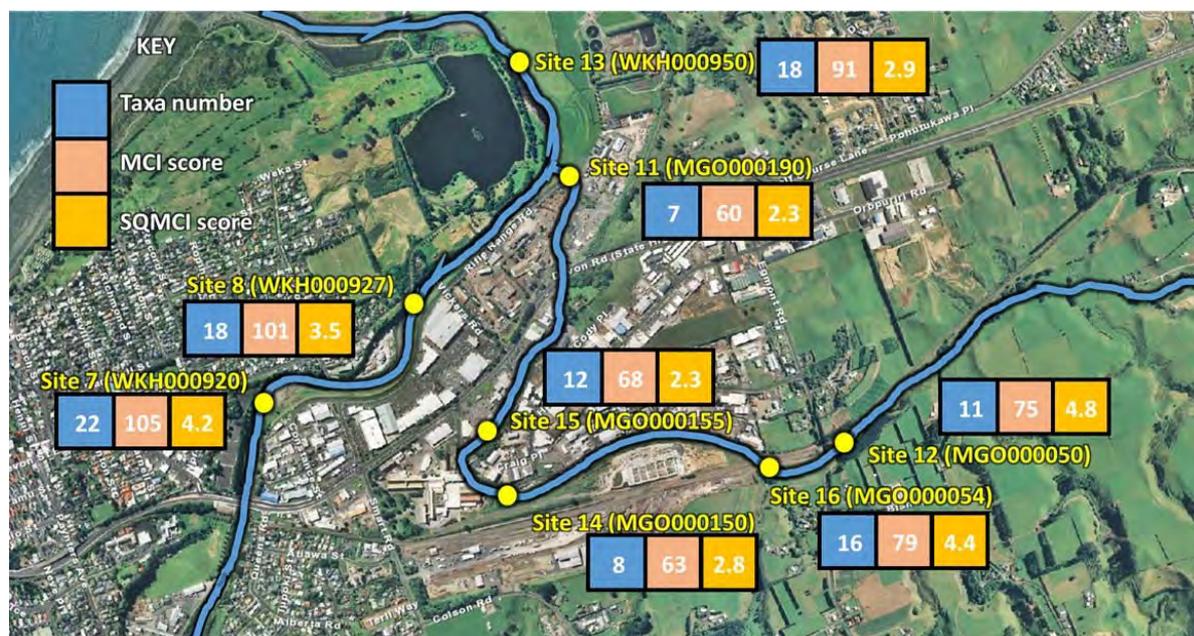
Overall, the results indicated that discharges from the industrial area were not having a significant negative effect on the macroinvertebrate communities in the lower Waiwhakaiho River. However, the taxa richness and MCI scores indicate that a pollution event had likely occurred upstream of the industrial area prior to the survey. The Mangaone Stream had a significant decline in macroinvertebrate indices between sites 16 and 14, which may be due in part to chronic pollution from historic sites but the results suggest that a more recent discharge lowering water quality has also occurred.

Figure 21 Biomonitoring sites in the Waiwhakaiho River Catchment with taxa number, MCI scores and SQMCI scores for each site (6 November 2019).
