# Lower Waiwhakaiho Catchment

Monitoring Programme

Annual Report

Technical Report 2020-64

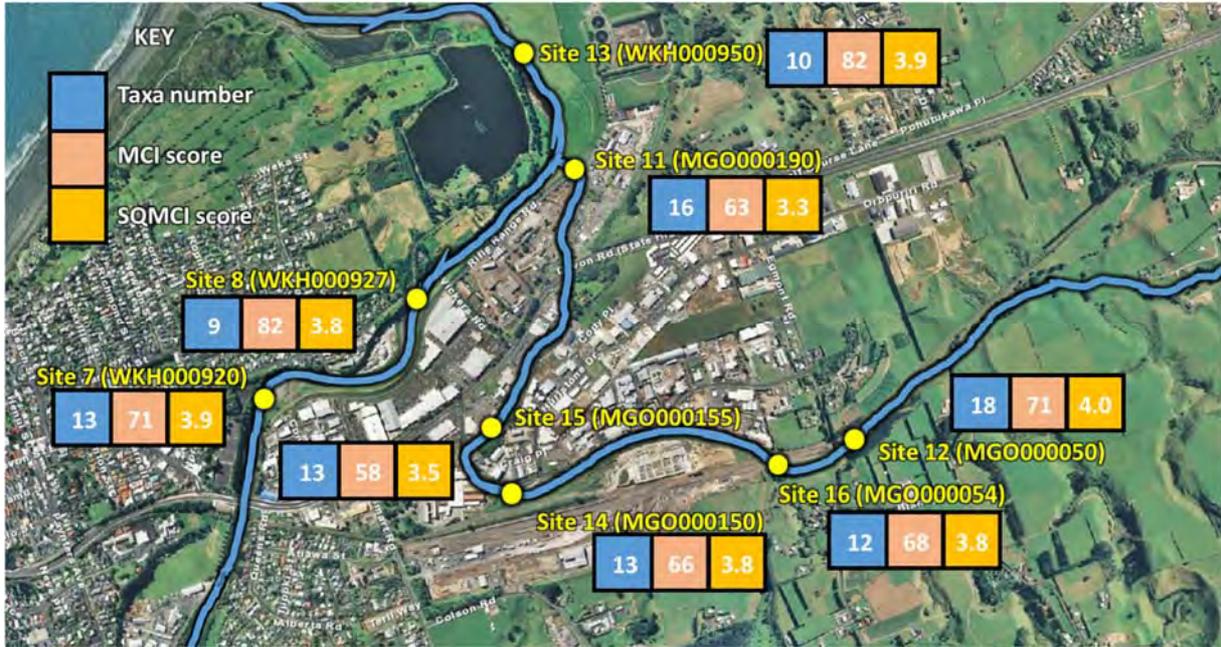
Overall, the results indicated that discharges from the industrial area were not having a significant negative effect on the macroinvertebrate communities in the lower Waiwhakaiho River. However, the taxa richness and MCI scores indicated that a pollution event had likely occurred upstream of the industrial area prior to this survey. The Mangaone Stream had a significant decline in macroinvertebrate indices between sites 16 and 14, which may due in part to chronic pollution from historic sites but the results suggest that a more recent discharge lowering water quality has also occurred.

Figure 22 Biomonitoring sites in the Waiwhakaiho River Catchment with taxa number, MCI scores and SQMCI scores for each site (11 February 2020).

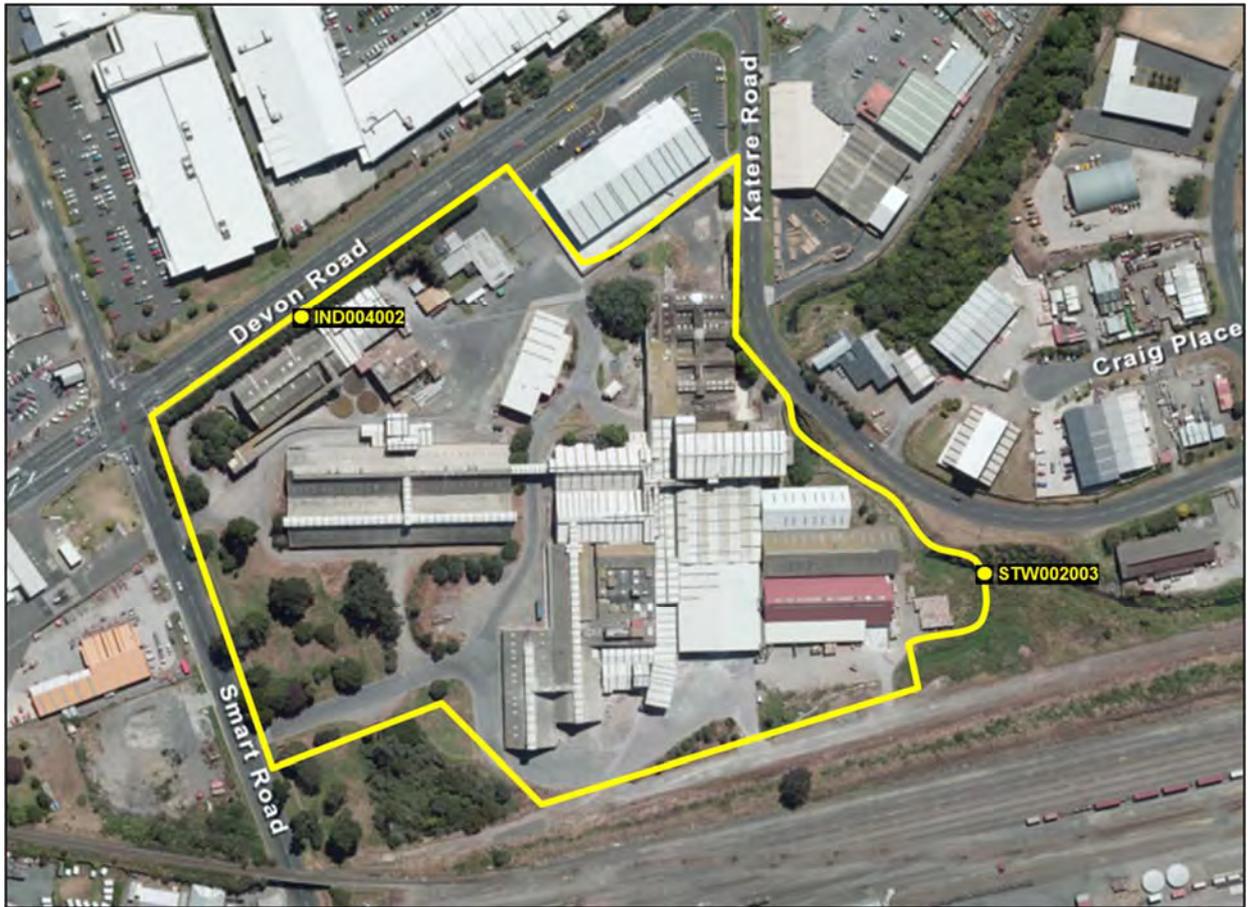
**Appendix 1.** Area showing stormwater catchment area permitted by this consent

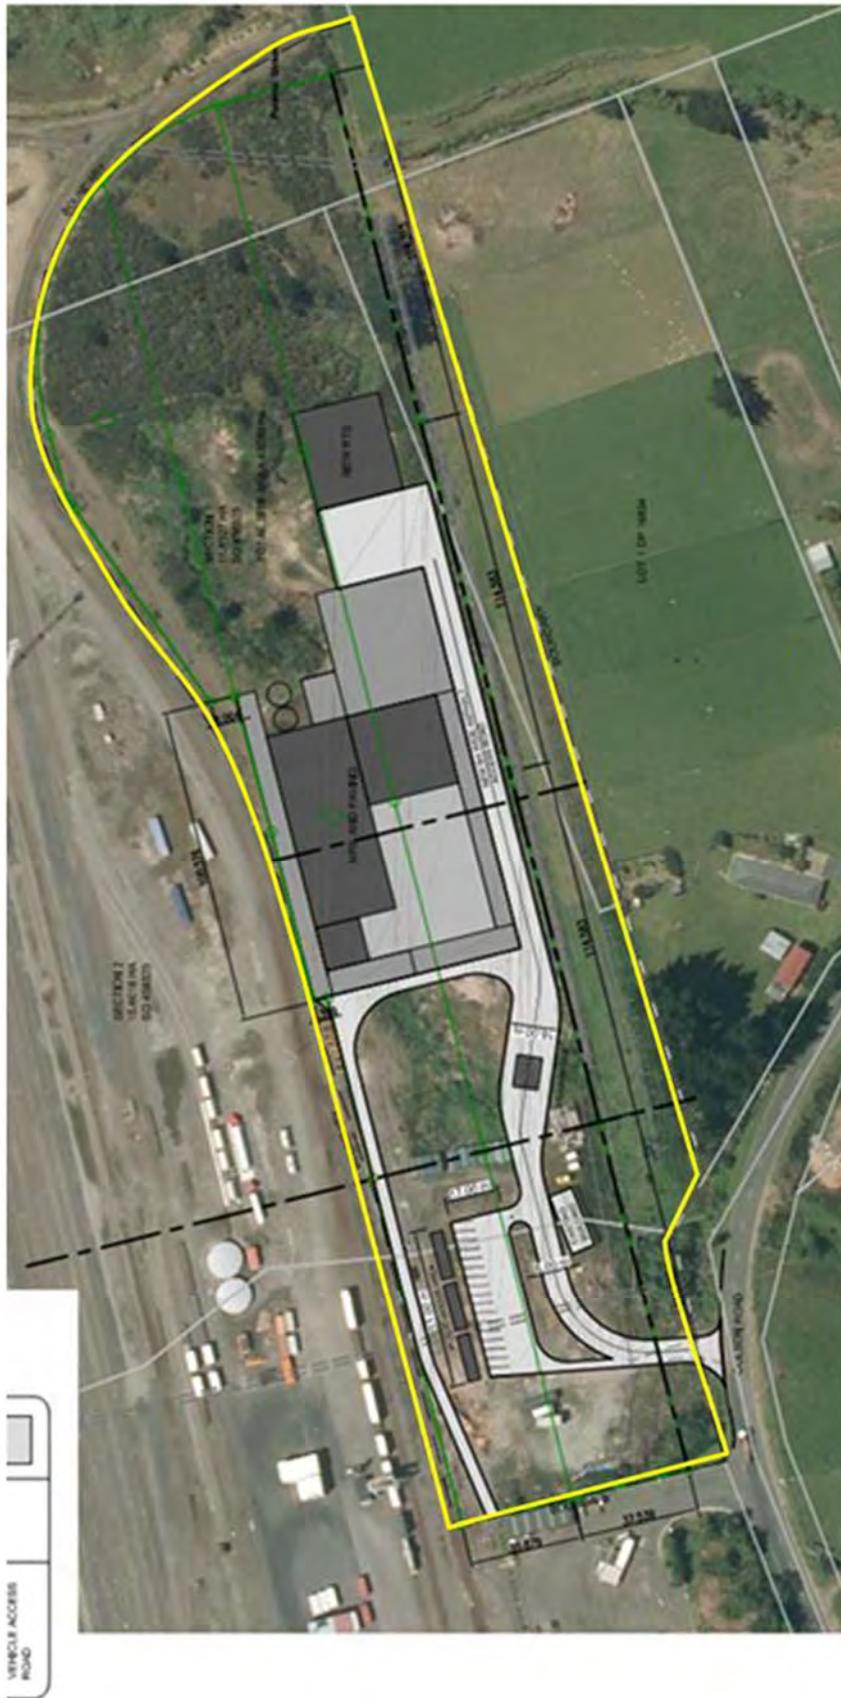
Figure 1 - Stormwater catchment area permitted by this consent (in yellow)

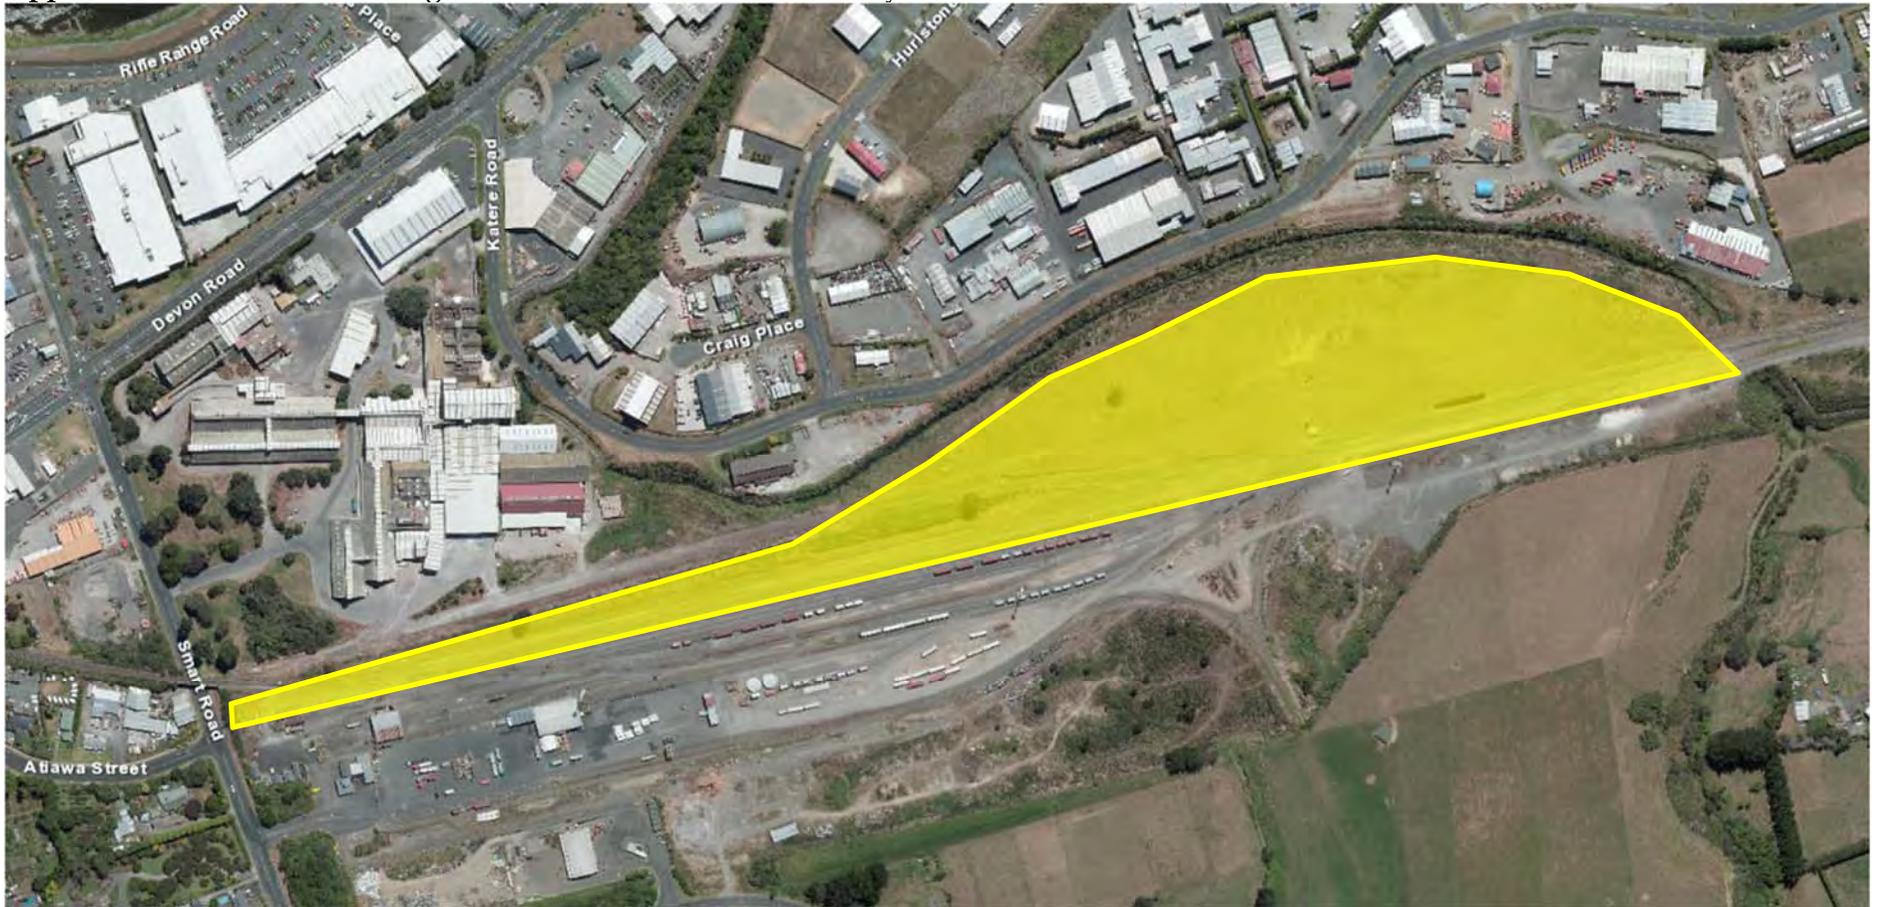
**Appendix 1:** Stormwater discharged shall be from the area shown in yellow

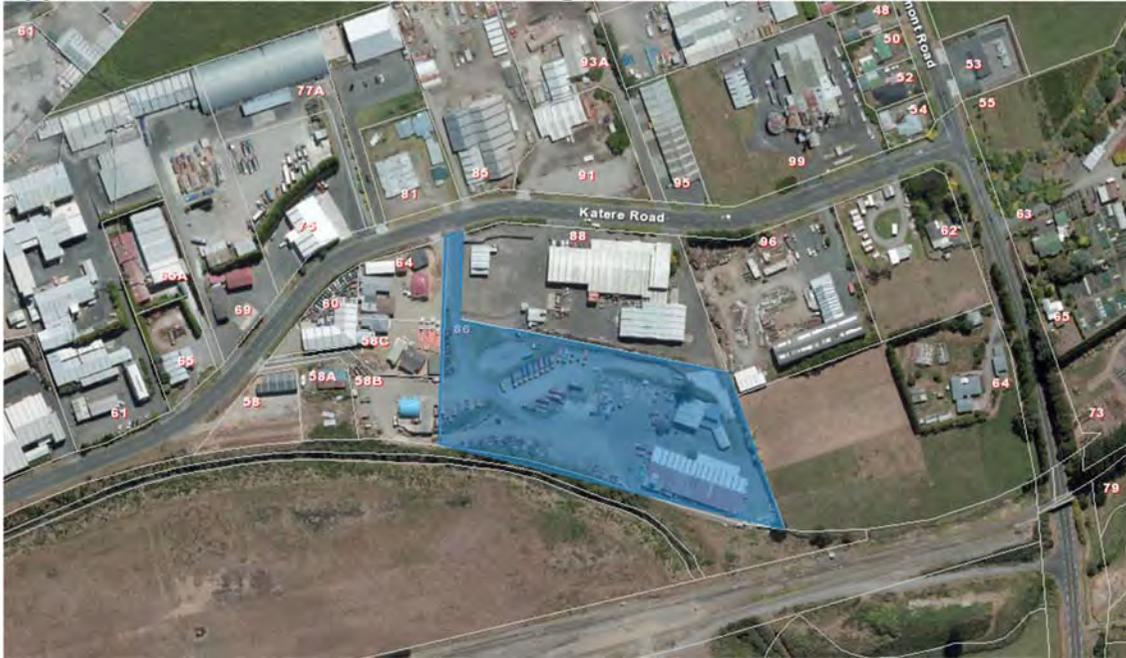
**Appendix 1: Area of stormwater discharge shown in blue.**
