# Stratford District Council Closed Landfills (Stratford, Huiroa and Pukengahu)

Monitoring Programme

Annual Report

Technical Report 2021-54

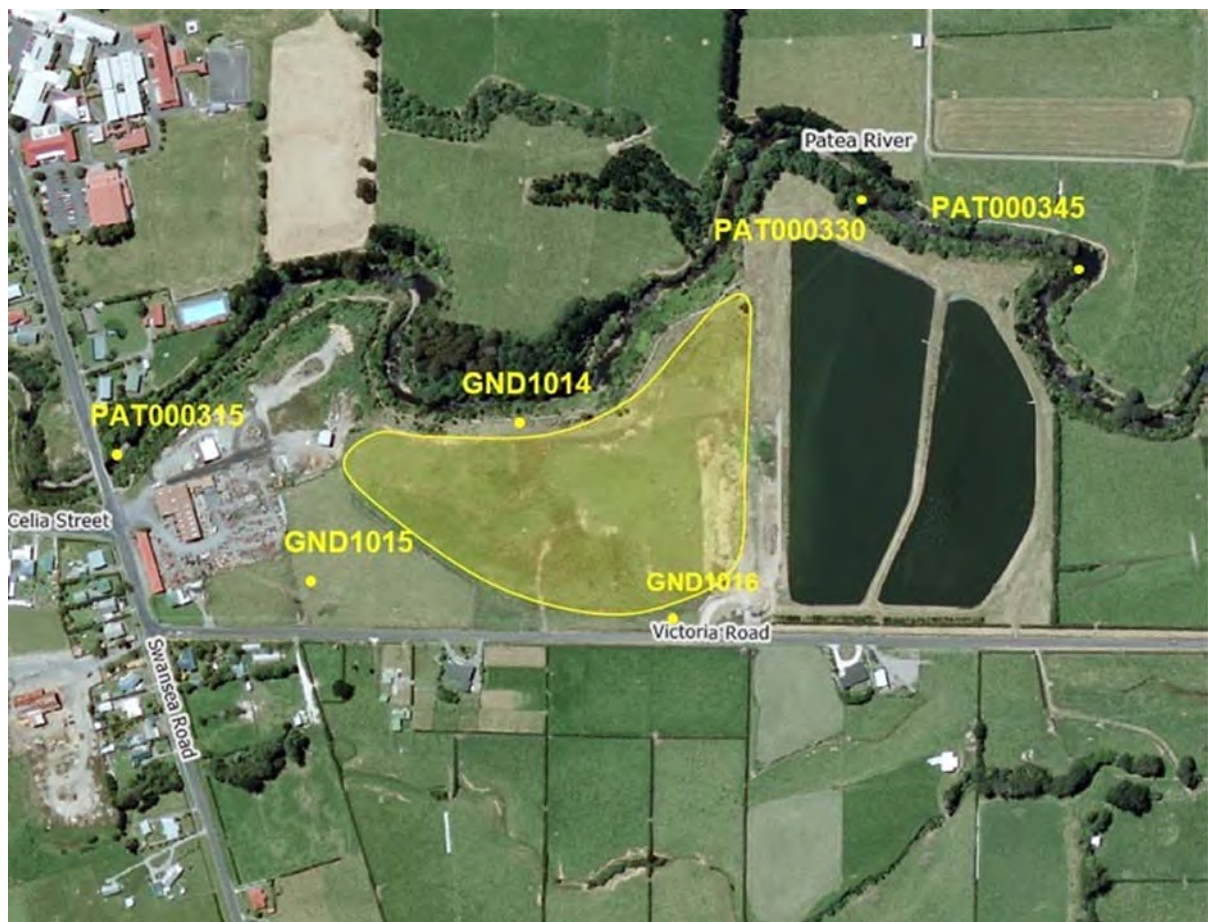
Figure 2 Stratford landfill (shaded in yellow) and sampling locations

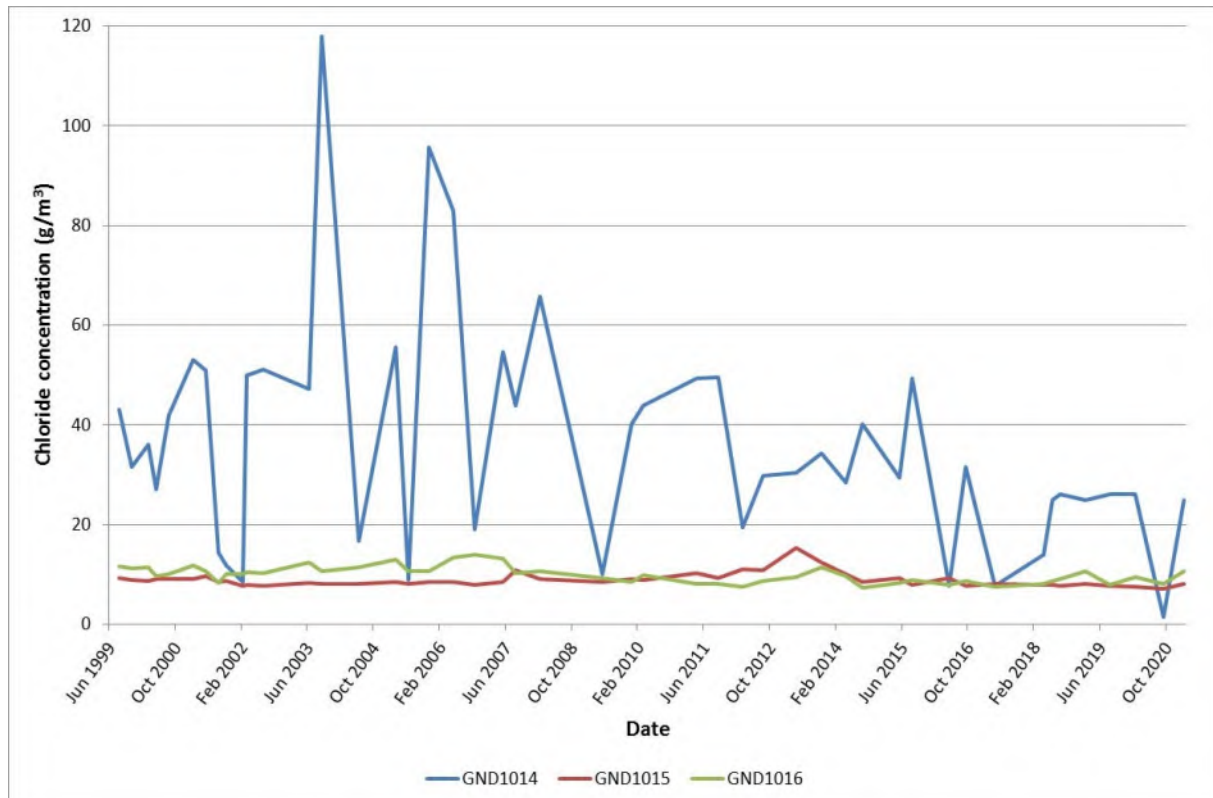
Figure 3, Figure 4 and Figure 5 show how bore GND1014 is affected by landfill indicator species; ammoniacal nitrogen, chloride, and zinc. The graphs also show how the levels of chloride and ammonia are apt to fluctuate against the more stable background levels found in the two bores mid and up gradient from the filled area (more so in the case of chloride and ammoniacal nitrogen). Historically zinc has found to be higher in the down gradient bore and has also fluctuated in the up gradient bores, which may indicate other local effects in the groundwater.

Figure 3 Graph showing chloride levels in the groundwater at the Stratford landfill

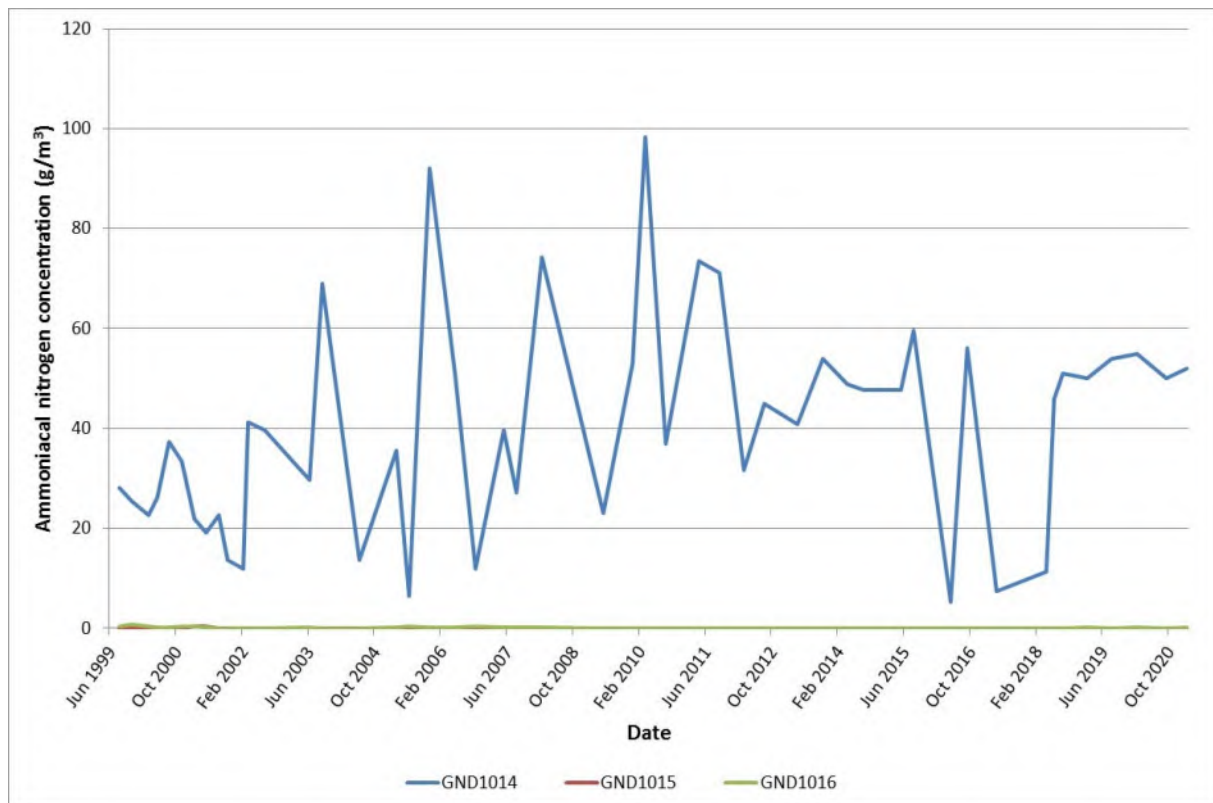
Figure 4 Graph showing ammoniacal nitrogen levels in the groundwater at the Stratford landfill

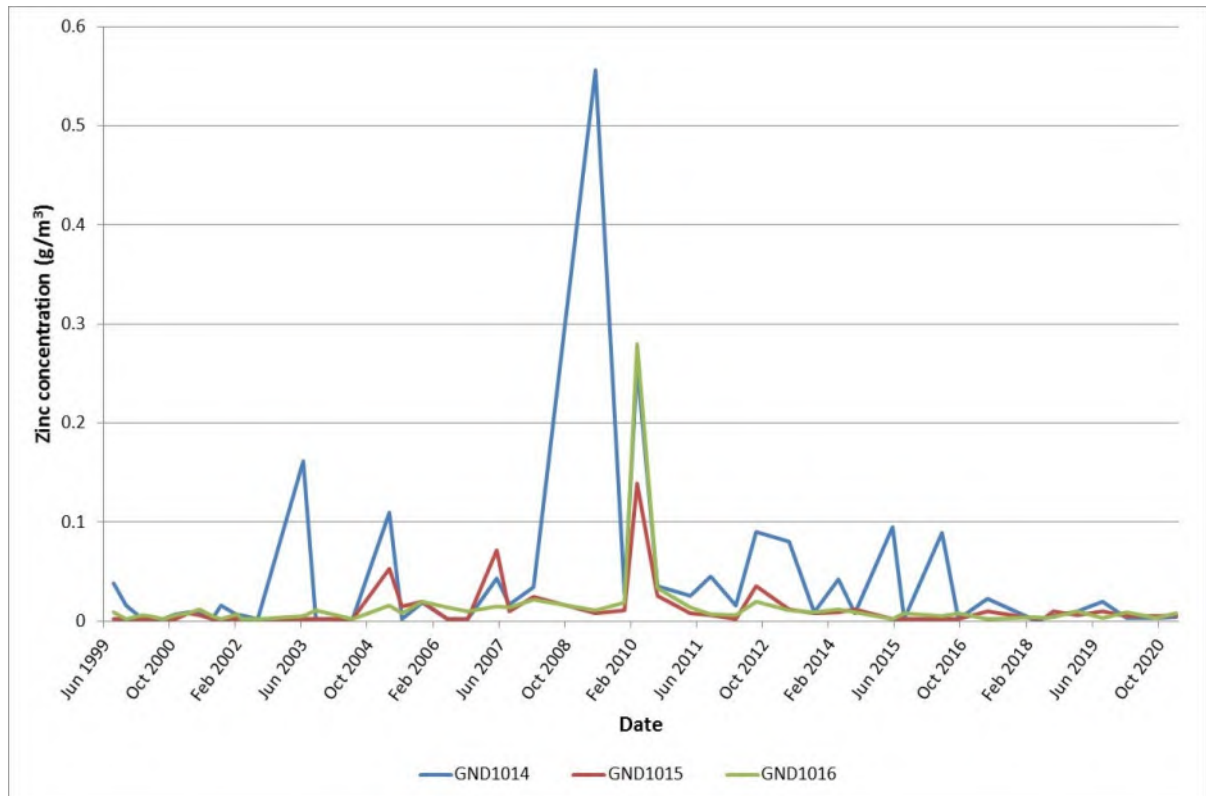
Figure 5 Graph showing dissolved zinc levels in the groundwater at the Stratford landfill

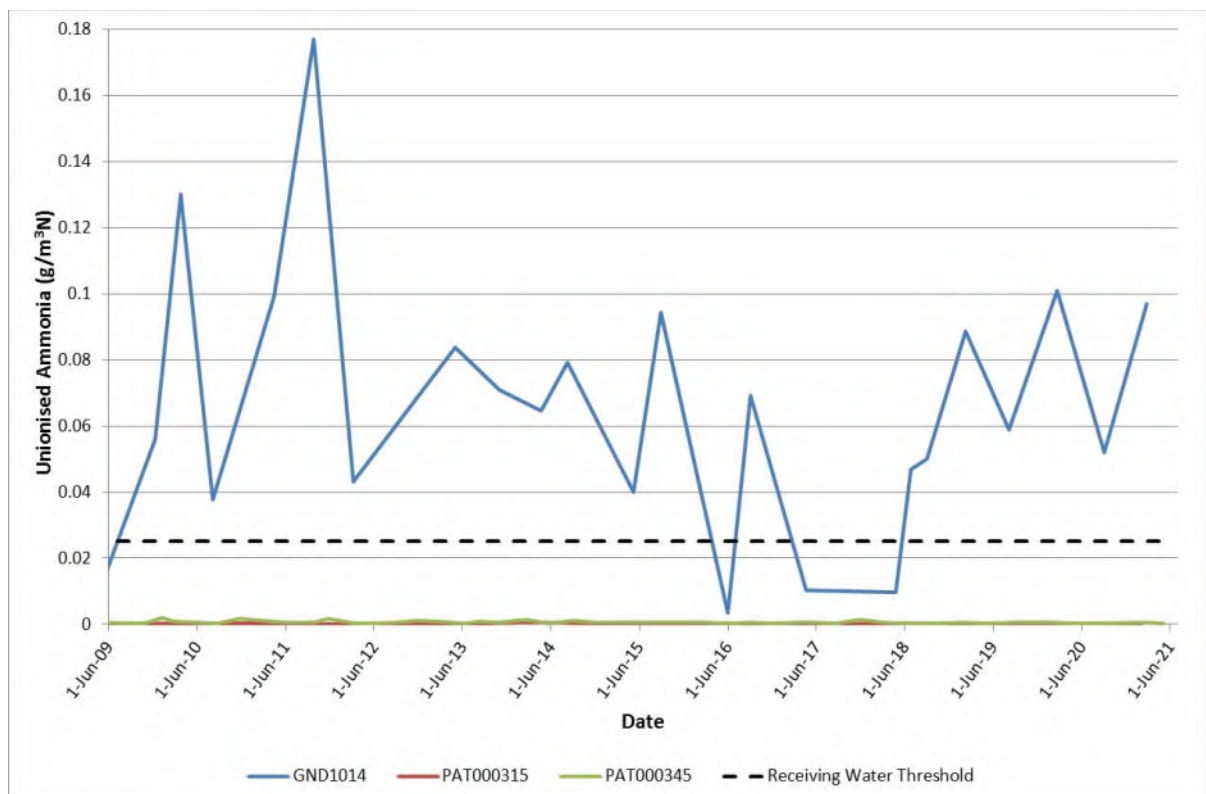
Figure 6 compares the unionised ammonia in the down gradient bore (GND1014) which is most impacted by the landfill due to its location. Given the dependency of unionised ammonia on pH and temperature there is a seasonal variation in ammonia levels which presents as a saw tooth pattern in Figure 6. This makes it hard to determine an overall trend. Although the unionised ammonia presented in the groundwater is high this doesn't appear to have significantly influenced levels in the surface water which remains well below the 0.025 g/m<sup>3</sup> guideline for the long term protection of aquatic ecosystems.

Figure 6 Graph showing unionised ammonia levels in the down gradient bore (GND1014) groundwater and the downstream surface water sites (PAT000315 and PAT000345) at the Stratford landfill

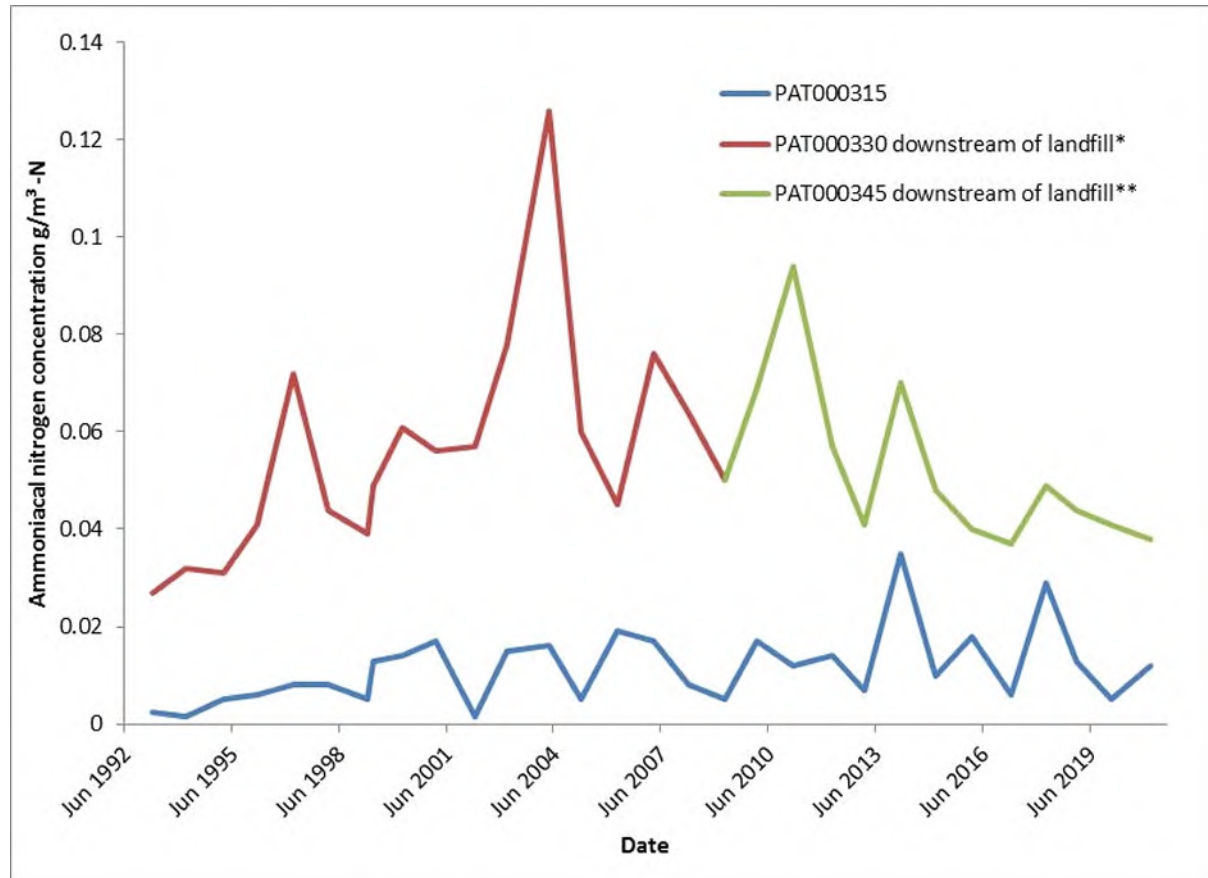
Figure 7 shows the ammoniacal nitrogen data gathered over the past 27 years. It is noted that, as the Stratford WWTP had an upgrade in 2009, the discharge point of the WWTP was moved and the sites used to

monitor the downstream effects of the landfill have also changed. Monitoring at site PAT000330 ceased in March 2009, with monitoring continuing at site PAT000345, further downstream.

Figure 7 Graph showing ammoniacal nitrogen levels in the Patea Stream up and downstream of the landfill (where comparative data is available)

Whilst there is some separation between the site's locations, the graph indicates that a similar, stable, and modest rise in ammoniacal nitrogen has occurred in the Patea River as result of the landfill's presence. The highest level of ammoniacal nitrogen found downstream of the landfill since monitoring began was  $0.87 \text{ g/m}^3$  at site PAT000345, on 16 March 2005 (prior to the WWTP upgrade and not plotted in Figure 7). Under the pH and temperature conditions prevailing at the time of sampling, this ammoniacal nitrogen concentration would have resulted in an unionised ammonia concentration of  $0.014 \text{ g/m}^3$ , well below the  $0.025 \text{ g/m}^3$  unionised ammonia guideline used for the long term protection of aquatic ecosystems.

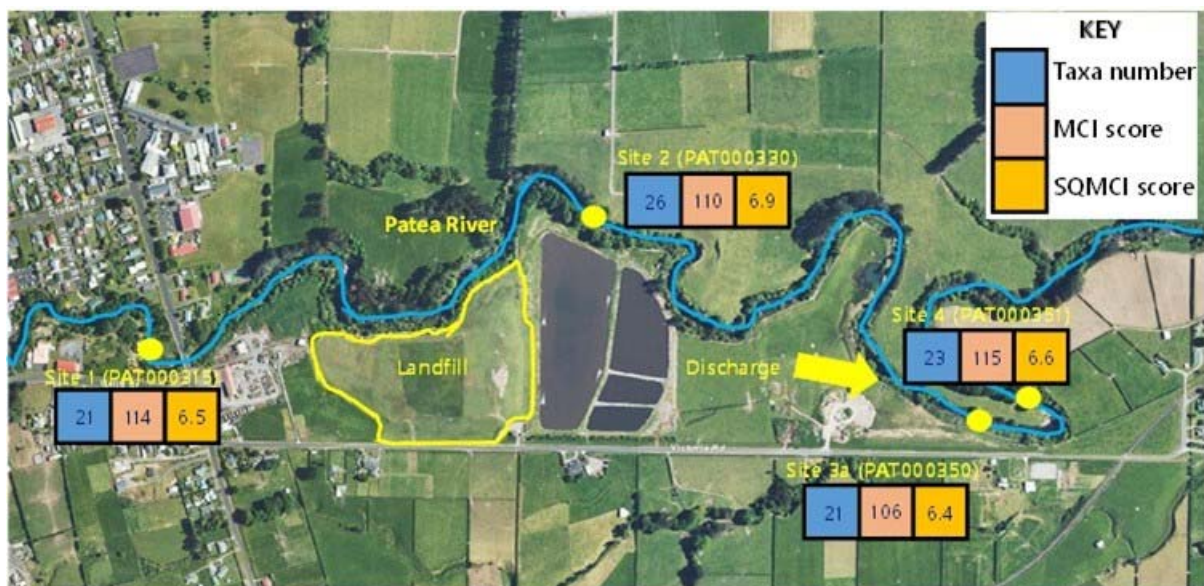
Macroinvertebrate richness at all four sites (Table 5, Figure 8) was moderate with little relative difference between sites. Furthermore, there was little difference between current taxa richness and historic richness with deviation both above and below historic medians. Nutrient enrichment can raise taxa numbers in rivers with relatively good water quality but there was no evidence of that for the current survey. Nor was there evidence of any acute toxic discharges from the closed landfill or WWTP lowering taxa richness.

**Figure 8** Biomonitoring sites with taxa number, MCI and SQMCI scores for each site, November 2020

The MCI scores categorised all four sites as being in 'good' health. There were no significant differences in MCI scores between sites (one-nine MCI units) with the highest MCI score recorded at the bottom most site. In addition, there were no significant differences between the current scores and their historic medians apart from site 4 having a significantly higher score, and its highest score to date. This indicates that macroinvertebrate communities at sites 1, 2 and 3a were in typical health while site 4, which has limited historic data, was in significantly better than normal health.

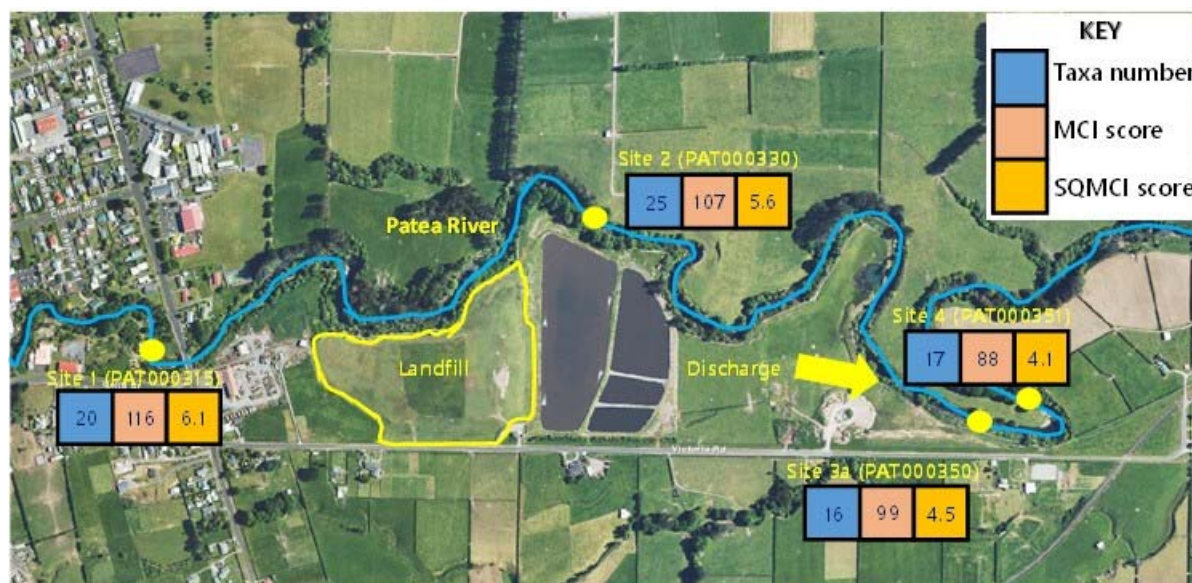
Macroinvertebrate taxa richness at all four sites were moderate to moderately high (Figure 9). There was a substantial decline between sites 2 and 3a of nine taxa. Other differences between adjacent sites were relatively minor (one-five taxa). Apart from site 2, taxa richness were lower than historic medians by six to seven taxa. Given the taxa decrease at site 1 (a control site) and the moderate taxa richness found at both impact sites for the WWTP (sites 3a and 4), it was unlikely that there had been any significant acute toxic discharges from the sewerage outfall. The increase in taxa richness between sites 1 and 2 provided strong evidence for no significant effects of the closed landfill on taxa richness from toxic discharges.

The MCI scores categorised the two upstream sites as being in good health and the two downstream sites as being in fair health. There were significant differences between site 1 and 3a and 4 and site 2 and 4 and a consistent decline in MCI scores in a downstream direction (eight-11 MCI units). There were no significant differences between these scores and historic medians, though site 4 had a lower than normal score by eight MCI units and was also the only site to have declined significantly from the previous survey.

The SQMCI categorised site 1 as being in very good health, site 2 as being in good health, and sites 3a and 4 as being in fair health. These results were generally consistent with MCI scores and showed a decline in a downstream direction. Sites 3a and 4 had significantly lower SQMCI scores than site 1 and site 2. This indicated that the closed landfill was not having a significant impact on macroinvertebrate communities but provided further evidence that WWTP discharges were having a significant impact on downstream macroinvertebrate communities. Generally, late spring/early summer results are better than late summer/early autumn results due to cooler temperatures, less sunlight, and greater flushing flows etc. which partially explains why the previous spring results did not show any significant effects.

Figure 9 Biomonitoring sites with taxa number, MCI and SQMCI scores for each site, March 2021

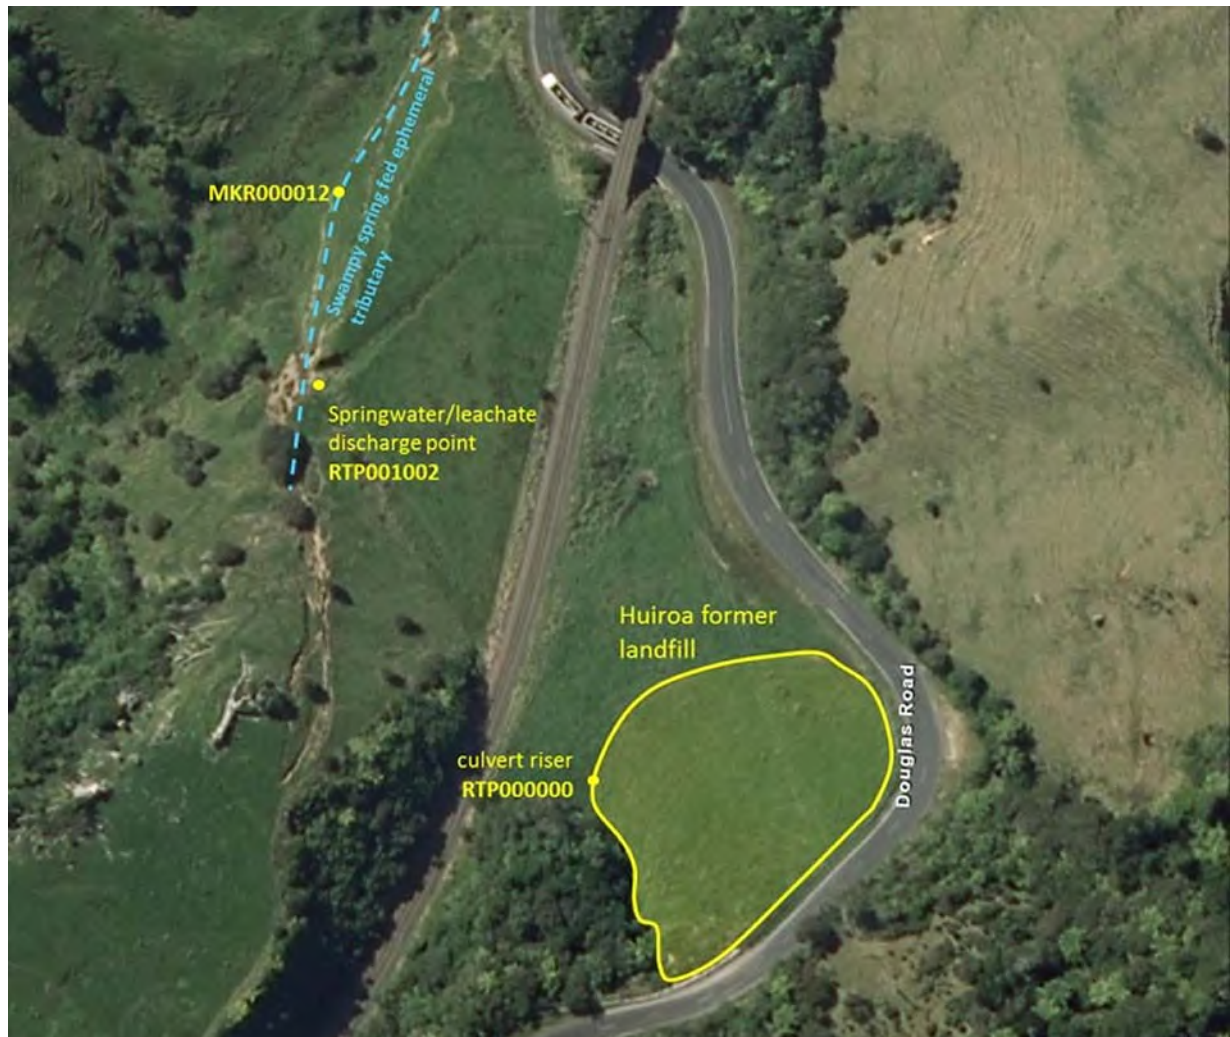
This closed landfill is monitored on a triennial basis, with inspections and sampling undertaken during 2020-2021 and next scheduled in 2023-2024. The location of the landfill and monitoring sites are shown in Figure 10.

Figure 10 Huiroa landfill and approximate sampling locations

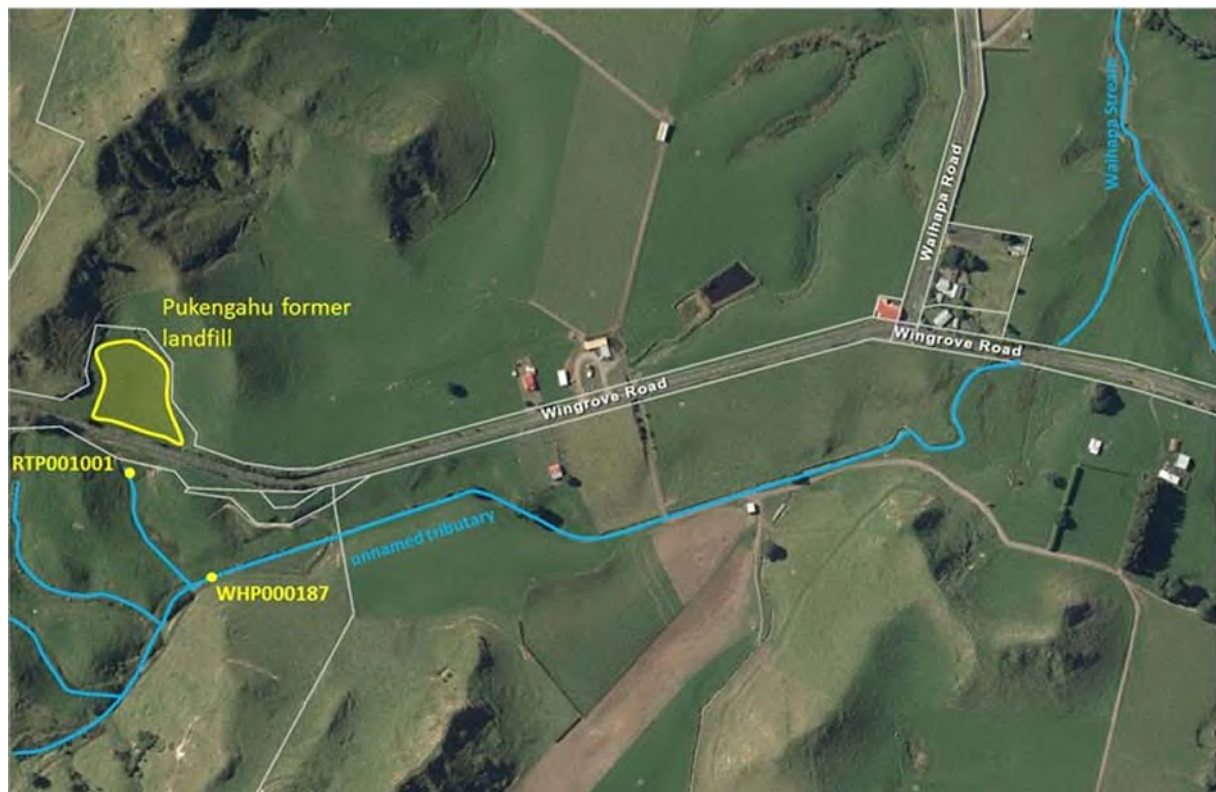
The site is situated in a small gully off Wingrove Road (Figure 11). At the base of the gully is a small wetland area, which is fed by a spring that is culverted beneath the road and feeds into a small unnamed stream. The site was unmanaged and was mostly used for the discharge of domestic waste by local residents. The landfill closed in 1991 and was reinstated by SDC. It is monitored on a triennial basis, with inspections and sampling undertaken during the 2020-2021 monitoring year, and next scheduled in 2023-2024.

Figure 11 Pukengahu landfill and approximate sampling locations
