Lower Waiwhakaiho Catchment

Monitoring Programme

Annual Report

Technical Report 2021-75

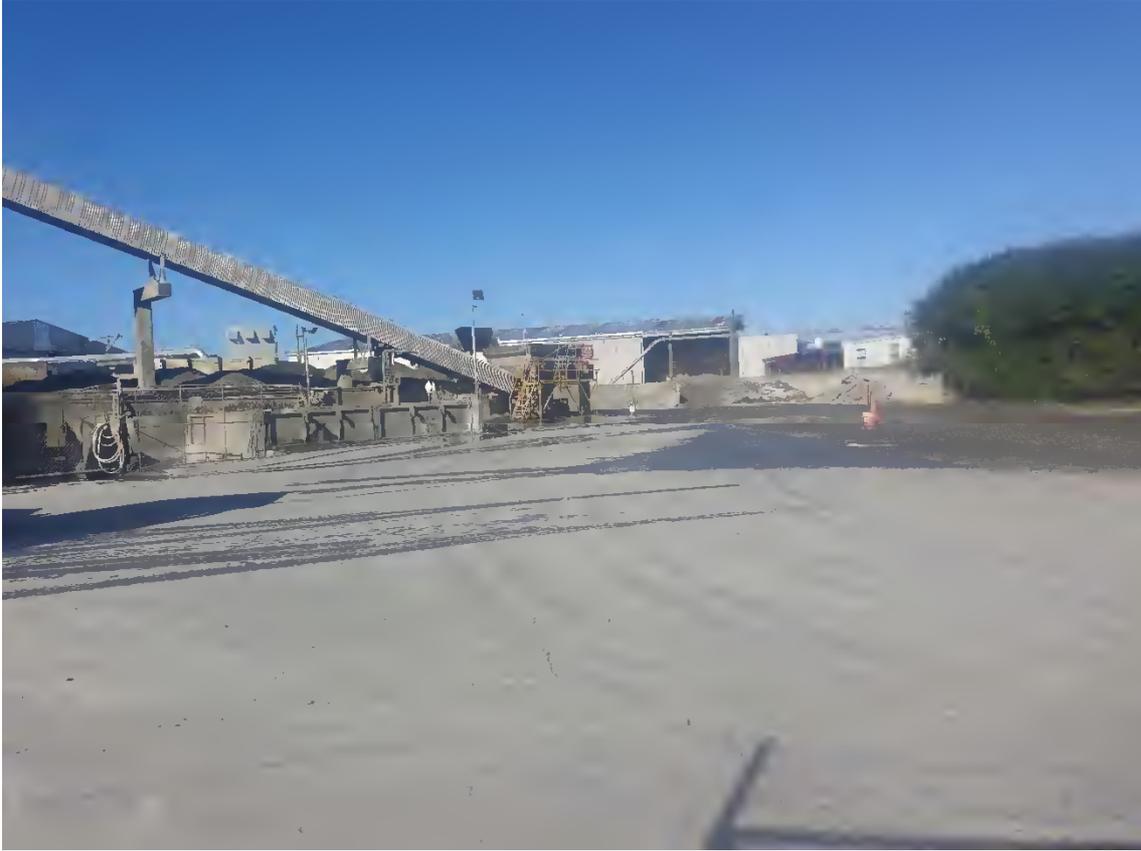
A site inspection was carried out in fine weather with moderate wind conditions. The site was clean and tidy, with sprinklers set up in the aggregate storage area to control any dust (Photo 1). There were no spills or issues noted on the site, and the stormwater system was tidy and not discharging at the time. There were no odour or dust issues and the site was compliant with consent conditions.

Photo 1 View of Allied Concrete yard, May 2021

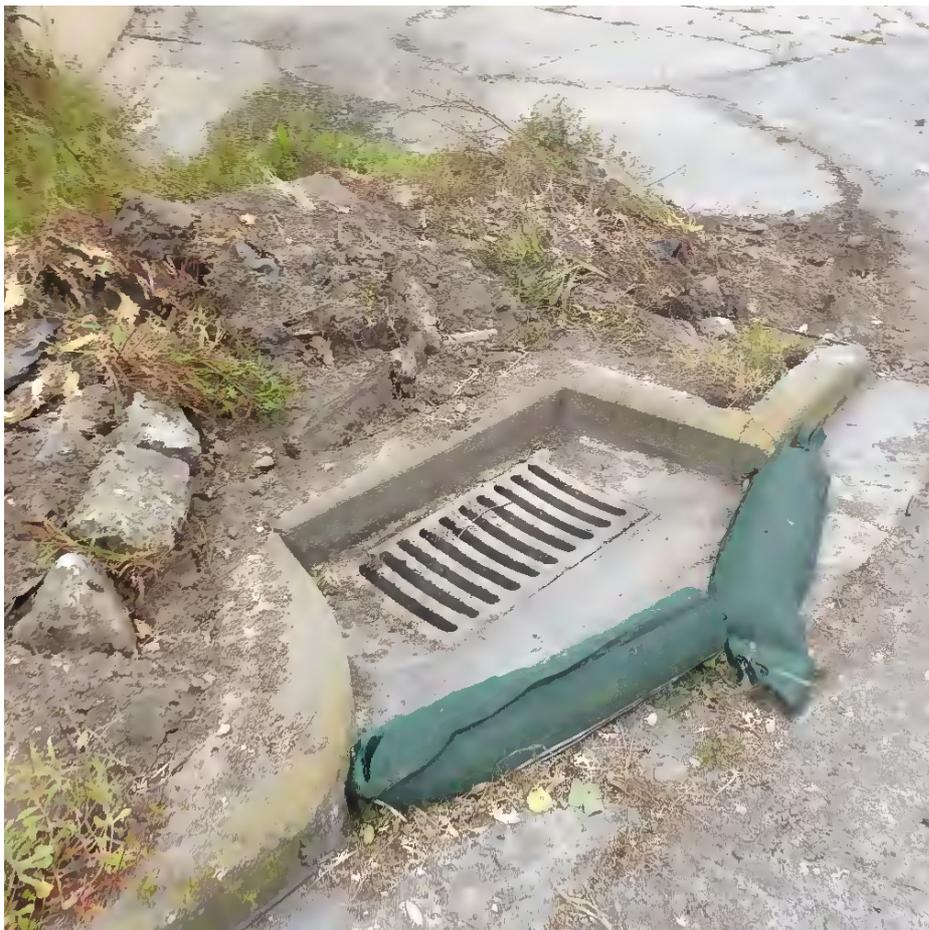
An inspection was conducted in overcast weather with calm wind conditions. Site demolition works had commenced, which included asbestos removal. All contaminated material, including residual fertiliser product, was scheduled for removal and disposal at an appropriate facility. The site was tidy and well managed, with all accessible stormwater drains banded and dry (Photo 2). The wetland was dry and well vegetated with no sign of discharge or dieback. There were no odour or dust issues onsite, and all consent conditions were being complied with.

Photo 2 Bunding on stormwater drains, November 2021

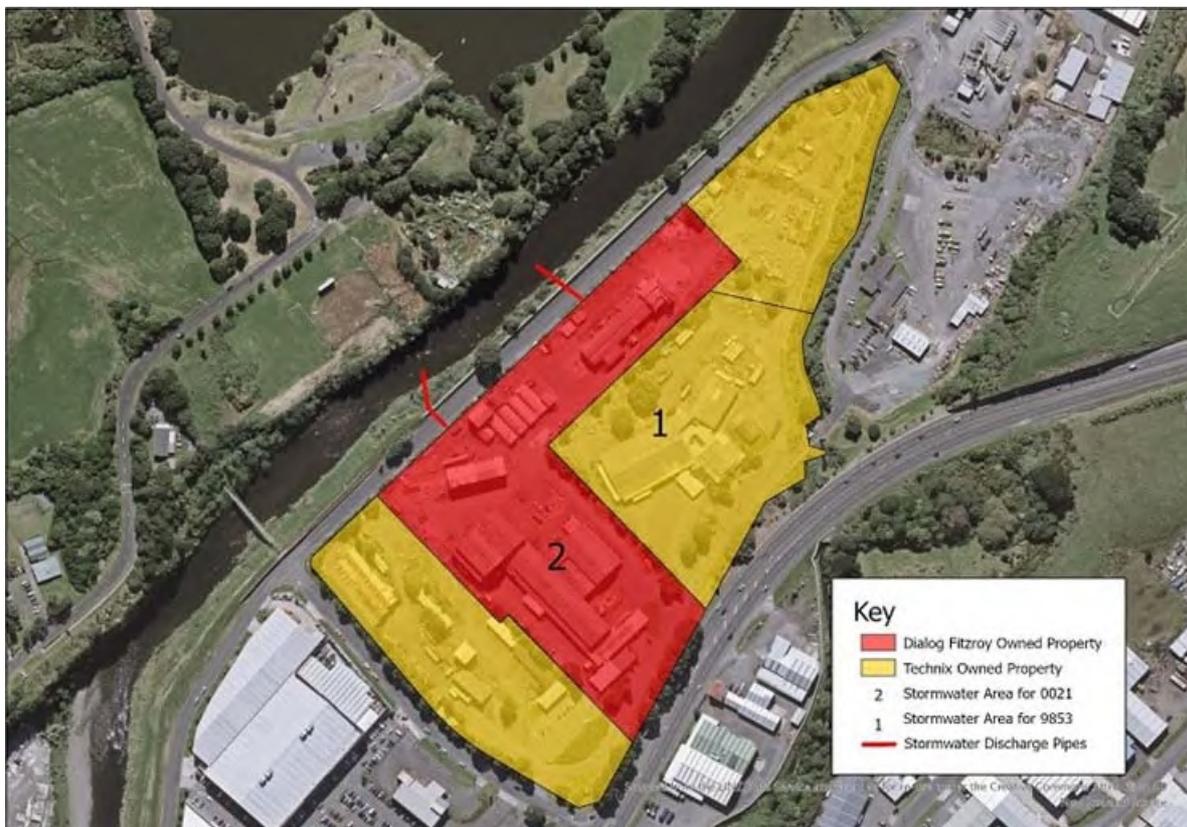
Figure 5 Aerial view of Technix Group Ltd and Dialog Fitzroy Ltd subdivided site

The site was previously leased from Technix Group Ltd (Technix), and the stormwater discharges from Dialog's activities were covered under consents held by Technix. In 2013 Dialog purchased the part of the property they operate on from Technix (Figure 5) and resource consent 0021-3 was transferred to Dialog. Resource consent 0291-3 was split into two consents as the northern area covered by this consent was now owned by Dialog, and a new consent number (9853) was assigned to this catchment area.

The stormwater area for consent 0021 covers the south-west section of Dialog Fitzroy's property. The stormwater drainage system runs from the south and east boundary towards the east boundary, the drainage then runs north towards the Waiwhakaiho River and discharges into the river via a stormwater drain (STW002001, Figure 6). There are multiple sumps along this system to collect stormwater.

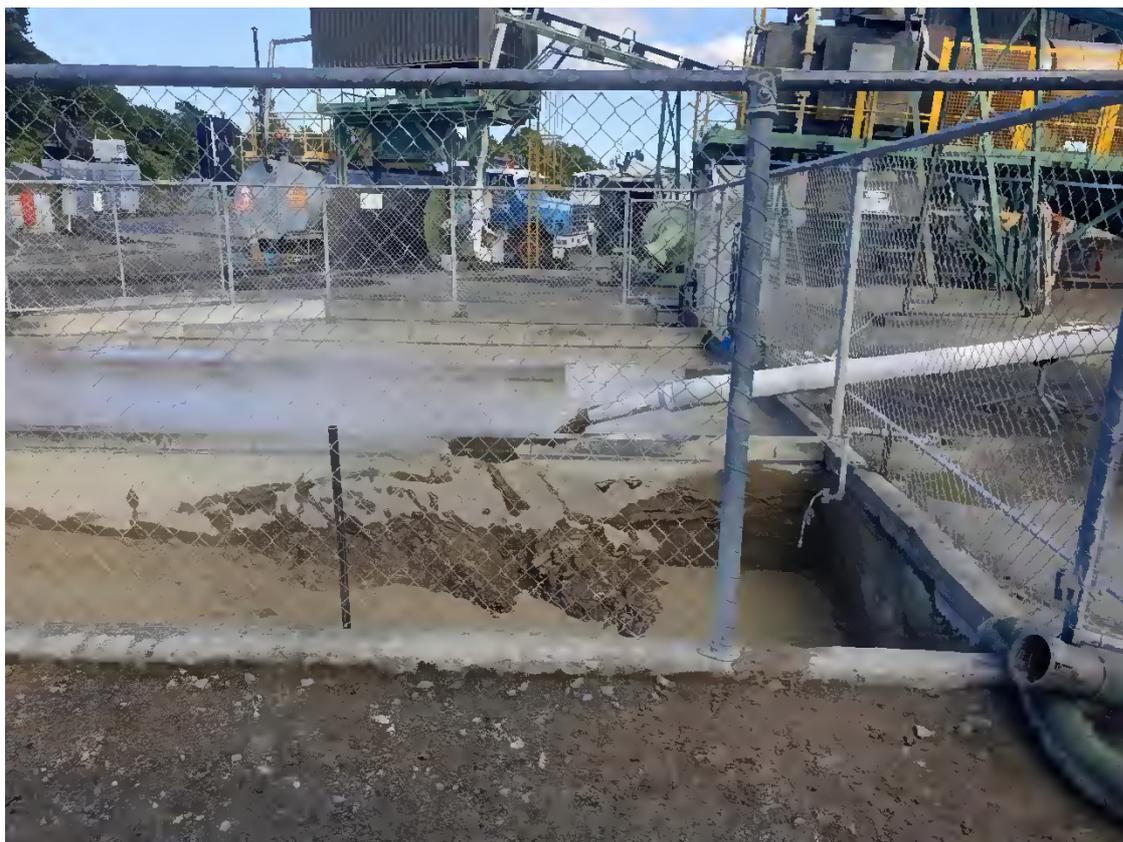
An inspection was conducted in overcast weather with light rain conditions. The yard was relatively tidy, but in need of sweeping. The plant was not operating at the time, and there were no discharges to air or water. It was noted that there had been excessive application of the slip agent Rhapsody which had caused the product and other contaminants to accumulate on the ground. Staff were advised that this had the potential to discharge to water. The wetland was discharging a clear flow into the Mangaone Stream, which was clear and uncoloured at the time. The new interceptor had not yet been installed. There were no odour or dust issues, and all consent conditions were being complied with.

Photo 4 View of Downer site with scrubber effluent settling ponds in foreground, May 2020

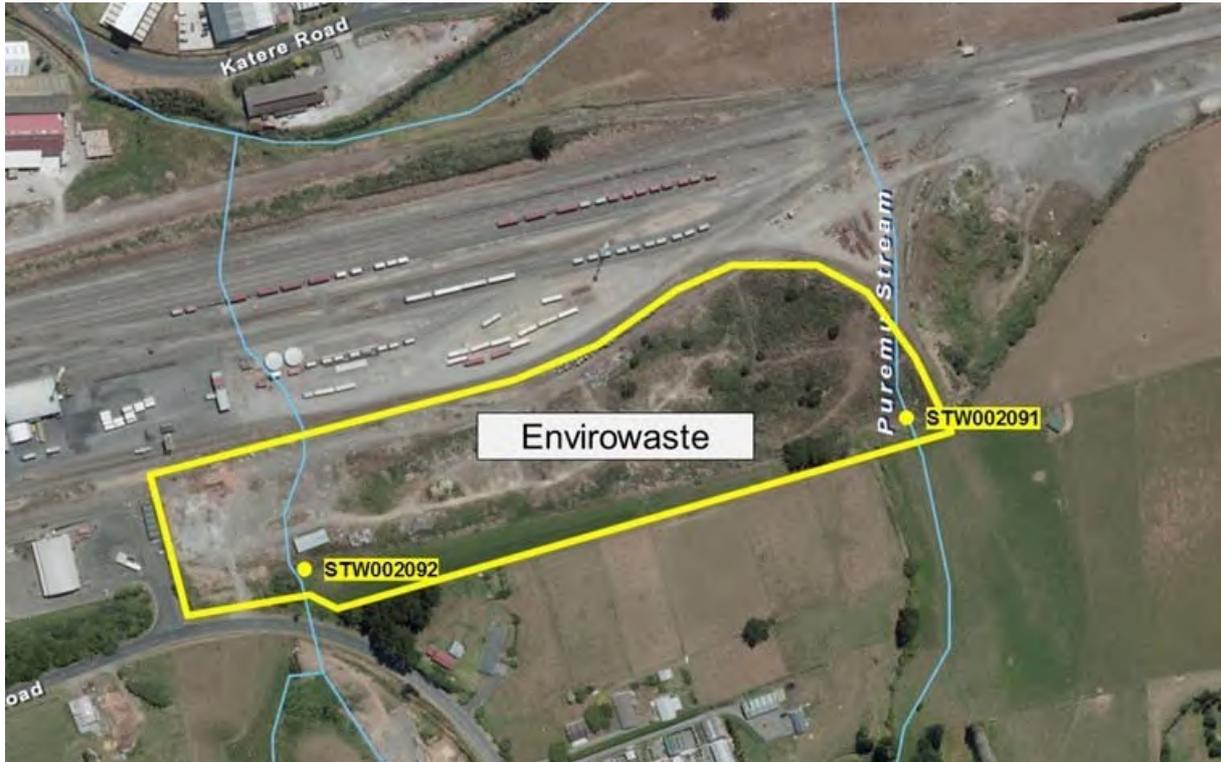
Figure 8 Aerial view of Envirowaste site and sampling locations

Envirowaste Services Ltd (Envirowaste) operates a material recovery facility (MRF) on Colson Road (Figure 8). The site receives and separates recyclable material sourced from district council kerbside collections and transfer stations for the entire Taranaki region.

Stormwater from the site discharges via retention ponds to the Puremu and Mangamiro Streams. Prior to discharge the stormwater is treated in long sediment ponds that discharge via grates to prevent litter being carried with it.

Monitoring of discharges from the Envirowaste site takes place at two points. Stormwater discharging to the Puremu Stream is sampled at STW002091 whilst stormwater discharging to the Mangamiro Stream is sampled at STW002092 (Figure 8).

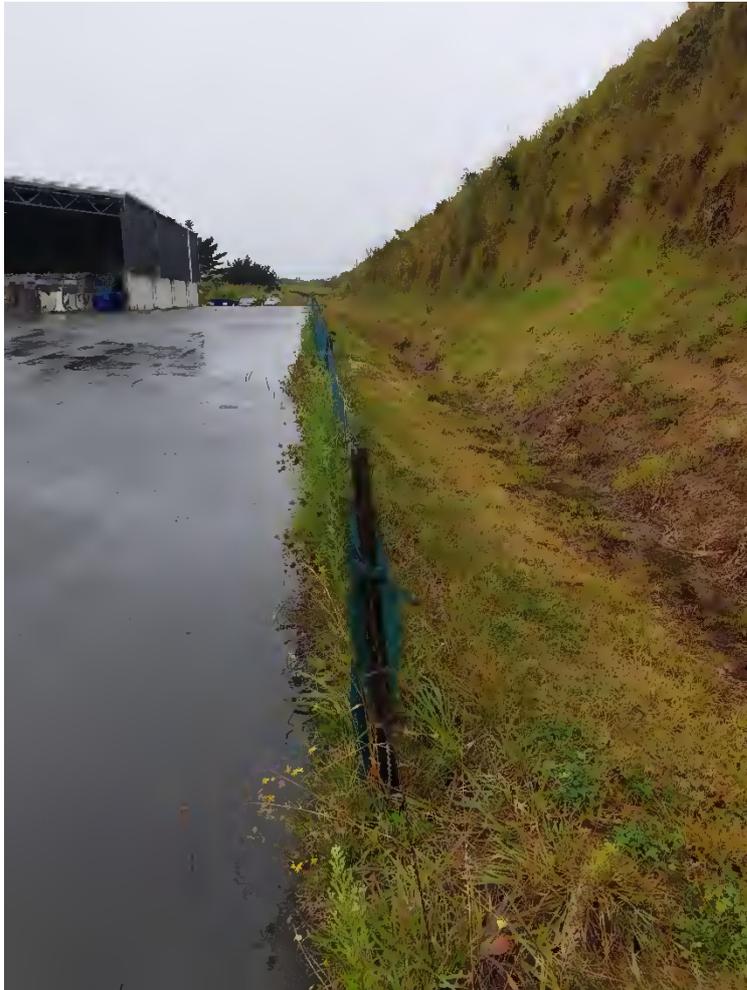
An inspection was conducted in fine weather with moderate south easterly wind conditions. The gusty winds had caused windblown rubbish to accumulate around the site, and staff advised that a clean-up was scheduled once the weather had settled. The stormwater system was fully contained and operational, and not discharging at the time. There were no odours or dust noted, and the site was compliant with resource consent conditions.

Photo 5 View of Envirowaste perimeter ring drain, February 2021

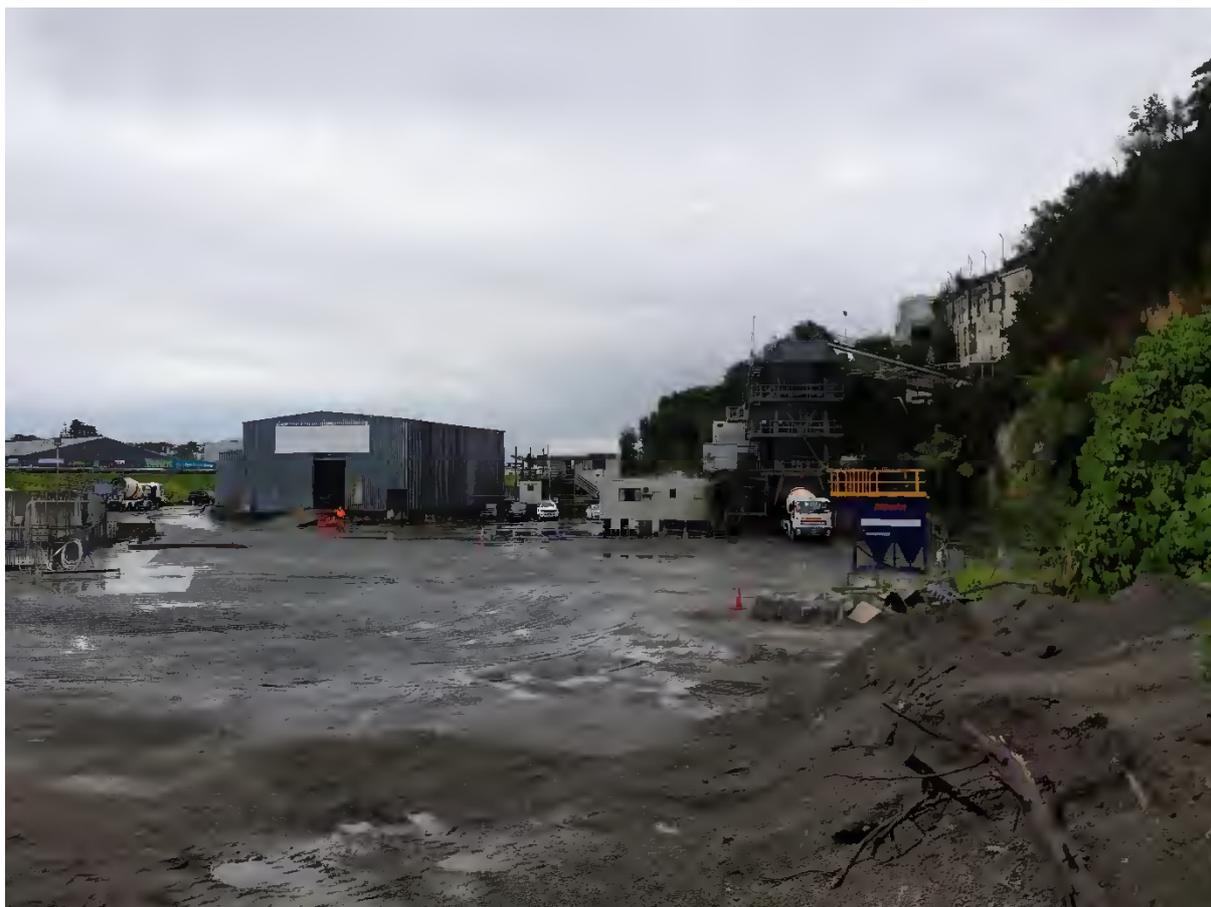
An inspection was carried out in warm, fine weather with moderate wind conditions. The site was clean and well maintained with no sign of spills or hydrocarbon sheens. The stormwater system was in good conditions and dry, with no discharge to the Waiwhakaiho River. There was no offensive or objectionable dust or odour discharging at the time, and the site was complying with resource consent conditions.

Photo 6 View of Firth lower yard with new Siltbuster treatment system on right, February 2021

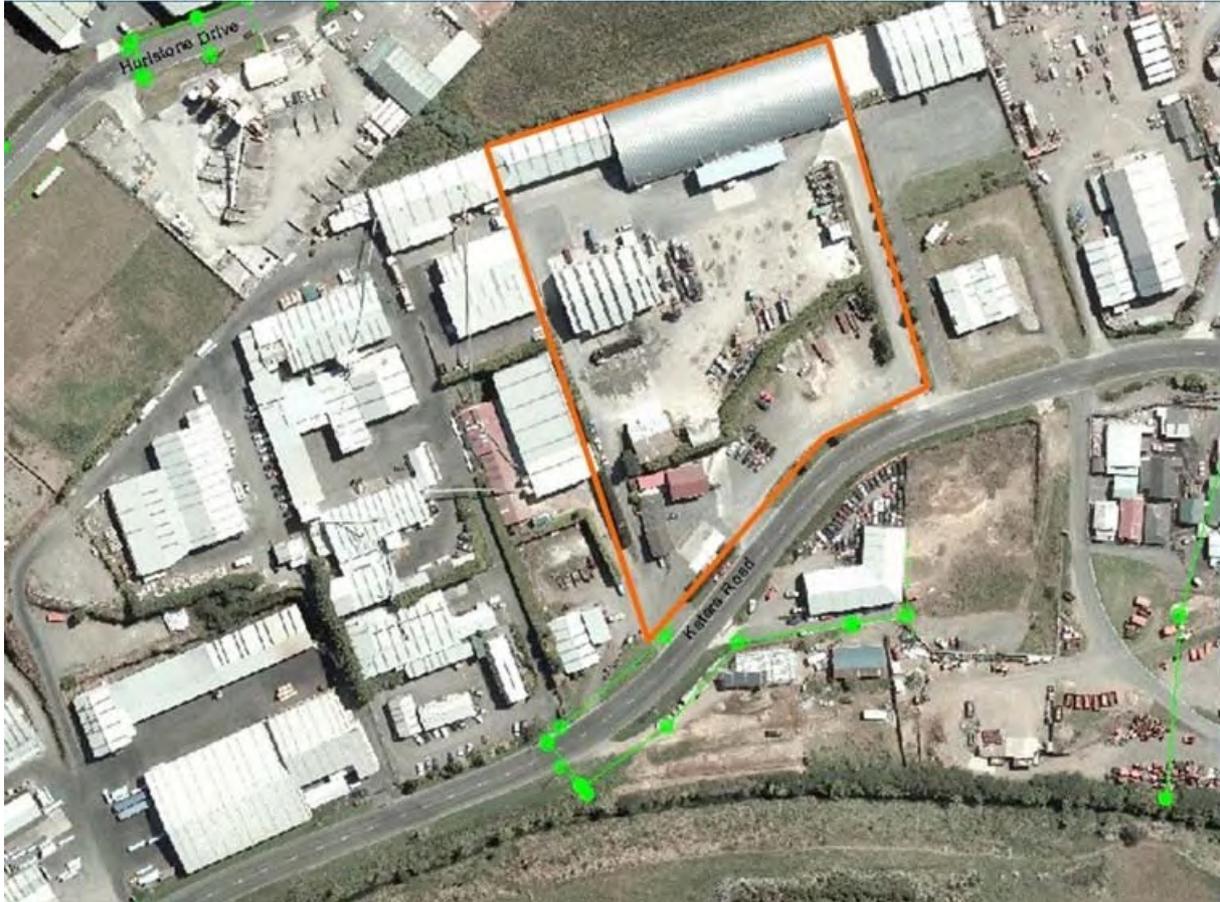
Figure 10 Aerial view of FBT site

Freight and Bulk Transport Holdings Ltd (FBT) operate a truck depot that services the rural sector from a 1.77 ha site on Katere Road (Figure 10).

FBT stores, blends and distributes dry stock feeds such as crushed meal, palm kernel and grains. Lime, fertiliser and gravel used for farm races are also stored at the site. The lime, stock feeds and fertilisers are stored in the sheds at the northern end of the site; only the gravel is stored outside in the stormwater catchment. Trucks are washed at the site and the wash water was historically (until expiry of consent 0241) discharged to soak holes. During the 2018-2019 monitoring period a truck wash was installed that recycles wash water and discharges contaminants to trade waste (Photo 7).

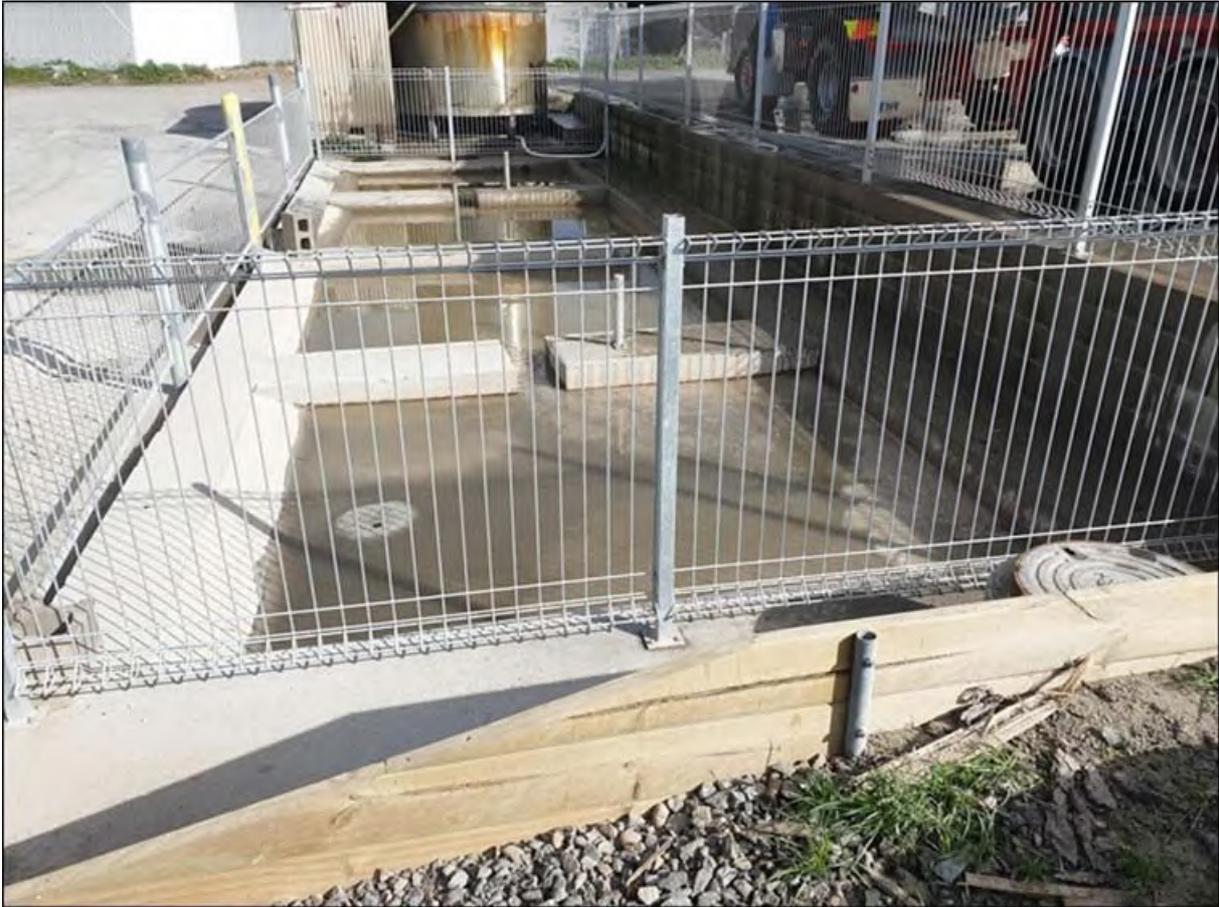
Photo 7 FBT truck wash discharge to trade waste

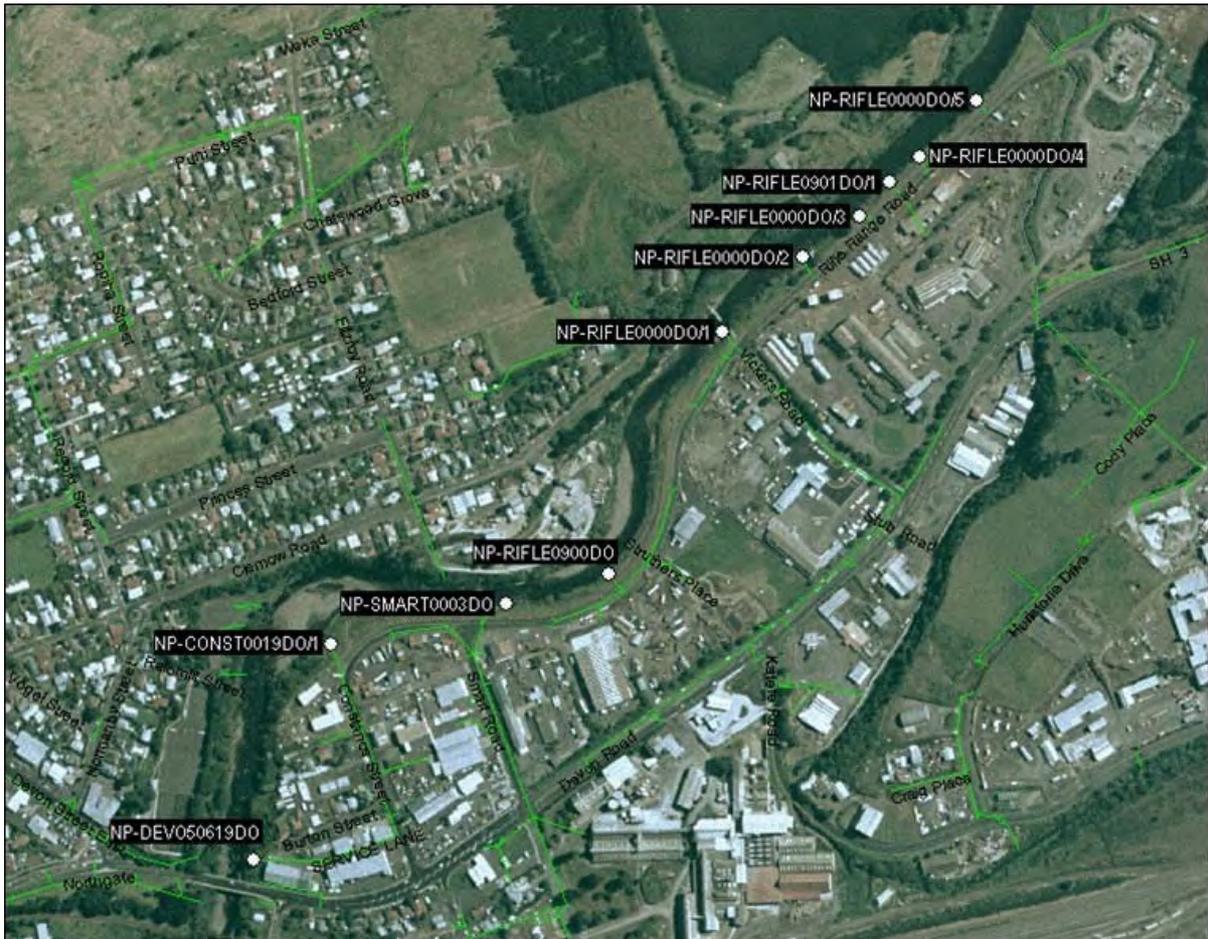
Figure 12 Aerial view of NPDC stormwater and leachate discharge locations in the Waiwhakaiho Catchment

NPDC holds consent **5163-2** to discharge stormwater from the Waiwhakaiho industrial area into the Waiwhakaiho River via multiple outfalls between State Highway 3 and the confluence with the Mangaone Stream.

The catchment area and location of stormwater and landfill leachate discharge points are shown in Figure 12.

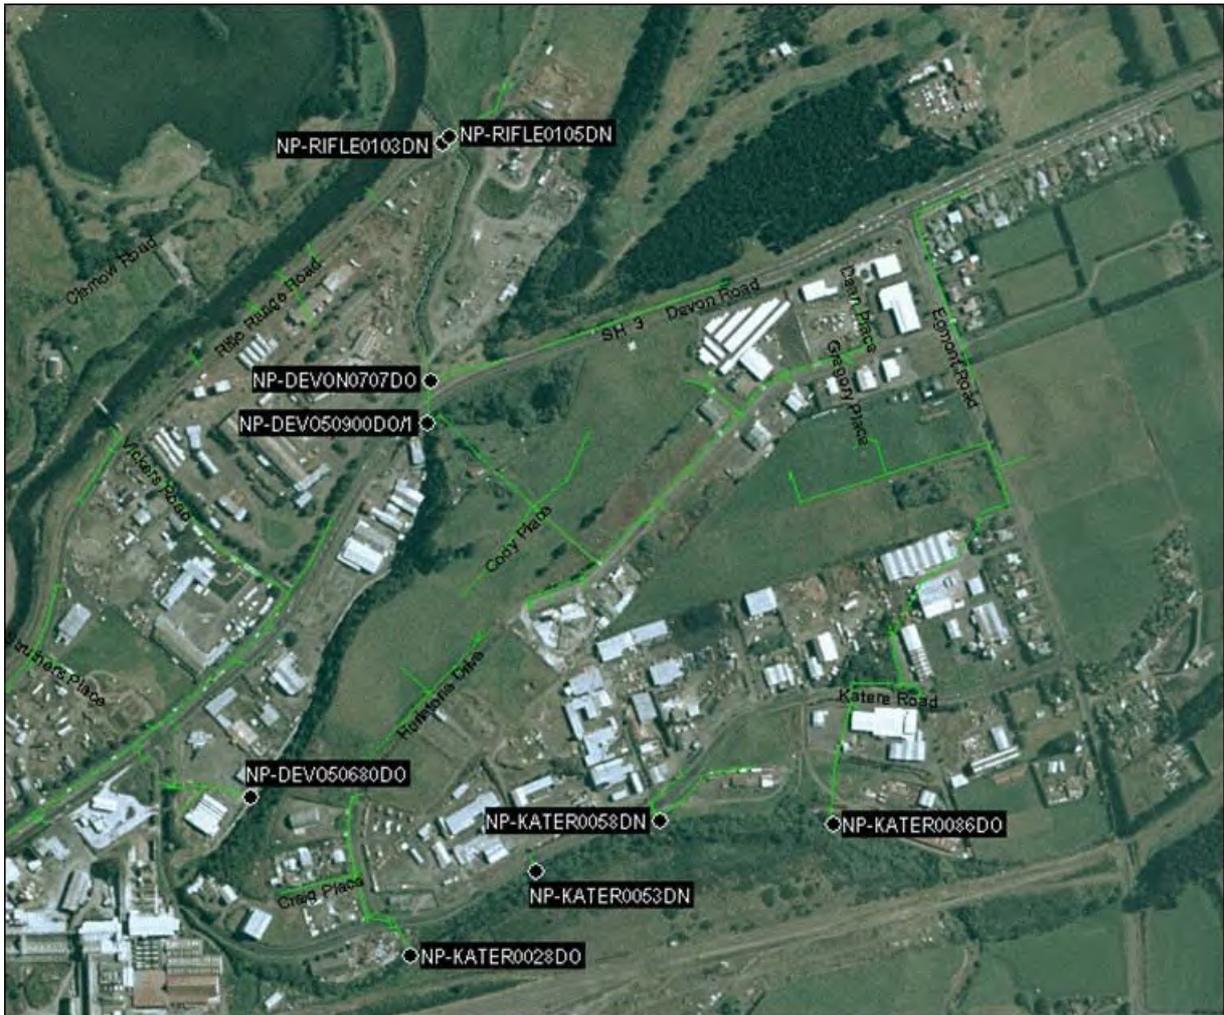
Figure 13 Aerial view of NPDC stormwater discharges to the Mangaone Stream

The catchment area and location of stormwater and landfill leachate discharge points are shown in Figure 13.

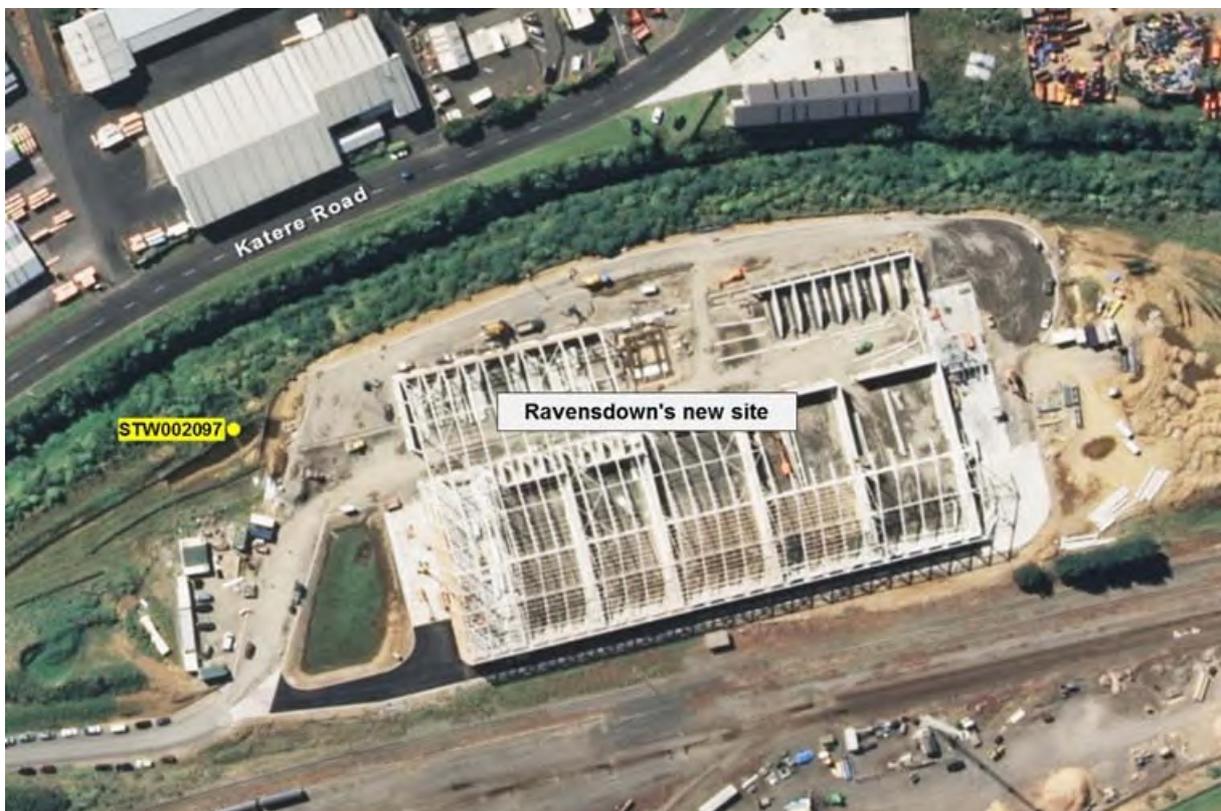
Figure 14 Aerial view of Ravensdown site (building construction since completed)

The New Plymouth depot of Ravensdown Fertiliser Co-operative Ltd (Ravensdown) occupies an area of about 8 Ha of land adjacent to the KiwiRail yard (Figure 14). The depot receives, bags, blends and distributes fertilisers in various forms, namely superphosphate, lime, dolomite and imported high analysis products such as ammonium sulphate, urea, triple super, potassium chloride (potash) and monoammonium and diammonium phosphates (MAP & DAP). Small volumes of trace element fertilisers such as zinc sulphate are also handled through the store.

Stormwater from the roof and the area immediately surrounding the main building is directed through a planted wetland prior to discharge to the Mangaone Stream. Stormwater from the upper end entrance road is diverted to setting ponds and discharged to the Mangaone further downstream. Stormwater from the lower part of the access road is diverted to the Waiwhakaiho River via MacLeod's drain on Smart Road.

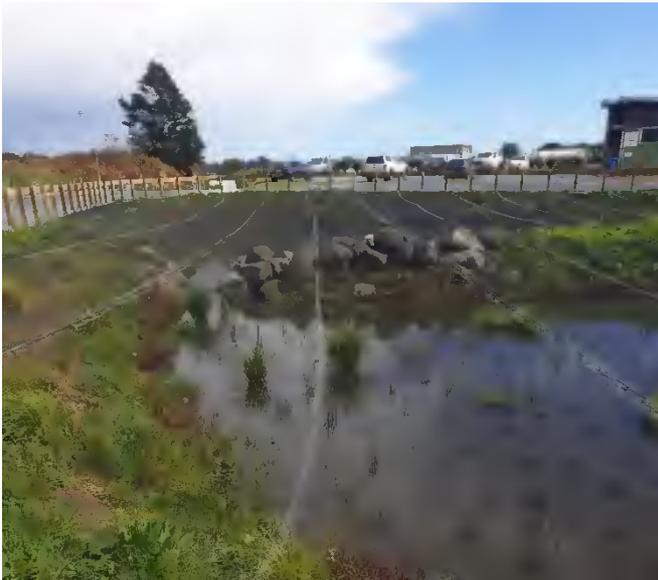
The site was visited in overcast weather with light rain conditions. The yard was reasonably clean and tidy with no sign of spills or tracking. The stormwater drains were inspected and found to be clear of debris apart from a small section on the northern side of the building, which was pointed out to staff at the time. The wetland was operating as normal, and the new plantings were establishing slowly. The operating level was low and there was a clear, trickle discharge from the pond. There were no odour or dust issues onsite and all consent conditions were being complied with.

Photo 8 View of Ravensdown treatment wetland with recent planting, April 2021

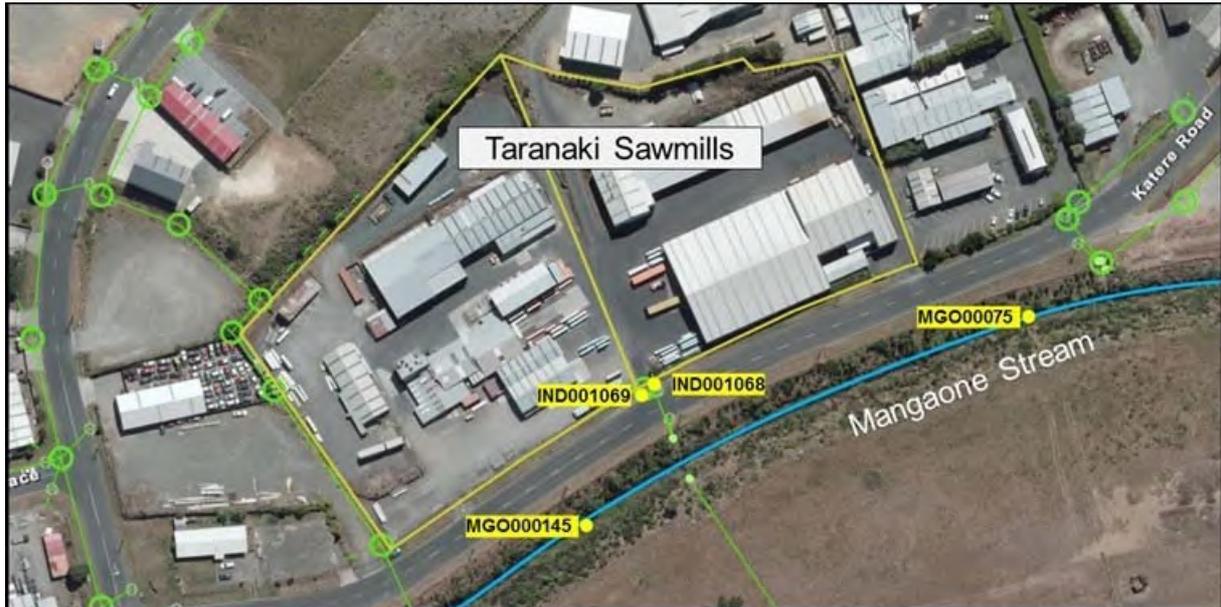
Figure 15 Aerial view of Taranaki Sawmills Katere Road site and sampling locations.

Taranaki Sawmills Ltd (TSM) has operated a timber treatment plant on Katere Road since 1956 (Figure 15). In 1997, an adjoining site was purchased and developed for painting and packaging, packaging componentry, and a domestic despatch yard, some of which has now been on-sold. About 30 persons are employed at the site.

Timber is treated at two plants. At one plant, timber is treated with copper, chromium and arsenic (CCA), and with boron. At the other plant, light organic solvent preservatives (LOSP) are used.

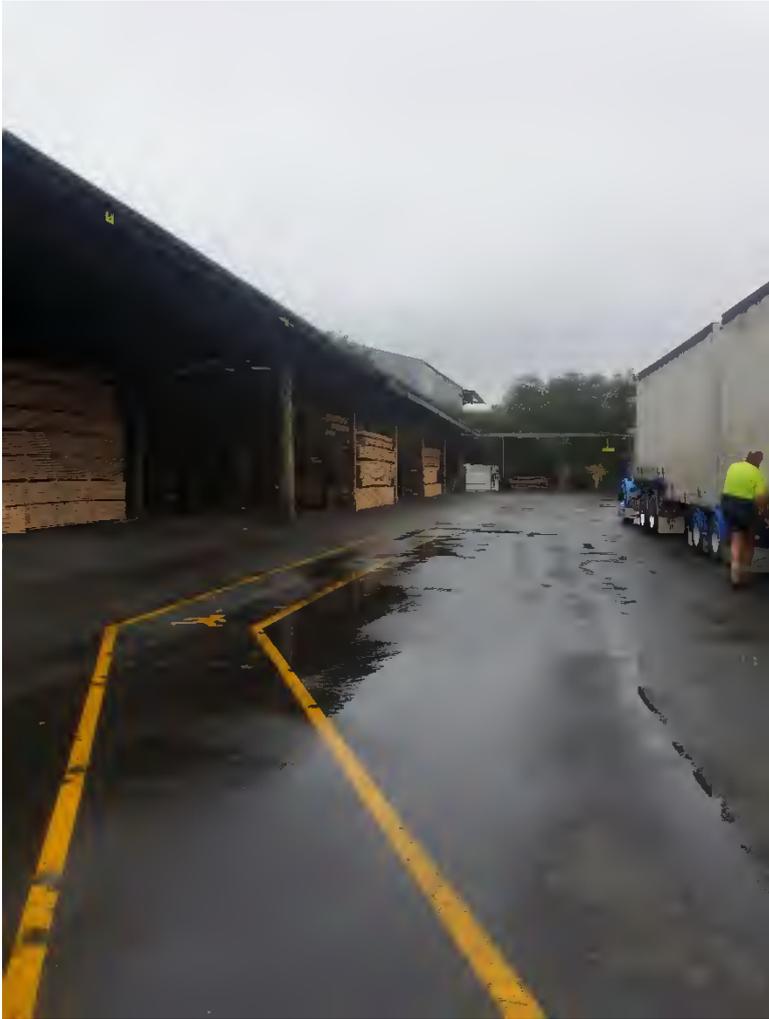
An inspection was conducted in overcast weather with light rain ongoing. The yard was generally tidy, however some housekeeping was required near the paint shed, with paint chip residues noted near the stormwater drains. The filter socks in place on the drains also required maintenance. There was no evidence of spills or sheens (Photo 9). The stormwater system was operating normally, and both east and west drains were discharging at the time. There were no issues with odour or dust on the site, and all consent conditions were being complied with.

Photo 9 View of stored timber on TSM yard

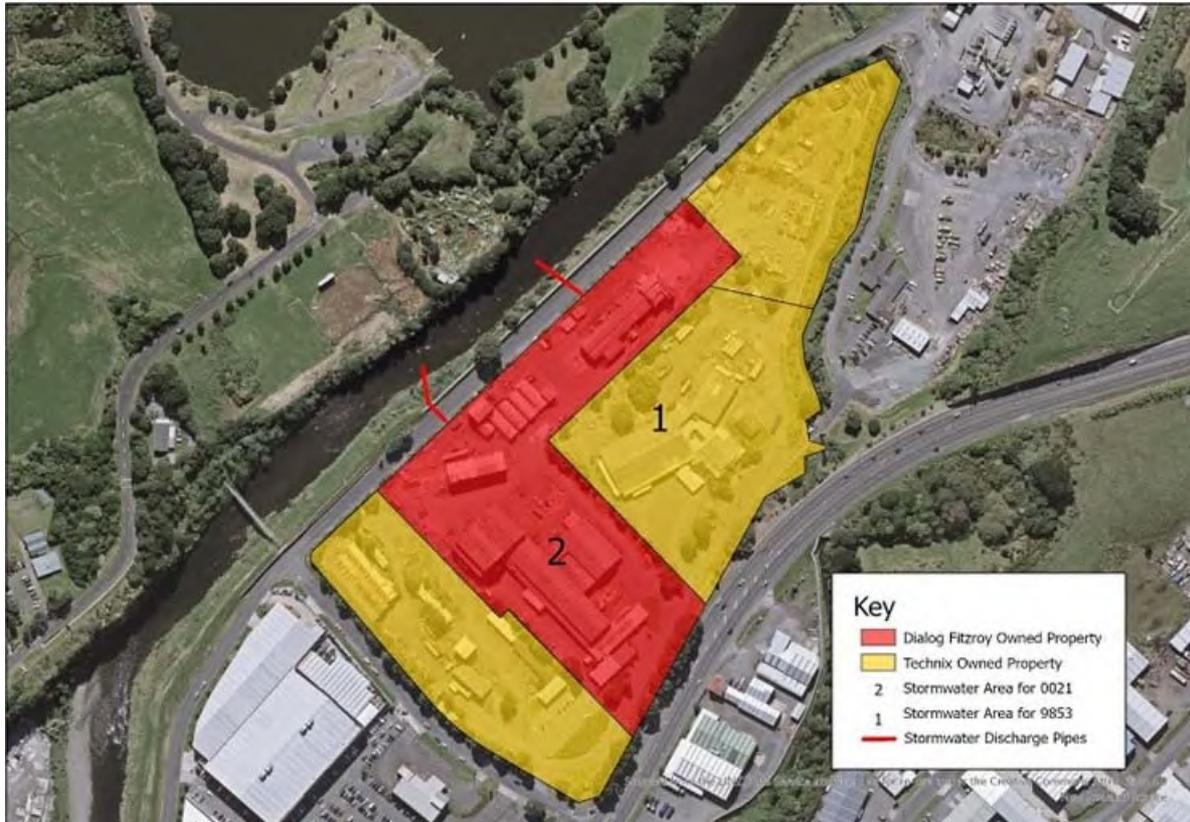
Figure 17 View of extent of Technix property (in yellow)

Technix Group leases buildings on the site to several tenant companies carrying out a range of activities. Dialog Fitzroy own and operate a significant part of the yard in the centre of the Technix boundary (Figure 17).

The original consented discharges were two discharges to the Waiwhakaiho River from the central areas of the site, and the one to the Mangaone Stream from the eastern area of the site. The other, previously unlicensed, discharge occurs from the western area of the site to the Waiwhakaiho River down Vickers Road, which also serves commercial properties on the opposite side of the road. This discharge point was included in NPDC's consent 5163-2 when it was renewed on 20 November 2007. Also during the 2007-2008 year, prior to the expiry of the consent held for the discharges to the Mangaone Stream (2230), the Council concluded that the activity in this area had become a permitted activity under Rule 23 of the RFWP (which

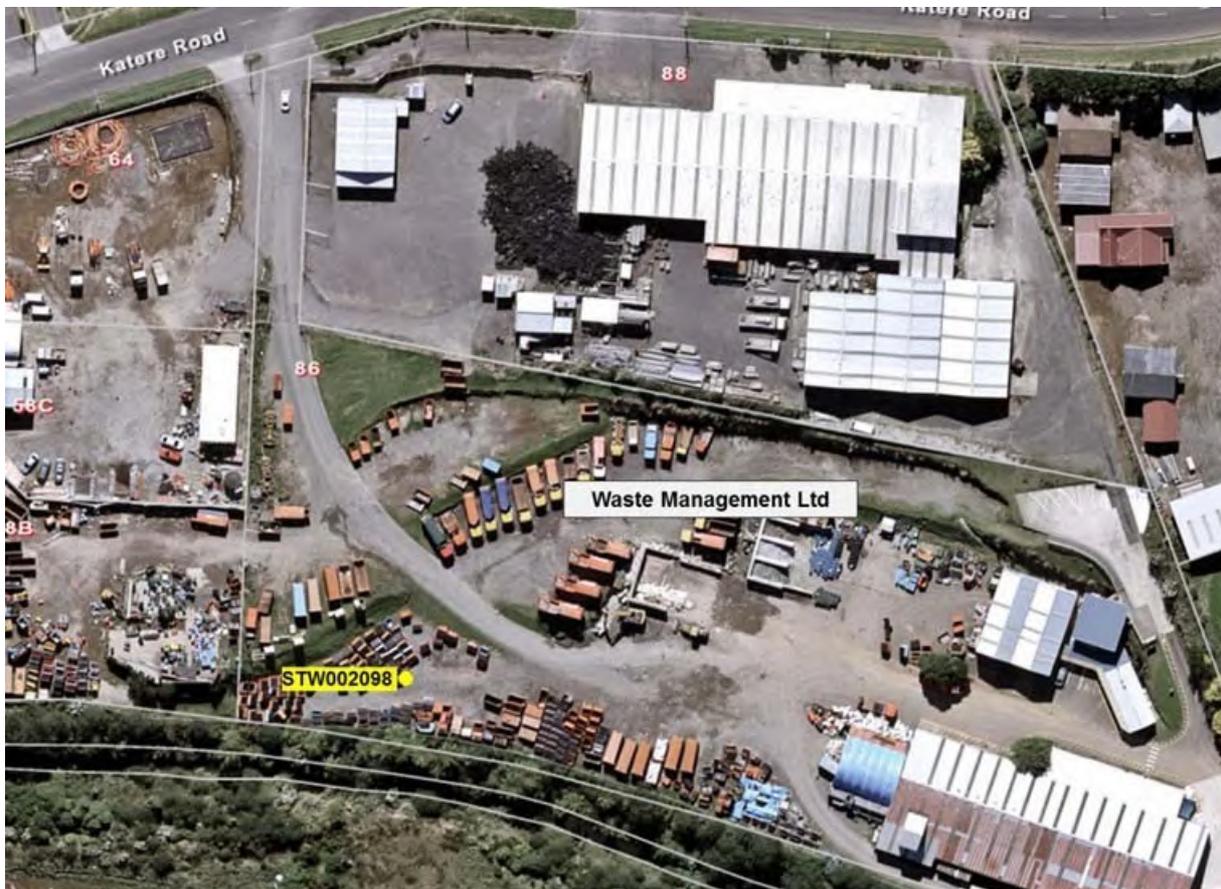
Figure 18 Aerial view of Waste Management site and sampling location

Waste Management NZ Ltd (Waste Management) operate a refuse transfer depot on Katere Road, New Plymouth (Figure 18). Activities on the site include the receipt and temporary storage of general refuse (non-hazardous solid waste). The site does not use or store any hazardous substances. Refuse is deposited onto a transfer pad on site by truck or from smaller bins. Sorting takes place into recyclables-glass cardboard and plastic. Most refuse is loaded onto a truck and driven to a landfill near Marton.

The refuse storage area is usually cleared at the commencement of each day's activities, but on occasions there is excess refuse left within the storage area over night. This is the first refuse to be loaded the next morning. Empty used bins are stored on the wash pad which is connected to the New Plymouth District Council (NPDC) trade waste system. These bins are then washed with a water blaster and the runoff is directed to the trade waste system. Washed bins are then generally moved to the yard where they are stored until required in the future.

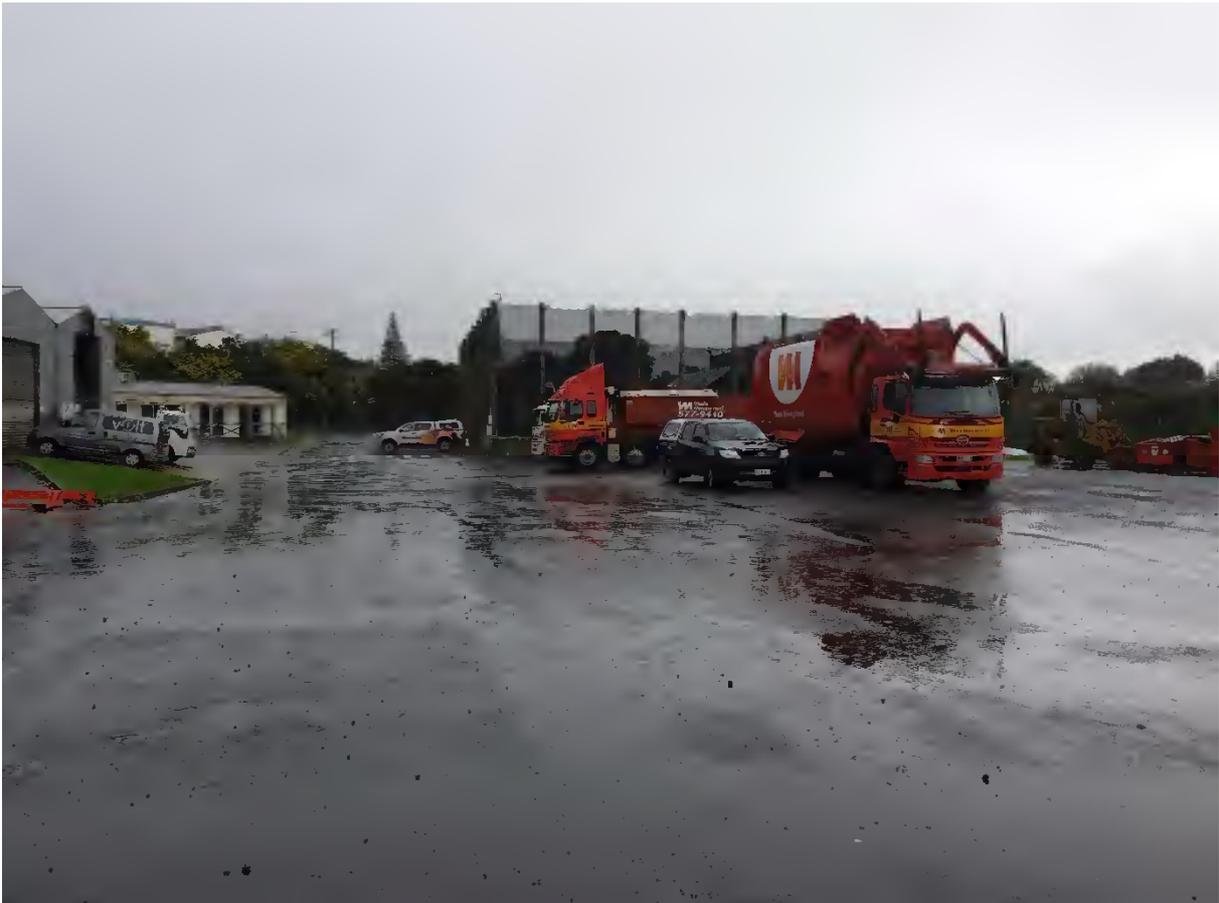
The site was inspected in warm, overcast weather with moderate rainfall ongoing. The site was clean and tidy with no rubbish noted in the stormwater drains or around the site perimeter (Photo 10). The yard was in need of sweeping, which had already been scheduled and was awaiting contractors for completion. The stormwater management plan was in the process of being updated. There were no odour or dust issues, and the site was compliant with consent conditions.

Photo 10 View of Waste Management yard, April 2021

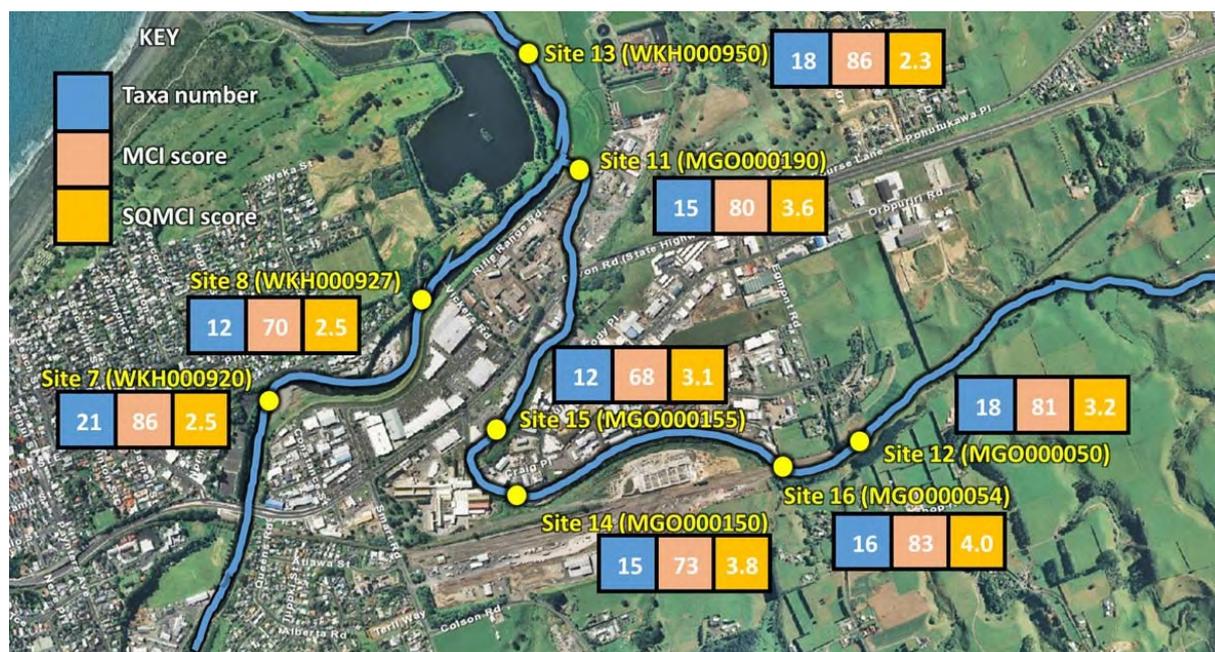
Figure 20 Biomonitoring sites in the Waiwhakaiho River Catchment with taxa number, MCI scores and SQMCI scores for each site, 18 January 2021

Overall, the results indicated that discharges from industrial areas may have caused localized negative effect on the macroinvertebrate communities in the Mangaone Stream (site 15) and lower Waiwhakaiho River (site 8). The Mangaone Stream had a significant decline in macroinvertebrate indices at site 15 and a noticeable decline at site 14 compared to the upstream control site. Site 8 in the Waiwhakaiho also showed a significant decrease in MCI compared with the control site. Because all sites across the survey had macroinvertebrate health metrics that were similar or higher than respective historical median values, it is likely that continuous and chronic discharges are contributing to the pattern of decline observed in this report and previous reports at the impacted sites.

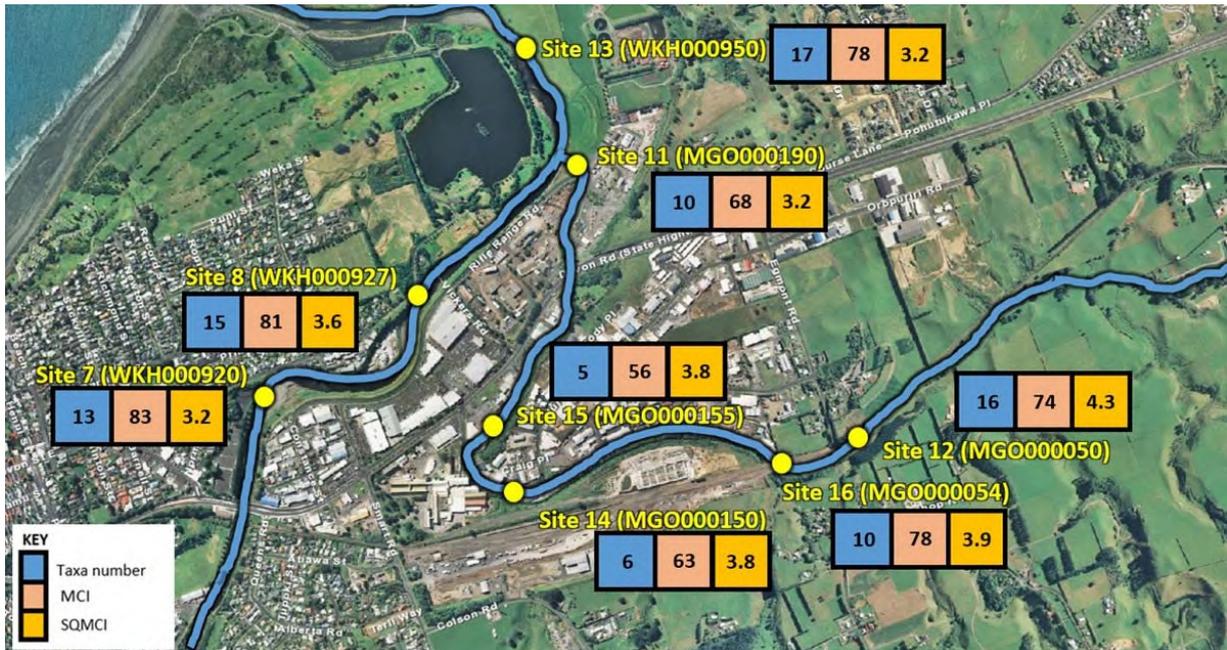
Figure 21 Biomonitoring sites in the Waiwhakaiho River Catchment with taxa number, MCI scores and SQMCI scores for each site, 25 March 2021

Overall, the results indicated that discharges from the industrial area were not having a significant negative effect on the macroinvertebrate communities of the lower Waiwhakaiho River. The Mangaone Stream sites indicated a highly significant decline in MCI and taxa richness in the middle reaches, which may be due in part to chronic pollution from historic sites but also indicates that a more recent discharge lowering water quality has also occurred. Groundwater inputs may have also contributed to some of the deterioration recorded immediately downstream of the old fertiliser depot in the lower reaches of the stream.
