Lower Waiwhakaiho Catchment

Monitoring Programme

Annual Report

Technical Report 2021-75

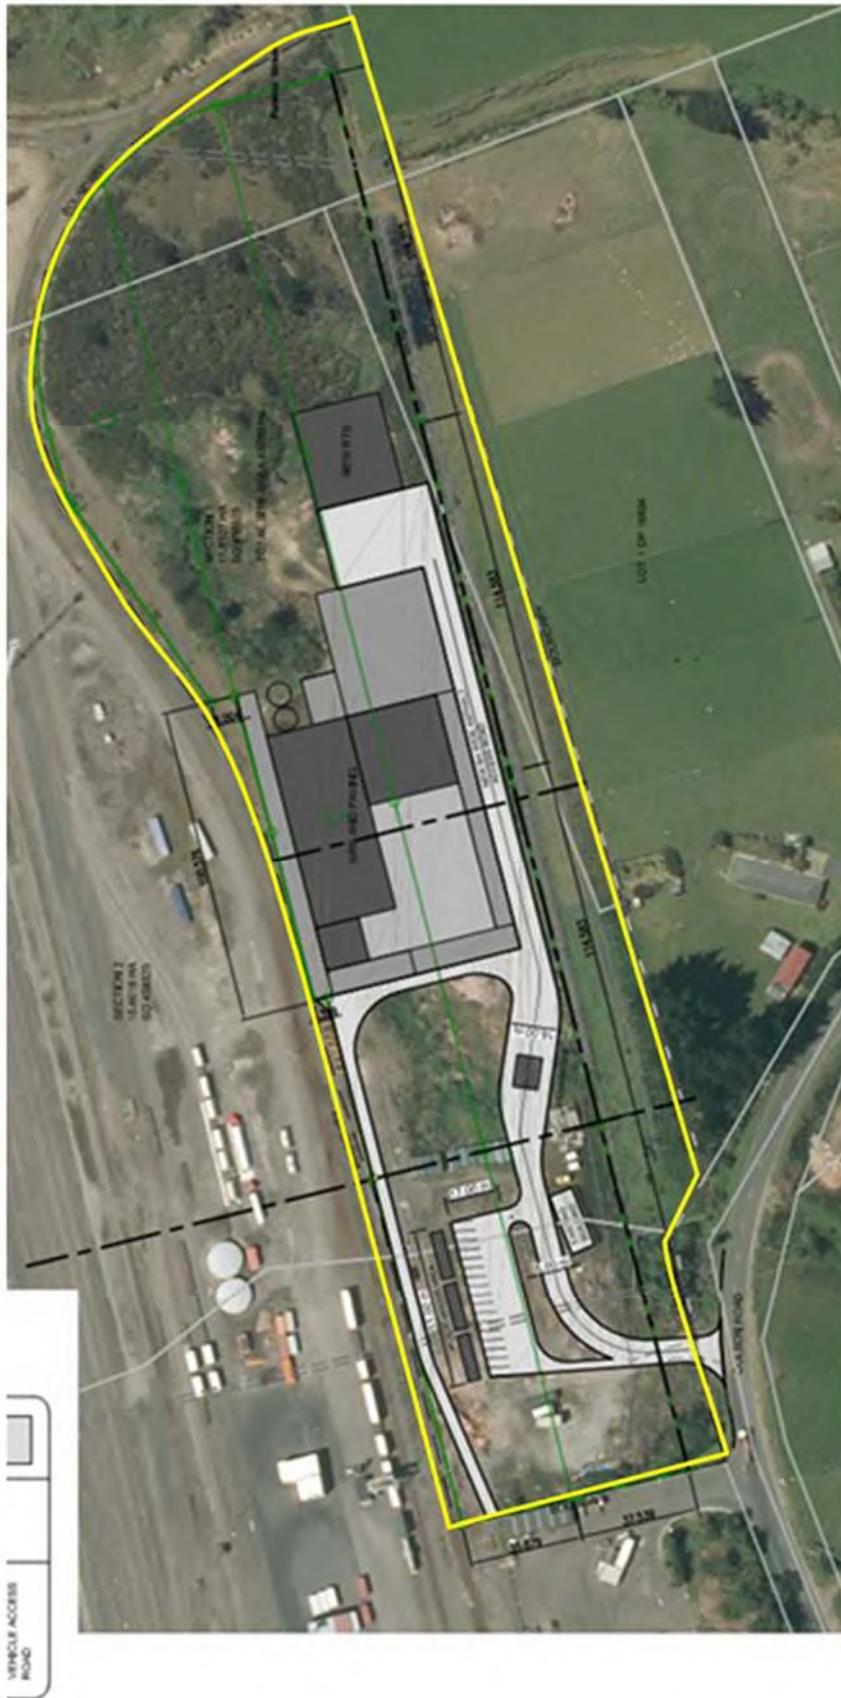
Figure 1 - Stormwater catchment area permitted by this consent (in yellow)

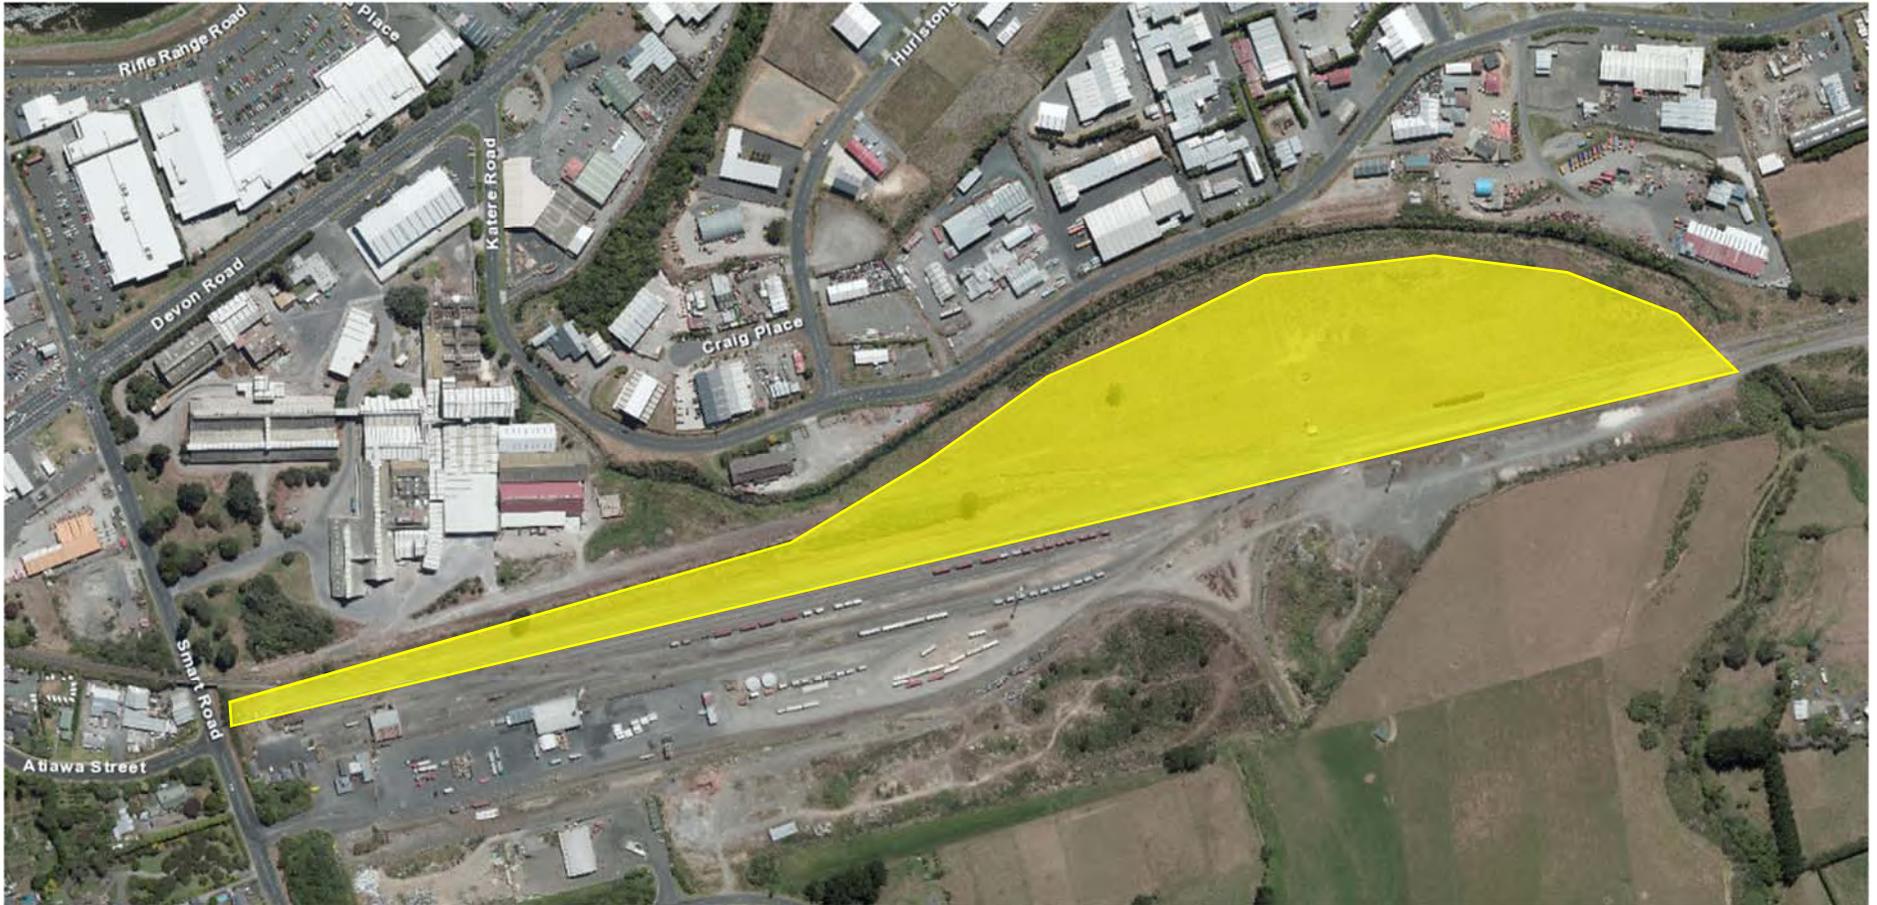
Appendix 1: Stormwater discharged shall be from the area shown in yellow

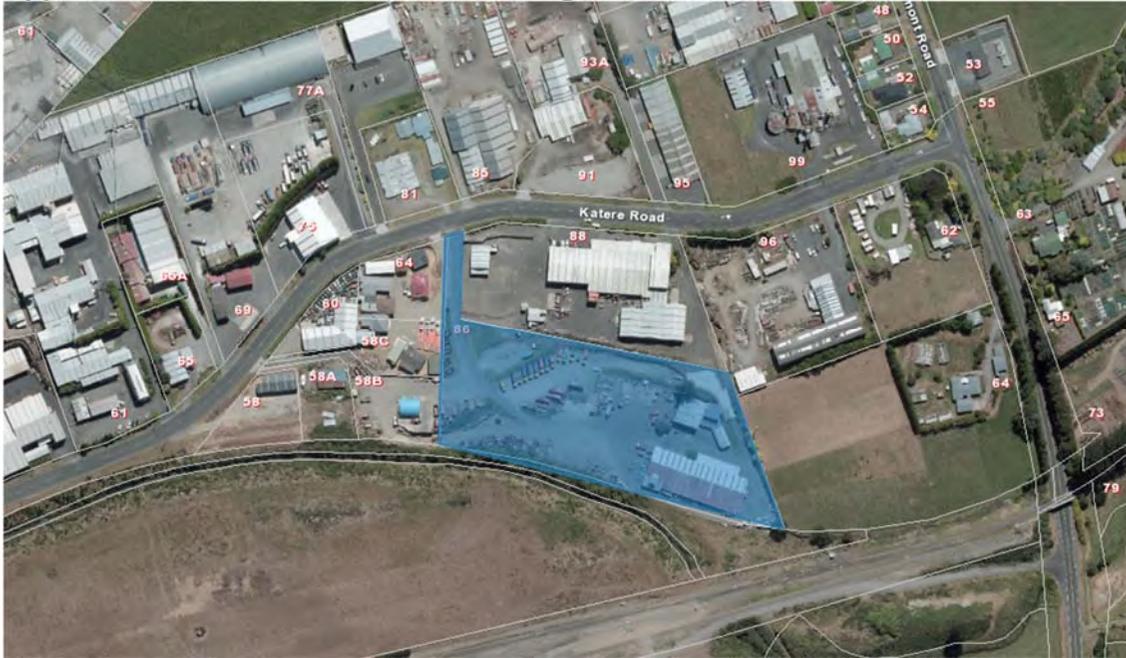
Appendix 1: Area of stormwater discharge shown in blue.

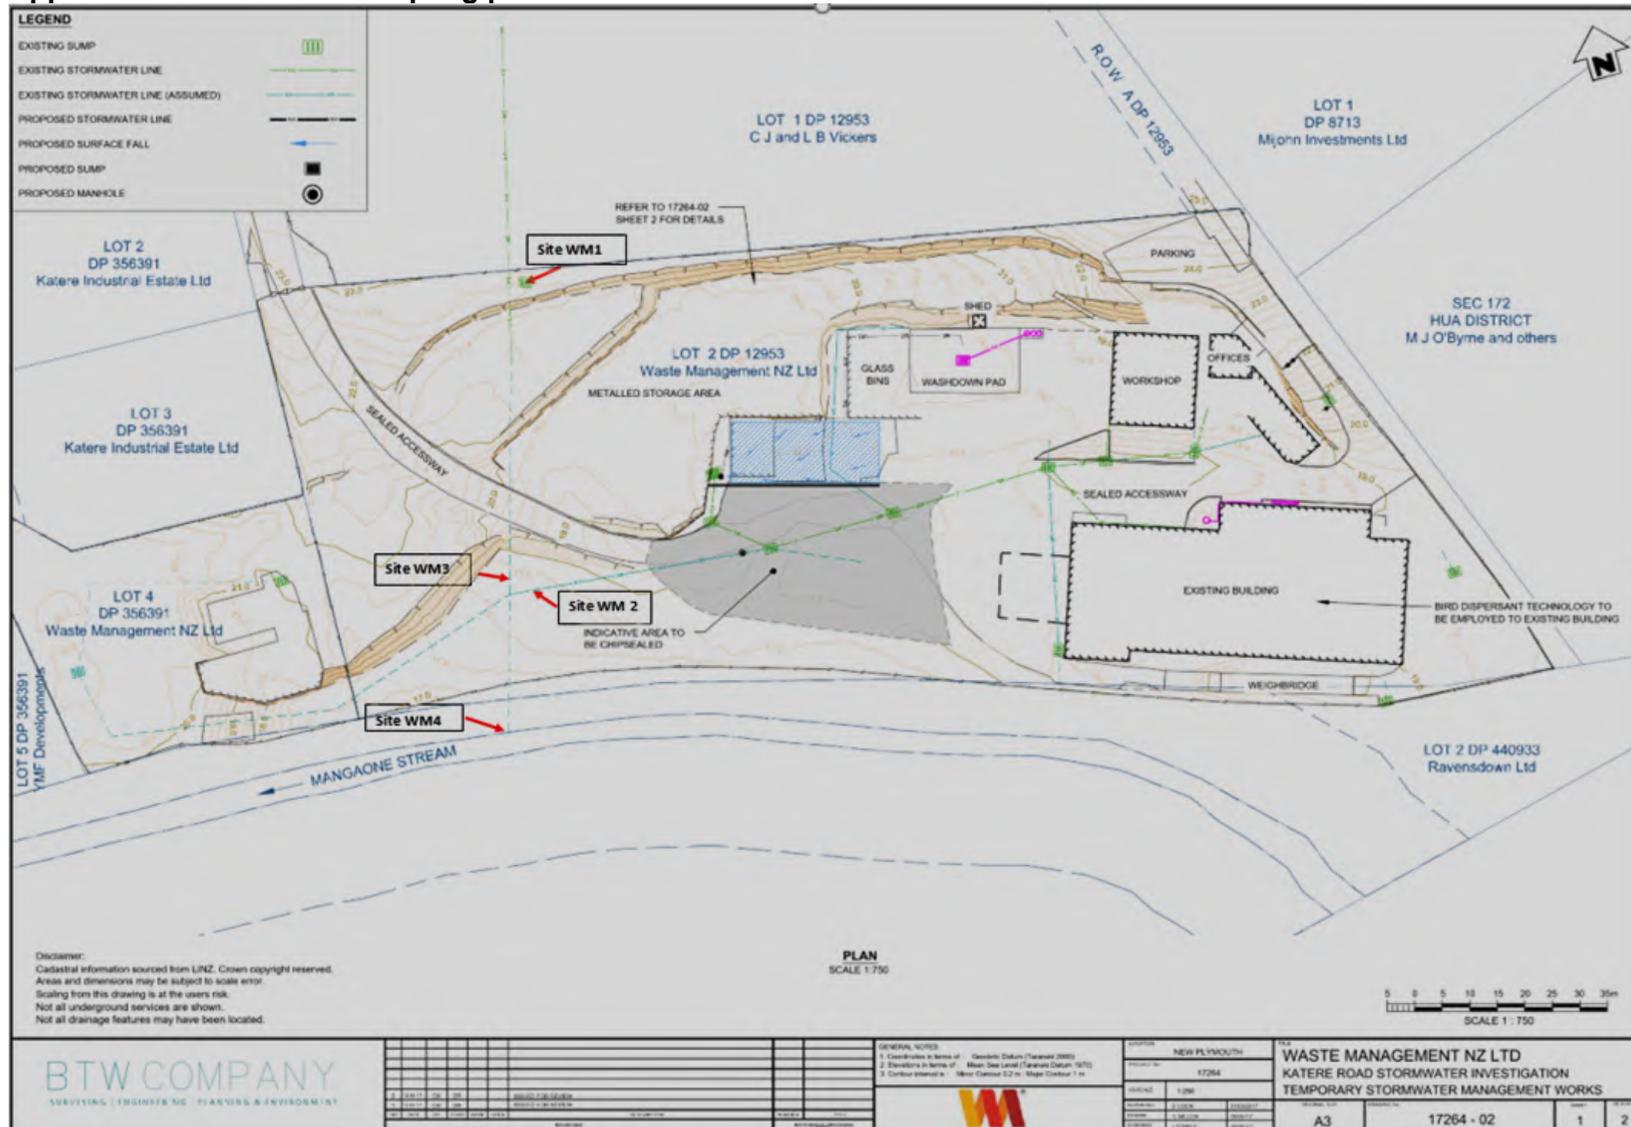
Appendix 2: Location of sampling points
