# Fonterra Kapuni

Monitoring Programme
Annual Report
2022-2023

Technical Report 2023-20

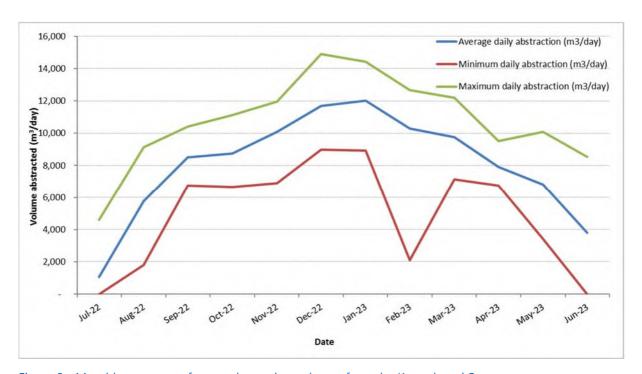
Figure 3 Monthly summary of water abstraction volumes from the Kaupokonui Stream

The daily stream abstraction data summaries in Table 3 and Figure 3 illustrate that the Company continued to take a significant volume of water from the stream during the 2022-2023 monitoring period. However, it is noted that the volumes abstracted were again significantly lower than the permitted take of 19,500 m<sup>3</sup>/day.

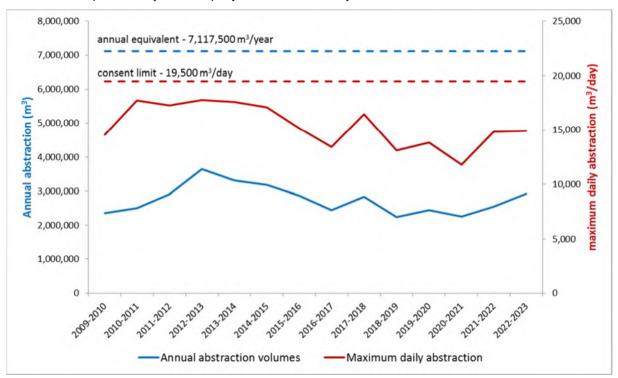
Figure 4 Daily and annual stream abstraction volumes July 2009 to June 2023

The changes in the river abstraction volumes since the 2009-2010 year are illustrated in Figure 4, which shows a general trend of decreasing water abstraction at the site since the 2012-2013 year. It is noted that the graph below is based on the data provided in the Company's monthly reports for the 2009-2020 years and the electronic data provided by the Company for the 2020-2021 year onwards.

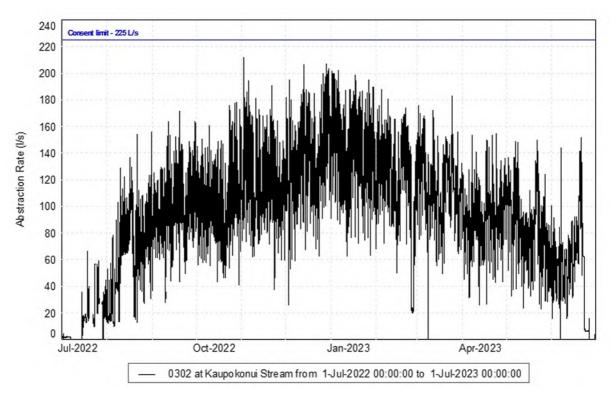
Figure 5 Abstraction rate from the Kaupokonui Stream (consent 0302-3)

The Company's abstraction of water from the Kaupokonui Stream was undertaken in a satisfactory manner and the abstraction rates complied with consent conditions as illustrated in Table 3 and Figure 5. The abstraction rate remained at or below 180 L/s for 99% of the year. Although there was just over 11 days of missing record, this was during the winter shutdown when water usage was very low.

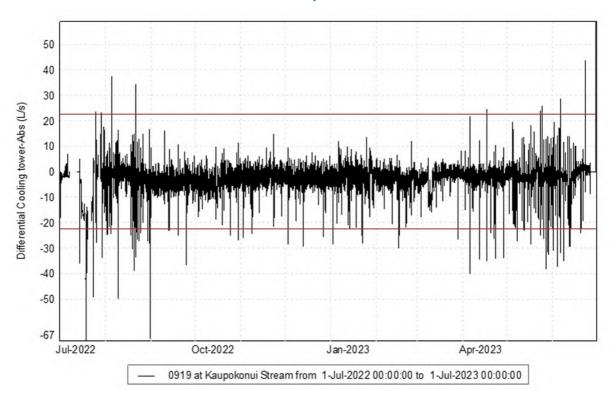
Figure 8 Differential between the rate of discharge from the cooling tower and the abstraction rate

Figure 8 shows the differential between the 15 minute data provided by the Company for the discharge and abstraction rates measured during the year under review, with negative values indicating consumptive use and positive values indicating an increase return rate. The maximum permitted error on the differential between the meters is  $\pm$  10 %. The error margins, if the abstraction and discharge were approximating to the maximum take rate of 225 L/s, are also shown in Figure 7, although it is noted that the highest average daily abstraction rate was only 180 L/s. For the majority of the year under review, the measured differential in the recorded flow rates was also predominantly within the margin of error of the recording devices.

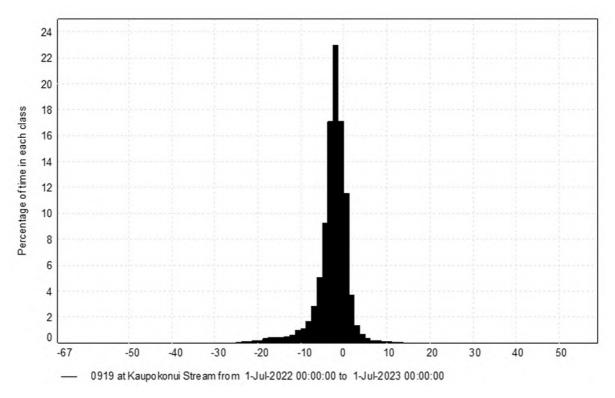
Figure 9 Probability density for the difference between the rate of flow from the cooling tower and the abstraction rate, full year's data

Figure 9 show the percentage of the time that the usage or additional return is at a given rate for the year under review.

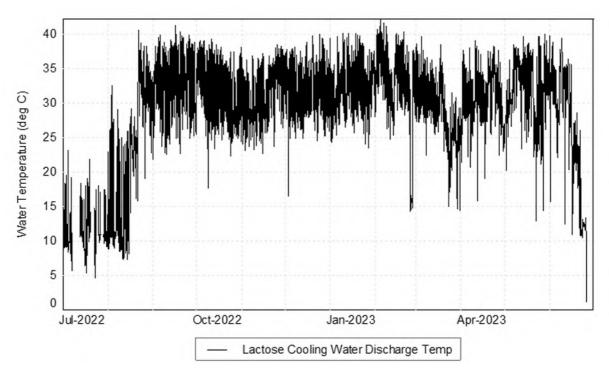
Figure 10 Temperature of the cooling water discharge permitted by consent 0919-3, 2022-2023

As already indicated, this data is not specifically required either by the current consents or the agreement made with the Company in lieu of the consent review. However, it will be useful to compare with the stream temperatures when evaluating potential environmental effects, the Company's implementation of the "best practicable option" to minimise effects, and the requirement that the discharge does not present a thermal barrier to fish passage within the mixing zone. In the assessment of environmental effects for the pending reissue of consent 0919 it was stated that the cooling tower design parameters are such that with fluid entering at 50°C, and the fans running at 100%, the discharge should be at 33°C at a wet bulb temperature of 22°C.

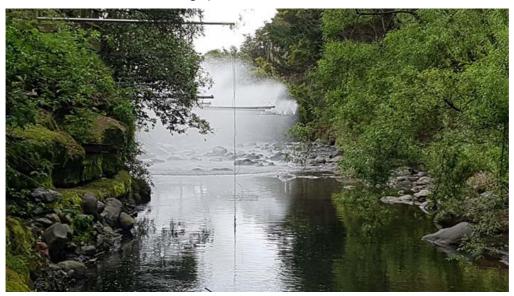
Photo 1 Upstream temperature probe (to May 2023) and cooling water discharge spray booms

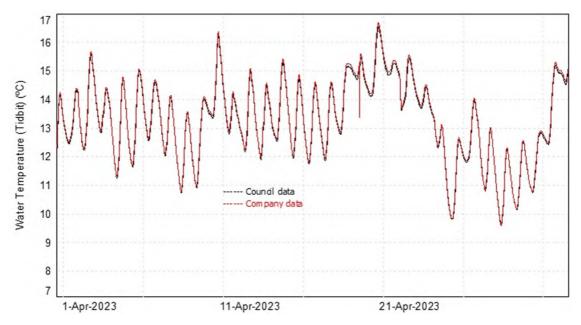
Figure 13 Parallel temperature monitoring upstream of the Company's site

Good agreement was observed at both monitoring sites, with the Company's data being no more than 0.2°C higher than the Council's data at the upstream site and no more than 0.2°C lower than the Council's data at the downstream site.

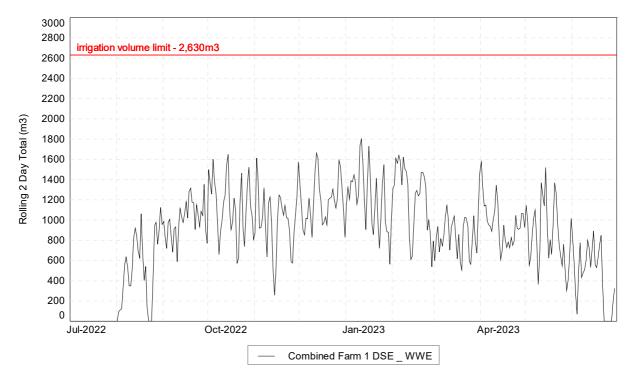
Figure 20 Irrigation volumes for Farm 1, 2 day rolling totals (FWW and DSE)

The irrigation data is summarised in Table 9, with the two day totals and the associated consent limits shown in Figure 20 and Figure 21.

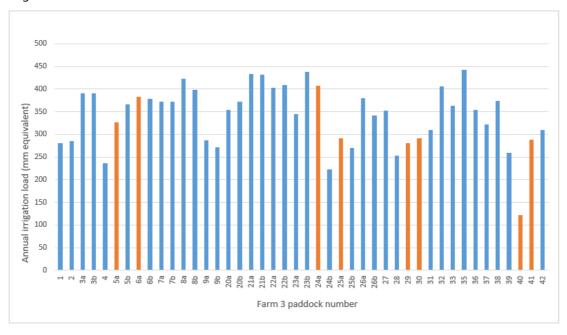
Figure 28 Farm 3 FWW and DSE irrigation load as mm per year equivalent for the year under review

The application rates in the Farm 3 paddocks where travelling irrigators are used were generally slightly lower, being in the range 290 to 350 mm equivalent. Paddock 40, which is identified in the WFMP as a paddock that should be avoided in wet conditions due to there being a swampy area on the west side, received the lowest irrigation load on Farm 3.

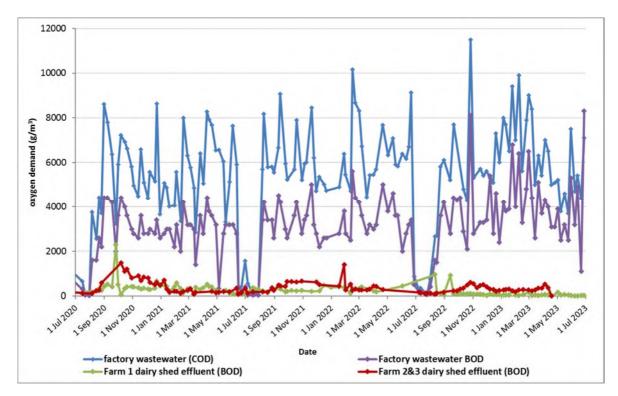
Figure 30 Oxygen demand of the factory wastewater and dairy shed effluents during the year under review, with previous two years for comparison

The DSE has generally been found to have much lower organic (BOD compared to BOD and COD, Figure 30) and higher mineral strength than factory wastewater (for example potassium, Figure 33), and is slightly alkaline.

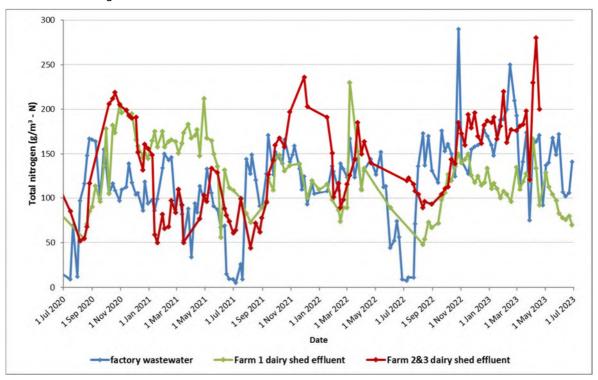
Figure 31 Nitrogen of the factory wastewater and dairy shed effluents during the year under review, with previous two years for comparison

Historically, the median total nitrogen concentrations of the Farm 1 and Farm 3 DSE were generally higher than those of the FWW. During the year under review, there was less of a difference between the annual median total nitrogen concentrations of these three wastewater streams.

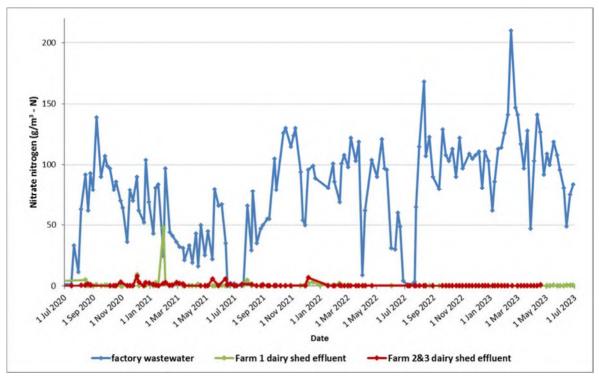
Figure 32 Nitrate nitrogen of the factory wastewater and dairy shed effluents during the year under review, with previous two years for comparison

The predominant nitrogen species present in the DSE are generally ammoniacal nitrogen and organically bound nitrogen, whereas the factory wastewater contains much higher concentrations of nitrate and slightly more nitrite nitrogen.

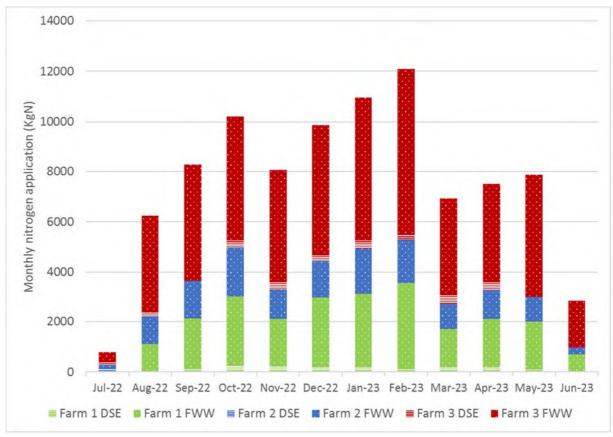
Figure 35 Cumulative monthly mass of nitrogen discharged to each farm for the year under review

It can be seen from Figure 35 that the relative contributions to the total nitrogen mass irrigated reflects the lower mass of nitrogen applied from the much lower volumes of DSE, and the differences in the area of land available for irrigation at each of the farms.

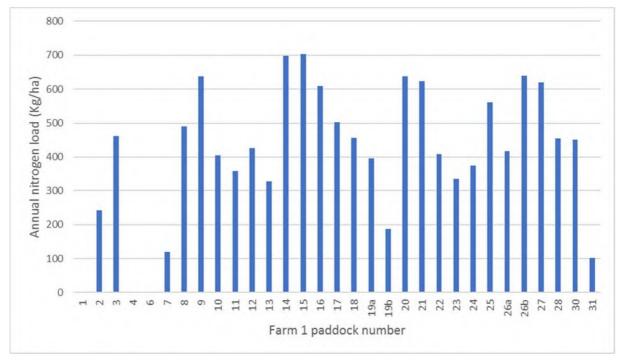
Figure 37 Paddock annual nitrogen application rates for Farm 1

the year under review, approximately 637 kgN/ha/y was applied to paddock 20 and 561 kgN/ha/y was applied to paddock 25.

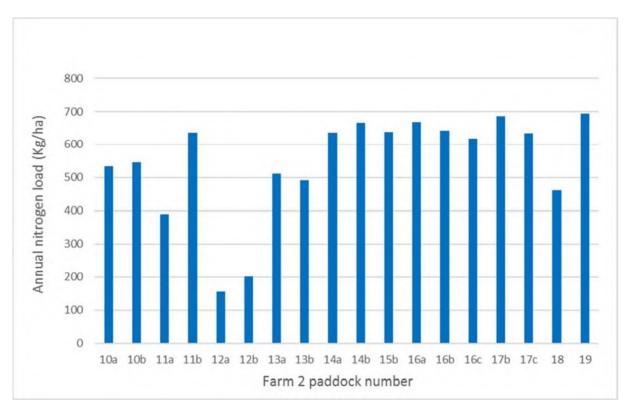
Figure 38 Paddock annual nitrogen application rates for Farm 2

The lowest annual nitrogen loads on Farm 2 were on paddocks 12a and 12b, where the application rates were at or below 200 kgN/ha/y. The nitrogen application rates on Farm 2 were more than 600 kgN/ha/y on 10 of the 18 paddocks used for irrigation.

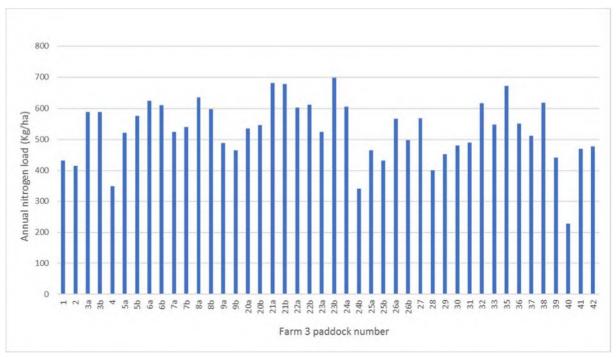
Figure 39 Paddock annual nitrogen application rates for Farm 3

The approximate per paddock nitrogen application rates for Farm 3 for the year under review are shown in Figure 39.

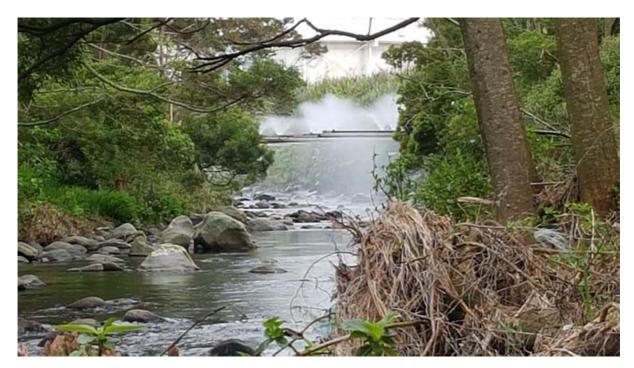
Photo 4 Cooling water spray discharge booms looking upstream from below the discharge area

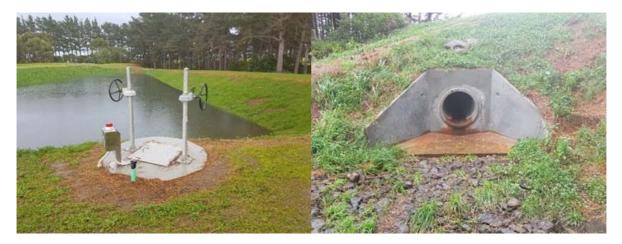
Photo 5 Northern stormwater pond, stop valves and outfall to the Kaupokonui Stream

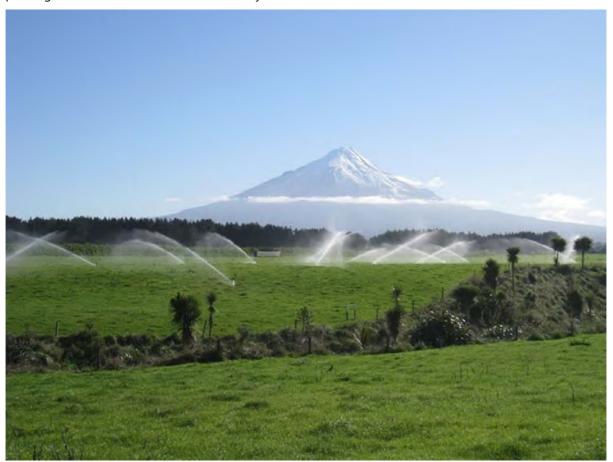
Photo 6 Riparian plantings along Waiokura Stream, Farms 2 with fixed irrigators in operation

An example of riparian planting is given in Photo 6, taken along the Waiokura Stream on Farm 2, and about 1.1 km south of Skeet Road (Riparian Management Plan RMP1425). Groundwater monitoring bore GND2050 is situated down gradient of the fixed-in-place irrigators and up-gradient of the riparian plantings.

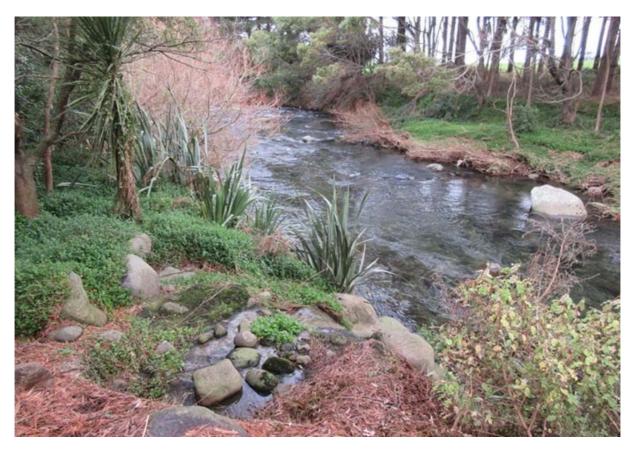
Photo 7 Outfall from the southern stormwater pond to Kaupokonui Stream (STW002078)

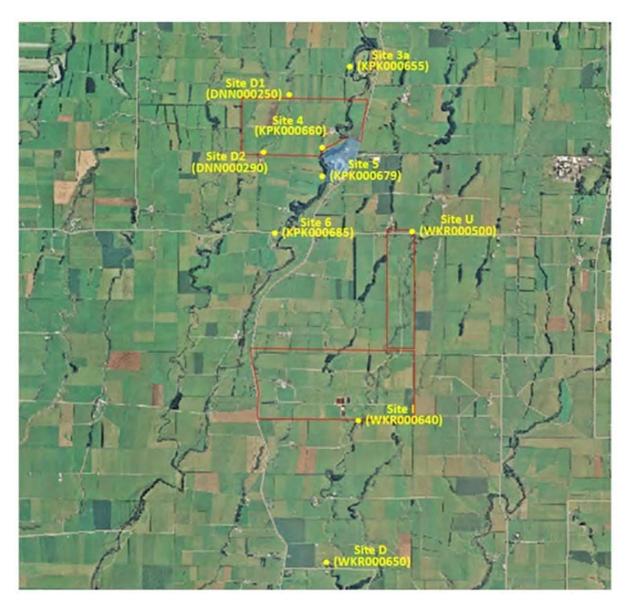
Figure 79 Biomonitoring sites in the Kaupokonui River sampled in relation to the Company's factory discharges

Figure 79. Samples were sorted and identified to provide the number of taxa (richness), MCI and SQMCI<sub>s</sub> scores for each site. The report summaries are provided below. Copies of the full reports are available from the Council upon request.
