Todd Energy Aquatic Centre

Monitoring Programme

Annual Report

Technical Report 2023-31

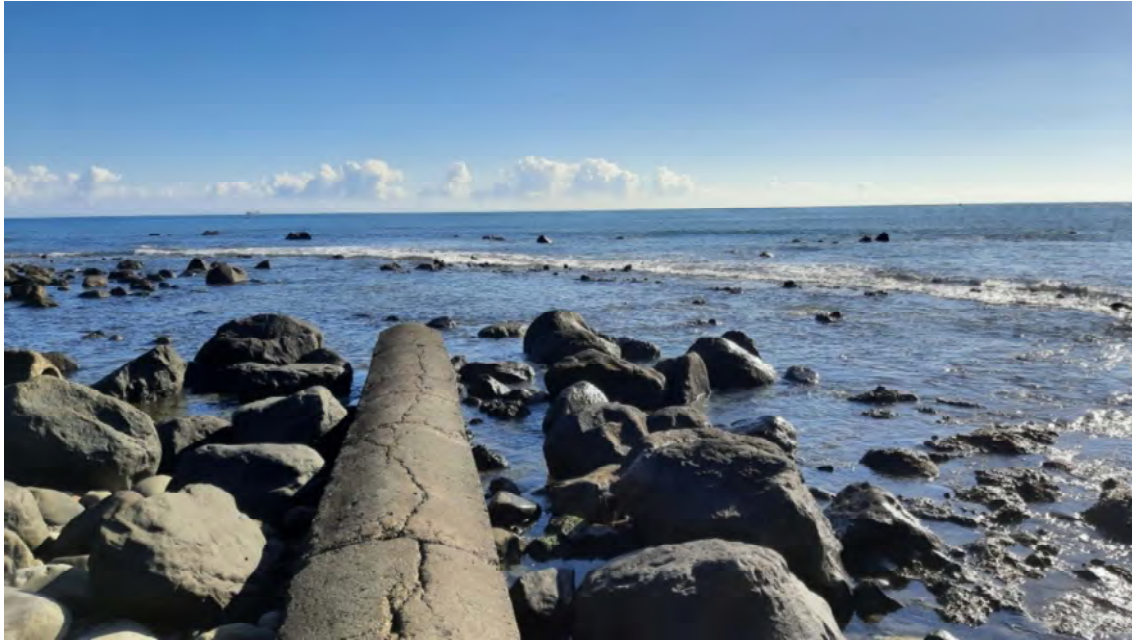
Photo 1 The ocean outfall, situated along the intertidal zone of Kāwaroa Reef (5 May 2022)

The ocean outfall was also inspected during the site visit and found to be compliant with consent conditions. Although the structural integrity of the ocean outfall has declined in recent years, the inspection indicated little change since a 2.4 m length of the structure dislodged in the 2016-2017 year.

Environmental performance for consent 4588-3.0 was rated “good” due to the condition of the ocean outfall structure. Although the integrity of the structure has not changed from the previous monitoring period and continues to function effectively as an outlet structure, its condition has deteriorated significantly since installation. Pre-existing cracks along the surface and the previous dislodgment of the end section of the structure warrant careful monitoring.

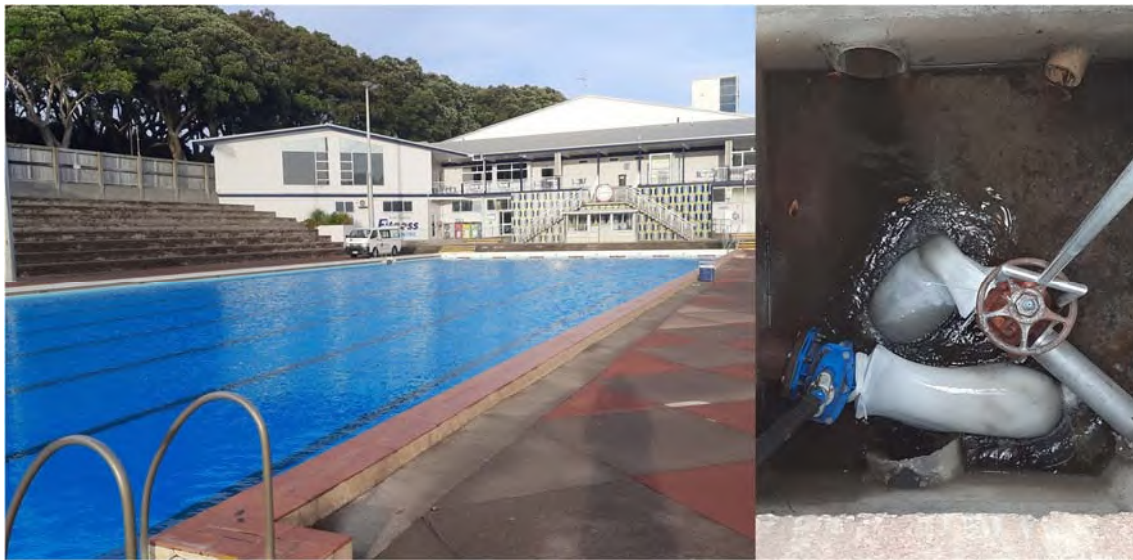
On the morning of 2 May 2023, the Council visited the Aquatic Centre to sample the outdoor pools prior to them being emptied at the end of the summer season. The pool water was clear with no odour (Photo 2), and the total residual chlorine was below consented limit (Table 3). Muslin cloths had been placed over the outlet pipes to catch any debris leaving the pool, and Aquatic Centre staff advised that they would be releasing the first batch of water within their consent window that same day (high tide 0726 NZST \pm two hours). The discharge commenced at approximately 0820 NZST, and a sample of the receiving waters taken at 0830 NZST was compliant with consent limits (Table 3).

Photo 2 Todd Energy Aquatic Centre outdoor pool, and muslin cloths in place over outlet pipes (2 May 2023)

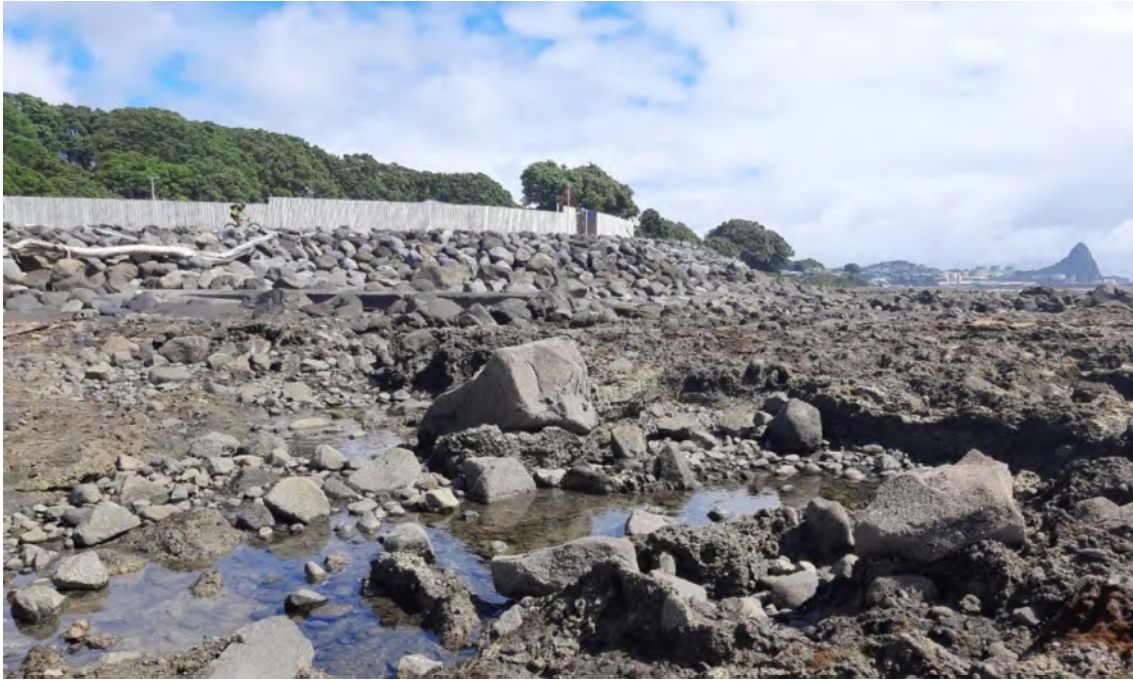
Two marine ecological inspections were conducted on Kāwaroa Reef in the vicinity of the outfall (Photo 3) on 3 March and 5 May 2023 following the backwash discharge and emptying of the outdoor pool. There were no objectionable odours, conspicuous films or scums at the discharge point during either inspection. Following the backwash discharge, several paint chips were present in the rock pools surrounding the outfall, some up to 50mm in size (Photo 4). No long-lasting environmental effects were detected at the time and the composition of intertidal species identified during inspections was considered normal for this environment. Copies of the marine ecological inspection reports are available from the Council upon request.

Photo 3 Downshore from the ocean outfall at Kāwaroa Reef (3 March 2023)

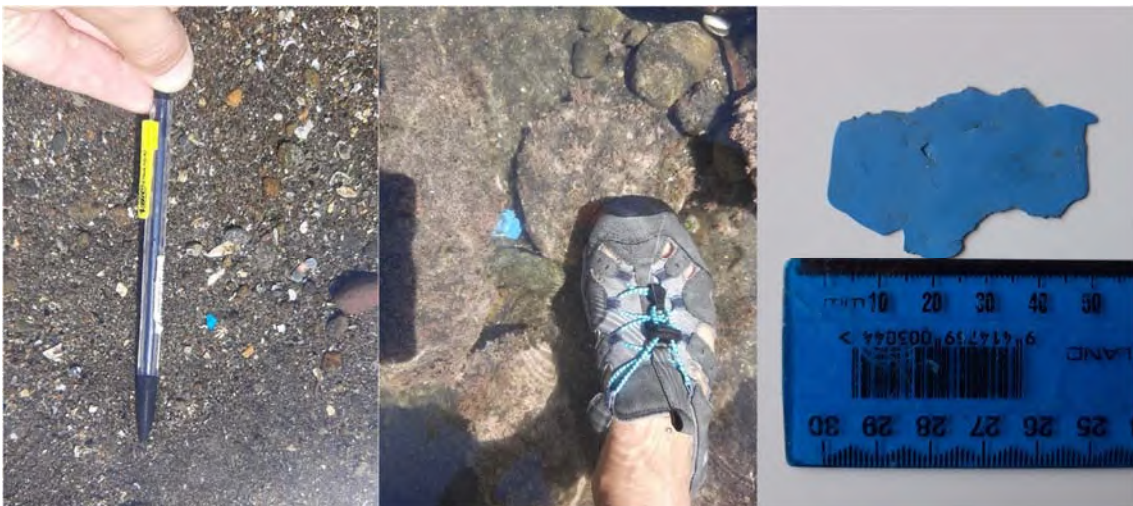
Photo 4 Examples of blue paint chips remaining on the reef in the vicinity of the outfall following the discharge of the backwash from the Aquatic Centre outdoor pools (5 March 2023)

During the backwash discharge on 3 March 2023 it was noticed that some small paint chips were present in the water being discharged onto the reef. This was raised with the Aquatic Centre Manager at the time who said there was no muslin cloth in place during the backwash discharge, or other method to prevent this. Several small paint chips were found lingering in the rock pools surrounding the outfall during the follow up intertidal ecological inspection, some up to 50 mm in size (Photo 4). The discharge of paint chips onto the reef is considered a minor breach of Special Conditions 1 and 6a of consent 2339-4.1, and as such a letter of explanation was issued to the Aquatic Centre. The Aquatic Centre responded that in this instance there is no mesh filter or muslin cloth on the discharge line due to the force of the water coming out of the pipe, however they do understand that it is not best practice to continue to allow this to occur. The Aquatic Centre has committed to investigating options to prevent this continuing, including installing a vinyl pool liner on all pools, sending backwash water to sewer, or installing an inline strainer that could sustain the force of water being discharged via the outfall.

The ecological reef inspection showed no adverse effects on local intertidal communities observed beyond the 5 m mixing zone as a result of the discharge on this occasion, and while some paint chips did remain on the reef after the completion of the discharge these would have dispersed quickly during subsequent tidal cycles. No adverse effects on local intertidal communities were observed beyond the 5 m mixing zone as a result of the outdoor pool discharge on this occasion, and no further enforcement action was taken at this time. It is stressed however that the Aquatic Centre does need to continue to investigate alternate options, and take preventative actions to ensure no further particles or contaminants are discharged onto the reef in future.

Date	Details	Compliant (Y/N)	Enforcement Action Taken?	Outcome
3 March 2023	Unauthorised discharge of suspended materials (paint chips) onto the reef during a backwash discharge from the outdoor pools	N	Letter of explanation issued - no further action taken	There were no long-term adverse effects on local intertidal communities caused by the backwash of the outdoor pool discharge on this occasion. NPDC has committed to investigating alternate options to prevent continued unauthorised discharges.
