Port Taranaki Limited  
Maintenance Dredging  
Monitoring Report  
2009 – 2014

Technical Report 2014-113

June 2015

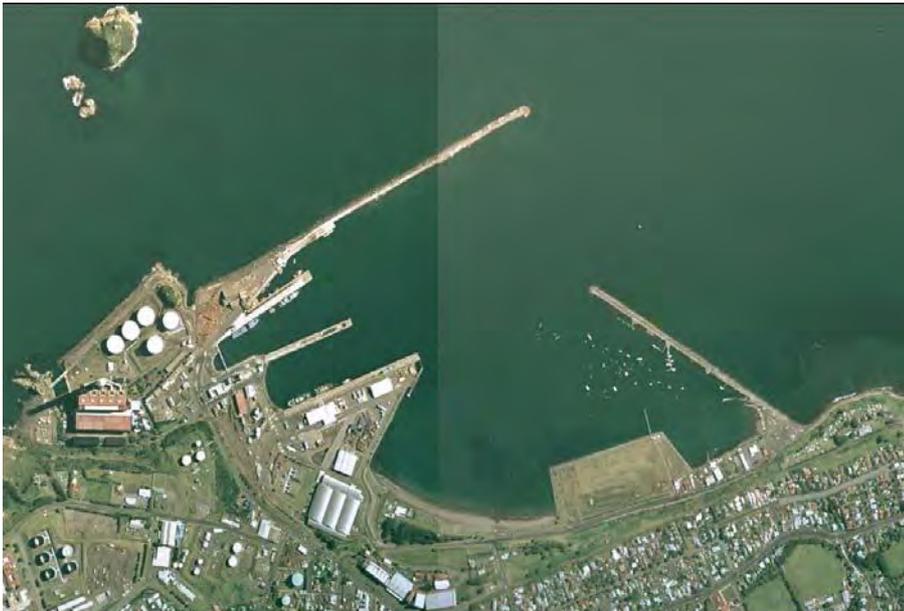
**Figure 1** Port Taranaki showing the Main Breakwater on the left and the Lee Breakwater on the right

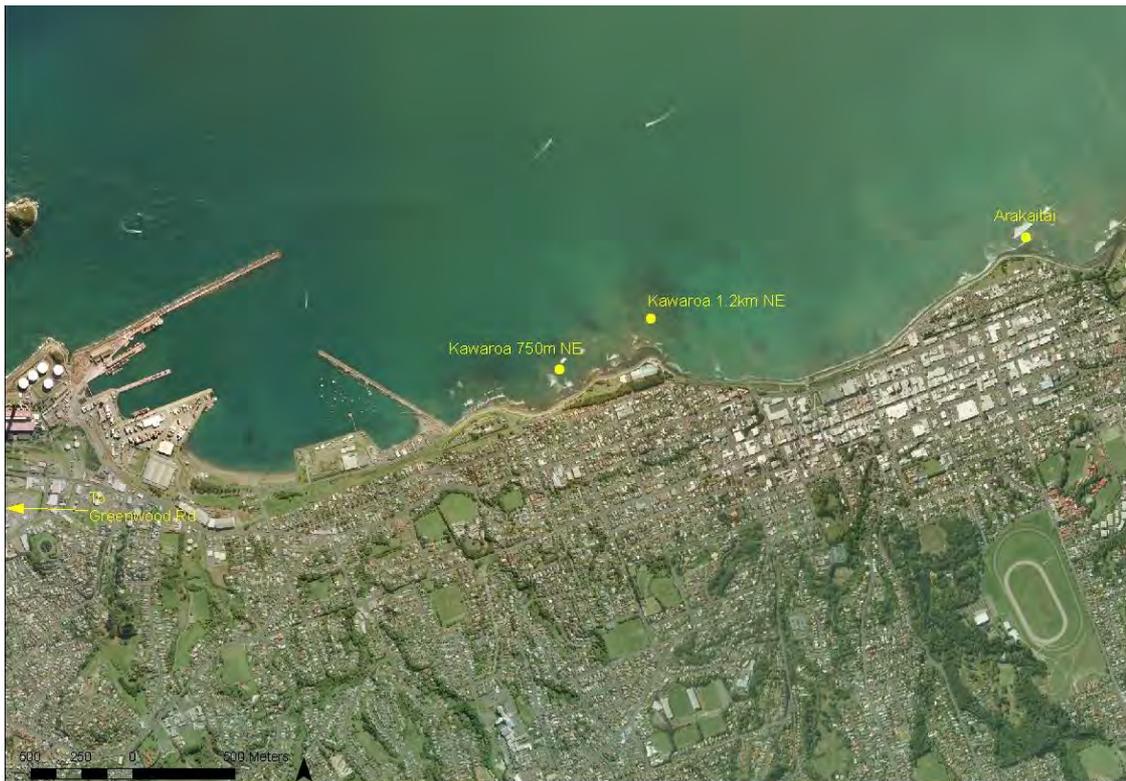
**Figure 4** Site locations used for intertidal monitoring

It is expected that detectable adverse effects of the dredging activities on the intertidal communities would have been evident as a significant decline in species richness and diversity at the potential impact sites relative to the control site. No such adverse effects were evident during the 2009-2014 monitoring period. During both the 2010 and 2012 surveys, number of species per quadrat and Shannon-Weiner Index per quadrat were either higher or comparable at the potential impact sites relative to the control site (Figure 5 and 6, see Appendix II for details).

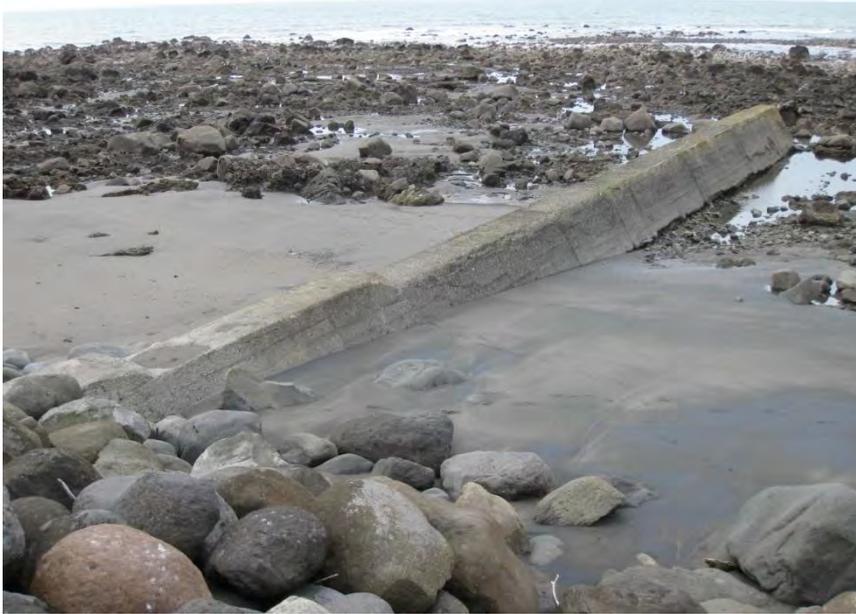
**Photograph 3** Sand accumulation on the high-shore at Arakaitai Reef, March 2010

Additional inspections of Kawaroa Reef and Arakaitai Reef were undertaken in March 2010, August 2011, November 2013 and May 2014 in order to assess the extent of sand accumulation on the reefs (Appendix III). In all inspections the reefs remained relatively sand free with the exception of occasional sand build up on the high shore at Arakaitai Reef at the top of the groyne along the base of the rock wall (Photograph 3, Appendix III).

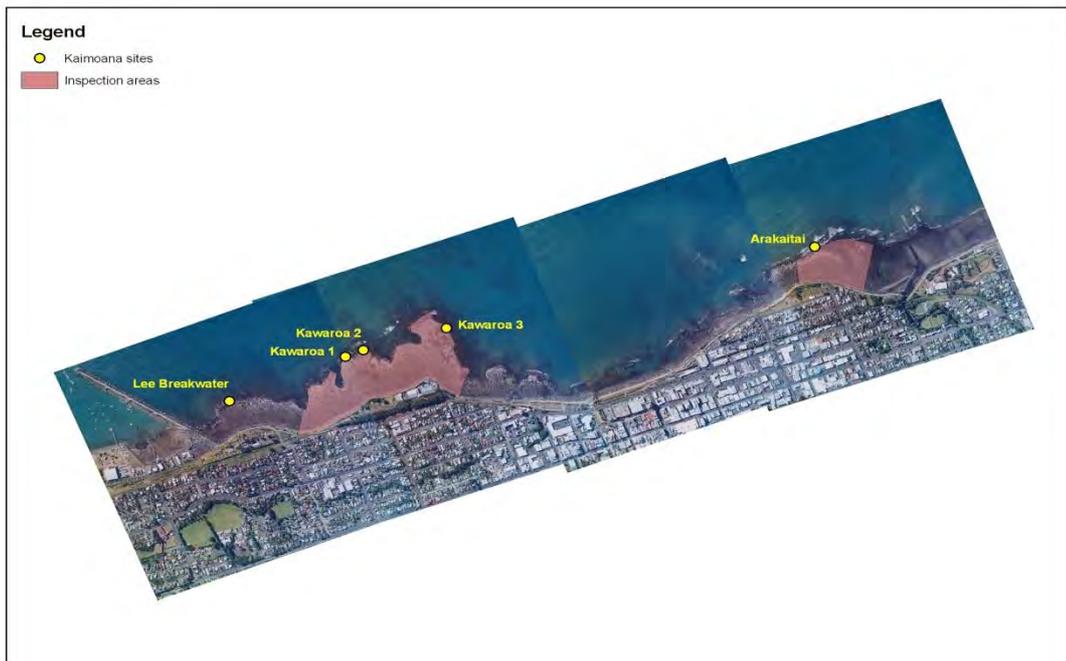
**Figure 8** Kaimoana survey sites

Surveys to estimate the relative abundance of kaimoana species were undertaken at three sites on Kawarua Reef, one site on Arakaitai Reef and one site off the Lee Breakwater during summer/autumn (March-April) 2011 and 2014. The surveys were conducted to determine whether the disposal of sand has had a detrimental effect on kaimoana species.

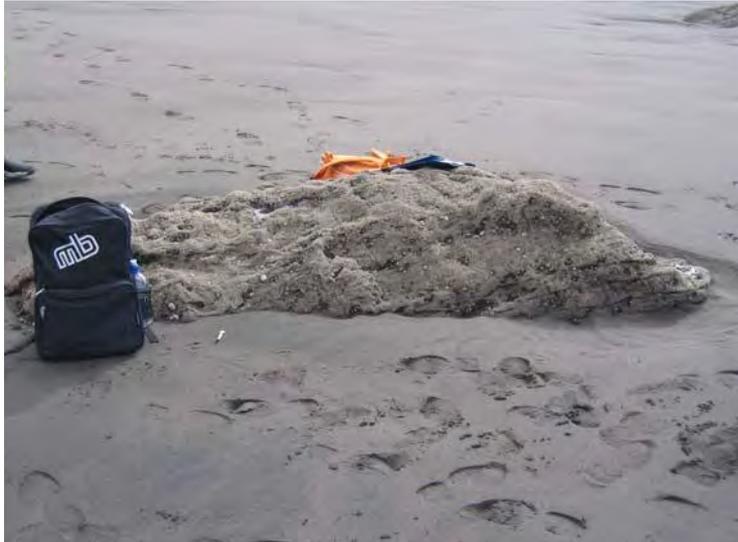
**Photo 4** Control site Greenwood Road (SEA 903070) inundated with sand, October 2010

The Greenwood Road site has on occasions been susceptible to heavy sand inundation. During the 2003, 2008 and 2010 sand/silt cover at this site was 41%, 62% and 76% respectively. The impact of this high sand cover on intertidal communities is discussed further in Section 4.

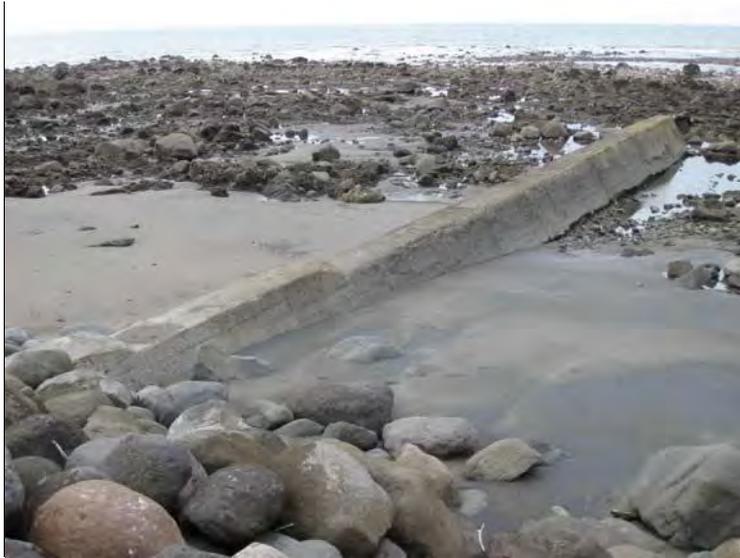
**Photograph 5** Sand build up on the high-shore at Arakaitai Reef 2010

Sand cover at the three potential impact sites has typically been low to moderate during surveys (Figure 5). Sand cover at the Kawarua 750 m NE site has been moderate on occasions, with sand often trapped in the turf which is abundant across the lahar platform that makes up the majority of this site. Low levels of sand cover are typically present at Arakaitai, with only two surveys showing sand cover of greater than 5%. Pockets of sand are occasionally present towards the top of the shore at this reef (Photograph 1). The site at Kawarua 1.2 km NE had moderate levels of sand in initial, pre-dredging surveys, however sand at this site has remained low in all post-dredging surveys with the exception of the 2010 survey, during which moderate sand cover was recorded.

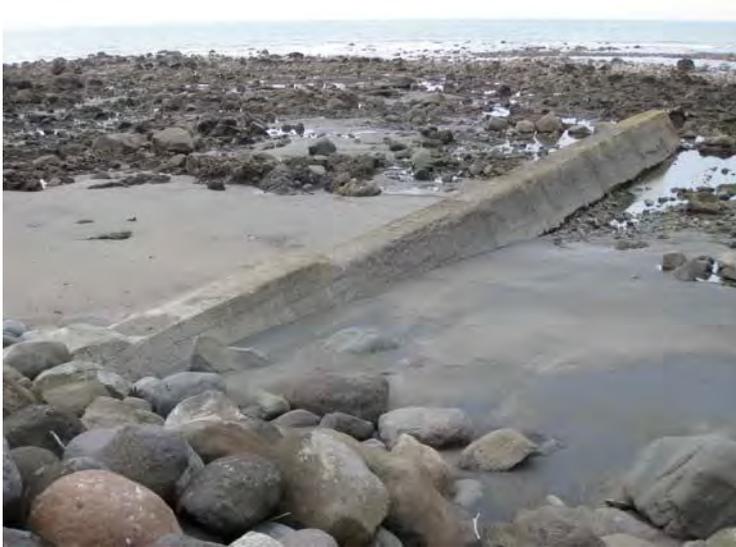
**Photograph 5** Sand accumulation observed on the high-shore at Arakaitai in 2010

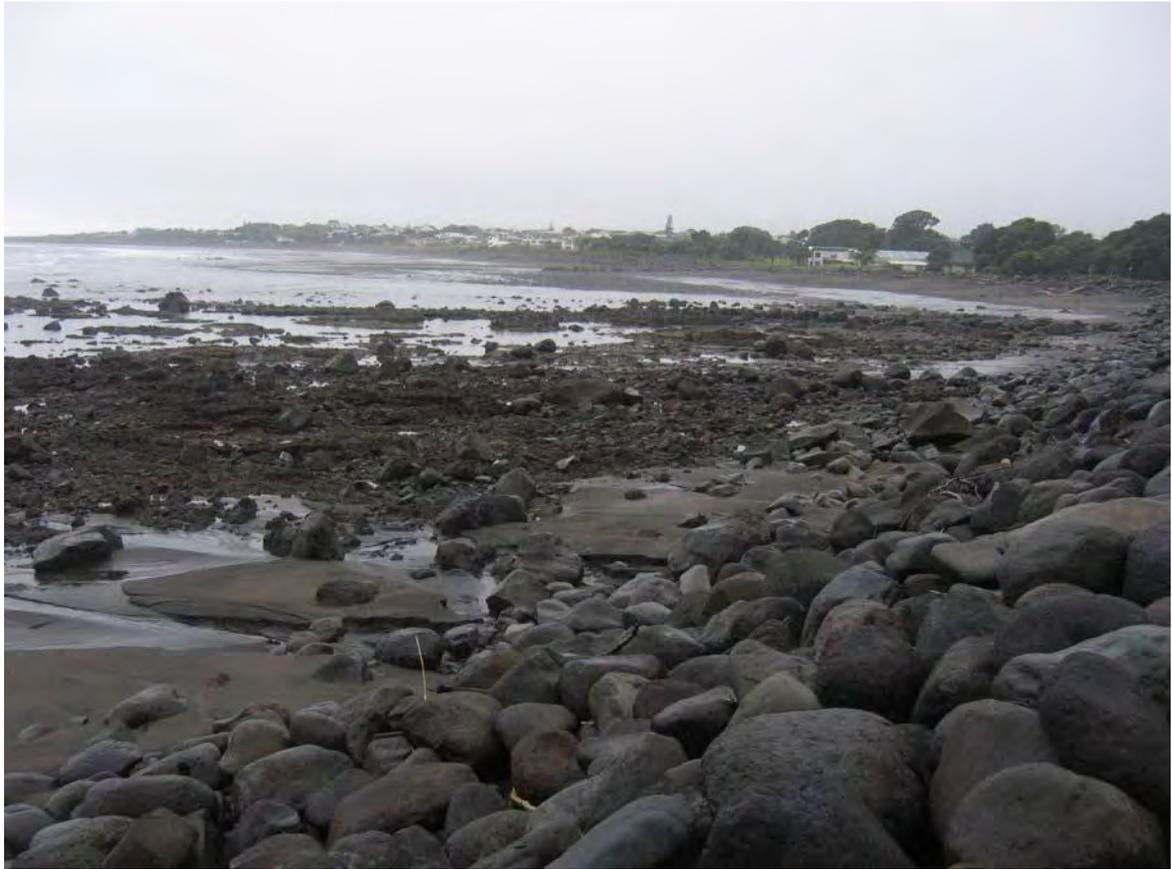
Photograph 7

Arakaitai Reef was also inspected. The area to the east of the groyne had the usual strip of sand around the base of the rock wall (Photograph 7). Sand was present around the groyne, up to the height of the groyne close to the rock wall (Photograph 8). There were also several patches of sand further to the west (Photographs 9 and 10). The usual strip of sand was present along the wall towards the wind wand (Photograph 11).

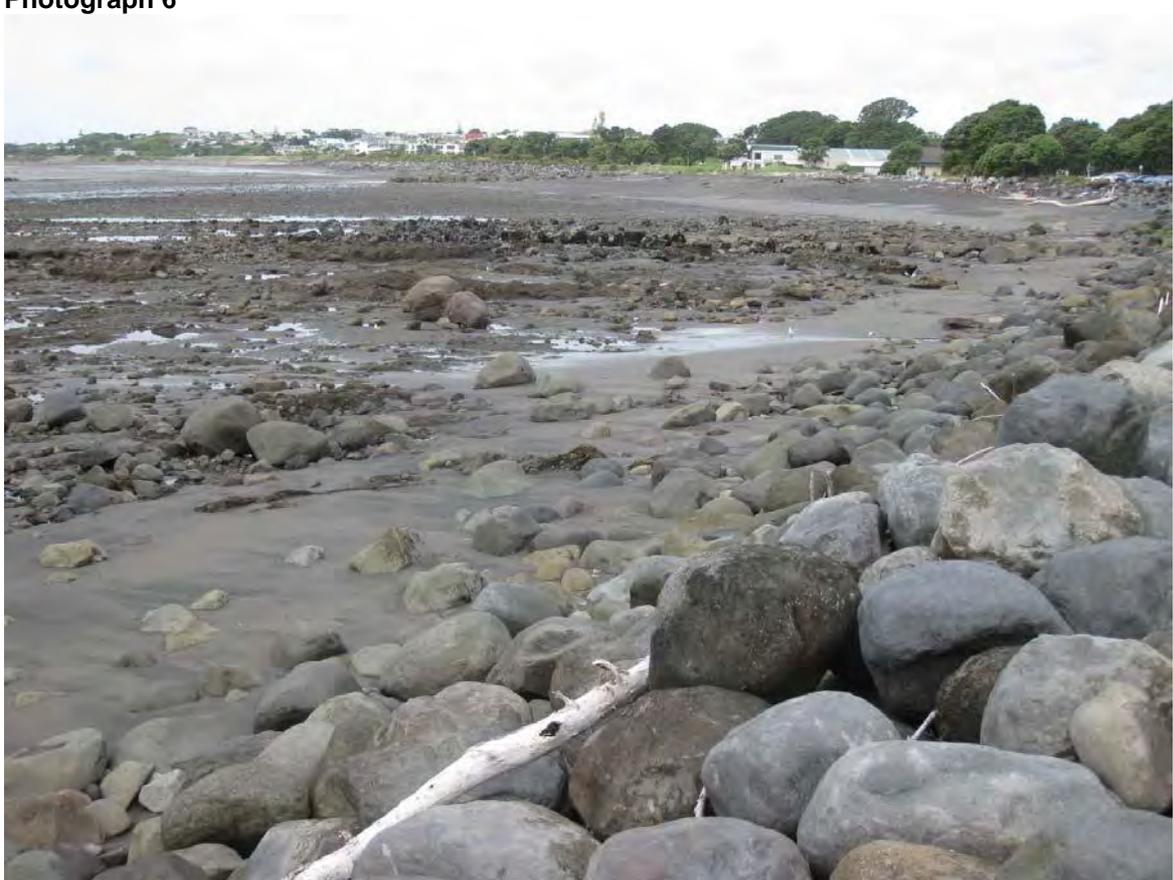
Photograph 7

Arakaitai Reef was also inspected. The area to the west of the groyne had a strip of sand around the base of the rock wall (Photograph 7). There was significantly less sand present around the groyne as has been observed in previous inspections (Photograph 8). There were also several patches of sand further to the west (Photograph 9) however these were all observed at the base of the rock wall. There was the usual strip of sand along the seawall through towards the wind wand (Photograph 10).

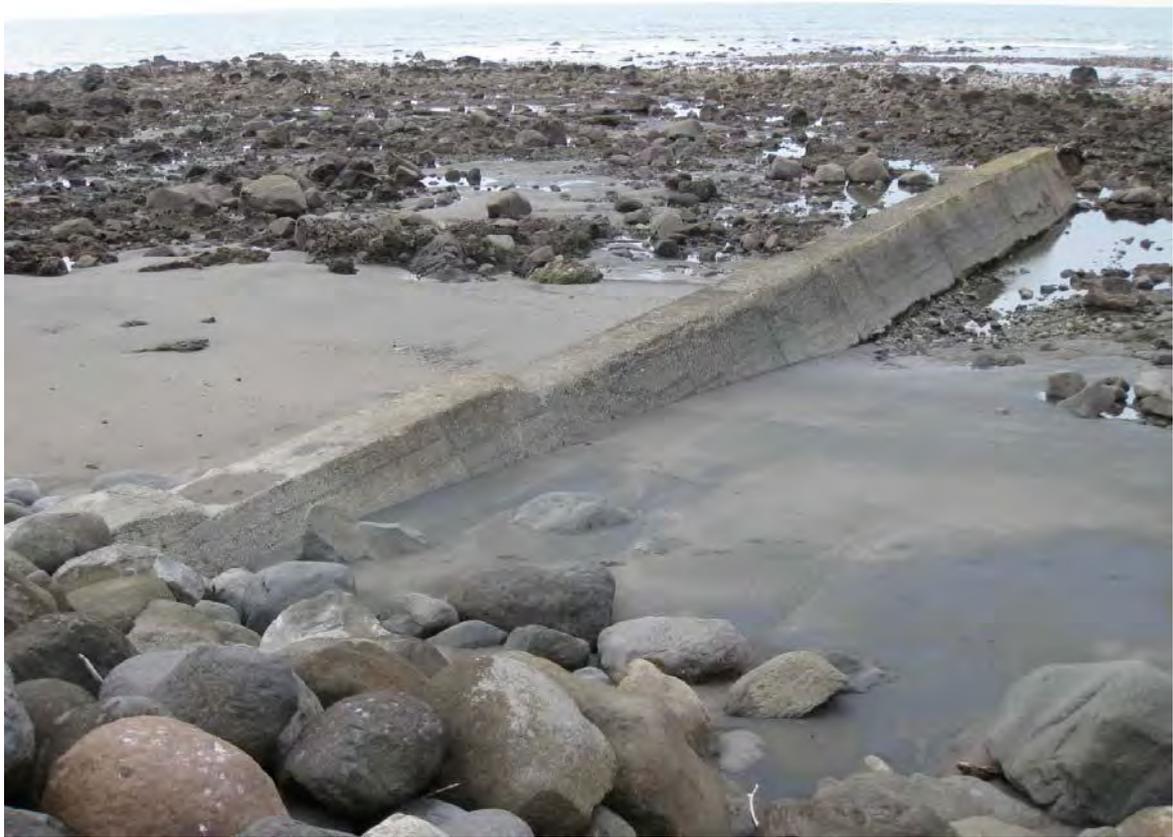
Photograph 8

Arakaitai Reef was also inspected. The area to the east of the groyne had the usual strip of sand around the base of the rock wall (Photograph 7). Sand was present in moderate quantities around the groyne (Photograph 8). There were also several patches of sand further to the west (Photograph 9). There was the usual strip of sand along the seawall through towards the wind wand (Photograph 10).

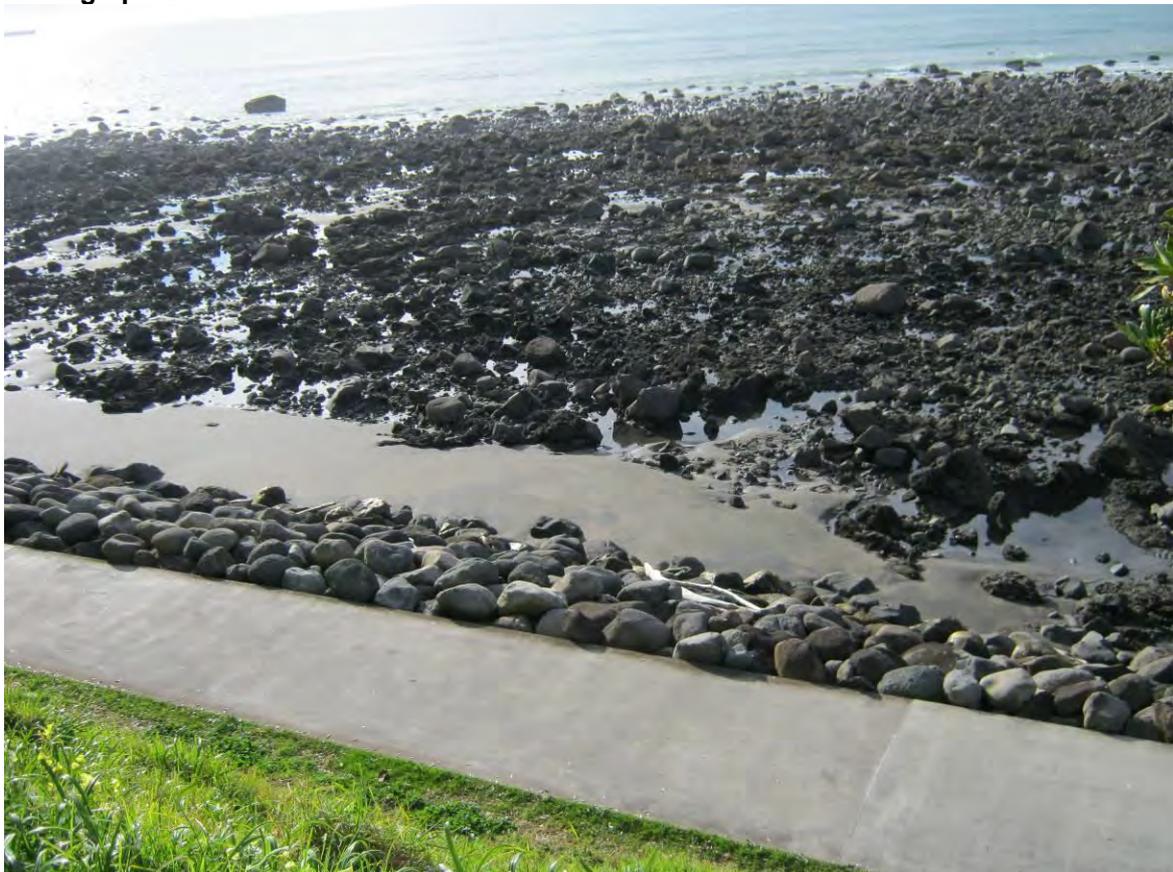
**Photograph 7**

Arakaitai Reef was also inspected. Compared to previous inspections (for example 1 March 2010, Photograph 7) relatively little sand had accumulated in the area to the east of the groyne around the base of the rock wall (Photograph 7). Relatively little sand was present around the groyne (Photograph 8). No large patches of sand were observed further to the west (Photographs 9). The usual strip of sand was present along the wall towards the wind wand (Photograph 10).

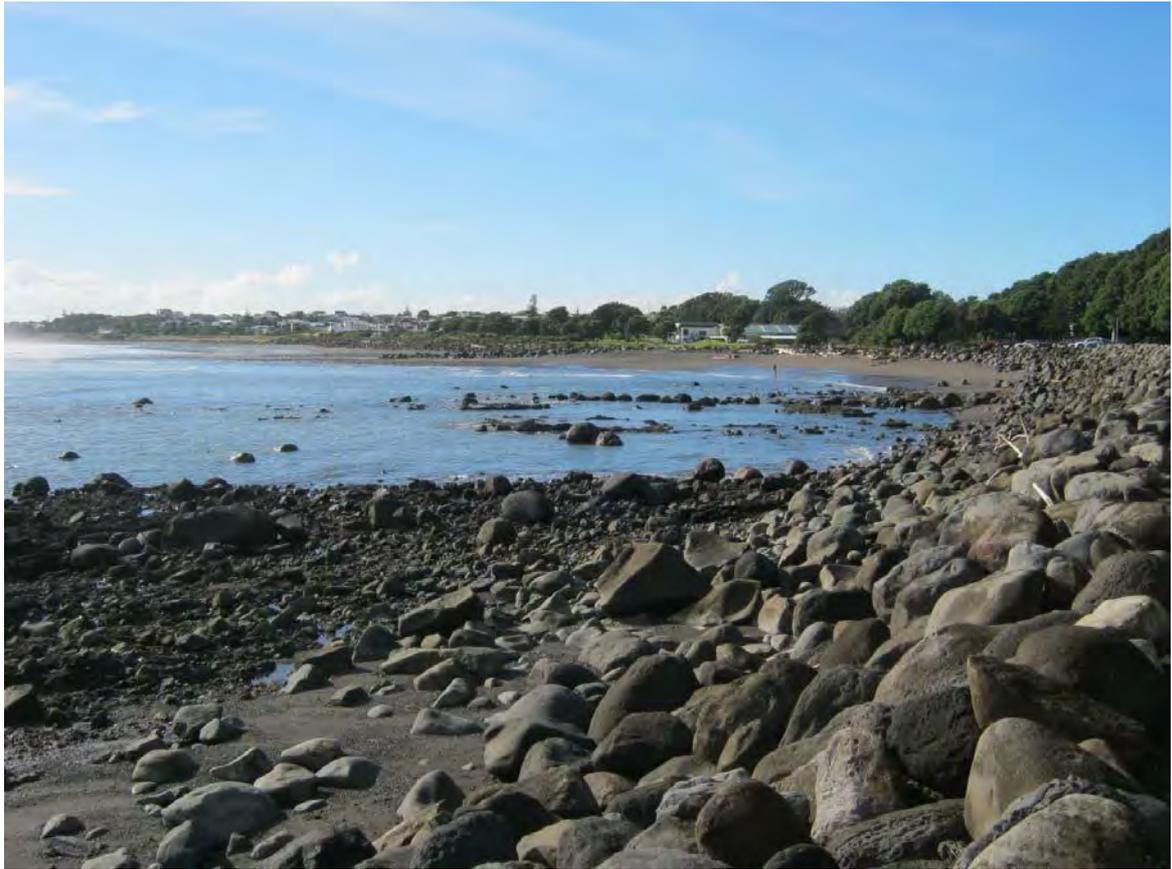
Photograph 7

Arakaitai Reef was also inspected. Compared to some previous inspections (e.g. 1 March 2010) relatively little sand had accumulated in the area to the east of the groyne around the base of the rock wall (Photograph 7), although there was more sand at the top of the shore compared to the previous survey (November 2013). More sand was present around the groyne (Photograph 8) than in November 2013, but not as much as in March 2010. No large patches of sand were observed further to the west (Photographs 9). Less sand was present along the wall towards the wind wand than usual, although a lower tide would have been useful to confirm the full extent of this (Photograph 10).
