Todd Energy Aquatic Centre  
Monitoring Programme  
Annual Report  
2013-2014  
Technical Report 2014–10

June 2014

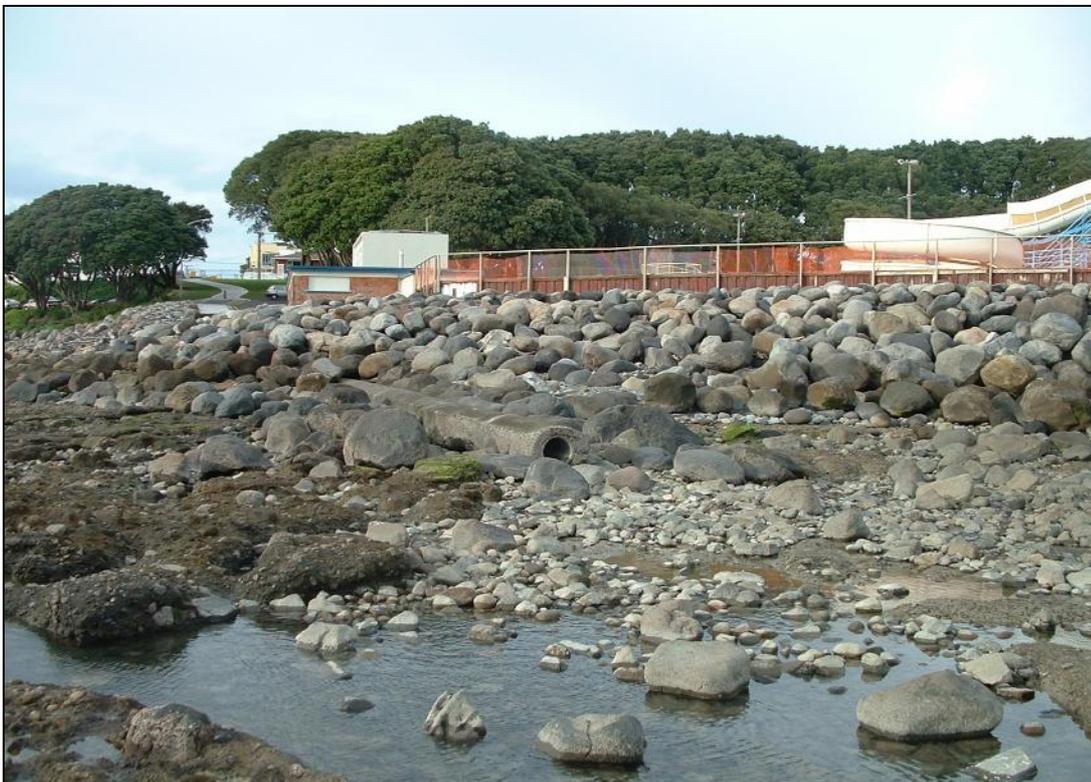
**Photograph 1** Todd Energy Aquatic Centre ocean outfall

The discharge pipe consists of a 300 mm diameter encased concrete pipe and discharges at approximately mid-tide level. This structure was constructed in 1962 and has been in use ever since for the purpose of backwashing the outdoor pool filters.

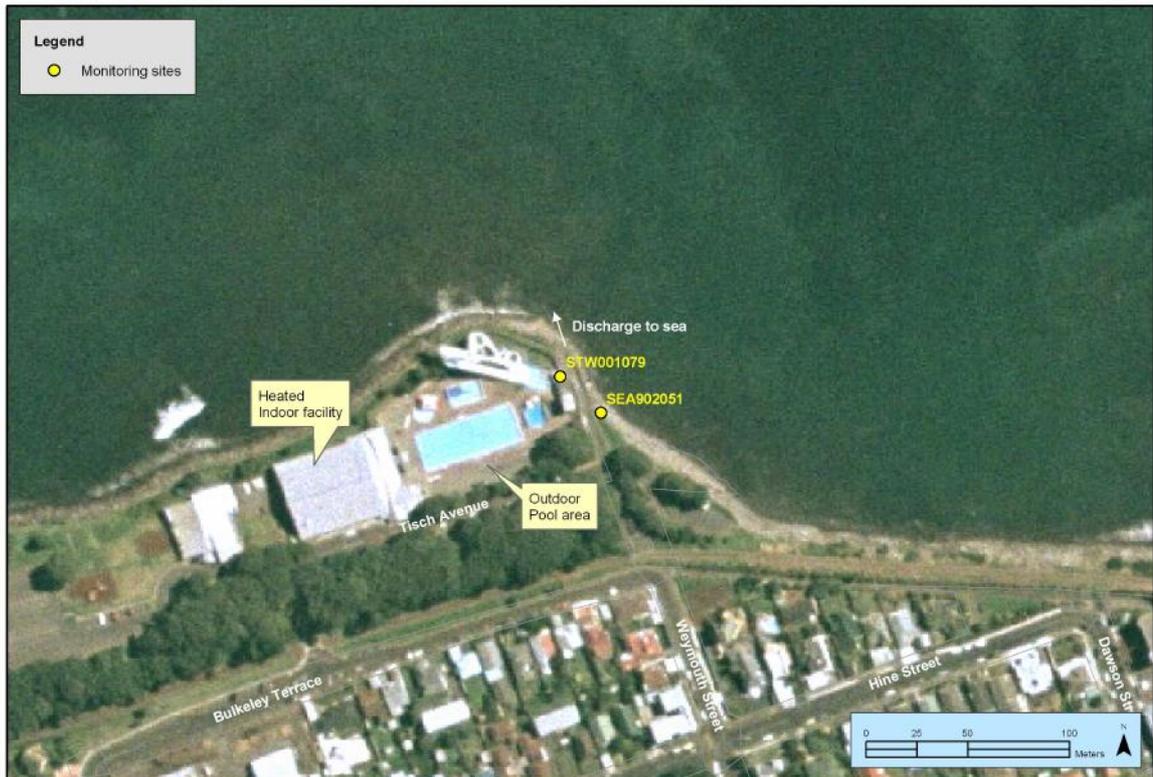
Figure 1 Location of Todd Energy Aquatic Centre

The Todd Energy Aquatic Centre (Aquatic Centre) is sited on the foreshore at Tisch Avenue, New Plymouth. The facility consists of outdoor pools, including a main pool, diving pool and children's pools, and an indoor pool complex (Figure 1).

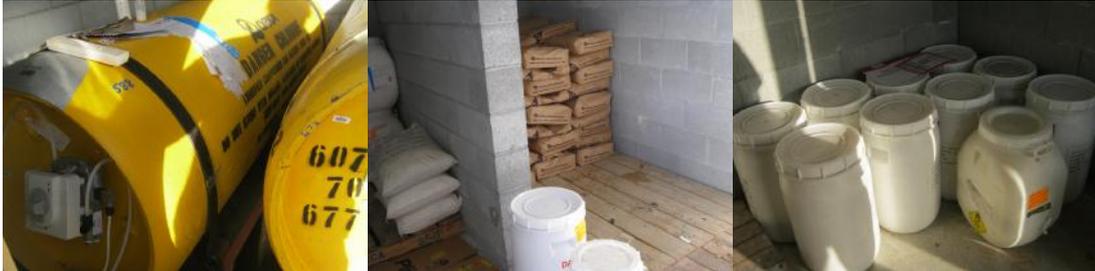
Photograph 2 Chemical storage onsite

The Todd Energy Aquatic Centre was inspected on 8 May 2014. The site was found to be tidy and well managed and no issues were noted.

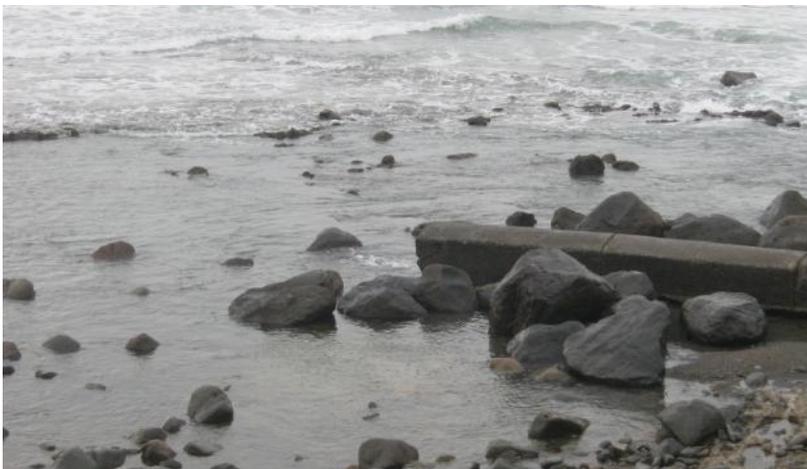
**Photograph 4** Pool discharge entering the receiving environment on 8 May 2014

Chlorine levels in the seawater sample collected at the 30 metre mixing zone boundary were less than 0.1 g/m<sup>3</sup>. The suspended solids and turbidity of the pool water collected on 8 May 2014 were much lower than found in the receiving waters and would not have caused any visual or environmental effects.

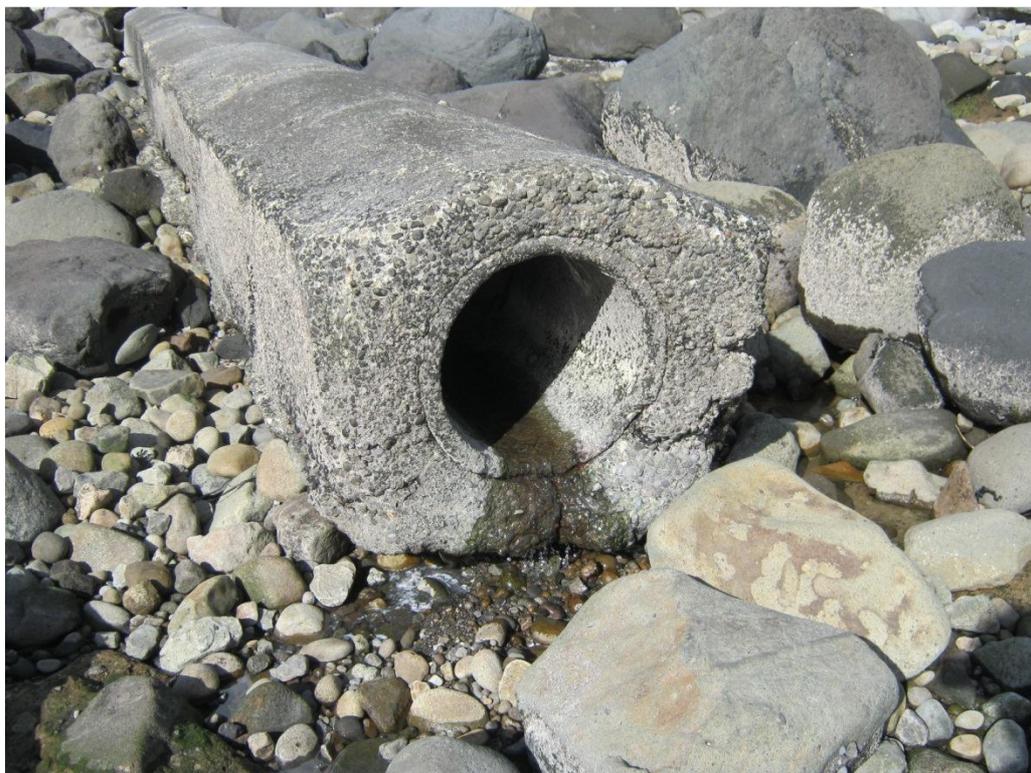
**Photograph 1** Todd Energy Aquatic Centre discharge pipe

A distinct chlorine odour could be detected at the end of the pipe where the discharge entered the receiving environment (Photograph 1). White foam/scum was present within 1m of the end of the discharge pipe (Photograph 2).

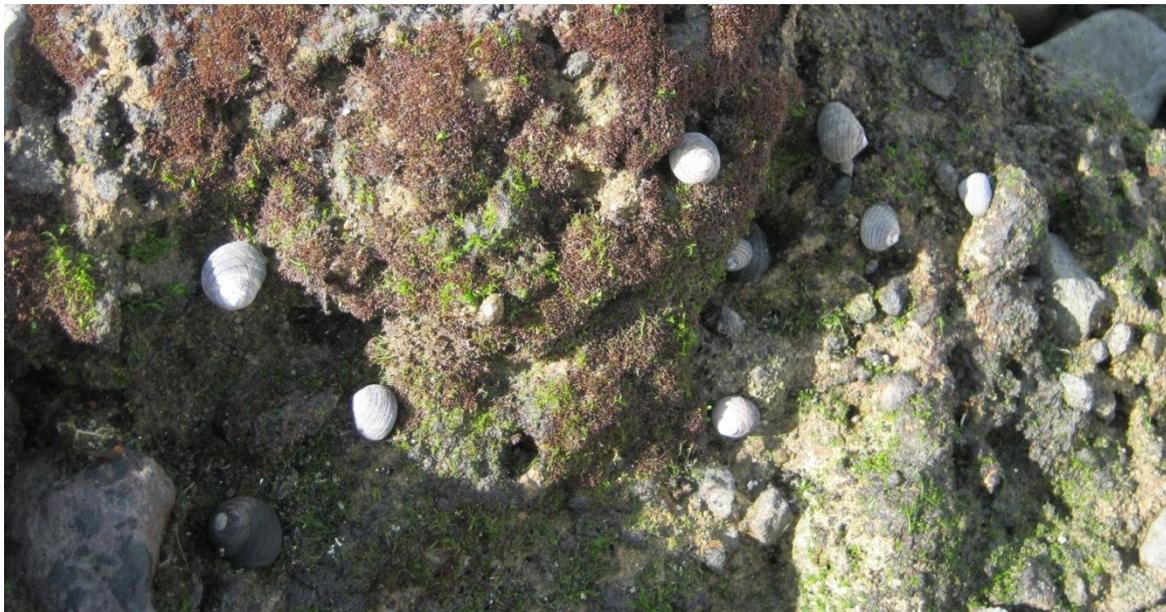
**Photograph 3** Macroalgae and molluscs adjacent to the end of the discharge pipe

The following invertebrates were present on the upper shore in the vicinity of the pipe: molluscs *Melagraphia aethiops* (very abundant, Photograph 3), *Diloma* spp., *Turbo smaragdus*, *Cellana radians* and *Sypharochiton pelliserpentis*, barnacle *Chamaesipho* sp., shrimp *Palaemon affinis* and the polychaete worm *Spirobranchus cariniferus*. A species of green algae resembling *Ulva intestinalis* covered rocks around the pipe (Photograph 3). The brown alga *Ralfsia* sp. and red alga *Gelidium caulacanthum* were also present. This assemblage is similar to that found on previous inspections in the vicinity of the pipe, and is typical for this height on the shore. The discharge from the outdoor pool did not appear to have had any observable adverse impacts on the organisms surrounding the outfall: no dead or dying animals were seen and *Palaemon affinis* were actively swimming in the pools.

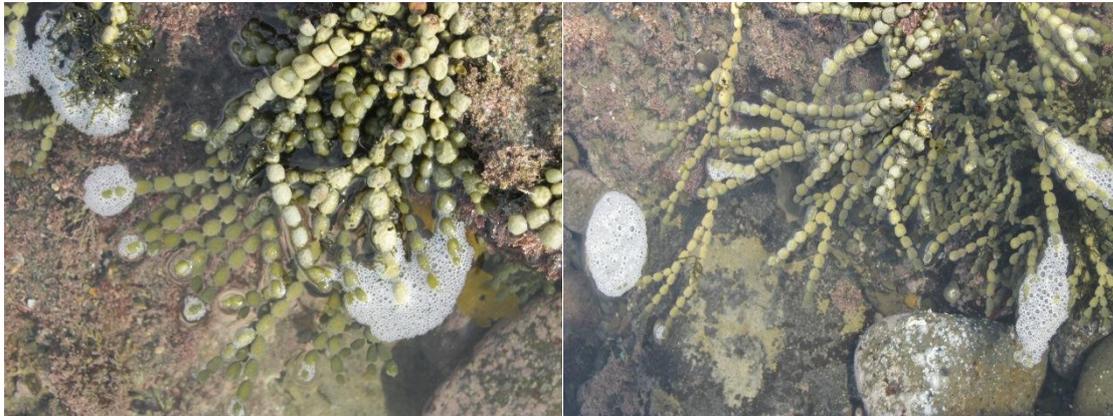
**Photograph 4** Foam in low shore rock pools

Foam was present around some clumps of *Hormosira banksii* at the low shore (Photograph 4). It was not obvious whether the foam was naturally occurring or had resulted from the pool discharge.

In summary, the range and abundance of intertidal species identified during this inspection are considered normal for this type of environment. No adverse effects on local intertidal biological communities were observed as a result of the outdoor pool discharge. Although a chlorine odour could be detected during the inspection and foam was present in the vicinity of the pipe outlet, physicochemical analysis of pool and seawater samples confirmed that the discharge was compliant with Special Condition 1, Consent 2339-3. As a precautionary measure, in future, it is recommended that the pool be left out of use for a longer time (during this monitoring year the pool was left one week prior to discharge) in order to minimise the risk of adverse effects.
