Waitaha Catchment
Joint Monitoring Programme
Annual Report
2013-2014

Technical Report 2014-111

April 2015

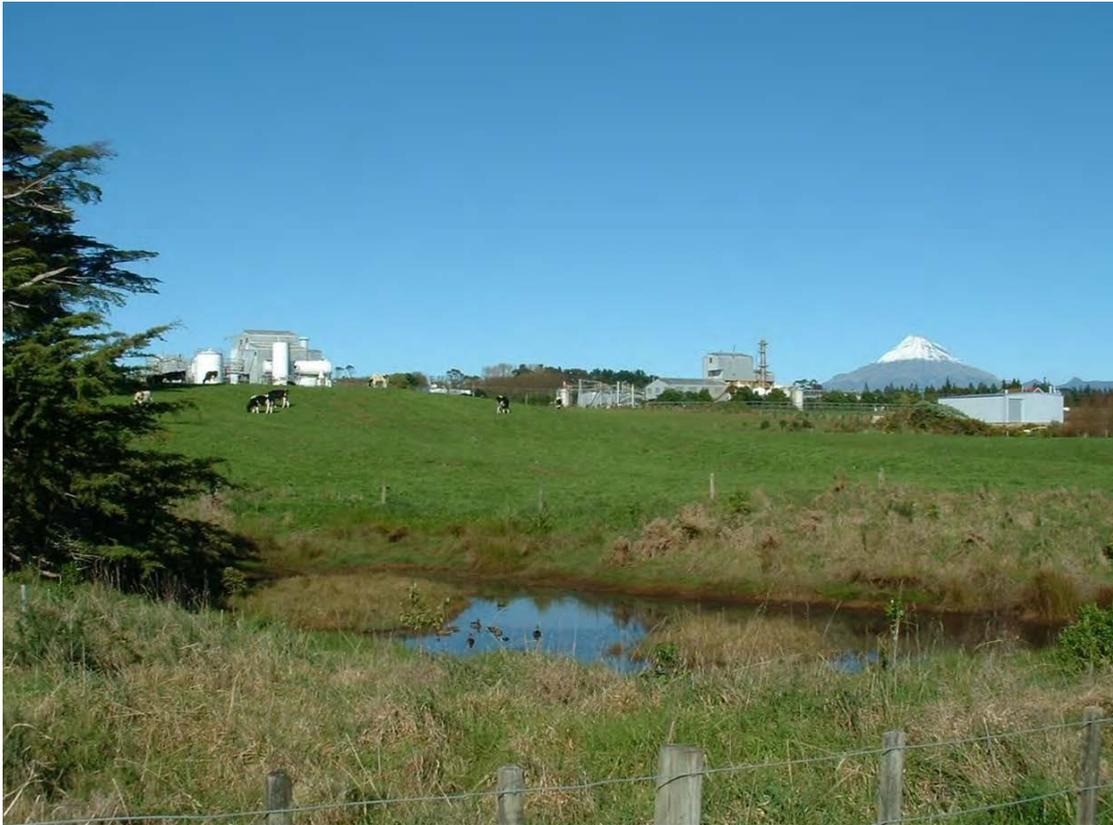
Photo 1 AICA (NZ) Ltd site

AICA (NZ) Limited (formerly Dynea NZ Limited) manufactures synthetic resins for the production of wood products at their plant situated above a wetland area at the headwaters of the Waitaha Stream.

There have been a number of changes at the site over the years in order to meet market demands. There are two processing areas on site, Plant 1 predominantly for formaldehyde based products, and Plant 2 which was primarily for phenol based products.

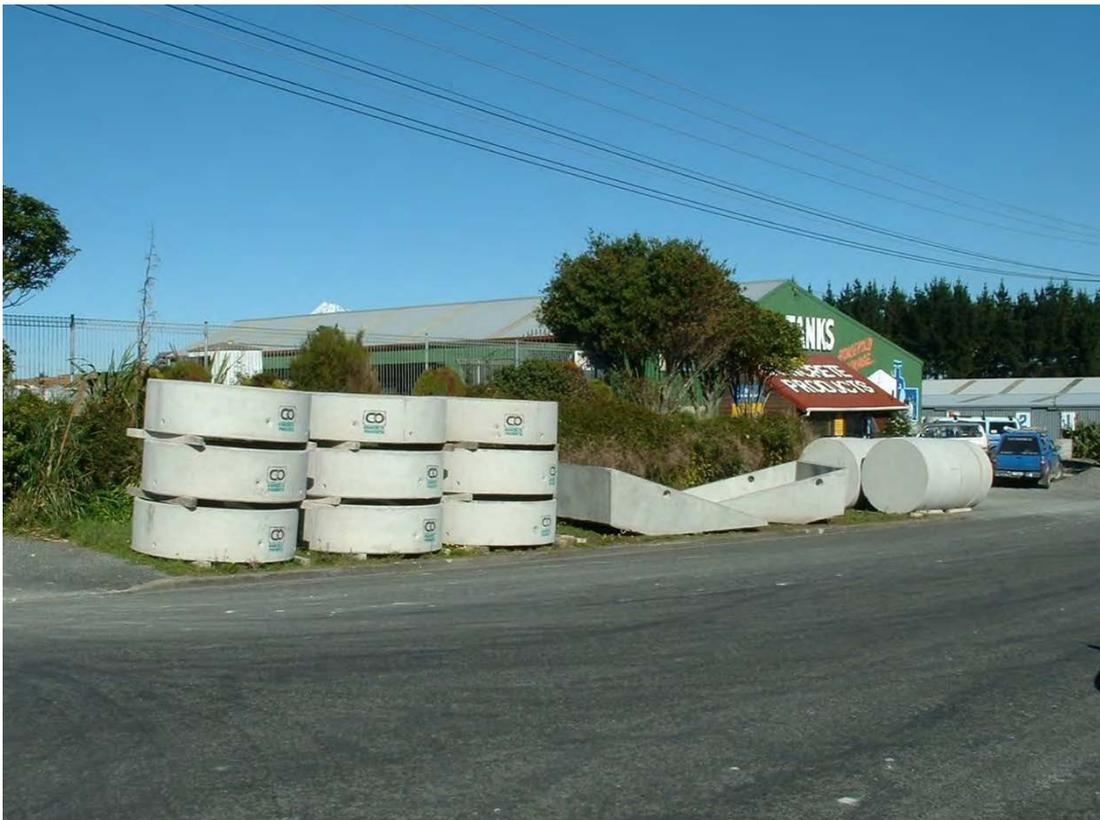
Photo 2 C&O Concrete Products site

The discharge from C&O Concrete is expected to potentially contain elevated suspended solids, high pH and alkalinity. The discharge is to the NPDC stormwater system where it mixes with stormwater from roads and other developed sites before discharging to the Waitaha Stream.

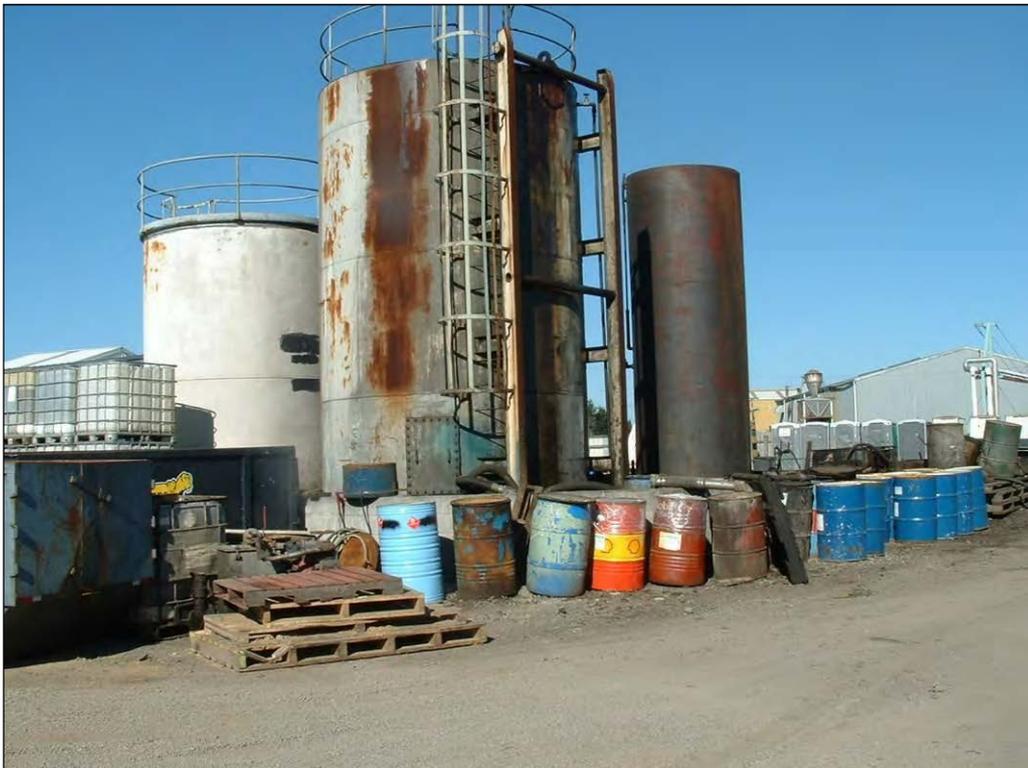
Photo 3 Intergroup Limited waste oil storage

The majority of the waste collected is waste oil, which is stored in tanks located in a bunded area.

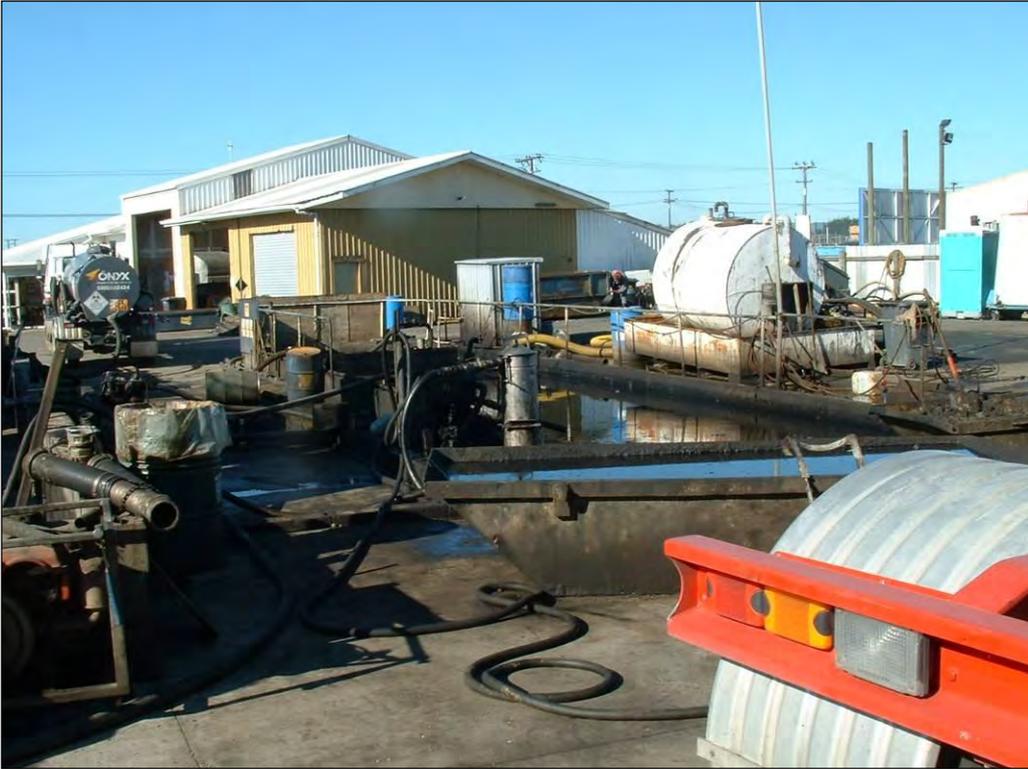
Photo 4 Intergroup Limited oil treatment facility

There are two open concrete pits in the yard. One contains a series of separators and is used for the separation of sludge and water from the waste oil. The waste water from this process is directed to trade waste and the oily sludge is taken to an off-site location for weathering/bioremediation prior to final disposal. The other open pit is a drive-in facility for the transfer of domestic septic tank effluent from the trucks to the trade waste system.

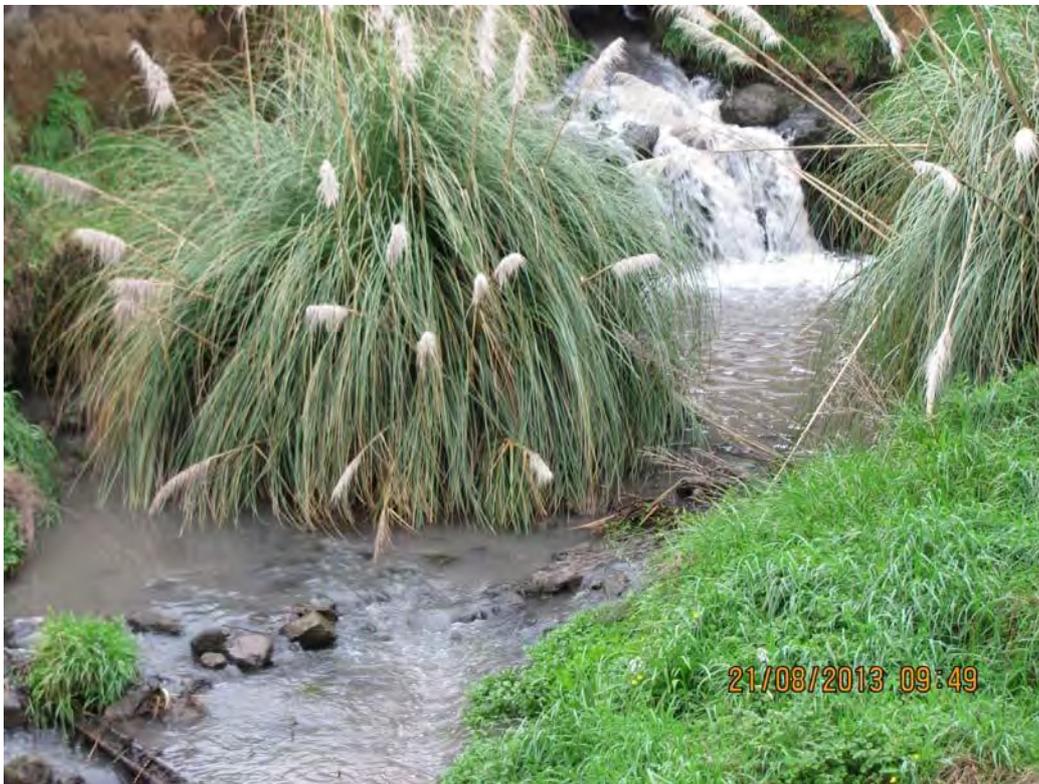
Photo 5 Waitaha Stream discolouration 21 August 2013

A complaint was received at 5:50 pm about a discoloured stream at the end of Wills Road, Bell Block. An inspection found the stream to be running a murky, milky, whitish colour for some distance. Photographs and samples were taken. The source of the contamination could not immediately be traced, with the investigation continuing the following day. Notification was received from NPDC about a sewage discharge occurring earlier that day. The samples were not therefore submitted for testing. A letter of explanation was received NPDC which provided evidence that the milky white discharge observed was not a consequence of the sewerage discharge.

The Council was advised that at some stage, someone had knocked the lid off a manhole, dropped debris in, and replaced the lid. This had resulted in the overflow to the stream. The blockage was cleared, the area was disinfected and signs advising that a sewerage discharge had occurred were put in place. NPDC advised that the matter was going to be followed up with the property owner.

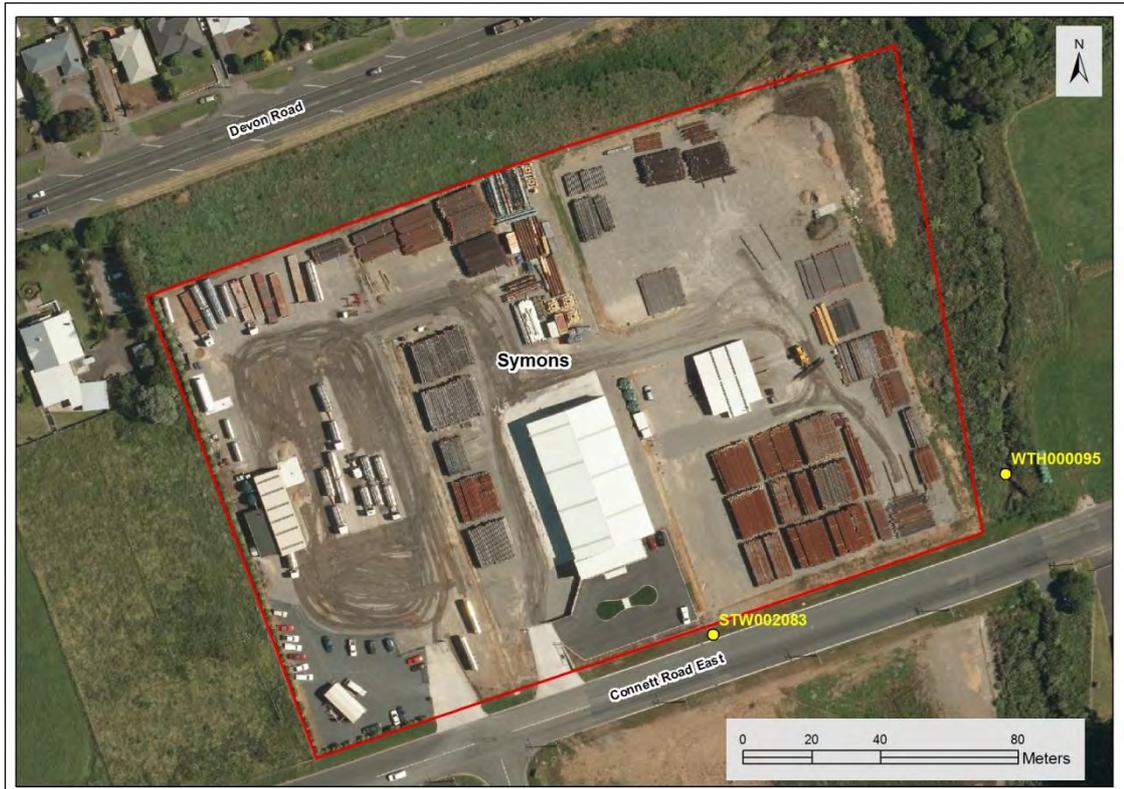
Figure 8 Symons Property Developments Limited property and monitoring site locations

The stormwater from the central section of the site combines with the stormwater from the eastern section of the site, after the eastern stormwater has passed through the detention tanks. This combined flow is sampled at site STW002083 (Figure 8).

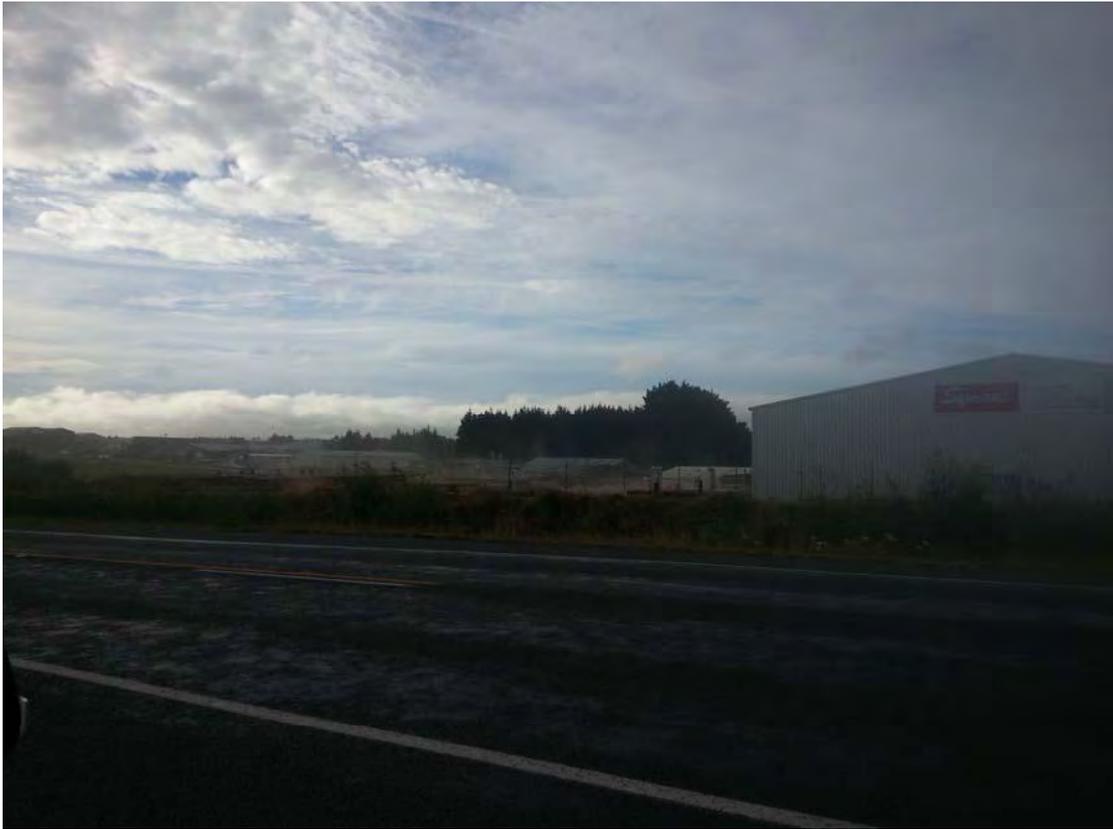
Photo 6 Objectionable dust discharging beyond the boundary of Symons site, 8 April 2014

At 7:50 am a complaint was received regarding dust discharging from a transport yard on Connett Road, Bell Block. Investigation found objectionable dust discharging beyond the boundary of the property. The water truck was filling at the time of inspection and the investigating officer was informed that this was to be used throughout the day. Photographs were taken. The Company was instructed to ensure no objectionable or offensive dust discharges beyond the boundary of the property. An infringement notice was subsequently issued.

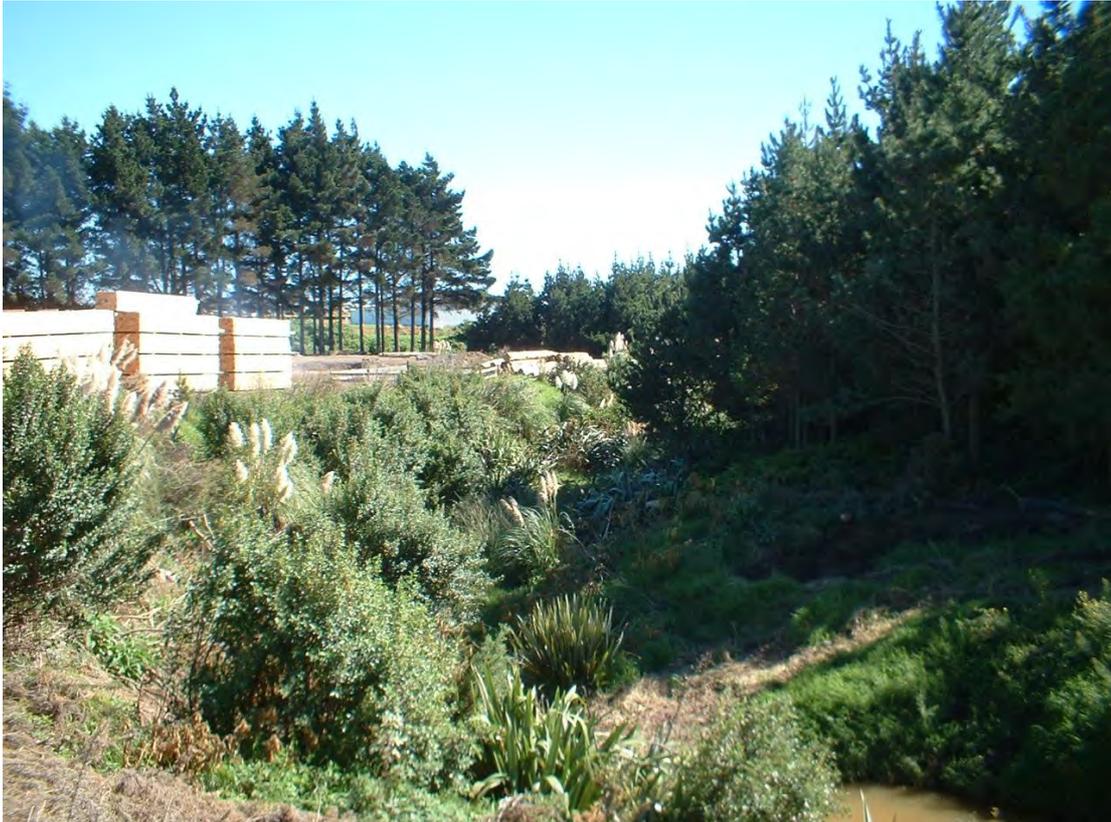
Photo 8 Taranaki Sawmills, riparian planting along tributaries

Taranaki Sawmills have undertaken riparian planting and improvement of the "wetland" areas along the three stormwater drains. The wetlands effectively act as silt traps and reduce the amount of sediment in the overland stormwater flow. The Council provided advice regarding appropriate riparian planting to reduce the amount of sediment entering the stormwater drain and discharging into the Waitaha Stream. Monitoring undertaken by the Council has shown that the wetland was having a positive effect on the downstream water quality.

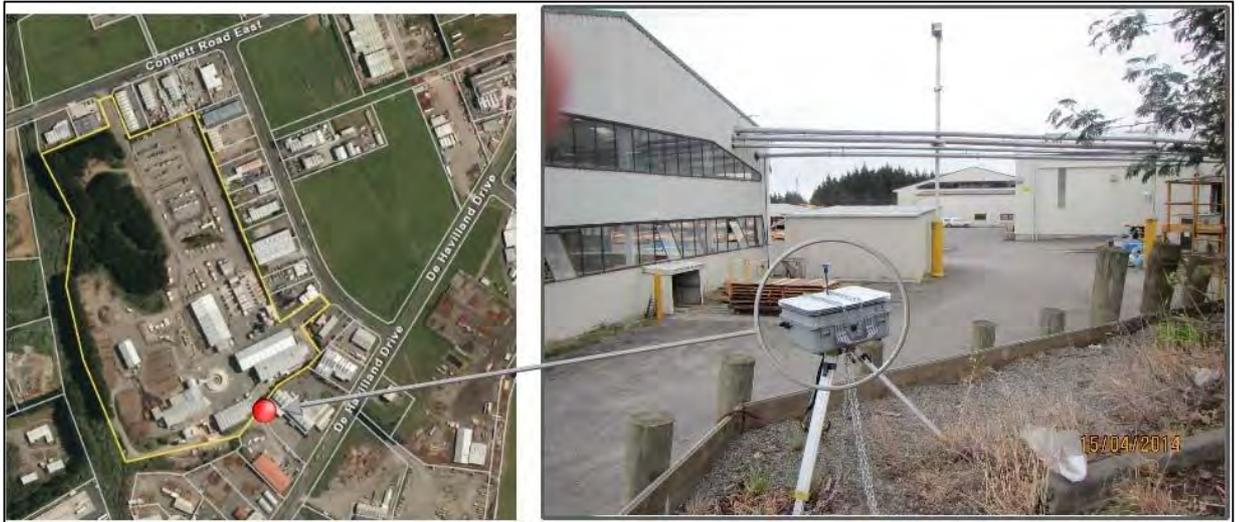
Figure 11 Location of the Taranaki Sawmills PM₁₀ monitoring site during the year under review

Continuous ambient PM₁₀ monitoring was conducted in the vicinity of the Taranaki Sawmills site from 15 April 2014 at 12:45 to 17 April 2014 at 07:45, 7 days after any significant rainfall. The PM₁₀ monitor was located off site to the east (Figure 11). A wind rose, illustrating the wind direction and strength, is presented in Figure 12. The PM₁₀ data expressed in terms of a 1 hour average, as per the Company's consent condition, is shown in Figure 13, and the time dependant PM₁₀ and wind direction data for the period of monitoring is shown in Figure 14.

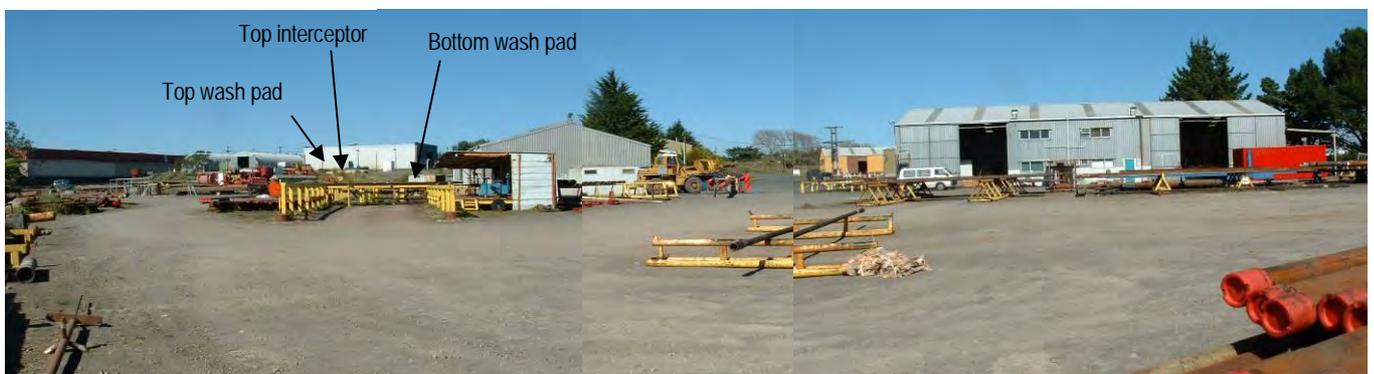
Photo 10 Weatherford New Zealand Ltd site - view from the northern corner

The larger wash pad in the lower yard drains via an in-ground pipe to a three stage interceptor on the bank of the unnamed tributary. The pipes overhang the wash pad slightly, so a moveable catchment facility has been installed to capture wash water at the end of the wash pad to avoid discharge on to land. This wash pad is used for the majority of the wash down that occurs at the site.

The property slopes towards the Waitaha Stream where it runs along the western boundary and towards the the unnamed tributary that runs along the northern boundary. The site is mostly metalled, with only the wash pad areas sealed. There is little constructed drainage at the site and the majority of the stormwater flows overland straight into the Waitaha Stream or the tributary.

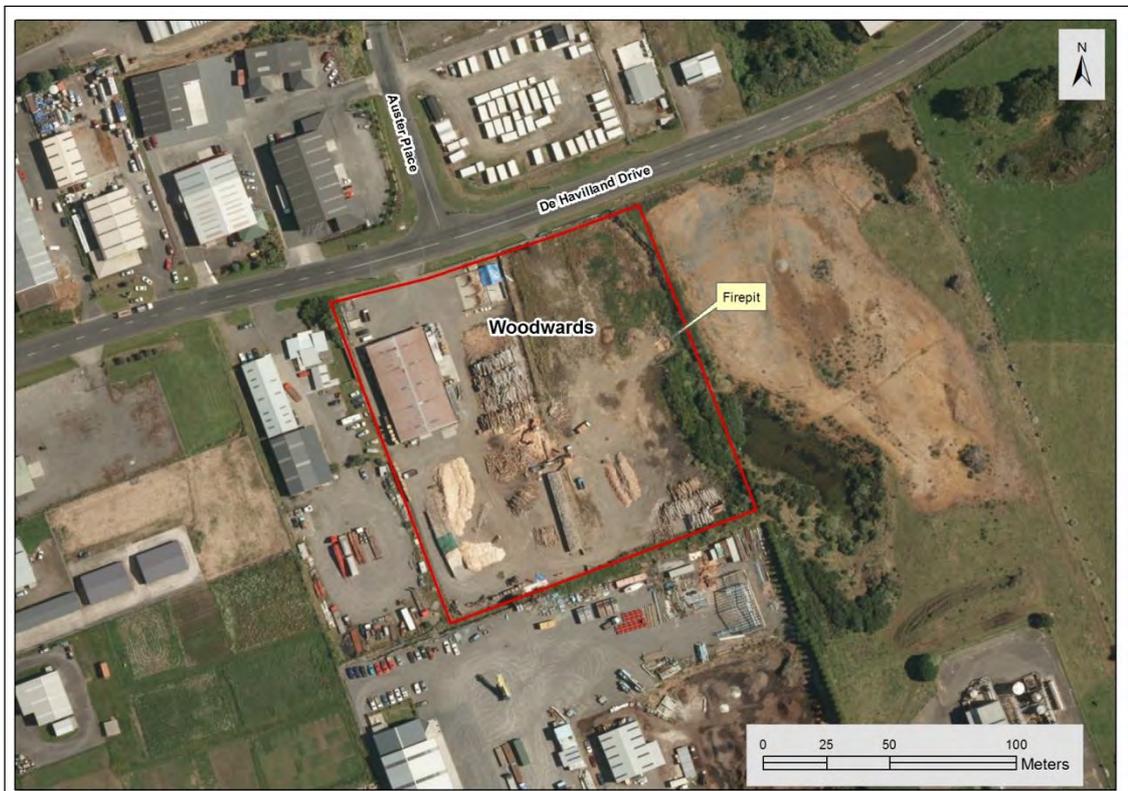
Figure 20 Woodward's 2008 Limited's property and fire pit location

The open fire-pit is located at the eastern side of the site approximately 75 metres south of De Havilland Drive (Figure 20); industrial premises are currently located to the north, west and south. The closest industrial premises are approximately 115 metres north of the fire pit across De Havilland Drive.

The Waitaha Stream flows through a pipe underneath the site and resurfaces on the Northern side of De Havilland Drive.

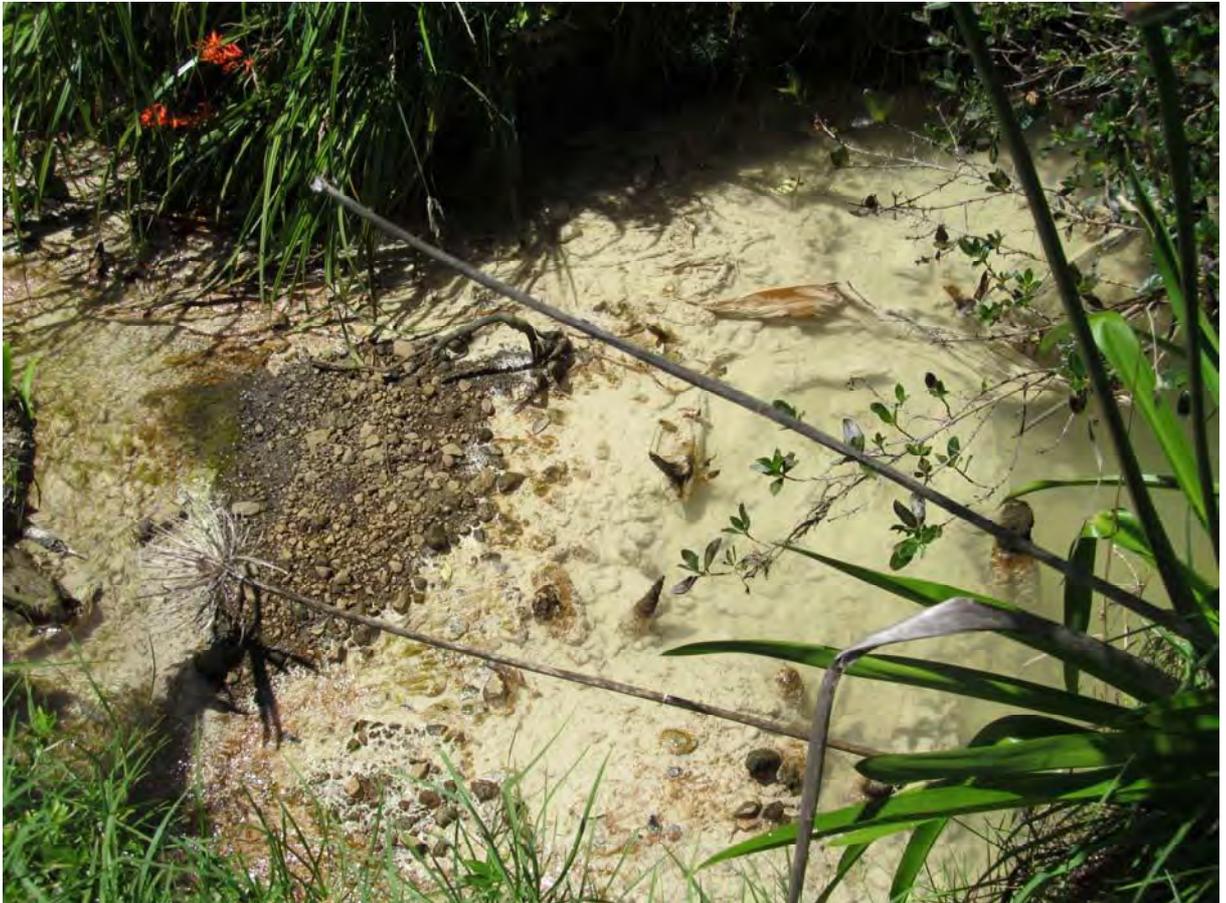
Figure 21 Waitaha Stream downstream of De Havilland Drive - Lime wash from Agri Fert 29 January 2014

Investigation found the stream to be discoloured, and the discharge was traced back to a property on De Havilland Drive. It was found that lime had been washed off the site as a result of an employee cleaning about the lime storage tanks. The lime had been washed into the stormwater system, which drains into the Waitaha Stream. Photographs and samples were taken.

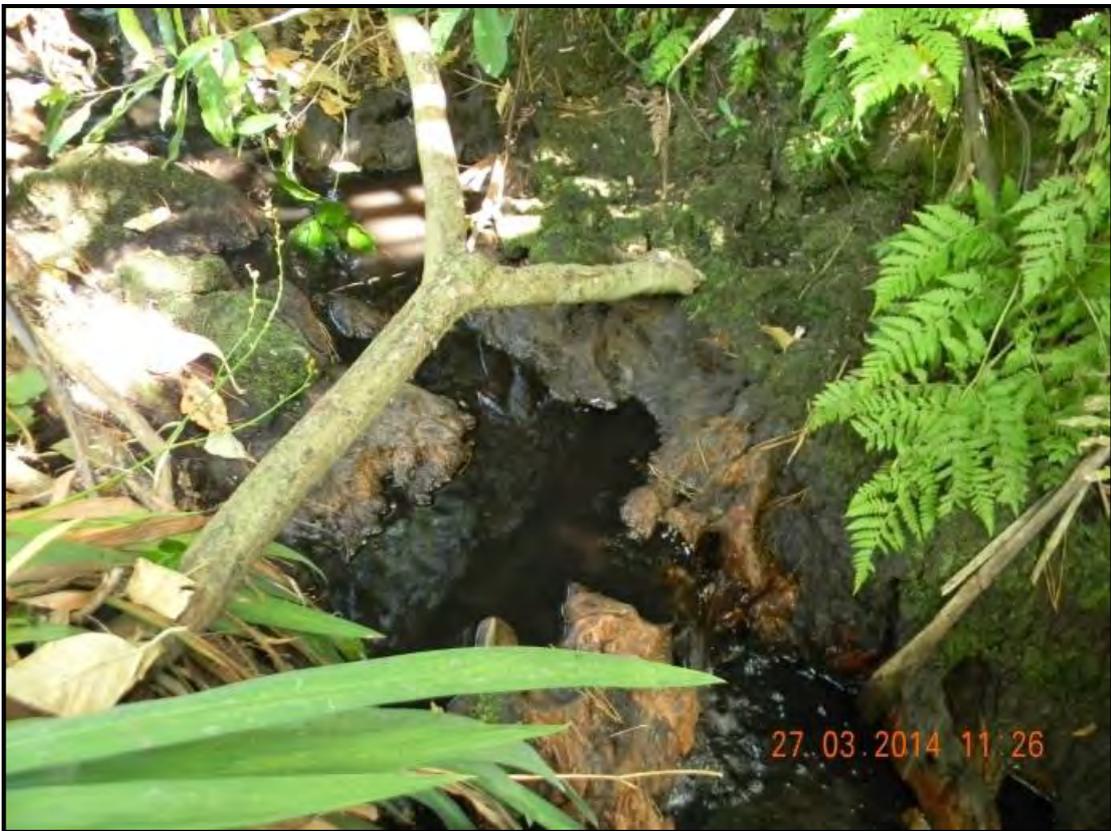
Photo 11 Monitoring site 1, Electric fishing survey 27 March 2014

It is important to note that contamination of the Waitaha Stream was observed at both sites 1 and 2 in the current survey, with site 1 having a very dark, almost black flow, which appeared to be caused by tannins (Photo 11) and a stormwater pipe near site 2 having recently discharged foamy water (Photo 12). Furthermore, this survey was originally planned for January 2014, but was abandoned due to the stream flowing almost white at site 1, which was subsequently found to be due to a lime discharge upstream of De Havilland Drive. There have also been relatively frequent discharges of raw sewage to the Waitaha Stream, primarily from the pumping station located at Connett Road which could explain the abundant population of worms observed at this location.

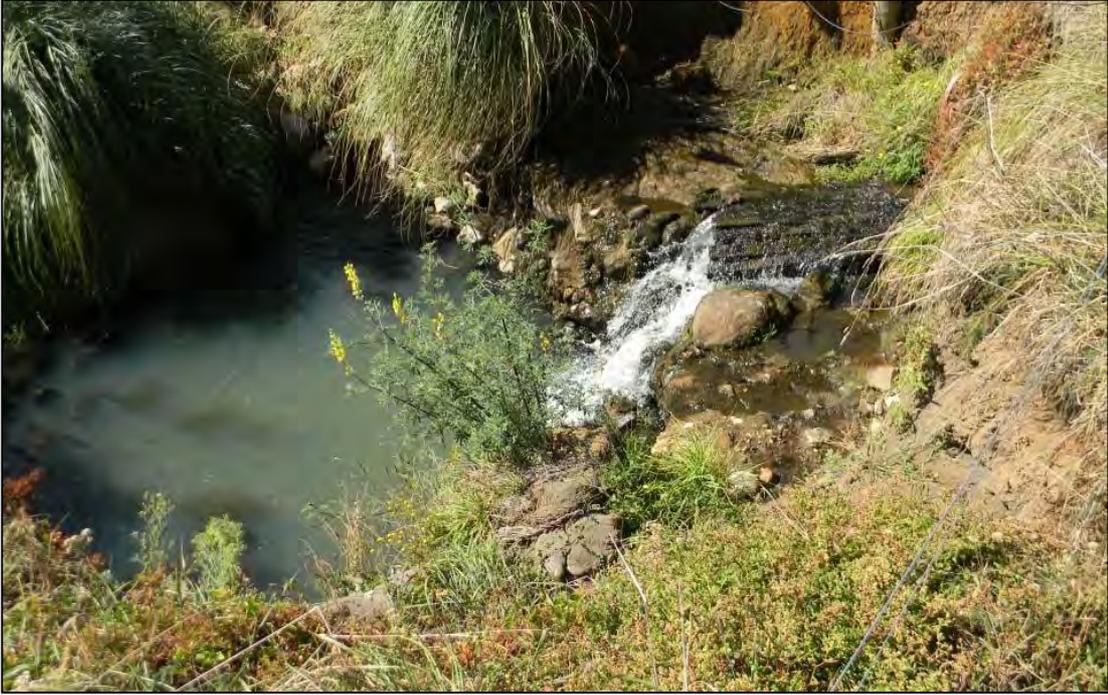
Photo 13 Naturally occurring waterfall in the Waitaha Stream near the coast

It is clear from the results that the stream has the potential to support good populations of redfin bully and eels, with banded kokopu also likely to be present. This can be concluded from the results at site 3, and what was previously recorded in the Mangati Stream. It is likely that banded kokopu are present in the lower catchment, but the survey technique was unlikely to record this nocturnal species. It is likely that redfin bully passage is restricted, with this species either not present or present in very low numbers upstream of SH3. However, there should still be a relatively normal population of eels upstream of this point, as habitat is suitable, and they are formidable climbers.

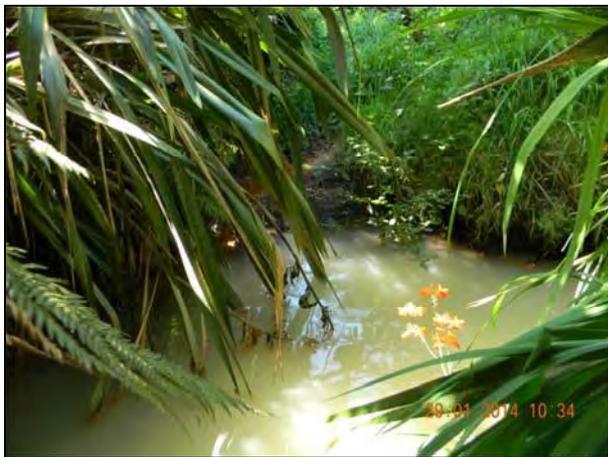
Figure 1 (left top)

This survey was originally planned for January, but upon arrival at this time, it was observed that the stream was discoloured (Figure 1 (left top)

Photo 1), and it was decided to defer the survey for both practicality and health and safety reasons. This is because it would not have been possible to see the fish. In addition, this survey had been preceded by a sewage spill to the stream, which resulted in similar discolouration. The potential that there was sewage in the stream presented a significant risk of infection to the survey staff. Investigation subsequently determined that the discolouration was caused by a well buffered lime discharge. Due to the buffering, there was little impact on the pH of the stream.

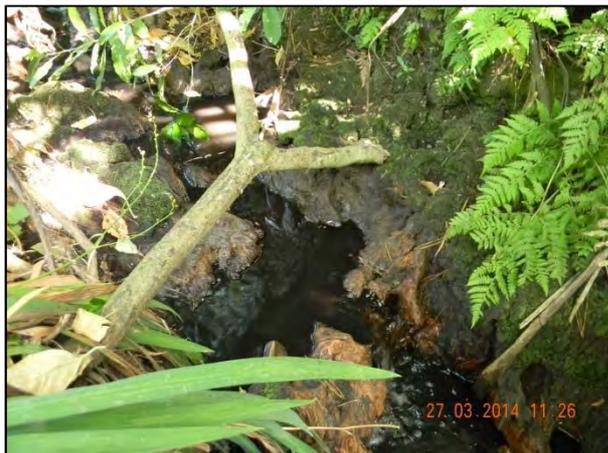
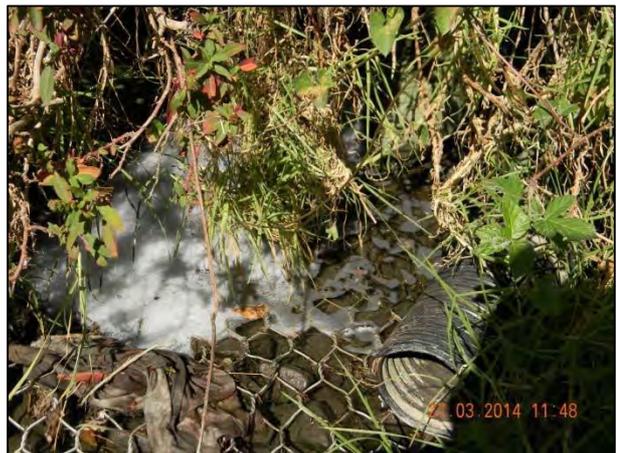
A foamy discharge at a stormwater pipe outlet, just downstream of Connett Road, 27 March 2014.

This survey, undertaken during slow and low flows, again found discolouration at site 1. However, rather than being the grey white colour observed in January, the stream had a very dark, almost black colour, which appeared to be caused by tannins (Photo 2). As a result, visibility at site one was very limited. Visibility had improved somewhat at site 2, although the water was yellow and cloudy, while at the coast, there was little visible indication of pollution, although the stream was still discoloured, this time by what appeared to be iron oxide precipitate, being grey and cloudy. However, contamination of a different kind was observed at site 2, where a foaming discharge had recently occurred, evident by foamy water remaining in a pooled area at the stormwater pipe outlet (Photo 3).

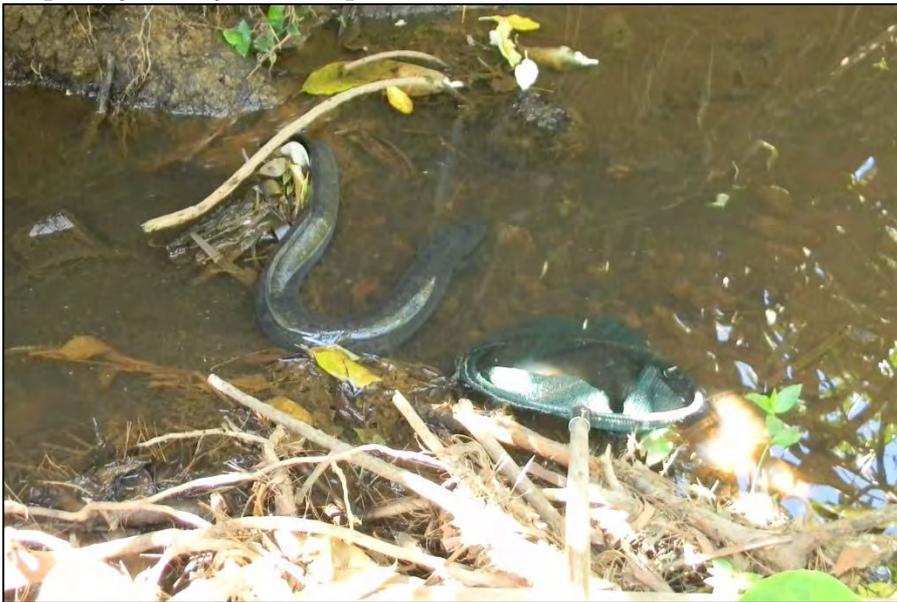
This site was sampled both upstream and downstream of Connett Road. Only one fish was recorded at this site, being a large shortfin eel. It was noted at the time that this eel had atypical markings on its back, and it did not respond to the electrical current in a manner normally exhibited by eels. Normally, large eels will actively attempt to evade the electrical field, but this fish simply moved a short distance upstream, where it remained, caught up in debris (Photo 4). The area surveyed downstream of Connett Road had plentiful cover, but no fish were recorded from this area. It was noted however, that this location supported an extremely abundant population of worms, which came out of the sediment when the electrical current was applied. This was indicative of significant organic enrichment at this site. It is noted that a sewage pump station is located immediately upstream of Connett Road, and this pump station is known to overflow to the Waitaha Stream relatively frequently (Emily Roberts pers. comm.).

Photo 4 A large shortfin eel, recorded immediately upstream of Connett Road.

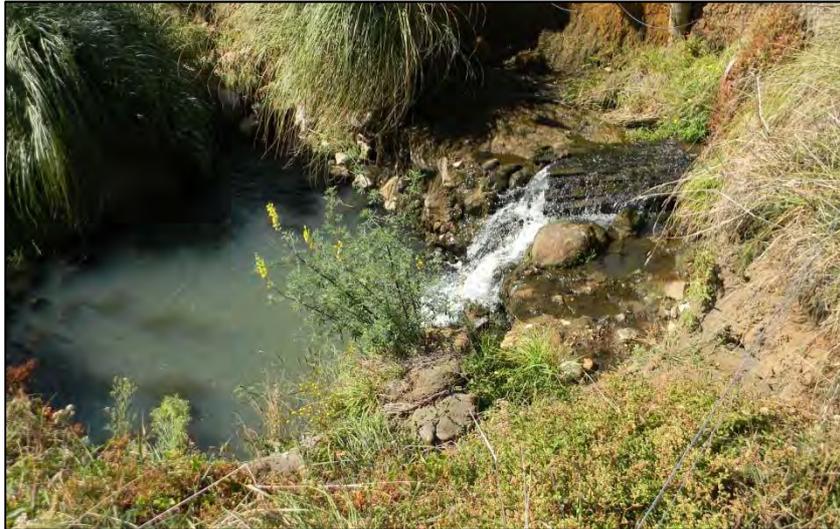
fish passage. These barriers may have influenced the community composition in the headwaters i.e. sites 1 and 2, and therefore need to be considered when drawing conclusions from the sampling results.

Photo 5 A natural barrier to fish passage in the Waitaha Stream located immediately upstream of the coast.
