Mangati Catchment Joint Monitoring Programme Annual Report 2014-2015

Technical Report 2015-119

June 2016

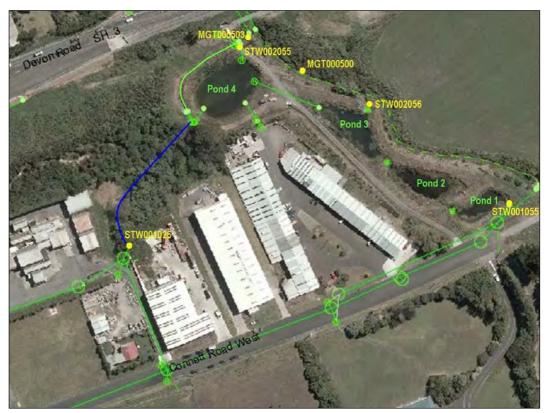
Figure 5 NPDC stormwater flow paths and sampling points

The plans submitted to the Council indicated that under light rainfall conditions, the stormwater flows under Connett Road, and passes through a downstream defender pollutant entrapment device installed in the 300mm pipeline in Connett Road, before entering pond 1 adjacent to Connett Road and the Mangati Stream (STW001055). The water from pond 1 flows through pond 2, and into pond 3 from which it then discharges into the Mangati Stream (STW002056). When there is higher flow from moderate rainfall, stormwater will also discharge via the industrial drain outlet (STW001026) and unnamed tributary into pond 4, which then flows into pond 3. There is a provision for pond 4 to discharge into the Mangati Stream (STW002055) when the water level in the pond increases to a certain point. There is also a drainage channel from the unnamed tributary to the Mangati Stream (MGT000503) to allow the ponds to be bypassed under heavy rainfall conditions, when it was expected that the level of contaminants in the stormwater would be at their lowest due to the high rate of dilution.

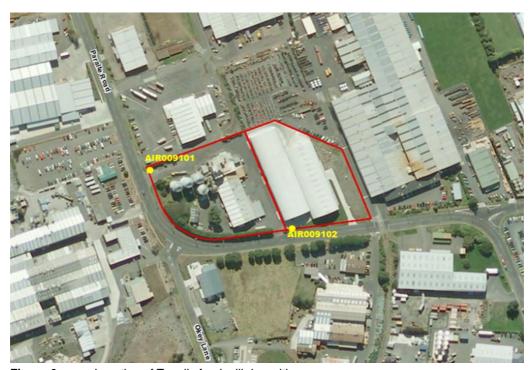
Figure 6 Location of Tegel's feed mill deposition gauges

Guideline values used by the Council for dust deposition are $4~g/m^2/30$ days or $0.13~g/m^2/day$ deposited matter. Consideration is given to the location of the industry and the sensitivity of the surrounding community, when assessing results against these values.

Deposition gauging was not undertaken during the period under review, this will next be monitored during the 2015-2016 monitoring period.

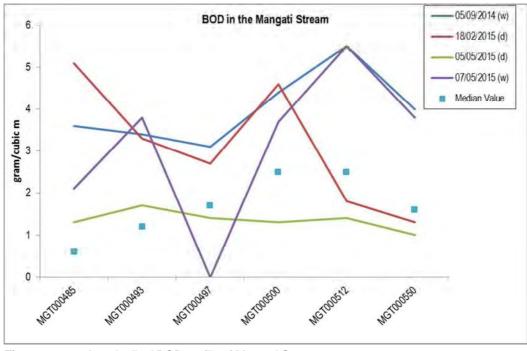
Figure 7 Longitudinal BOD profile of Mangati Stream

In all but one of the surveys, BOD results were found to be above the median values at most sites. However this may be the result of the original input concentrations at the upstream control site being elevated above the median value during the period under review.

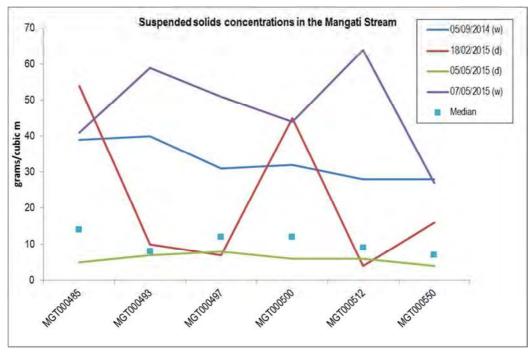
Figure 8 Longitudinal suspended solids profile of Mangati Stream

Rises in suspended solid up and downstream of the inputs from Greymouth and Tasman Tools (between sites MGT000493 and 497) were not observed this period.

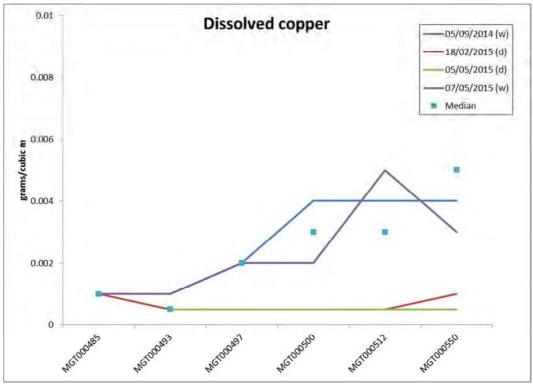
Figure 11 Longitudinal dissolved copper profile of Mangati Stream

The concentrations of dissolved copper had similar patterns to that of dissolved zinc with wet weather surveys returning elevated results at sites MGT000500 and MGT000512 wet during weather surveys and lower more stable concentrations during dry weather surveys.

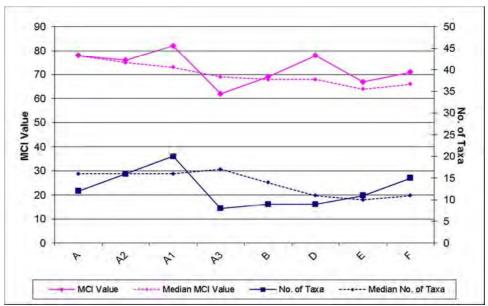
Figure 12 Numbers of taxa and MCI values recorded at sites in the Mangati Stream in the December 2014 survey

been no significant adverse effects on macroinvertebrate communities resulting from discharges from Tegel Poultry. However, downstream of De Havilland Drive, where stormwater from De Havilland Drive West, Tasman Oil and Greymouth Petroleum enter, there was some deterioration in macroinvertebrate communities from that recorded upstream. This deterioration was relatively subtle and as such could not be attributed to a specific discharge or site. The lower discharge from the wetland ponds may have had subtle impacts on the macroinvertebrate community of site D2, as indicated by the dominance of 'tolerant' taxa in the community. The lowest two sites indicated some recovery in water quality in the survey undertaken in February, with above average community richness, MCI and SQMCI_s scores.

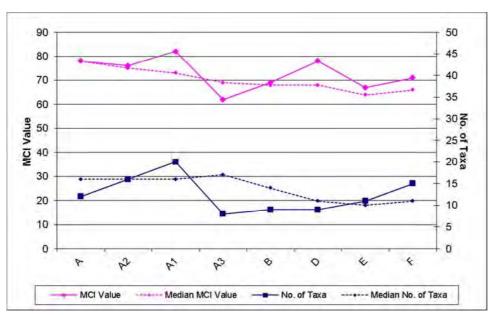
Figure 2 Numbers of taxa and MCI values recorded at sites in the Mangati Stream by the current survey

Numbers of taxa and MCI scores recorded by the current survey in the Mangati Stream are illustrated in Figure 2.

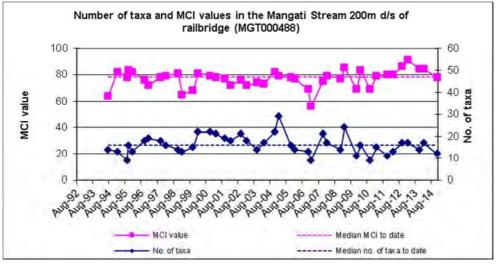
Figure 4 Numbers of taxa and MCI values recorded at site A to date

Twelve taxa were found at this site near the head of the catchment above the industrial area, five taxa fewer than found by the previous (summer) survey, and four taxa fewer than the historical median for this site (Table 3, Figure 2). This reduced richness reflected the frequent freshes that preceded this survey, resulting in frequent disturbance to the substrate and scouring out of invertebrates. Although there were macrophytes present on the edges of the stream, due to the incised nature of the stream there were no macrophytes actually within the wetted area. The community was characterised by one 'tolerant' taxon [snail (*Potamopyrgus*)] and one 'moderately sensitive' taxon [very abundant amphipod (*Paracalliope*)]. These taxa were typical 'generalists' found in weedy, steady-flowing, softer-bottomed habitats, typical of low gradient, lowland streams.

The MCI value of 78 ('poor' ecological health (TRC, 2013) reflected the significant proportion of 'tolerant' taxa in the community at this site (58%). This was six units less than the score recorded by the previous (summer) survey, but within the range of scores recorded over the

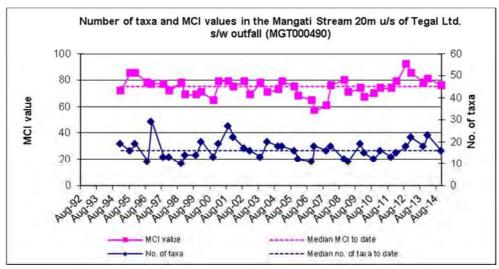
Figure 5 Numbers of taxa and MCI values recorded at site A2 to date

A moderately rich community (16 taxa) was recorded at this site, equal to the median for this site but seven less than recorded by the previous (summer) survey (Table 3, Figure 5). However there was a small decrease in MCI score (76 units) from this previous summer survey, with the current score only one unit higher than the median for this site (Table 3). This score was only two units below that recorded at site A, due to a lower proportion of 'sensitive' taxa (37%) in the community than recorded upstream. The community was dominated by only one 'moderately sensitive' taxon [extremely abundant amphipod (*Paracalliope*)] and three 'tolerant' taxa [oligochaete worms, snail (*Potamopyrgus*), and sandfly larvae (*Austrosimulium*) (Table 2). The resultant SQMCI_s score of 4.1 units was similar to that recorded upstream and only 0.4 unit less than the highest score recorded at this site to date. The slight increase in the number of taxa found was coincident with improved habitat due primarily to less reed sweet grass cover, allowing some algal growth. This will have also contributed to the changes in characteristic taxa and individual taxon abundances recorded between sites A and A2.

The SQMCI_s and MCI scores were marginally higher than their medians for this site (Table 3), and as a result, not considered to indicate a deleterious influence from the Tegel wetland discharges through this reach of the stream.

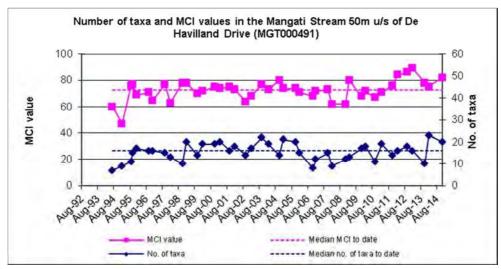
Figure 6 Numbers of taxa and MCI values recorded at site A1 to date

An improved richness (20 taxa) was recorded at this site downstream of industrial stormwater discharges and about 100 m below site A2 compared with the previous spring 2013 survey richness (10 taxa), and that recorded upstream. It was however slightly less than that recorded in the previous summer 2014 survey (23), but was four taxa more than the median richness and amongst the highest richness found to date at site A1 (Figure 6). This site has stabilised well since the stream was moved in 2008 to accommodate the installation of a culvert downstream.

The MCI score recorded by the current survey was 82 units (indicative of 'fair' biological health (TRC, 2013)), which was seven units higher than that recorded by the previous (summer) survey and six units higher than the score at site A2, due to an increased proportion of 'moderately sensitive' taxa in the community (50%). The current score was nine units higher than the median score for this site (Table 3, Figure 6), indicating a relatively healthy community health for this site.

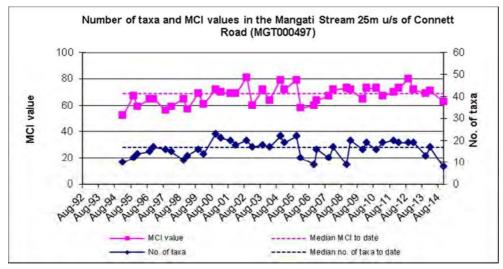
Figure 7 Numbers of taxa and MCI values recorded at site A3 to date

that this site was completely overgrown and shaded by reed sweet grass, and that only a small area was sampled, this large reduction in taxa richness and taxon abundance may be indicative of some sort of external influence. It should also be noted that there may also have been some influence from the farmland through which the Mangati Stream flows at this site as there is often unrestricted stock access to the stream.

This community also had a significantly reduced MCI score (63) compared with the score at site A1 (Stark, 1998), due to a large reduction (38%) in the proportion of 'sensitive' taxa present. This score was nineteen units less than that recorded at site A1 upstream, eight units less than that recorded in the previous survey, and six units less than the long term median for this site. This is the lowest MCI score recorded at this site since December 2006, and goes against the pattern of above or near-to median scores generally observed at this site since 2007 (Figure 7). The SQMCI_s score (2.5 units) was similar to the median for this site (Table 3) but significantly less than that recorded in the previous (summer) survey and that recorded at site A1 in the current survey. This is primarily due to the near complete loss of 'sensitive' taxa, as some of these taxa were abundant at this site in the previous survey, and at the upstream site in the current survey.

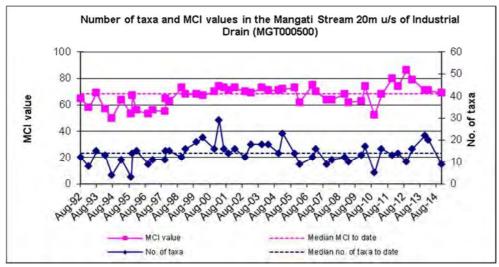
Figure 8 Numbers of taxa and MCI values recorded at site B to date

There was little change in the number of taxa in the stream reach between site A3 (8 taxa) and site B (9 taxa), in which the wetland that receives discharges from a large industrial area discharges to the Mangati Stream. The current richness recorded at site B was five taxa less than the median, and other than in 2010, when a pollution incident resulted in only 5 taxa being recorded, there has not been a lower richness recorded since 1995 (Figure 8, Table 3).

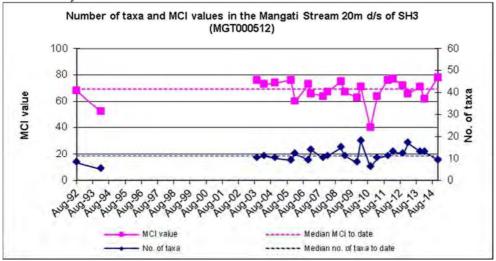
Figure 9 Numbers of taxa and MCI values recorded at site D2 to date

a slightly misleading result. When compared with site B (Table 3), there was an insignificant nine unit increase in MCI score (Stark, 1998), suggestive of some improvement in community health between the two sites.

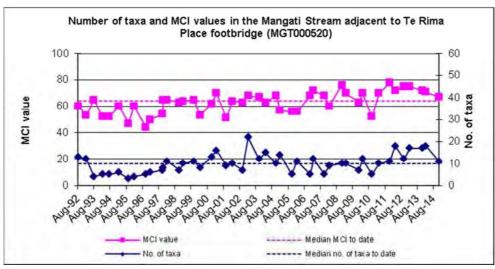
Figure 10 Numbers of taxa and MCI values recorded at site E to date

A downstream increase of two taxa in richness was found at site E (11 taxa), which was one taxon more than the median richness for this site (Table 3, Figure 10). This community was characterised by four 'tolerant' taxa [extremely abundant oligochaete worms and snail (*Potamopyrgus*), algal-piercing caddisfly (*Oxyethira*), and sandfly (*Austrosimulium*)], representing a change in only one characteristic taxon compared with the community at the nearest upstream site D2. There were no significant differences in individual taxon abundance found between sites D2 and E, although it is worth noting that *Potamopyrgus* snails increased in abundance from very abundant at site D2 to extremely abundant at site E.

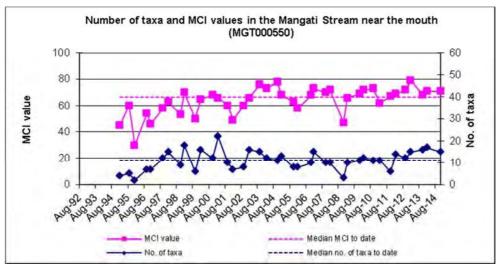
Figure 11 Numbers of taxa and MCI values recorded at site F to date

Taxa richness (15 taxa) was very slightly lower than that recorded by the previous (summer) survey and four taxa higher than the historical median richness (Figure 11, Table 3). This was considered to indicate continued recovery from the significant habitat loss caused by erosion of the stream bed and banks by high flows and possibly high seas documented by the survey of spring 2011.

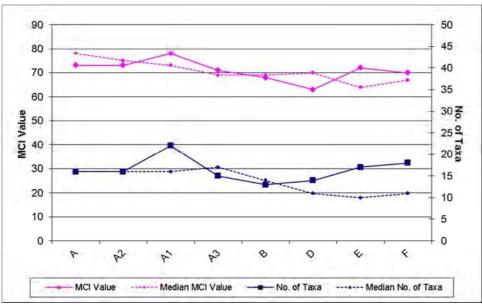
Figure 2 Numbers of taxa and MCI values recorded at sites in the Mangati Stream by the current survey

Numbers of taxa and MCI scores recorded by the current survey in the Mangati Stream are illustrated in Figure 2.

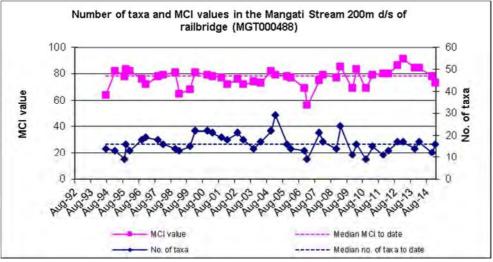
Figure 4 Numbers of taxa and MCI values recorded at site A to date

Sixteen taxa were found at this site near the head of the catchment above the industrial area, four taxa more than found by the previous (spring) survey, but equal to the historical median for this site (Table 3, Figure 2). This improved richness reflected the more stable flow conditions that preceded this survey, resulting in less disturbance to the substrate and scouring out of invertebrates. Although there were macrophytes present on the edges of the stream, due to the incised nature of the stream there were no macrophytes actually within the wetted area. The community was characterised by two 'tolerant' taxa [oligochaete worms and snail (*Potamopyrgus*)] and one 'moderately sensitive' taxon [extremely abundant amphipod (*Paracalliope*)]. These taxa were typical 'generalists' found in weedy, steady-flowing, softer-bottomed habitats, typical of low gradient, lowland streams.

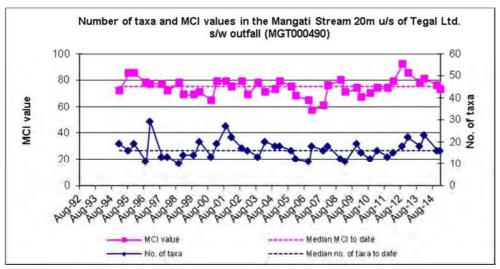
Figure 5 Numbers of taxa and MCI values recorded at site A2 to date

A moderately rich community (16 taxa) was recorded at this site, equal to the median for this site and that recorded by the previous (spring) survey (Table 3, Figure 5). However there was a small decrease in MCI score (73 units) from this previous spring survey, with the current score two units less than the median for this site (Table 3). This score was equal to that recorded at site A, despite a higher proportion of 'sensitive' taxa (37%) in the community than recorded upstream. The community was dominated by only one 'moderately sensitive' taxon [extremely abundant amphipod (*Paracalliope*)] and two 'tolerant' taxa [snail (*Physa* and *Potamopyrgus*)] (Table 2). The resultant SQMCI_s score of 4.7 units was slightly higher than that recorded upstream and was the highest score recorded at this site to date. There were five significant differences in individual taxon abundance between sites A and A2, and this is due primarily to the change in habitat sampled. At site A2 there was reed sweet grass growing within the stream, and this is the habitat that was sampled.

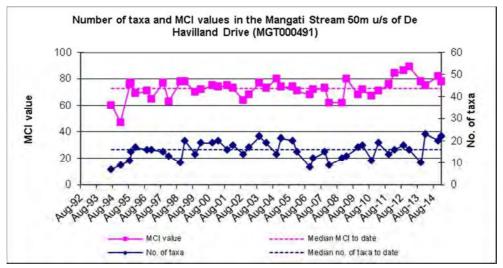
Figure 6 Numbers of taxa and MCI values recorded at site A1 to date

A similar richness (22 taxa) was recorded at this site downstream of industrial stormwater discharges and about 100 m below site A2. This result is similar to that recorded at this site in the previous two surveys, being some of the highest richnesses recorded at this site to date (Figure 6). The current richness was six taxa more than the median richness for this site, and also six more than that recorded upstream. This site has stabilised well since the stream was moved in 2008 to accommodate the installation of a culvert downstream.

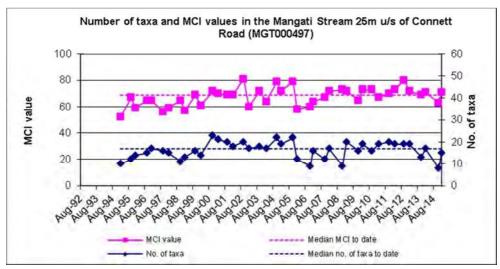
Figure 7 Numbers of taxa and MCI values recorded at site A3 to date

A1, and the increased abundance of *Physa* snails, a taxon often associated with enrichment (Table 2). Although it was noted at the time of sampling that this site was completely overgrown and shaded by reed sweet grass, this change in taxon abundance may be indicative of some sort of external influence, especially considering the results of the previous survey. It should also be noted that there may also have been some influence from the farmland through which the Mangati Stream flows at this site as there is often unrestricted stock access to the stream.

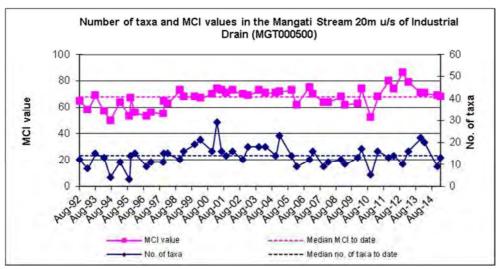
Figure 8 Numbers of taxa and MCI values recorded at site B to date

There was little change in the number of taxa in the stream reach between site A3 (15 taxa) and site B (13 taxa), in which the wetland that receives discharges from a large industrial area discharges to the Mangati Stream. The current richness recorded at site B was only one taxon taxa less than the median, a recovery from that recorded in the previous survey (Figure 8, Table 3).

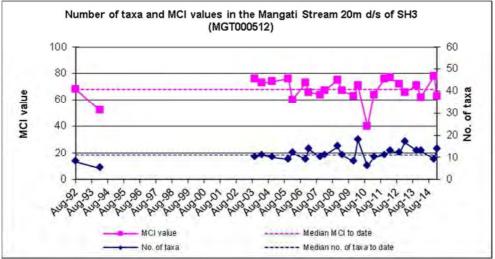
Figure 9 Numbers of taxa and MCI values recorded at site D2 to date

recorded by the previous (spring) survey but three more than the median for this site (Figure 9, Table 2). The community was dominated by the same 'tolerant' taxa as at sites B, with the exception of orthoclad midges, which dropped in abundance to rare (less than five individuals). As at sites A3 and B, no 'sensitive' taxa were present in abundance (Table 3). The community contained a reduced proportion (21%) of 'moderately sensitive' taxa which was reflected by the MCI score (63 units). This is two units less than the long term median score for this site, but a significant (Stark, 1998) reduction from that recorded in the previous survey, which recorded the highest MCI score recorded at this site to date (Figure 9). When compared with site B (Table 3), there was an insignificant five unit reduction in MCI score (Stark, 1998), possibly indicating further deterioration in community health between the two sites.

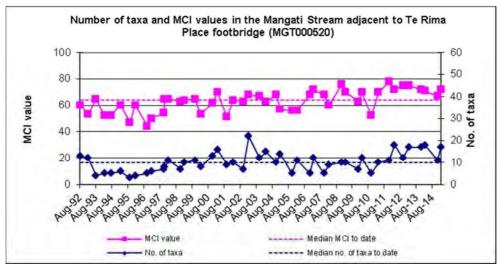
Figure 10 Numbers of taxa and MCI values recorded at site E to date

A downstream increase of three taxa in richness was found at site E (17 taxa), which was seven taxa more than the median richness for this site (Table 3, Figure 10). This community was characterised by two 'tolerant' taxa [oligochaete worms and extremely abundant snail (*Potamopyrgus*)], and one 'moderately sensitive' taxon [caddisfly (*Triplectides*)], representing a change in only one characteristic taxon compared with the community at the nearest upstream site D2. There were no significant differences in individual taxon abundance found between sites D2 and E, although it is worth noting that oligochaete worms decreased in abundance from extremely abundant at site D2 to very abundant at site E.

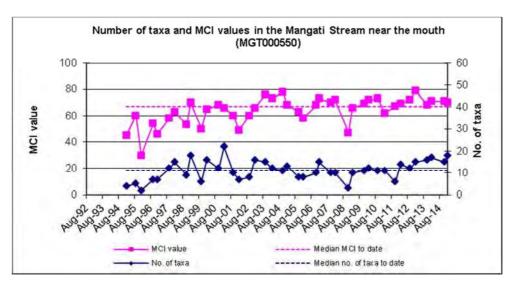
Figure 11 Numbers of taxa and MCI values recorded at site F to date

Taxa richness (18 taxa) was slightly higher than that recorded by the previous (spring) survey and seven taxa higher than the historical median richness (Figure 11, Table 3). This was considered to indicate continued recovery from the significant habitat loss caused by erosion of the stream bed and banks by high flows and possibly high seas documented by the survey of spring 2011. However, it will also be a reflection of the change in sampling technique, which involved sweeping through macrophyte habitat in slow to still water.
