Remediation NZ Limited
Monitoring Programme
Annual Report
2014-2015

Technical Report 2015-68

February 2016

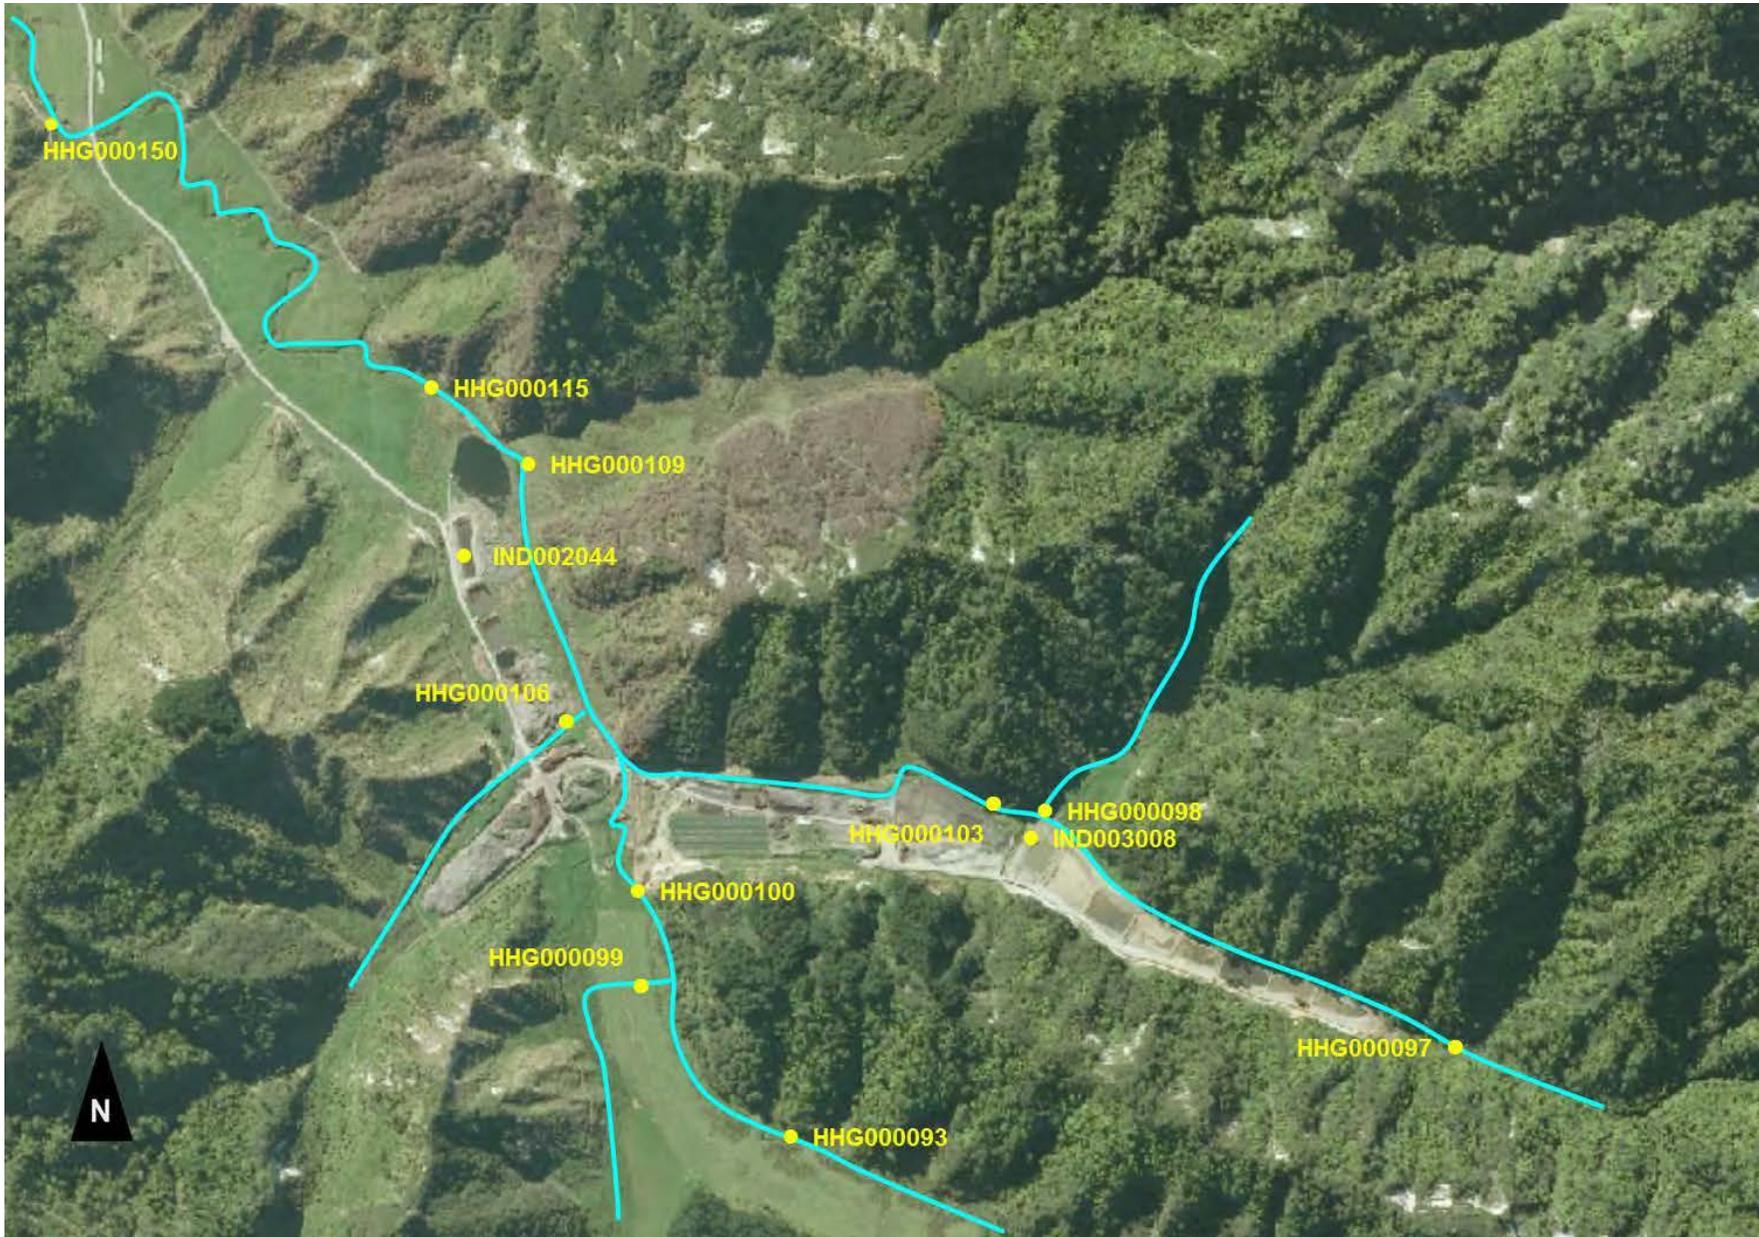
Figure 3 Freshwater sampling sites at RNZ Uruti sites

One macroinvertebrate biological survey was performed across six sites in the Haehanga Stream and its tributaries to determine whether or not the discharge of treated leachate and irrigation activities from the site has had a detrimental effect upon the aquatic communities of the stream. The Council also undertook one fish survey to ascertain any effects on fish health from the activities on the site.

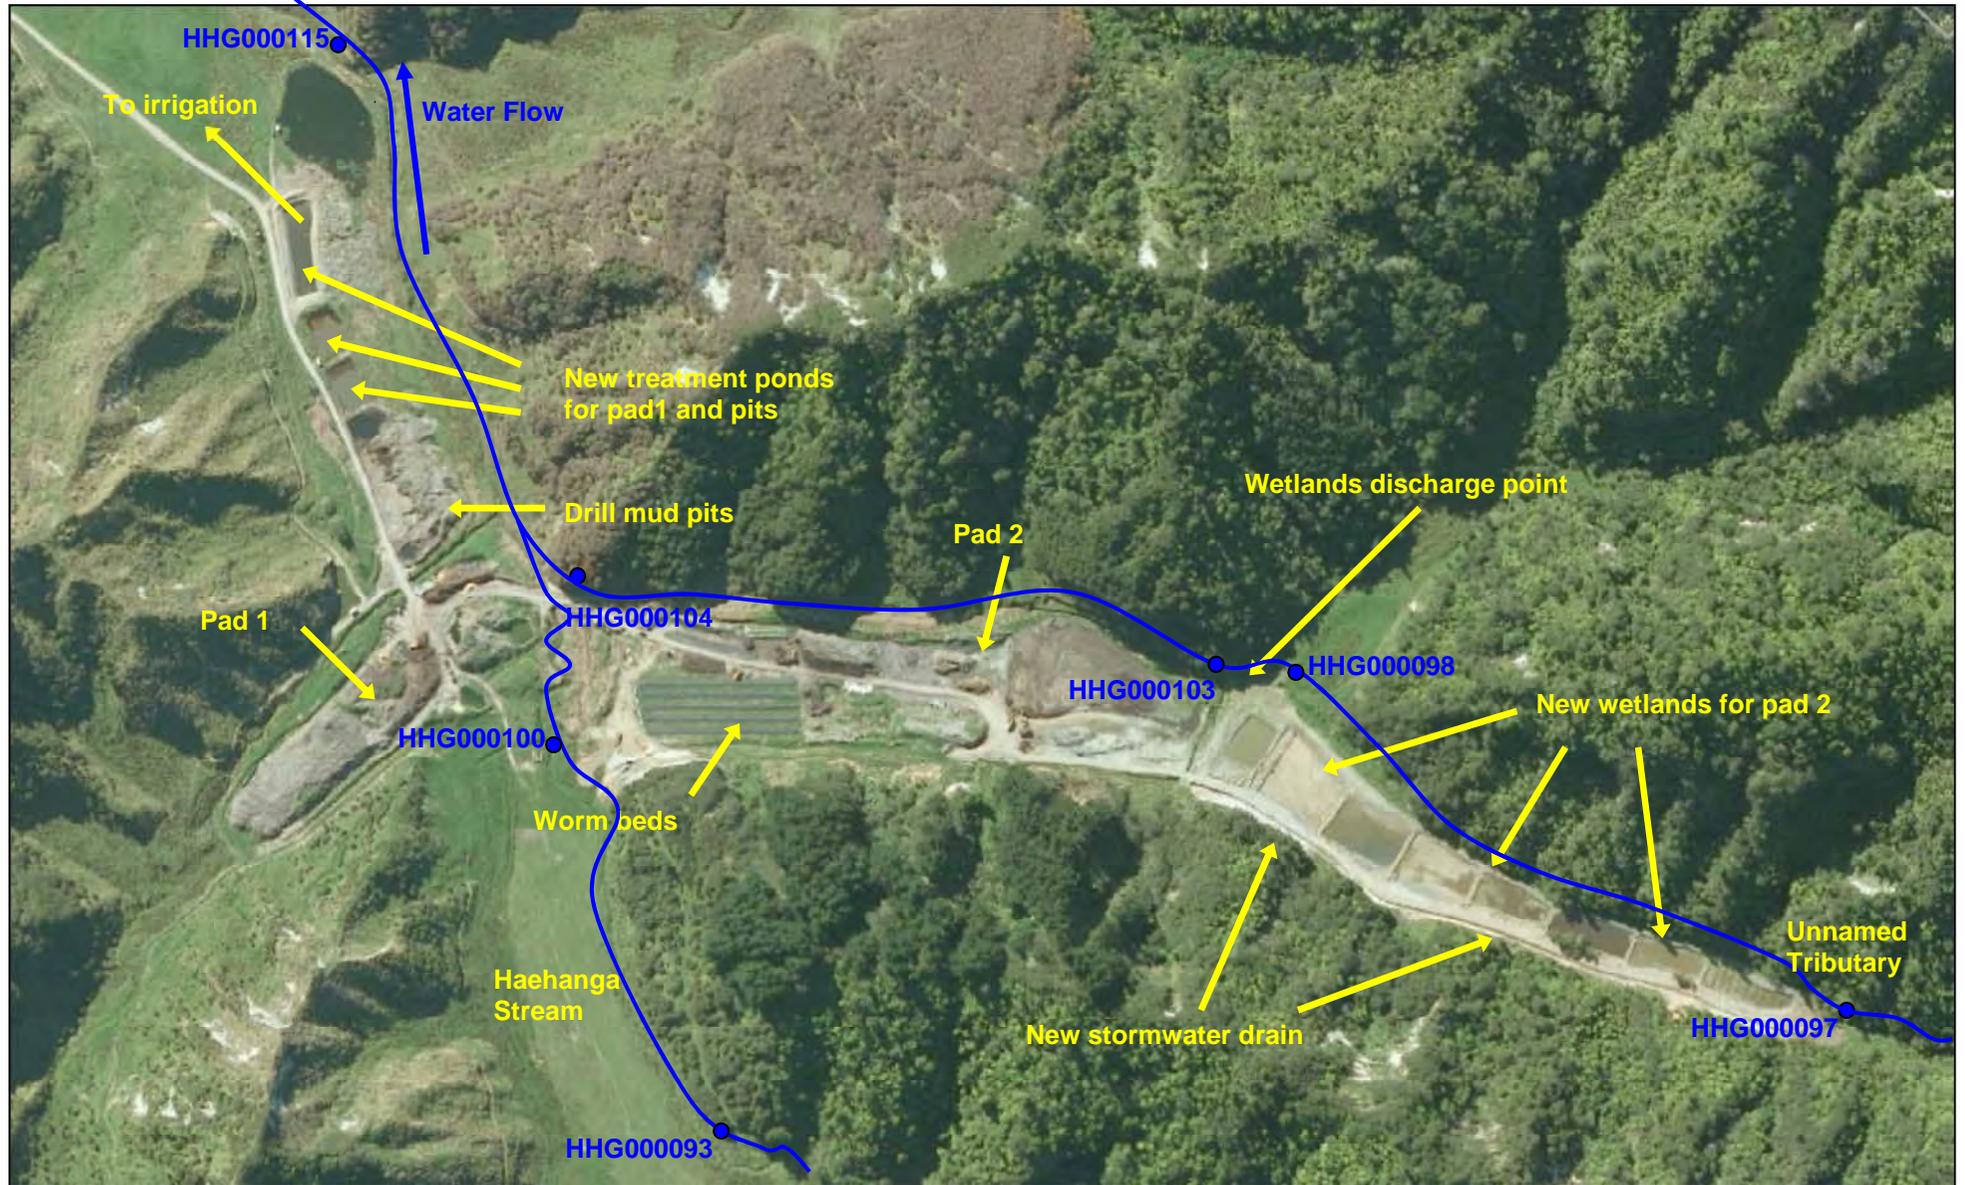
Figure 1 Location of biomonitoring sites in the Haehanga Stream catchment

HHG000190 ~1900m DS
HHG000150 ~ 675m DS

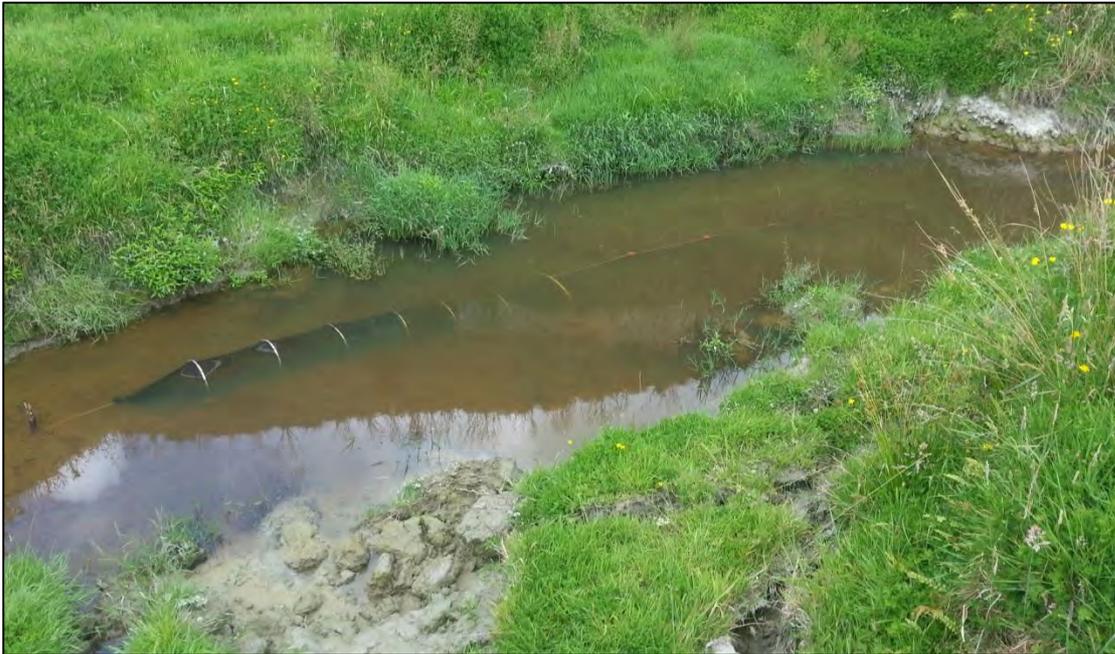
Photo 1 A fyke net, set at site 2, Haehanga Stream.

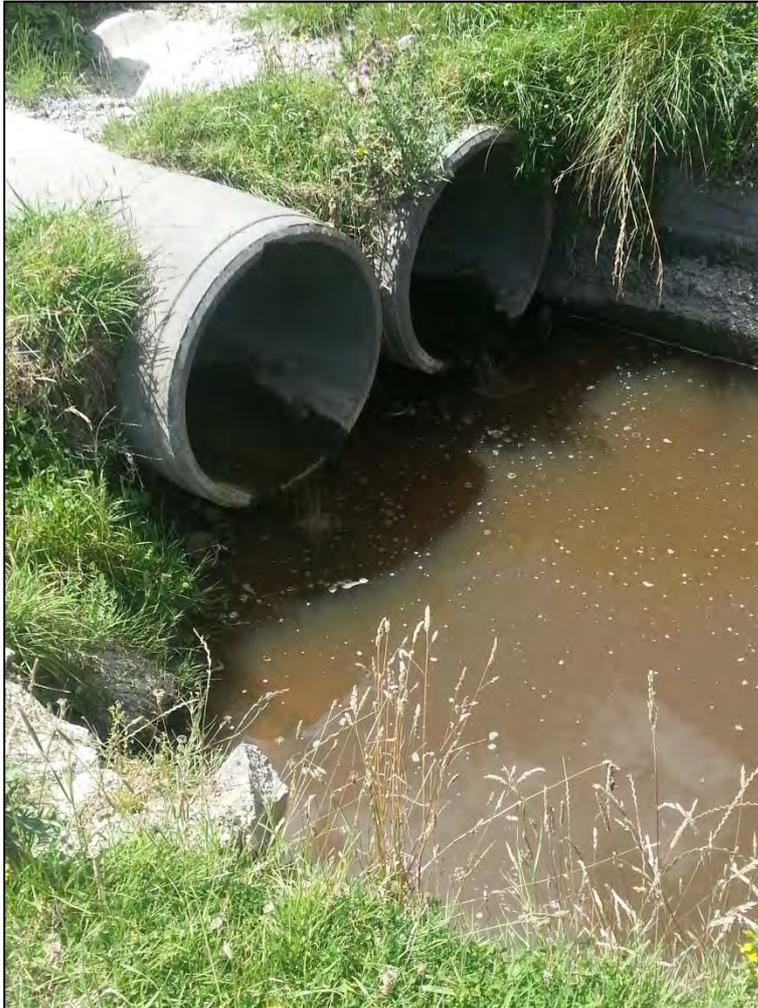
Photo 2 The access culvert immediately upstream of site 2.

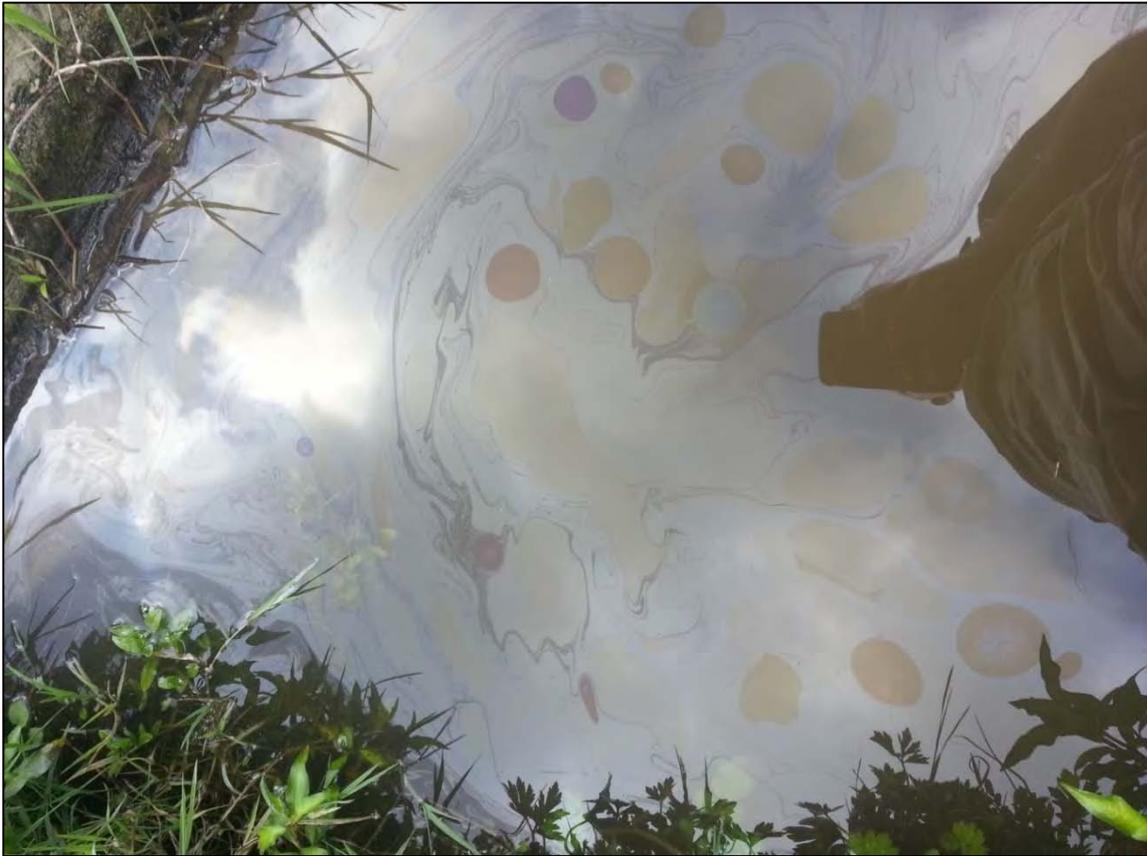
Located just upstream of State Highway, this site provides some perspective, in that it would provide an indication as to the extent of influence from the upstream composting activities. This site contained some of the best habitat, with large logs, deep water and undercut banks. These three habitat features are frequently used by nocturnal fish as cover. Of concern was the release of hydrocarbons from the sediment when this sediment was disturbed (Photo 3).

Photo 3 A hydrocarbon sheen that resulted from the release of hydrocarbons from the sediment at site 3 when this sediment was disturbed.

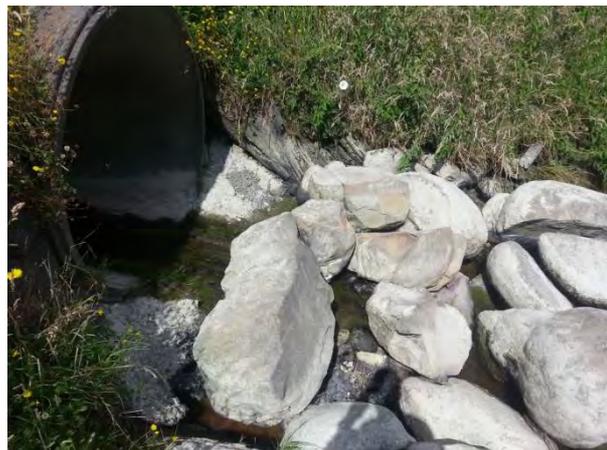
Culvert 3 was the greatest barrier observed on this occasion, with both culvert outlets significantly perched and shallow flows through the culvert. This would be best remediated by increasing the height of the riffle that leaves this pool, using large cobble substrate. The intention would be to lift the water level of the pool so that the outlet of the culverts is inundated, and preferably so that water also backs up into the culvert, to provide for poorer swimming species, such as inanga.

Photo 4 Culvert 1 (above) and culvert 2 (left) on 9 January 2015

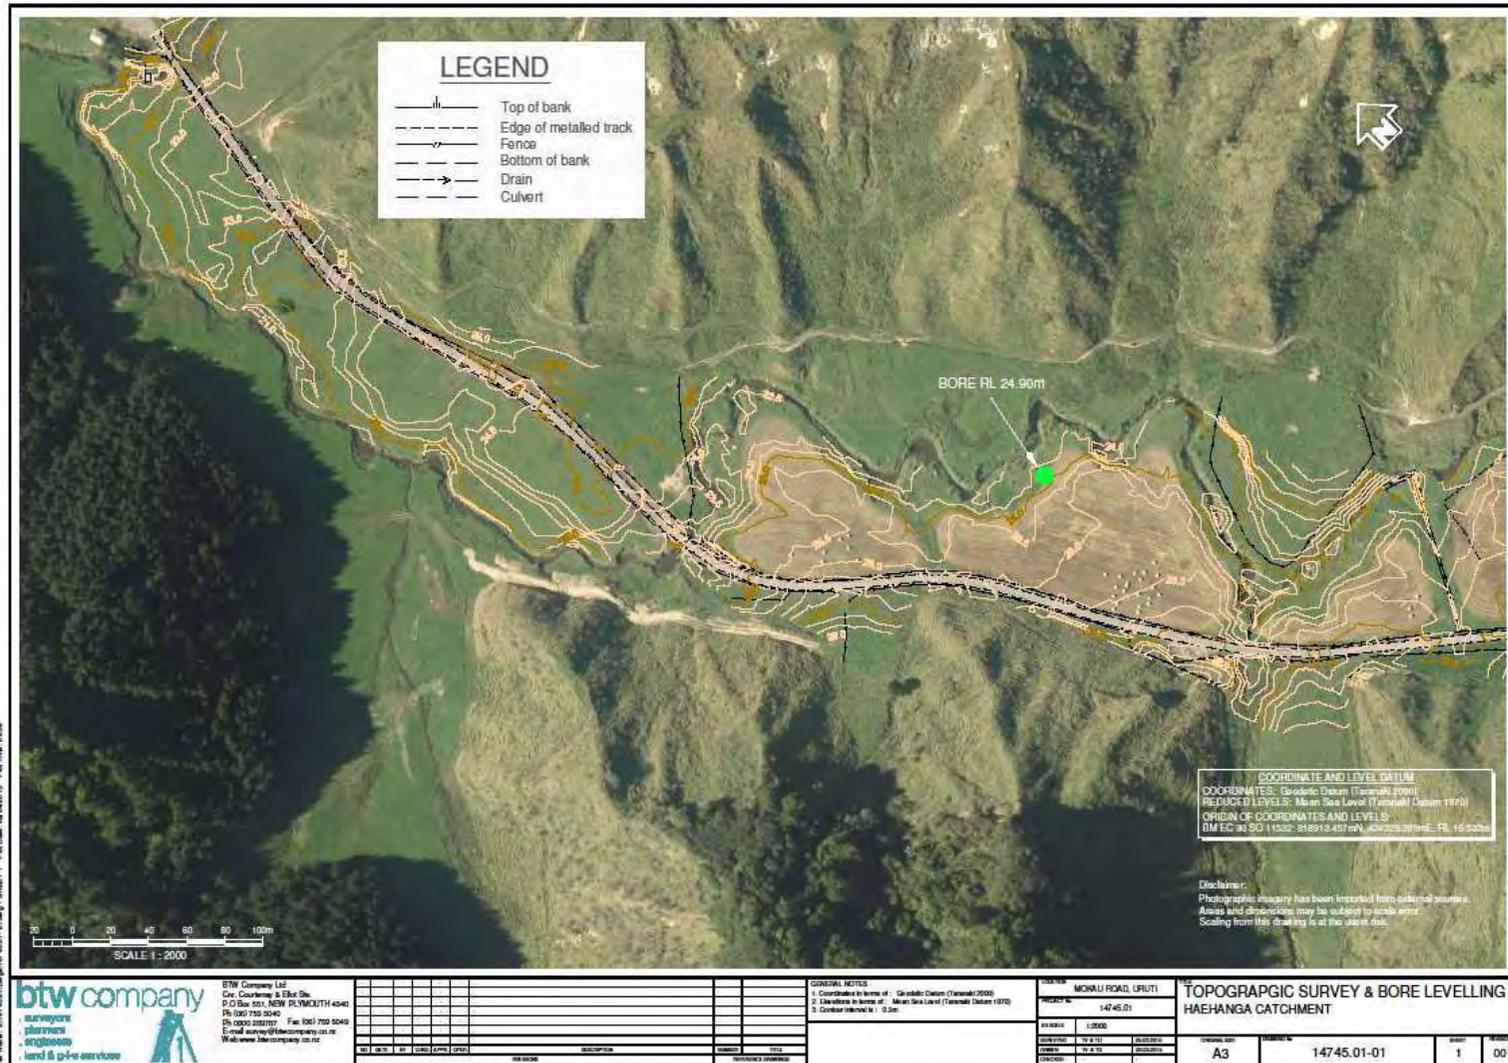
Figure 2.1:Uruti Composting Topography Survey-lower part of site. Green dot denotes GND 2190 and reduced level

Monitoring bore locations are shown on the site plan in Figure 2.1-2.3. Monitoring bore construction details are in Appendix A. Photographs of the well construction are presented in Appendix B.

Based on these parameters above, average hydraulic gradients and linear groundwater velocities have been estimated. Hydraulic gradients have been determined from the groundwater reduced levels in the monitoring bores GND 2188 to GND 2190 and distances between bores taken from the Topographic Survey (Figure 2.1-2.3).

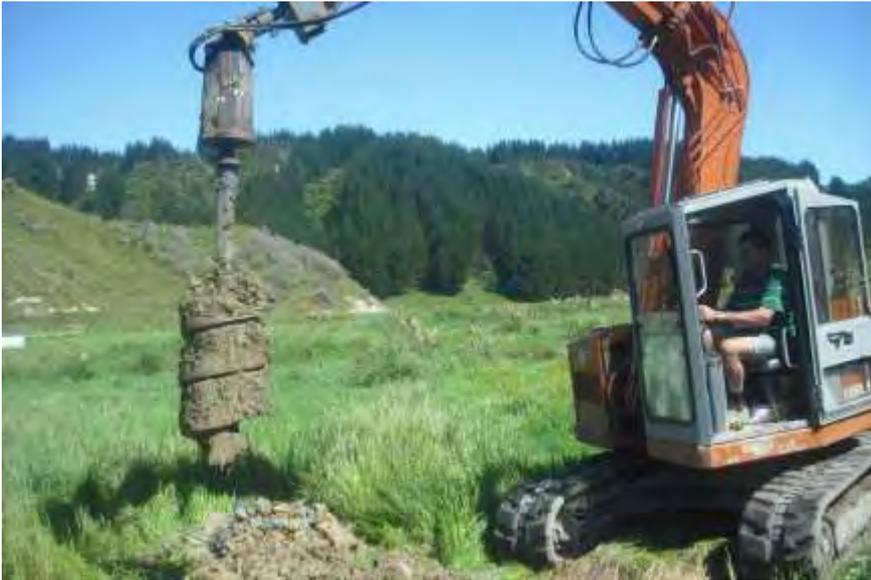
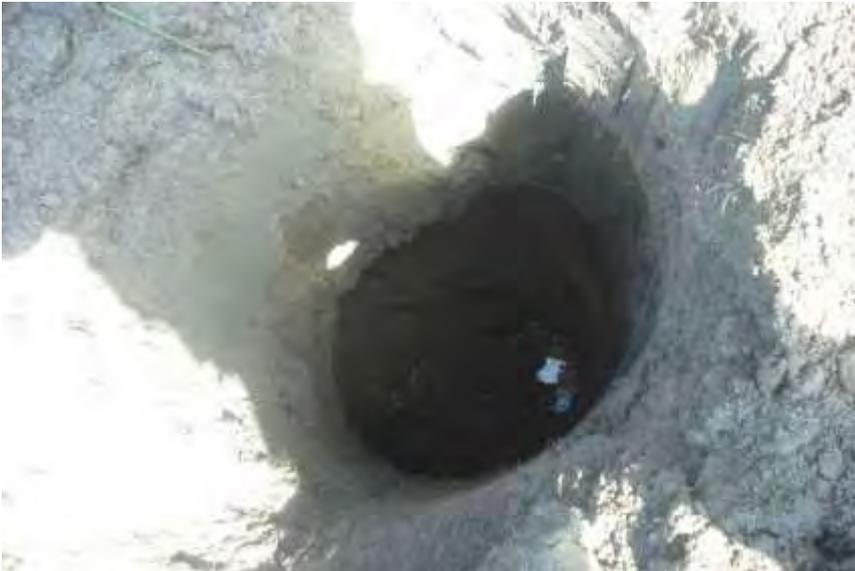
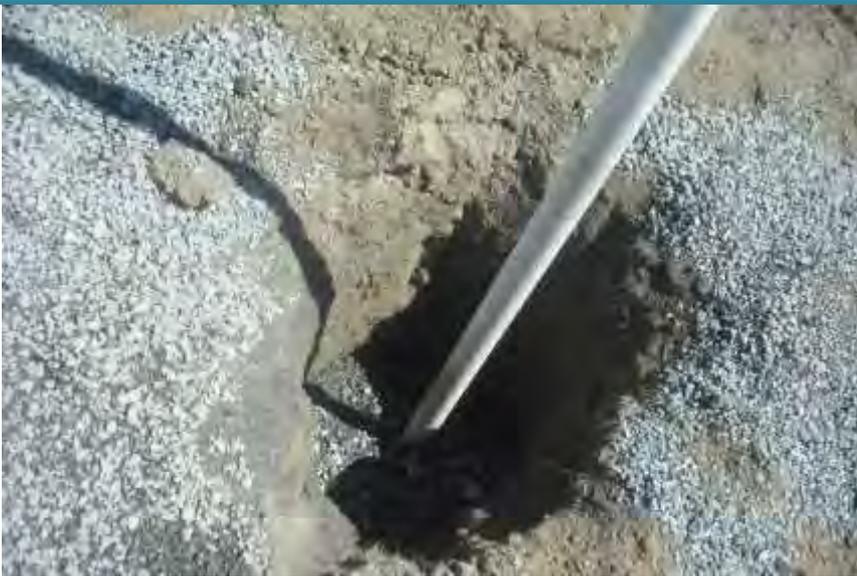
APPENDIX B MONITORING BORE INSTALLATION

Although the bores were advanced under a supervision of a hydrogeologist, bore logs and/or description of the soils and aquifer properties encountered were not recorded. From available site photos taken on the day of installation, the full length of the screen appears to be slotted. This is in contrast to the design specification in Appendix A. Details related to the filter pack, cementing and/or gravel around the screen are also not accurately known. The influence this data gap has on bore development, permeability tests and velocity calculations is uncertain.

- Final depths should be measured and recorded
- The slotted portion of the pipe should start 0.2m below the ground level as per the schematic. This is not the case in all the bores.
- The top of the monitoring well should be capped to prevent contaminants entering the bore
- The top of the casing should be 300 mm above the ground and sealed so that potential contaminants or small animals cannot get in.
- A 2 meters perimeter fence should be erected around the monitoring well (i.e, 0.5 x 0.5 x0.5 x 0.5)

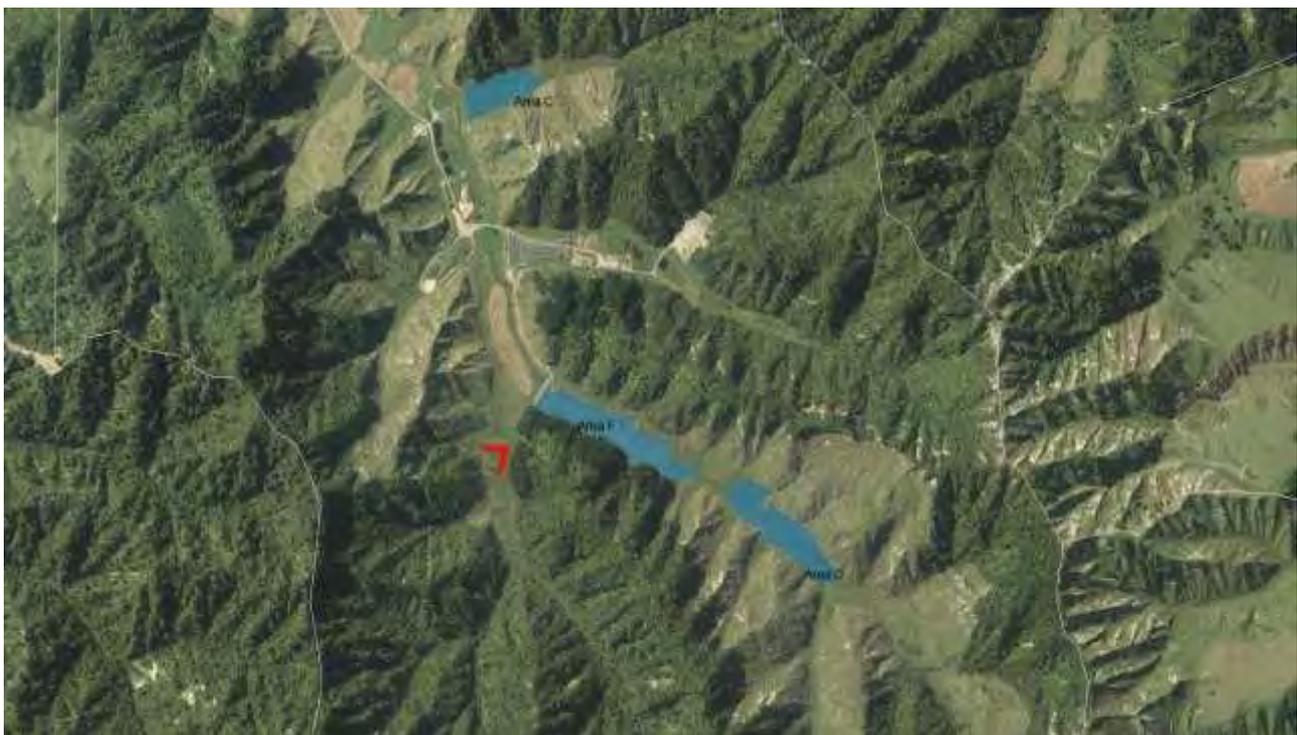
Figure 4.1: Proposed Irrigation Areas C, D & F and Storage Dam in red
