Fonterra Kapuni
Air and Water
Monitoring Programme
Annual Report
2015-2016
Technical Report 2016–52

November 2016

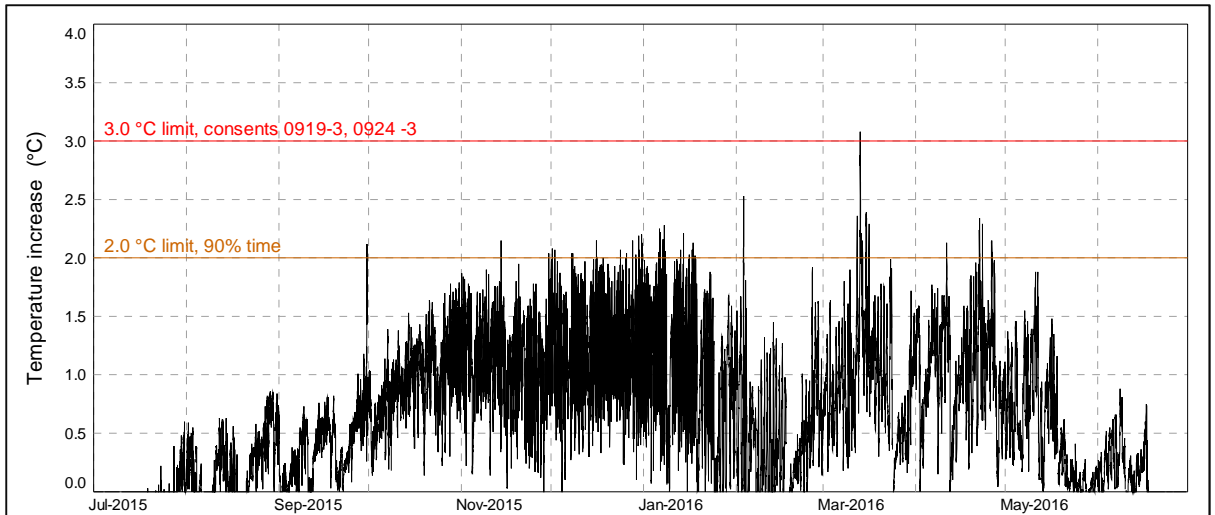
Figure 5 Kaupokonui Stream temperature increase below lactose plant for period 1 July 2015 to 30 June 2016

The temperature record over the 2015-2016 reporting period for the Kaupokonui Stream upstream and downstream of the lactose plant discharge is presented in Figure 3 and Figure 4. The increase in temperature is given in Figure 5.

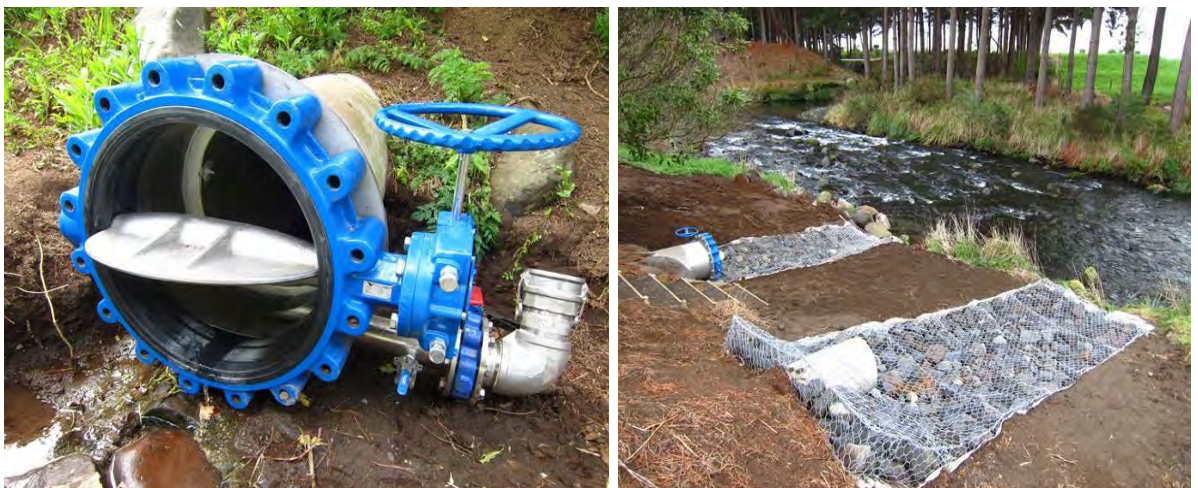
The stormwater outfalls, from the IGL plant installed upstream of the old rail bridge and the detention pond downstream of the cooling water sprayers, did not cause concern during the monitoring period, due to either very low discharge rates or limited contamination of the discharge.

Photo 1 Valve on northern storm drain, and Reno mattresses laid out below storm drains to Kaupokonui Stream

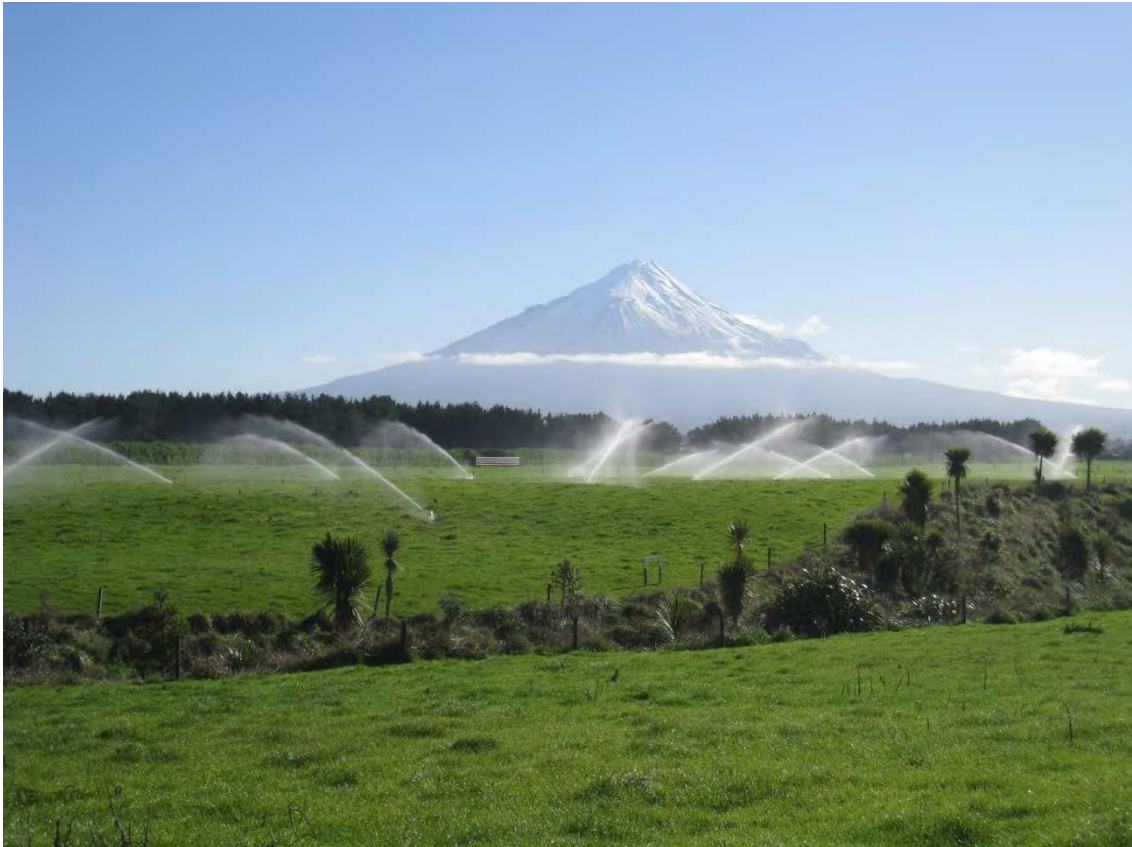
An example of riparian planting is given in Photo 2, along the Waiokura Stream on Farm 2, and about 1.1 km south of Skeet Road (Riparian Management Plan RMP1425). Groundwater monitoring bore GND2050 is situated down-gradient of the fixed-in-place irrigators and up-gradient of the riparian plantings.

Photo 2 Riparian plantings along Waiokura Stream, Farm 2 with fixed irrigators in operation

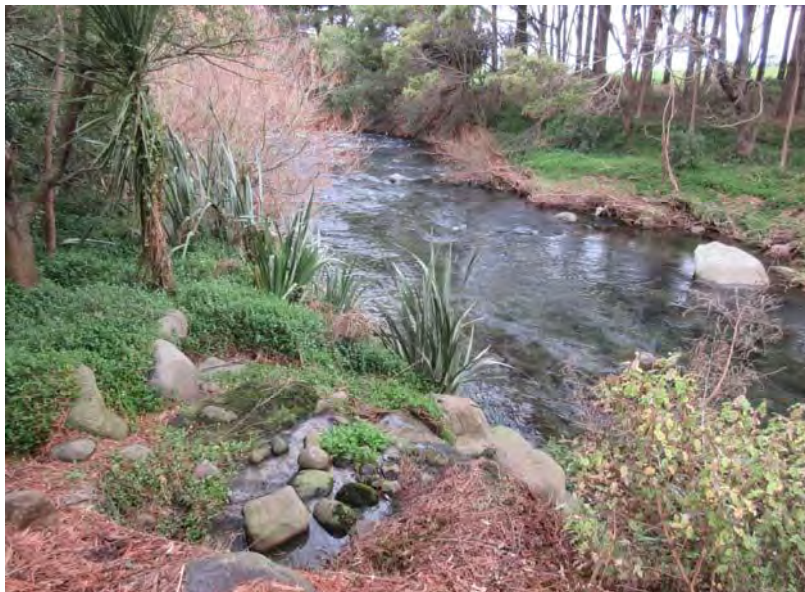
Samples were also collected from the outlet of the stormwater pond (Site STW002078, Table 14 and Photo 3) on four occasions during 2015-2016. The results of the grab samples collected are presented in Table 14. There had been a recent rainfall event prior to the collection of each sample. The stormwater pond outlet valve was closed on all but the last sampling occasion, suggesting groundwater seepage. On 18 February 2016, the stormwater pond contents were being discharged; there was a slight organic odour.

Photo 3 Outfall from stormwater pond to Kaupokonui Stream

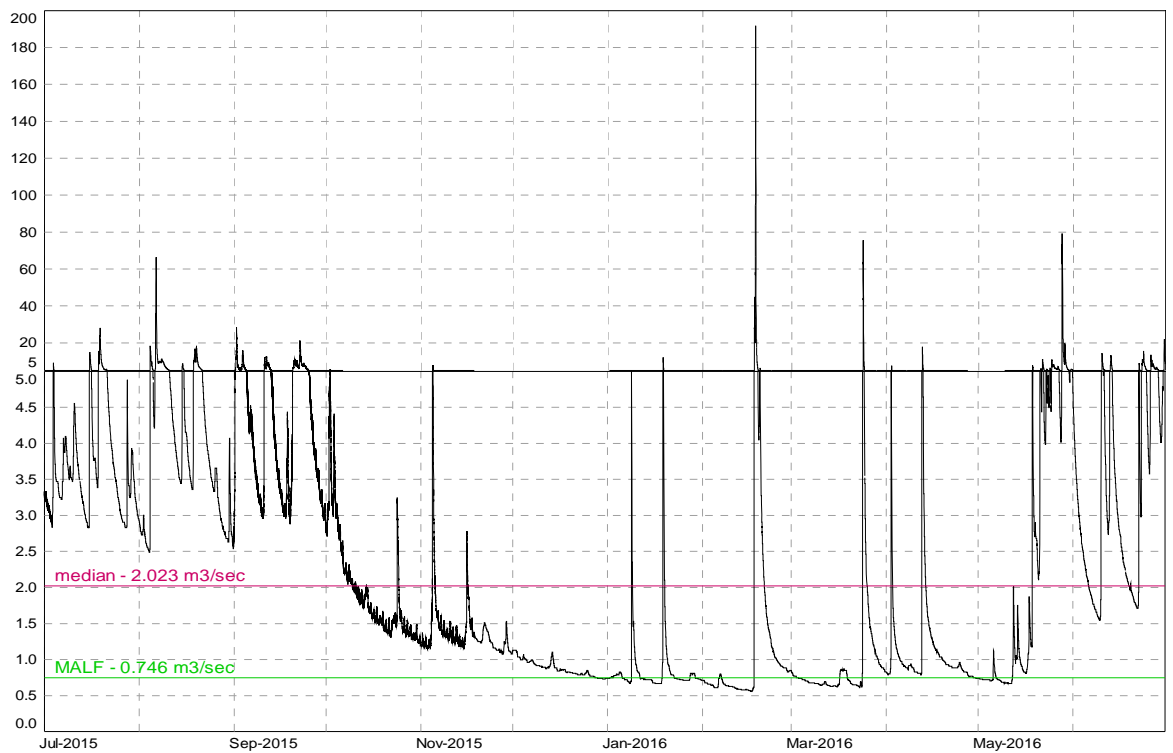
Kaupokonui Stream flow records for the monitoring period for the Glenn Road recording station are presented in Figure 13.

Figure 13 Kaupokonui Stream at Glenn Road flow record (m³/s) for period 1 July 2015 to 30 June 2016

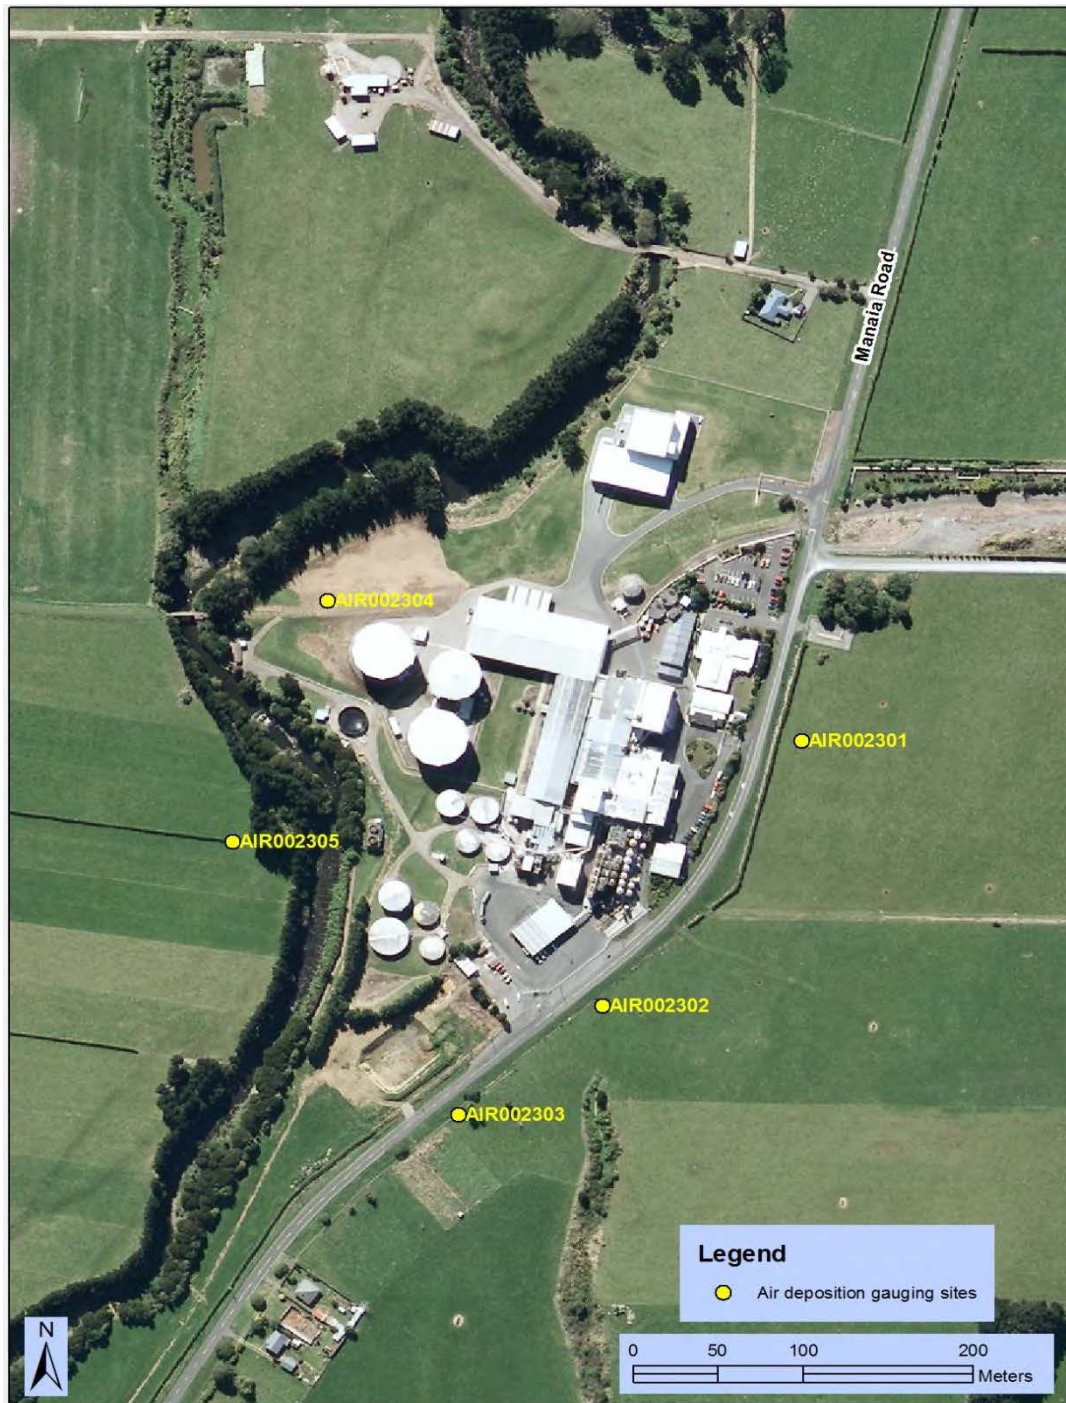
Site number	Description
AIR002301	east of plant, across Manaia Road adjacent to the plant
AIR002302	east of plant, opposite the tanker bay
AIR002303	south of plant
AIR002304	west of plant
AIR002305	south west of plant

Figure 16 Location of air deposition gauging sites

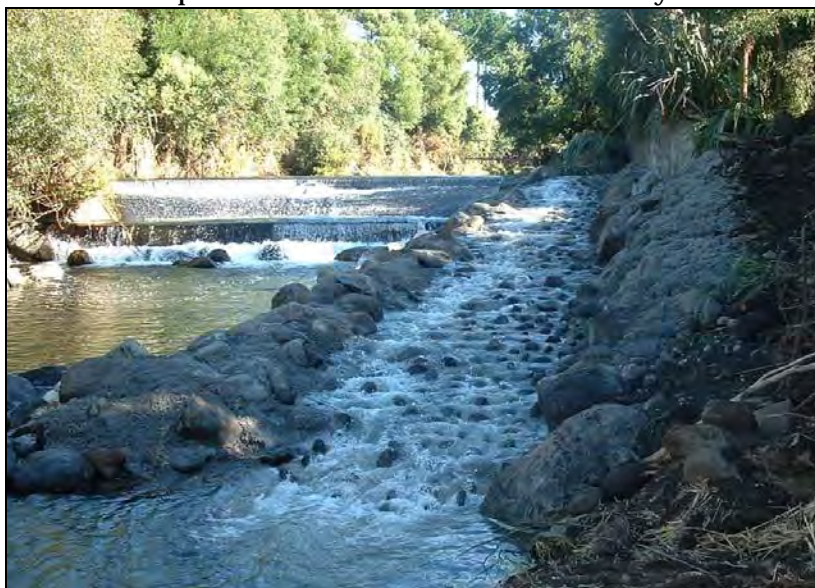
Before any results are interpreted, it is necessary to provide some context. Located downstream of the Kapuni Lactose factory, there is a weir, known as the Glenn Road weir. This weir is an orphaned structure, but is considered to have historical significance. It also presents a significant barrier to the passage of most fish, with only the best climbers being able to negotiate it. It is considered highly unlikely that swimming species, such as common smelt, inanga and torrentfish, could negotiate this weir, and as such they are not expected to be in the Kaupokonui River near the lactose factory.

Figure 1 Kaupokonui Stream, Kapuni Lactose weir and fish pass
