Taranaki Galvanizers  
Monitoring Programme  
Annual Report  
2015-2016

Technical Report 2016-32

November 2016

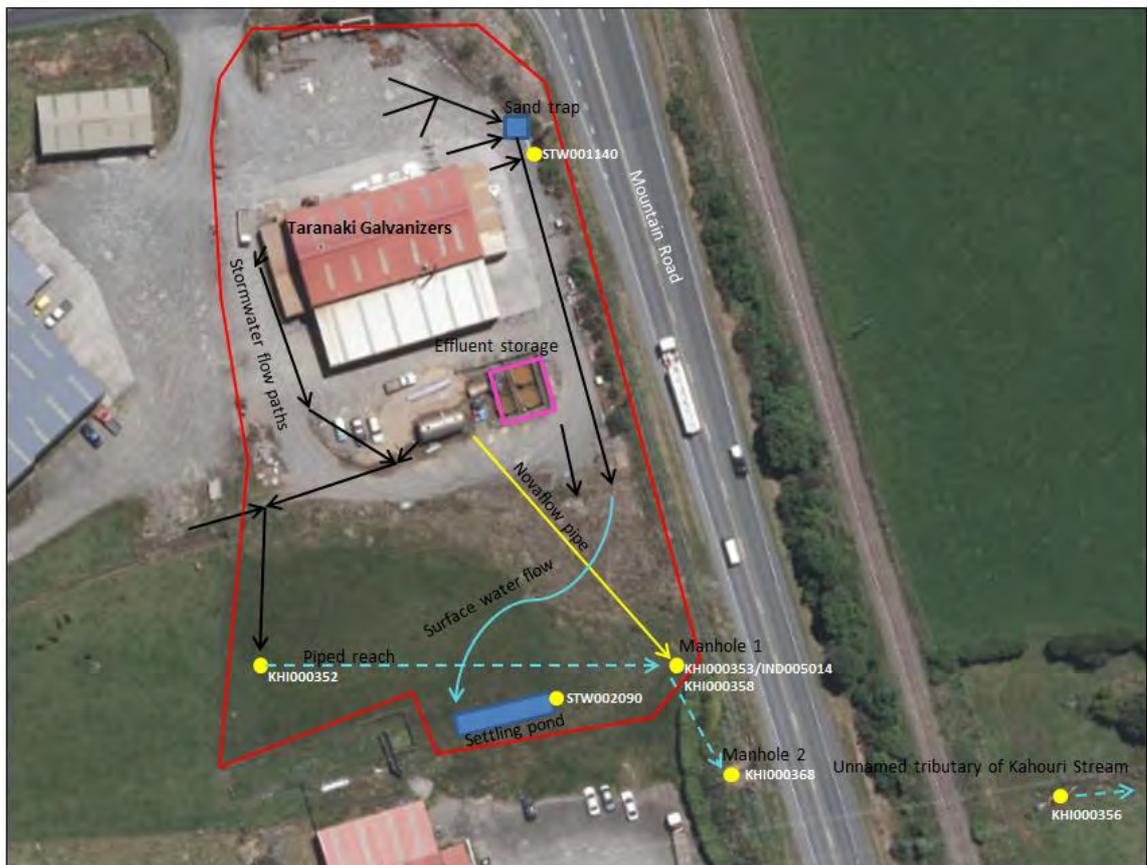
**Figure 1** Taranaki Galvanizers site layout

Stormwater from the southern side of the site either flows overland to a grated manhole (manhole 1 in Figure 1) on the southeastern corner of the site or via a yellow nova flow pipe that then discharges into this same manhole. The yellow novaflow pipe conveys both site stormwater and some groundwater seepage from the southern end of the site and is therefore referred to as an industrial discharge as opposed to only a stormwater discharge. The piped unnamed tributary enters manhole 1 immediately above the point of discharge from the yellow novaflow pipe (Photo 1).

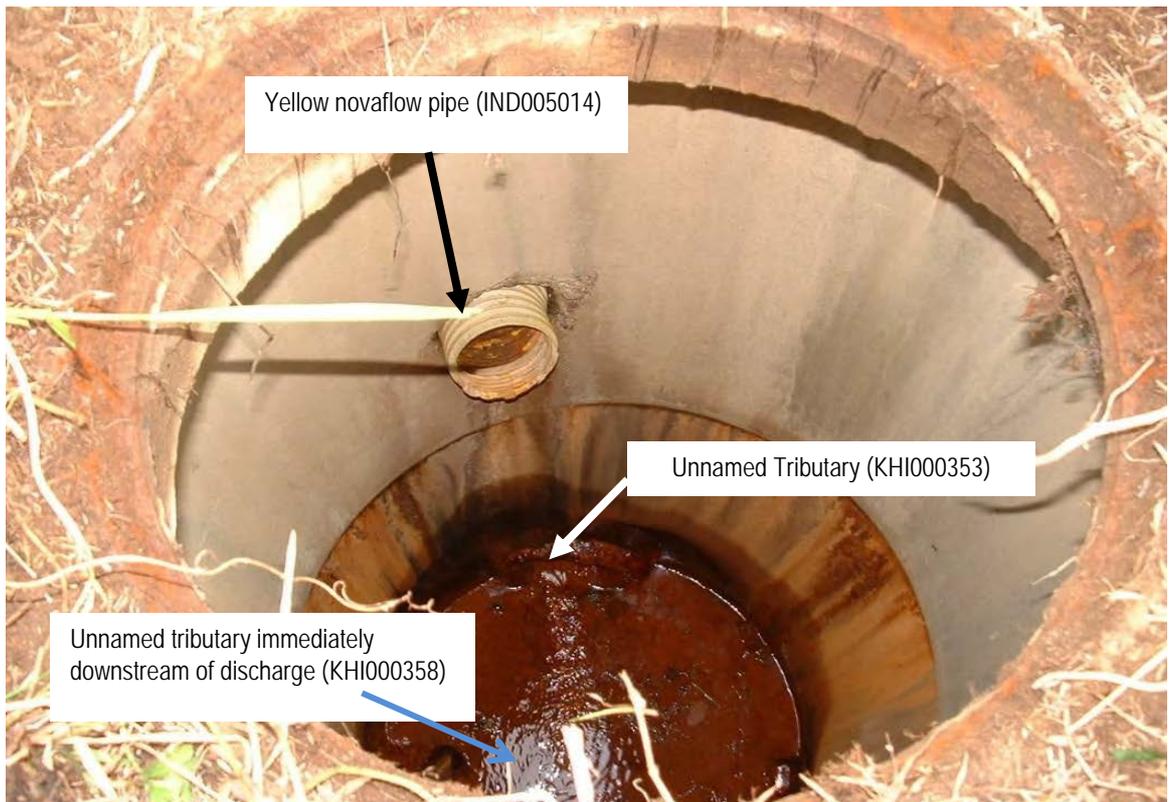
Photo 1 The view down manhole 1<sup>2</sup>

<sup>2</sup> including outlet of the unnamed tributary, the yellow novaflow pipe from the Company's site (IND005014) and the tributary immediately downstream of the discharge (KHI000358)

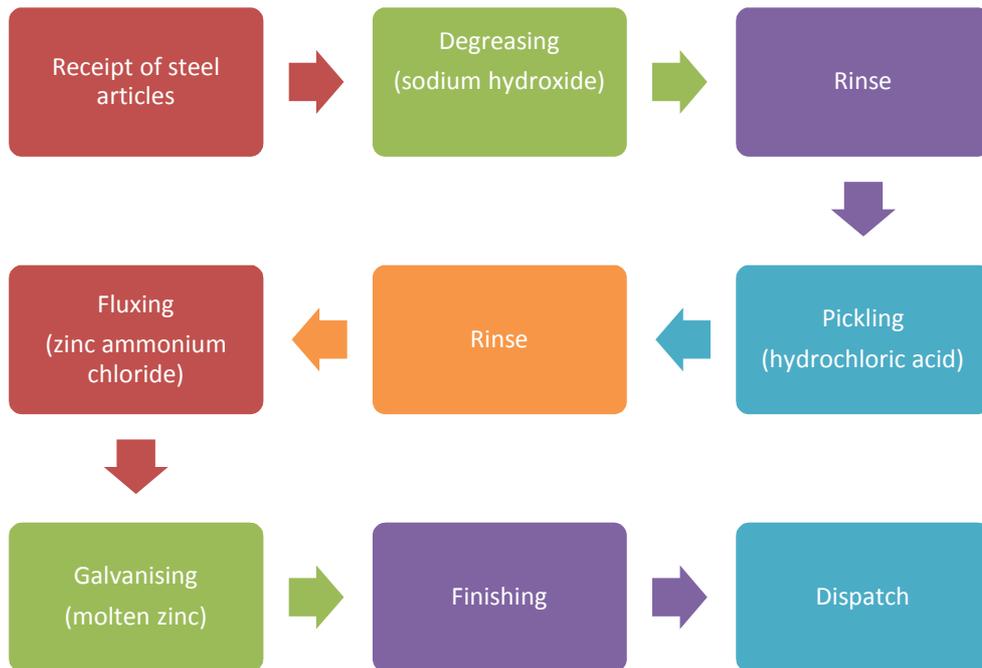
**Figure 2** Hot-dip galvanising process undertaken at Taranaki Galvanizers

The Company utilise a hot-dip galvanising process which protects steel from corrosion by providing a thick, tough metallic zinc alloy coating. The process consists of various stages of preparation and treatment prior to completion of the process. A brief description of the process is given in Figure 2.

The next stage of the process involves the removal of mill scale, rust, paint and other oxides from the article being galvanised by 'pickling', or acid treatment, in

hydrochloric acid. Again, the article is rinsed in water to remove any excess acid and to minimise the amount of acid carried over to the next stage in the process.

The acid-cleaned steel is then immersed in a flux solution containing zinc ammonium chloride to remove the oxide film which forms on the highly reactive steel surface after acid cleaning and prevents further oxidation prior to galvanising. The fluxing treatment also assists with the adhesion of the molten zinc to the steel, thereby providing a more uniform coating.

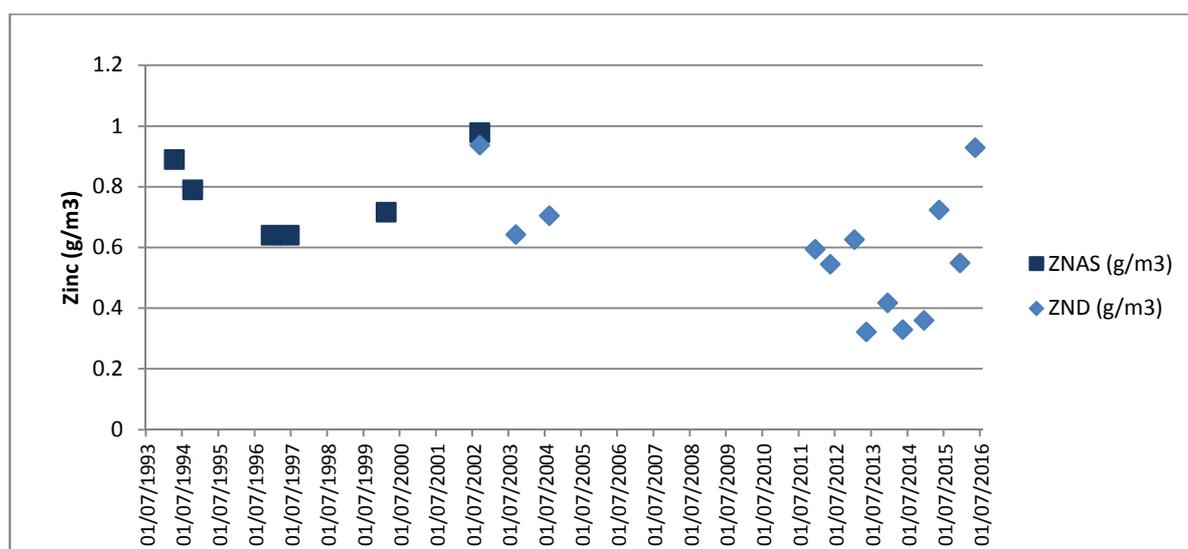
Discharge sampling undertaken in the reported period, at site upstream 2 (KHI000353) showed that the latest concentrations of dissolved zinc ( $0.549 \text{ g/m}^3$  and  $0.929 \text{ g/m}^3$ ) were slightly below or substantially higher than median of historical dissolved zinc concentrations ( $0.640 \text{ g/m}^3$ ) (Figure 3).

**Figure 3** Zinc concentrations in the unnamed tributary of the Kahouri Stream immediately upstream of the Company's industrial discharge since 1994 (site KHI000353).

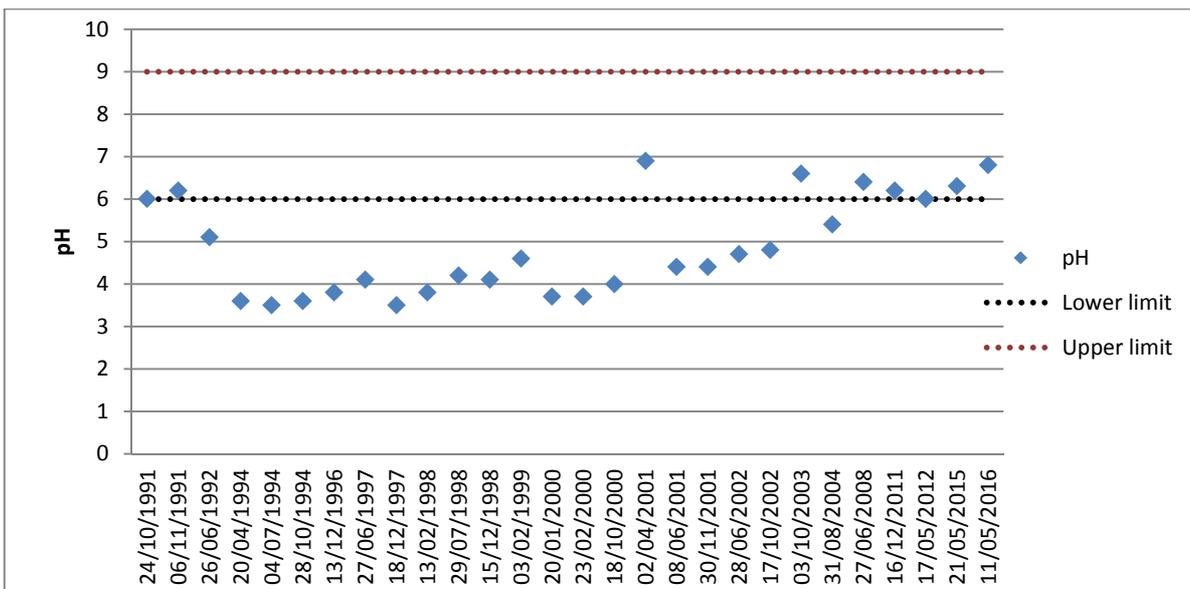
Special condition 4 of consent 4657-2 has specified limits on certain constituents of the discharges including; pH, hydrocarbons, suspended solids and zinc. Although historical discharges do not relate to this consent, these conditions can be a useful guide, to which comparisons can be made. Previous sampling records have shown that pH levels have increased markedly since the 1990's to within the lower end of the consented pH range in the last few years (Figure 4). The concentrations of suspended solids have consistently fallen within the specified consent limits at the industrial discharge site (IND005014) (Table 3).

**Figure 4** pH levels recorded in the discharge (IND005014) from the Company's site between October 1991 and May 2016<sup>3</sup>

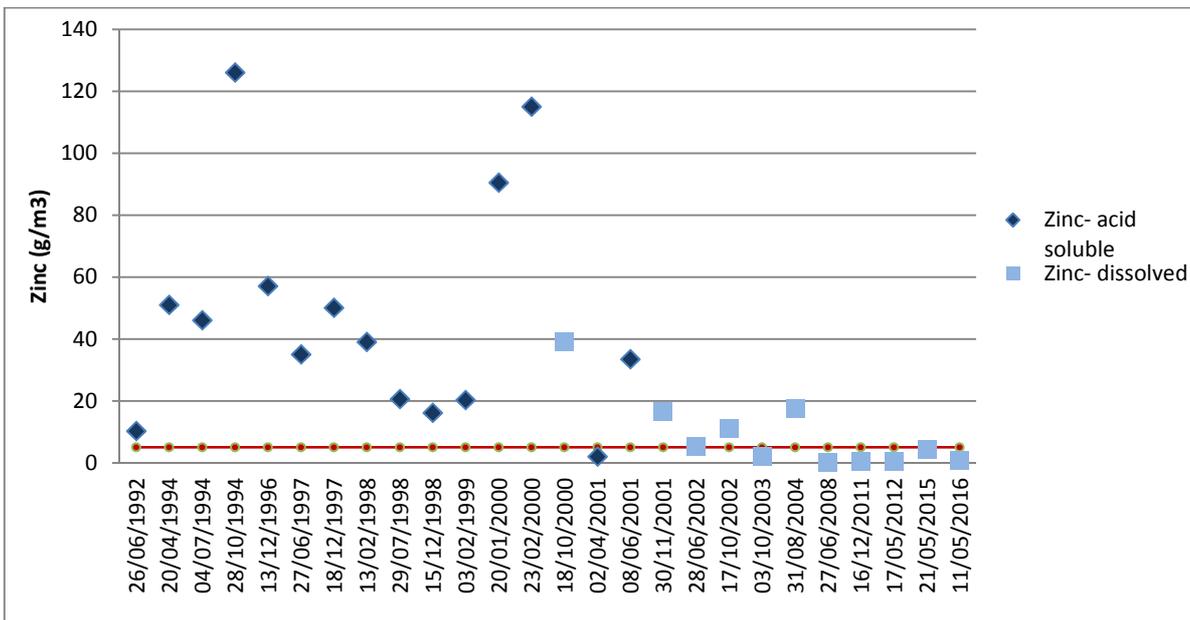
Dissolved zinc concentrations have fallen within the consent limit of 5 g/m<sup>3</sup> (consent conditions granted June 2010) and have decreased considerably in the last 12 years and the current result (0.808 g/m<sup>3</sup>) continued the trend of falling values at the site (Figure 5).

**Figure 5** Zinc concentrations recorded in the discharge sample (IND005014) from the Company's site between June 1992 and May 2015<sup>4</sup>

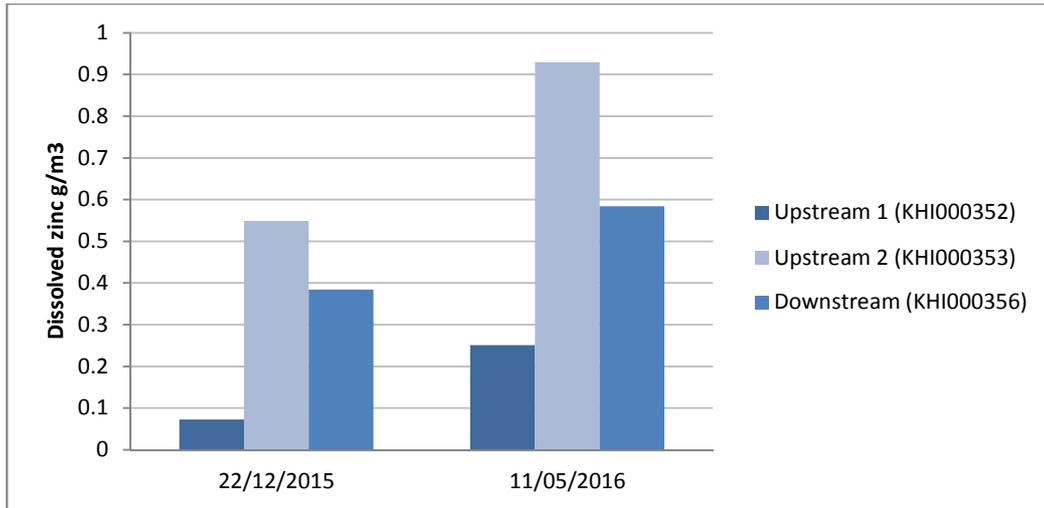
There was a decrease of zinc by 0.165 g/m<sup>3</sup> between site upstream 2 and the downstream site (0.384 g/m<sup>3</sup>) during the 22 December 2015 survey (Figure 6). Typically, freshwater waterbodies do not naturally have zinc concentrations above 0.060 g/m<sup>3</sup>. As there was no industrial (IND005014) or stormwater discharge (STW001140) at the time of survey it was assumed the elevated zinc concentrations at the downstream site was due to the contaminated bore underneath the Company's site. There was a decrease of zinc by 0.345 g/m<sup>3</sup> between site upstream 2 and the downstream site (0.584 g/m<sup>3</sup>) (Figure 6) during the 11 May 2016 survey despite elevated zinc concentrations from the industrial discharge. The reduction in zinc concentration may have been a result of dilution due to the high rainfall which occurred at the time of the survey.

**Figure 6** Dissolved zinc concentrations in the unnamed tributary of the Kahouri Stream upstream and downstream of the site on two survey occasions in 2015-2016.

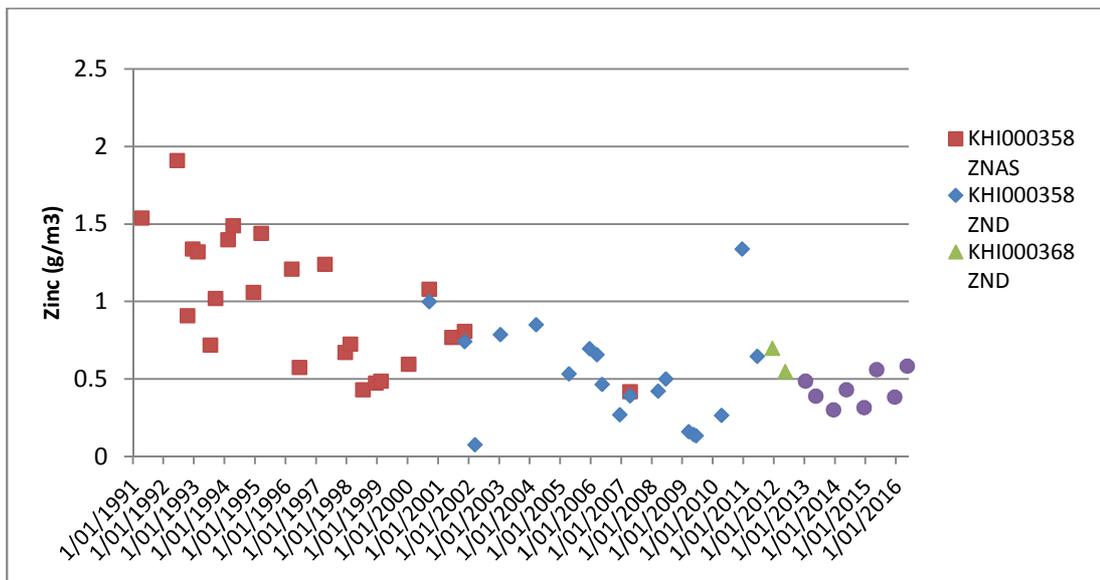
Monitoring of the unnamed tributary of the Kahouri Stream began after the discovery of the contaminated bore on the Company’s site. This monitoring has shown that zinc concentrations in the tributary decreased during the 1990’s, then remained relatively constant, varying between the detection limit of 0.005 g/m<sup>3</sup> and 1 g/m<sup>3</sup>. Recent monitoring data suggest that zinc concentrations are still relatively stable with an average of 0.584 g/m<sup>3</sup> recorded at the site (KHI000356). Results for the downstream sites previously sampled (KHI00058 (1991-2010) and KHI000368 (2010-2012), and the current downstream site (KHI000356) show a decline over time (Figure 7). It is considered likely that it will take some years before the zinc concentrations in the tributary are reduced significantly due to the level of contamination (from the bore) under the Company’s site.

**Figure 7** Zinc concentrations in the unnamed tributary of the Kahouri Stream downstream of the Taranaki Galvanizers industrial discharge since 1991<sup>5</sup>
