Lower Waiwhakaiho Catchment
Monitoring Programme
Annual Report
2016-2017

Technical Report 2017-07

March 2018

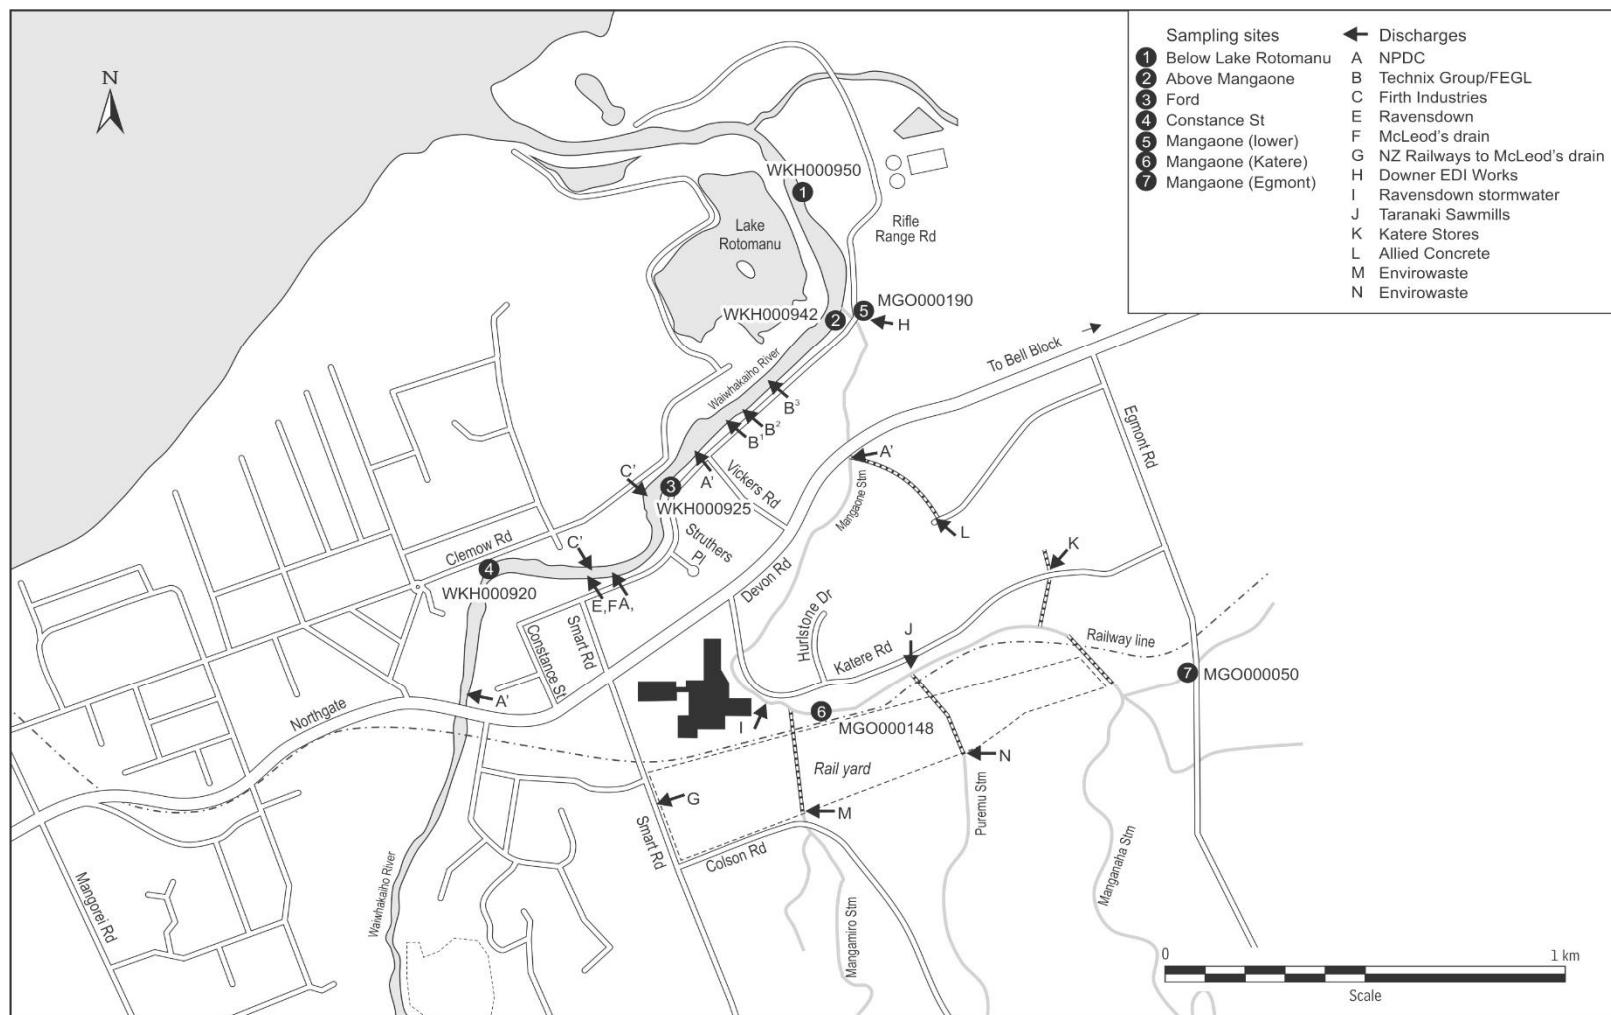
Figure 2 Lower Waiwhakiahi River and Mangaone Stream discharges

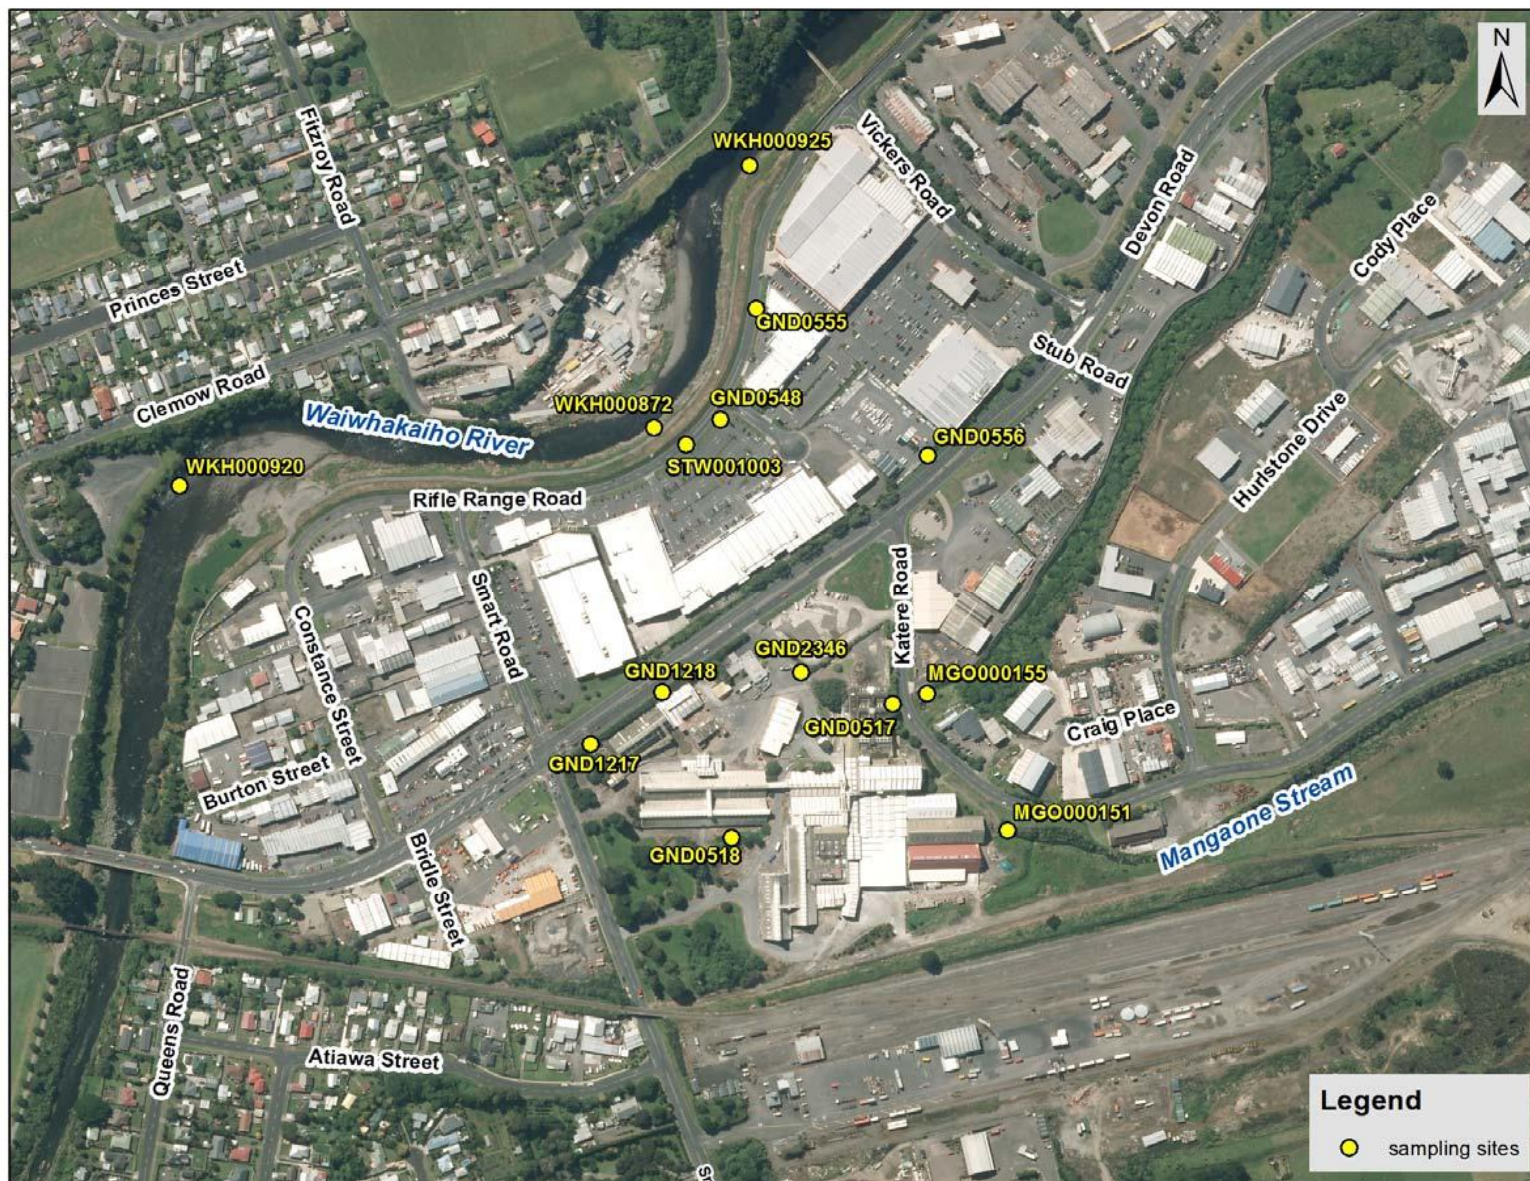
Figure 4 Location of groundwater monitoring bores and associated sampling sites

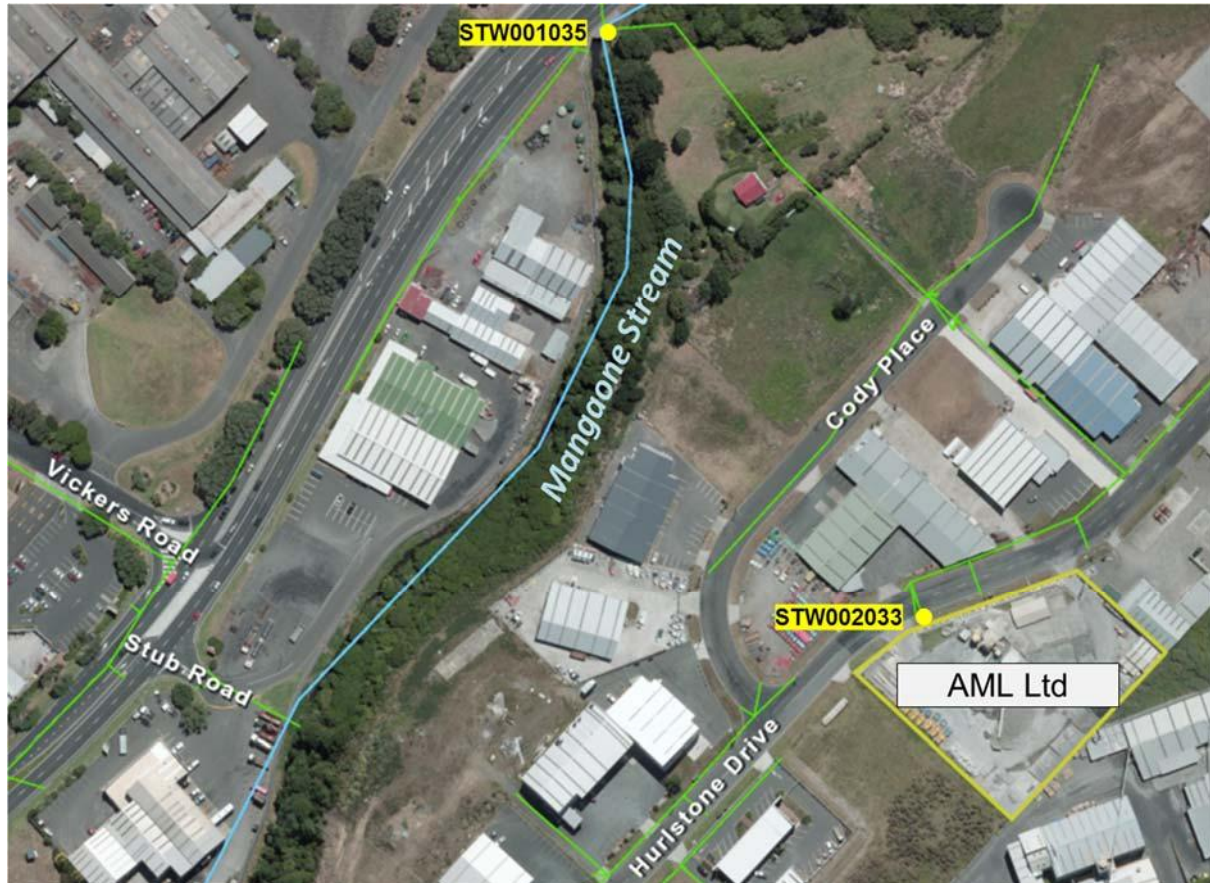
Stormwater from the majority of the site drains directly to the New Plymouth District Council (NPDC) stormwater system and then to the Mangaone Stream.

Figure 5 AML Ltd (trading as Allied Concrete) site location and stormwater drainage

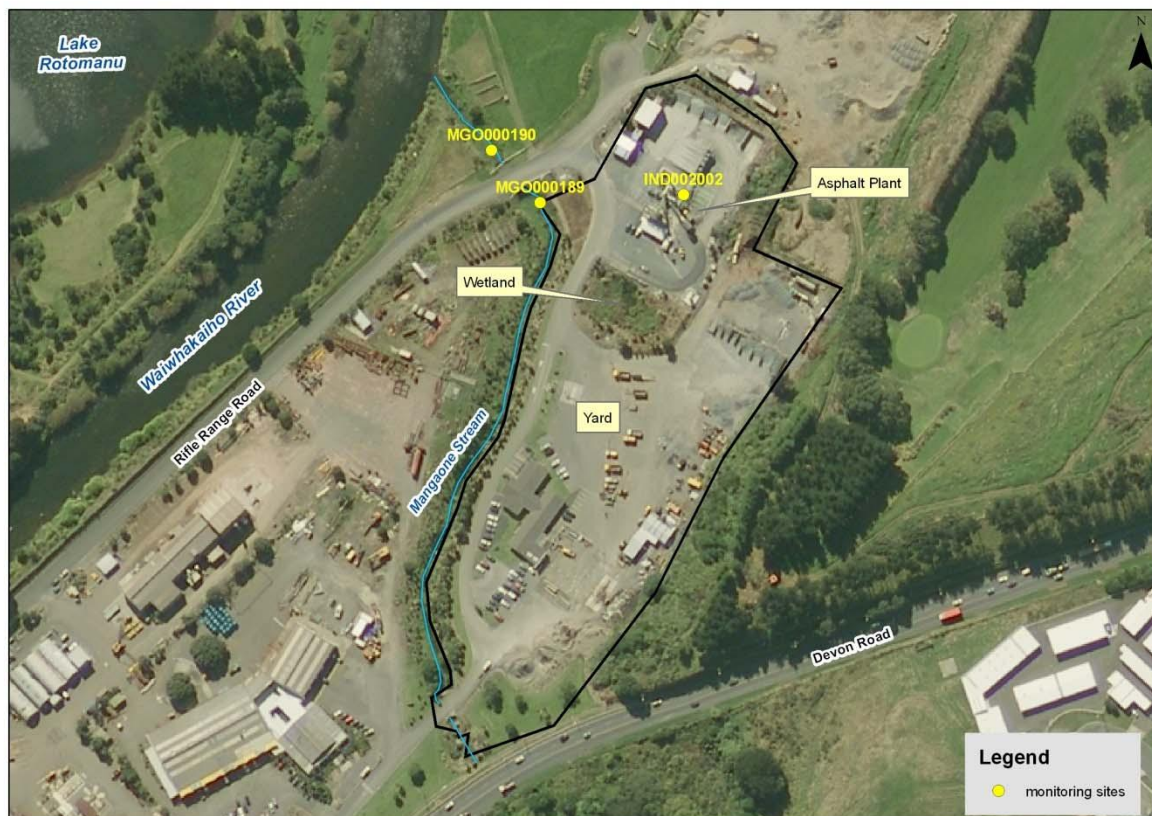
Downer EDI Works Ltd (Downer) operates an asphalt manufacturing plant at a site off Rifle Range Road. A depot for maintenance, parking and storage of equipment and materials used in road-making is also on the site.

Figure 6 Downer's site and sampling point locations

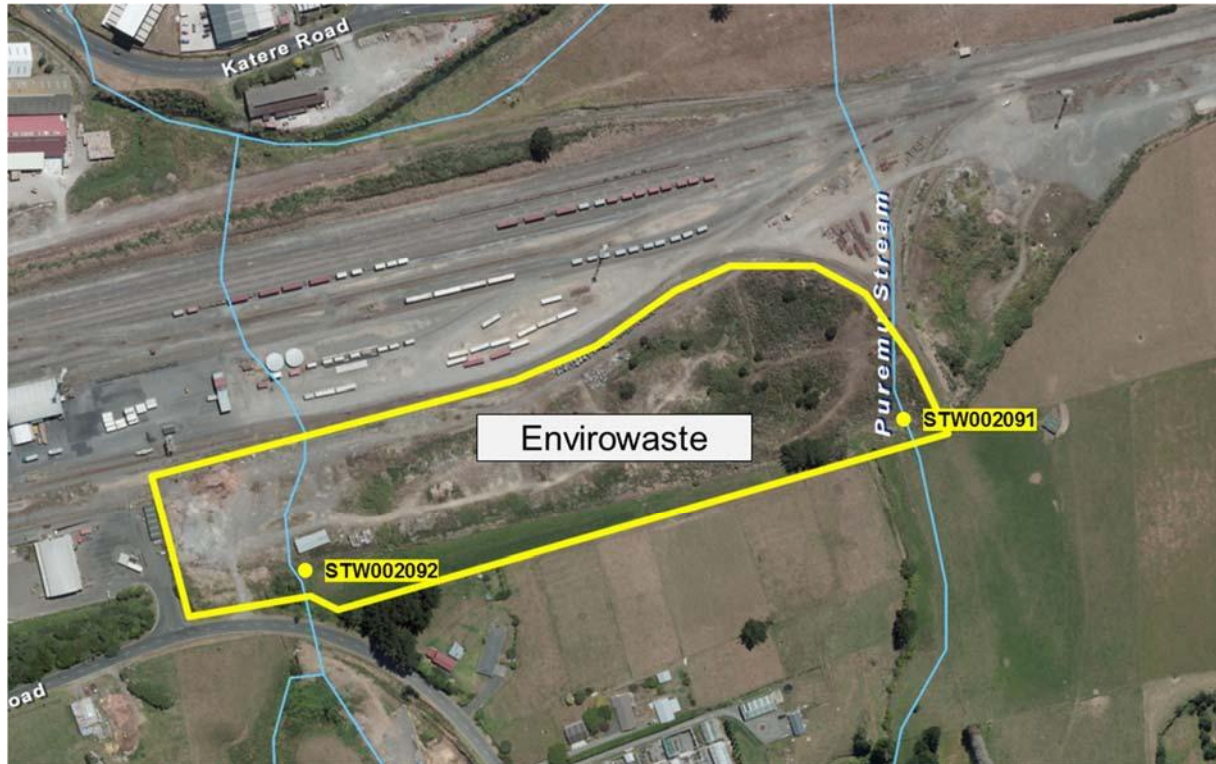
Stormwater from the site discharges via retention ponds to the Puremu and Mangamiro Streams. Prior to discharge the stormwater is treated in long sediment ponds that discharge via grates to prevent litter being carried with it.

Figure 7 Envirowaste's site and sampling locations

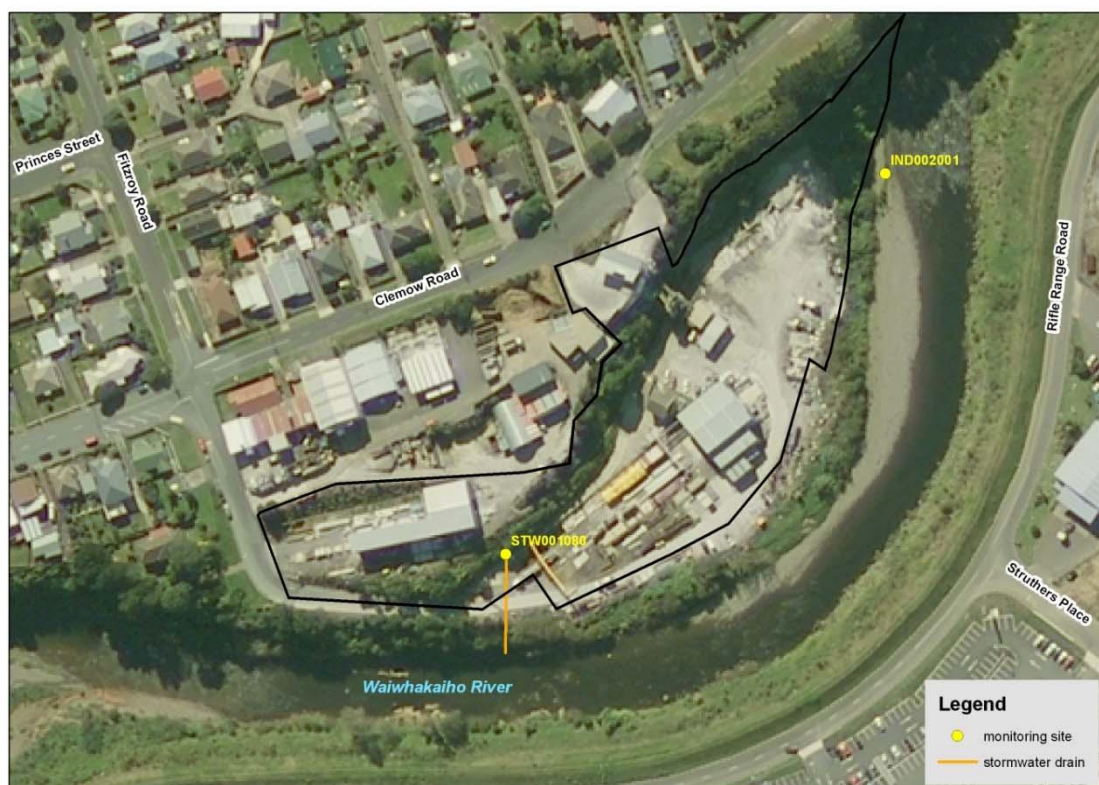
Firth Industries Ltd (Firth) operates a concrete batching plant on a 1.19 ha site off Clemow Road, on the true left bank of the Waiwhakaiho River. The plant is situated partly on the flood plain and partly above the escarpment formed by the river. A concrete precast factory operated by Ultimate Engineered Concrete Ltd is also on the site. This includes a bedding plant, which operates from an area above the escarpment.

Figure 8 Firth Industries site location and discharge points

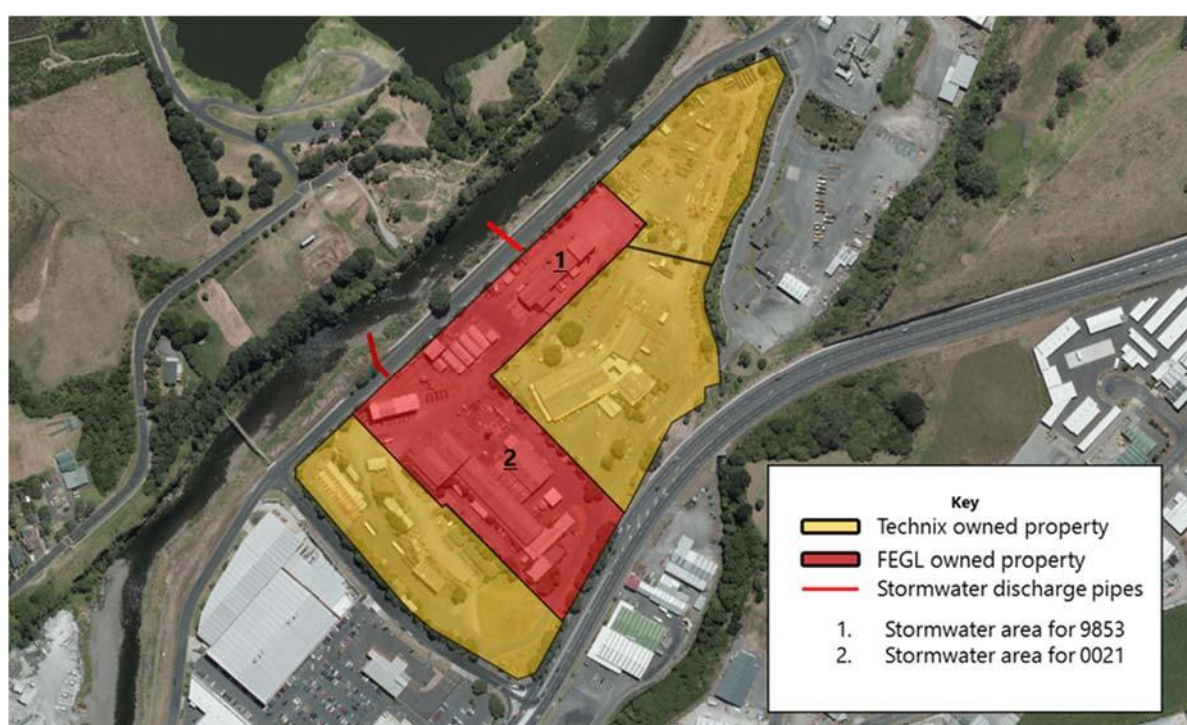
Figure 9 Technix Group Ltd and Fitzroy Engineering Group Ltd subdivided site

The site was previously leased by FEG from Technix Group Ltd (TGL), and the stormwater discharges from FEG's activities were covered under consents held by TGL. In 2013 FEG purchased the part of the property they operate on from Technix (Figure 9). After the purchase of the property resource consent 0021-3 was transferred from Technix to FEG. Resource consent 0291-3 was split into two consents as the northern area covered by this consent was now owned by FEG. The consent number assigned to this catchment area was consent number 9853.

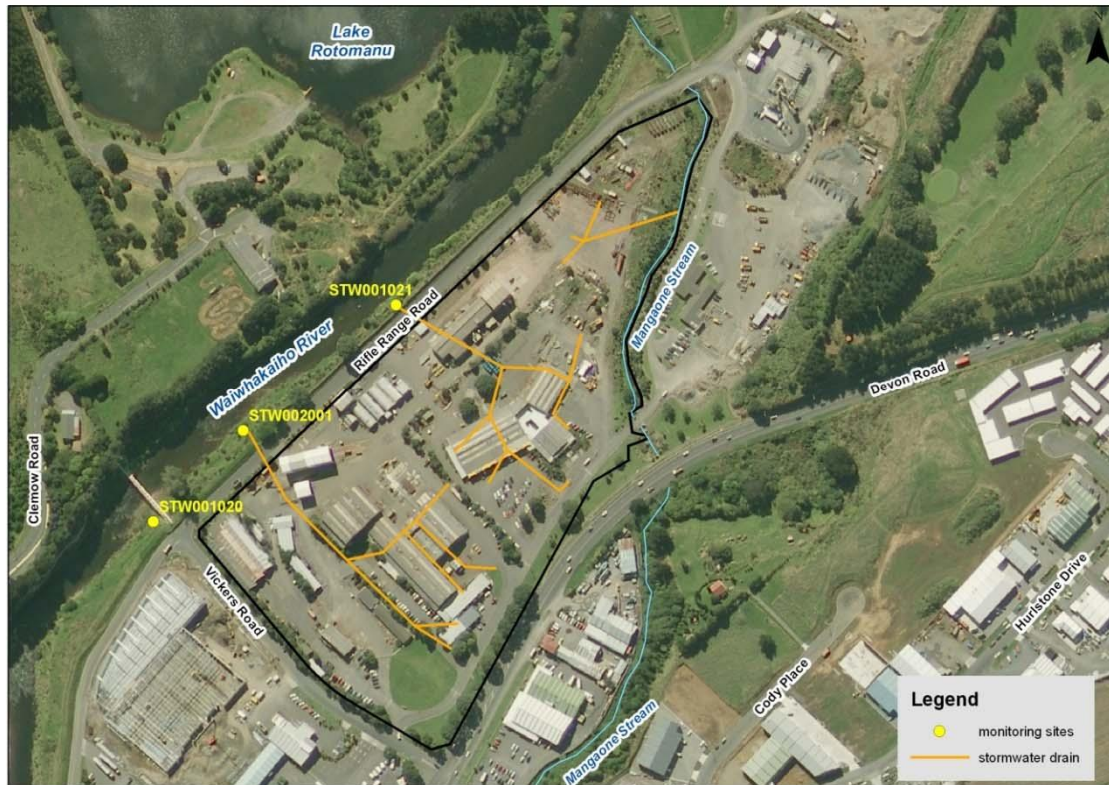
- Staff offices and facilities,
- Workshops (Machining, plate and general),
- Dangerous goods storage,
- Liquid oxygen tanks, and
- Blast and paint storage.

Figure 10 Fitzroy Engineering Group Ltd site and stormwater discharge points

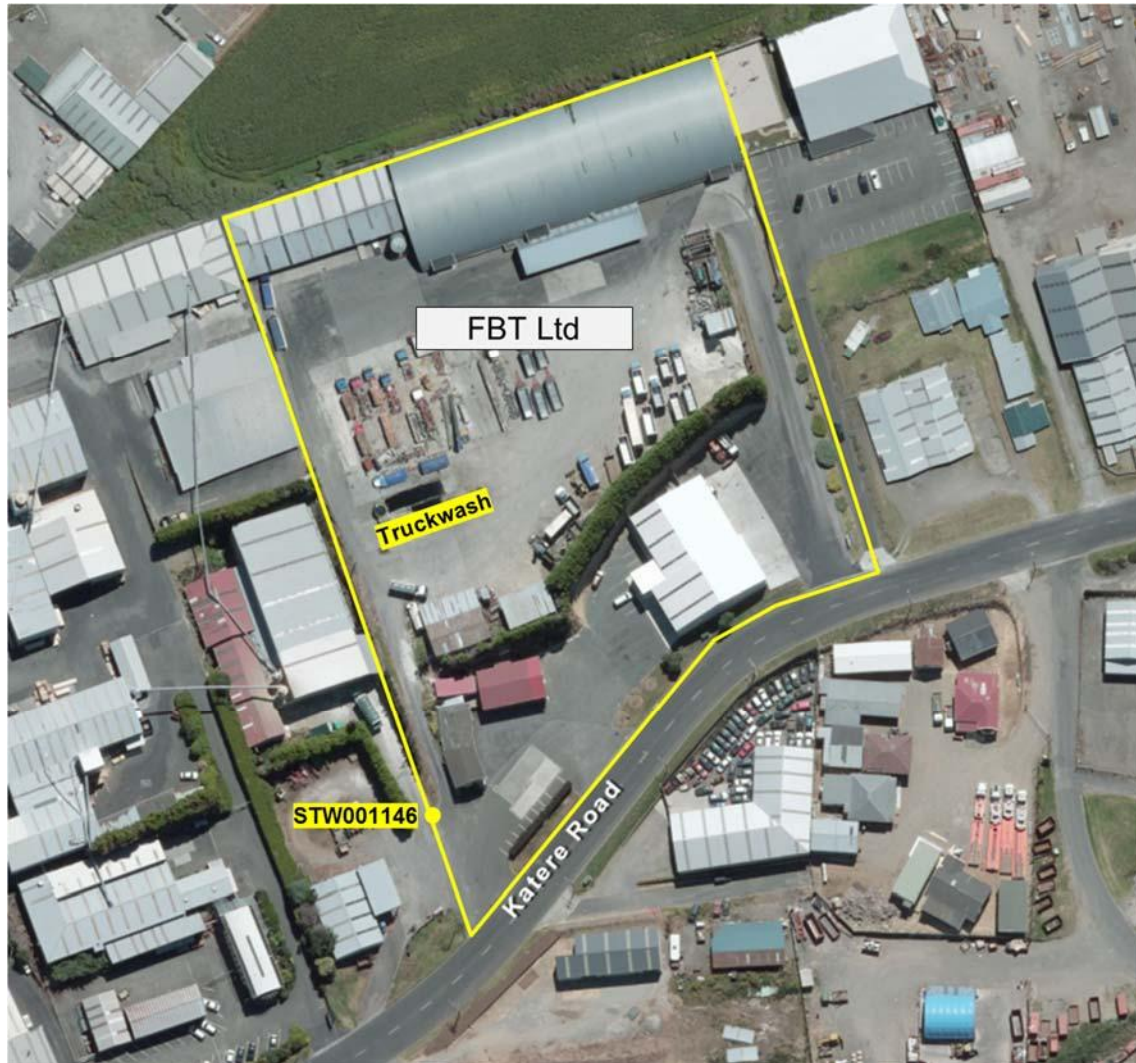
Figure 11 Location of Freight and Bulk Transport Holdings site

Freight and Bulk Transport Holdings Ltd (FBT) operate a truck depot that services the rural sector from a 1.77 ha site on Katere Road (Figure 11).

FBT stores, blends and distributes dry stock feeds such as crushed meal, palm kernel and grains. Lime, fertiliser and gravel used for farm races are also stored at the site. The lime, stock feeds and fertilisers are stored in the sheds at the northern end of the site; only the gravel is stored outside in the stormwater catchment. Trucks are washed at the site and the wash water is directed to soak holes.

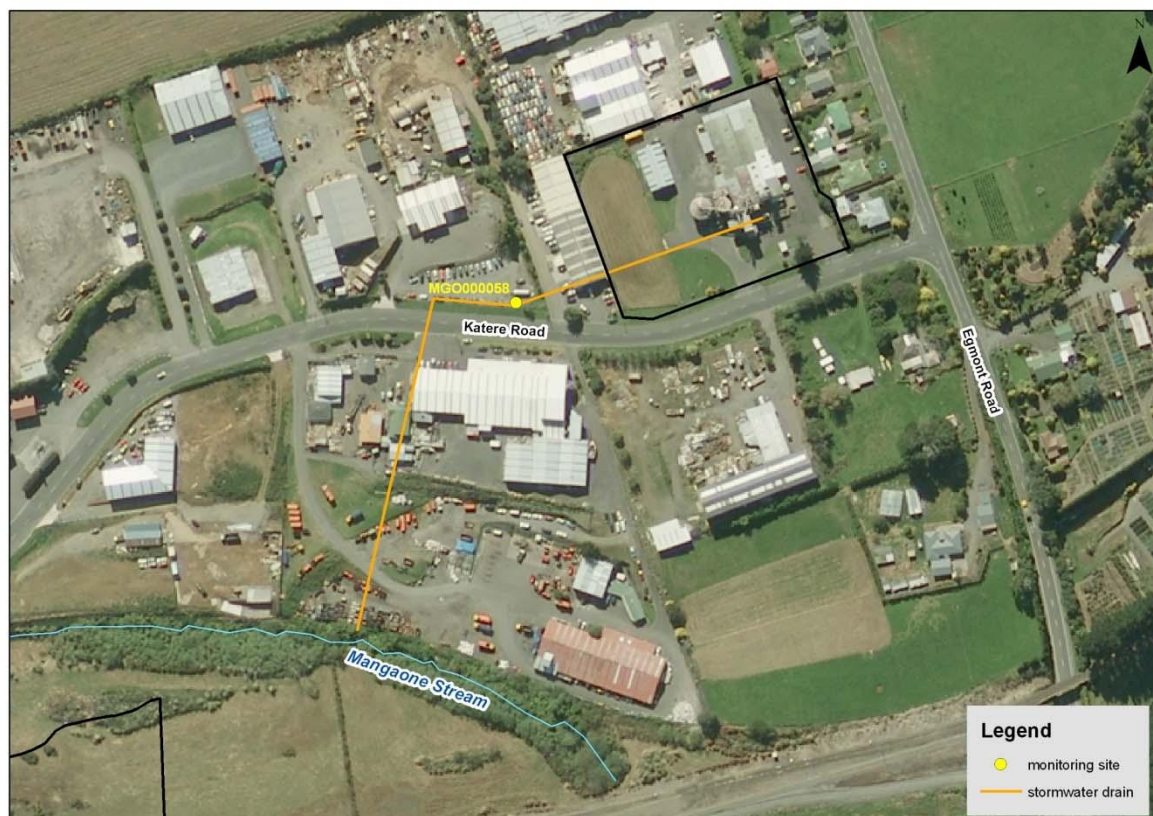
Until recently the decommissioned New Plymouth Feed Mill site was occupied by Farmlands Co-operative Society Ltd (Farmlands). Farmlands had been in operation on this 1.03 ha site at the eastern end of Katere Road, New Plymouth from 1966 to 2011. Raw grain and supplements were processed into feed for central North Island divisions of PCL Industries Ltd and then Viterra (NZ) Ltd. The site is now occupied by its owner, Katere Stores Ltd (Katere Stores) and is used for feed truck storage.

Figure 12 Katere Stores site and sampling point location

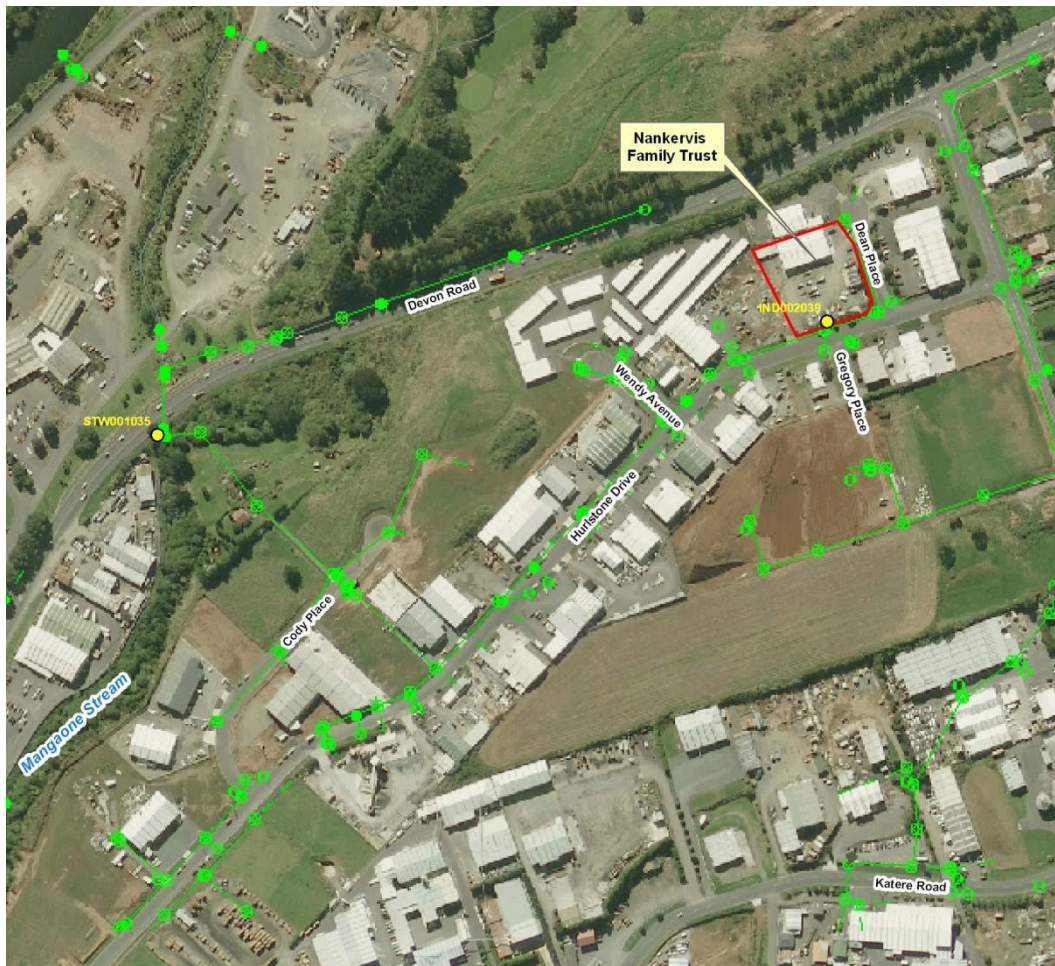
Wash down water, from the truck wash bay discharges to a drain which is directed to an inceptor system. This then discharges into the NPDC's stormwater system (via discharge site IND002039) and then into the Mangaone Stream (via discharge site STW001035). It was stated at the time of the application that up to approximately 1.0 m³ of wash water would be discharged per day.

Figure 13 Nankervis Family Trust site location and discharge point

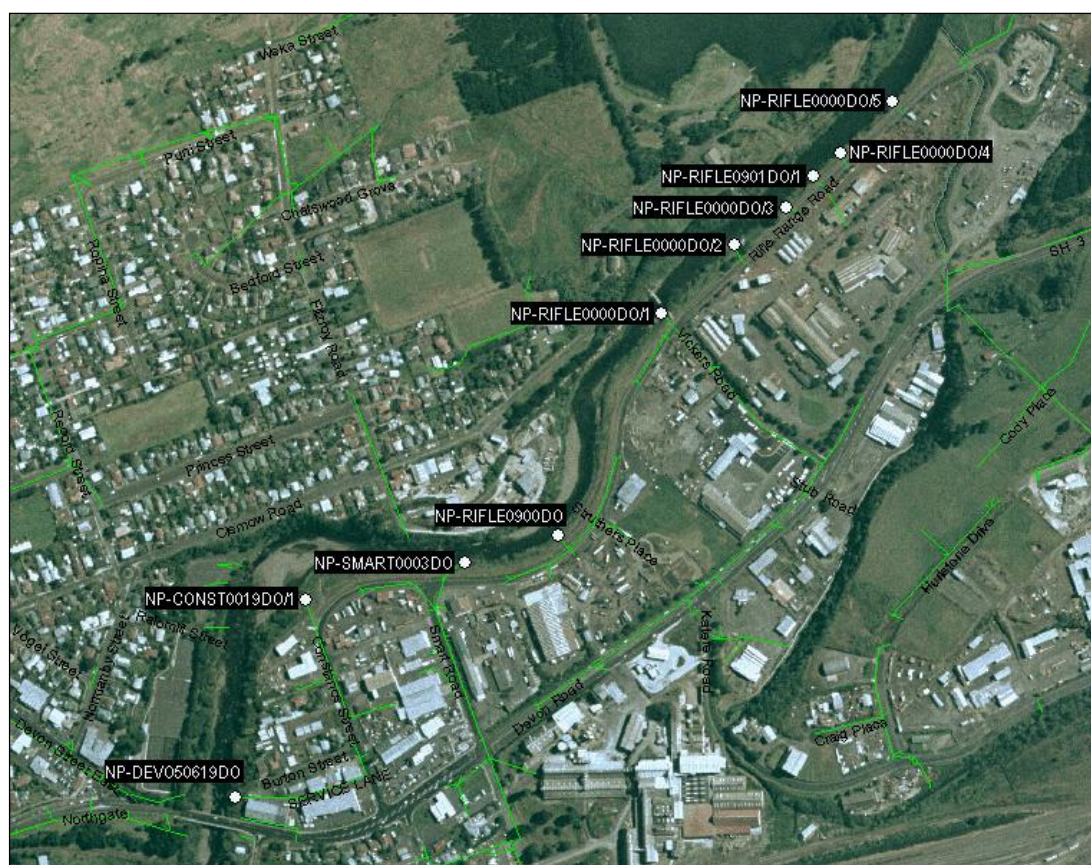
NPDC holds two resource consents in relation to discharges to the Lower Waiwhakaiho River below State Highway 3, and one consent in relation to discharges to the Mangaone Stream.

Figure 14 NPDC stormwater drainage and consented discharge points to the Waiwhakaiho River

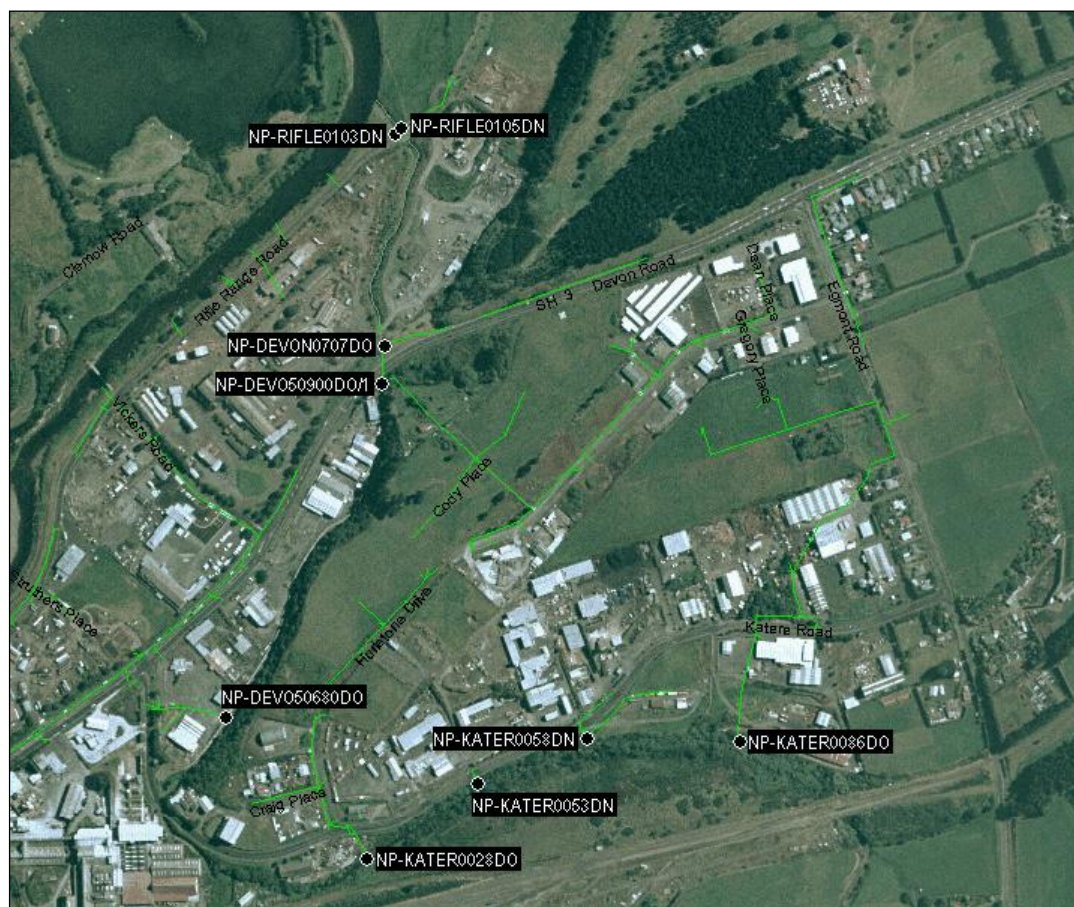
Figure 15 NPDC stormwater drainage and consented discharge points to the Mangaone Stream

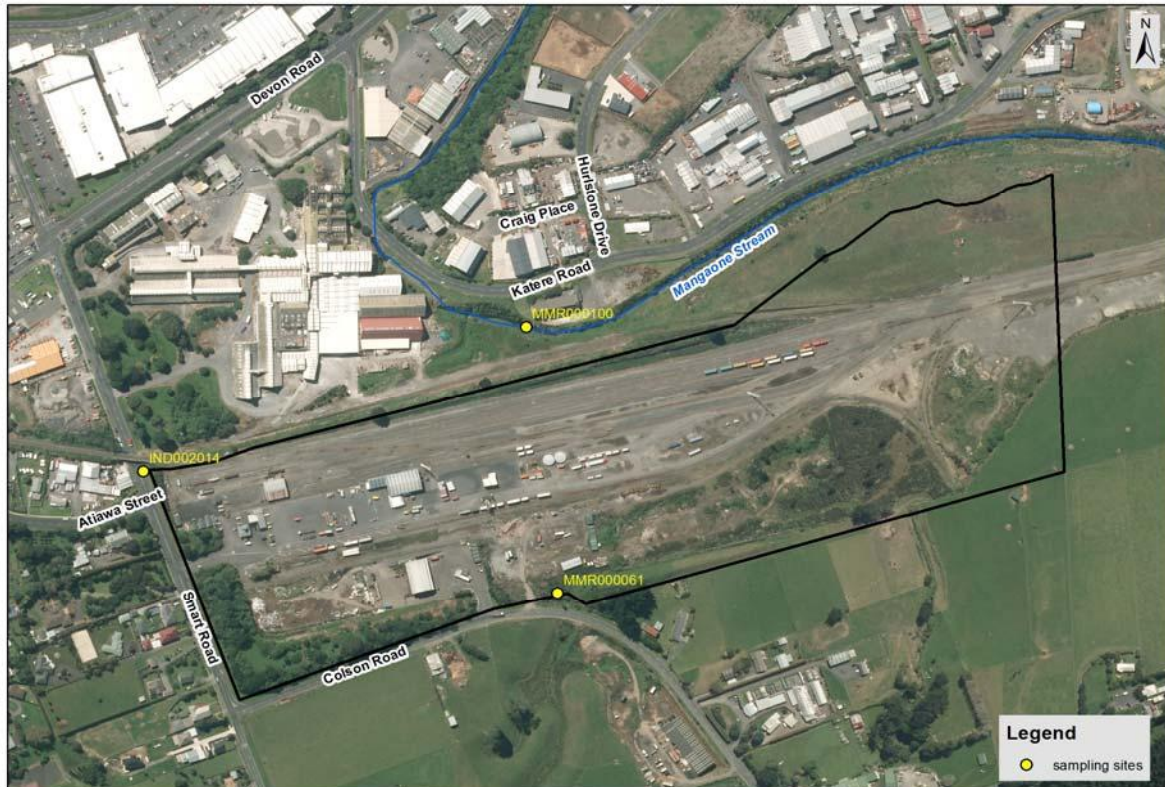
New Zealand Railways Corporation/KiwiRail (KiwiRail) owns a rail terminal on a site off Smart Road. In addition to transportation of freight, the terminal is utilised as a maintenance depot. The freight receipt and dispatch area and the refuelling and maintenance depots are situated at the Smart Road end of the site.

Figure 16 New Zealand Railways Corporation's rail yard and sampling point locations

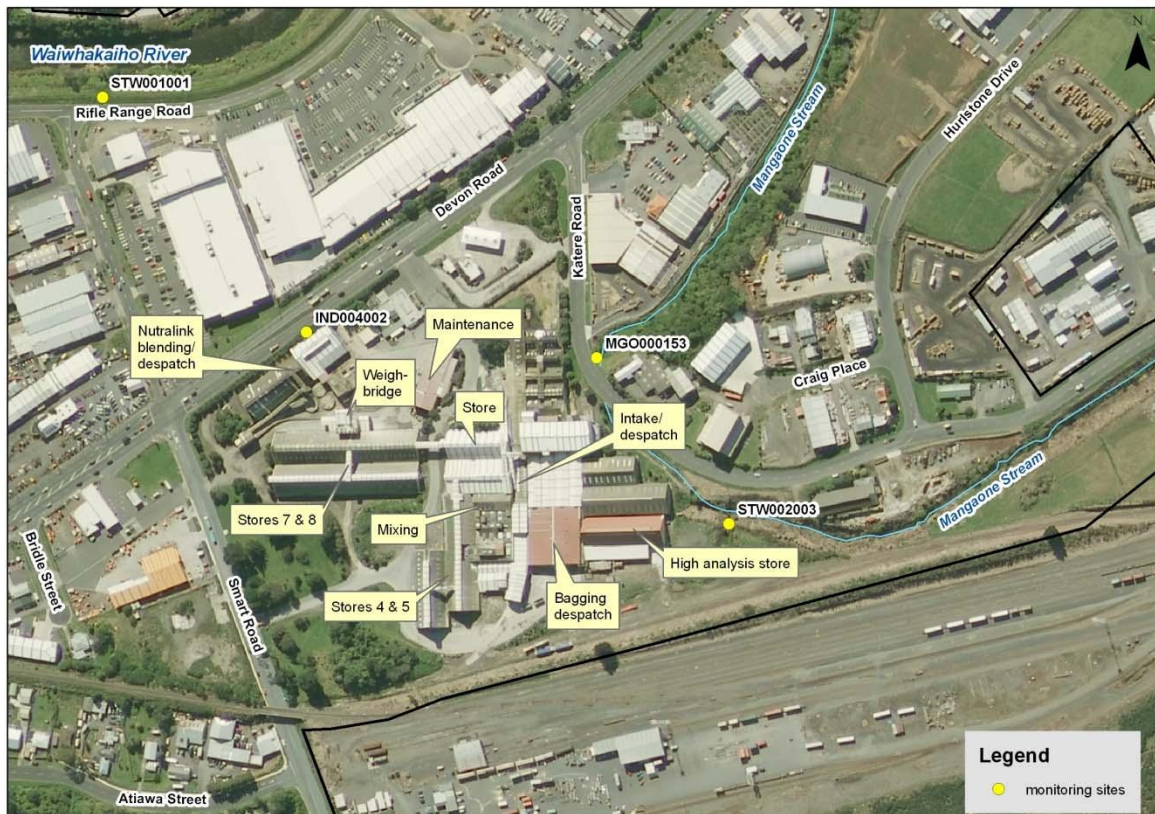
The New Plymouth depot of Ravensdown Fertiliser Co-operative Ltd (Ravensdown) occupies an area of about 7 ha bounded by Devon, Smart and Katere Roads, and the Smart Road rail yard (Figure 17). The Mangaone Stream touches the eastern boundary. The depot receives, bags, blends and distributes fertilisers in various forms, namely superphosphate, lime, dolomite and imported high analysis products such as ammonium sulphate, urea, triple super, potassium chloride (potash) and monoammonium and diammonium phosphates (MAP & DAP). Small volumes of trace element fertilisers such as zinc sulphate are also handled through the store. Approximately 250,000 tonnes of fertiliser are distributed per annum.

Figure 17 Ravensdown Fertiliser Co-operative Ltd site and sampling point locations

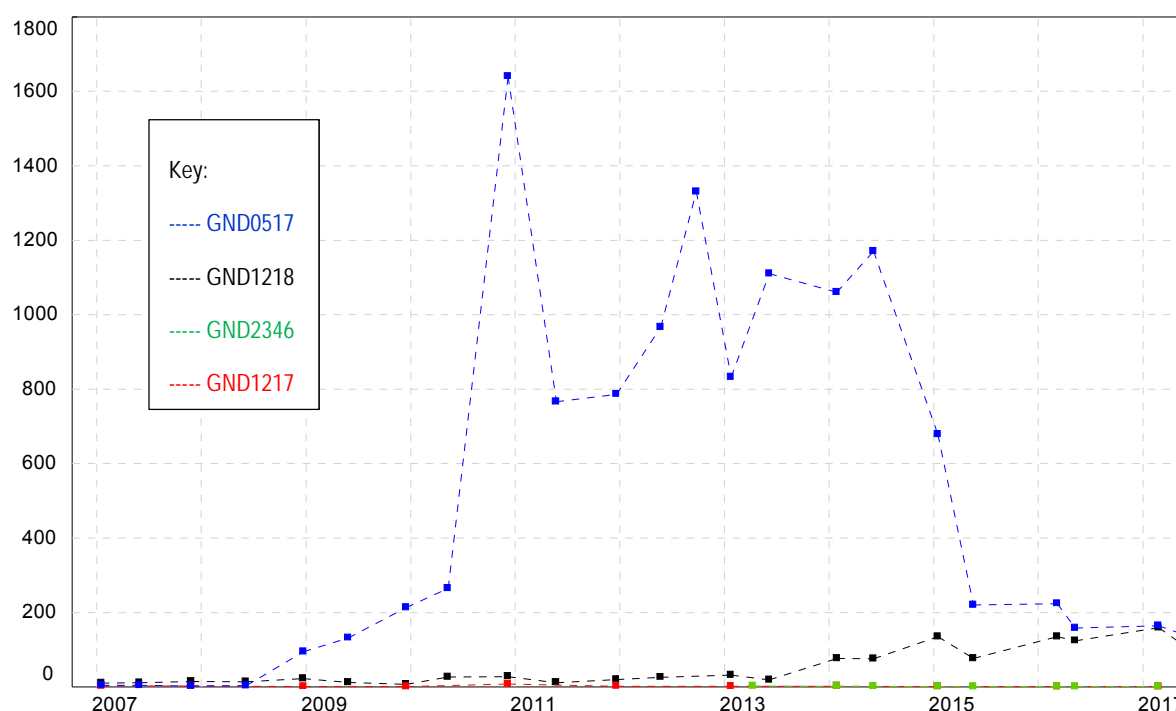
Parameter	Unit	GND1218	GND2346	GND0517	MGO000151	MGO000155
Conductivity @ 20°C	mS/m	144	36.8	214	16.7	17.0
DRP	g/m ³ P	0.004	0.084	1.52	0.005	0.006
Un-ionised ammonia	g/m ³	0.02567	0.03390	3.20062	0.00052	0.00063
Ammoniacal nitrogen	g/m ³ N	107	0.893	138	0.114	0.139
pH	pH	5.8	8.0	7.8	7.2	7.2
Sulphate	g/m ³	413	<1	147	7.2	
Temperature	Deg.C	16.9	17.3	16.7	13.1	13.2
Total phosphorus	g/m ³ P	0.018	0.194	1.58	0.021	0.019

Figure 18 Ammoniacal nitrogen concentration at sites GND0517, GND1218, GND2346 and GND1217 from 2006 to June 2017

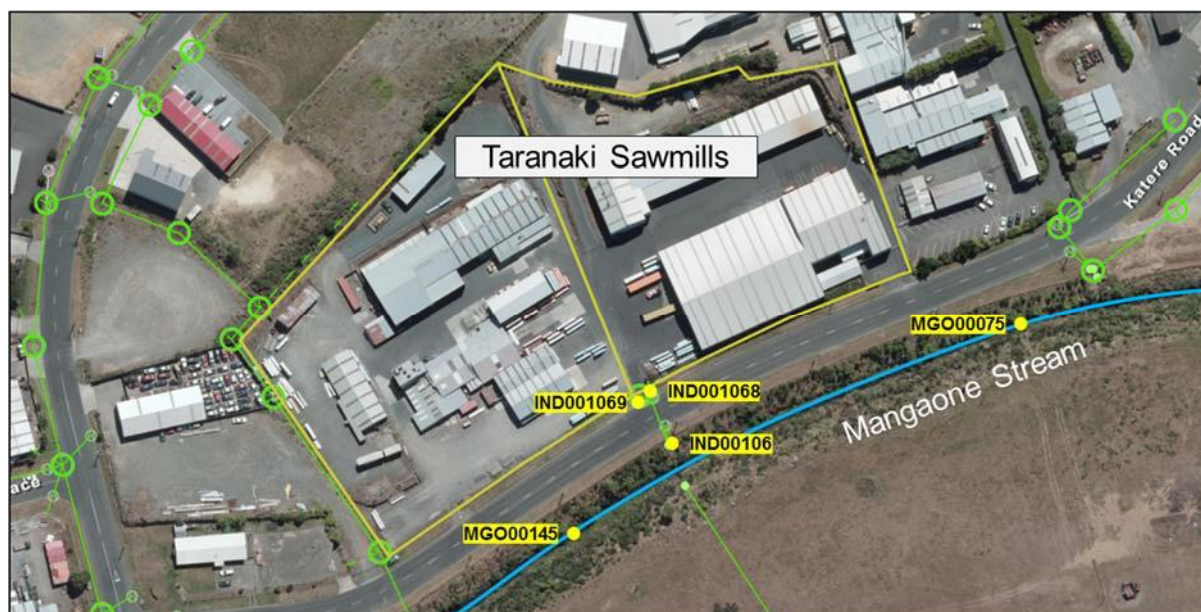
Timber is treated at two plants. At one plant, timber is treated with copper, chromium and arsenic (CCA), and with boron. At the other plant, light organic solvent preservatives (LOSP) is used.

Figure 19 Taranaki Sawmills site and sampling point locations

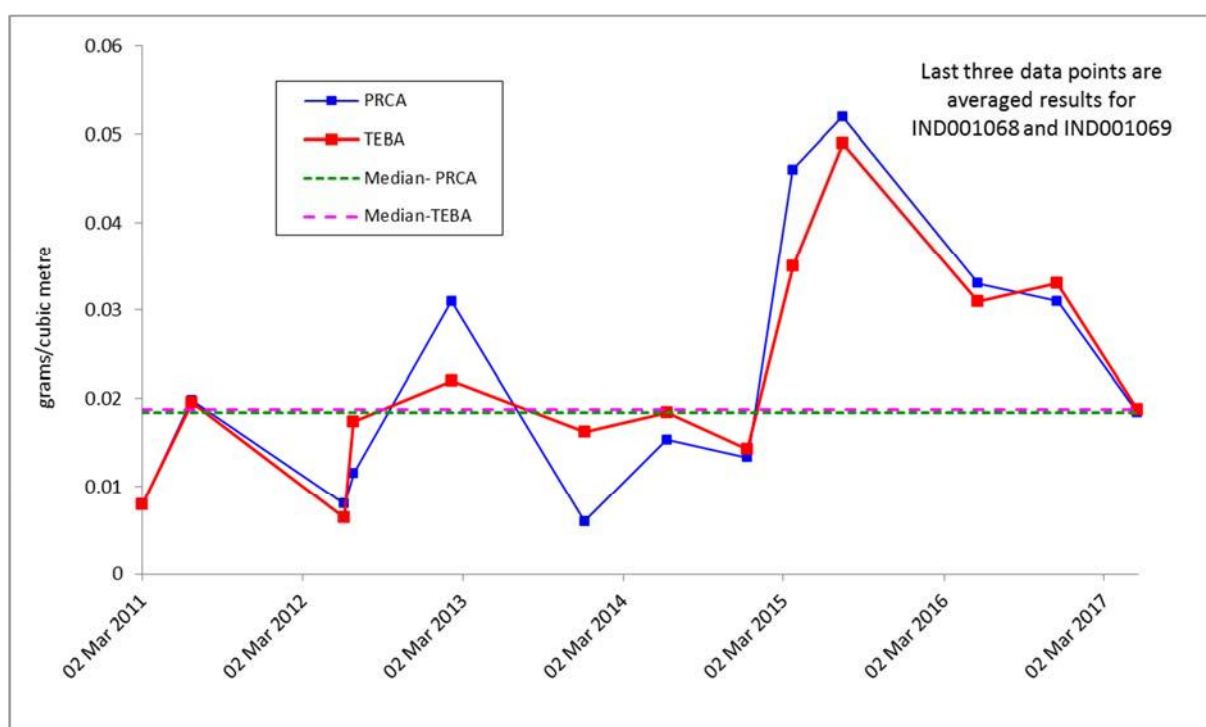
Monitoring of the treatment chemicals IPBC, permethrin, PRCA and TEBA was initiated in the 2010-2011 year after TSM changed to using these chemicals rather than tributyltin. Levels of these contaminants have been known to fluctuate over time with the latest results being similar to the median of all results from TSM discharges.

Figure 20 LOSP chemical concentrations in TSM's discharge

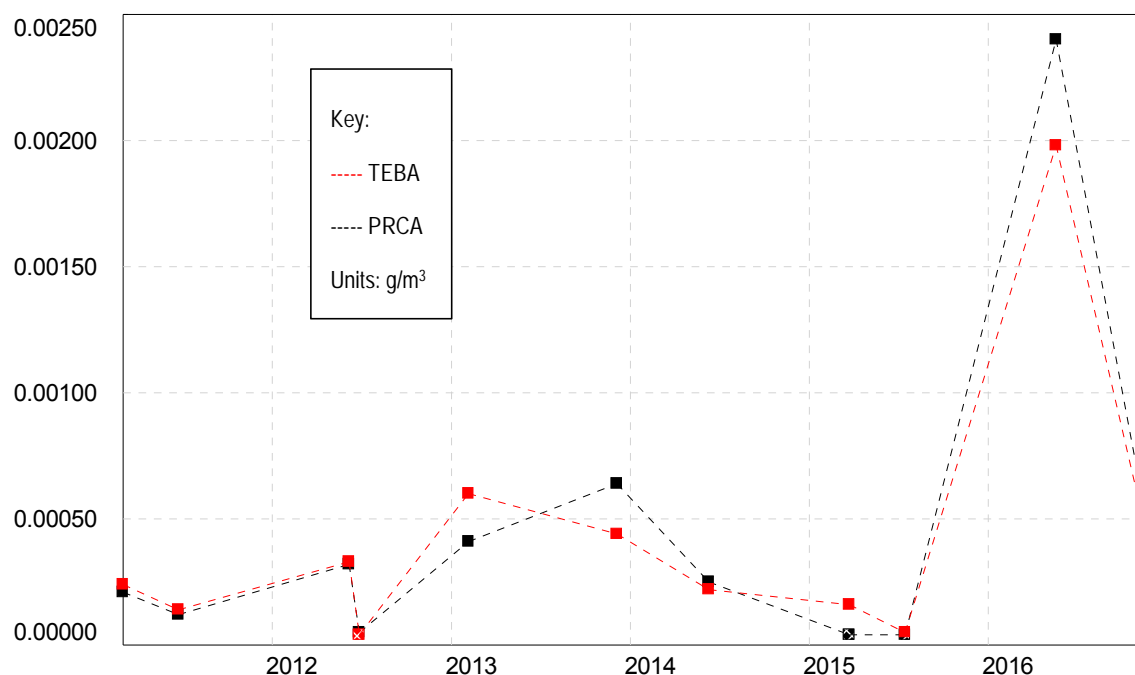
Tributyltin tin was not detected in the discharge or the Manganone Stream water during the monitoring period.

Figure 21 Tebuconazole and Propiconazole concentrations downstream of TSM's discharge (site MGO000145)

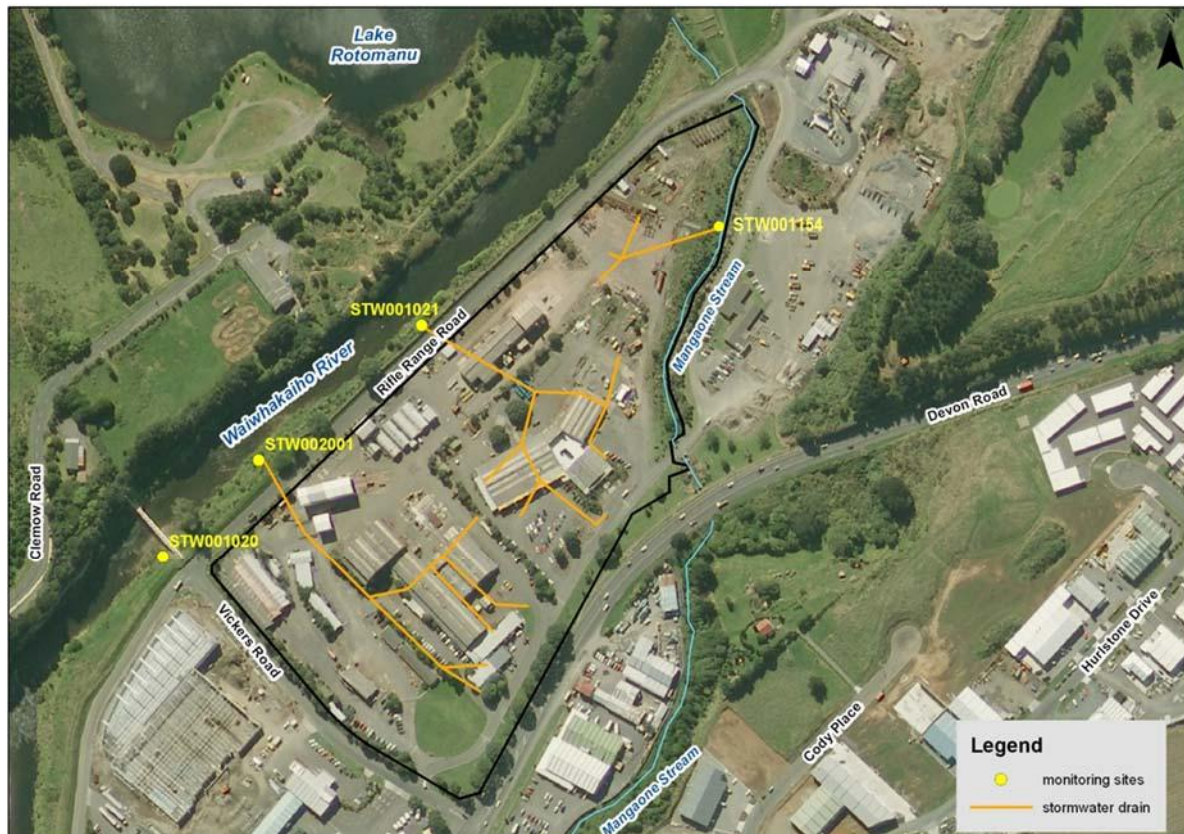
The engineering complex of Technix Group Ltd (Technix) is the largest industrial site along the lower Waiwhakaiho River. Situated on the true right bank of the river immediately above its confluence with the Mangaone Stream, the 8.4 ha area of land is bounded by Rifle Range Road, Vickers Road, State Highway 3, and the Mangaone Stream. The development comprises several building complexes, roading and drainage systems.

Figure 22 Technix site, drainage system and sampling point locations

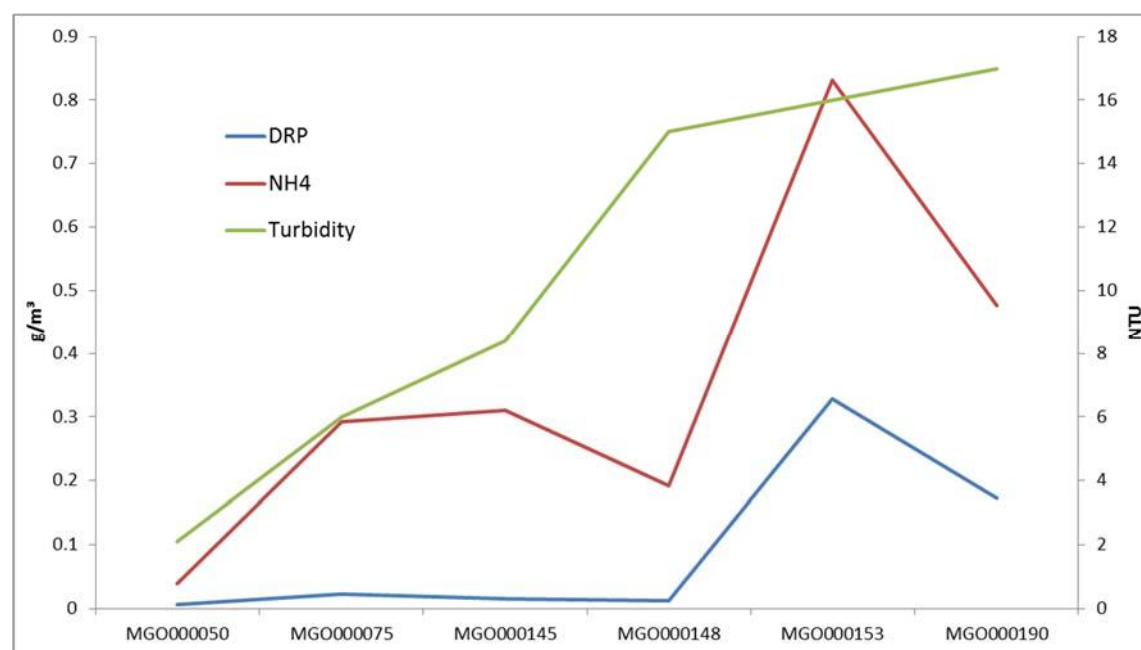
DRP was also found to increase at the site downstream of the Ravensdown site, however all values were found to be similar or below the historical medians as DRP concentrations appear have reduced at this site since Ravensdown decommissioned and demolished the rock store. In the event that the site is completely demolished and remediated it is expected that phosphorus levels will improve.

Figure 23 Longitudinal profiles of three parameters in the Mangaone Stream
