Lower Waiwhakaiho Catchment
Monitoring Programme
Annual Report
2016-2017

Technical Report 2017-07

March 2018

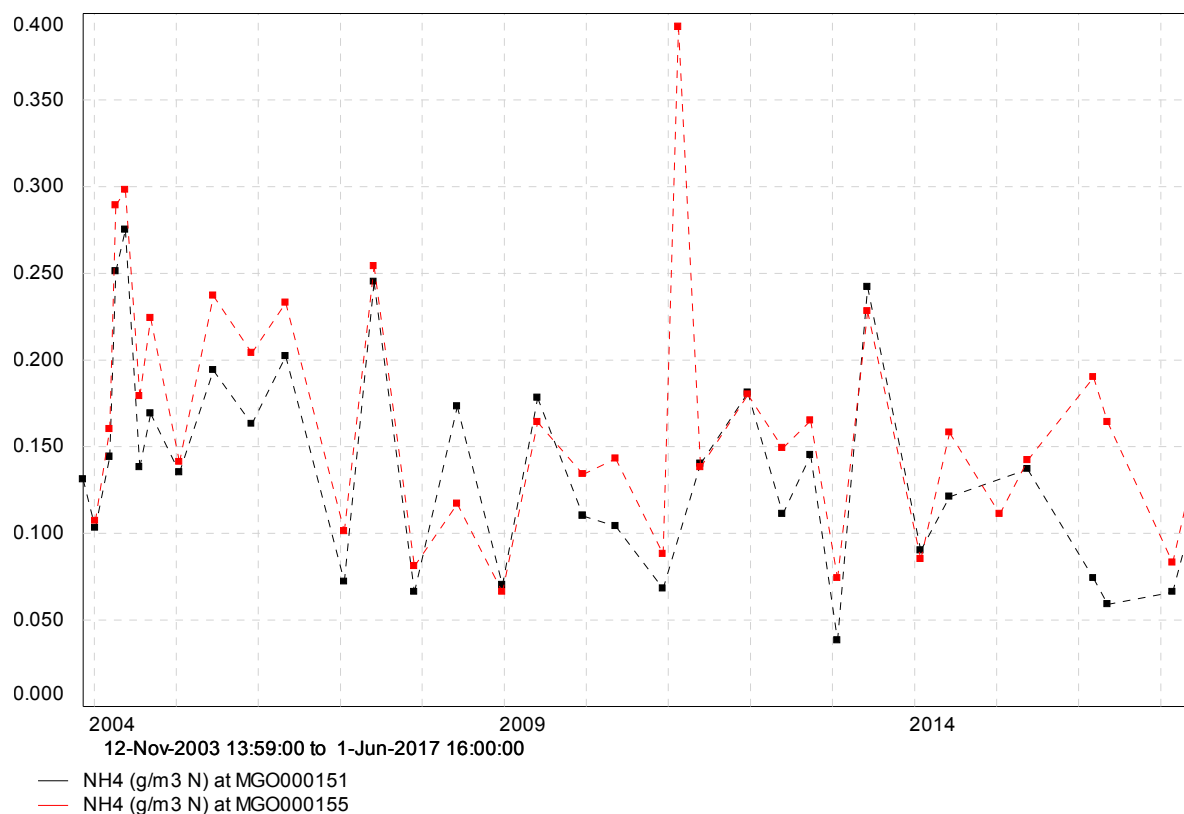
Due to elevations in the ammoniacal nitrogen concentration observed in a Ravensdown bore on Katere Road, this is the parameter of primary interest here and Figure 24 shows the trends in ammoniacal nitrogen concentrations at the upstream and downstream sites.

Figure 24 Mangaone Stream ammoniacal nitrogen concentrations in the vicinity of the Ravensdown site under dry weather conditions 2010-2017

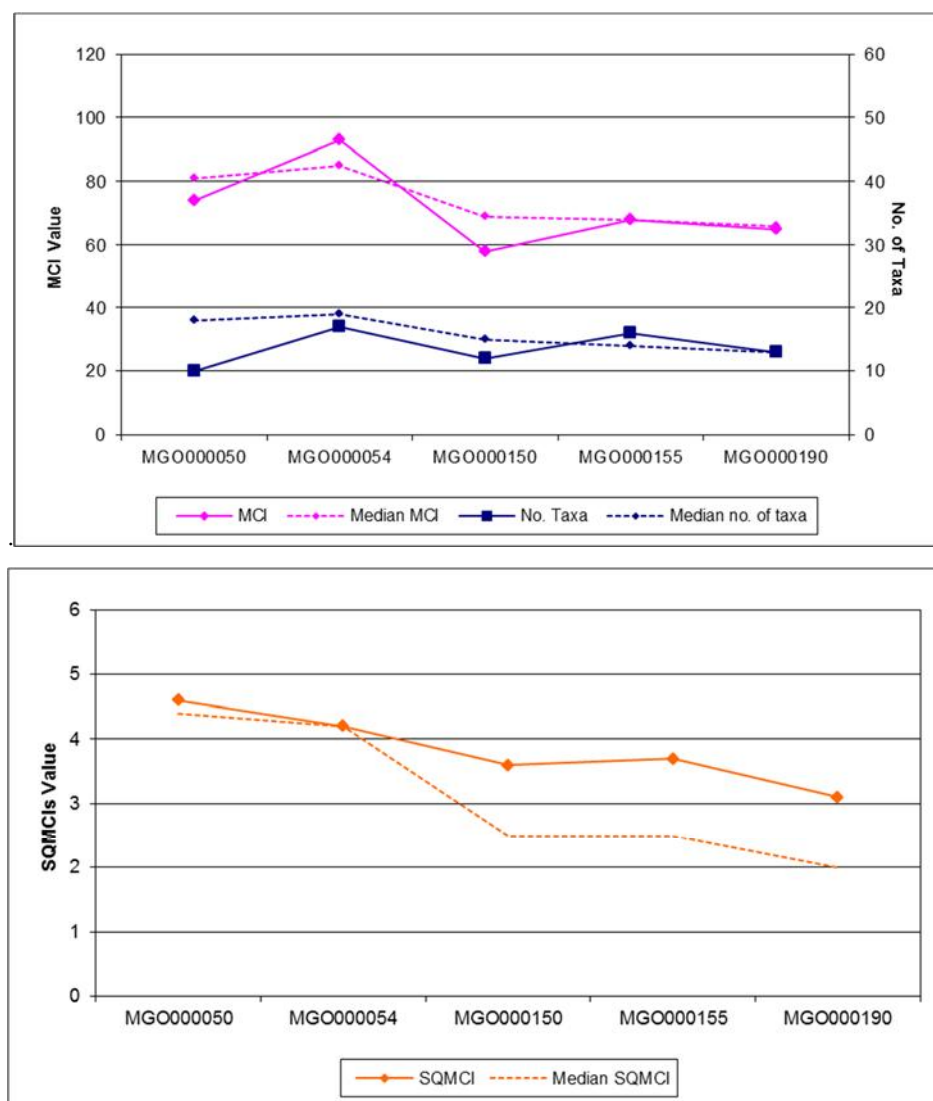
Overall, the results indicated that discharges from the industrial area was not having an effect on the macroinvertebrate communities in the lower Waiwhakaiho River but there was evidence that discharges were having a negative effect on macroinvertebrate communities present in the lower Mangaone Stream. Groundwater inputs may have contributed to some of this deterioration recorded immediately downstream of the fertiliser depot but other industries may also be contributing to poor water quality in the lower reaches of the Mangaone Stream.

Figure 25 Longitudinal trend in number of taxa, MCI and SQMCI values in the Mangaone Stream for the survey of 15 February 2016

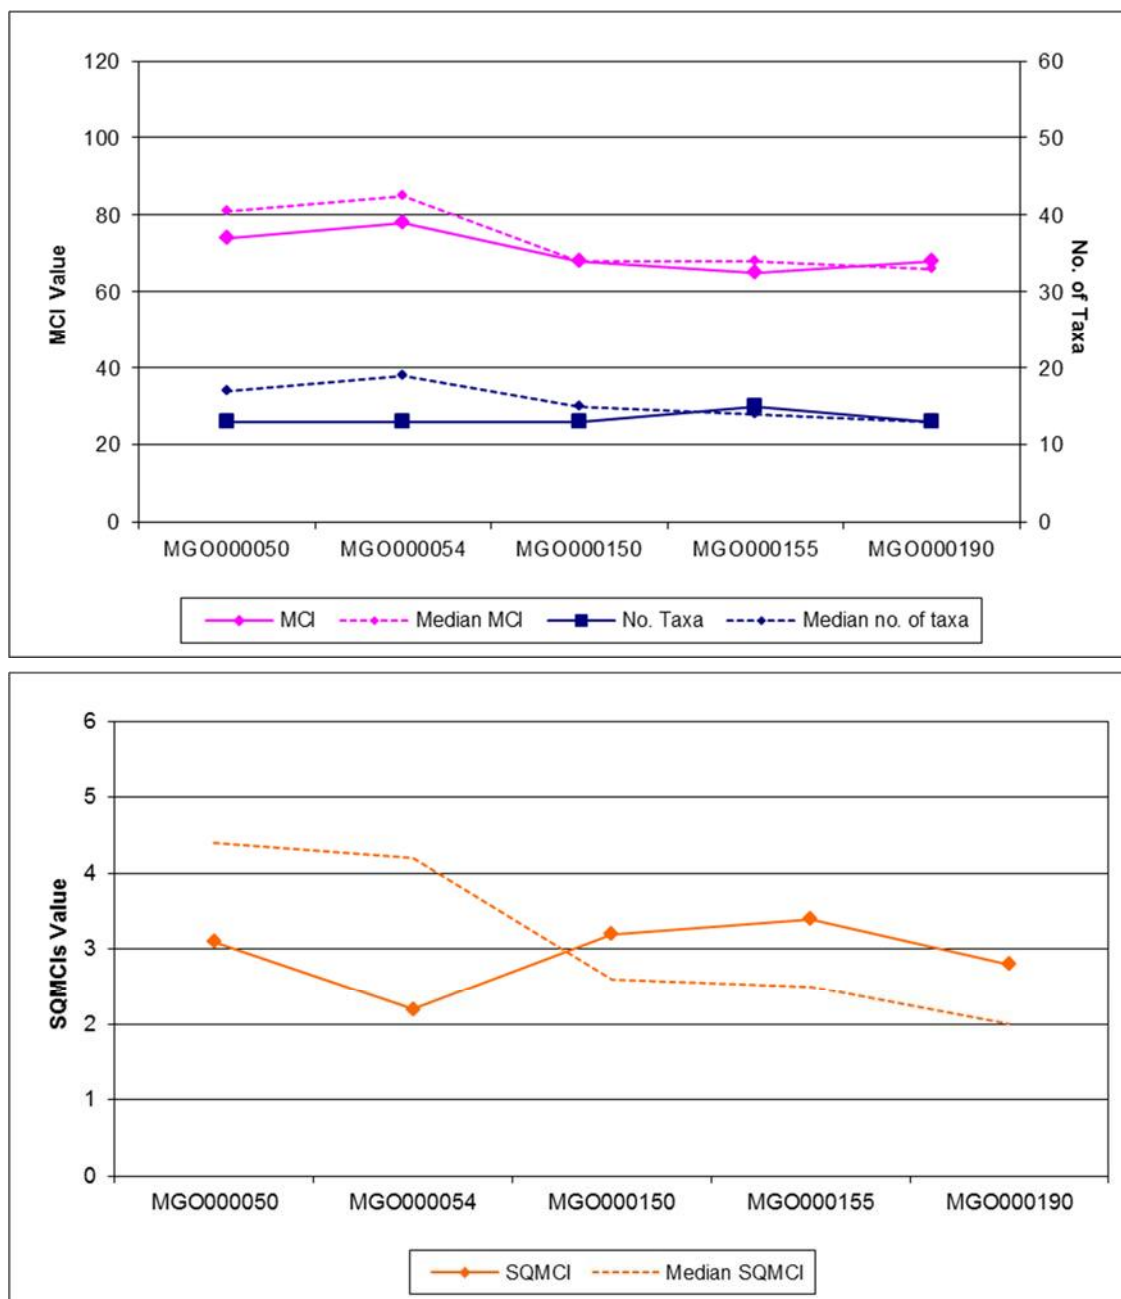
Overall, the results indicated that discharges from the industrial area were not having a significant negative effect on the macroinvertebrate communities in the lower Waiwhakaiho River. The Mangaone Stream sites indicated no recent toxic discharges but sedimentation in the upper catchment and nutrient enrichment in the lower catchment was potentially affecting sites in the surveyed reach.

Figure 26 Longitudinal trend in number of taxa, MCI and SQMCIs values in the Mangaone Stream for the survey of 27 April 2017

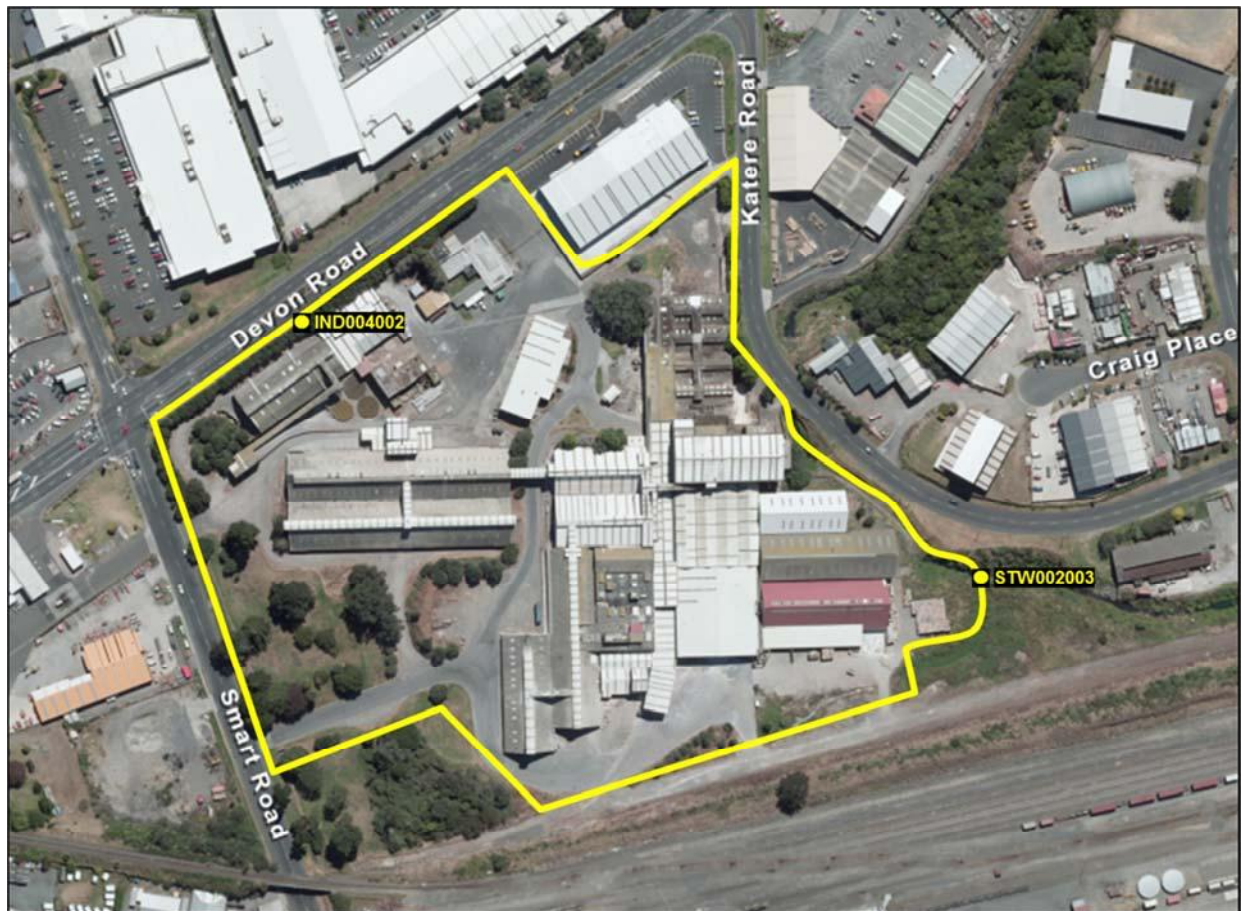
Appendix 1. Area showing stormwater catchment area permitted by this consent

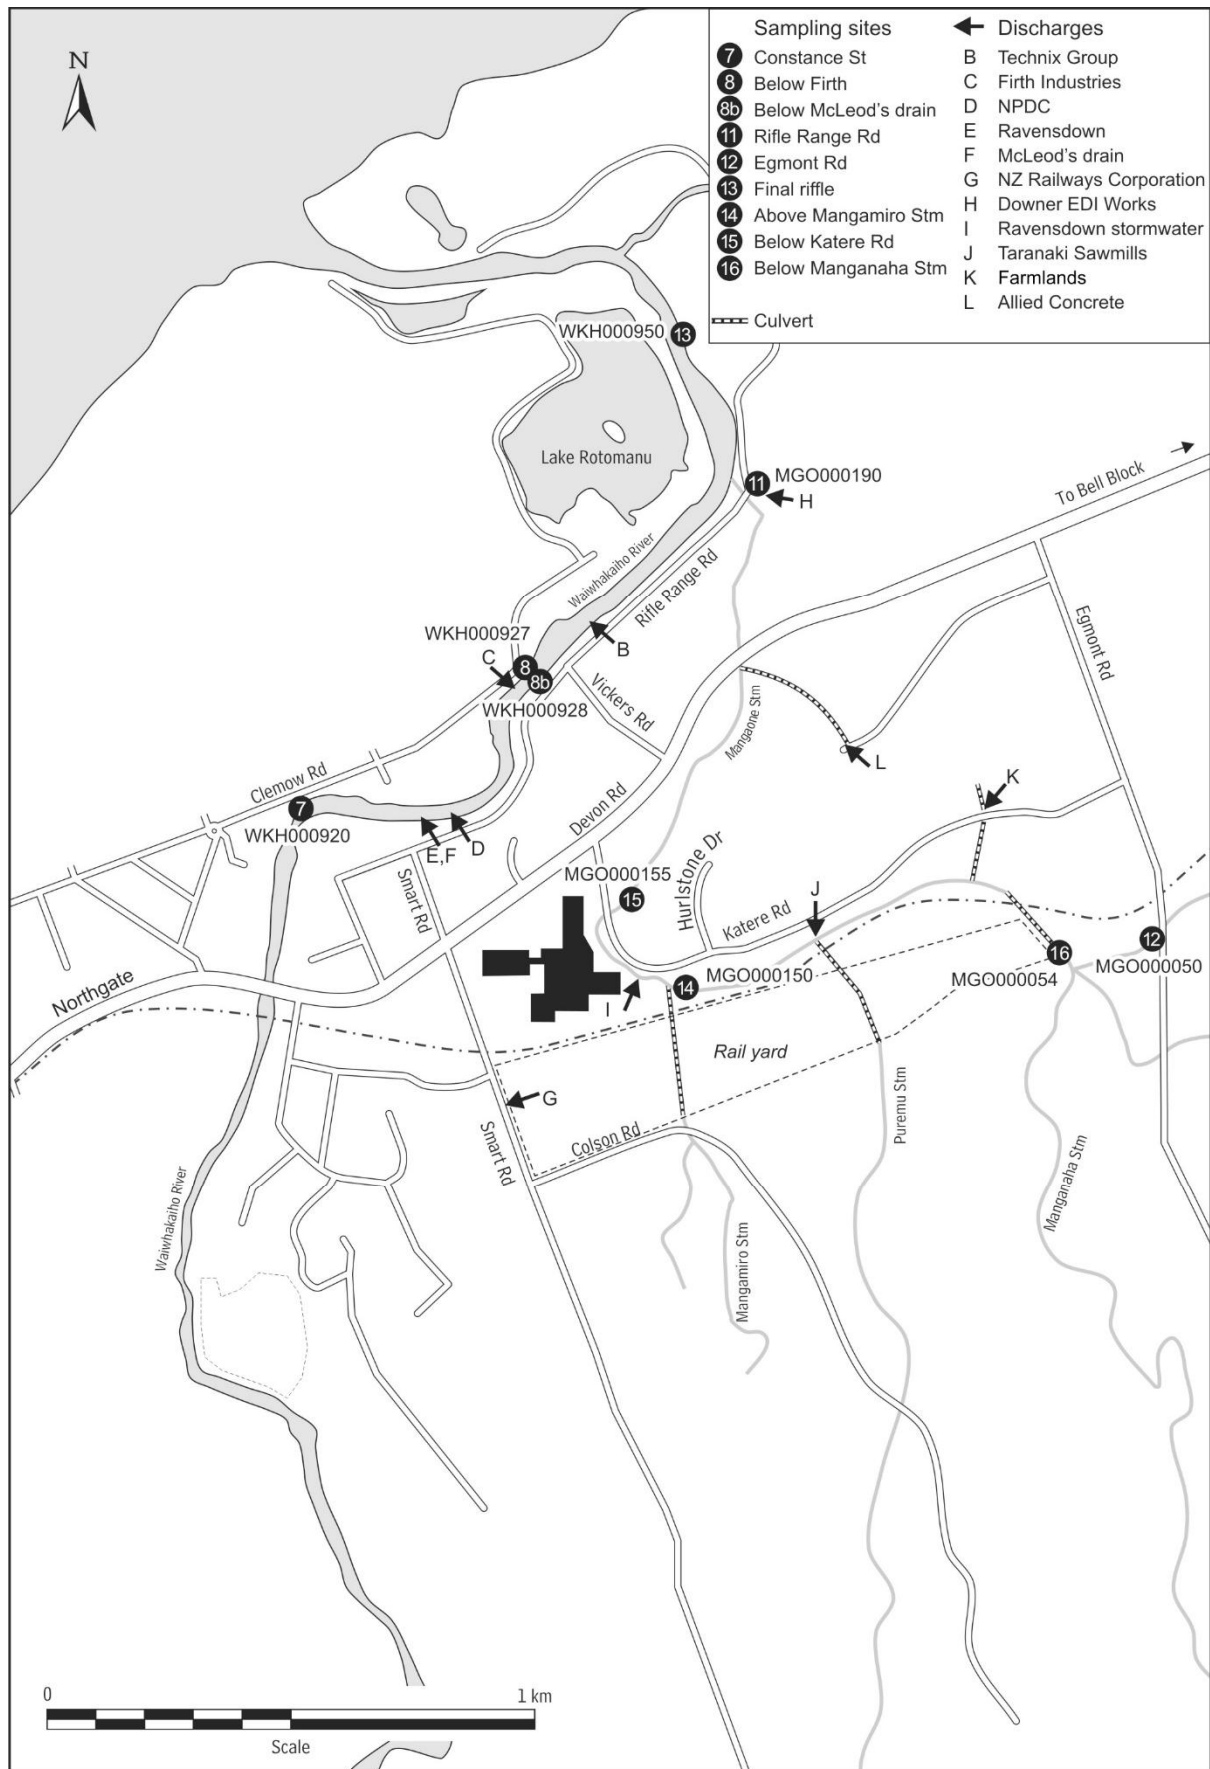
Figure 1 Biomonitoring sites in the Lower Waiwhakaiho River and the Mangaone Stream

The three sites from the Waiwhakaiho River used in this survey have been sampled biannually in recent years. In the Mangaone Stream, two sites have been sampled biannually, with three further sites (14, 15 and 16) added since February 2005 and sampled under the same regime.

On 27 April 2017, the standard '400 ml kick sampling' technique was used to collect streambed macroinvertebrates from three sites in the lower Waiwhakaiho River and from four sites in the Mangaone Stream, while a combination of 'kick sampling' and the standard '400 ml sweep-sampling' techniques were used to collect streambed macroinvertebrates from site 12 in the Mangaone Stream (Table 1, Figure 1). The 'sweep-net- sampling technique is very similar to Protocol C2 (soft-bottomed, semi-quantitative), and the 'kick-sampling' technique is very similar to Protocol C1 (hard-bottomed, semi-quantitative), of the New Zealand Macroinvertebrate Working Group (NZMWG) protocols for macroinvertebrate samples in wadeable streams (Stark *et al*, 2001).

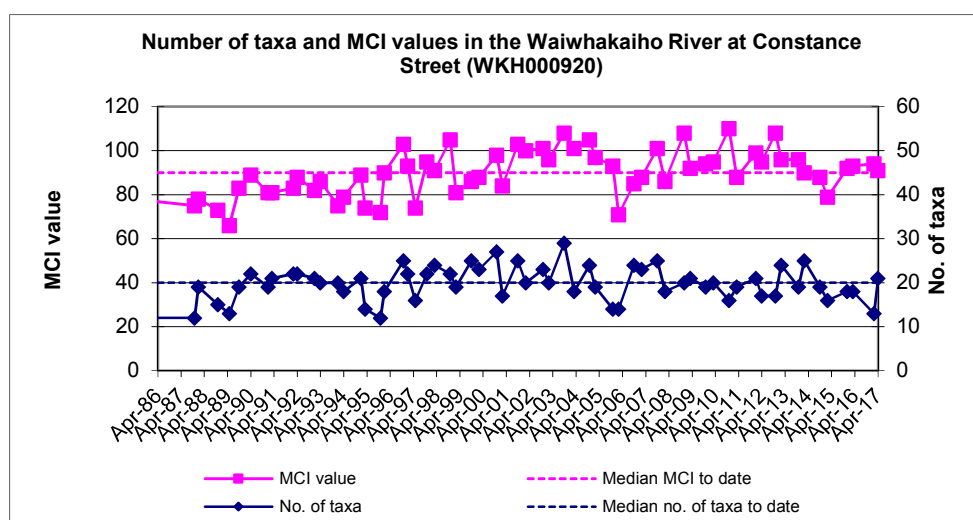
The community was characterised by three 'tolerant' taxa [oligochate worms, caddisfly (*Hydropsyche/Aoteapsyche*) and orthoclad midges] and one 'highly sensitive' taxon [mayfly (*Deleatidium*)] (Table 7).

Figure 2 Numbers of taxa and MCI values for Waiwhakaiho River at Constance Street since 1987

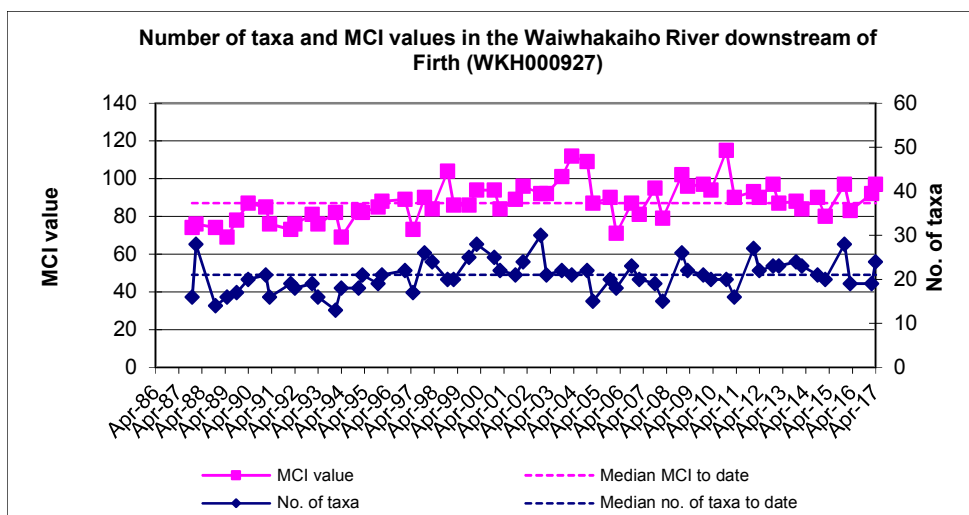
The community was characterised by four 'tolerant' taxa [oligochate worms, caddisflies (*Hydropsyche/Aoteapsyche* and *Oxyethira*) and orthoclad midges] and one 'moderately sensitive' taxon [crane fly (*Aphrophila*)] (Table 7).

Figure 3 Numbers of taxa and MCI values for Waiwhakaiho River below Firth Industries (left bank) since 1987

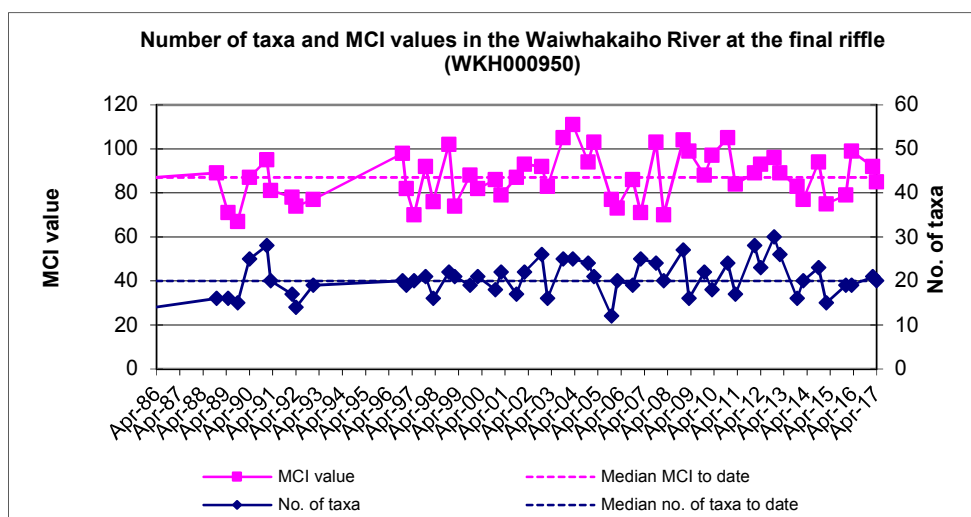
The community was characterised by four 'tolerant' taxa [oligochaete worms, caddisflies (*Hydropsyche/Aoteapsyche* and *Oxyethira*) and orthoclad midges (Table 7).

Figure 4 Numbers of taxa and MCI values for Waiwhakaiho River d/s of Lake Rotomanu since 1987

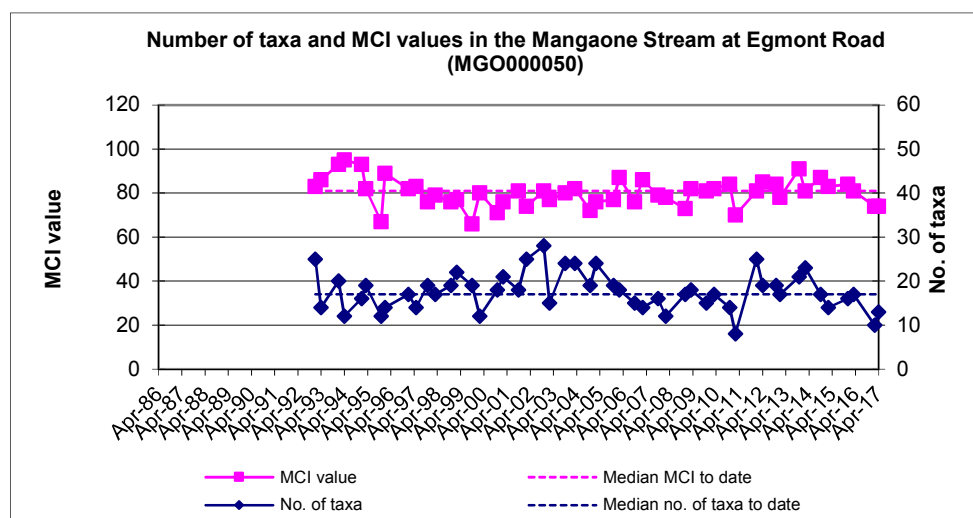
The community was characterised by two 'tolerant' taxa [worms (Nemerta) and seed shrimp (Ostracoda)] and one 'moderately sensitive' taxon [amphipod (*Paracalliope*)] (Table 8).

Figure 5 Number of taxa and MCI values for Mangaone Stream at Egmont Road since 1992

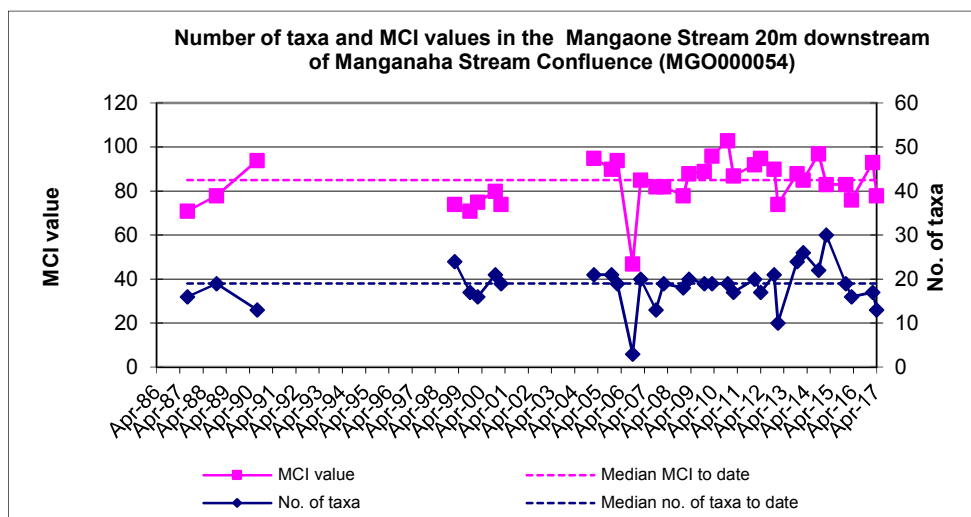
The community was characterised by two tolerant' taxa [oligochaete worms and snail (*Potamopyrgus*)] and one 'moderately sensitive' taxon [amphipod (*Paracalliope*)] (Table 8).

Figure 6 Numbers of taxa and MCI values for the Mangaone Stream downstream of the confluence with Manganaha Stream since 1987

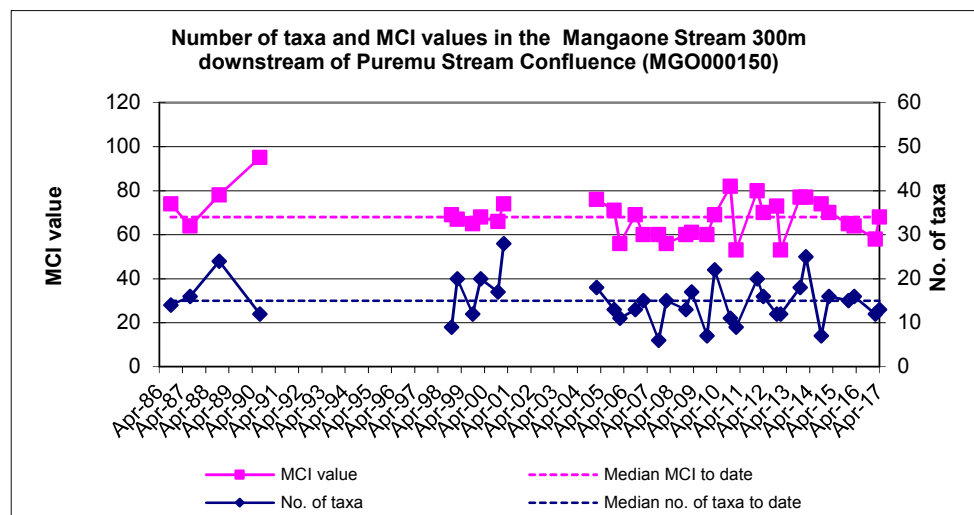
The community was characterised by three tolerant' taxa [oligochaete worms and snail (*Potamopyrgus*) and midge (Orthocladiinae)] and one 'moderately sensitive' taxon [amphipod (*Paracalliope*)] (Table 8).

Figure 7 Numbers of taxa and MCI values for Mangaone Stream downstream of the confluence with Puremu Stream since 1986

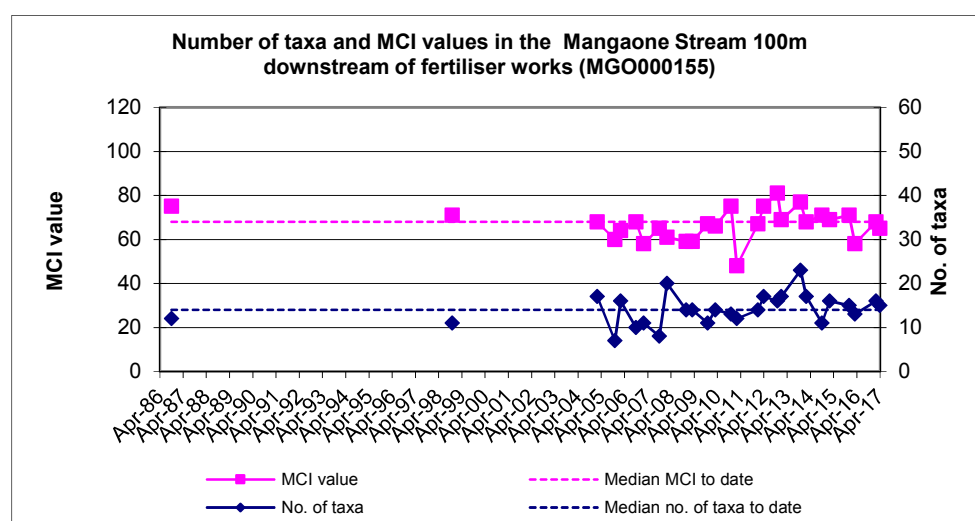
The community was characterised by four tolerant' taxa [oligochaete worms, snail (*Potamopyrgus*), seed shrimp (Ostracoda) and midge (Orthoclaadiinae)] and one 'moderately sensitive' taxon [amphipod (*Paracalliope*)] (Table 8).

Figure 8 Numbers of taxa and MCI values for Mangaone Stream 100 m downstream of the fertilizer works/depot since 1986

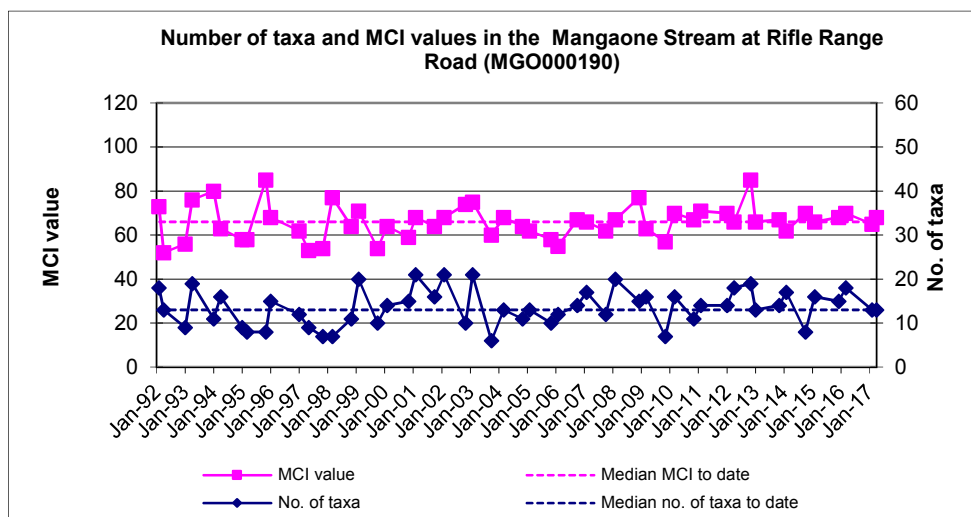
Figure 9 Numbers of taxa and MCI values for Mangaone Stream at Rifle Range Road since 1992

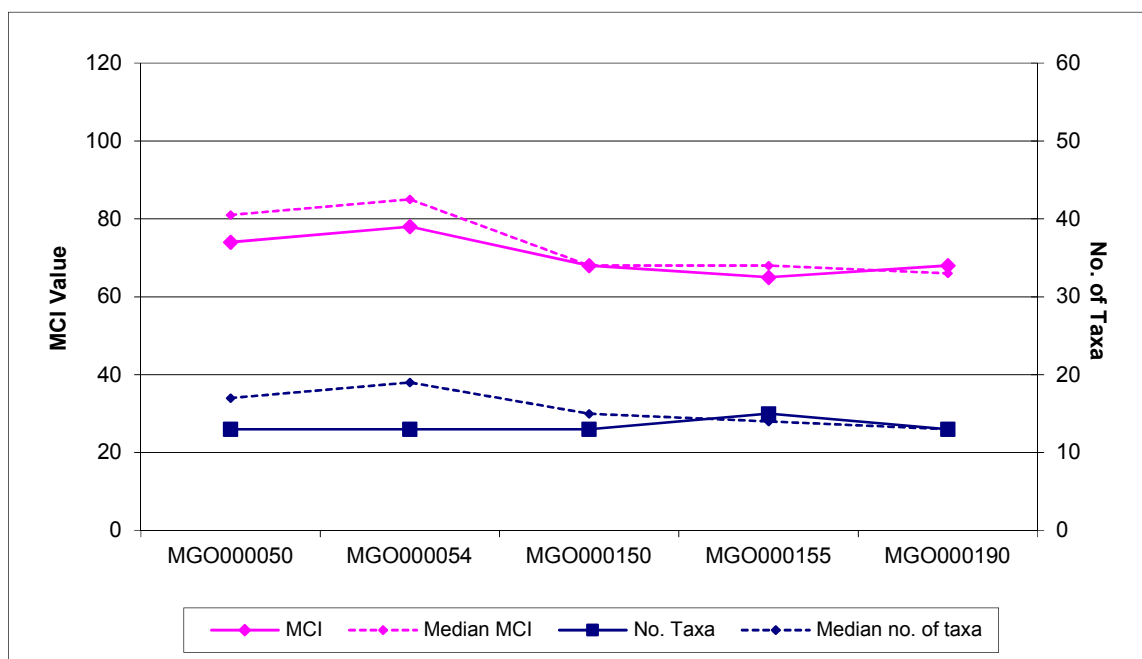
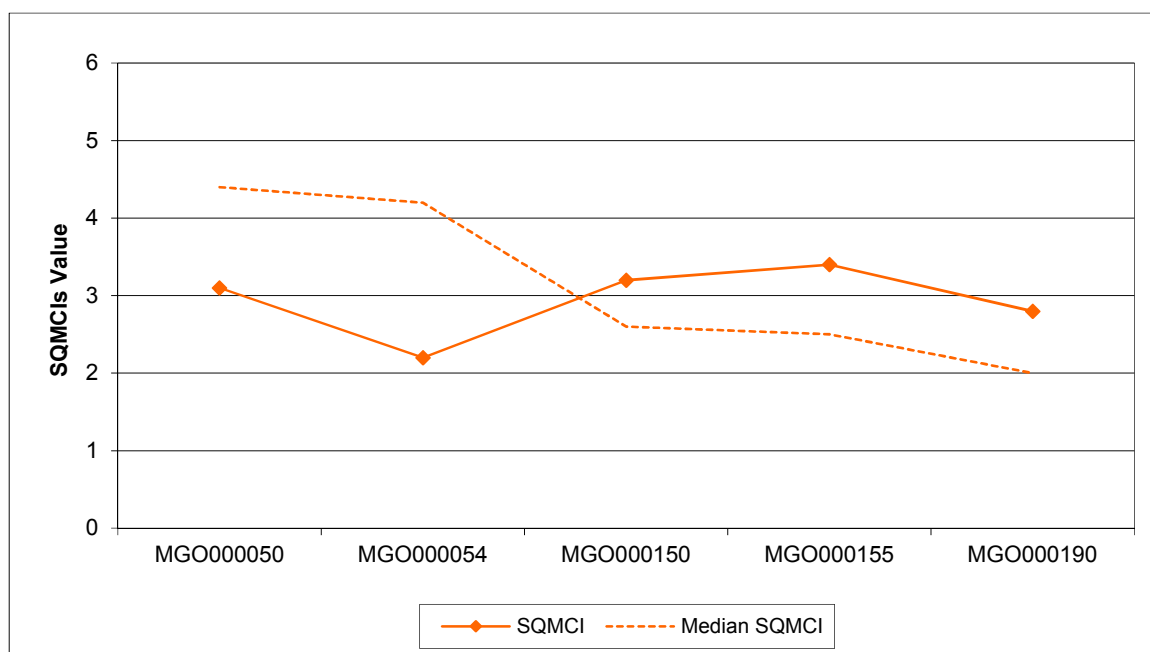
Figure 10 Longitudinal trend in number of taxa, MCI and SQMCI_s values in the Mangaone Stream for the survey of 15 February 2017

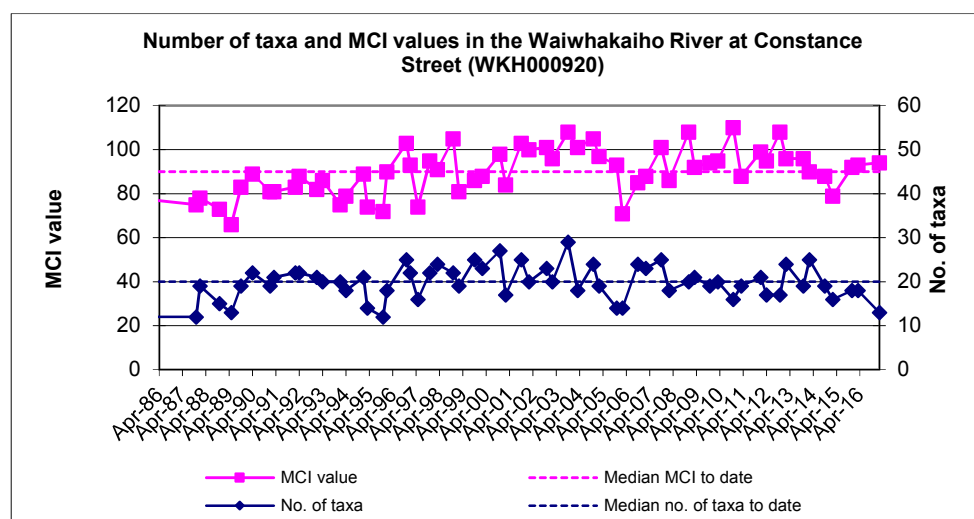
Figure 2 Numbers of taxa and MCI values for Waiwhakaiho River at Constance Street since 1987

The SQMCI_s score of 4.5 units was significantly higher (Stark, 1998) to the historical median SQMCI_s score of 3.3 units and to the previous score of 2.8 units (Stark, 1998) (Table 6).

The community was characterised by two 'tolerant' taxa [orthoclad midges and sandflies (*Austrosimulium*)] and one 'highly sensitive' taxon [mayfly (*Deleatidium*)] (Table 7).

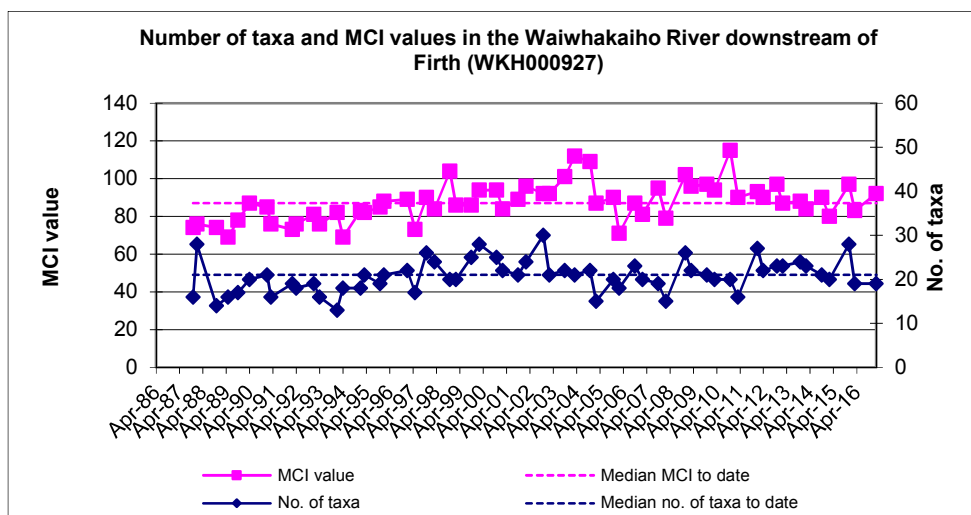
The SQMCI_s score of 2.8 units was not significantly different (Stark, 1998) to the historical median SQMCI_s score of 3.3 units and to the previous score of 2.3 units (Stark, 1998) (Table 6).

The community was characterised by three 'tolerant' taxa [orthoclad midges and caddisflies (*Hydropsyche/Aoteapsyche* and *Oxyethira*)] (Table 7).

Figure 3 Numbers of taxa and MCI values for Waiwhakaiho River below Firth Industries (left bank) since 1987
Downstream of Lake Rotomanu (site 13)

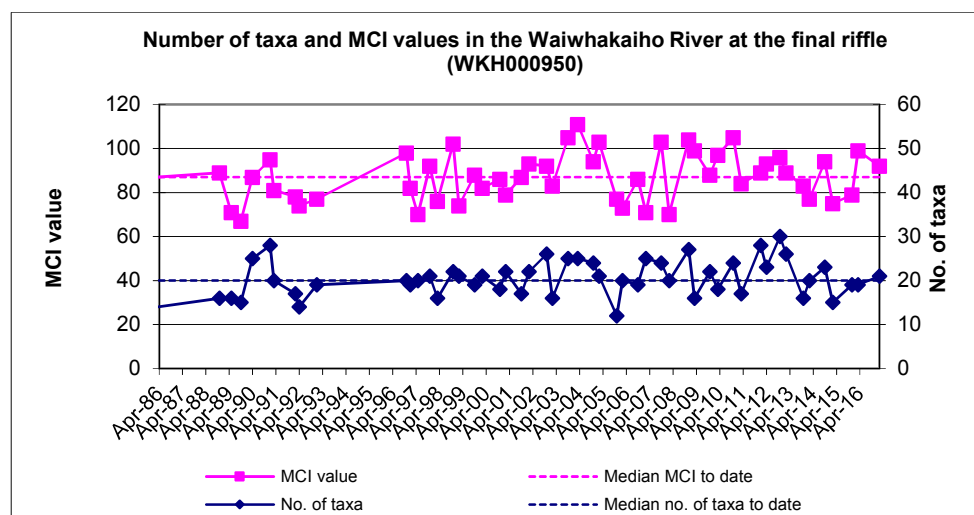
Figure 4 Numbers of taxa and MCI values for Waiwhakaiho River d/s of Lake Rotomanu since 1987

A moderate macroinvertebrate community richness of 21 taxa was found at site 13 at the time of this summer survey. This was one taxon higher than the historical median for this site and two taxa higher than the previous survey (19 taxa) (Table 6 and Figure 4).

The SQMCI_s score of 2.9 units was the same as the historical median SQMCI_s score and not significantly different to the previous survey (3.6 units) (Stark, 1998) (Table 6).

The community was characterised by three 'tolerant' taxa [caddisfly (*Hydropsyche/Aoteapsyche*) and midges (*Maoridiamesa* and *Orthoclaadiinae*)] (Table 7).

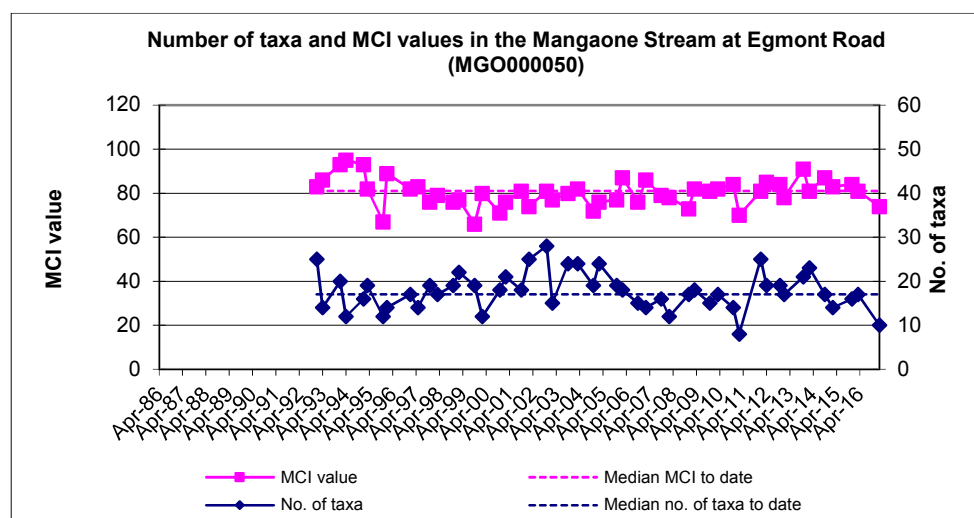
Figure 5 Number of taxa and MCI values for Mangaone Stream at Egmont Road since 1992

The SQMCI_s score of 4.6 units was not significantly different (Stark, 1998) to the historical median SQMCI_s score of 4.4 units but was significantly higher than the previous survey (2.3 units) (Stark, 1998) (Table 6).

The community was characterised by one 'moderately sensitive' taxon [amphipod (*Paracalliope*)] (Table 8).

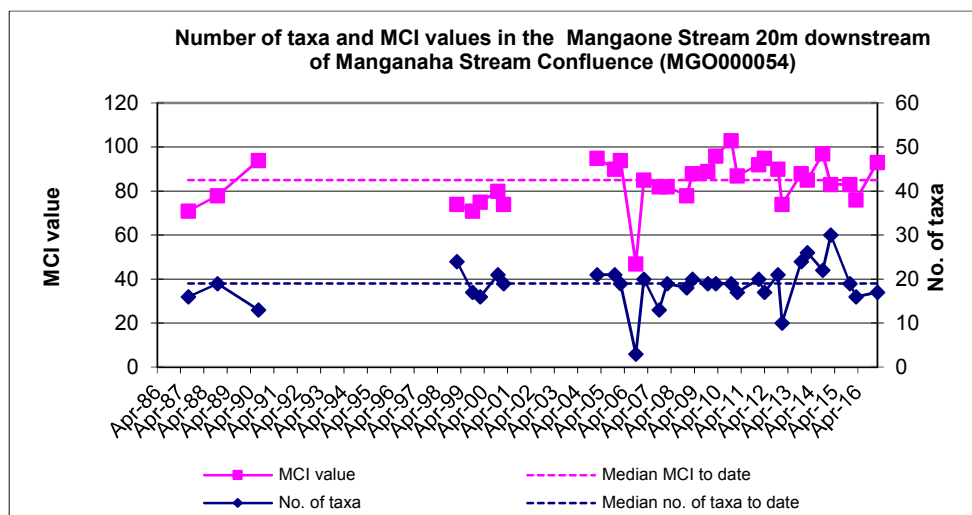
Figure 6 Numbers of taxa and MCI values for the Mangaone Stream downstream of the confluence with Manganaha Stream since 1987

The SQMCI_s score of 4.2 units was the same as the historical median SQMCI_s score of 4.2 units and significantly higher than the previous survey (2.3 units) (Stark, 1998) (Table 6).

The community was characterised by two tolerant taxa [snail (*Potamopyrgus*) and sandfly (*Austrosimulium*)] and one 'moderately sensitive' taxon [amphipod (*Paracalliope*)] (Table 8).

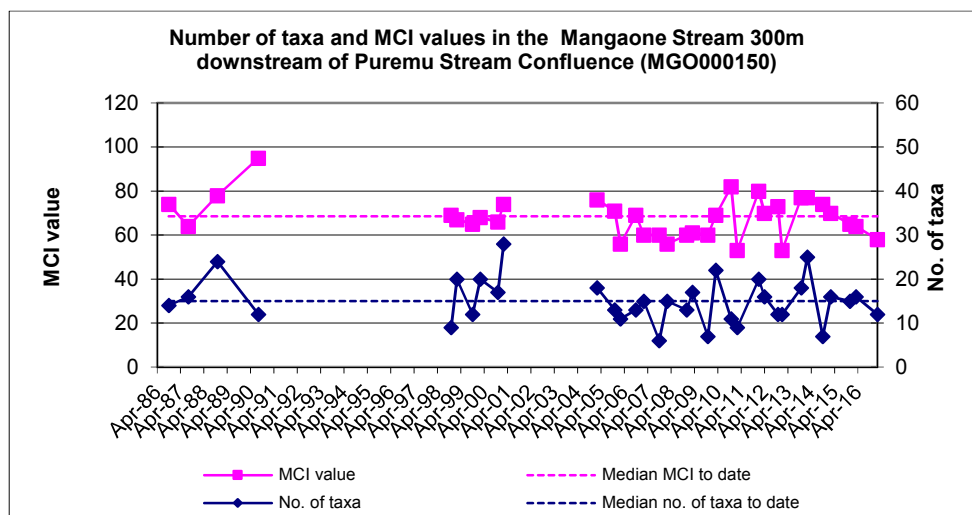
Figure 7 Numbers of taxa and MCI values for Mangaone Stream downstream of the confluence with Puremu Stream since 1986

The SQMCI_s score of 3.6 units was significantly higher (Stark, 1998) than the historical median SQMCI_s score of 2.5 units and to the previous survey (2.4 units) (Stark, 1998) (Table 6).

The community was characterised by two tolerant' taxa [snail (*Potamopyrgus*) and midge (Orthoclaadiinae)] and one 'moderately sensitive' taxon [amphipod (*Paracalliope*)] (Table 8).

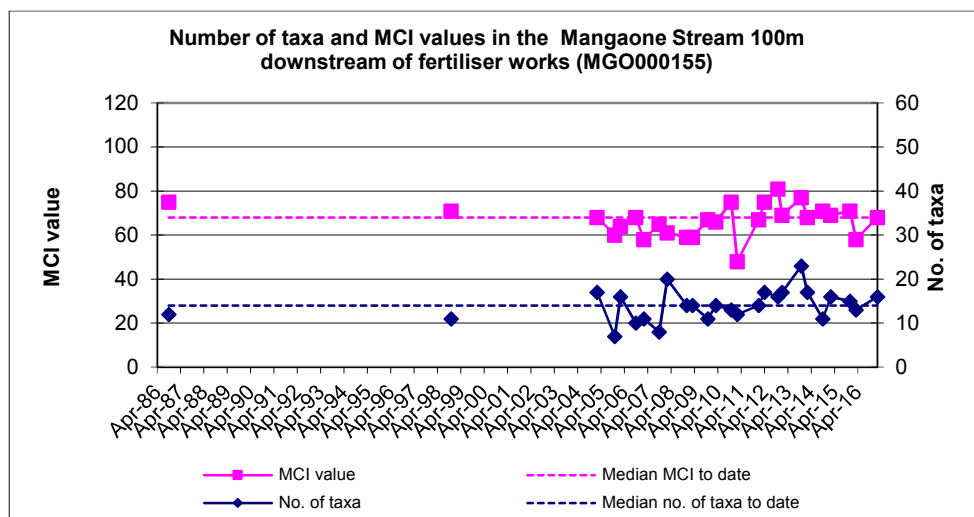
Figure 8 Numbers of taxa and MCI values for Mangaone Stream 100 m downstream of the fertilizer works/depot since 1986

The SQMCI_s score of 3.7 units was significantly higher (Stark, 1998) than the historical median SQMCI_s score of 2.5 units and to the previous survey (2.2 units) (Stark, 1998) (Table 6).

The community was characterised by four tolerant taxa [oligochaete worms, snail (*Potamopyrgus*), seed shrimp (Ostracoda) and midge (Orthocladiinae)] and one 'moderately sensitive' taxon [amphipod (*Paracalliope*)] (Table 8).

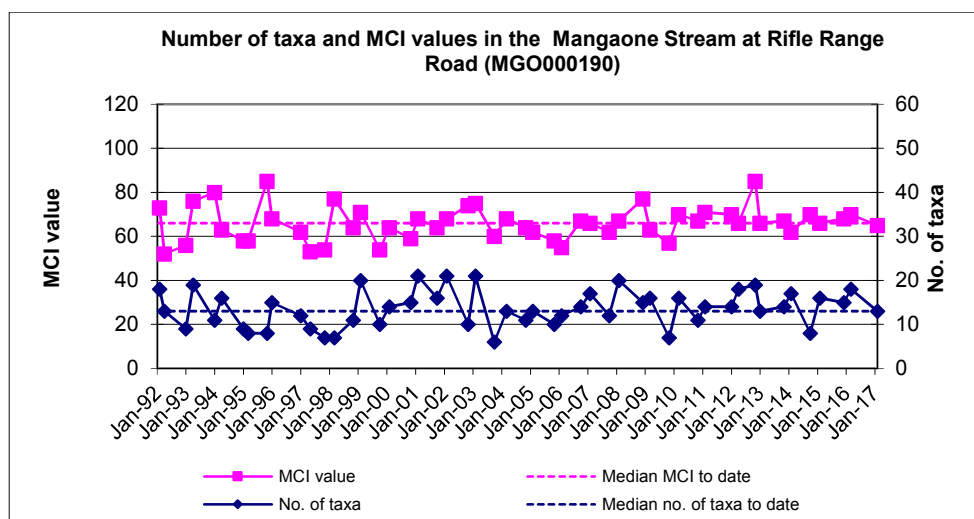
Figure 9 Numbers of taxa and MCI values for Mangaone Stream at Rifle Range Road since 1992

The SQMCI_s score of 3.1 units was significantly higher (Stark, 1998) than the historical median SQMCI_s score of 2.0 units and but not significantly different to the previous survey (2.9 units) (Stark, 1998) (Table 6).

The community was characterised by four 'tolerant' taxa [oligochaete worms, snail (*Potamopyrgus*), seed shrimps (Ostracoda), and orthoclad midges] (Table 8).

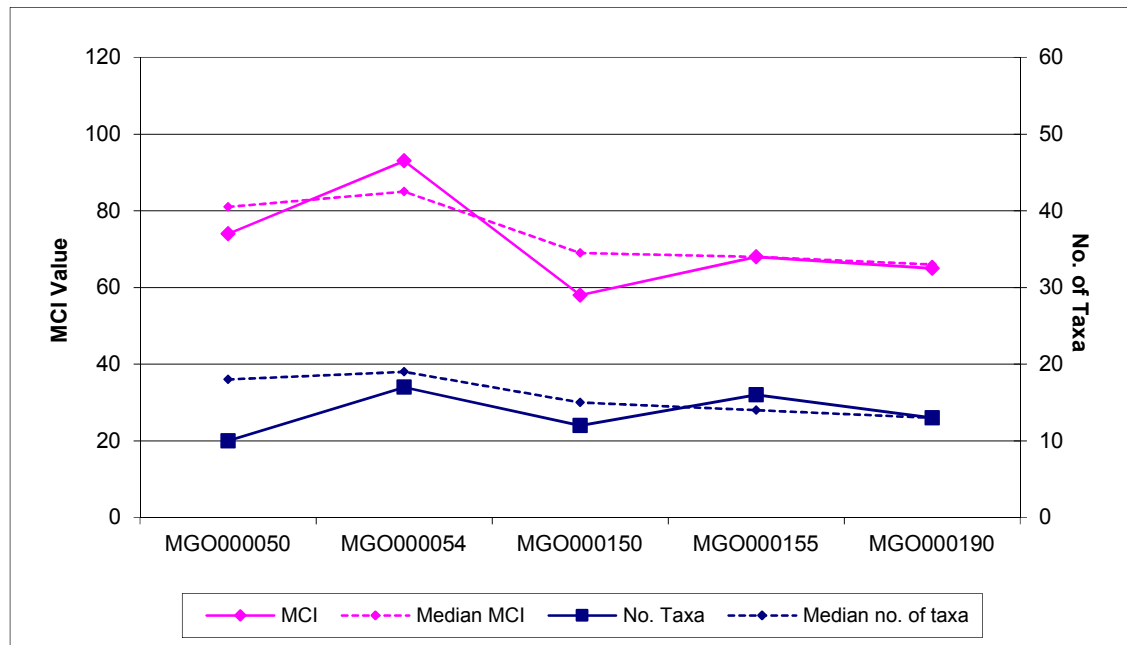
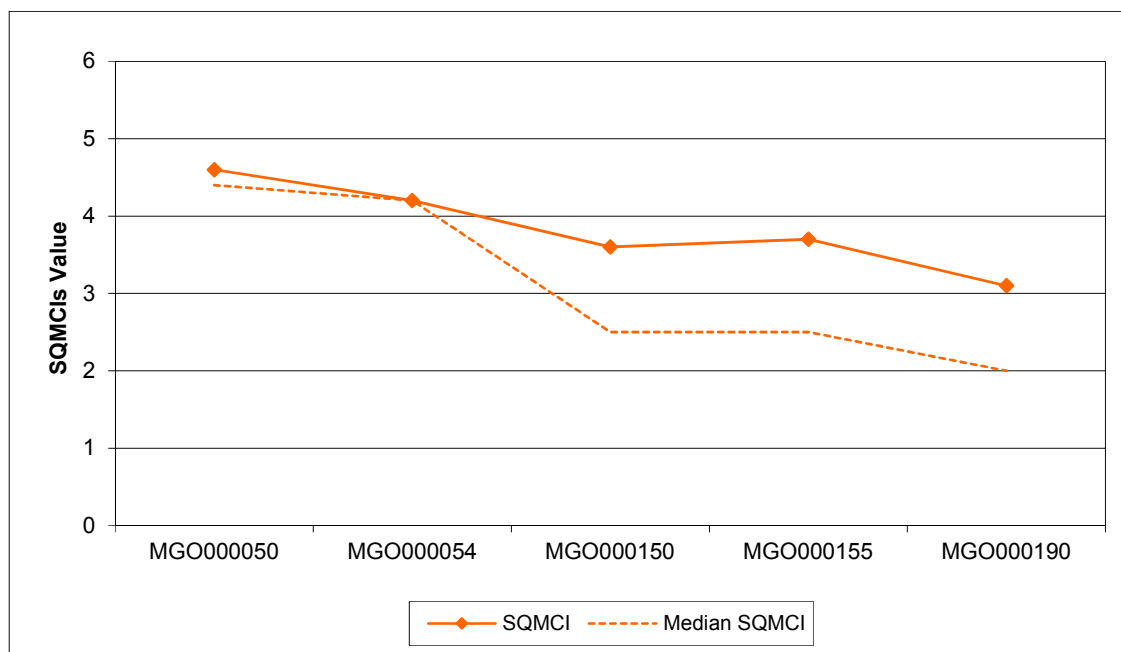
Figure 10 Longitudinal trend in number of taxa, MCI and SQMCI_s values in the Mangaone Stream for the survey of 15 February 2017
