Remediation NZ Ltd
Monitoring Programme
Annual Report
2016-2017

Technical Report 2017-11

Taranaki Regional Council
Private Bag 713
STRATFORD
January 2018

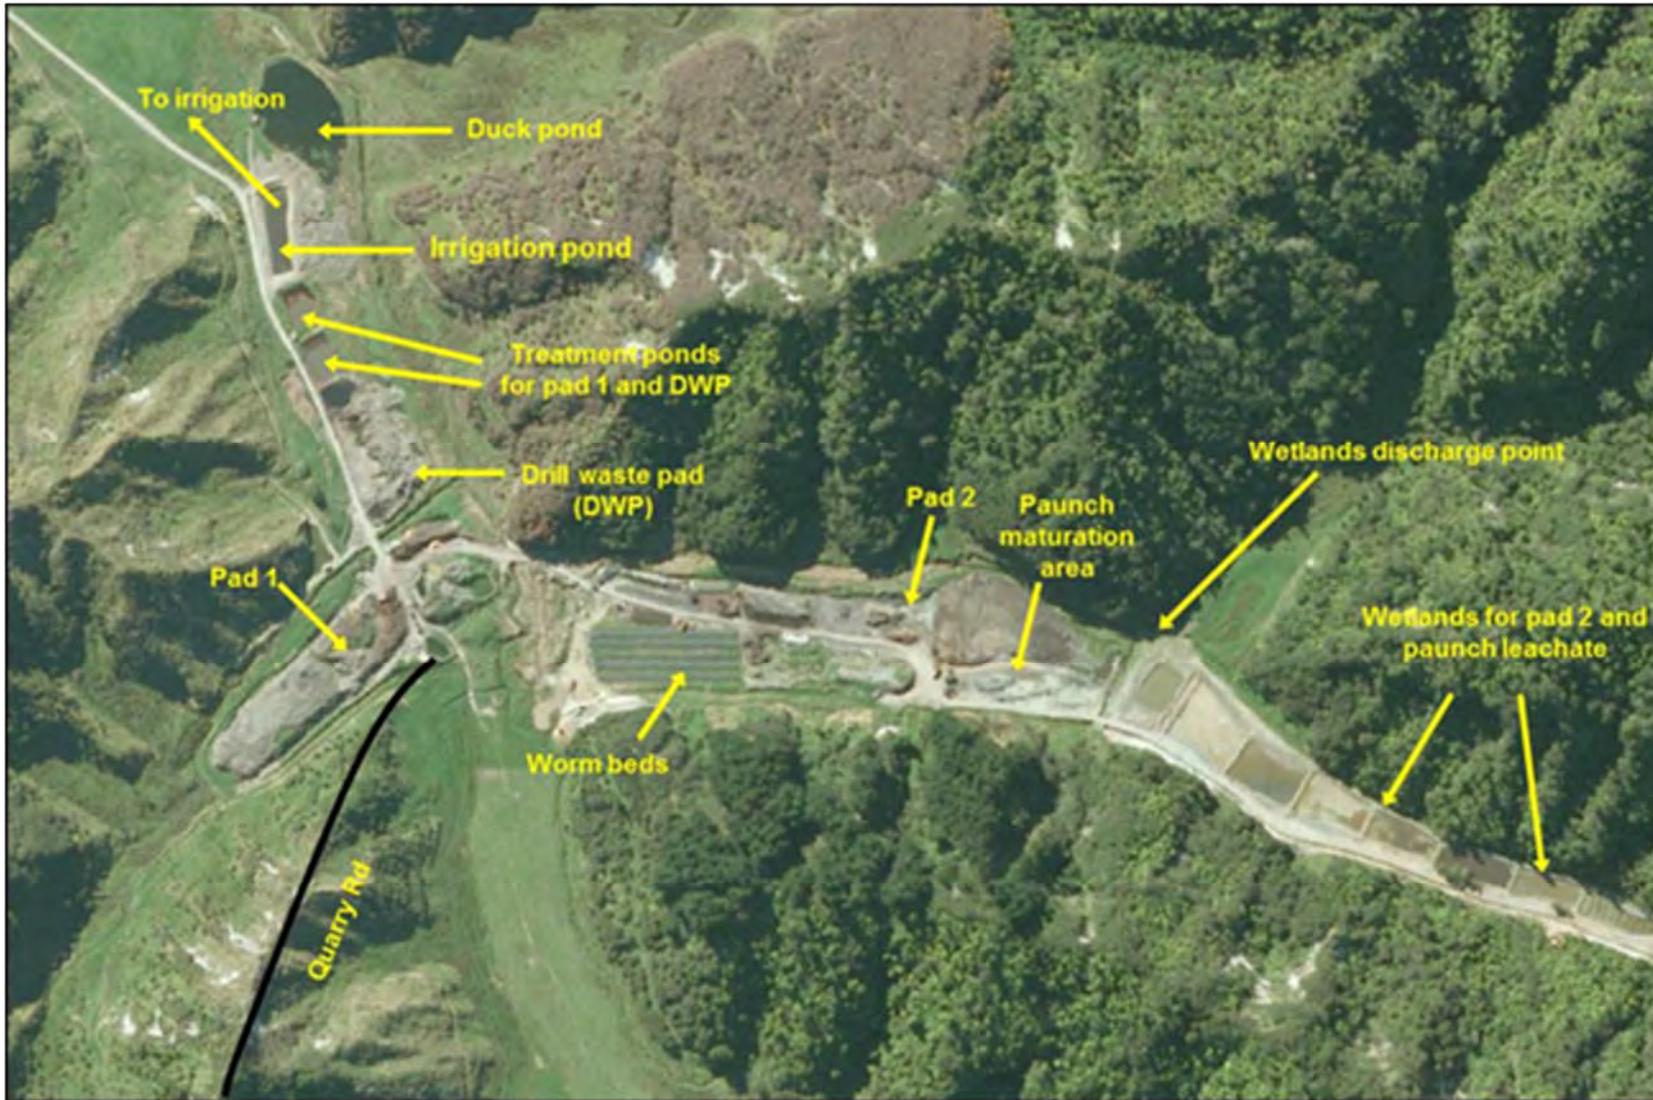
Figure 2 RNZ Uruti site

Surface water samples were collected from 13 specific monitoring locations on the unnamed tributary of the Haehanga Stream and the main stem (Figure 2 and 3) which bisects the Uruti site. The samples collected from these 13 locations were tested for a range of analytes which are detailed in Table 2. The Council assesses these 13 surface water locations six times per annum.

The Wetland Treatment System (WTS) (Figure 2) functions by pumping primarily ammonia enriched fluid from the paunch mixing pond, to the top of a multi layered wetland treatment system. This effectively treats the ammonia enriched water and allows the system to assimilate as much nitrogen as possible. At the base of this treatment system is sample location IND003008.

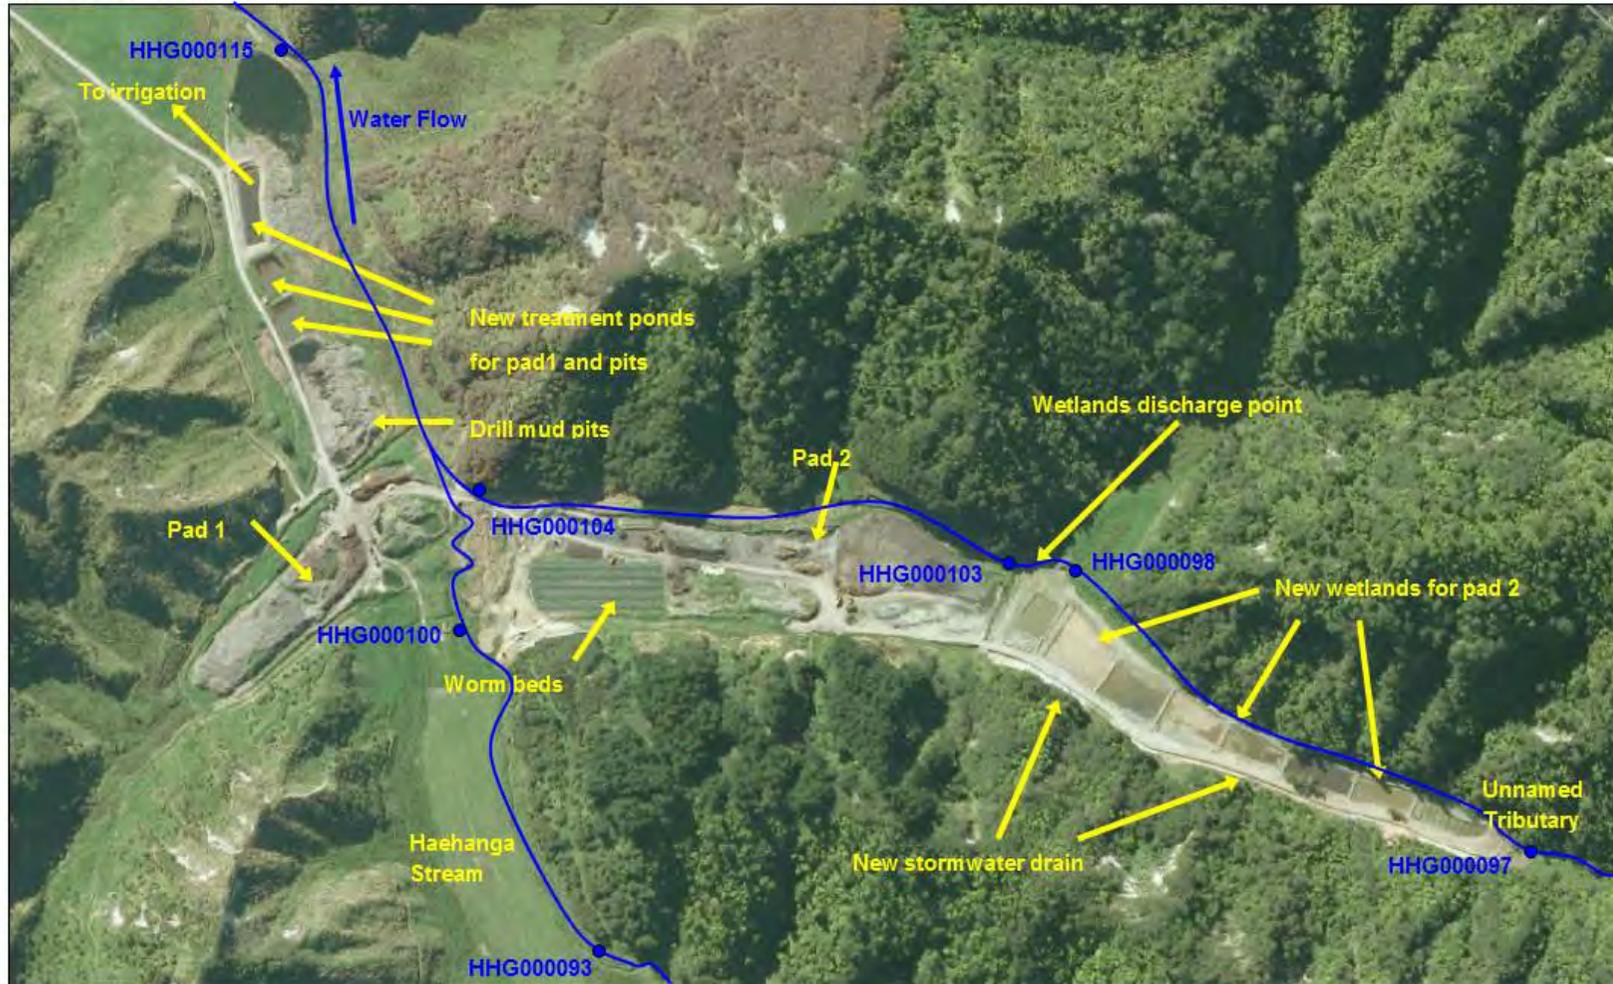
Figure 8 Location of bio-monitoring locations in the Haehanga stream catchment

The current biological survey was conducted to monitor the effects of discharges from the composting site to the Haehanga Stream and tributaries in relation to composting areas (pads 1 & 2), the irrigation of treated liquid to land, and the discharge of treated stormwater and leachate to the unnamed tributary. During the May 2012 survey an additional site was included (HHG000150), at the downstream extent of the irrigation area. This site is now referred to as site 6, with HHG000112 now referred to as site 5. This is important to note, as HHG000112 was previously referred to as site 6. Table 9 details the monitoring sites and associated sampling method, while Figure 8 details a map of the locations.

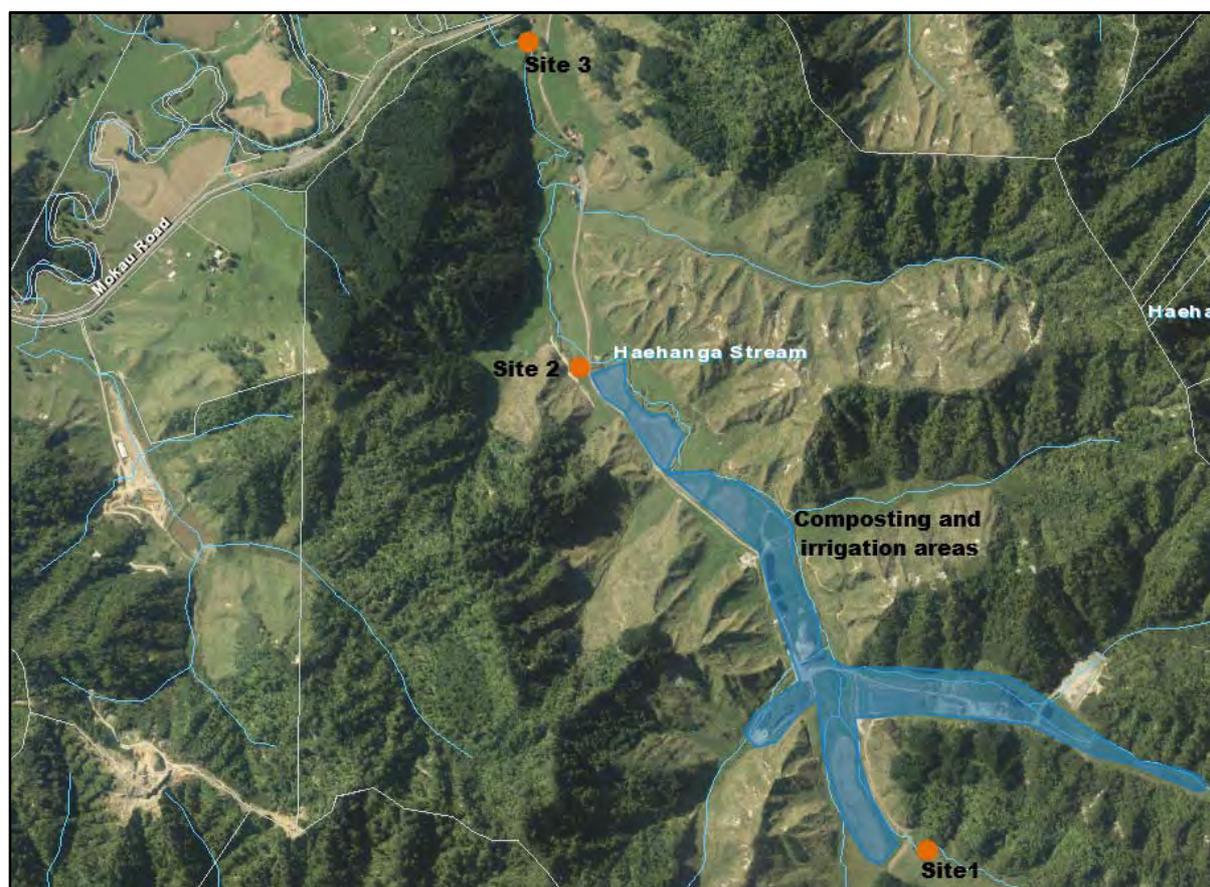
Figure 1 Location of the three sampling sites in relation to composting and waste water irrigation areas.

Table 1 Sampling sites surveyed in the Haehanga Stream in relation to the Remediation NZ composting operations

Site	Site code	Location
1	HHG000093	Upstream of all composting and waste water irrigation areas
2	HHG000150	30 meters downstream of Remediation NZ irrigation area
3	HHG000190	50 metres upstream of State Highway 3 bridge

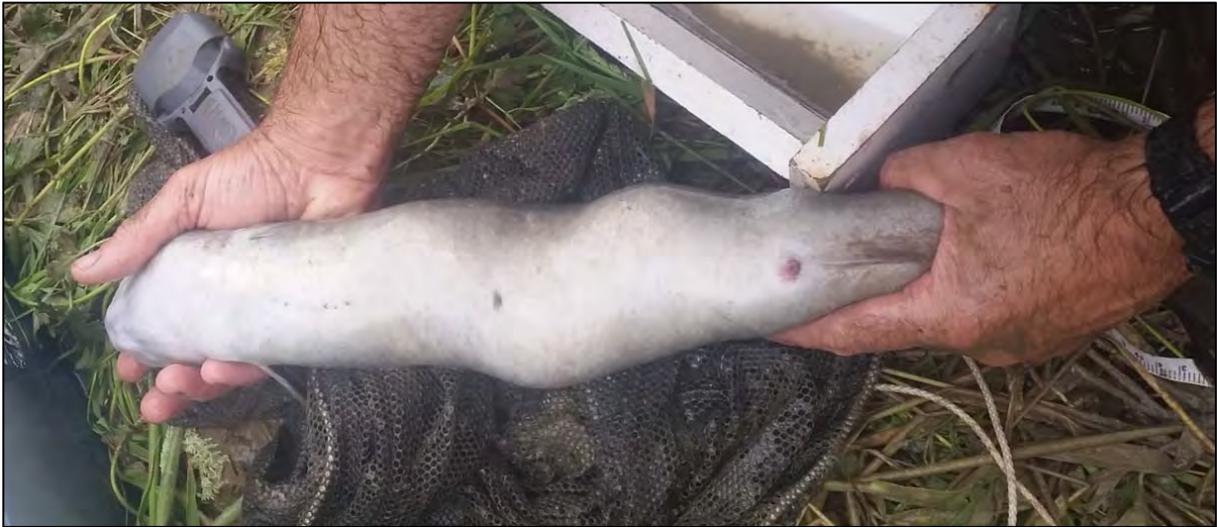
Photo 3 A large longfin eel recorded at site 2, with a consumed eel evident through the deformation of the eel's underside.

including either a tube shelter and/or an eel excluder, the number of large longfins captured increased the risk of predation. Three eels were observed to have eaten relatively large eels, as the consumed eel was discernible when handling and viewing the consuming eel (Photo 3). It is likely smaller eels were also consumed, but they were not discernible in the large eels stomach. Therefore, it is likely to the number of eels recorded at site 2 was an under-representation of the actual number of eels captured.

It may also be that shortfin eels were the species predated upon by the large longfin eels, and this would explain the reduction in shortfin eel numbers at this site. Longfin eel have been observed to predate upon shortfin eels when in aquariums (pers. obs.). Unlike in the previous survey, no dead eels were observed around this site.

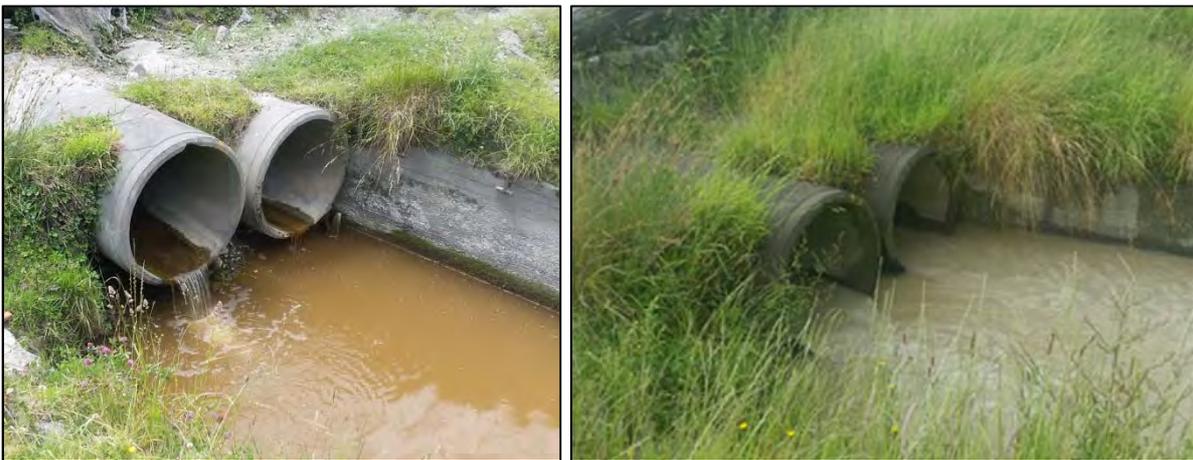
Photo 4 The access culvert immediately upstream of site 2, December 2015 (left) and December 2016 (right).

It is apparent that site 2 still had a much higher abundance than that recorded upstream at site 1. This suggests that the access culvert immediately upstream of this site may still be posing a barrier to fish passage (Photo 4). Some remedial works had been undertaken, with gravel being used to build up the bed level at the outlet of the first pool downstream of the culvert. While this is an appropriate approach, as it will lift the water level and resolve the perched nature of the culverts, the material used was too fine and had already begun scouring away (Photo 5). During the current survey, the culverts were not perched, although this may have been partly because flows were high.

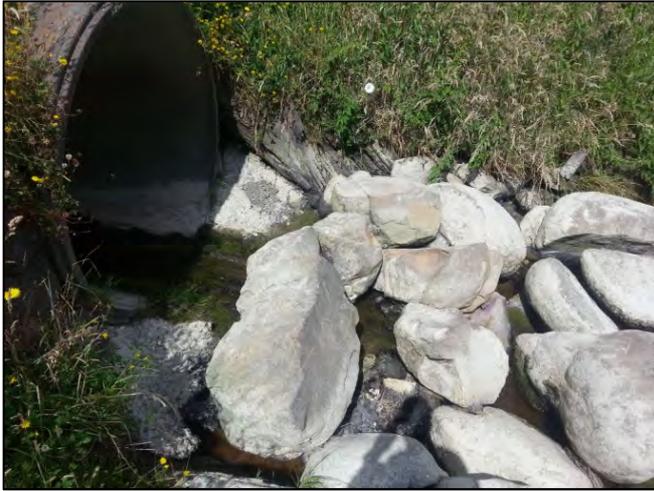
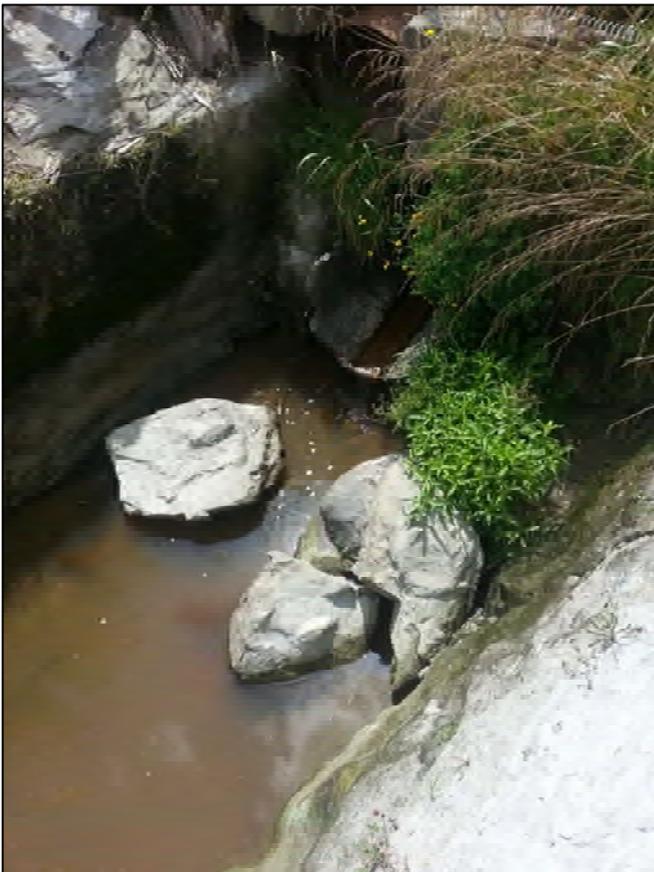
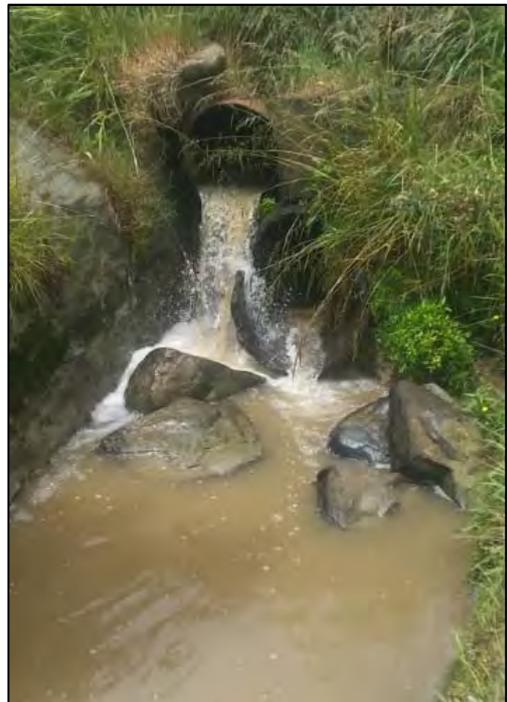
Photo 7

Top left: Culvert 1 December 2015

Bottom Right: Culvert 2 December 2016
