Lower Waiwhakaiho Catchment
Monitoring Programme
Annual Report
2017-2018

Technical Report 2018-9

Taranaki Regional Council
Private Bag 713
STRATFORD
March 2019

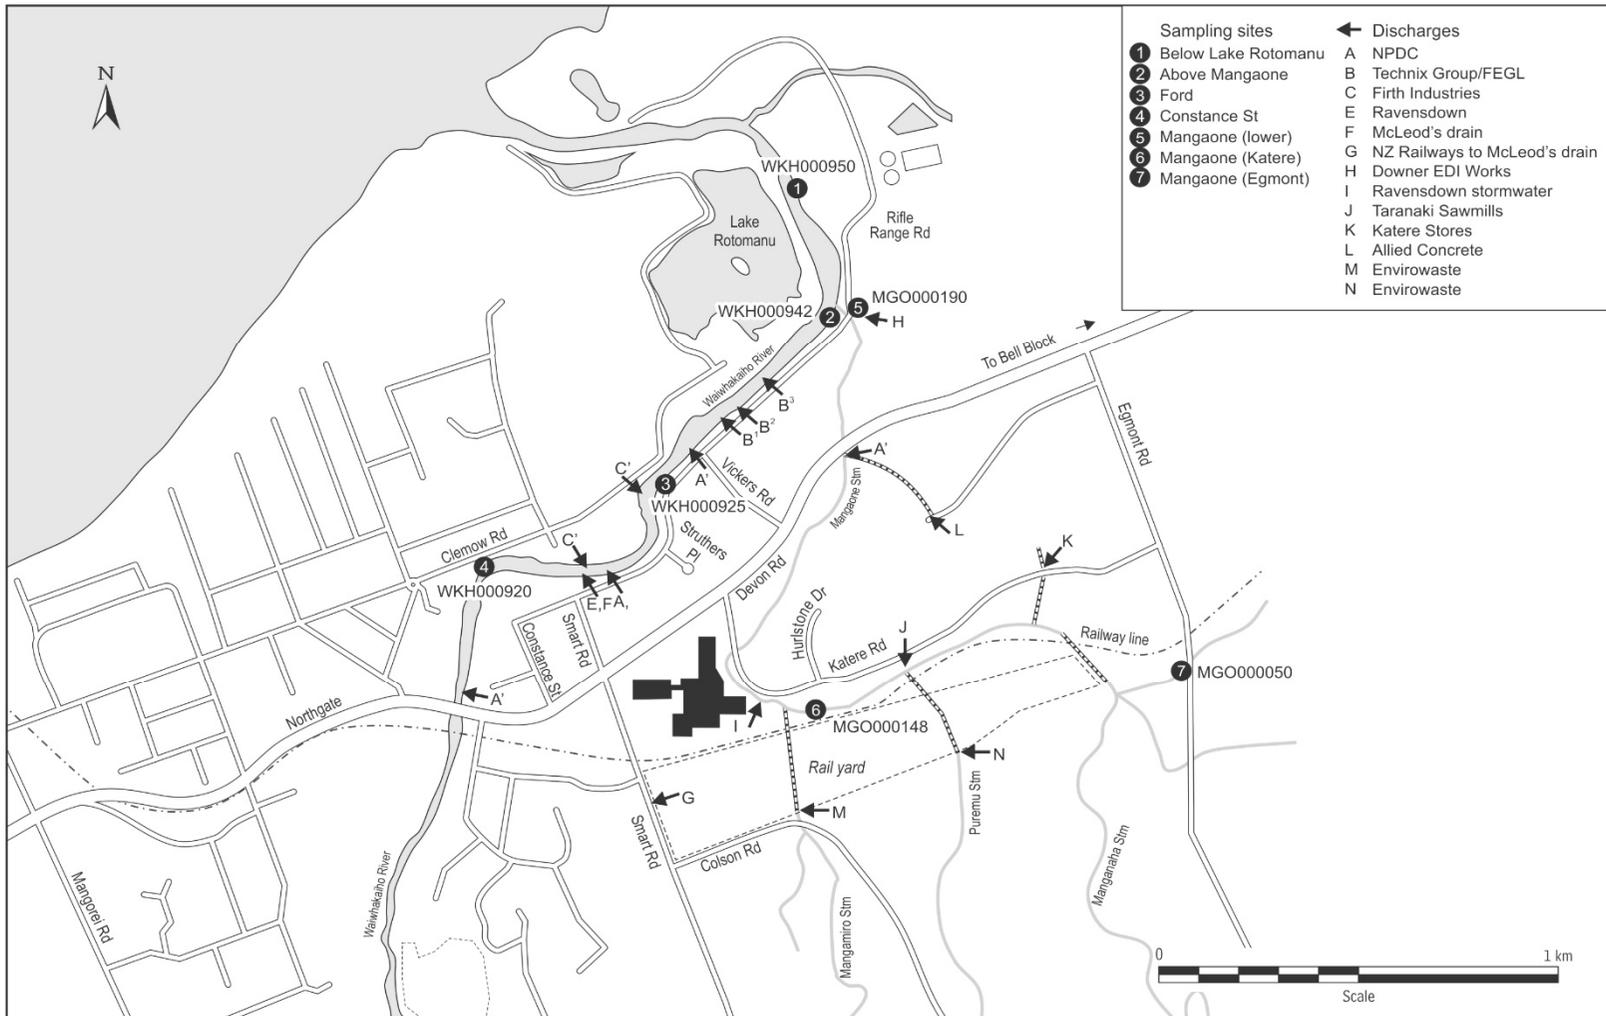
Figure 2 Lower Waiwhakaiho River and Mangaone Stream discharges

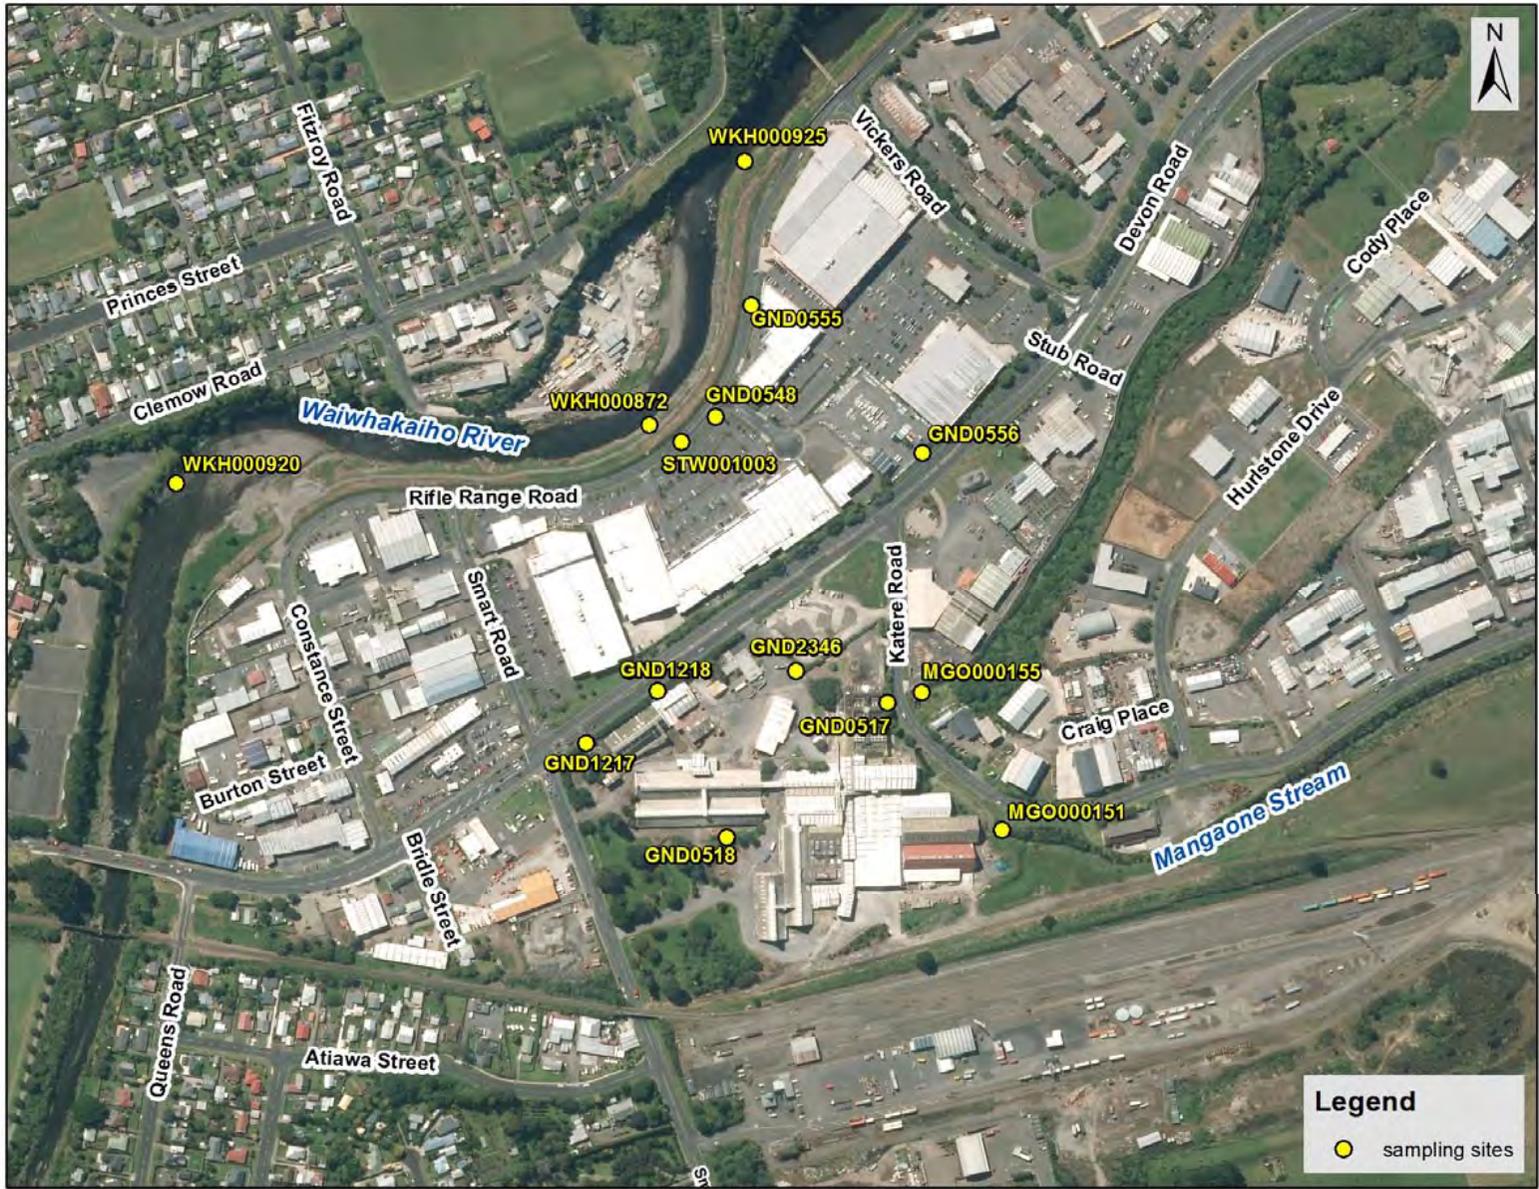
Figure 4 Location of groundwater monitoring bores and associated sampling sites

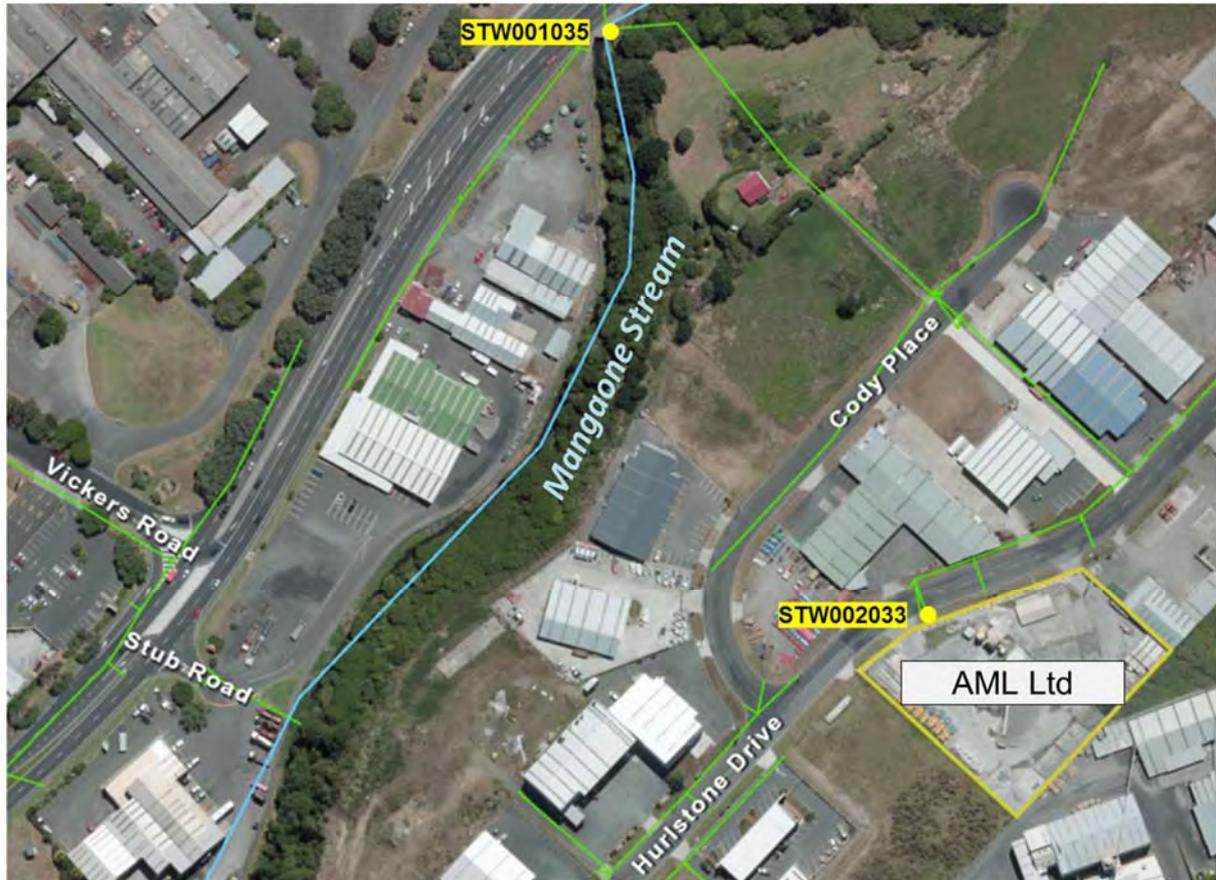
Stormwater from the majority of the site drains directly to the New Plymouth District Council (NPDC) stormwater system and then to the Mangaone Stream.

Figure 5 AML Ltd (trading as Allied Concrete) site location and stormwater drainage

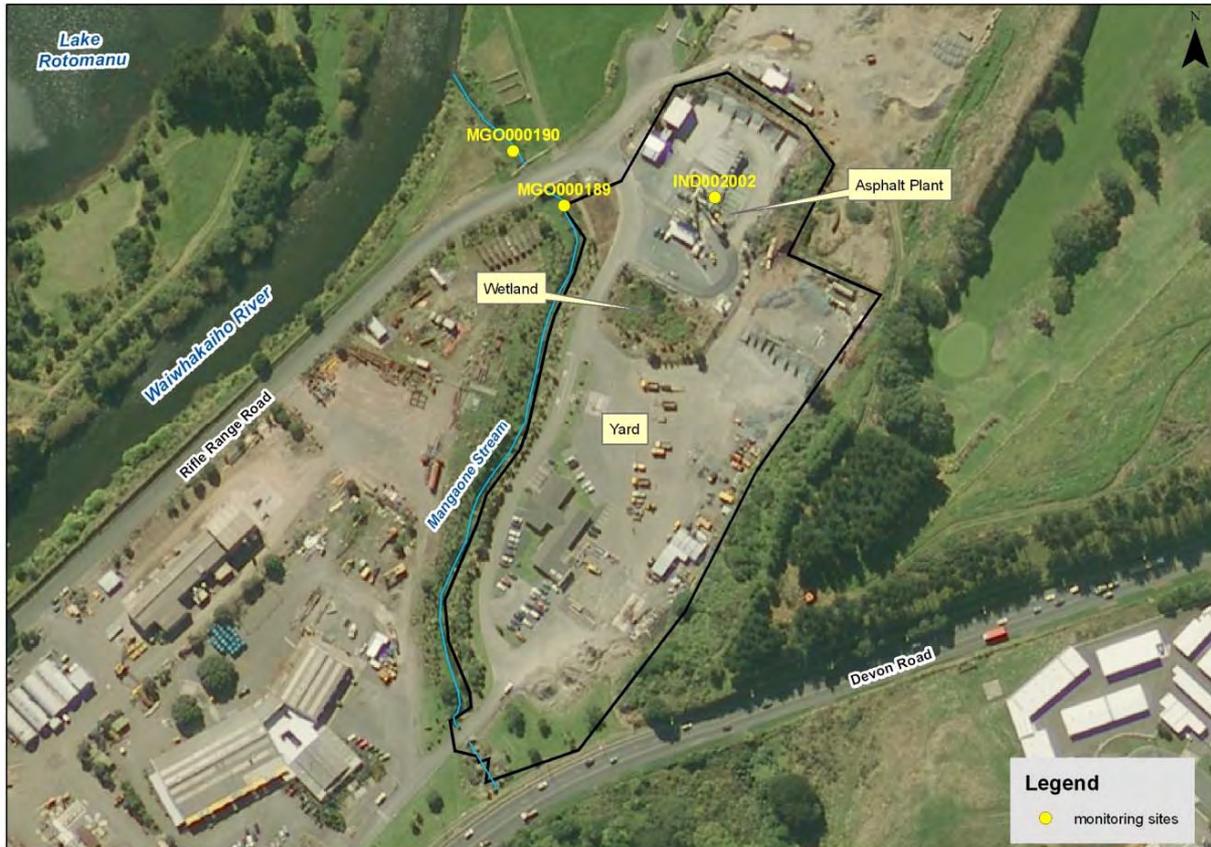
Downer EDI Works Ltd (Downer) operates an asphalt manufacturing plant at a site off Rifle Range Road. A depot for maintenance, parking and storage of equipment and materials used in road-making is also on the site.

Figure 6 Downer's site and sampling point locations

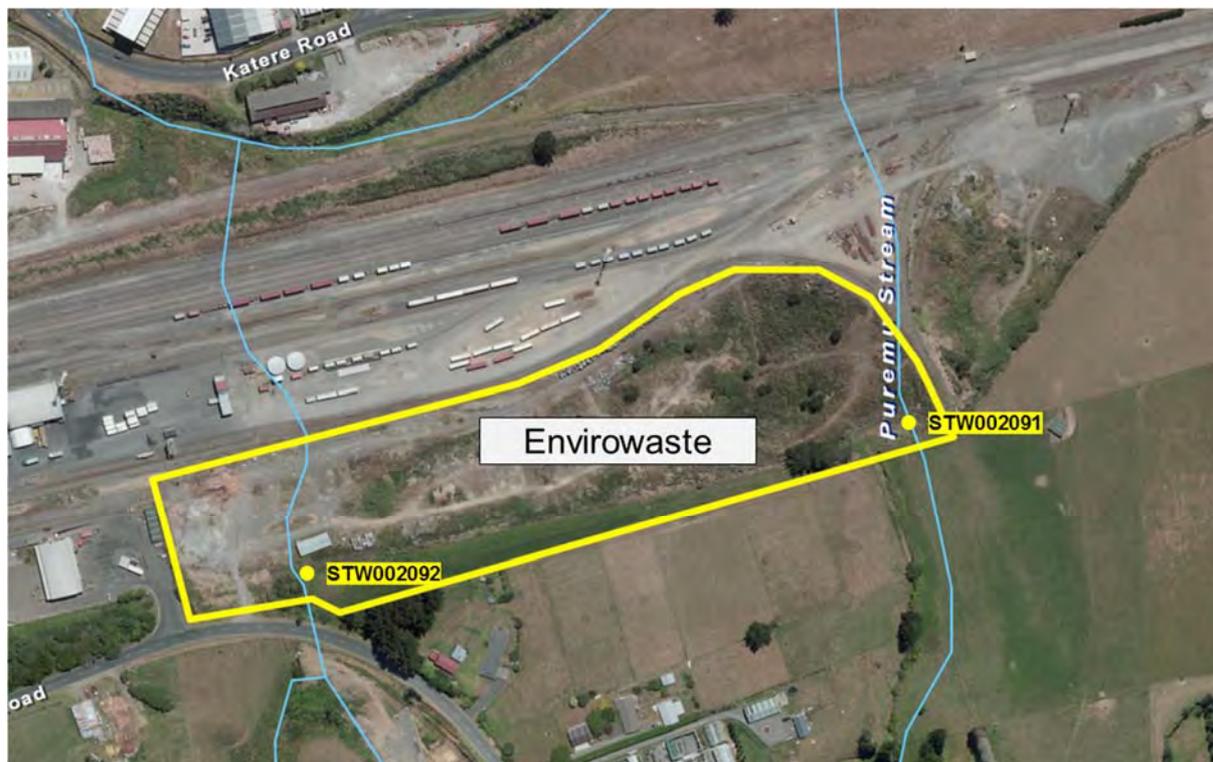
Stormwater from the site discharges via retention ponds to the Puremu and Mangamiro Streams. Prior to discharge the stormwater is treated in long sediment ponds that discharge via grates to prevent litter being carried with it.

Figure 7 Envirowaste's site and sampling locations

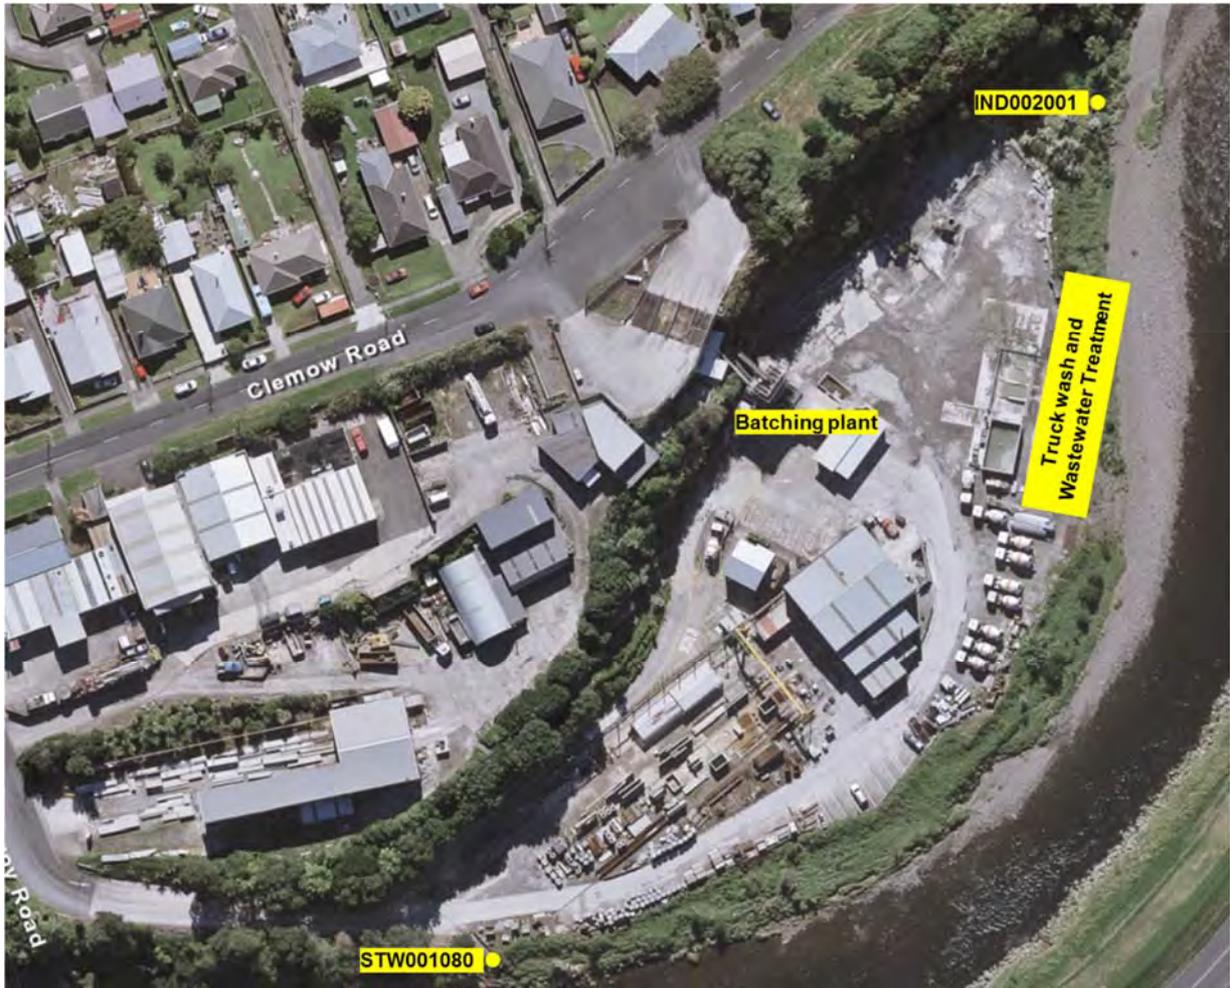
Firth Industries Ltd (Firth) operates a concrete batching plant on a 1.19 ha site off Clemow Road, on the true left bank of the Waiwhakaiho River. The plant is situated partly on the flood plain and partly above the escarpment formed by the river. A concrete precast factory operated by Ultimate Engineered Concrete Ltd is also on the site. This includes a bedding plant, which operates from an area above the escarpment.

Figure 8 Firth Industries site location and discharge points

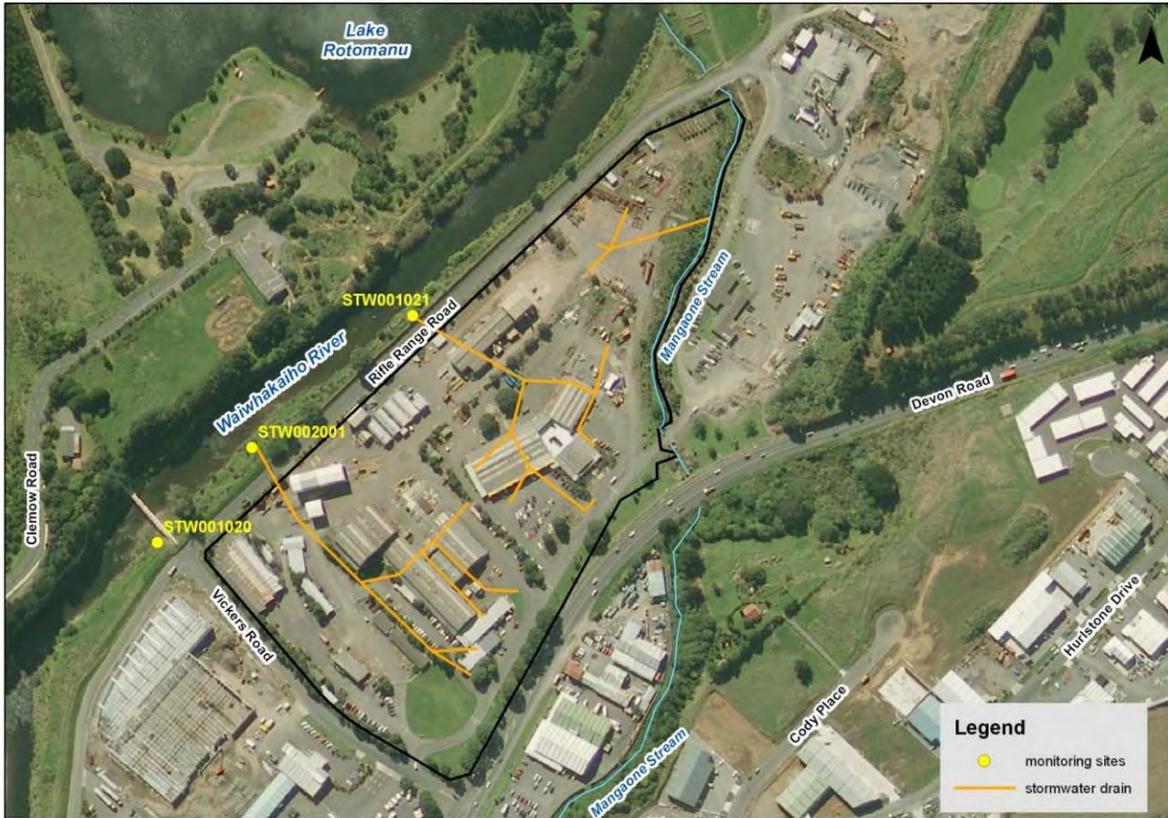
- Staff offices and facilities,
- Workshops (Machining, plate and general),
- Dangerous goods storage,
- Liquid oxygen tanks, and
- Blast and paint storage.

Figure 10 Fitzroy Engineering Group Ltd site and stormwater discharge points

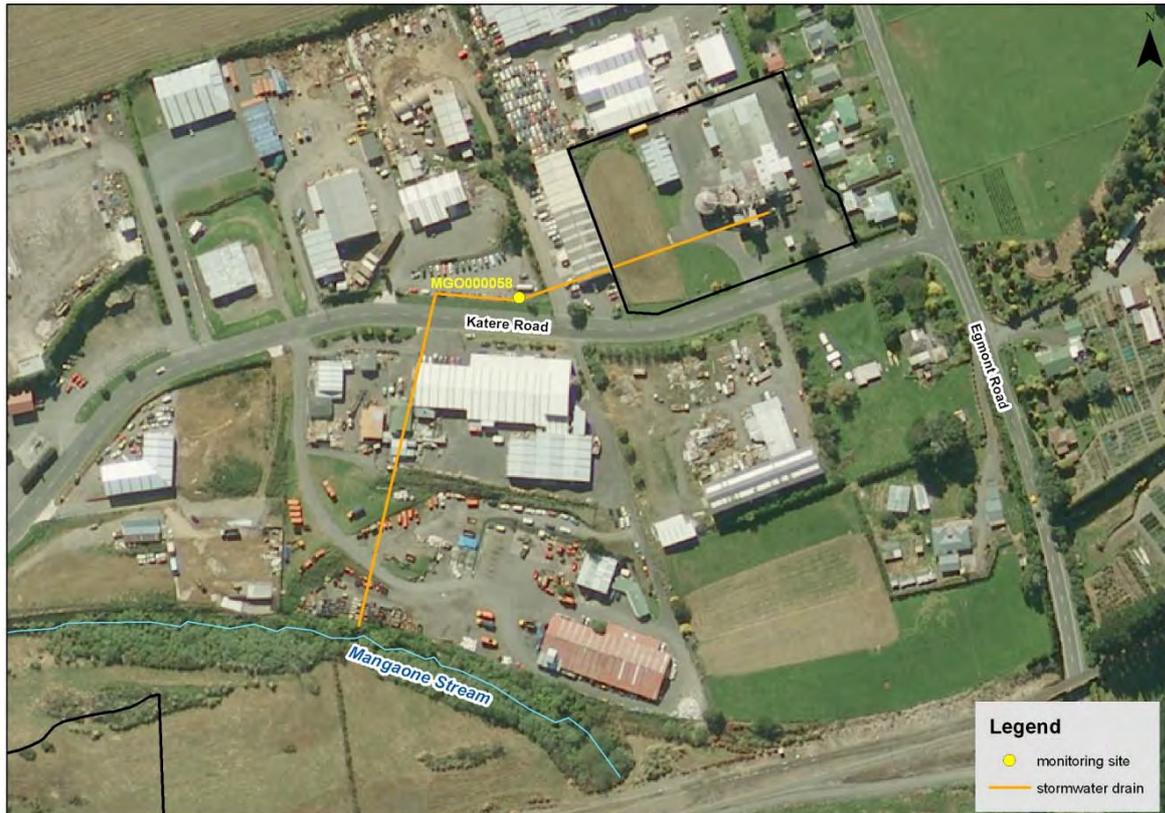
Figure 12 Katere Stores site and sampling point location

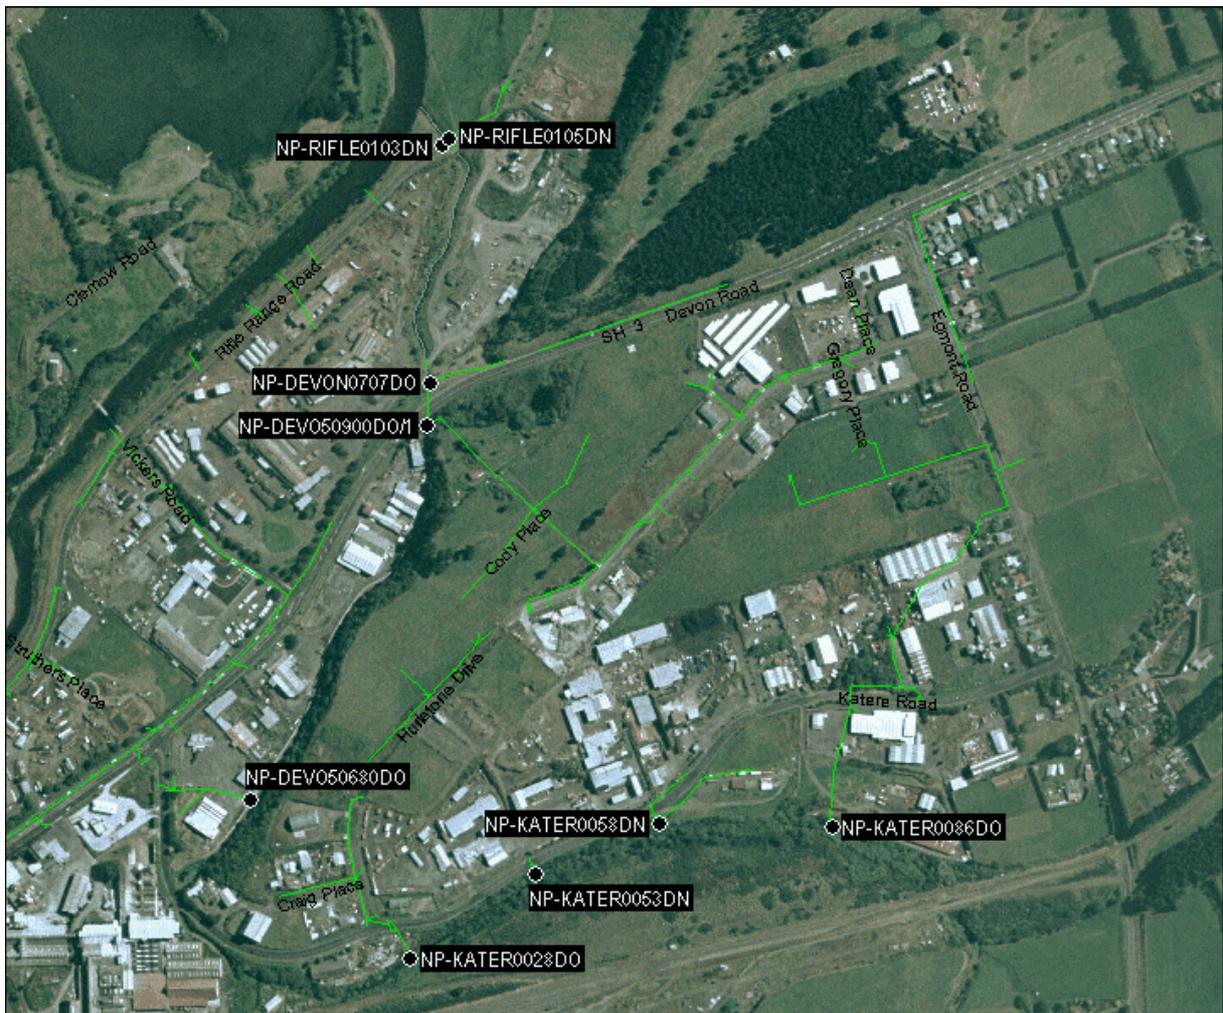
During periods of high rainfall, one of the key features of the performance of the stormwater drainage system is its susceptibility to inlet and outlet blockages. The NPDC maintenance plan aims to reduce reactive maintenance and improve the operation and reliability of the system through preventative maintenance. This includes pipeline condition assessment using video inspection.

Figure 15 NPDC stormwater drainage and consented discharge points to the Mangaone Stream

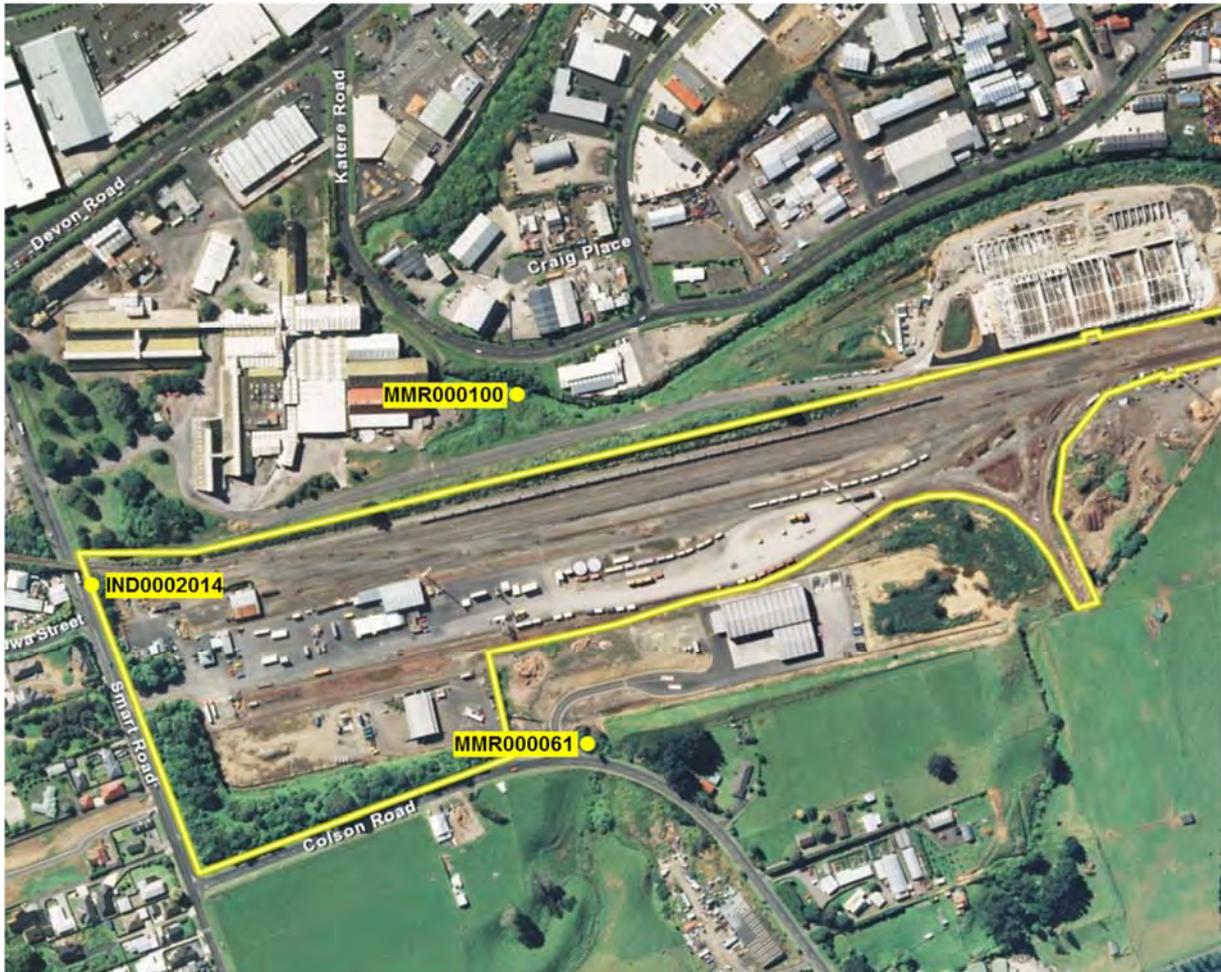
New Zealand Railways Corporation/KiwiRail Holdings Ltd (KiwiRail) own a rail terminal on a site off Smart Road. In addition to transportation of freight, the terminal is utilised as a maintenance depot. The freight receipt and dispatch area and the refuelling and maintenance depots are situated at the Smart Road end of the site.

Figure 16 KiwiRail's yard and sampling point locations

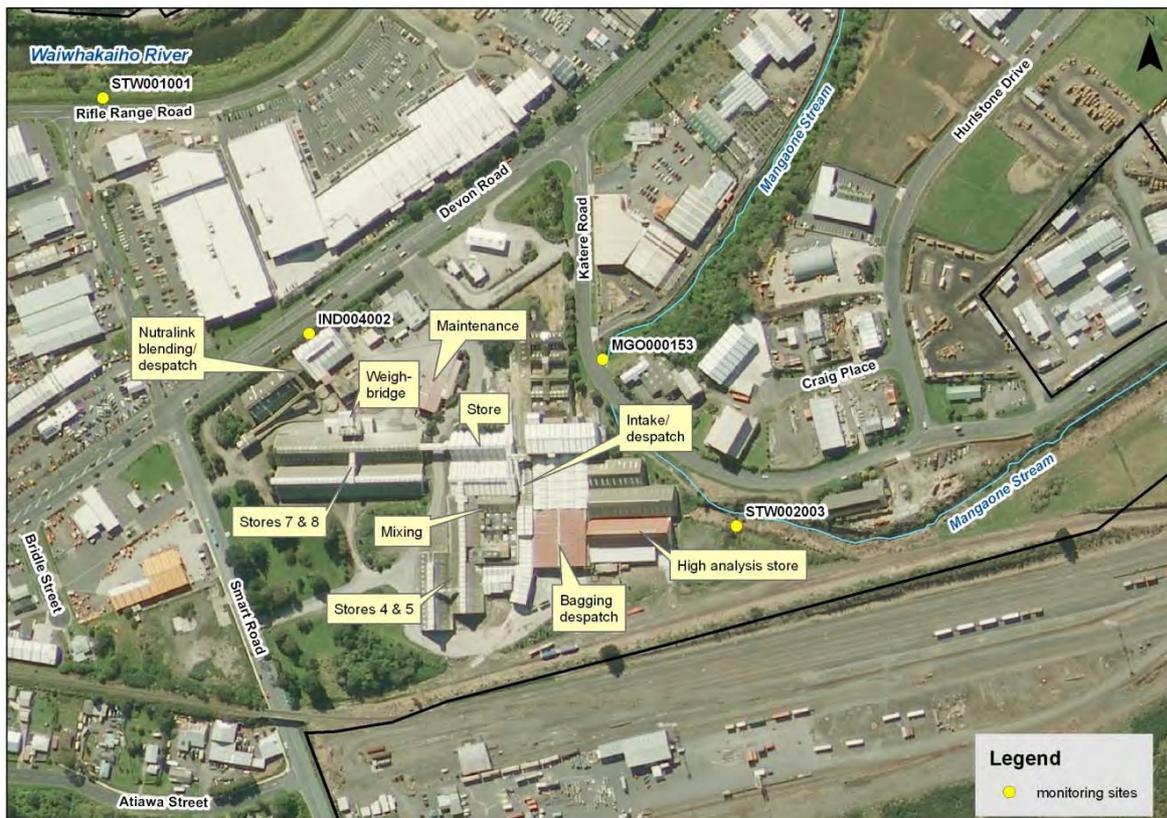
Figure 17 Ravensdown Fertiliser Co-operative Ltd site and sampling point locations

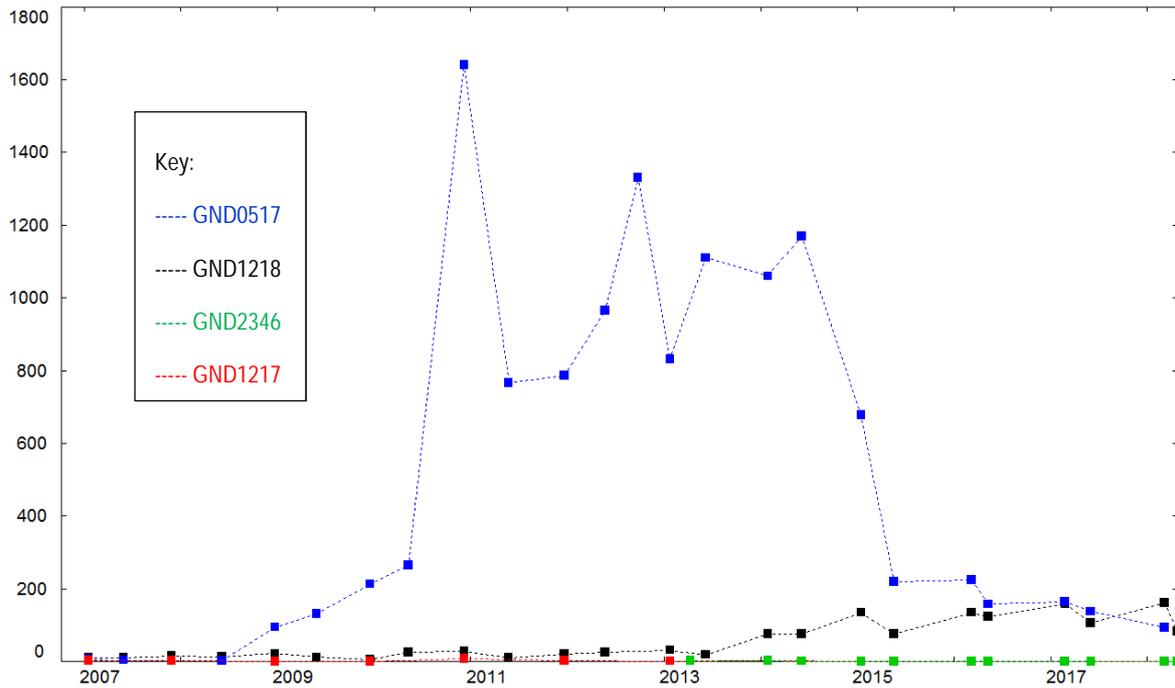
Figure 18 Ammoniacal nitrogen concentration at sites GND0517, GND1218, GND2346 and GND1217 from 2006 to June 2018

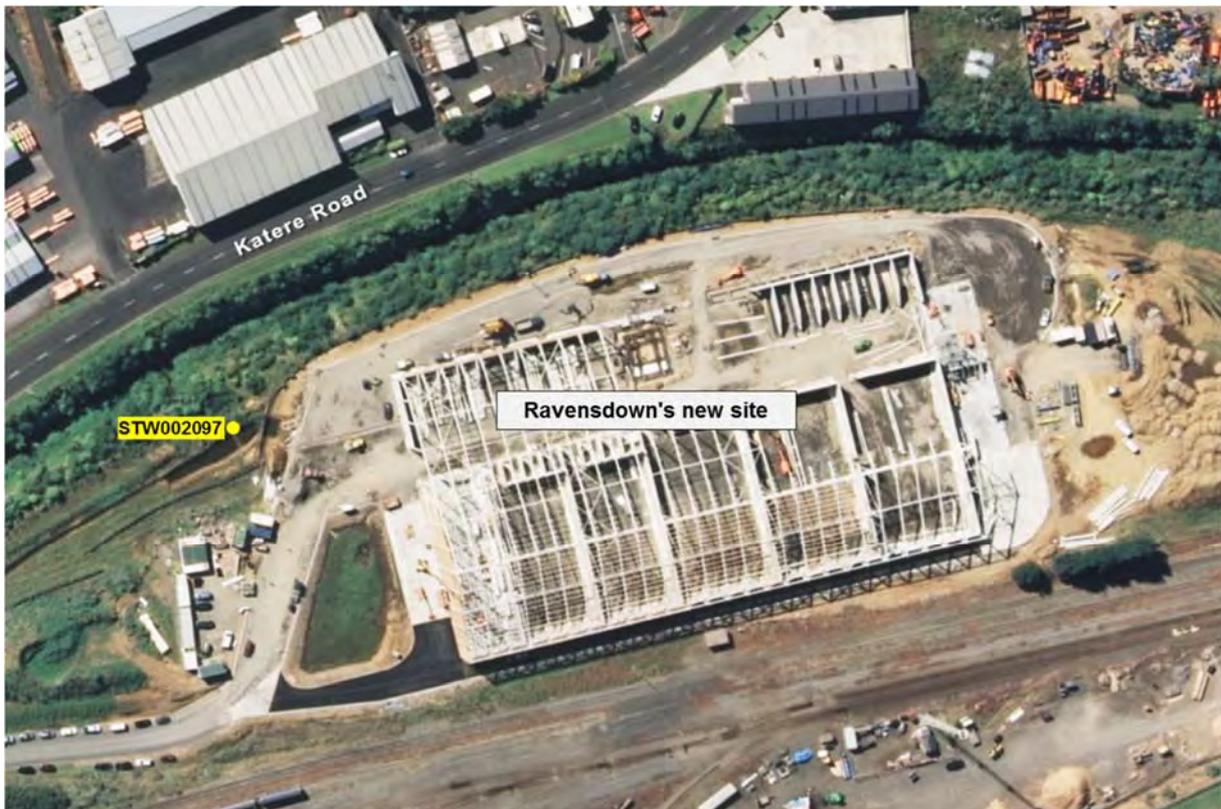
Stormwater from the roof and the area immediately surrounding the main building is directed through a planted treatment pond prior to discharge to the Mangaone Stream. Stormwater from the upper end entrance road is diverted to setting ponds and discharged to the Mangaone further downstream. Stormwater from the lower part of the access road is diverted to the Waiwhakaiho River via MacLeod's drain on Smart Road.

Figure 19 Ravensdown's new site location and discharge point

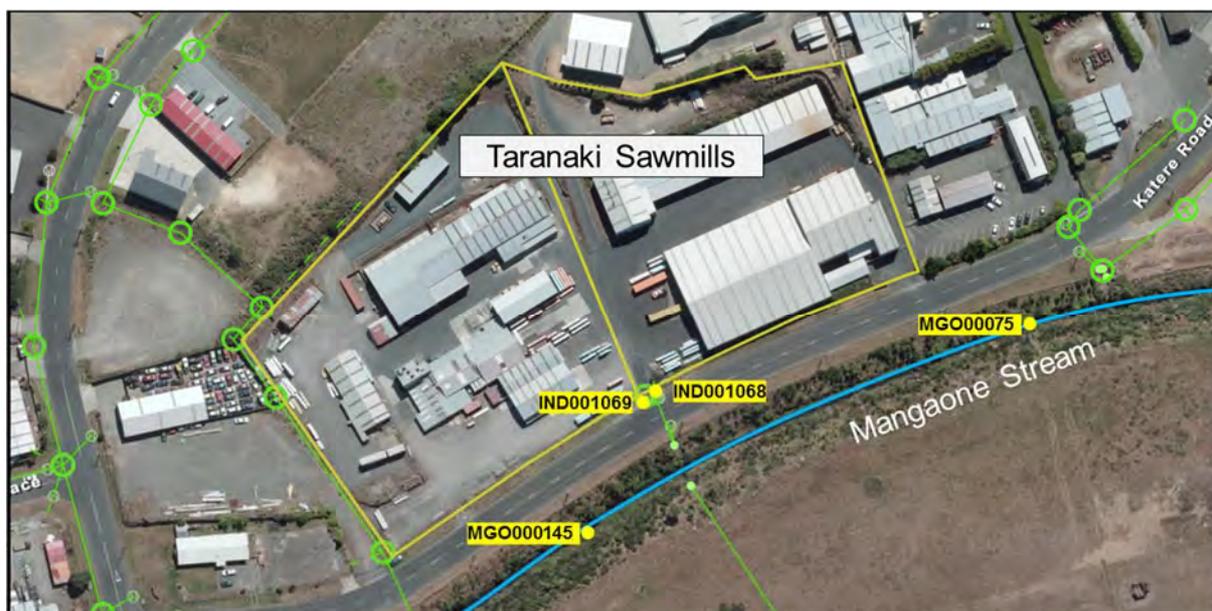
Timber is treated at two plants. At one plant, timber is treated with copper, chromium and arsenic (CCA), and with boron. At the other plant, light organic solvent preservatives (LOSP) are used.

Figure 20 Taranaki Sawmills site and sampling point locations

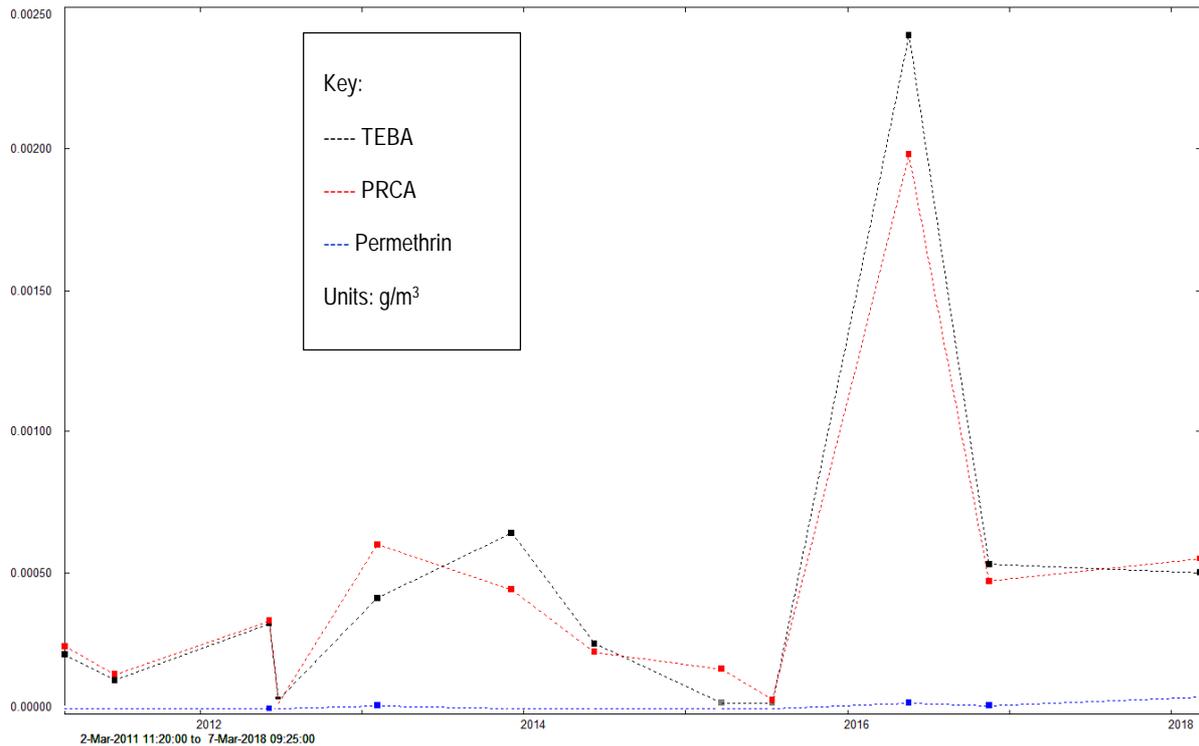
Figure 21 LOSP concentrations downstream of TSM's discharge

Light organic preservative chemicals Tebuconazole and Propiconazole were found in the Mangaone Stream downstream of Taranaki Sawmills Ltd during one wet weather survey. The levels were found to be well within the empirical NOECs (no observable effect concentrations) for aquatic life developed by the European Chemical Agency and the Cawthron Institute.

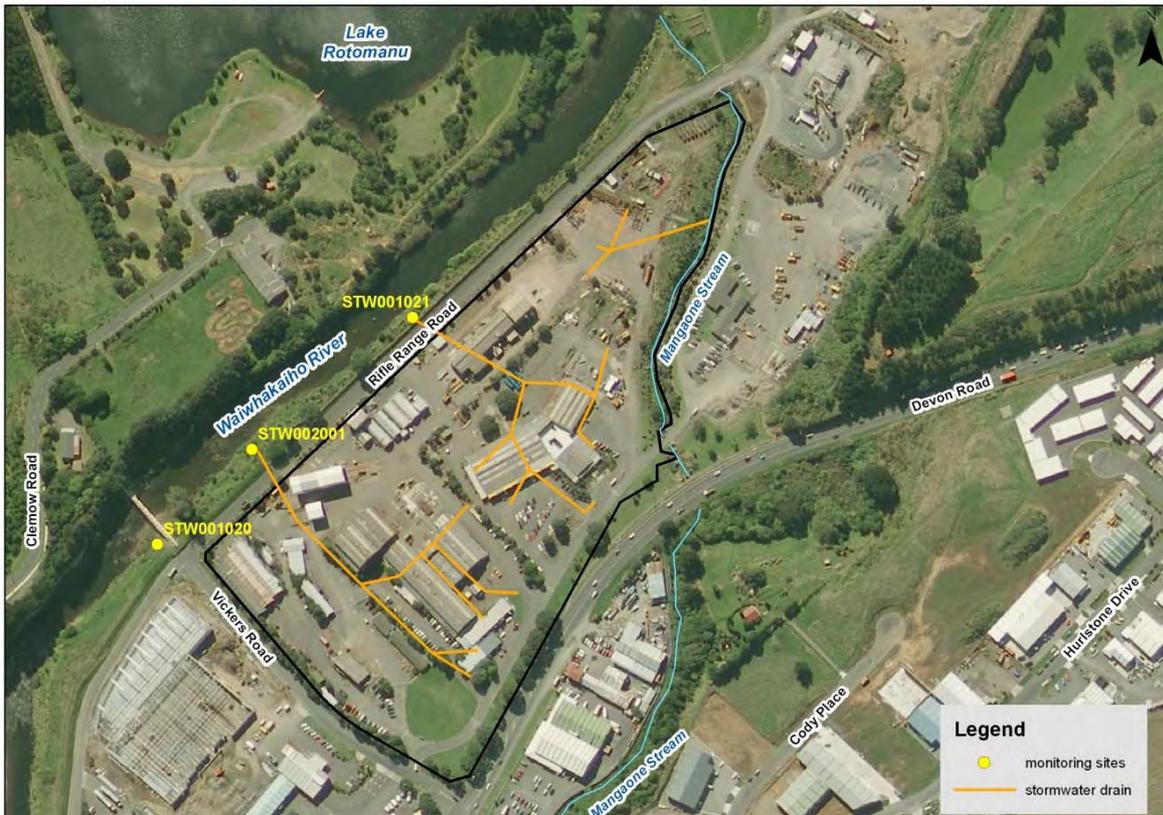
The engineering complex of Technix Group Ltd (Technix) is the largest industrial site along the lower Waiwhakaiho River. Situated on the true right bank of the river immediately above its confluence with the Mangaone Stream, the 8.4 ha area of land is bounded by Rifle Range Road, Vickers Road, State Highway 3, and the Mangaone Stream. The development comprises several building complexes, roading and drainage systems.

Figure 22 Technix site, drainage system and sampling point locations

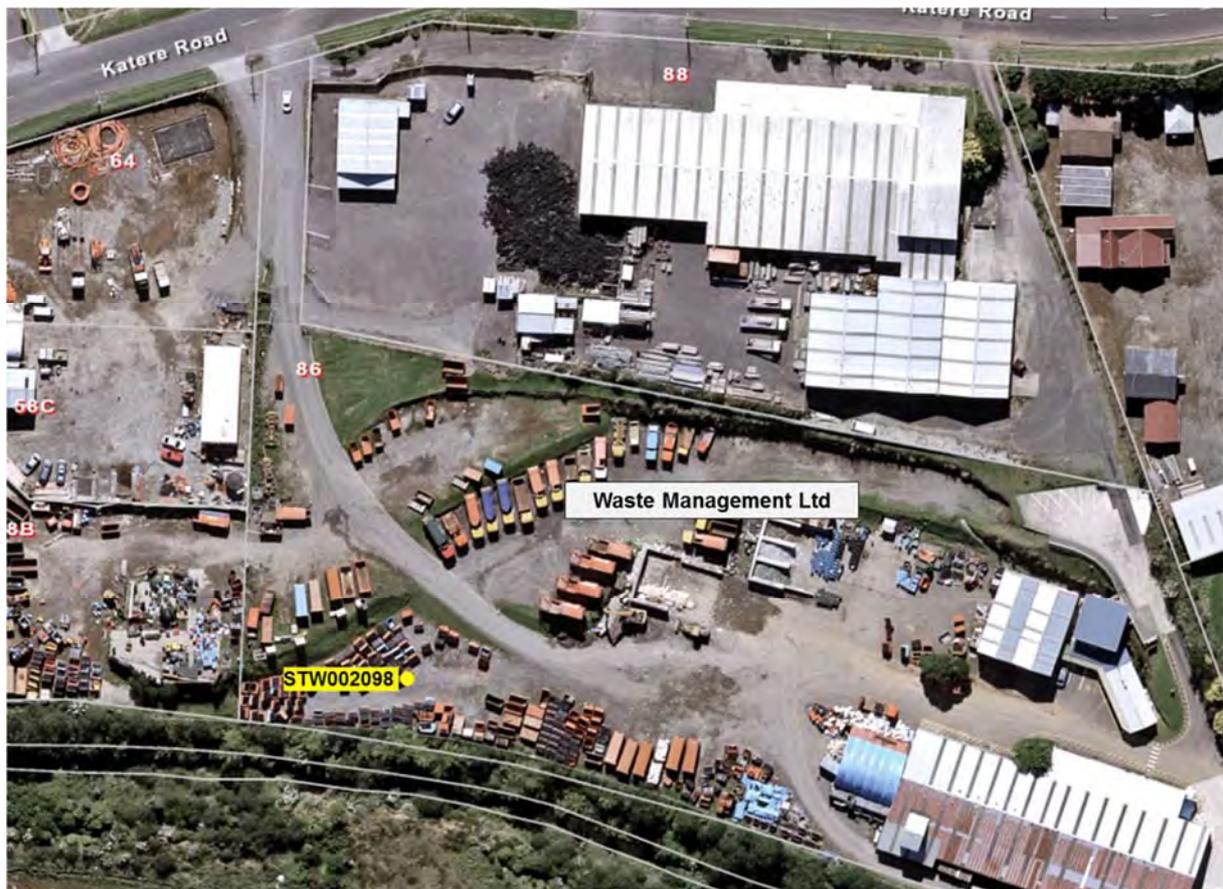
Figure 23 WML's site and discharge point

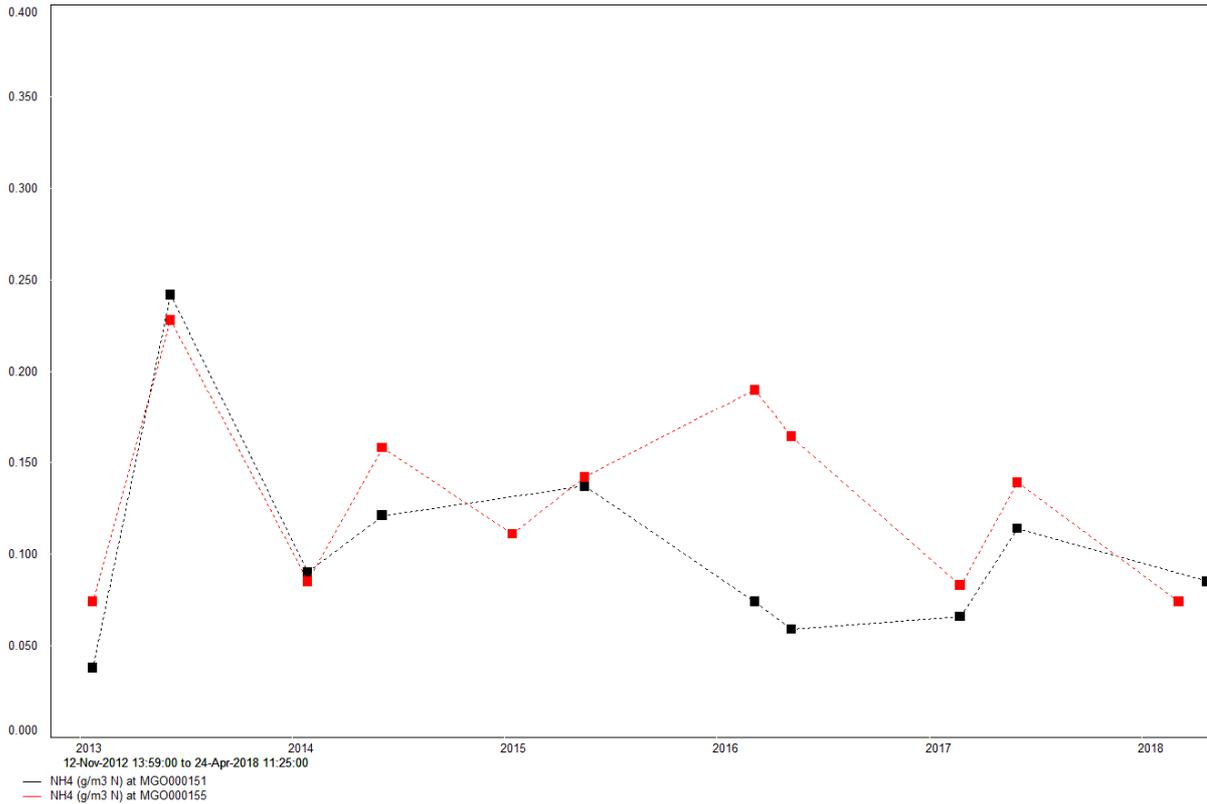
Due to elevations in the ammoniacal nitrogen concentration observed in a Ravensdown bore on Katere Road, this is the parameter of primary interest here and Figure 24 shows the trends in ammoniacal nitrogen concentrations at the upstream and downstream sites.

Figure 24 Mungaone Stream ammoniacal nitrogen concentrations in the vicinity of the Ravensdown site under dry weather conditions 2010-2018

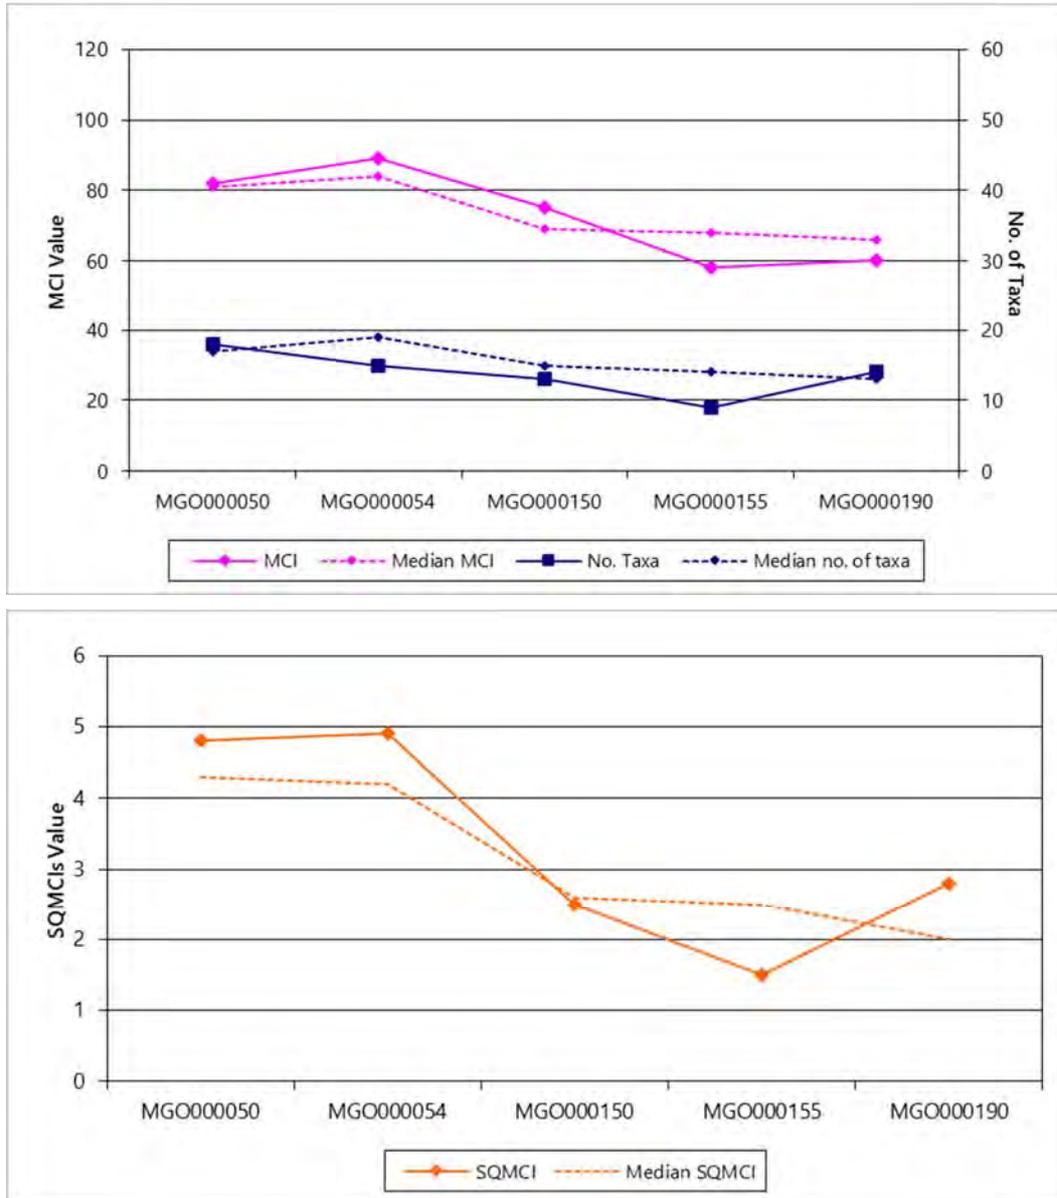
Overall, the results indicated that discharges from the industrial area were not having a significant negative effect on the macroinvertebrate communities in the lower Waiwhakaiho River. The Mangaone Stream sites indicated no recent toxic discharges but sedimentation in the upper catchment and nutrient enrichment in the lower catchment was potentially affecting sites in the lower reach.

Figure 25 Longitudinal trend in number of taxa, MCI and SQMCI₅ values in the Mangaone Stream for the survey of 25 October 2017
