Lower Waiwhakaiho Catchment
Monitoring Programme
Annual Report
2017-2018

Technical Report 2018-9

Taranaki Regional Council
Private Bag 713
STRATFORD
March 2019

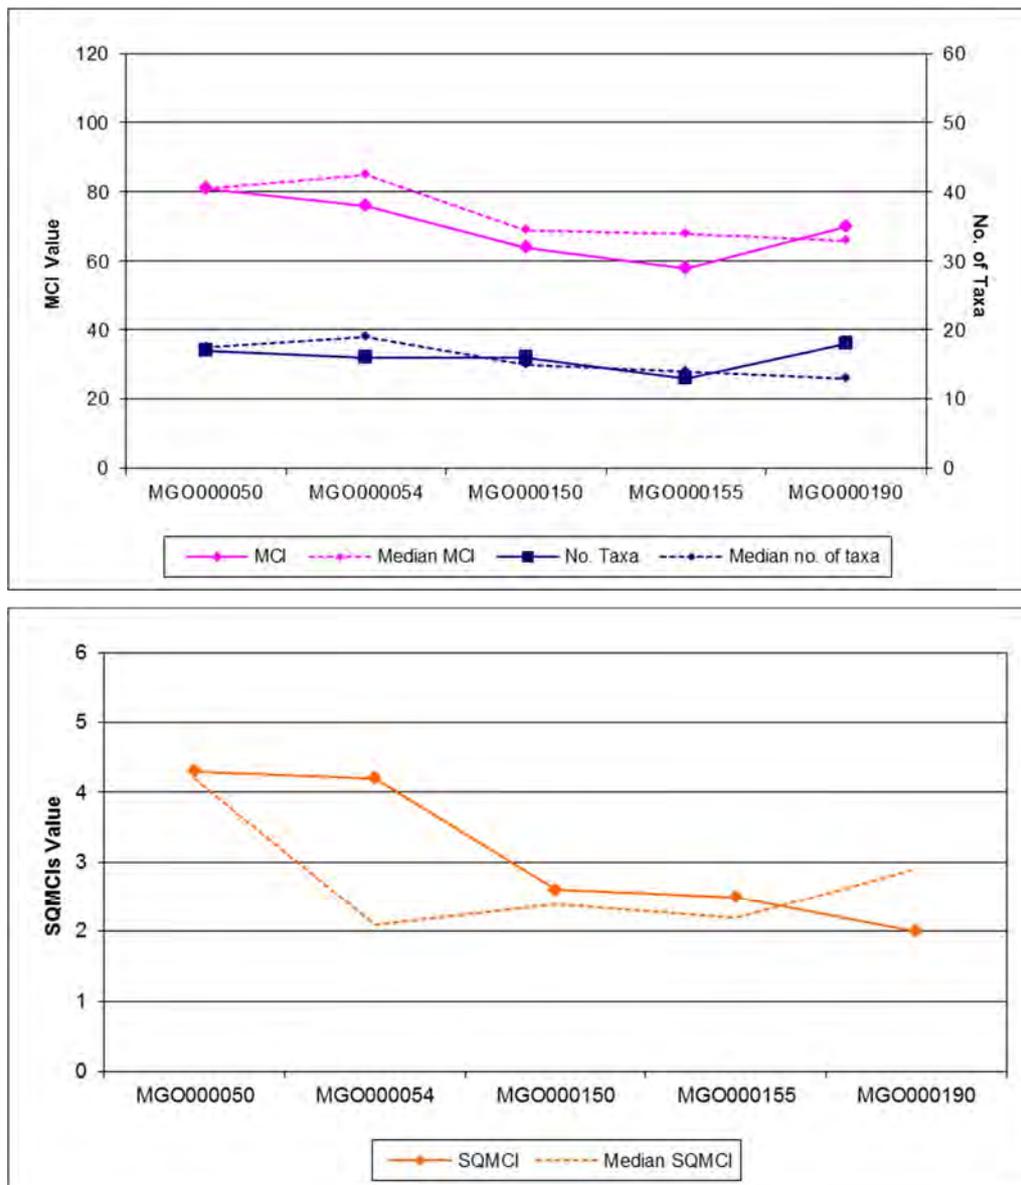
Overall, the results indicated that discharges from the industrial area were not having a significant negative effect on the macroinvertebrate communities in the lower Waiwhakaiho River. The Mangaone Stream macroinvertebrate communities had a typical deterioration in health due to chronic pollution from historic sites downstream of site 16 with some evidence more recent toxic discharges may have affected the macroinvertebrate community at site 15.

Figure 26 Longitudinal trend in number of taxa, MCI and SQMCI₅ values in the Mangaone Stream for the survey of 2 March 2018

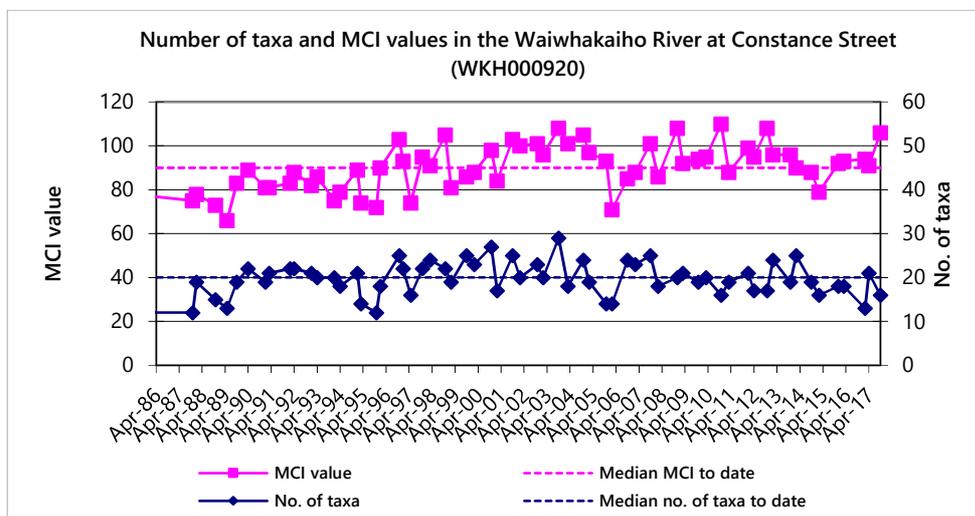
The community was characterised by one 'tolerant' 'taxon [orthoclad midge], one 'moderately sensitive' taxon [crane fly (*Aphrophila*)], and one 'highly sensitive' taxon [mayfly (*Deleatidium*)] (Table 7).

Figure 2 Numbers of taxa and MCI values for Waiwhakaiho River at Constance Street since 1987

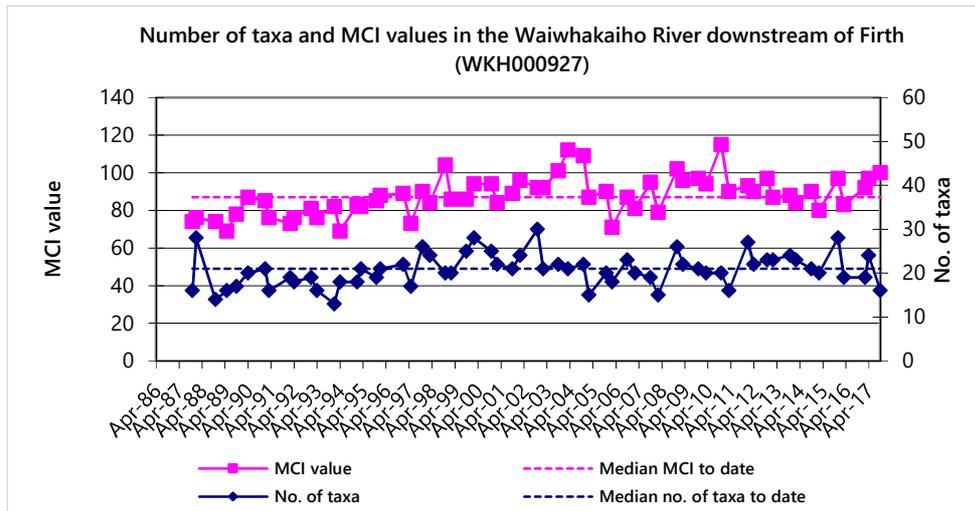
The community was characterised by one 'tolerant' 'taxon [orthoclad midge], one 'moderately sensitive' taxon [crane fly (*Aphrophila*)], and one 'highly sensitive' taxon [mayfly (*Deleatidium*)] (Table 7).

Figure 3 Numbers of taxa and MCI values for Waiwhakaiho River below Firth Industries (left bank) since 1987

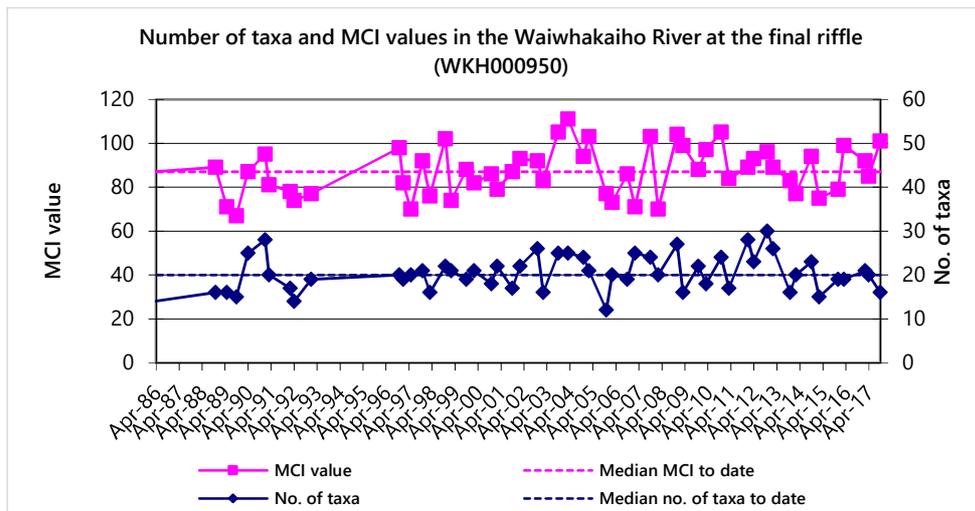
The community was characterised by two 'tolerant' taxa [oligochate worms and orthoclad midge], one 'moderately sensitive' taxon [crane fly (*Aphrophila*)], and one 'highly sensitive' taxon [mayfly (*Deleatidium*)] (Table 7).

Figure 4 Numbers of taxa and MCI values for Waiwhakaiho River d/s of Lake Rotomanu since 1987

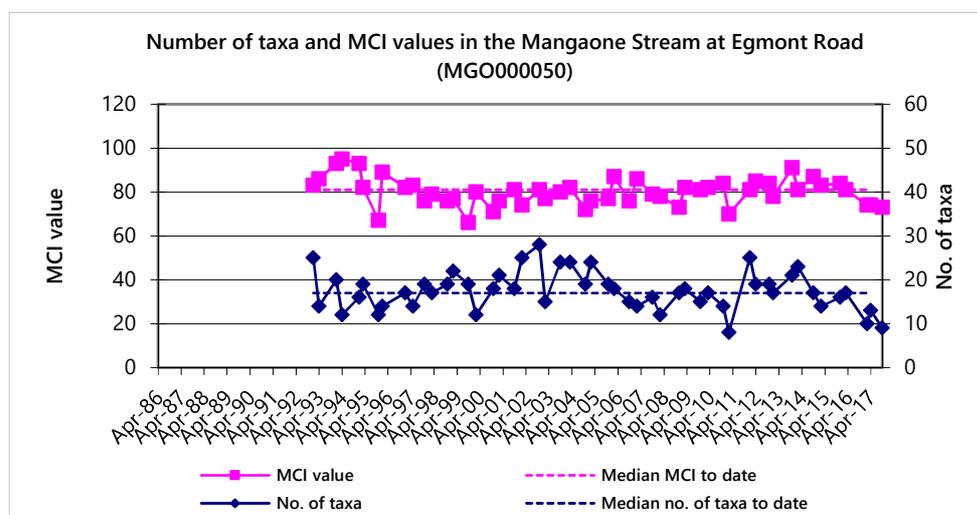
The community was characterised by three 'tolerant' taxa [oligochaete worms, snail (*Potamopyrgus*), and orthoclad midge], and one 'moderately sensitive' taxon [amphipod (*Paracalliope*)] (Table 8).

Figure 5 Number of taxa and MCI values for Mangaone Stream at Egmont Road since 1992 20m downstream of Manganaha Stream confluence (site 16)

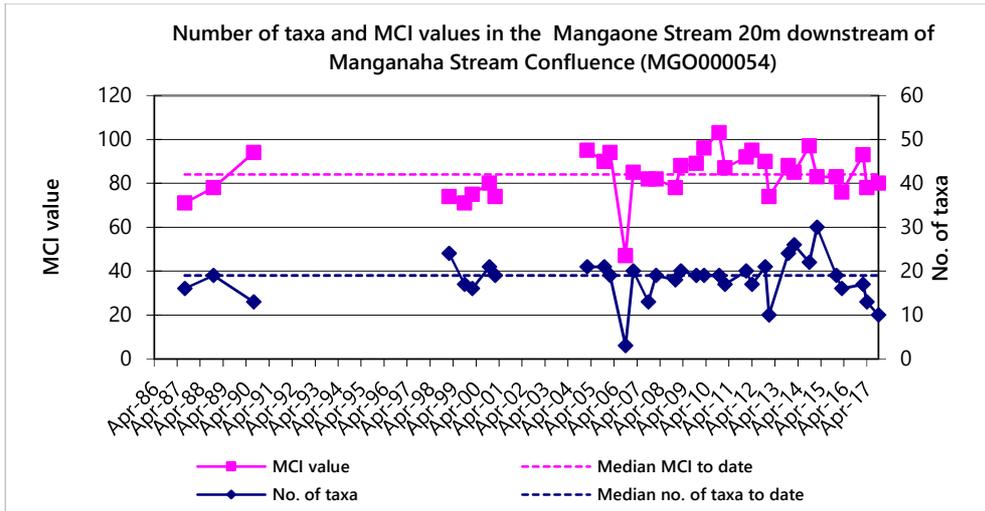
The community was characterised by two 'tolerant' taxa [oligochaete worms and sandfly (*Austrosimulium*)] and one 'moderately sensitive' taxon [amphipod (*Paracalliope*)] (Table 8).

Figure 6 Numbers of taxa and MCI values for the Mangaone Stream downstream of the confluence with Manganaha Stream since 1987

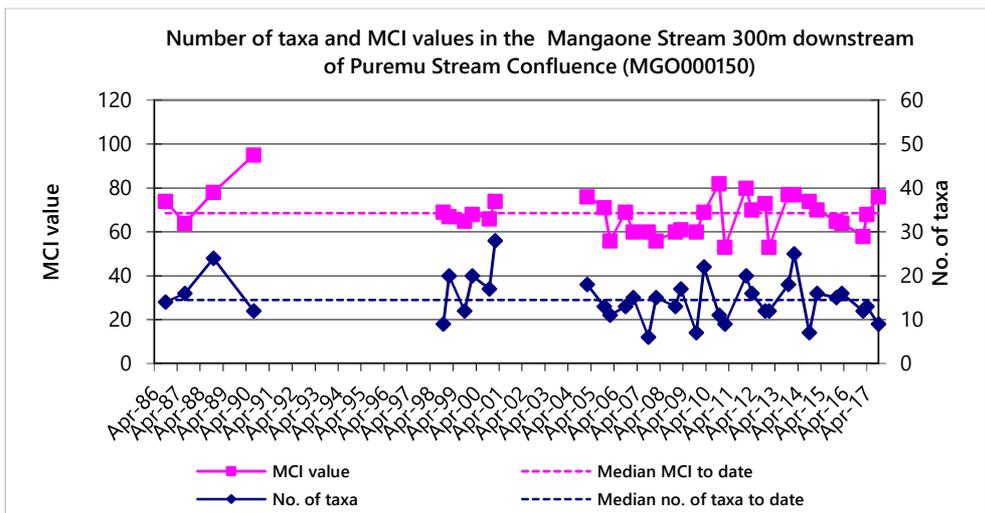
The community was characterised by two tolerant' taxa [oligochaete worms and midge (Orthoclaadiinae)] (Table 8).

Figure 7 Numbers of taxa and MCI values for Mangaone Stream downstream of the confluence with Puremu Stream since 1986

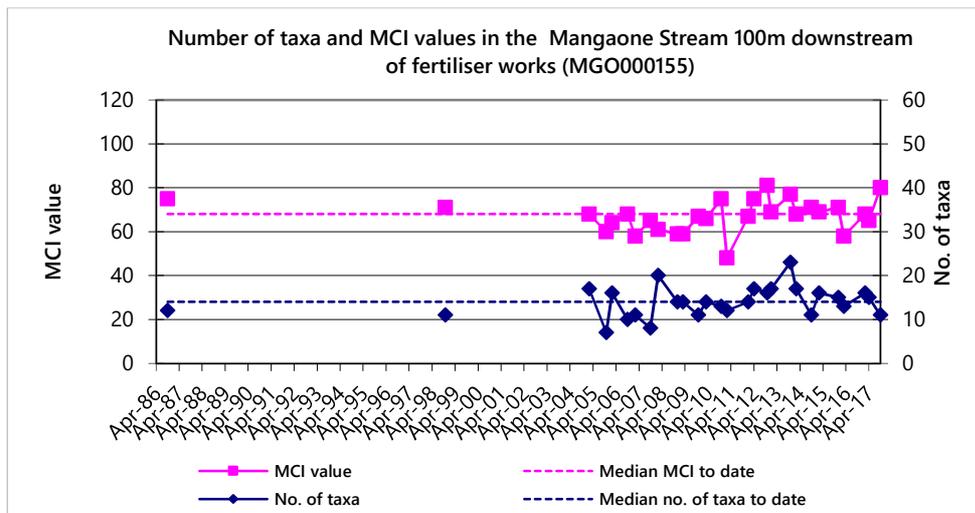
The community was characterised by two tolerant taxa [oligochaete worms and midge (Orthocladiinae)] (Table 8).

Figure 8 Numbers of taxa and MCI values for Mangaone Stream 100 m downstream of the fertilizer works/depot since 1986

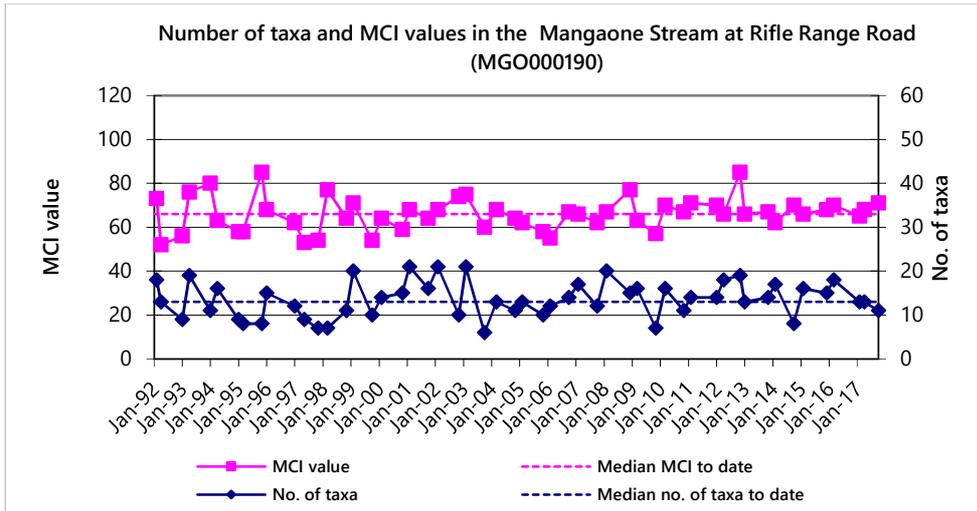
The community was characterised by three 'tolerant' taxa [oligochaete worms, snail (*Potamopyrgus*), and midges (Orthocladiinae and *Polypedium*)] (Table 8).

Figure 9 Numbers of taxa and MCI values for Mangaone Stream at Rifle Range Road since 1992

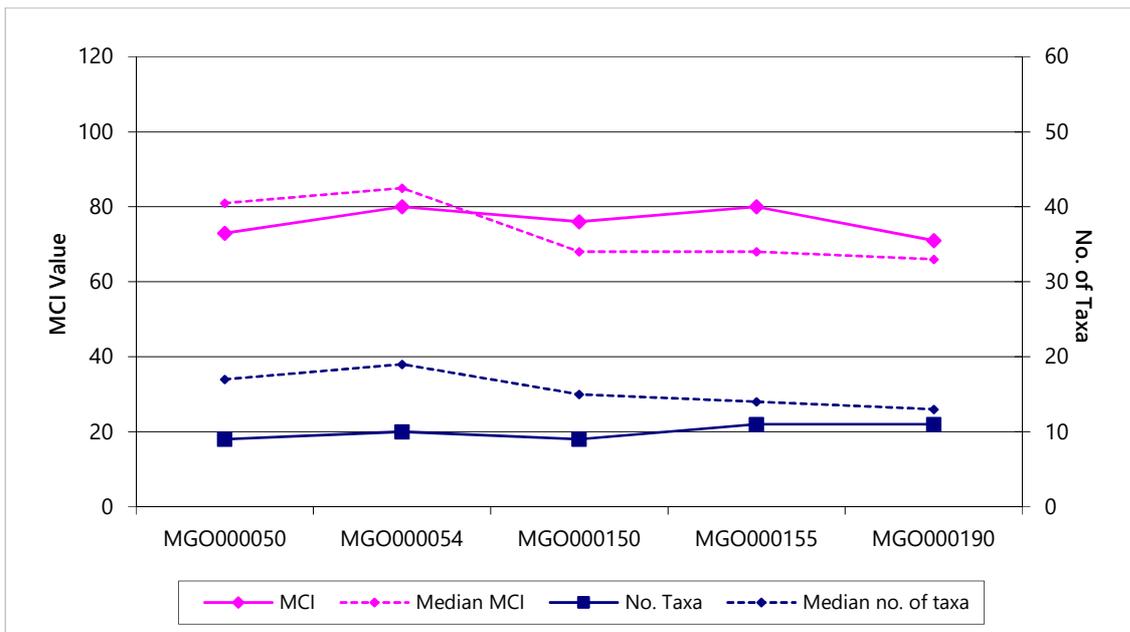
Figure 10 Longitudinal trend in number of taxa and MCI values in the Mangaone Stream for the survey of 25 October 2017

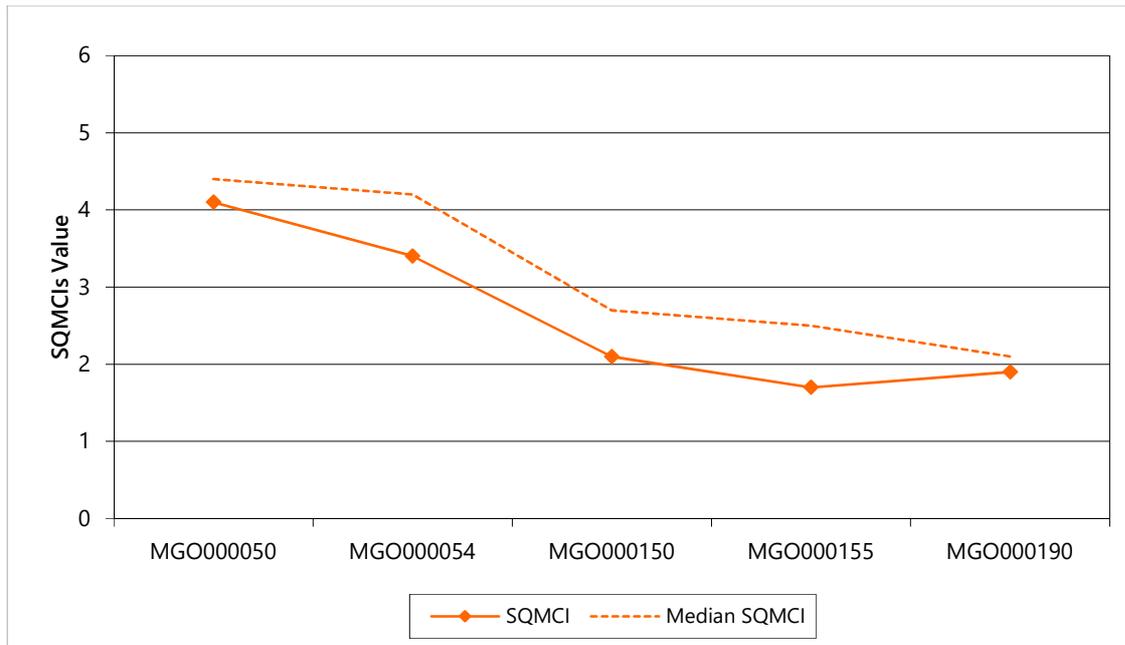
Figure 11 Longitudinal trend in SQMCI₅ values in the Mangaone Stream for the survey of 25 October 2017

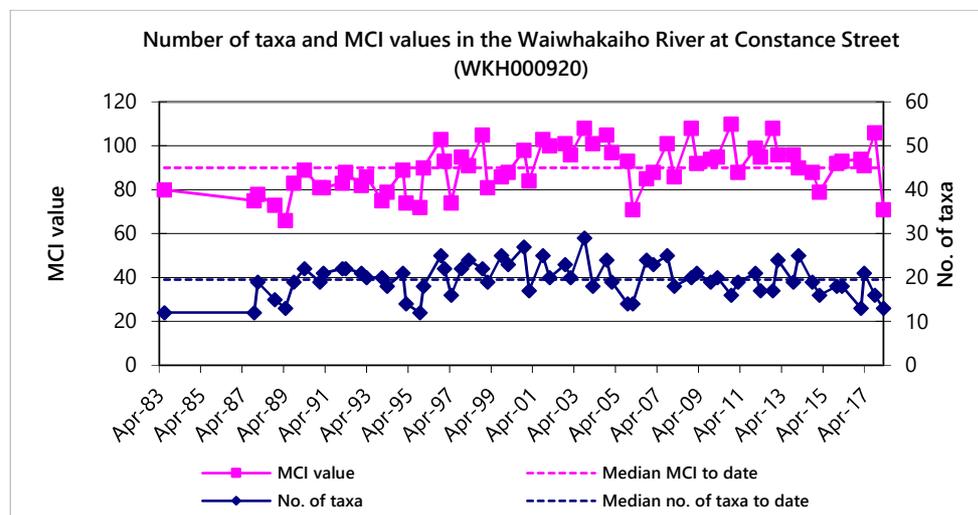
The community was characterised by two 'tolerant' taxa [midges (Orthoclaadiinae and Ephydriidae)] (Table 7).

Figure 2 Numbers of taxa and MCI values for Waiwhakaiho River at Constance Street since 1987

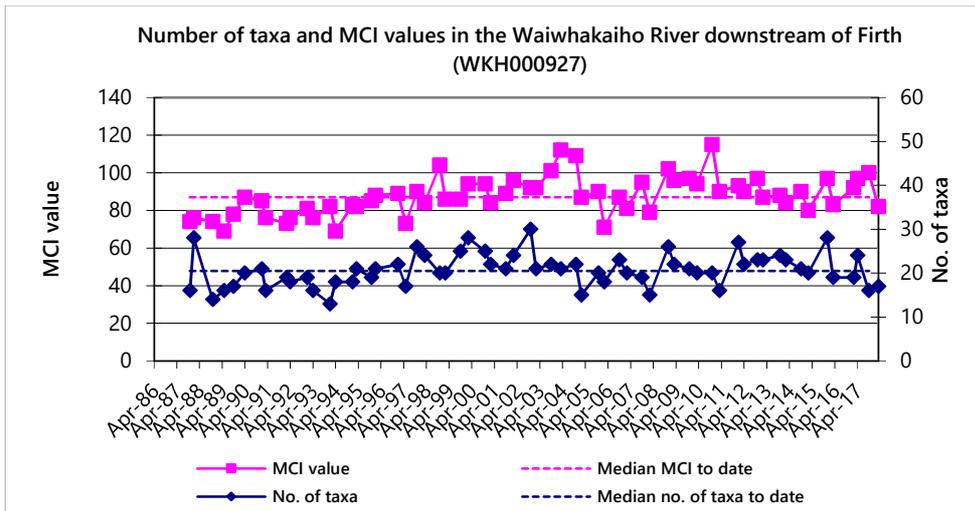
Figure 3 Numbers of taxa and MCI values for Waiwhakaiho River below Firth Industries (left bank) since 1987

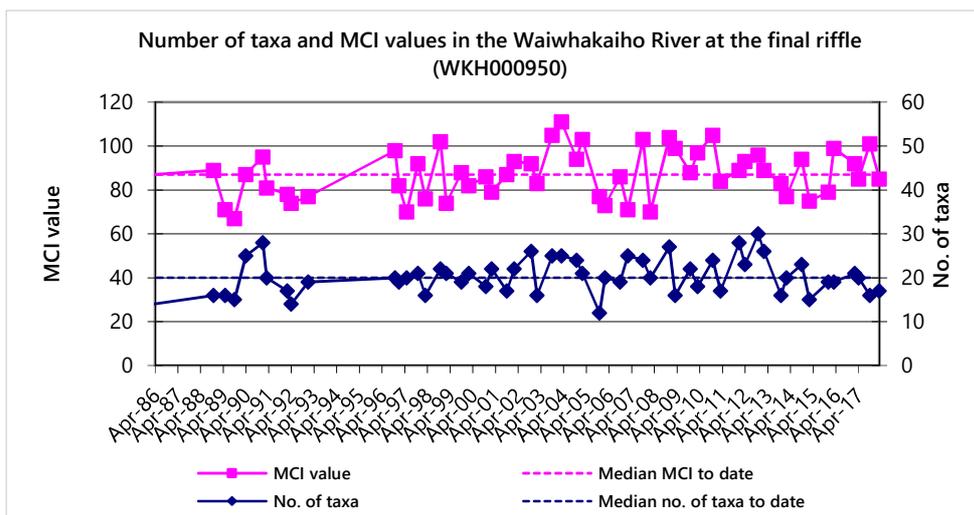
Figure 4 Numbers of taxa and MCI values for Waiwhakaiho River d/s of Lake Rotomanu since 1987

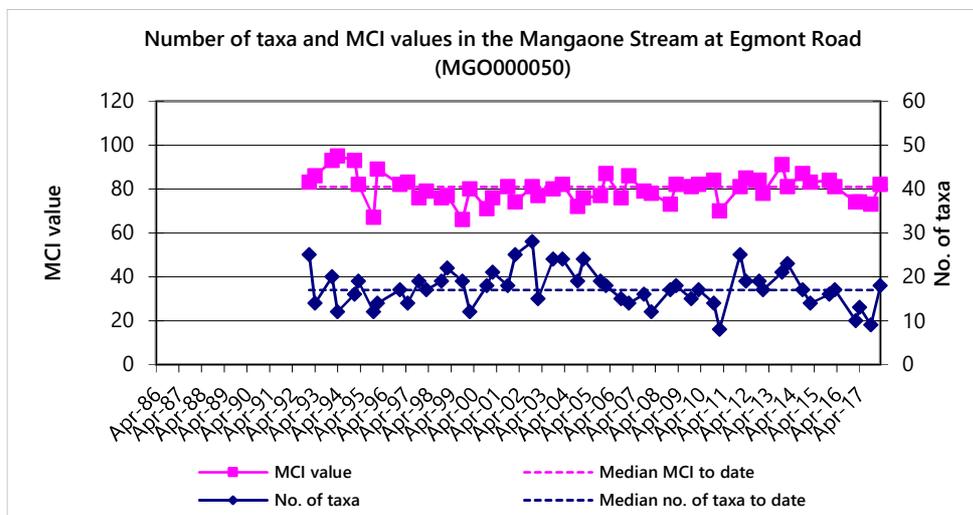
Figure 5 Number of taxa and MCI values for Mangaone Stream at Egmont Road since 1992

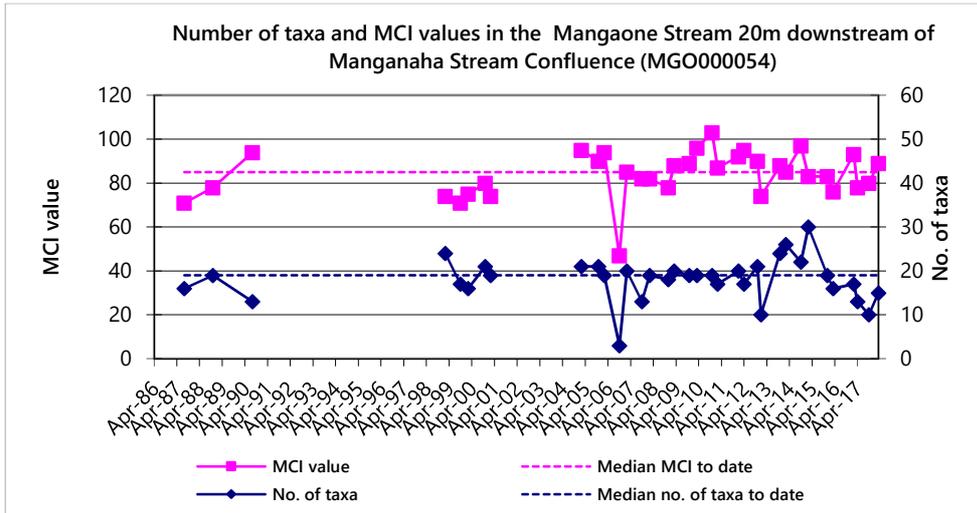
Figure 6 Numbers of taxa and MCI values for the Mangaone Stream downstream of the confluence with Manganaha Stream since 1987

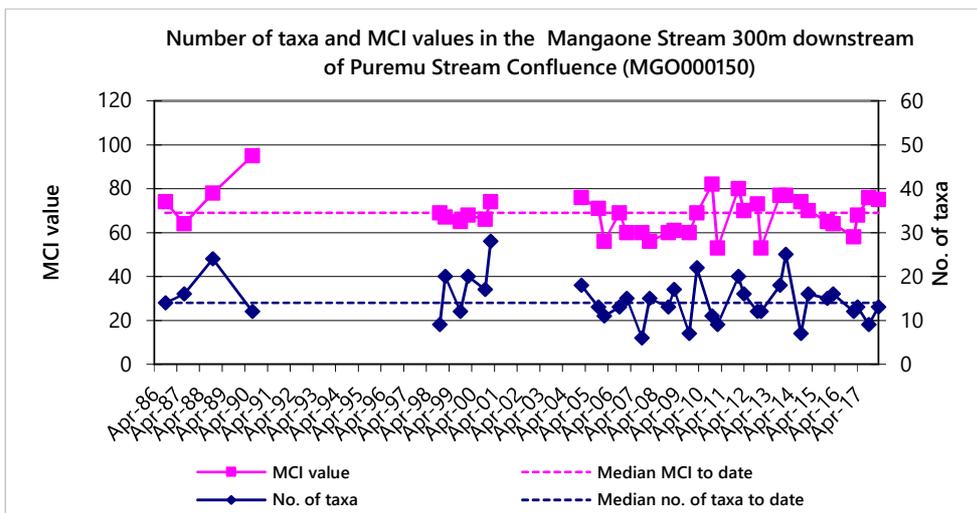
Figure 7 Numbers of taxa and MCI values for Mangaone Stream downstream of the confluence with Puremu Stream since 1986

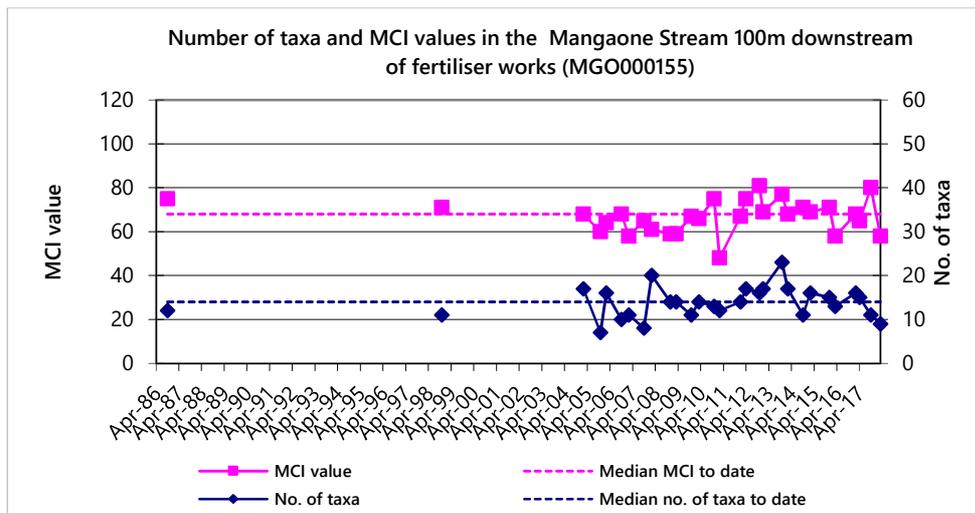
Figure 8 Numbers of taxa and MCI values for Mangaone Stream 100 m downstream of the fertilizer works/depot since 1986

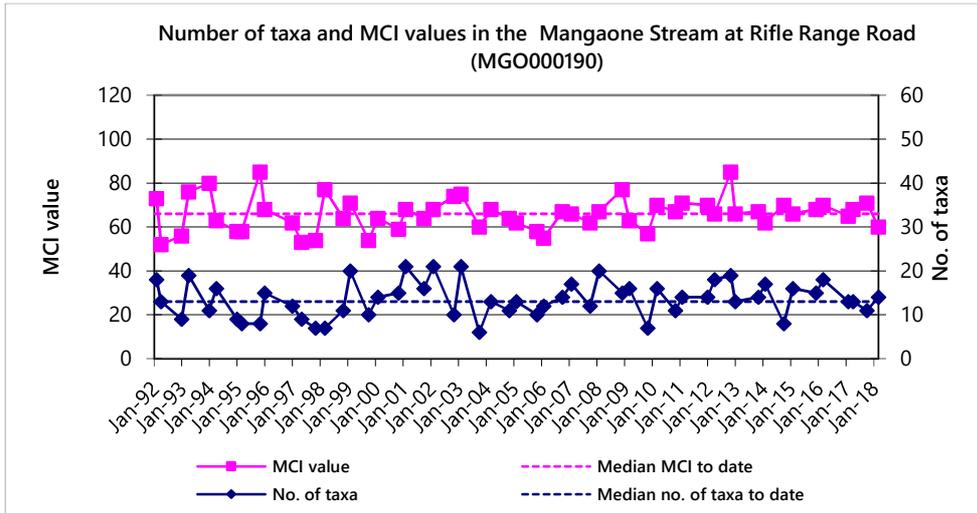
Figure 9 Numbers of taxa and MCI values for Mangaone Stream at Rifle Range Road since 1992

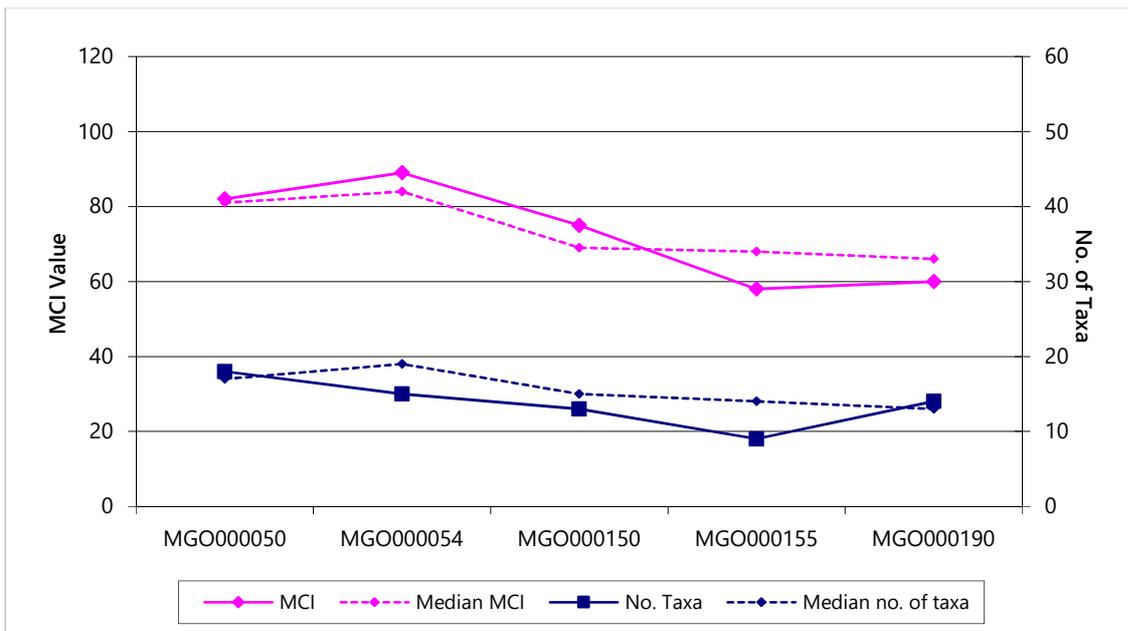
Figure 10 Longitudinal trend in number of taxa and MCI values in the Mangaone Stream for the survey of 2 March 2018

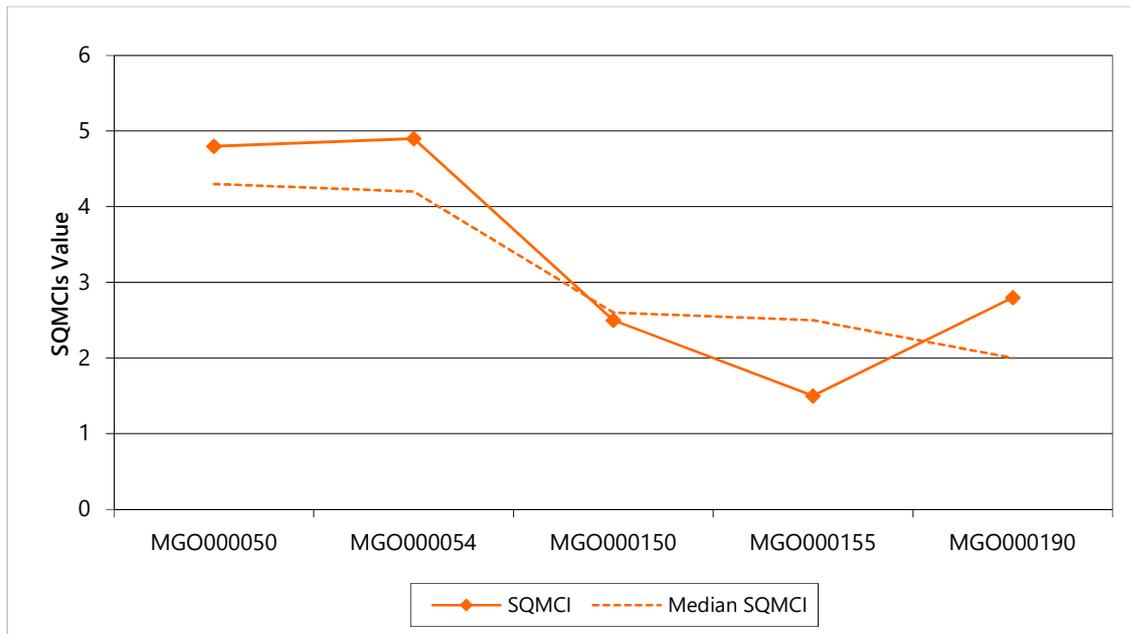
Figure 11 Longitudinal trend in SQMCI₅ values in the Mangaone Stream for the survey of 2 March 2018
