Taranaki Galvanizers Ltd  
Monitoring Programme  
Annual Report  
2018-2019

Technical Report 2019-16

Taranaki Regional Council  
Private Bag 713  
STRATFORD  
September 2019

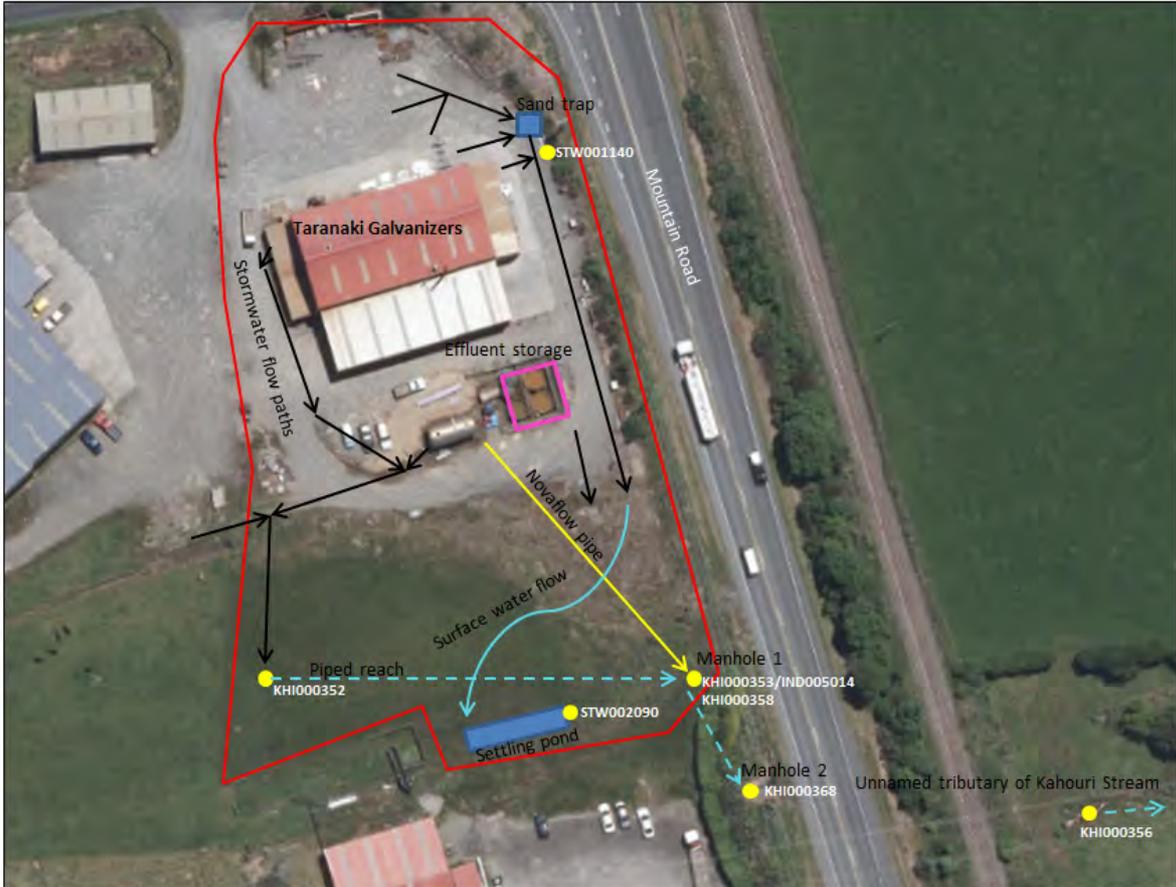
Figure 1 Taranaki Galvanizers site layout

The galvanising plant owned and operated by the Company is situated at the corner of State Highway 3 and Monmouth Road, approximately 1 km north of Stratford (Figure 1). Road access to the site is via Monmouth Road.

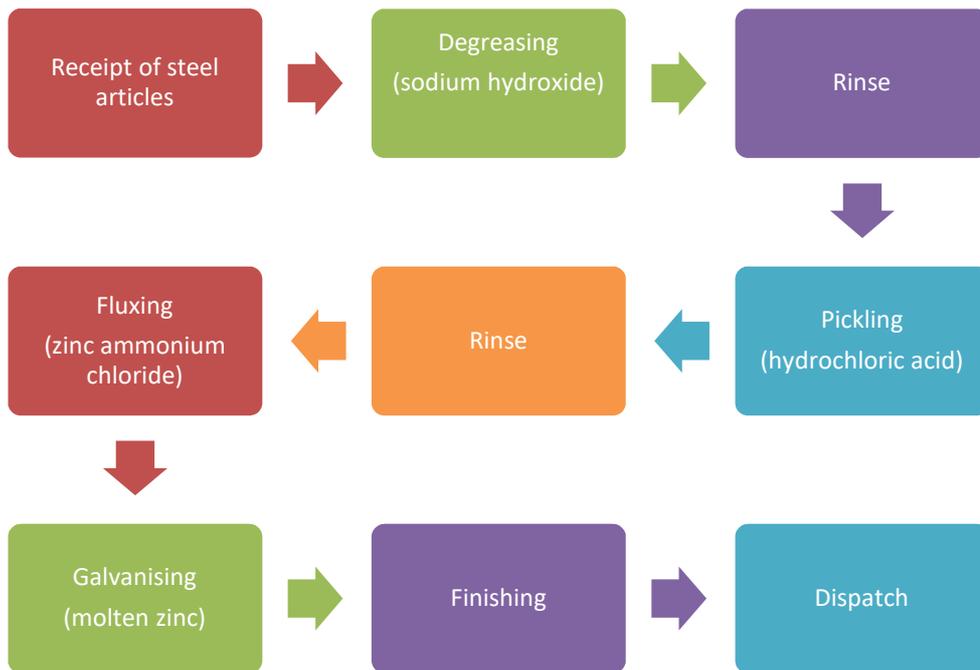
Figure 2 Hot-dip galvanising process undertaken at Taranaki Galvanizers

The Company utilise a hot-dip galvanising process which protects steel from corrosion by providing a thick, tough metallic zinc alloy coating. The process consists of various stages of preparation and treatment prior to completion of the process. A brief description of the process is given in Figure 2.

Articles of steel to be galvanised are initially immersed in a hot sodium hydroxide degreasing or stripping bath to remove any oil or grease contaminants. Oils removed from the surface of the steel remain on the surface of the degreasing bath. After degreasing, the articles are rinsed in a water bath to reduce the carry-over of caustic solution into the next phase of the process.

The next stage of the process involves the removal of mill scale, rust, paint and other oxides from the article being galvanised by 'pickling', or acid treatment, in hydrochloric acid. Again, the article is rinsed in water to remove any excess acid and to minimise the amount of acid carried over to the next stage in the process.

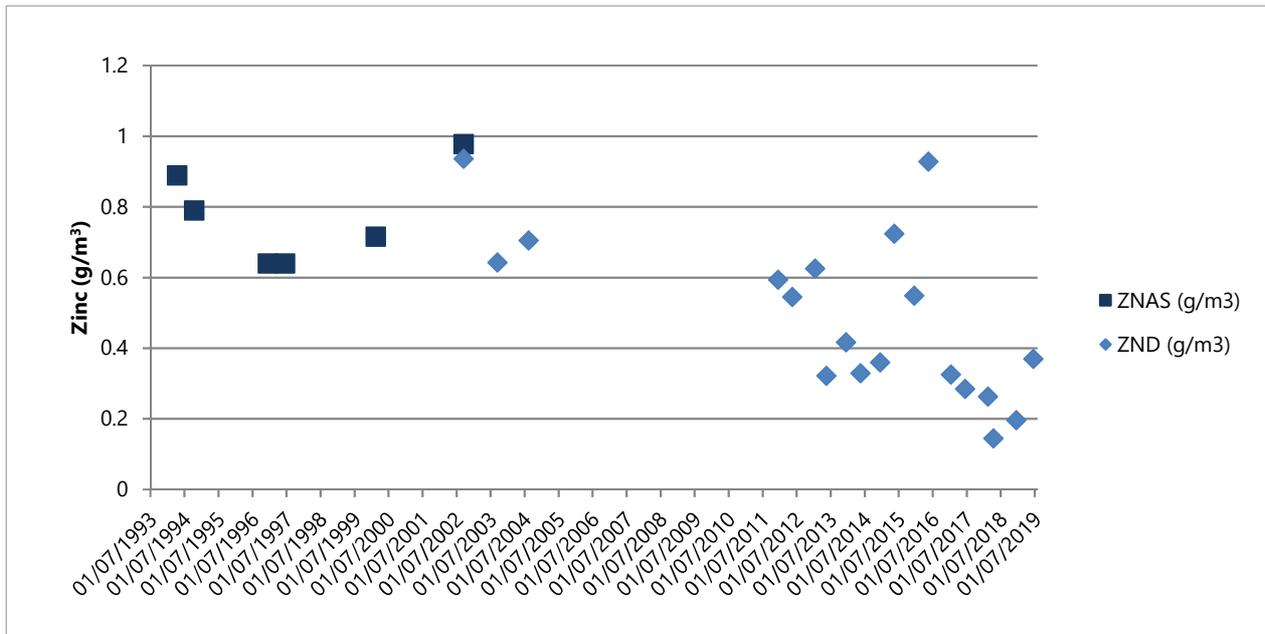
Discharge sampling undertaken in the reported period, at site upstream 2 (KHI000353) showed that the latest concentrations of dissolved zinc (0.196 g/m<sup>3</sup> and 0.37 g/m<sup>3</sup>) were below the median of historical dissolved zinc concentrations (0.594 g/m<sup>3</sup>) (Figure 3).

Figure 3 Zinc concentrations in the unnamed tributary of the Kahouri Stream immediately upstream of the Company's industrial discharge since 1994 (site KHI000353)

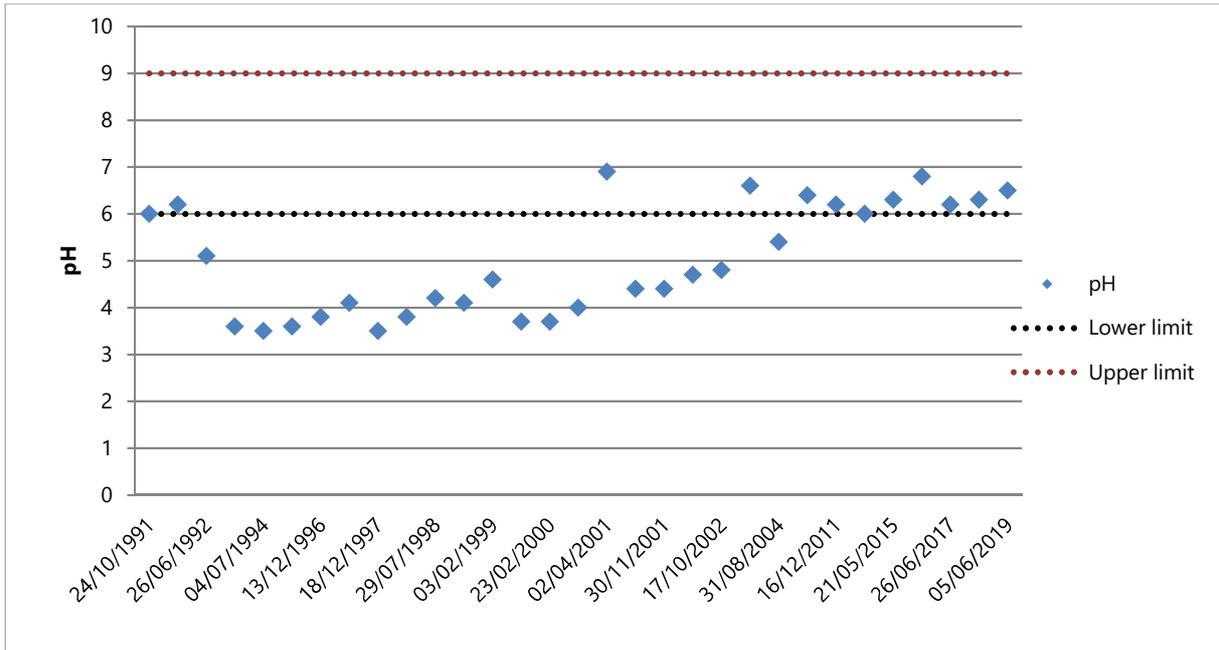
Figure 4 pH levels recorded in the discharge (IND005014) from the Company's site between October 1991 and June 2019

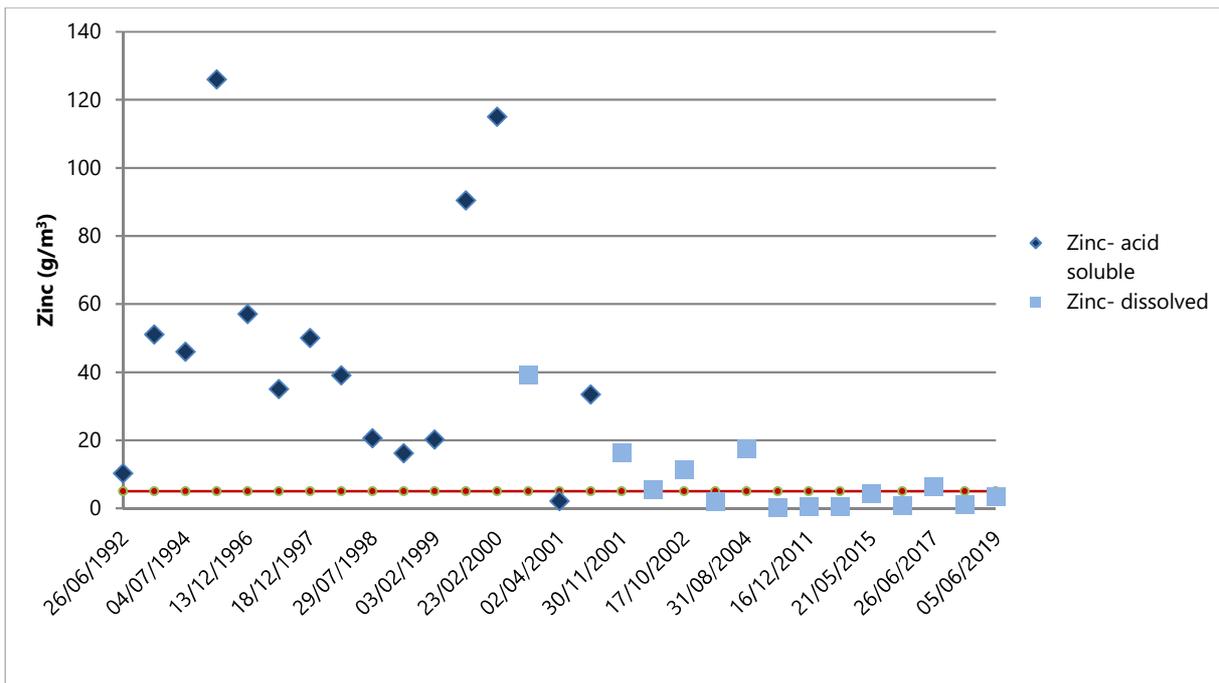
Dissolved zinc concentrations have fallen within the consent limit of 5 g/m<sup>3</sup> (consent conditions granted June 2010) and have decreased considerably over the last 12 years. The most recent result (3.3 g/m<sup>3</sup>) was within the consent limit, but had increased substantially since the previous sampling occasion (0.931 g/m<sup>3</sup>) (Figure 5). The historical disposal of galvanising waste materials into a bore on the Company's site is considered to be the most likely source of zinc contamination in this discharge; although zinc in stormwater from the southern end of the site may have also contributed to this result.

Figure 5 Zinc concentrations recorded in the discharge sample (IND005014) from the Company's site between June 1992 and June 2019

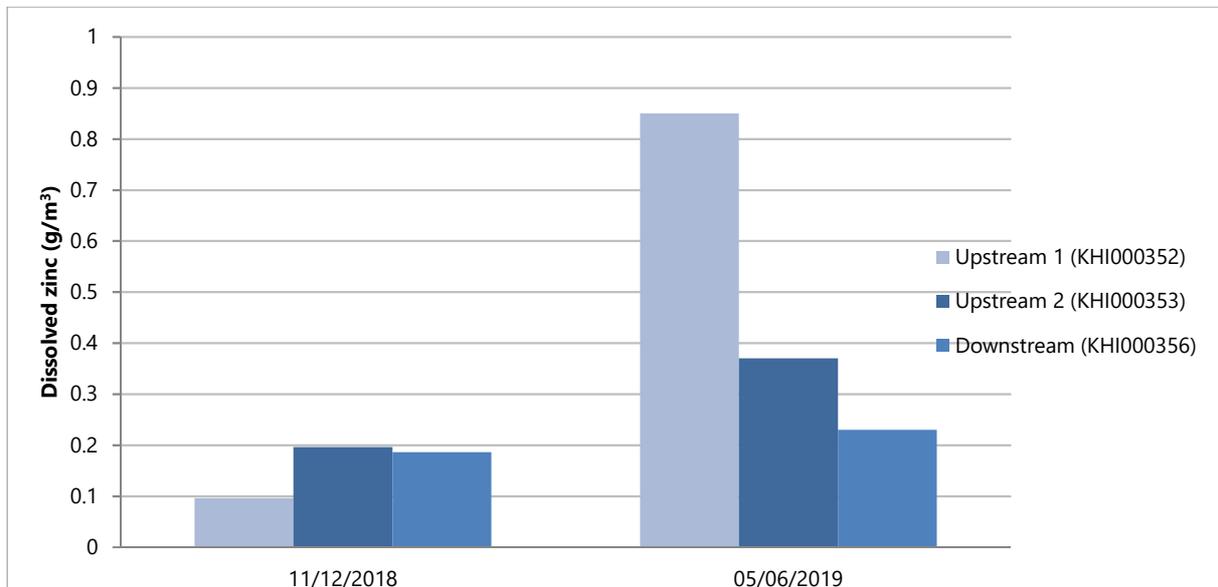
The results of the 11 December 2018 survey showed an increase in zinc concentration of 0.1 g/m<sup>3</sup> between the upstream site 1 and lower upstream site 2 (Figure 6). There was a slight decrease in zinc from the upstream site 2 and downstream site (0.01 g/m<sup>3</sup>). Typically, freshwater waterbodies do not naturally have zinc concentrations above 0.060 g/m<sup>3</sup>.

During the 5 June 2019 survey, the highest level of zinc was recorded at upstream site 1 (0.85 g/m<sup>3</sup>). A decrease in zinc of 0.48 g/m<sup>3</sup> was recorded between upstream site 1 and upstream site 2, and a further decrease of 0.14 g/m<sup>3</sup> between upstream site 2 and the downstream site (Figure 6). Seepage from the contaminated bore under the Company's site is the most likely source of the contamination recorded upstream of the industrial and stormwater discharges.

Figure 6 Dissolved zinc concentrations in the unnamed tributary of the Kahouri Stream upstream and downstream of the site.

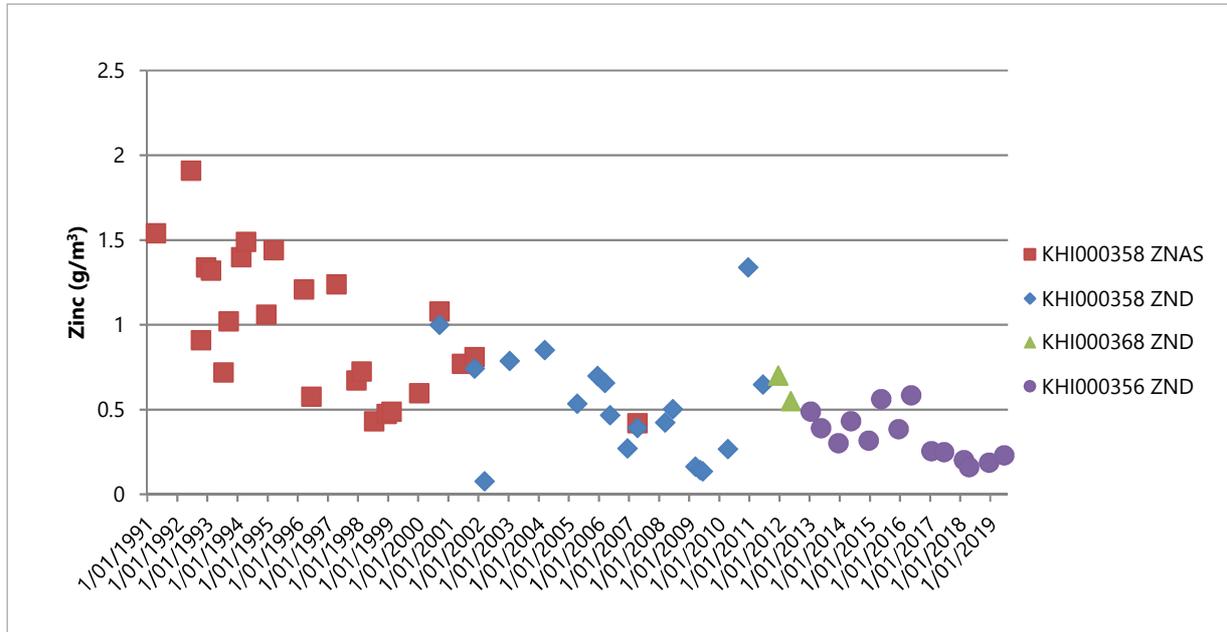
Monitoring of the unnamed tributary of the Kahouri Stream has shown that zinc concentrations decreased through the 1990's, then remained relatively constant, varying between the detection limit of 0.005 g/m<sup>3</sup>

and 1 g/m<sup>3</sup>. Recent monitoring data suggest that zinc concentrations increased slightly from the previous monitoring year but are still relatively stable and generally decreasing over time at the downstream site (KHI000356) (Figure 7). It is considered likely that it will take some years before the zinc concentrations in the tributary are reduced significantly due to the level of contamination (from the bore) under the Company's site.

Figure 7 Zinc concentrations in the unnamed tributary of the Kahouri Stream downstream of the Taranaki Galvanizers industrial discharge since 1991
