Value Timber Ltd
Monitoring Programme
Annual Report
2019-2020

Technical Report 2020-7

Taranaki Regional Council
Private Bag 713
STRATFORD
October 2020

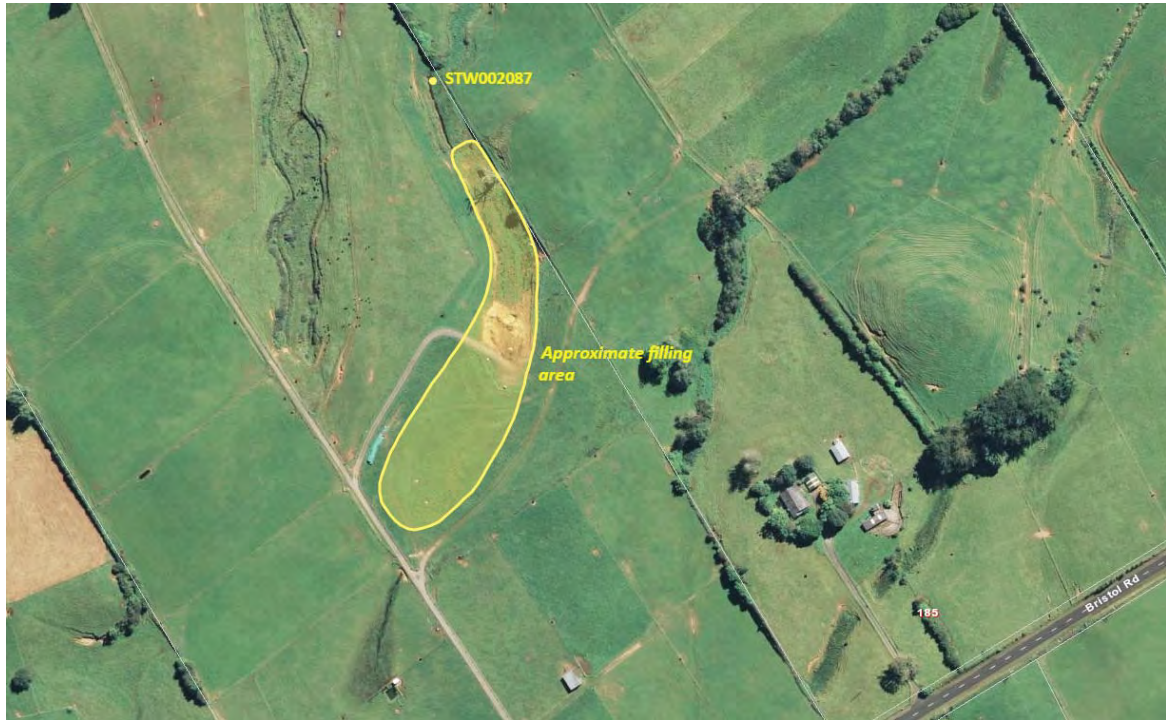
Figure 1 Aerial image of the Bristol Road site and sampling site

The samples were taken from site STW002087, which is in the receiving drain downstream of the fill area, just upstream of the property's boundary fence (Figure 1).

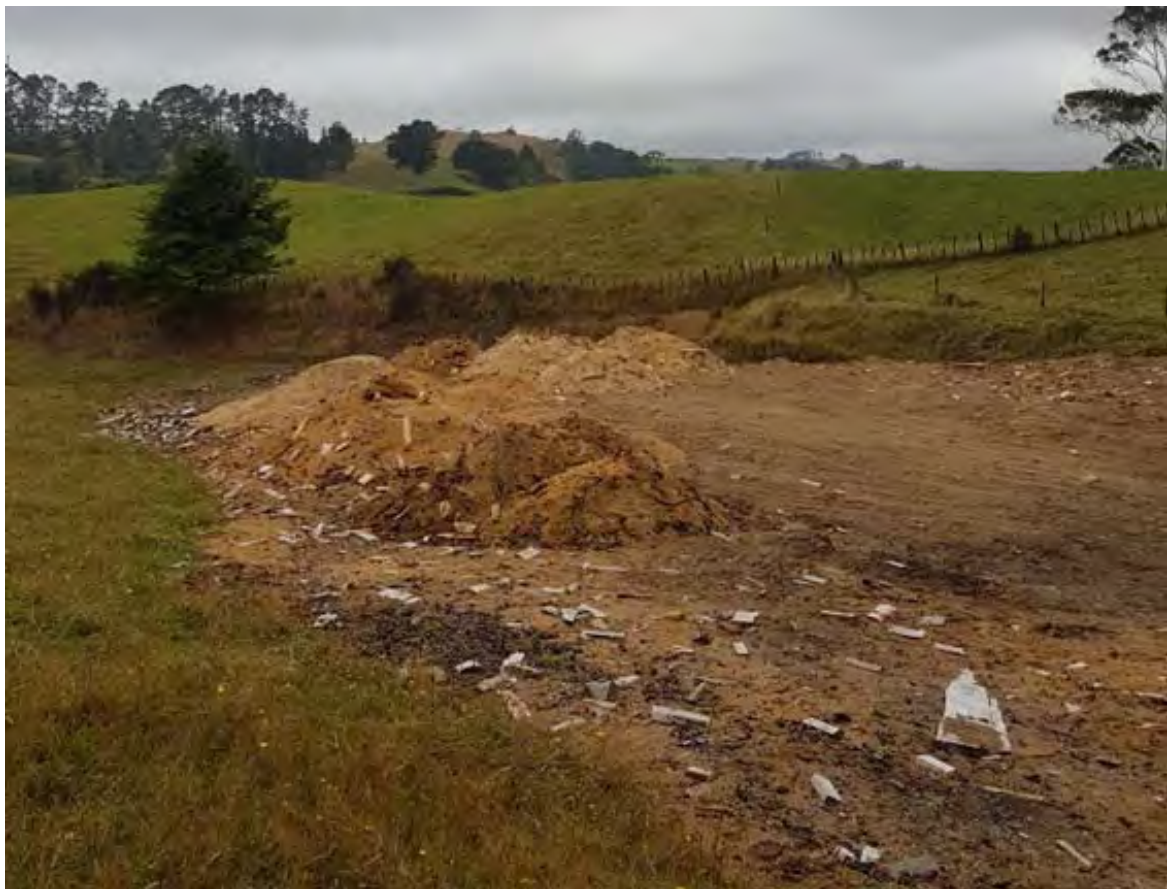
Photo 1 Value Timber Ltd wood waste cap, January 2020

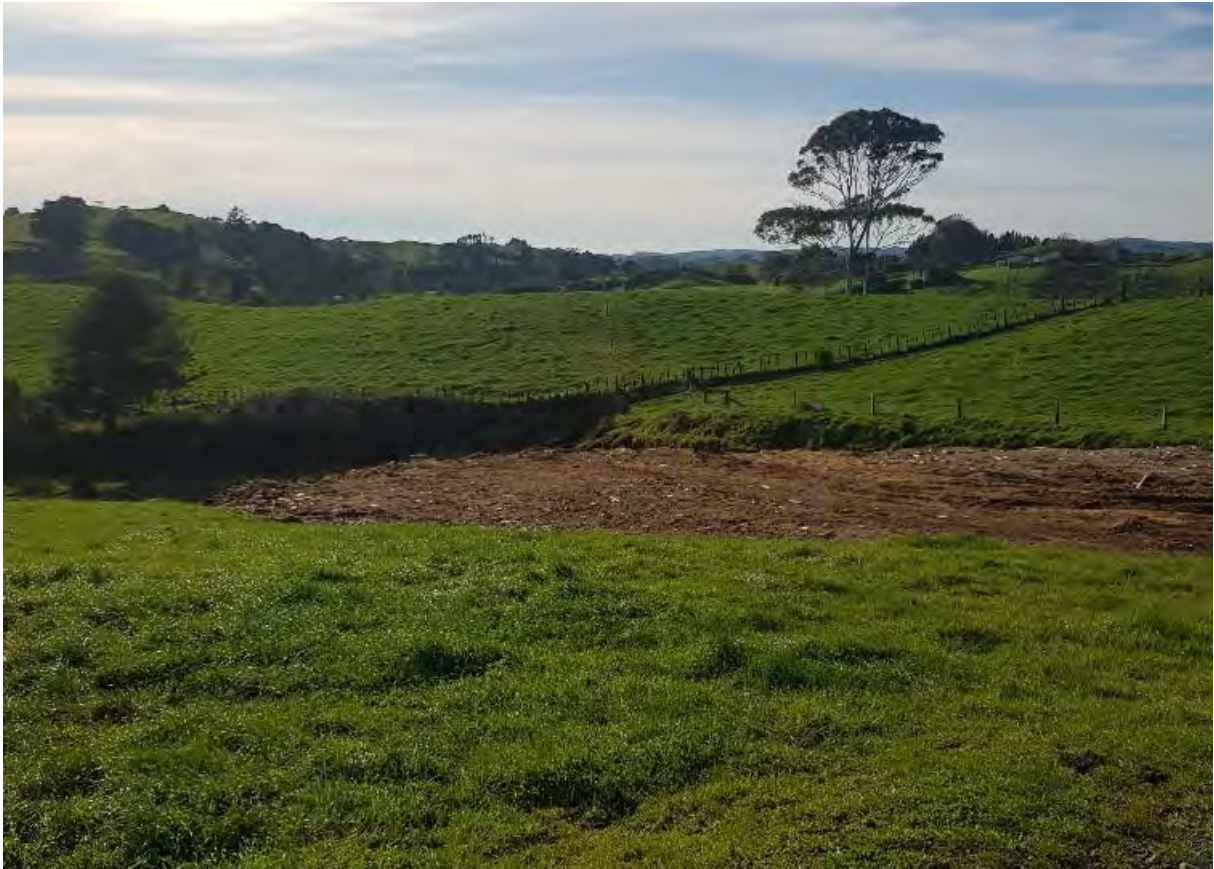
The site was inspected in fine weather. The fill area had approximately fifteen small stockpiles of sawdust to be spread. The cap area was tidy and well-managed. The tip face appeared stable with no cracking or slumping observed. The pre-fill gully was tidy and well-grassed with no sign of runoff. The post-fill gully was well-grassed and intact, with no slumping or ponding.

Photo 2 Value Timber Ltd wood waste cap, 27 May 2020
