# NPDC Closed and Contingency Landfills

(Inglewood, Okato, and Marfell Park)

Annual Report

Technical Report 2020-12

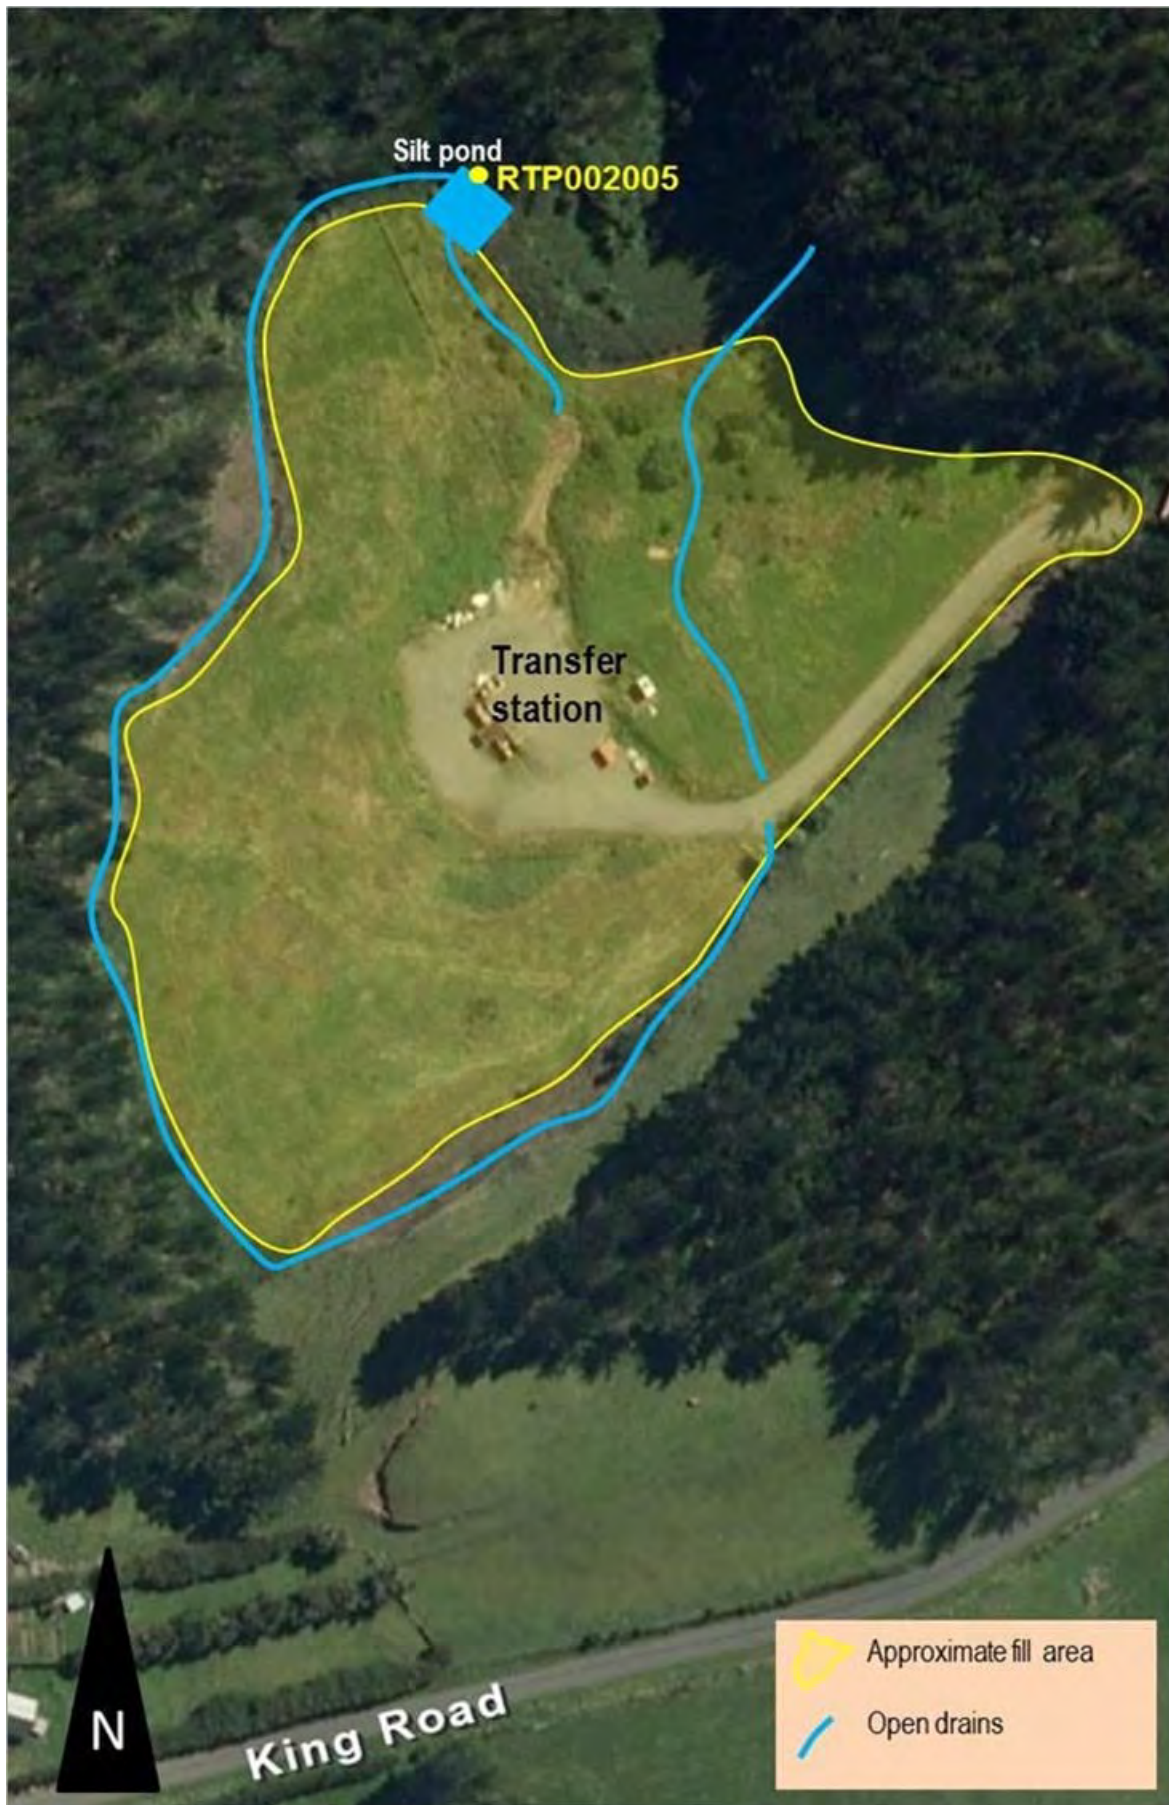
Figure 1 Site layout at Inglewood contingency landfill

Figure 1 shows the approximate extent of the fill and the general layout of the Inglewood landfill site. The discharge and receiving water monitoring site locations are shown in Figure 2.

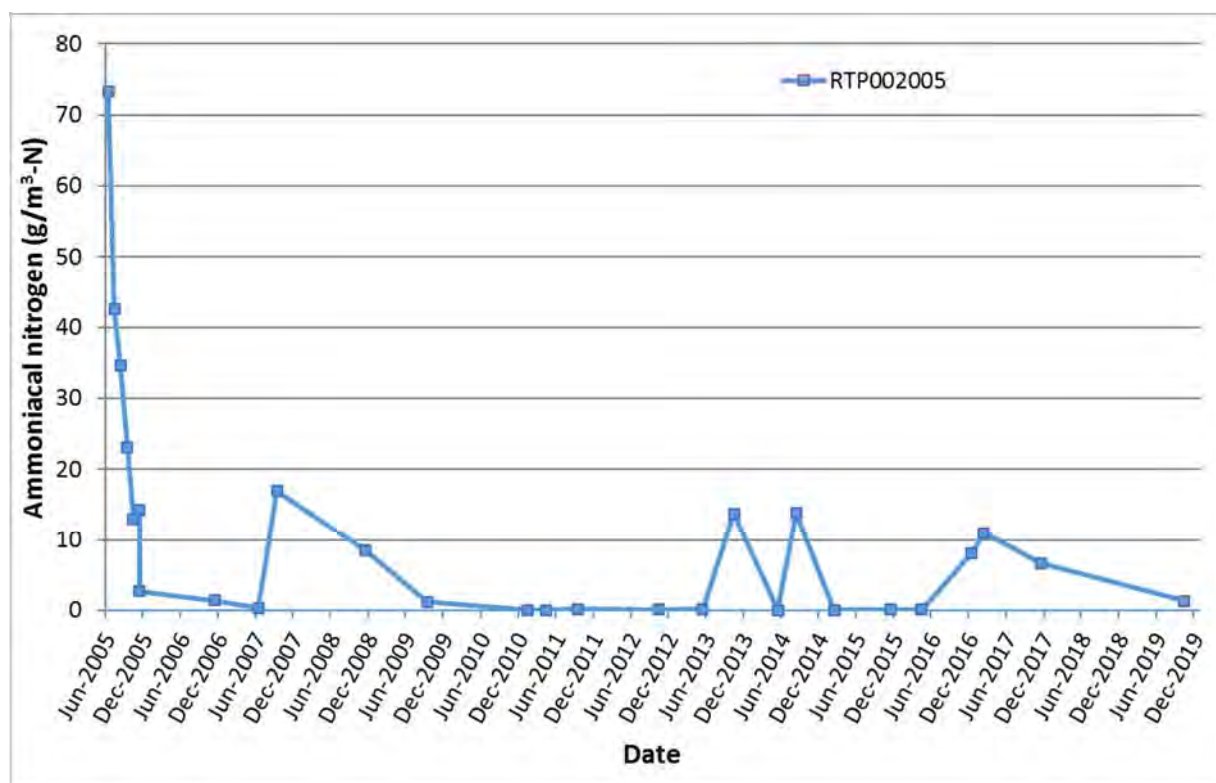
Figure 3 Ammoniacal nitrogen concentration of the Inglewood landfill stormwater/leachate (RTP002005) for monitoring to date

Factors like recent grazing, topography of the surrounding area and/or leachate generation from additional stormwater infiltration are factors that can increase the values of ammoniacal nitrogen in samples. The autumn sampling in 2013-2016 sampling periods were collected after heavy rainfall which resulted in elevated the ammoniacal nitrogen concentrations of the samples compared to those collected in 2009-2012 (Figure 3).

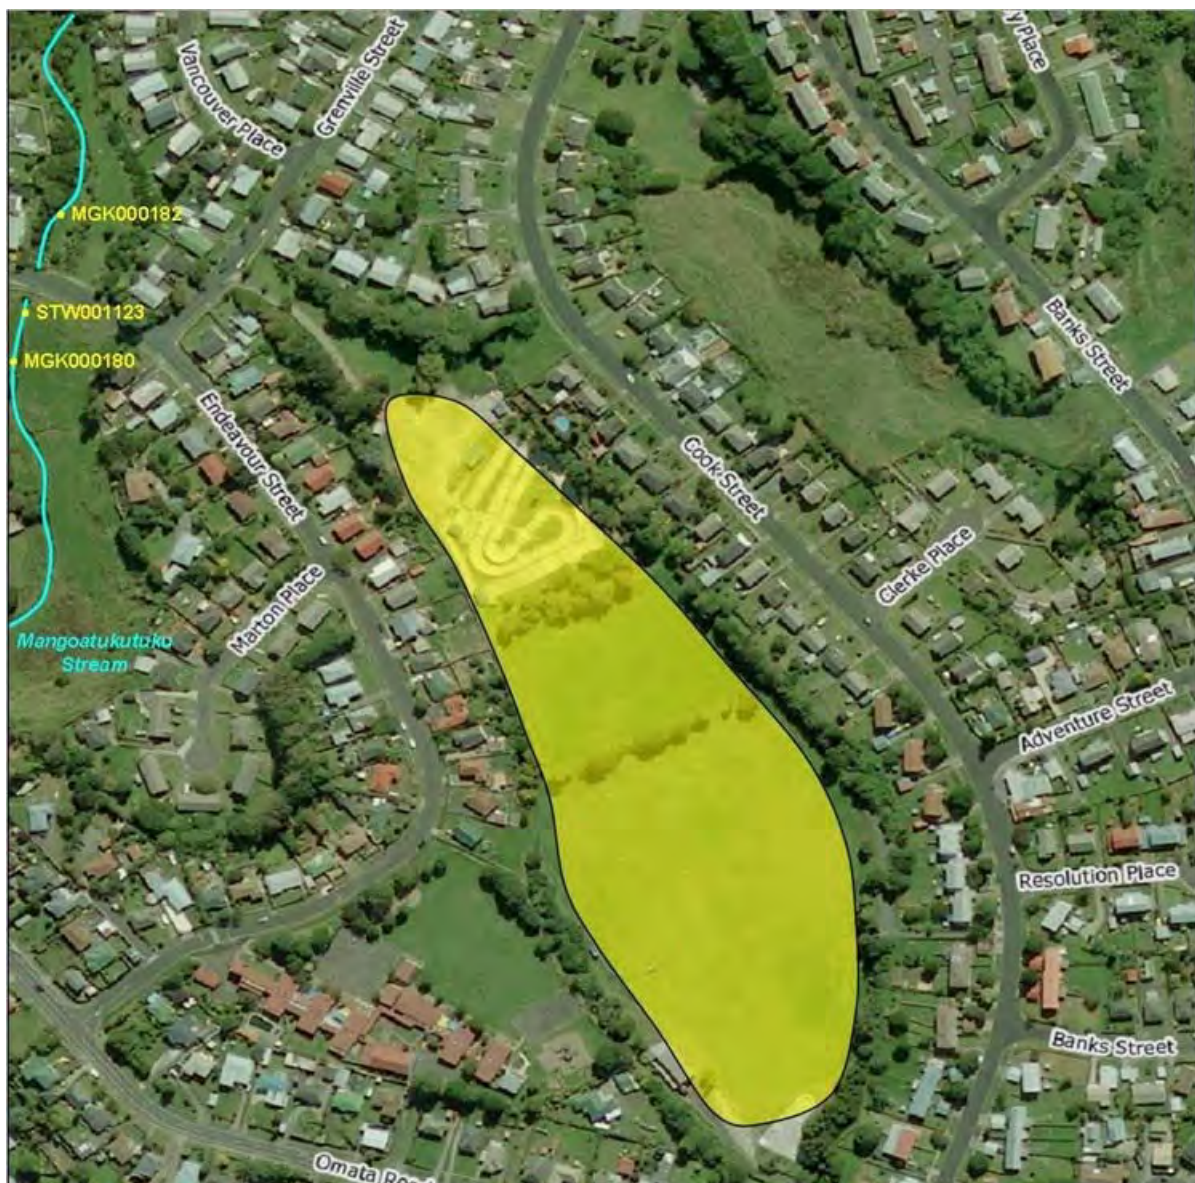
Figure 13 An aerial view showing the former landfill at Marfell Park and associated sampling sites

The discharge from the site now is predominantly stormwater. Presently the site is a park with sports field, playground and a BMX track.

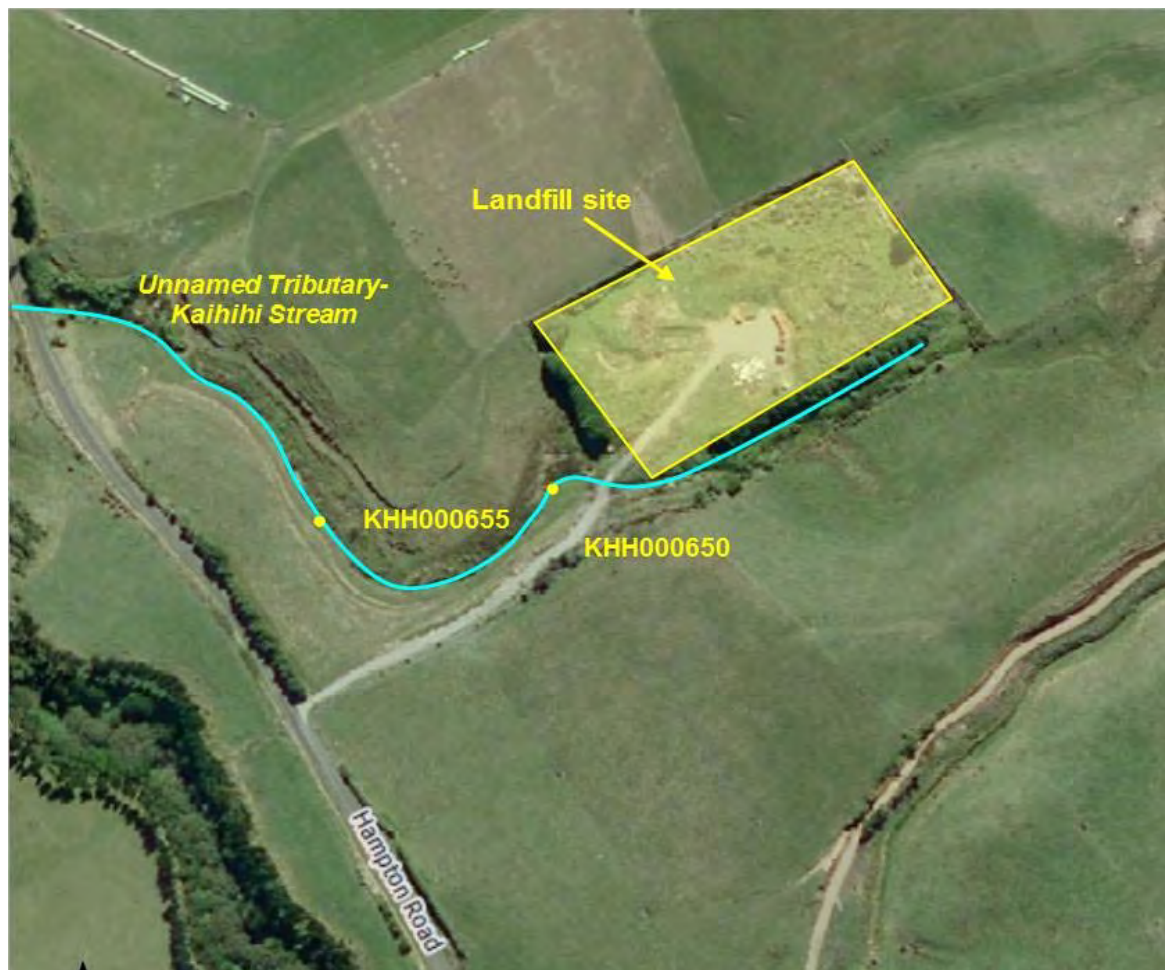
Figure 14 Okato landfill and sampling sites

The Okato landfill stopped accepting general waste for discharge to land in 2005. The landfill was capped and the site became a transfer station. The NPDC also continued to exercise consent 4529-3 (discharge of contaminants to land) for the purpose of accepting and discharging green waste and cleanfill. All other refuse accepted at the site is transferred to New Plymouth for disposal or recycling. The site is also designated as a contingency landfill in the event that Colson Road landfill and/or Inglewood landfill became unusable or inaccessible.
