Value Timber Ltd

Monitoring Programme Annual Report 2021-2022

Technical Report 2022-59

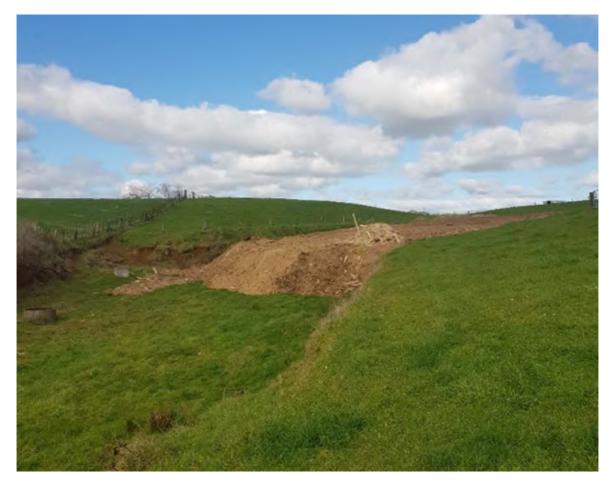
Figure 1 Aerial image of the Bristol Road site and sampling site

The samples were taken from site STW002087, which is in the receiving drain downstream of the fill area, just upstream of the property's boundary fence (Figure 1).

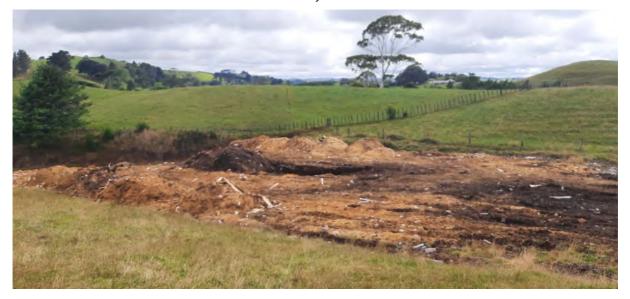
Photo 2 Value Timber Ltd site inspection 26/01/2022

The site was inspected in fine weather. The fill area had approximately 10 small stockpiles of sawdust on top of the cap yet to be spread. The area was tidy and the tip face appeared stable with no cracking or slumping observed. The pre-fill gully was tidy and well-grassed with no sign of runoff. The post-fill gully was well-grassed and intact, with no slumping or ponding. The stormwater drains were clear and dry with no sign of recent flow. The stormwater ponds were empty and not discharging. The site was well fenced and secure. There were no stock in the area around the cap. There were no odour or dust issues. Samples of sawdust material were collected and sent to Scion for CCA analysis. No unauthorised material was noted onsite.

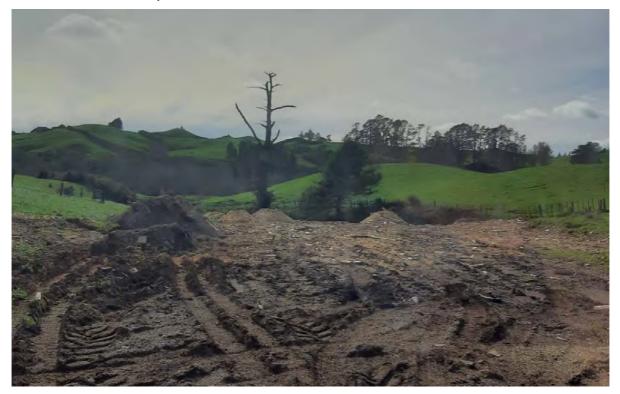
Photo 3 Value Timber Ltd site inspection 20/06/2022

The site was inspected in cold weather conditions, with a strong south-easterly wind and light rain. Drainage was flowing freely after a heavy, prolonged period of rain. An orange sediment layer was present on the drain bed. Some sheen was observed on the water surface in stagnant sections of the drain. The stormwater ponds were relatively full, containing slightly turbid, dark coloured water. The bottom of the gully was very wet and boggy from recent rainfall. There were approximately eight sawdust or wood-waste piles present yet to be spread out. The wood-waste base layer was compact and stable with no evidence of slumping, cracking or slipping. No stock were present in the area surrounding the fill. There was no odour or dust

issues to note. A storm-water sample as well as a saw dust sample was collected. The saw dust sample was sent to Scion for CCA analysis.
