# Stratford District Council Closed Landfills (Stratford, Huiroa and Pukengahu)

Monitoring Programme Annual Report 2023/24 Technical Report 2024-31

Taranaki Regional Council Private Bag 713 Stratford

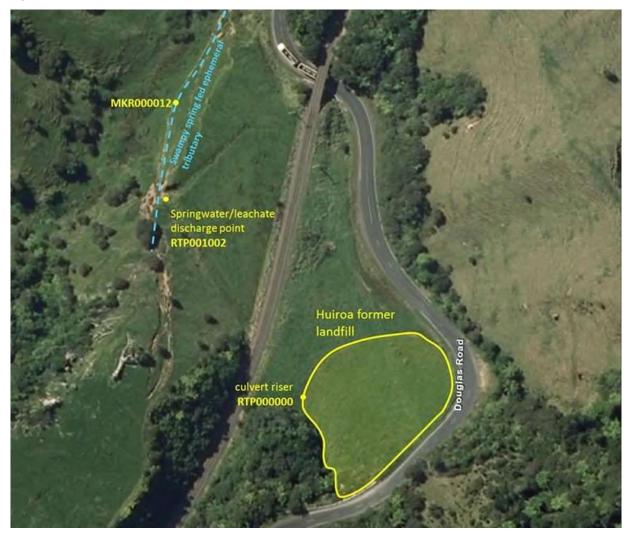
Figure 10 Huiroa landfill and approximate sampling locations

This closed landfill is monitored on a triennial basis, with inspections and sampling undertaken during 2023/24 and next scheduled in 2026/27. The location of the landfill and monitoring sites are shown in Figure 10.

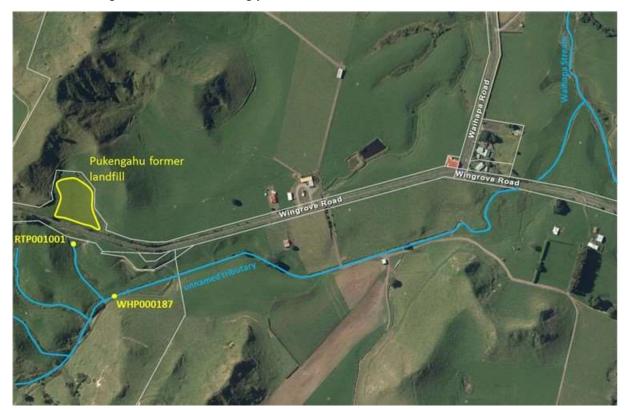
Figure 11 Pukengahu landfill and approximate sampling locations

The site is situated in a small gully off Wingrove Road (Figure 11). At the base of the gully is a small wetland area, which is fed by a spring that is culverted beneath the road and feeds into a small unnamed stream. The site was unmanaged and was mostly used for the discharge of domestic waste by local residents. The landfill closed in 1991 and was reinstated by SDC. It is monitored on a triennial basis, with inspections and sampling undertaken during the 2023/24 monitoring year, and next scheduled in 2026/27.
