NPDC – Colson Road Landfill  
Monitoring Programme  
Annual Report  
2013-2014

Technical Report 2014-59

November 2014

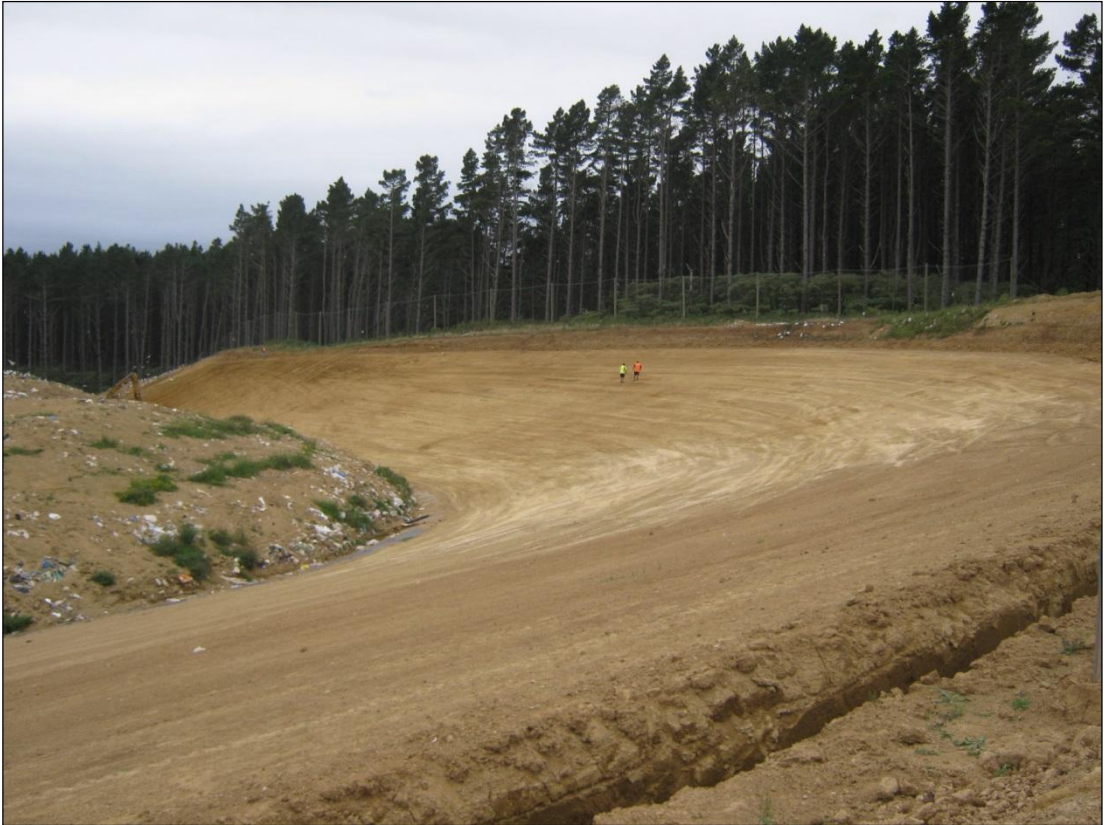
**Photograph 1** Stage three extension works, February 2011

The current stage in use (stage three) has a fully engineered liner consisting of high density polyethylene (HDPE) laid over compacted clay. Leachate is collected in porous pipes that have been put down in herring bone configuration over the polyethylene liner. During the period under review, the lining of stage three was completed so that the liner now covers stage three's entire footprint.

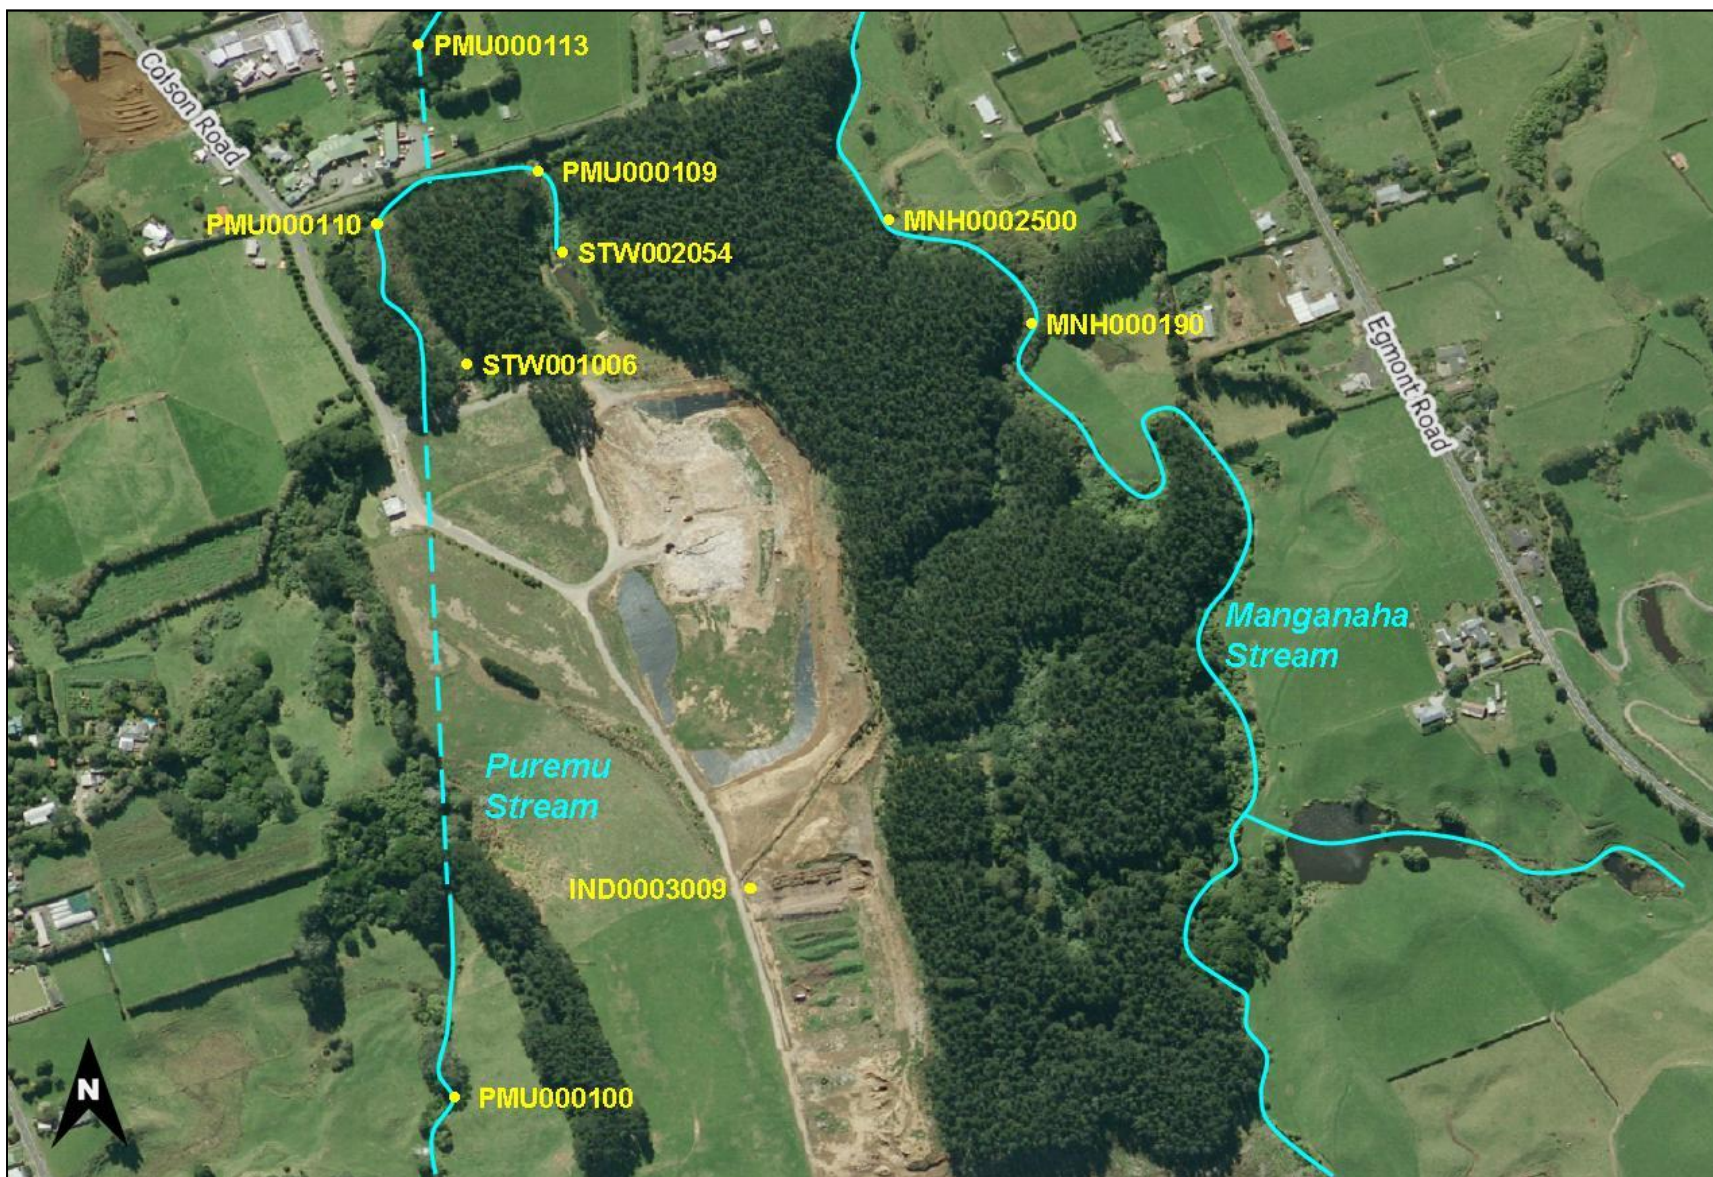
**Figure 2** Aerial photo showing the stormwater and receiving water sampling sites at Colson Rd landfill

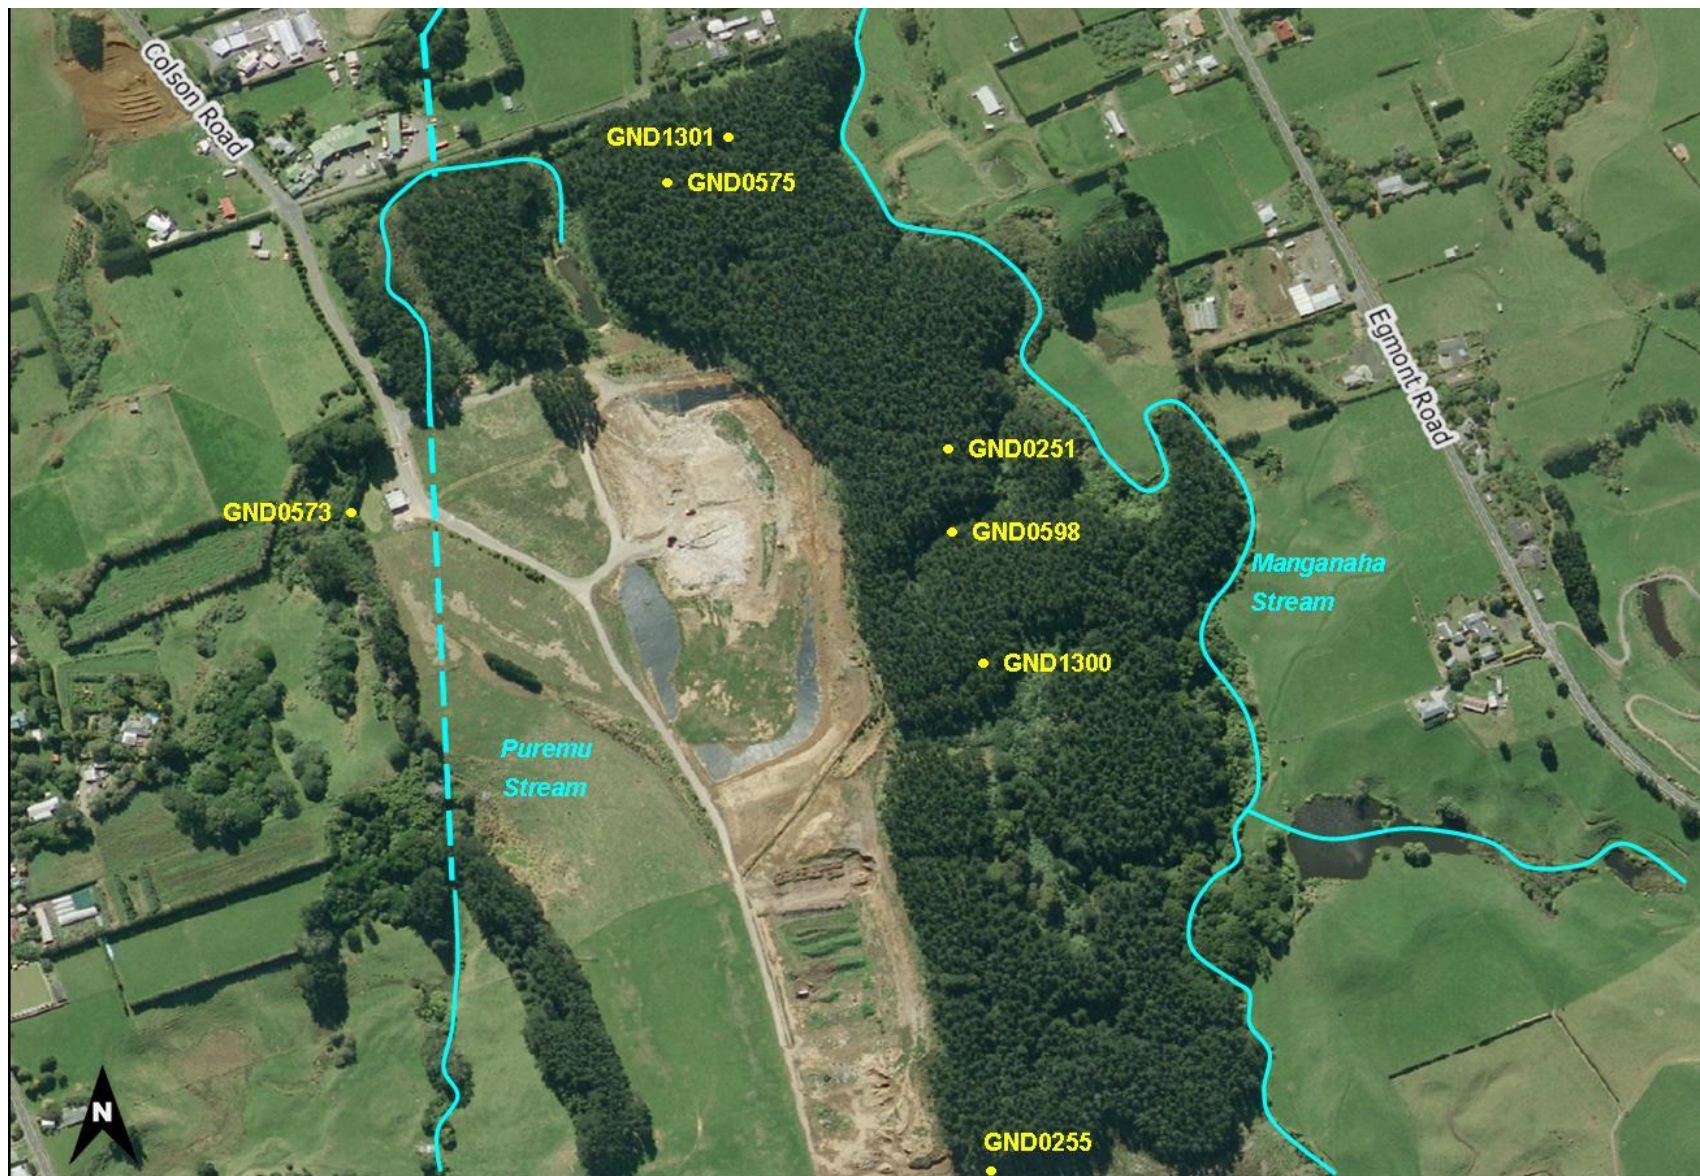
**Figure 3** Aerial view of Colson Rd landfill showing the positions of groundwater monitoring bores

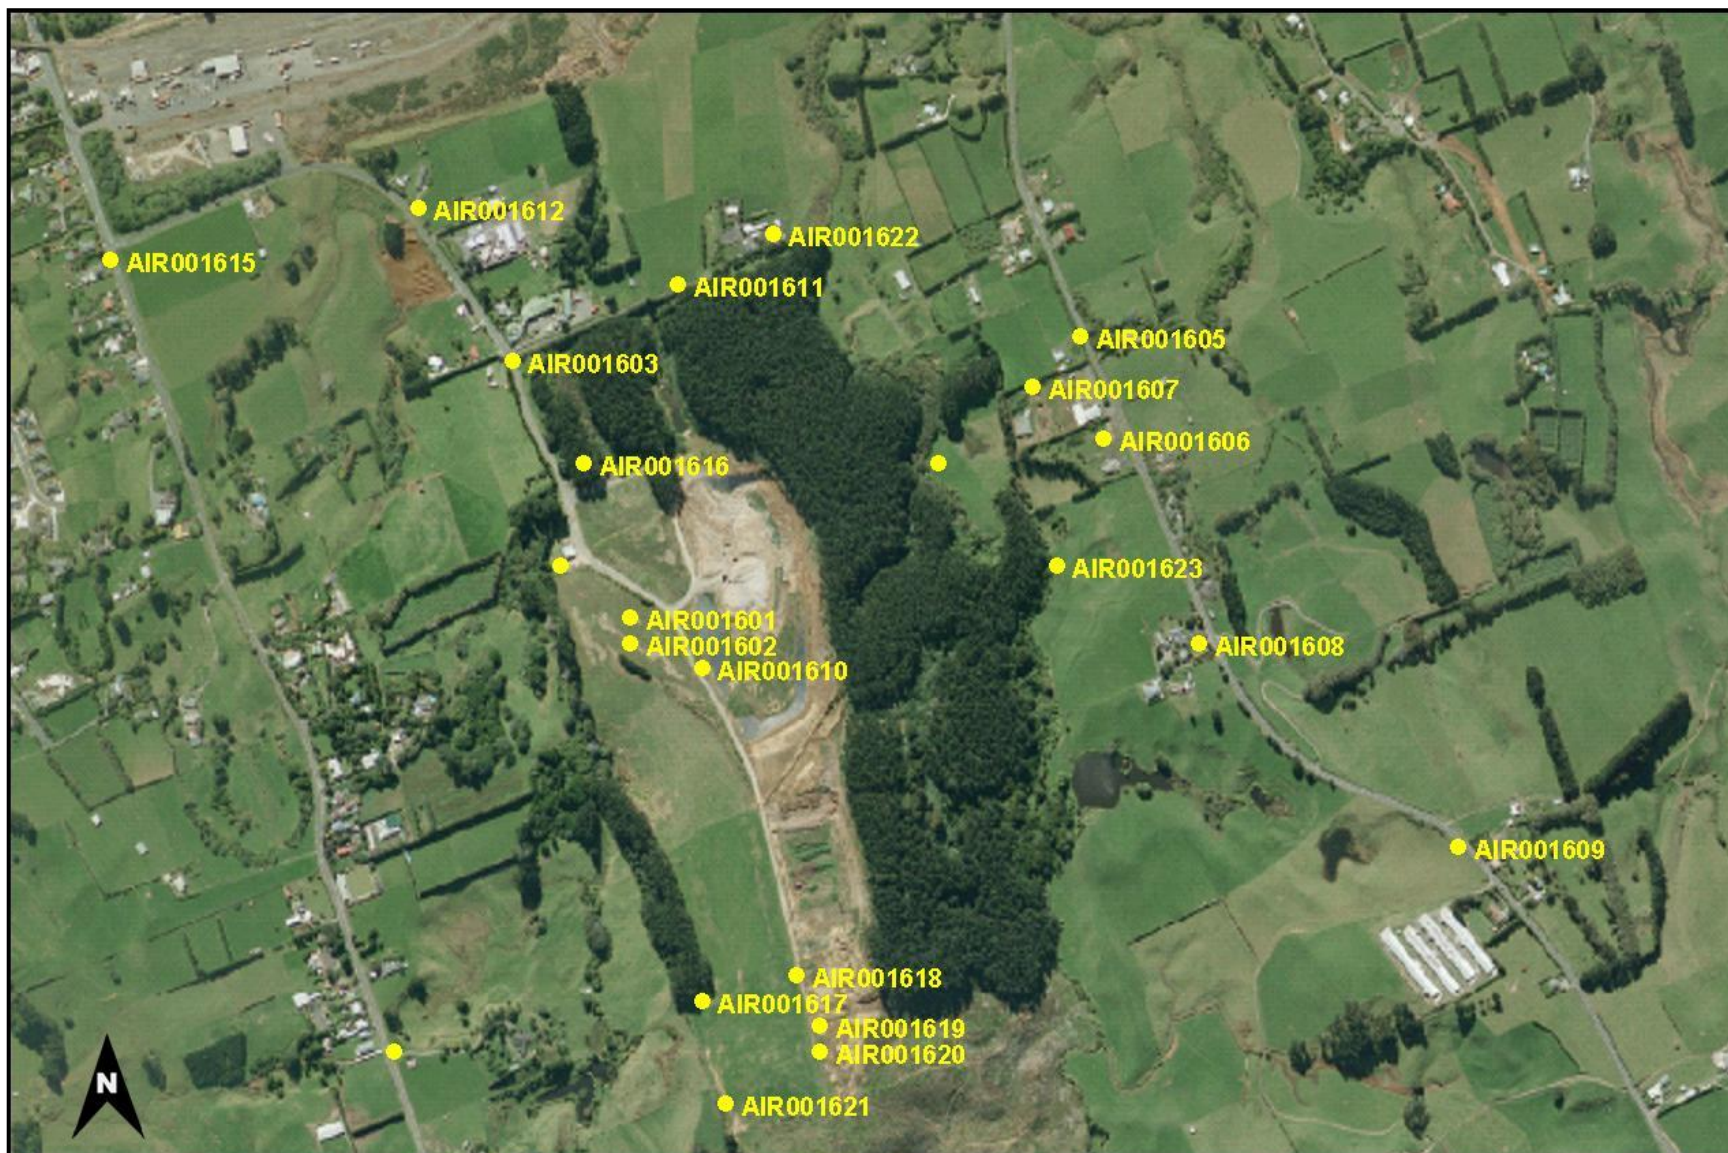
**Figure 4** Aerial view of Colson Rd landfill showing the positions of air quality monitoring sites

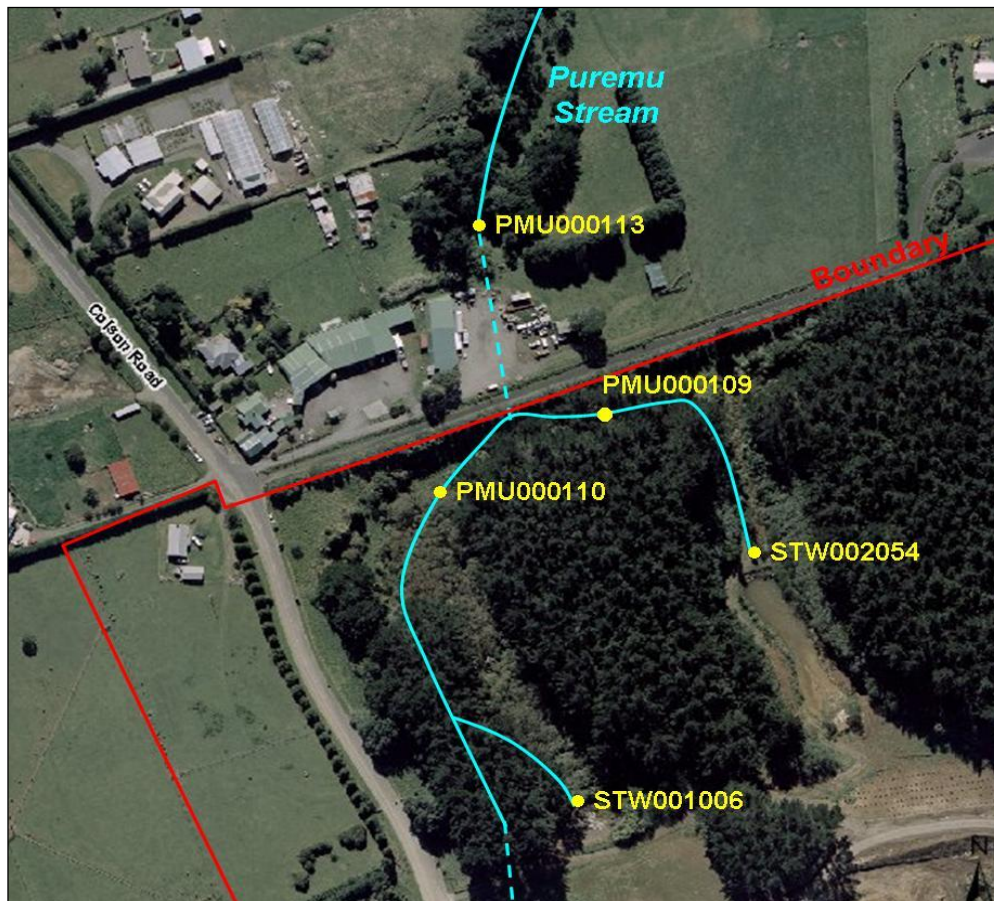
A close up diagram of the down stream sampling sites is given in Figure 5 and the results are given in Tables 6 and 7.

**Figure 5** Sampling sites on the Puremu Stream down stream of the landfill

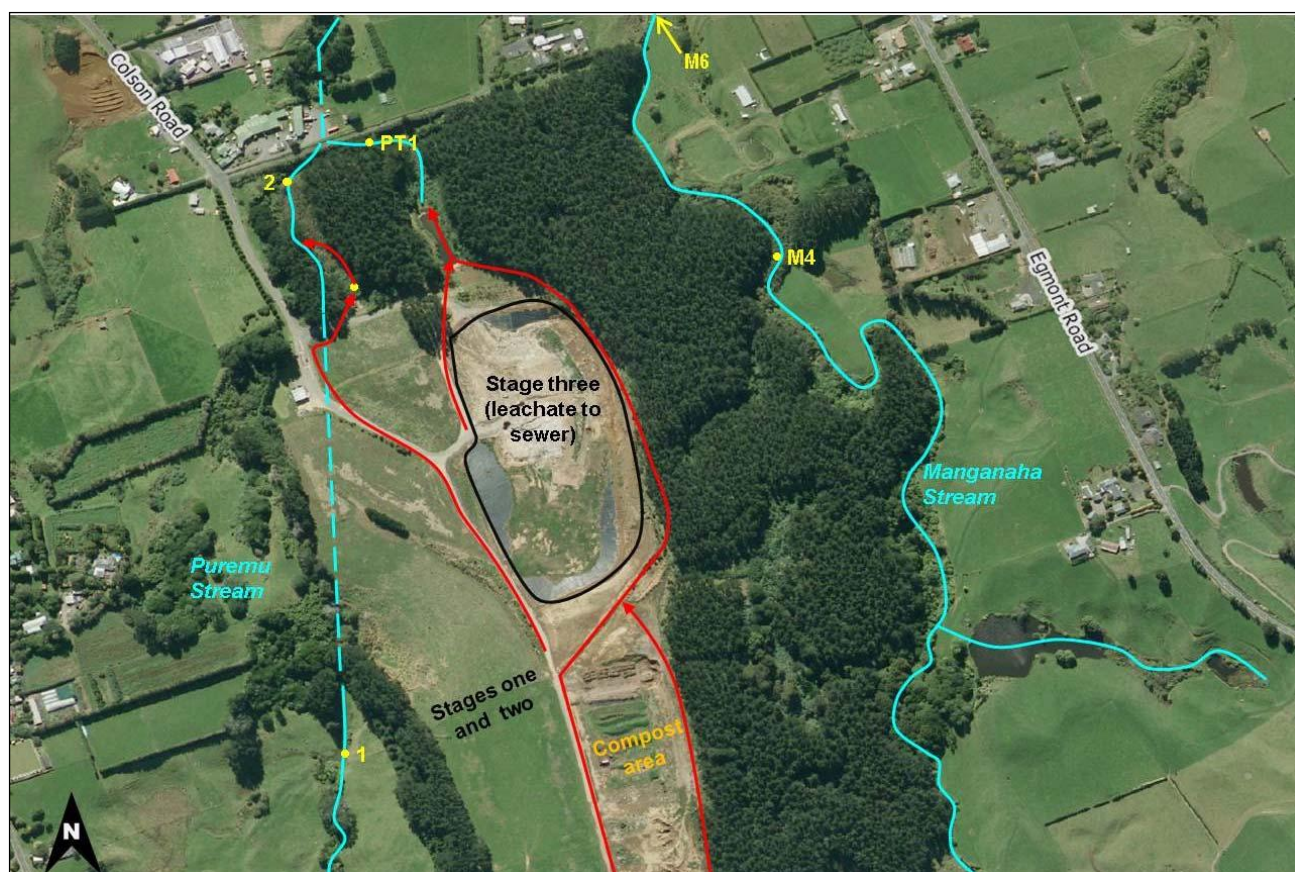
**Figure 1** Biomonitoring sites related to the Colson Road landfill, New Plymouth. The red lines on the aerial photograph indicate the direction of stormwater runoff from the land fill site.

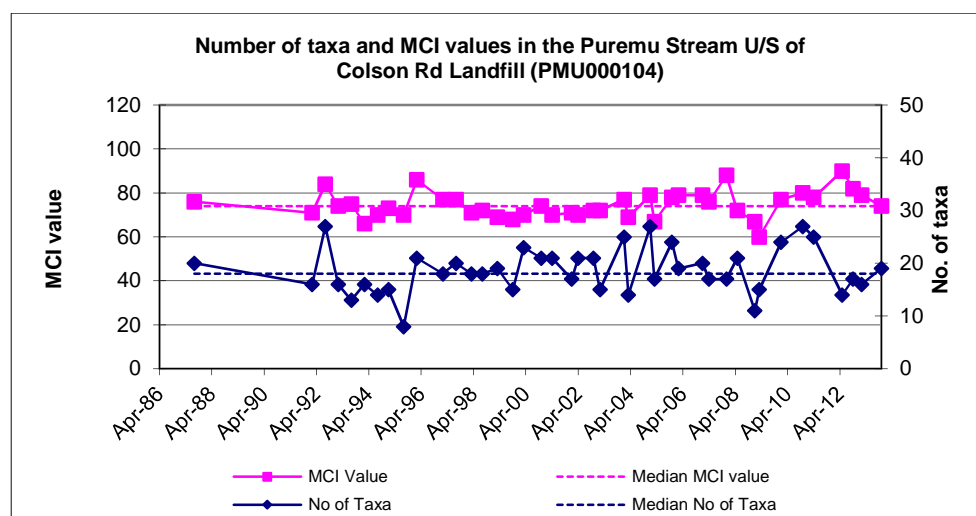
A total taxa richness of 19 taxa was recorded at site 1 in this early summer survey (Table 3 and Figure 2). This result was one taxon more than the historical median.

**Figure 2** Number of macroinvertebrate taxa and MCI values recorded at site 1 in the Puremu Stream, upstream of Colson Road Landfill since April 1987

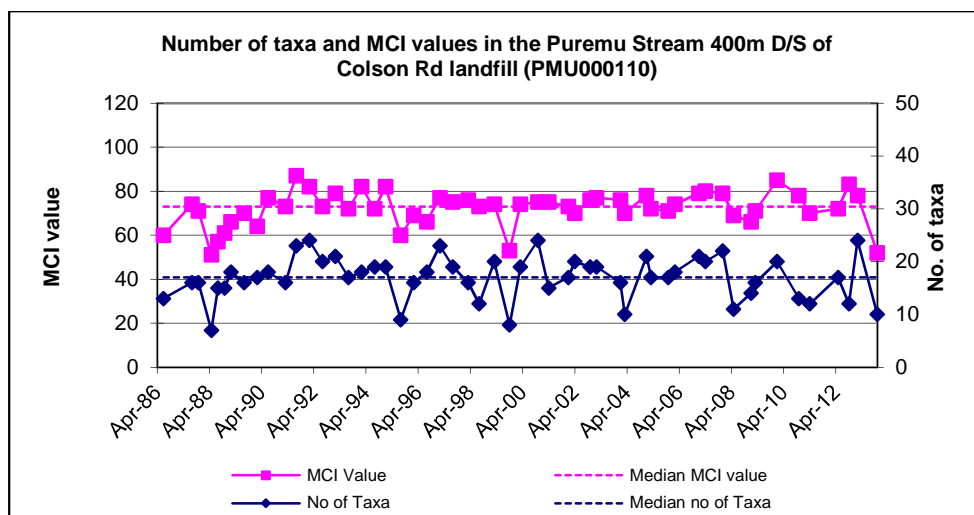
A low number of taxa (10) was recorded at this site, seven taxa less than the median of previous surveys at this site, and 14 taxa less than the richness recorded in the previous survey and only three taxa more than the minimum richness recorded at this site to date (Table 3 and Figure 3).

**Figure 3** Taxa numbers and MCI values recorded at site 2, 400 m downstream of Colson Rd Landfill

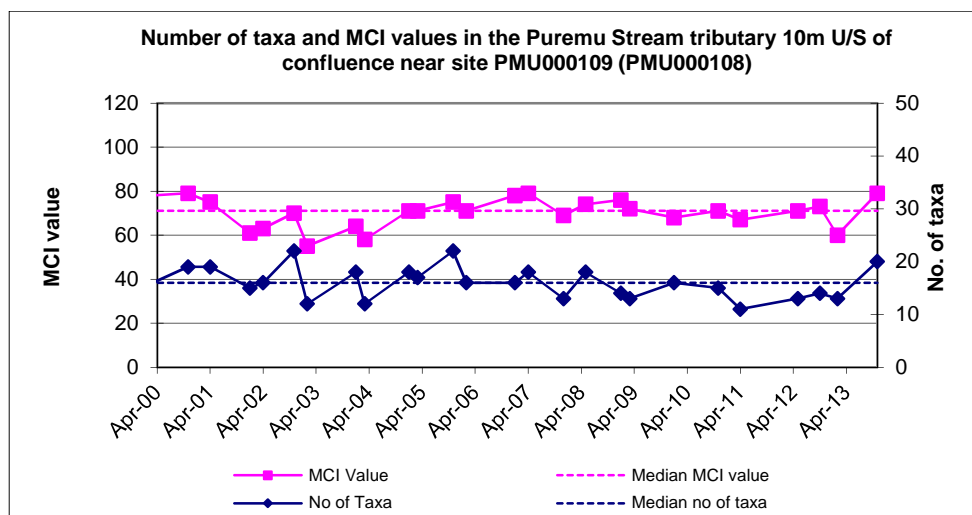
Twenty taxa were recorded at site PT1 in the unnamed tributary of the Puremu Stream, four taxa more than the historical median for the site and a higher richness than recorded at sites 1 and 2 in the Puremu Stream (Table 3 and Figure 4).

**Figure 4** Numbers of taxa and MCI values recorded to date at site PT1, downstream of Colson Road Landfill

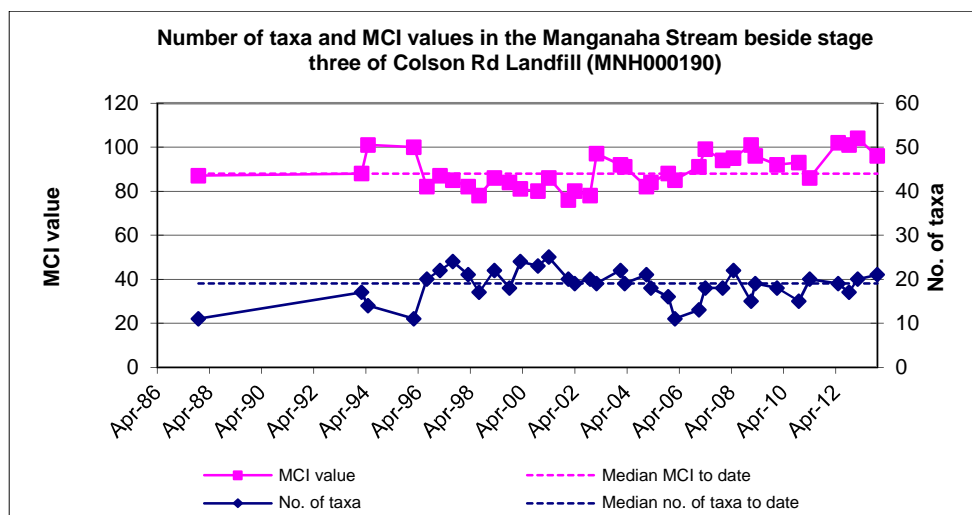
Twenty-one taxa were recorded at site M4 in this survey which was two taxa more than the historical median for the site (Table 3 and Figure 5). The community at this site was characterised by three 'moderately sensitive' taxa (amphipods (*Paracalliope*) and mayflies (*Austroclima* and *Coloburiscus*)) and one 'tolerant' taxon (snail (*Potamopyrgus*)) (Table 5), which was indicative of moderate preceding water quality.

**Figure 5** Taxa numbers and MCI values recorded at site M4, in the Manganaha Stream adjacent to Colson Road landfill

The moderate proportion of ‘sensitive’ taxa (62% of total taxa) in the community resulted in the MCI score of 96 units, which was an insignificant (Stark, 1998) eight units higher than the historical median and an insignificant eight units lower than the previous survey results for this site (Table 3 and Figure 5).

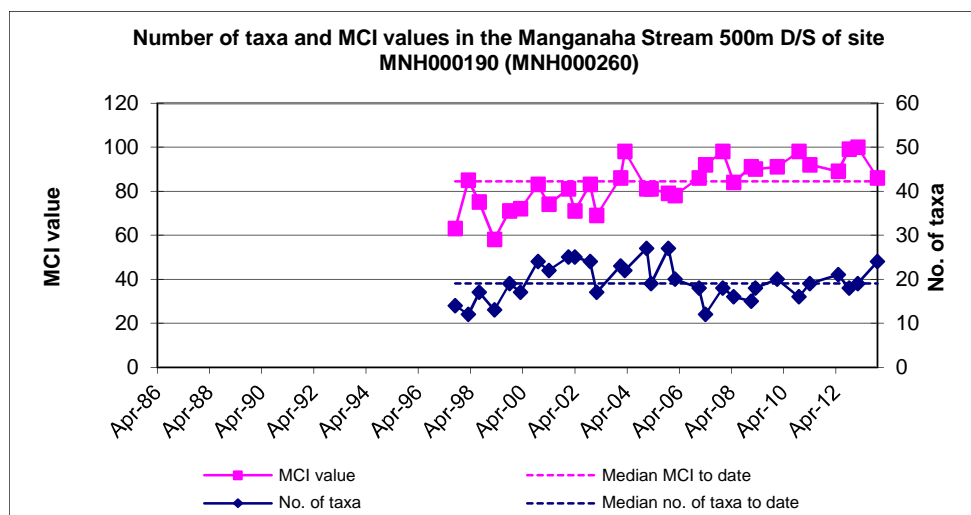
Twenty-four taxa were recorded at site M6, five taxa more than the median for the site and three taxa more than that recorded at the upstream site M4 (Table 3 and Figure 6 ).

**Figure 6** Taxa numbers and MCI values recorded at site M6, in the Manganaha Stream downstream of Colson Road landfill

The moderate proportion of 'tolerant' taxa (46%) in the community resulted in an MCI score of 86 units, 10 units lower than the MCI score recorded at site M4. This score was two units higher than the historical median recorded for the site and a significant (Stark, 1998) 14 units lower than that recorded by the previous survey at this site (Table 3 and Figure 6).

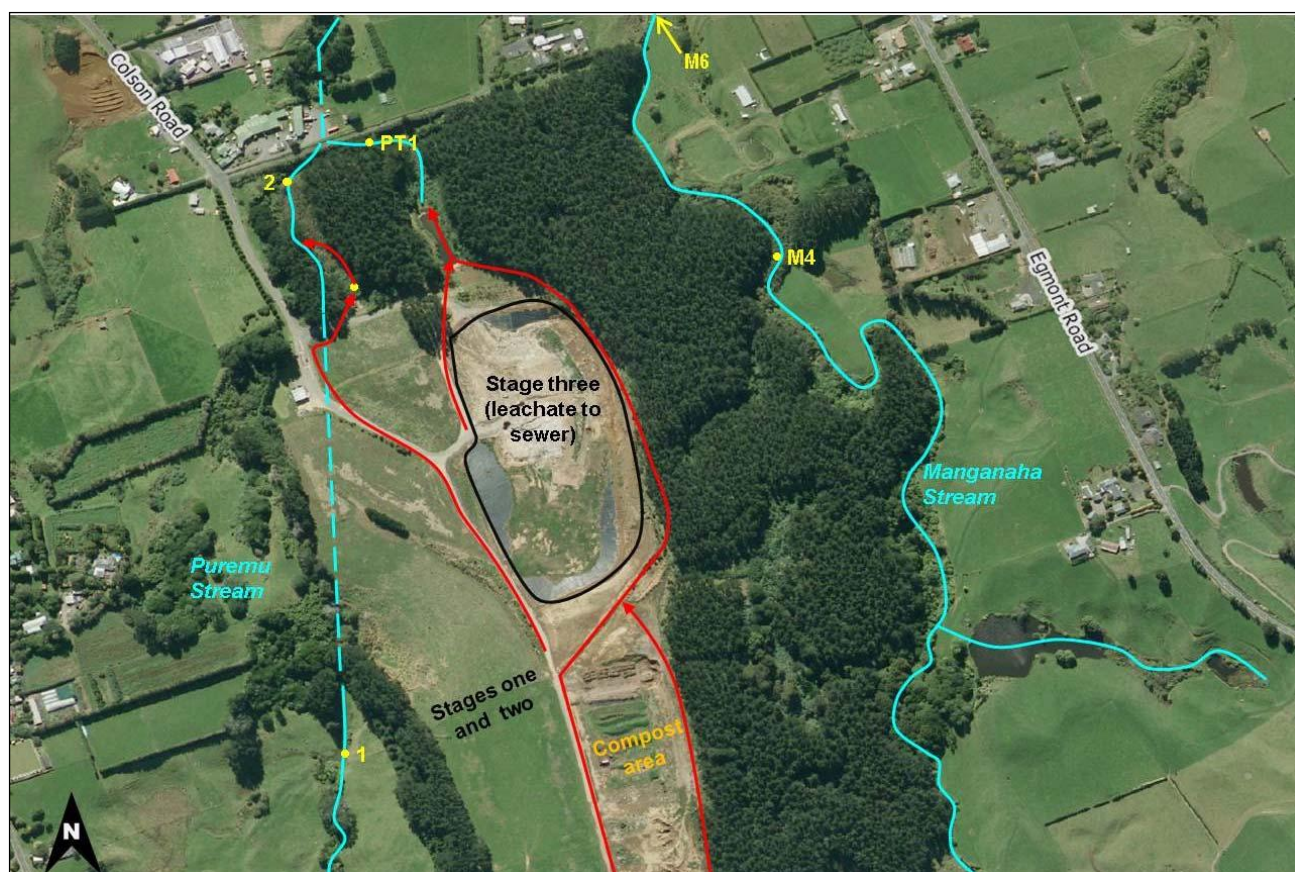
**Figure 1** Biomonitoring sites related to the Colson Road landfill, New Plymouth. The red lines on the aerial photograph indicate the direction of stormwater runoff from the land fill site.

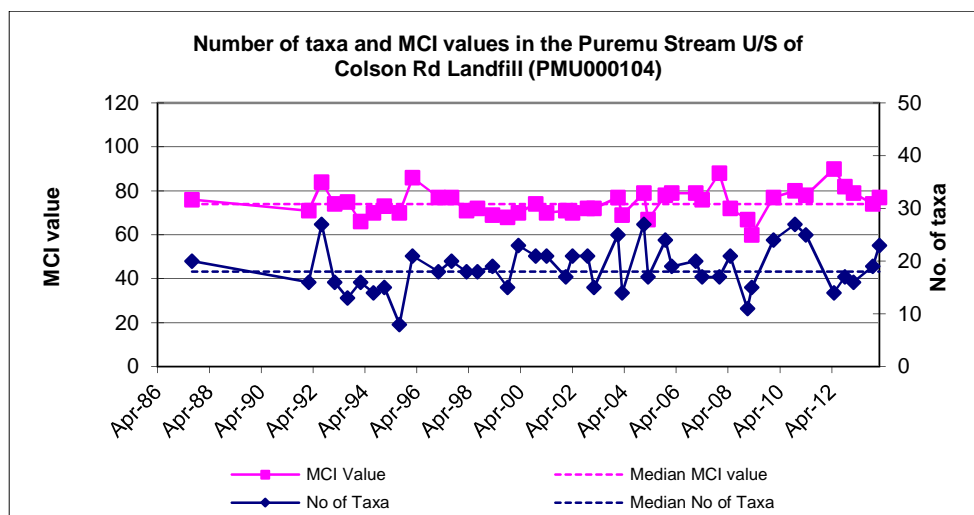
A total taxa richness of 23 taxa was recorded at site 1 in this late summer survey (Table 3 and Figure 2). This result was five taxa more than the historical median.

**Figure 2** Number of macroinvertebrate taxa and MCI values recorded at site 1 in the Puremu Stream, upstream of Colson Road Landfill since April 1987

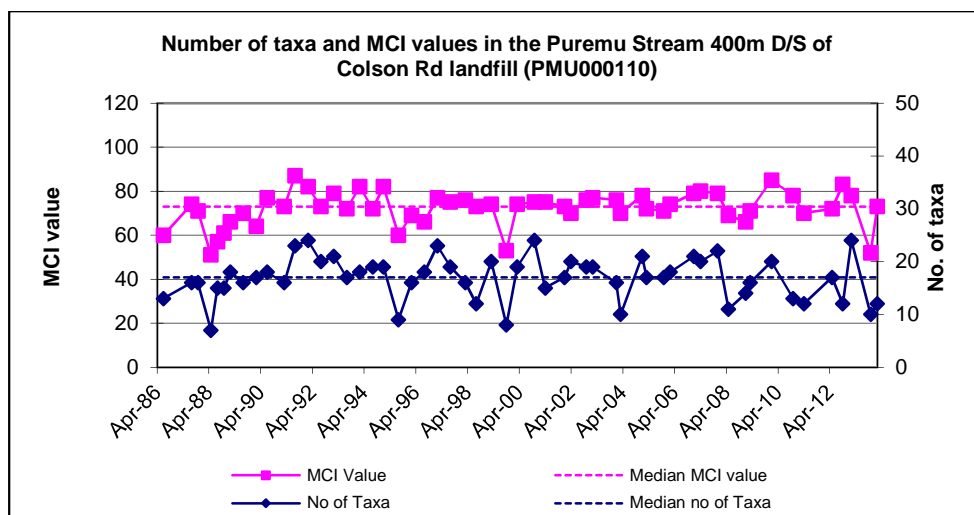
A low number of taxa (12) was recorded at this site, five taxa less than the median of previous surveys at this site, and two taxa more than the richness recorded in the previous survey (Table 3 and Figure 3).

**Figure 3** Taxa numbers and MCI values recorded at site 2, 400 m downstream of Colson Rd Landfill

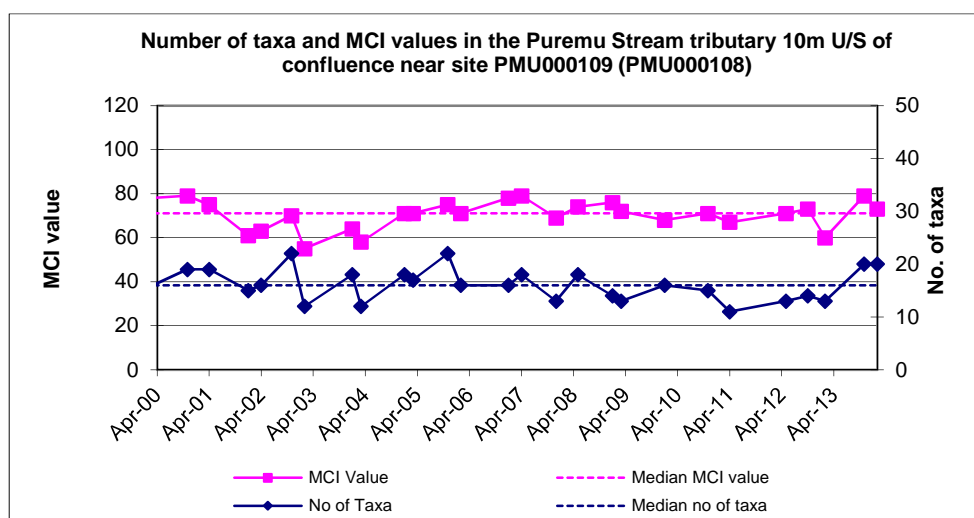
Twenty taxa were recorded at site PT1 in the unnamed tributary of the Puremu Stream, four taxa more than the historical median for the site and a higher richness than recorded at site 2 in the Puremu Stream (Table 3 and Figure 4).

**Figure 4** Numbers of taxa and MCI values recorded to date at site PT1, downstream of Colson Road Landfill

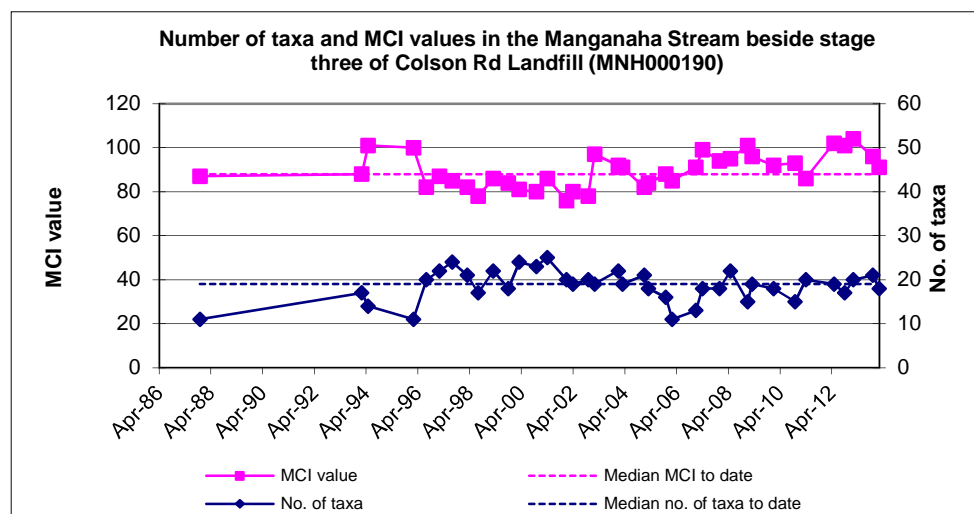
Eighteen taxa were recorded at site M4 in this survey which was one taxon less than the historical median for the site (Table 3 and Figure 5). The community at this site was characterised by three 'moderately sensitive' taxa (amphipods (*Paracalliope*) and mayflies (*Austroclima* and *Coloburiscus*)) and two 'tolerant' taxa (snail (*Potamopyrgus*) and oligochaete worms) (Table 5), which was indicative of moderate preceding water quality.

**Figure 5** Taxa numbers and MCI values recorded at site M4, in the Manganaha Stream adjacent to Colson Road landfill

The moderate proportion of 'sensitive' taxa (56% of total taxa) in the community resulted in the MCI score of 91 units, which was an insignificant (Stark, 1998) three units higher than the historical median and an insignificant five units lower than the previous survey results for this site (Table 3 and Figure 5).

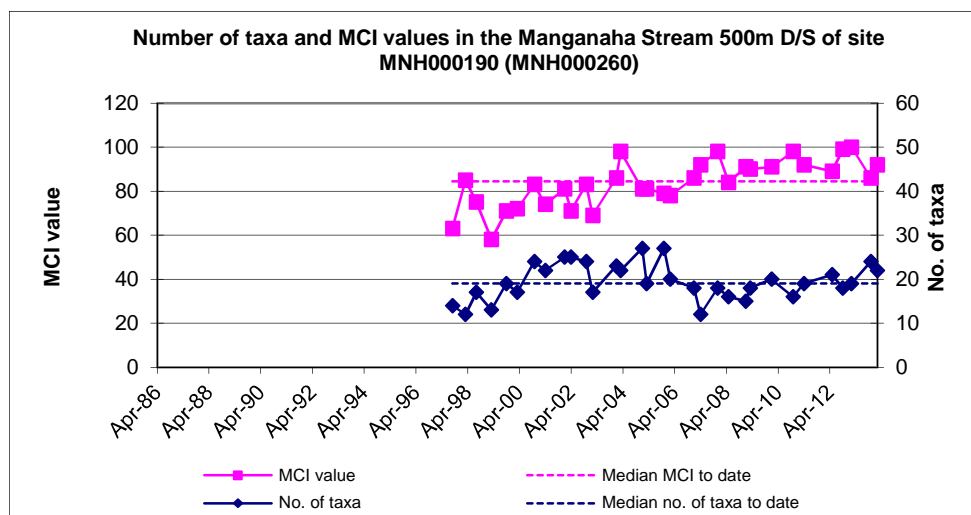
Twenty-two taxa were recorded at site M6, three taxa more than the median for the site and four taxa more than that recorded at the upstream site M4 (Table 3 and Figure 6). In this survey, the dominant taxa at this site included the same three 'moderately sensitive' taxa recorded at site M4, with the addition of one 'tolerant' taxon (oligochaete worms). The community structure was similar to that found at site M4, with only three significant differences in taxon abundance between the two sites (Table 5). This may be attributed to changes in habitat, primarily the change from mainly willow roots to silt sampled by this survey, but also to the change in sampling technique used at this site.

**Figure 6** Taxa numbers and MCI values recorded at site M6, in the Manganaha Stream downstream of Colson Road landfill

The moderate proportion of 'tolerant' taxa (45%) in the community resulted in an MCI score of 92 units, 1 unit higher than the MCI score recorded at site M4. This score was eight units higher than the historical median recorded for the site and an insignificant (Stark, 1998) six units higher than that recorded by the previous survey at this site (Table 3 and Figure 6).
