New Plymouth District Council  
Inglewood, Okato, Okoki,  
and Marfell Park Landfills  
Monitoring Programme  
Annual Report 2014-2015

Technical Report 2015-106

May 2016

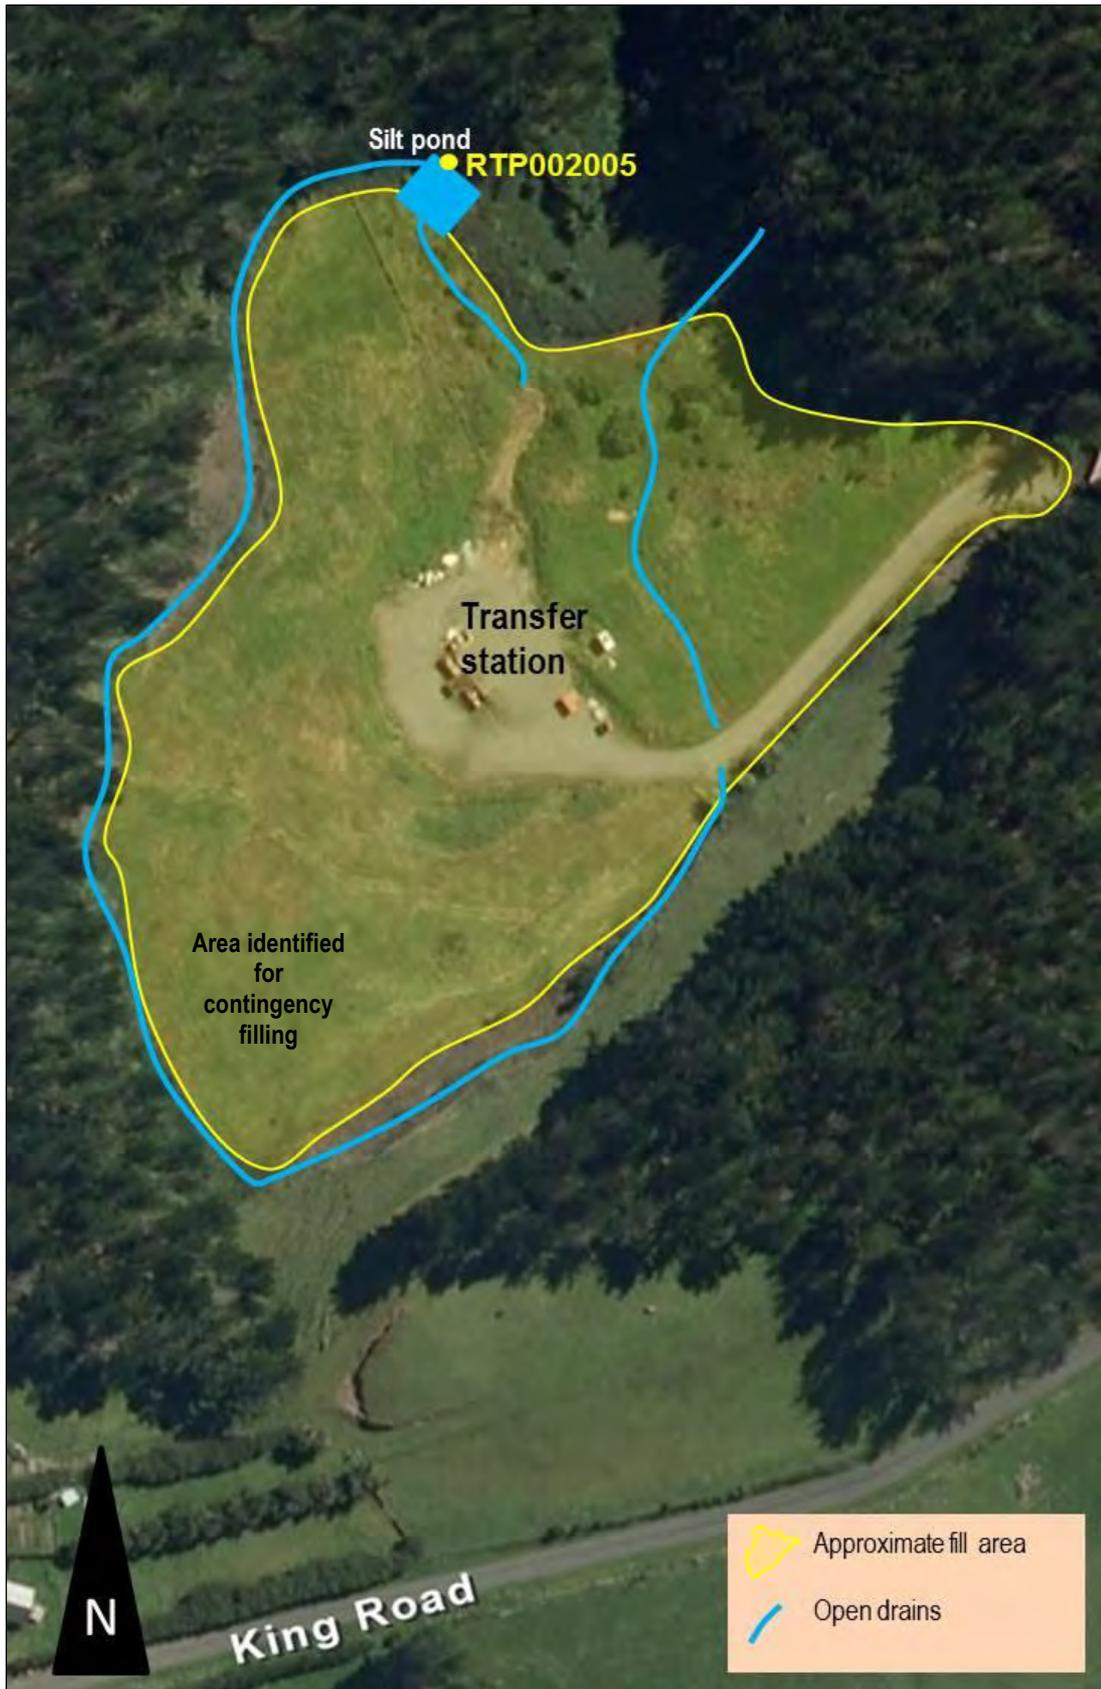
Figure 1 Site layout at Inglewood contingency landfill

Figure 1 shows the approximate extent of the fill and the general layout of the Inglewood landfill site. The discharge and receiving water monitoring site locations are shown in Figure 2.

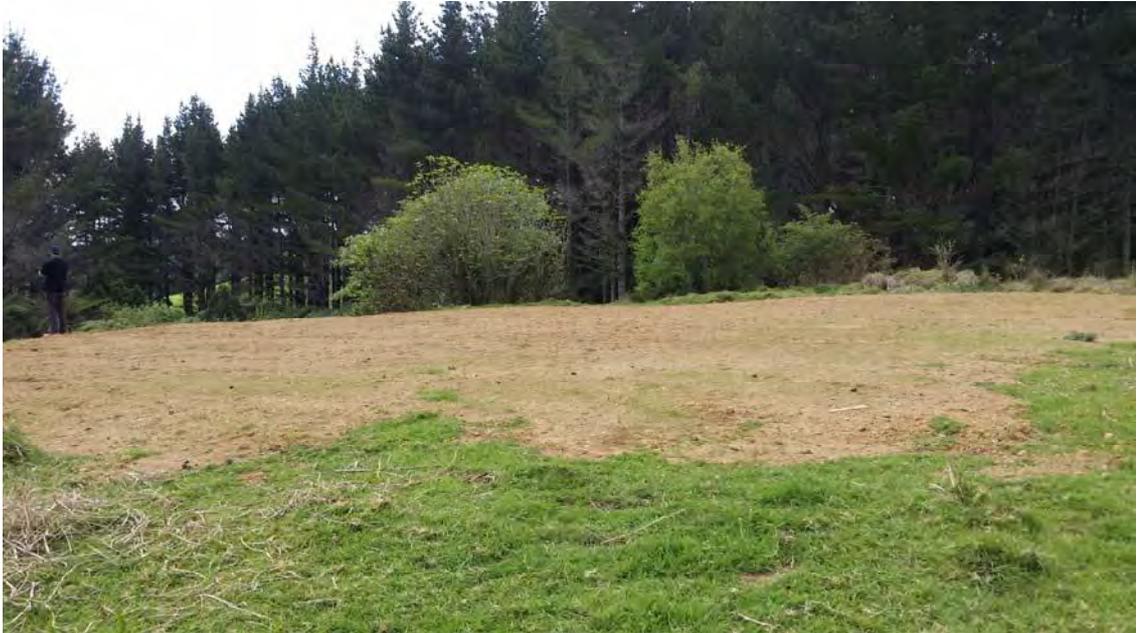
It was found that a significant amount of work had been undertaken in the cleanfill area, and on the area where exposed refuse was observed at the previous inspection

(Photo 1). The area had new cover applied and some early grass growth was noted. There was no exposed refuse, the area felt stable underfoot, and no unauthorised cleanfill material was found to be present.

**Photo 1** Remediated central cap at the Inglewood landfill 24 October 2014

- Continue to monitor the integrity of the cap in respect of the minor cracking in the southern area and the rabbit activity at the site.
- Monitor the amount of vegetation in the stormwater drains, and action if required.

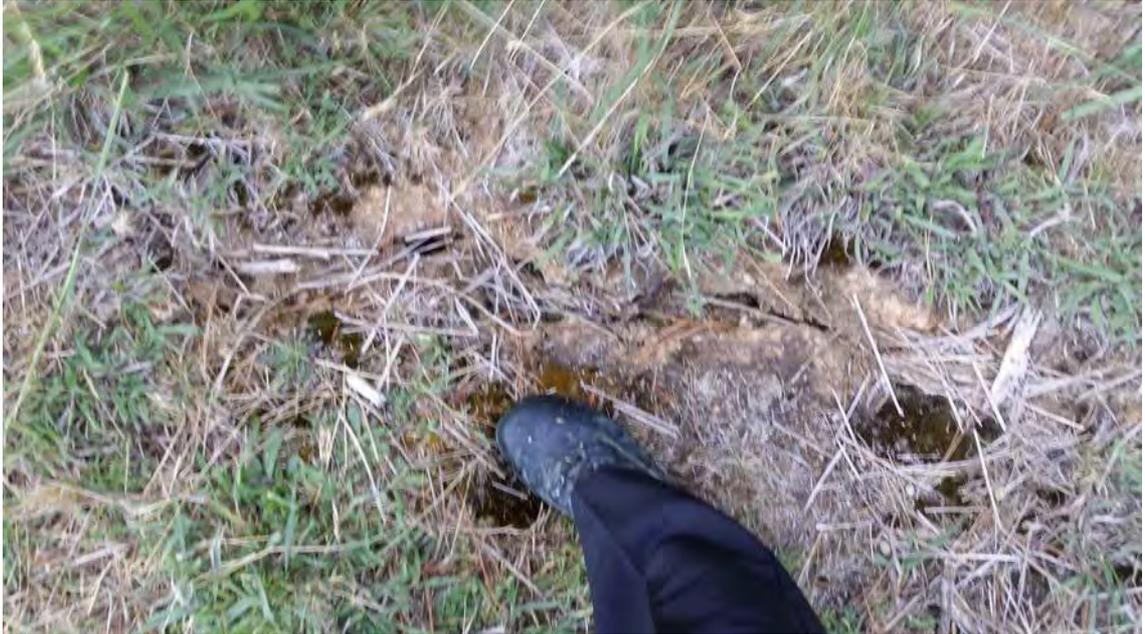
The cracks noted in the southern paddock on the two previous inspections appeared to have widened. Photographs were taken (Photo 2). NPDC was advised that these needed to be investigated further and addressed if they were more than shallow surface cracks.

**Photo 2** Section of the crack in the in southern area of Inglewood landfill cap 10 February 2015

It was found that the crack was approximately 400 mm deep, and at the time of inspection there was a light intermittent refuse odour in the immediate vicinity of the crack.

- Investigate the extent of the cracking in the southern paddock, and remediate if these are anything more than shallow surface cracks.
- Monitor the cracking in the recently covered area, and address if necessary.
- Monitor the amount of vegetation in the stormwater drains, and action if required.

An on-site meeting was held with the NPDC Senior Engineering Officer Solid Wastes to investigate and discuss remediation options for the crack in the cap (southern paddock).

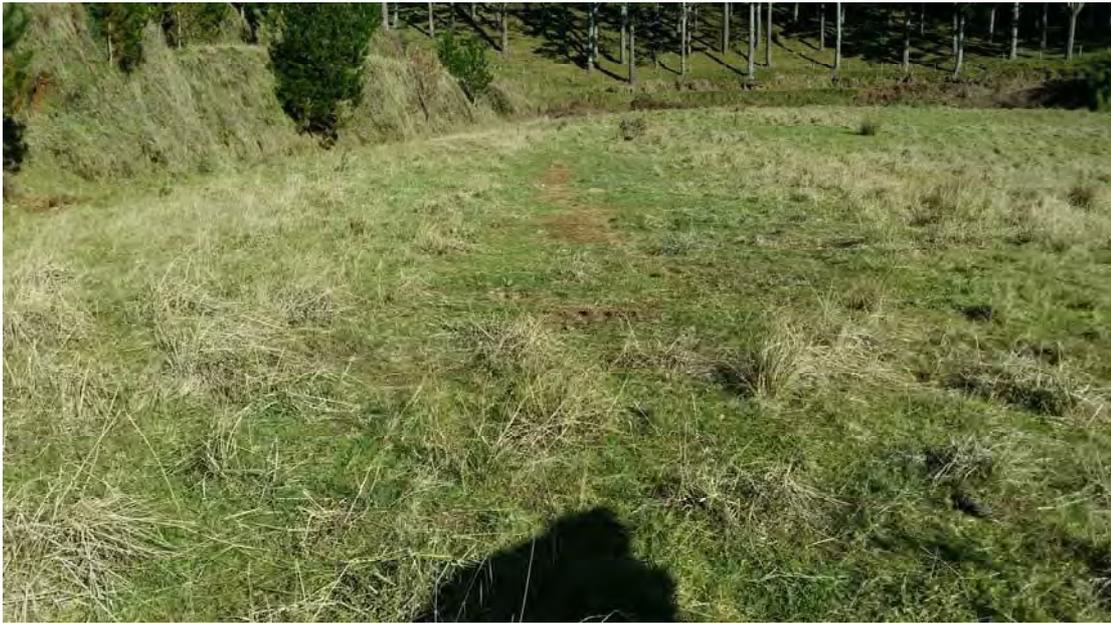
The site was inspected in fine and sunny conditions. The cap was well-vegetated and grass was establishing on areas where the crack remediation had taken place on the southern cap (Photo 3). No erosion, slumping, cracking or ponding was evident. No rabbit holes were observed. Grass was still establishing on the area remediated prior to the inspection on 22 October 2014. The stormwater system had some vegetation in the drains which appeared to be sprayed and dead. There was not enough vegetation to impede stormwater flow, and no ponding was observed. The leachate pond was full but not discharging at the time of inspection. The fencing on site was in a good condition and signage and security were satisfactory, with padlocked gates and visible signage.

**Photo 3** Remediated southern cap crack at Inglewood landfill 17 June 2015

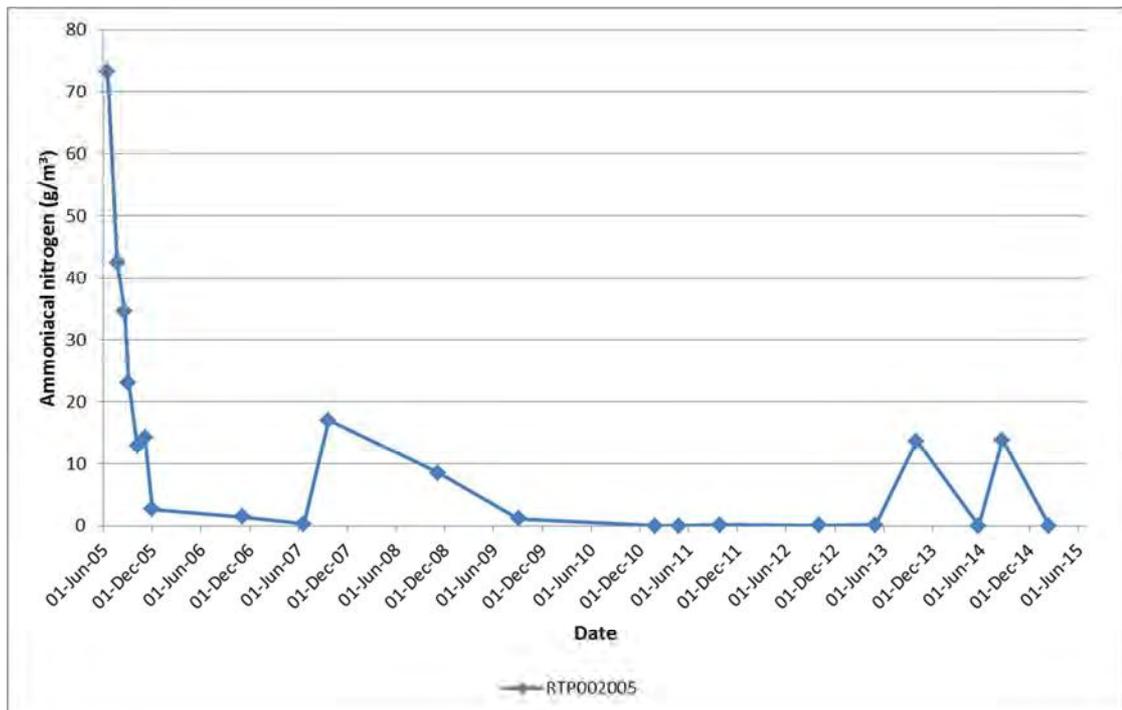
As with the autumn sample collected after heavy rainfall in the 2013-2014 year, the ammoniacal nitrogen concentration of the August 2014 sample was inconsistently high when compared to more recent historical results (Figure 3)

**Figure 3** Ammoniacal nitrogen concentration of the Inglewood landfill stormwater/leachate (RTP002005) for monitoring to date

This may have been the result of one or more of a number of factors including; the surrounding area and the drain being cleared of vegetation, the dying sprayed vegetation in the stormwater drains, the recent grazing, seasonal variation and/or additional stormwater infiltration causing increased leachate generation due to the condition of the cap on the central area of the landfill as noted at the August 2014 inspection.

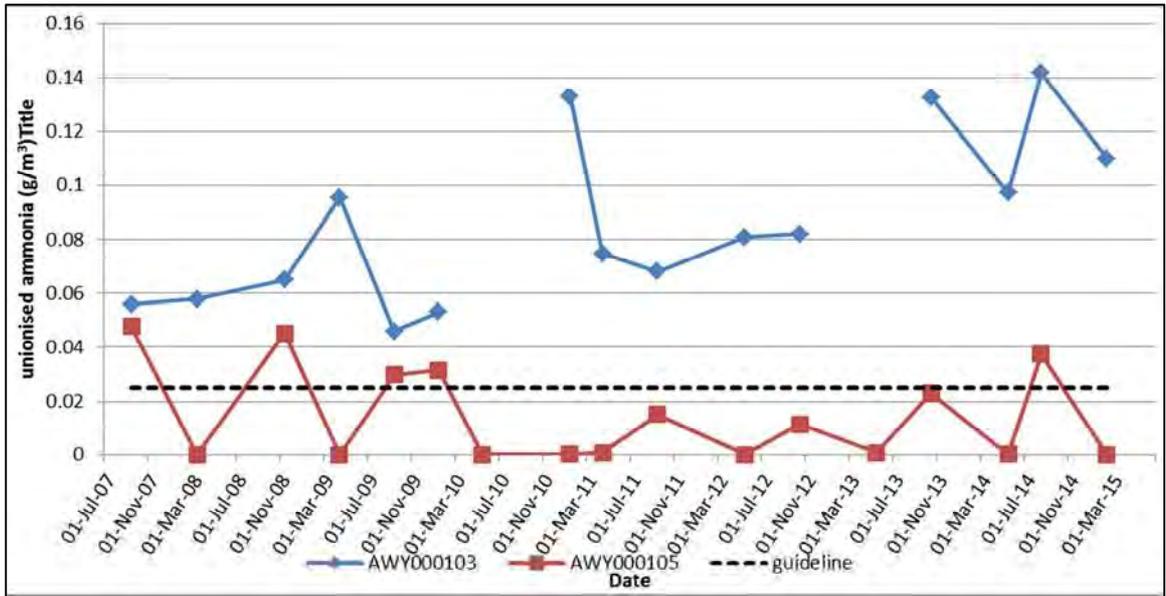
It is also noted that the unionised ammoniacal nitrogen concentration has been consistently above the 0.025 g/m<sup>3</sup> guideline adopted by the Council to protect aquatic organisms from chronic effects at the culvert outlet. From a review of the historical results, it appears that there is an emerging trend of increasing levels of this contaminant at this site. It is however noted that, for the most part, this is generally assimilated in the wetland area, and the concentrations found at the lower end of the landfill tributary are normally well below this guideline value(Figure 4).

**Figure 4** Unionised ammonia concentration in the landfill tributary below Inglewood landfill

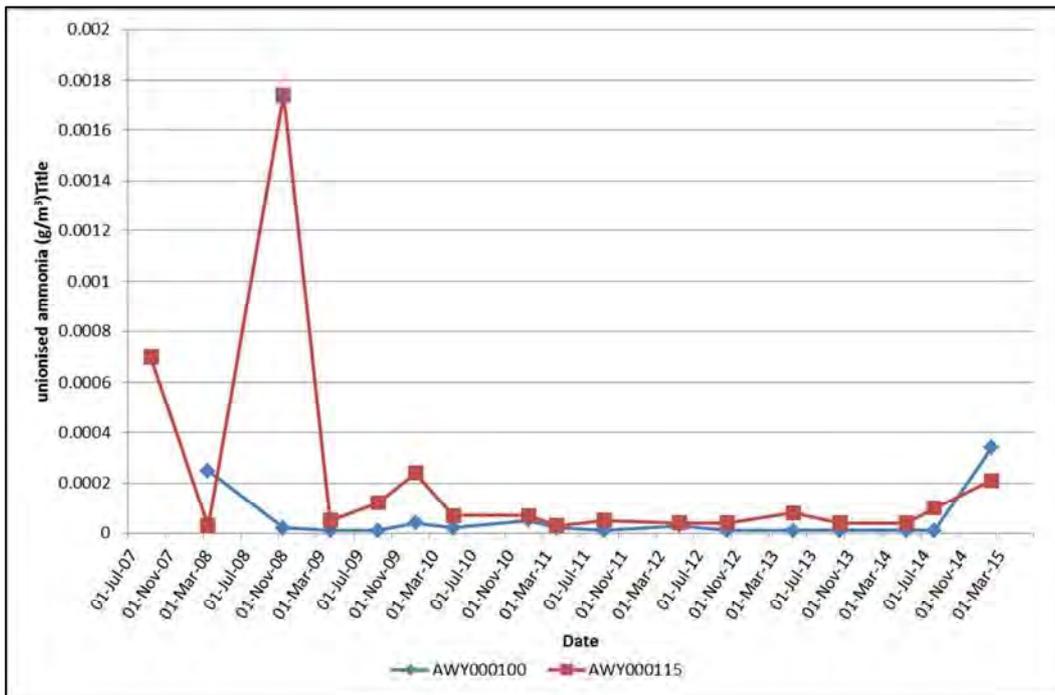
The concentration range above which acute toxic effects may be seen for New Zealand native fish, for example a fish kill, is 0.75 to 2.35 g/m<sup>3</sup>, and the levels of unionised ammonia found at all monitoring sites during the year under review were well below this concentration range. It can be seen from Figure 5 that, although the unionised ammonia concentration was found to be above the 0.025 g/m<sup>3</sup> guideline at the lower end of the tributary on 19 August 2014, there was little, if any, effect found on the unionised ammonia concentration of the larger (main) tributary (site AWY000115).

**Figure 5** Unionised ammonia concentration in the main tributary below Inglewood landfill

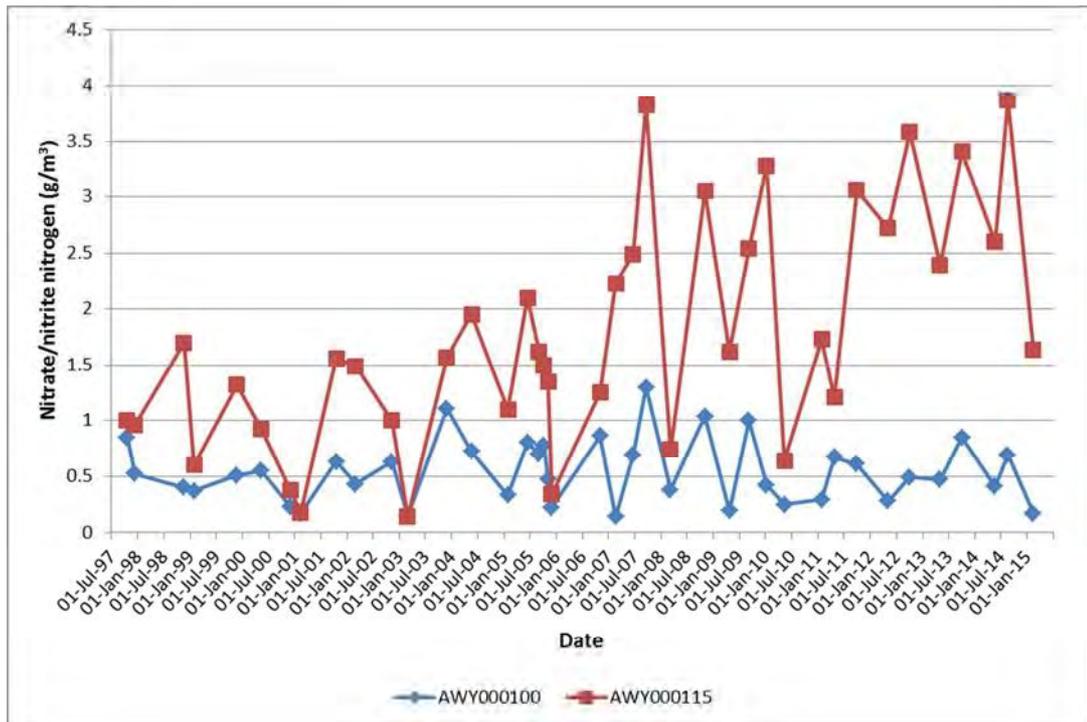
The main unnamed tributary that receives the discharge from the landfill tributary displays slight elevations in conductivity, pH, alkalinity and ammoniacal nitrogen and nitrite/nitrate nitrogen at AWY000115 when compared to the upstream site (AWY000100). These minor increases have been noted in previous monitoring years and have been considered most likely a result of the presence of the landfill and from inputs from stock grazing in the area immediately downstream of the landfill site.

**Figure 6** Nitrate/nitrite nitrogen results in the main tributary upstream and downstream of the Inglewood landfill tributary discharge

A review of the historical data also shows that the difference in the nitrate/nitrite nitrogen concentrations between sites AWY000100 and AWY000115 appears to be increasing (Figure 6). However, the current levels of contaminants found were within acceptable ranges in the main tributary and would therefore be considered a minor effect, at most, on the aquatic environment.

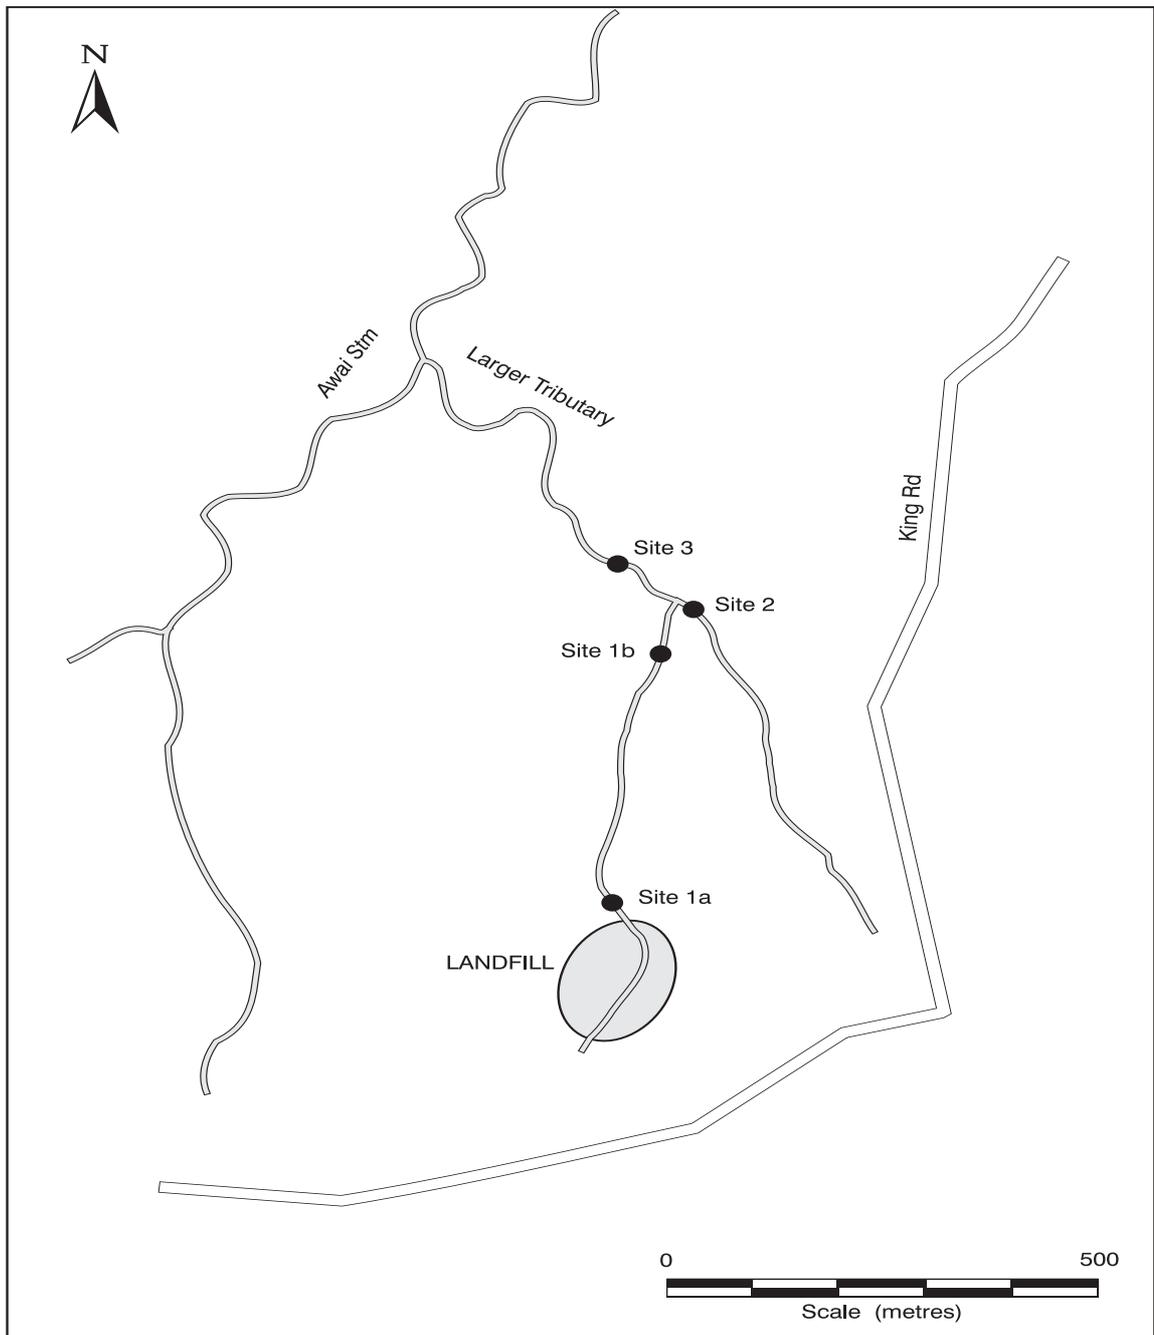
**Figure 7** Biomonitoring sites in tributaries of the Awai Stream related to the Inglewood landfill

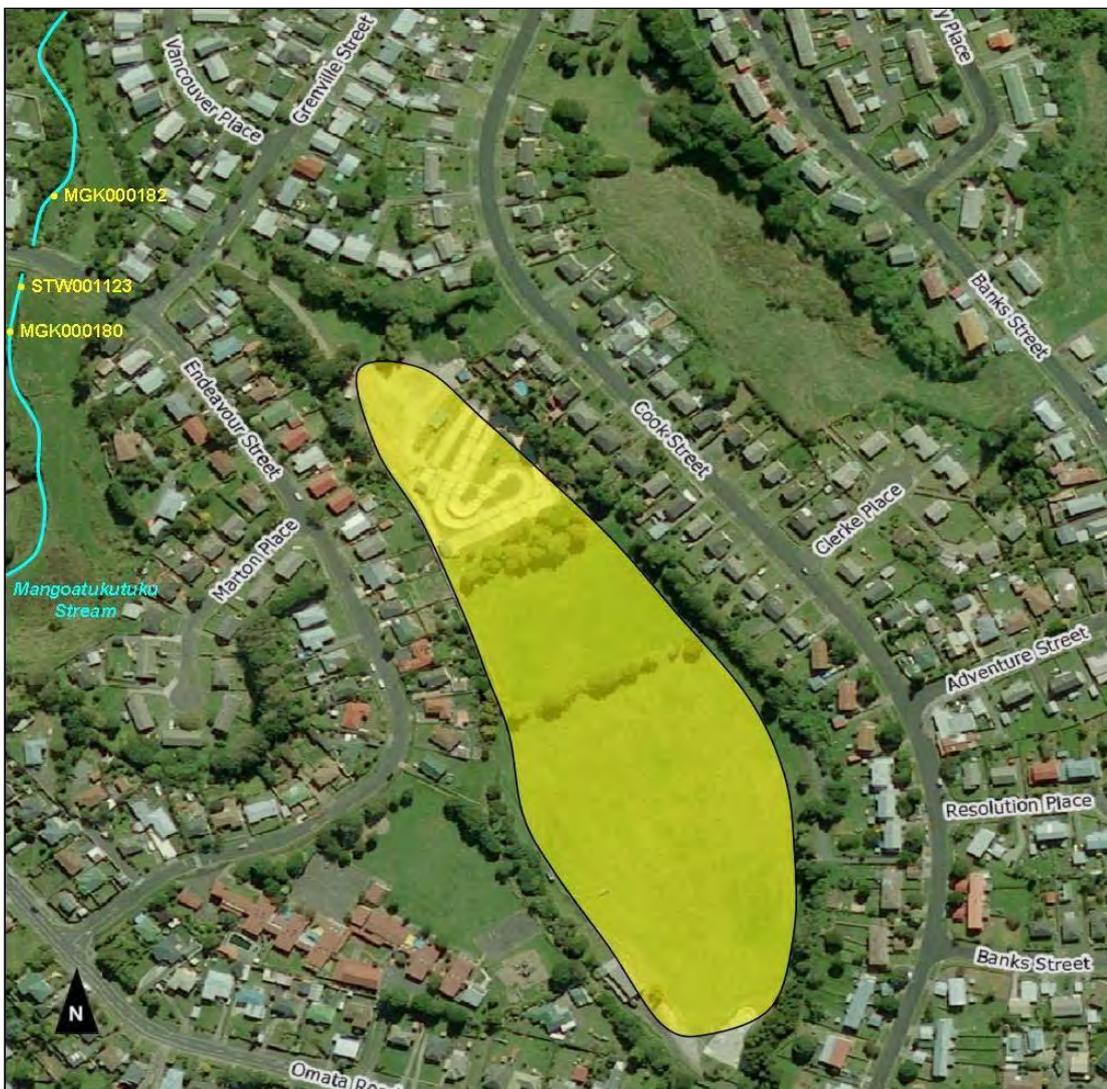
**Figure 8** An aerial view showing former landfill at Marfell Park and sampling sites

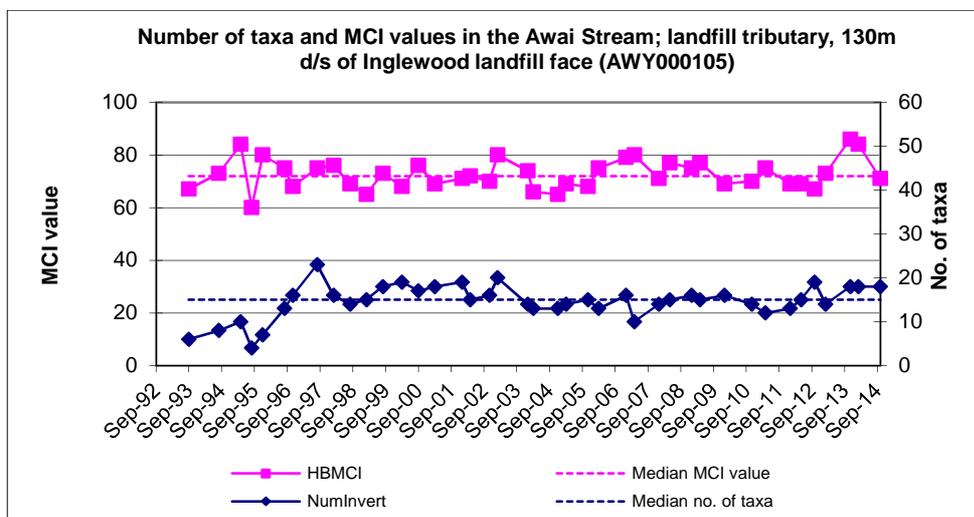
The MCI score of 71 units indicated a community of 'poor' biological health which was not significantly different (Stark, 1998) to the median value calculated from previous surveys at the same site (median MCI score 73 units; Table 2) but was significantly lower (Stark, 1998) than the previous survey score (MCI score 84 units; Figure 2). The SQMCI<sub>s</sub> score of 2.4 units was similar to the median value calculated from previous surveys at the same site (median SQMCI<sub>s</sub> score 2.6 units; Table 2) and was lower than the previous survey score (SQMCI<sub>s</sub> score 3.6 units).

**Figure 2** Number of taxa and MCI values at site 1a in a tributary of the Awai Stream.

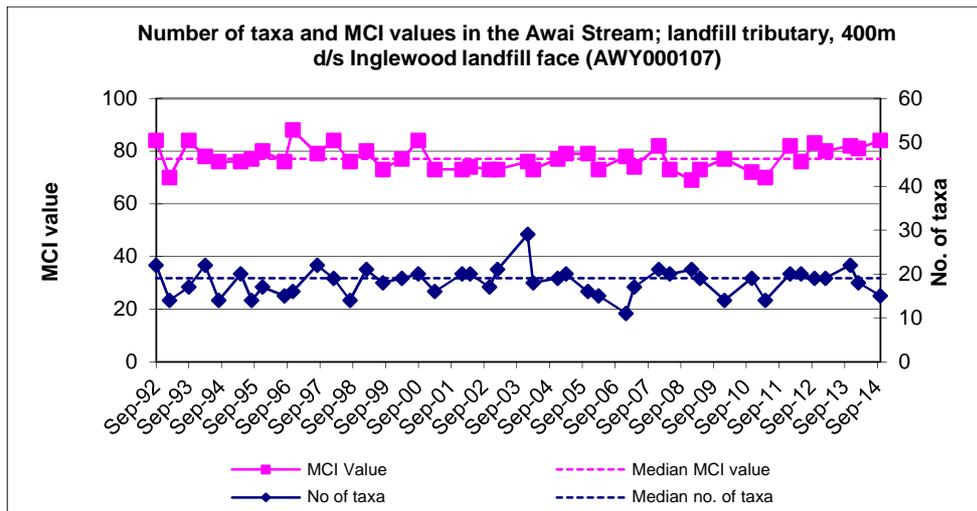
The MCI score of 84 units indicated a community of 'fair' biological health which was not significantly different (Stark, 1998) to the median value calculated from previous surveys at the same site (median MCI score 77 units; Table 2) or to that of previous survey score (MCI score 84 units; Figure 3). The SQMCI<sub>s</sub> score of 3.8 units was similar to the median value calculated from previous surveys at the same site (median SQMCI<sub>s</sub> score 3.2 units; Table 2) and was lower than the previous survey score (SQMCI<sub>s</sub> score 3.6 units).

**Figure 3** Number of taxa and MCI values at site 1b in a tributary of the Awai Stream.

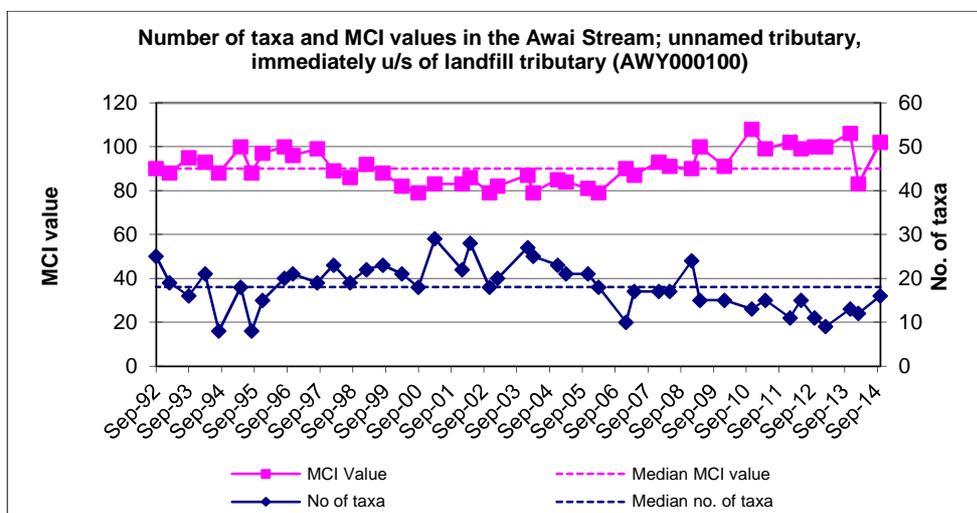
The MCI score of 103 units indicated a community of ‘good’ biological health which was significantly higher (Stark, 1998) than the median value calculated from previous surveys at the same site (median MCI score 90 units; Table 2) and to that of previous survey score (MCI score 83 units; Figure 4). The SQMCI<sub>s</sub> score of 5.5 units was markedly higher than the median value calculated from previous surveys at the same site (median SQMCI<sub>s</sub> score 3.9 units; Table 2) and to that of the previous survey score (SQMCI<sub>s</sub> score 4.3 units).

**Figure 4** Number of taxa and MCI values at site 2 in a tributary of the Awai Stream.

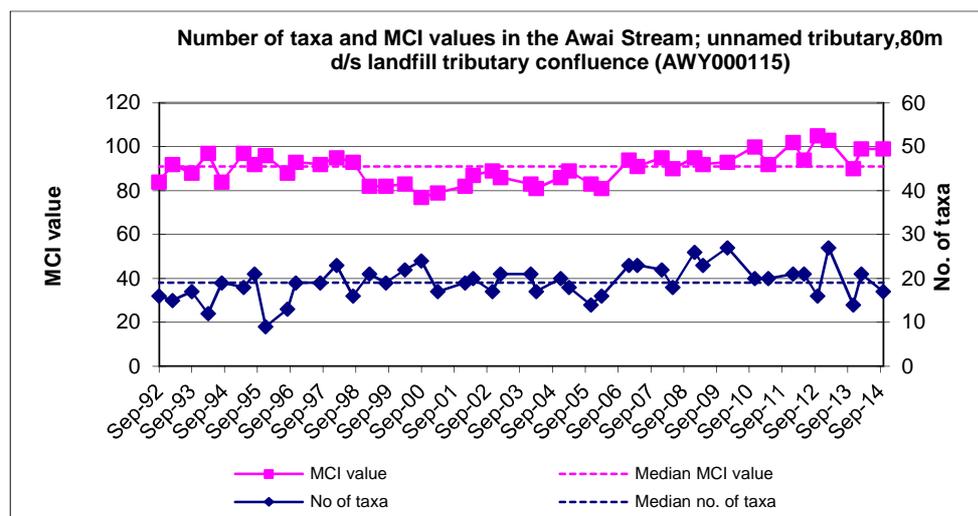
The MCI score of 99 units indicated a community of ‘fair’ biological health which was not significantly different (Stark, 1998) to the median value calculated from previous surveys at the same site (median MCI score 91 units; Table 2) and was the same score as the previous survey score (MCI score 99 units; Figure 4). The SQMCI<sub>s</sub> score of 5.2 units was markedly higher than the median value calculated from previous surveys at the same site (median SQMCI<sub>s</sub> score 3.3 units; Table 2) and similar to the previous survey score (SQMCI<sub>s</sub> score 5.0 units).

**Figure 5** Number of taxa and MCI values at site 3 in a tributary of the Awai Stream.

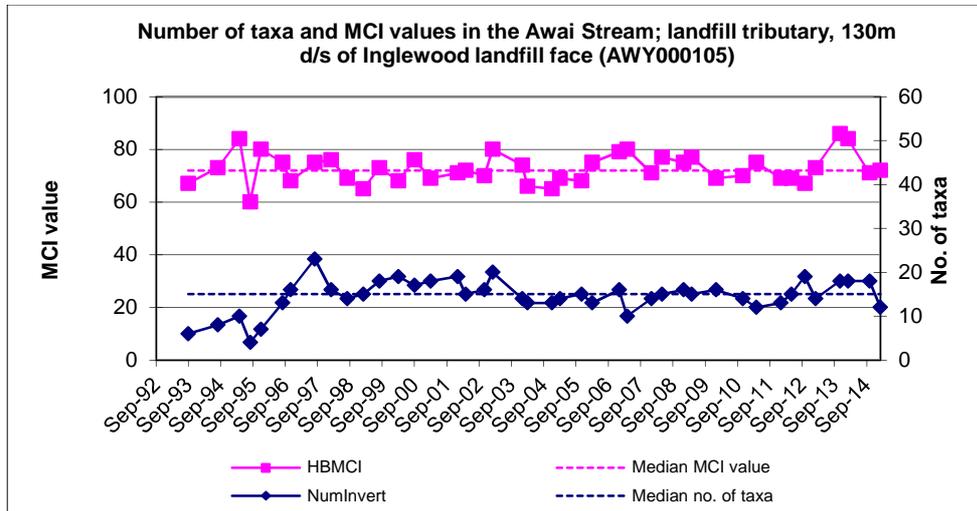
The MCI score of 72 units indicated a community of ‘poor’ biological health which was the same number as the median value calculated from previous surveys at the same site (median MCI score 72 units; Table 2) but was not significantly different (Stark, 1998) to the previous the survey score (MCI score 73 units; Figure 2). The SQMCI<sub>s</sub> score of 2.2 units was similar to the median value calculated from previous surveys at the same site (median SQMCI<sub>s</sub> score 2.6 units; Table 2) and to the previous survey score (SQMCI<sub>s</sub> score 2.4 units).

**Figure 2** Number of taxa and MCI values at site 1a in a tributary of the Awai Stream.

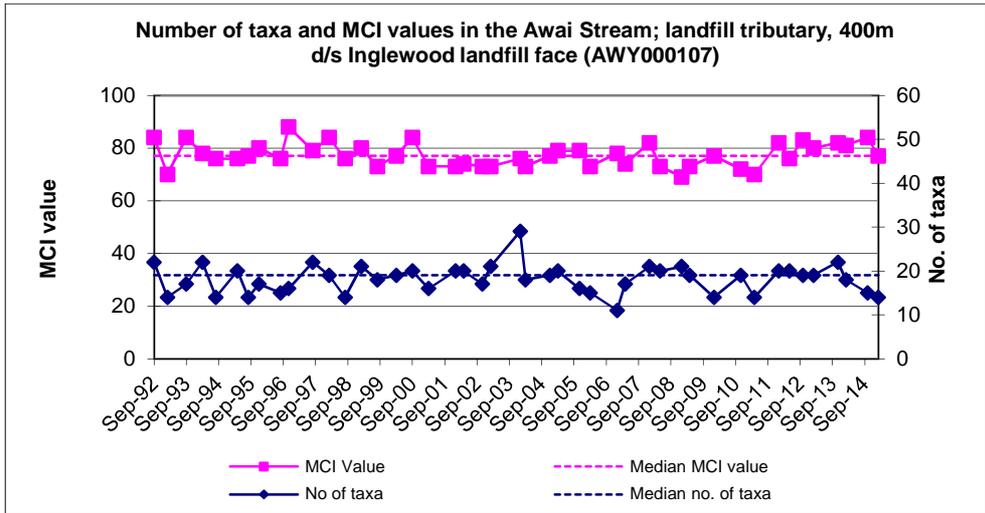
The MCI score of 77 units indicated a community of ‘poor’ biological health which was the same as the median value calculated from previous surveys at the same site (median MCI score 77 units; Table 2) and not significantly different (Stark, 1998) to that of previous survey score (MCI score 84 units; Figure 3). The SQMCI<sub>s</sub> score of 3.9 units was similar to the median value calculated from previous surveys at the same site (median SQMCI<sub>s</sub> score 3.2 units; Table 2) and to the previous survey score (SQMCI<sub>s</sub> score 3.8 units).

**Figure 3** Number of taxa and MCI values at site 1b in a tributary of the Awai Stream.

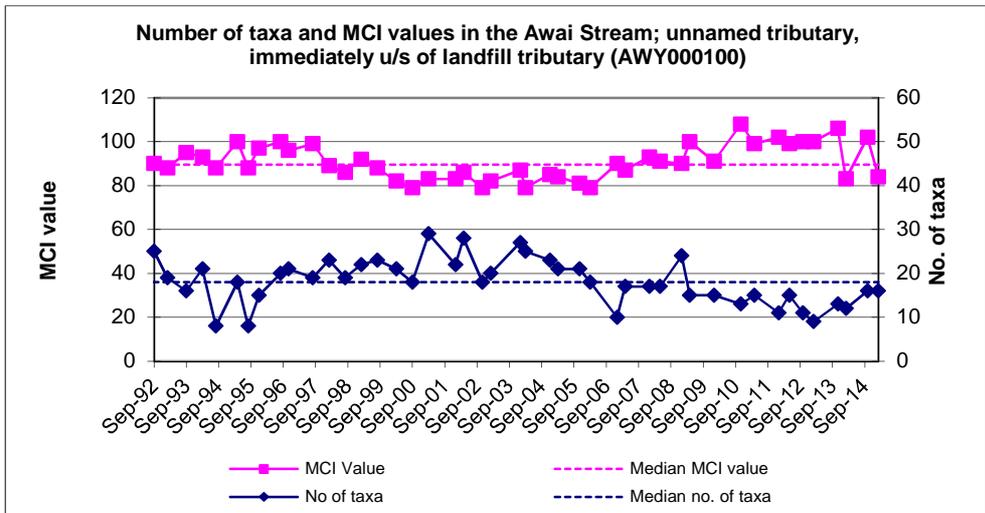
The MCI score of 90 units indicated a community of ‘fair’ biological health which was the same as the median value calculated from previous surveys at the same site (median MCI score 90 units; Table 2) and significantly lower (Stark, 1998) than the survey score (MCI score 102 units; Figure 4). The SQMCI<sub>s</sub> score of 3.8 units was similar to the median value calculated from previous surveys at the same site (median SQMCI<sub>s</sub> score 3.9 units; Table 2) and markedly lower than the previous survey score (SQMCI<sub>s</sub> score 5.5 units).

**Figure 4** Number of taxa and MCI values at site 2 in a tributary of the Awai Stream.

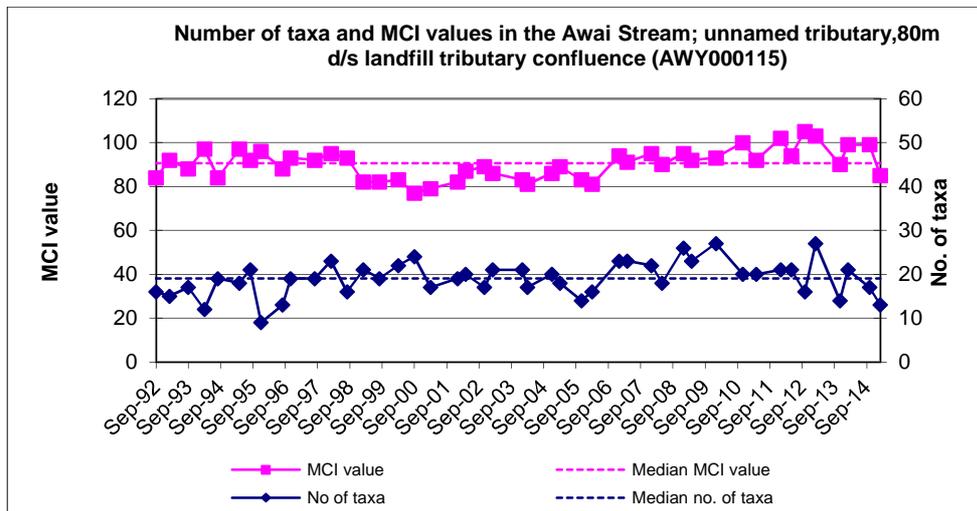
The MCI score of 85 units indicated a community of 'fair' biological health which was not significantly different (Stark, 1998) to the median value calculated from previous surveys at the same site (median MCI score 91 units; Table 2) and was significantly lower (Stark, 1998) than the previous survey score (MCI score 99 units; Figure 4). The SQMCI<sub>s</sub> score of 2.9 units was similar to the median value calculated from previous surveys at the same site (median SQMCI<sub>s</sub> score 3.3 units; Table 2) and markedly lower than the previous survey score (SQMCI<sub>s</sub> score 5.2 units).

**Figure 5** Number of taxa and MCI values at site 3 in a tributary of the Awai Stream.
