Dimar Partnership Landfill Monitoring Programme Annual Report 2015-2016

Technical Report 2016-66

August 2016

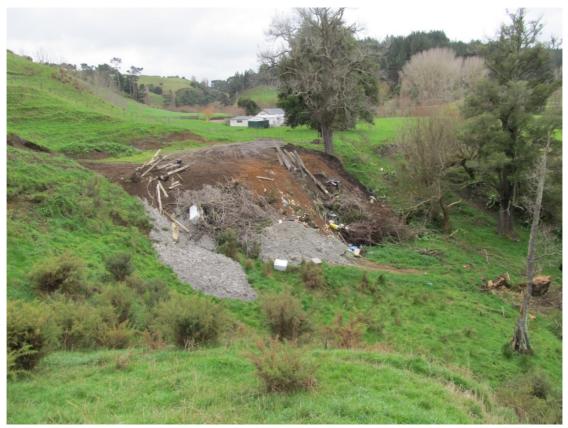
For a number of years the dump was filled with household rubbish, broken concrete, timber, tree prunings and farm waste from several of the surrounding properties. The dump was located approximately 22 m away from the Mangimangi Stream, therefore the discharge of contaminants (leachate) into the Mangimangi Stream has the potential to result in the contamination of surface water.

Photo 1 Photograph showing the refuse dump prior to capping

Since the closure of the dump, the consent holder has rehabilitated the site. This has involved removing all rubbish located within 25 m of the stream, covering the site with 500 mm of clay, which was shaped to the desired contour, capping with 500 mm of top soil and re-vegetating with grass.

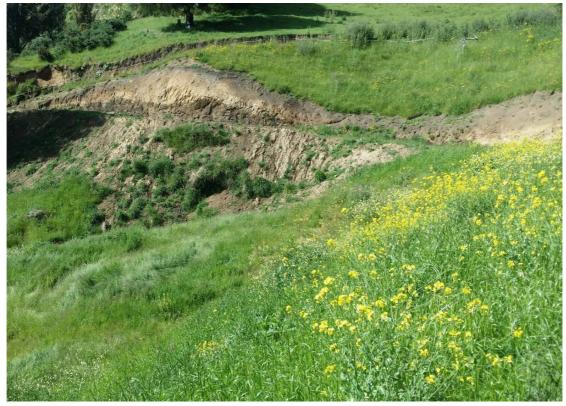
Photo 2 Photograph showing the refuse dump after capping (foreground)

The cap appeared to be in sound condition with no evidence of slumping or erosion. The cap had reasonable grass cover and appeared to have performed well over the wet winter season. Spring water from the hill above the area continued to be directed around the cap.

The site was inspected in overcast conditions following recent wet weather. It was found that the area had been grazed recently. The top of the cap was intact with no ponding, slumping, or cracking present. There was reasonable grass cover present apart from a few isolated patches. It was noted that there was some minor stock erosion starting to occur on the face sloping down towards the stream where the soil had become exposed in small patches. There was some minor pugging on the flat below this face. The consent holder was asked to monitor the stock erosion to ensure that the refuse does not become exposed. It was noted that the stormwater from above the filled area was being directed around the cap. Receiving water samples were also collected.

The consent holder was advised that the following action was to be taken: Ensure that stock management on the site is such that damage to the cap is avoided, and permanent grass cover is maintained across the cap as required by special condition 1.
