South Taranaki District Council Eltham, Hawera, Kaponga, Manaia, Patea, Opunake and Otakeho Landfills Monitoring Programmes Annual Report 2018-2019

Technical Report 2019-18

ISSN: 1178-1467 (Online) Document: 2284358 (Word) Document: 2320277 (Pdf) Taranaki Regional Council Private Bag 713 STRATFORD November 2019

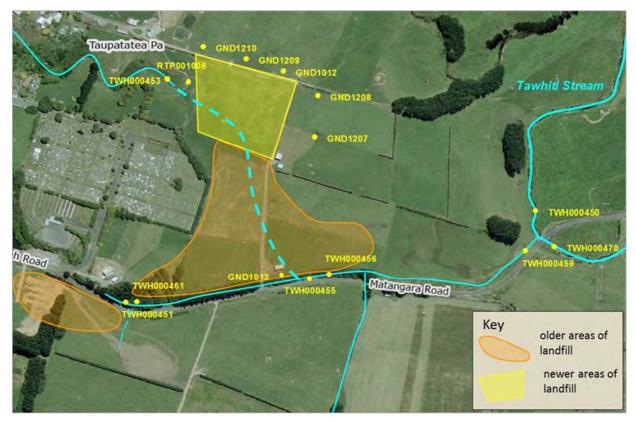
Figure 3 Aerial view of Hawera landfill and sampling sites

The landfill closed in September 1998, and STDC reinstated the site. Leachate is captured via leachate collection lines in the landfill and is pumped to the Hawera wastewater treatment plant from a pump station located near the upstream end of the culvert under the landfill as illustrated in Figure 2 (RTP001008). Groundwater monitoring has shown that some leachate is entering the groundwater in the immediate vicinity of the site, but this appears to be having only a very minor effect at the southern boundary of the site.

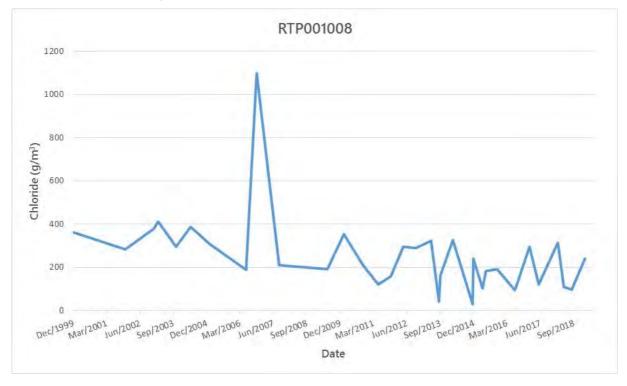
Figure 4 Hawera landfill leachate chloride concentration; 1999-2019

Results indicate that waste in the landfill is still actively degrading and releasing contaminants. The high chloride, chemical oxygen demand and ammoniacal nitrogen concentrations are typical values for landfill leachate and, as expected, these contaminants are gradually trending down over time (Figure 4, Figure 5, and Figure 6). All of the results obtained during the year under review were below the maximum values previously recorded, although a number were above the historical medians, particularly at the time of the February survey.

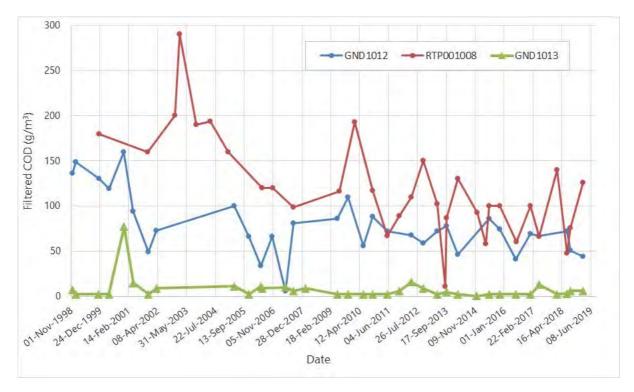
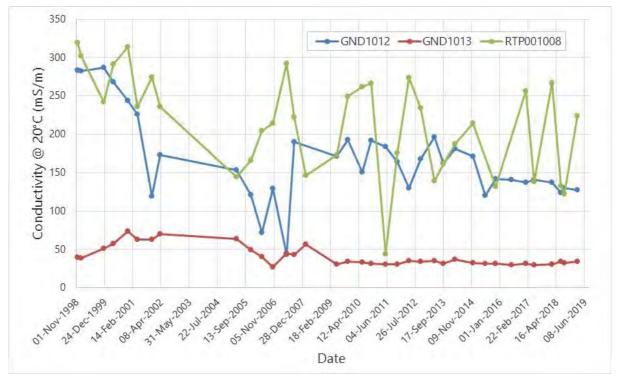
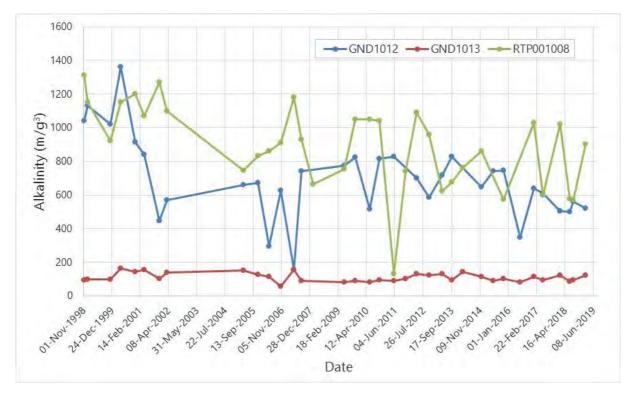
As with previous monitoring periods, bore GND1012 exhibits elevated levels of landfill contamination indicators, such as increased chlorides, alkalinity, iron, and ammoniacal nitrogen. This bore is immediately adjacent to, and down gradient of the landfill footprint, and in recent years has contained a similar level of contaminants to the leachate as indicated by the relative alkalinity, conductivity and chemical oxygen demands. It is noted that bore GND1013 is further from the most recently landfilled areas and as a result has far lower levels of these landfill indicator species (Figure 7, Figure 8 and Figure 9).

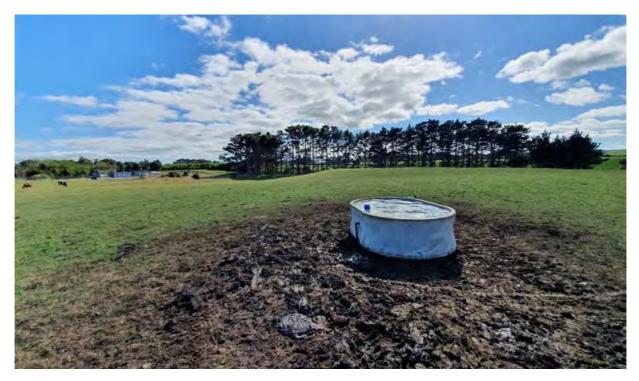
Photo 1 Stock damage around a water trough on Manaia landfill cap, 17 April 2019

The site was inspected in fine weather with a light south-east wind. The cap was relatively dry underfoot and had been recently grazed by dairy cows. Two water troughs had been installed on the cap, one of which was located in the middle of the stormwater swale on the north western cap area. This had the potential to impact stormwater drainage and reduce the integrity of the cap. Some stock damage was noted in the vicinity of the other water trough, as well as to the south where a temporary feed pad appeared to have been located (Photos 1 and 2). The loss of vegetative cover in these areas had the potential to create localised ponding and reduce the integrity of the cap.

| Date | Details | Compliant<br>(Y/N) | Enforcement<br>Action<br>Taken? | Outcome |
|---|--|---|---|--|
| 17/04/2019 | During routine monitoring it was<br>discovered that the lessee had installed<br>water troughs on the capped area in<br>locations that could impact stormwater<br>runoff. Poor stock management had<br>resulted in damage to the cap around<br>the trough and feed-pad areas. | Ν | Explanation<br>requested | Works undertaken to<br>remove the trough and<br>relocate this and the<br>feed-pad away from<br>the cap. Stormwater<br>drains reinstated. |

During the final inspection of the year it was observed that the lessee had installed water troughs on the cap. One of which was located in the middle of a stormwater swale, with the potential to impact stormwater drainage and reduce the integrity of the cap. There was stock damage to the cap around the other one and a feed pad located on the cap had also resulted in stock damage. STDC arranged for the relocation of the troughs and feed pad away from the capped area.

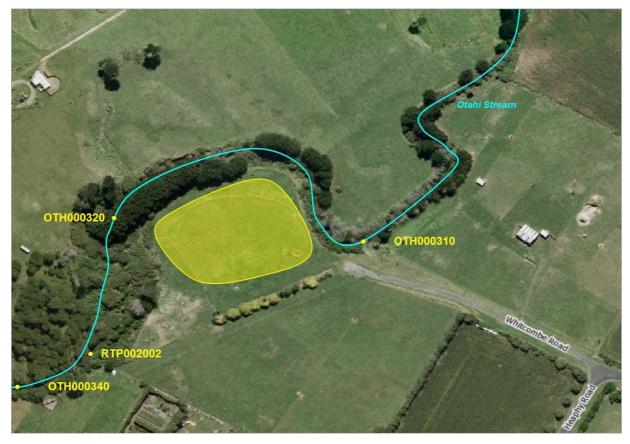
Figure 12 Aerial view of Opunake landfill footprint and sampling sites

Samples were collected from the leachate drain, and the Otahi Stream at sites above, below and adjacent to the landfill on 30 August 2017 (Figure 12). The results are presented in Table 13.
