Taranaki Ventures Limited  
Copper Moki 1 Wellsite  
Monitoring Programme Report

Technical Report 2011–102

September 2013

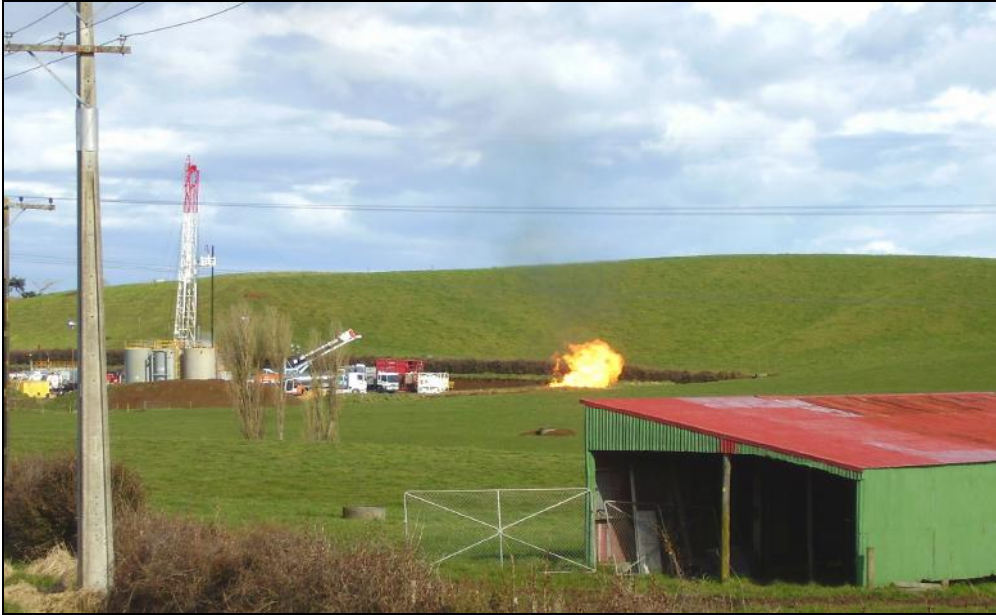
**Photograph 2** Flaring undertaken at the Copper Moki wellsite

Flaring was undertaken at the Copper Moki wellsite during the period under review. Due to the crude oil having a high pour point it was difficult for site operators to completely separate oil from gas. As a result the gas that was directed to the flare pit was "wet" and did not burn cleanly. This caused smoke to discharge from the flare pit. The operators onsite used numerous strategies to reduce the amount of smoke generated by the flaring of gas, including increasing the air/gas ratio and spraying water over the flare to suppress the smoke. The discharge of smoke from the site was monitored closely by Council officers. No effects were noted during the monitored period. One complaint was received regarding continuous flaring being undertaken at the site. The Council's investigation found the flaring complied with resource consent conditions.

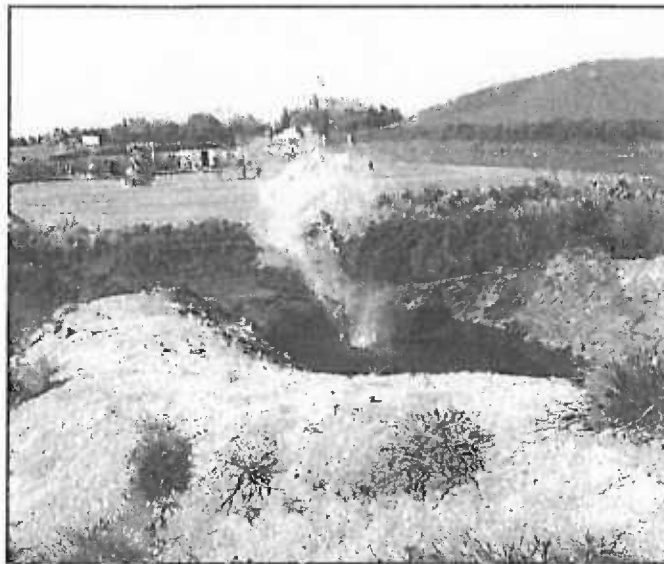
Figure 1: Copper Moki 1 Gas Flare

Figure 1 shows a picture of the gas flare in operation.

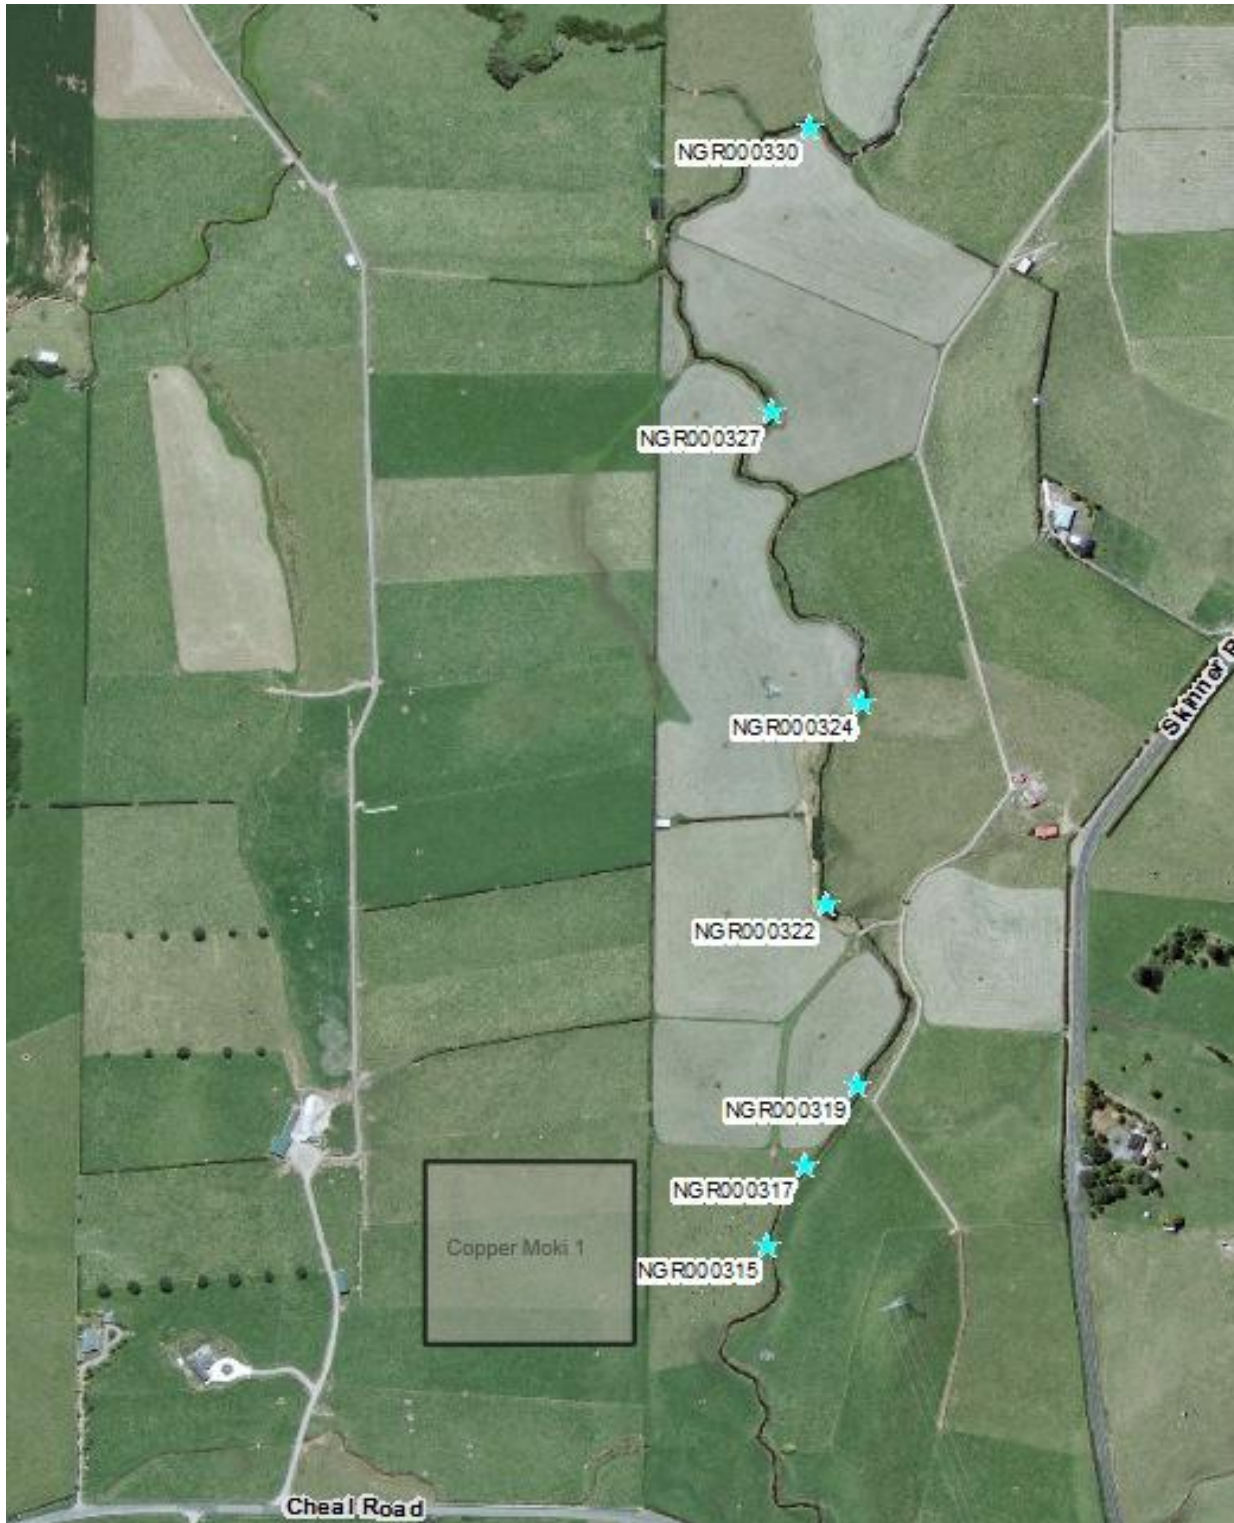
The area sampled in the investigation is shown in Figure 2. The established sample sites are also identified on this map, as is the approximate location of the Copper Moki-1 wellsite. Sampling site details are presented in Table 1. The discharge point is shown as NGR000317 to the east of the wellsite.

**Figure 2** Showing the approximate location of Copper Moki wellsite and the sampling sites in the Unnamed Tributary of the Ngaere Stream, sampled in relation to the unauthorised discharge from the wellsite. Sampling site NGR000317 is identified as the point of discharge.

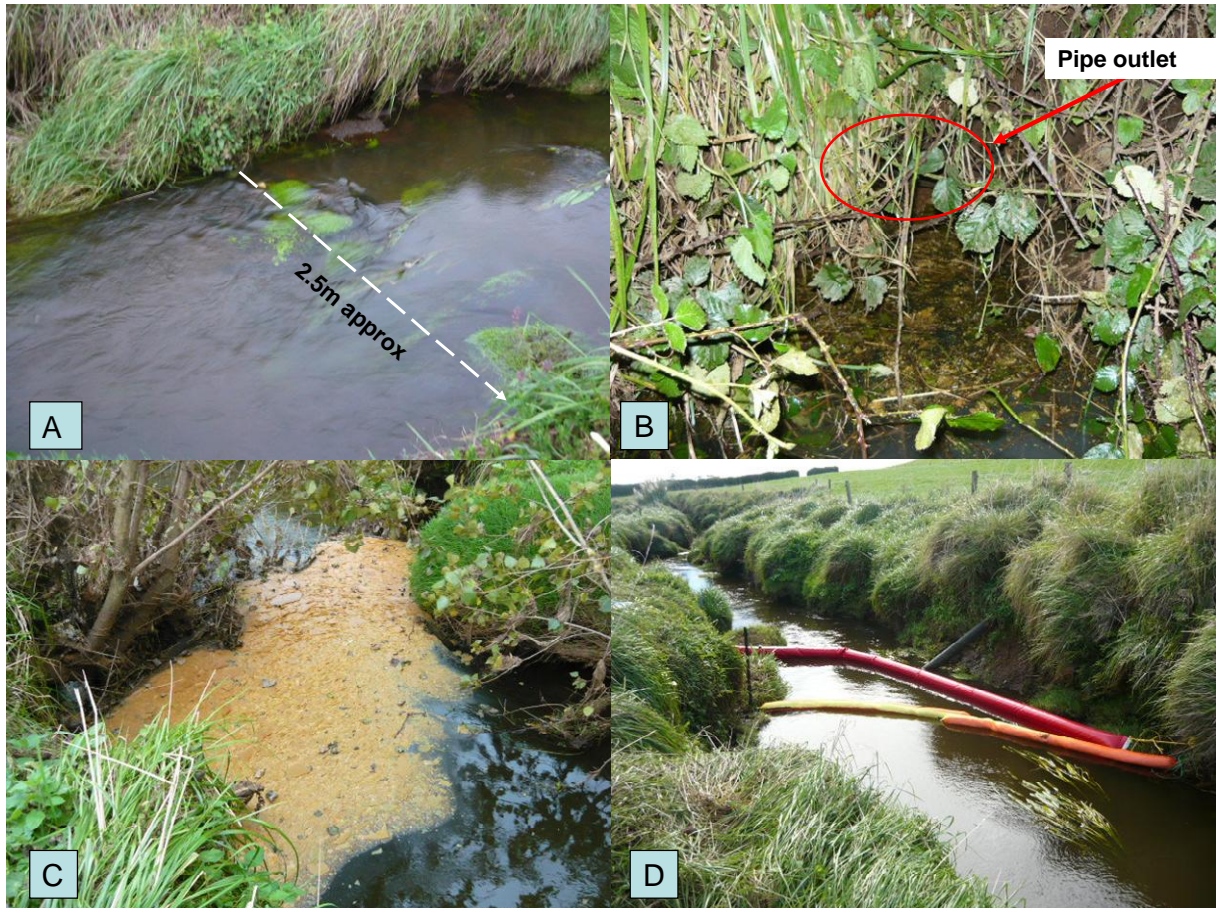
At the time of sampling, the weather was fine, with a Southerly breeze. There had been no rainfall in the previous two days. Sampling began at 17:50 just prior to the onset of darkness. Stream flow was steady. Stream width was between 1.5 and 5m, with an average width of approximately 2.5m over the reaches sampled. Depth was between 0.5 and 0.75m. The water had a brown and turbid appearance at all sites. I observed accumulations of waxy material at sites NGR000317 (Figure 3, B) NGR000319 and NGR000322 (Figure 3, C). I observed that Site NGR000315 upstream of the discharge point showed no evidence of any contamination (Figure 3, A). Further downstream sites NGR000324-330 showed no significant signs of contamination (Figure 3, D). While we were collecting samples, Inspectorate installed booms in the stream. Sites NGR000327 (Impact 4) and NGR000330 (Impact 5) were downstream of the southern boom, and were sampled the following day. Impact site 3 was immediately upstream of the southern boom pictured in Figure 3 (Photo D).

**Figure 3** Visual record of sites NGR000315 (Control site, photo A), NGR000317 (Discharge point to stream, photo B), NGR000322 (Impact 2, photo C) and NGR000324 (Impact 3, photo D). Photos A-C were taken on 17 April on the initial sampling run, photo D was taken the following day. Note the accumulation of solids in the stream in photos B and C, and the absence of solids in photo A of the upstream site. Photo D also shows the use of booms to catch surface contaminants. The end of the discharge pipe is identified in Photo B. It was obscured by vegetation at the time of sampling, but yellow solids can be seen in the water in front of the pipe.

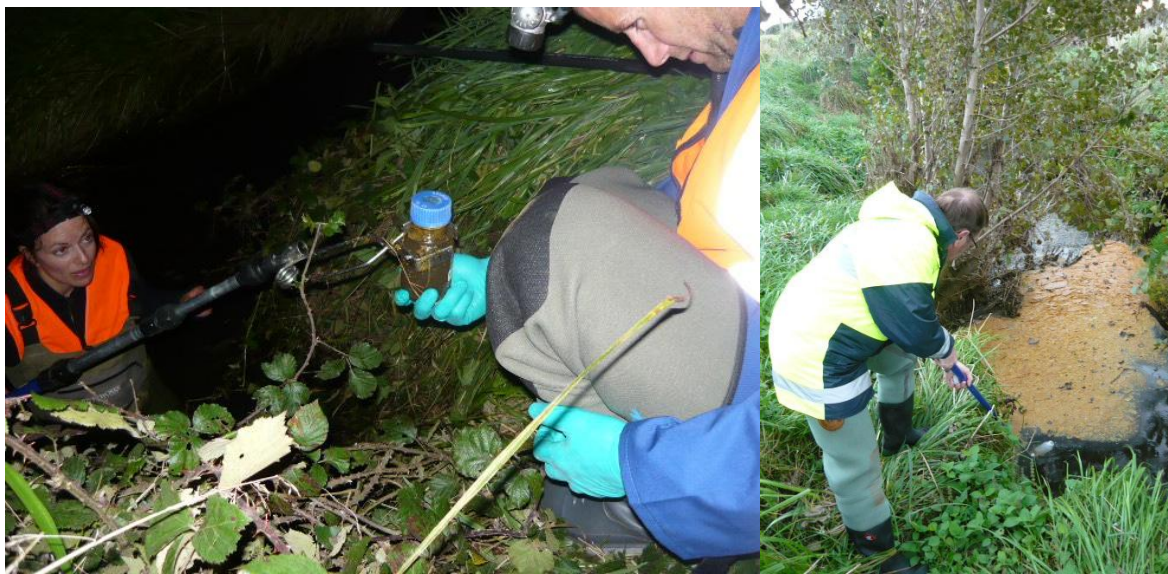
Samples were retrieved from the stream using an extension pole. At each site, a glass hydrocarbon bottle was collected. These samples were taken from the surface, no bottle rinsing was performed, and 1-2 inches of headspace was left for the required lab analyses. Additionally, at each site a plastic 1L bottle was taken to test for common water quality parameters (pH, turbidity and conductivity). These bottles were rinsed and samples were again taken from the surface and filled to capacity (Figure 4).

**Figure 4** KS and RH retrieving samples from the discharge site NGR000317 (left) and the accumulation at NGR000322 (Impact 2) (Right)

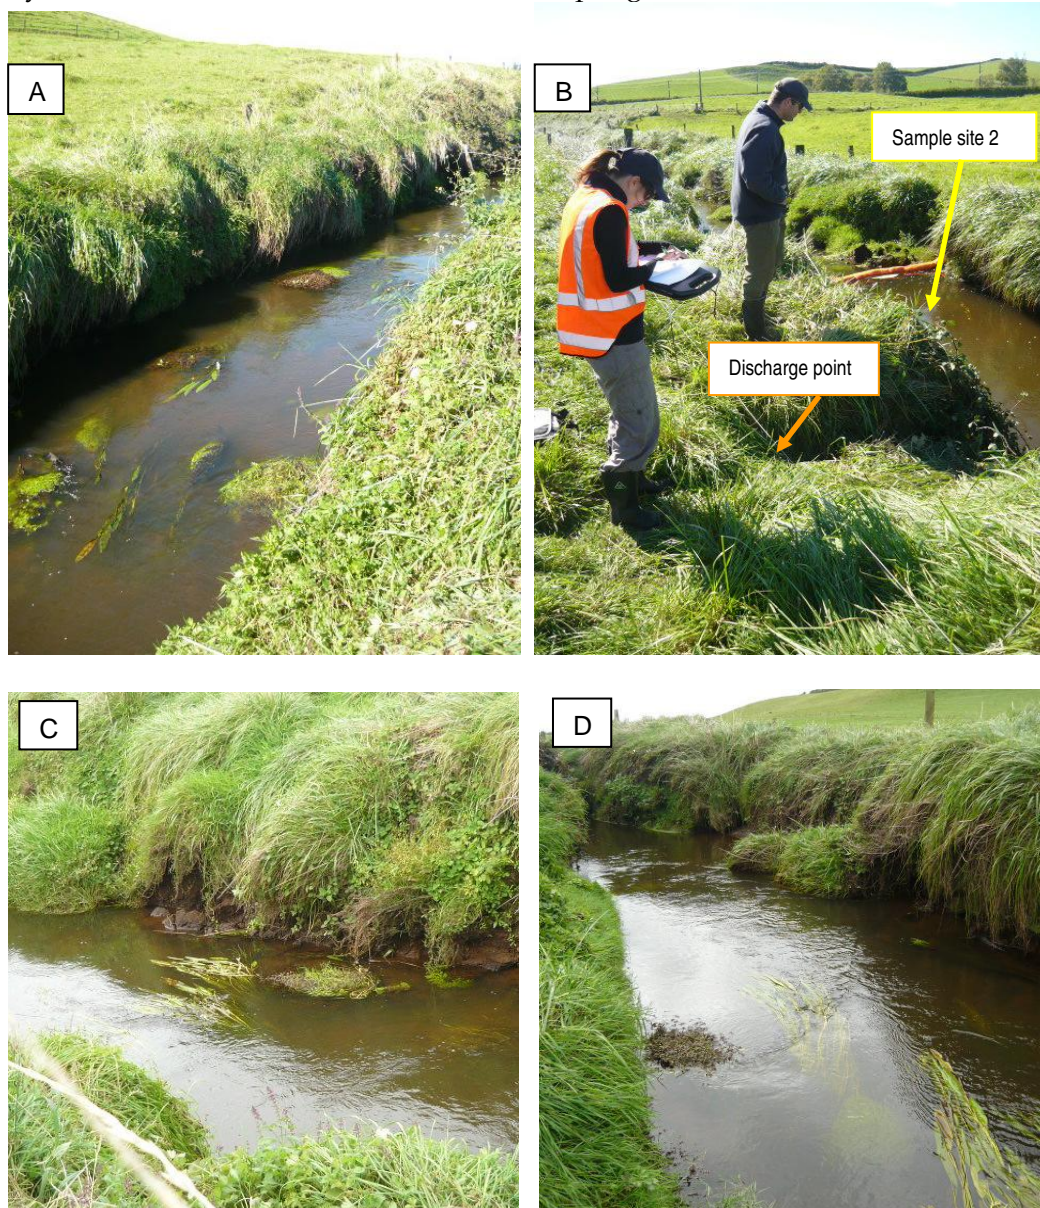
I observed waxy hydrocarbon material entering the tributary from the alleged discharge pipe which was immediately upstream of site 2. The waxy hydrocarbon material was observed floating on the surface of the water in and around the discharge point. Some of this material coated overhanging vegetation at site 2. Floating waxy hydrocarbon material was also noted at

site 3 and site 4. Site 4 was located approximately 3 metres down stream of a major accumulation of product which had become naturally impounded by a log jam. A strong hydrocarbon odour was detected whilst sampling sites 2 and 4.

**Figure 2** A -site 1, 70 metres u/s of discharge; B -site 2, immediately d/s; C-site 3, 180 metres d/s of discharge; D -site 4, 270 metres d/s of the discharge.
