Todd Energy Limited
Mangahewa-C Wellsite
Monitoring Programme Report
2012-2014

Technical Report 2014-12

October 2014

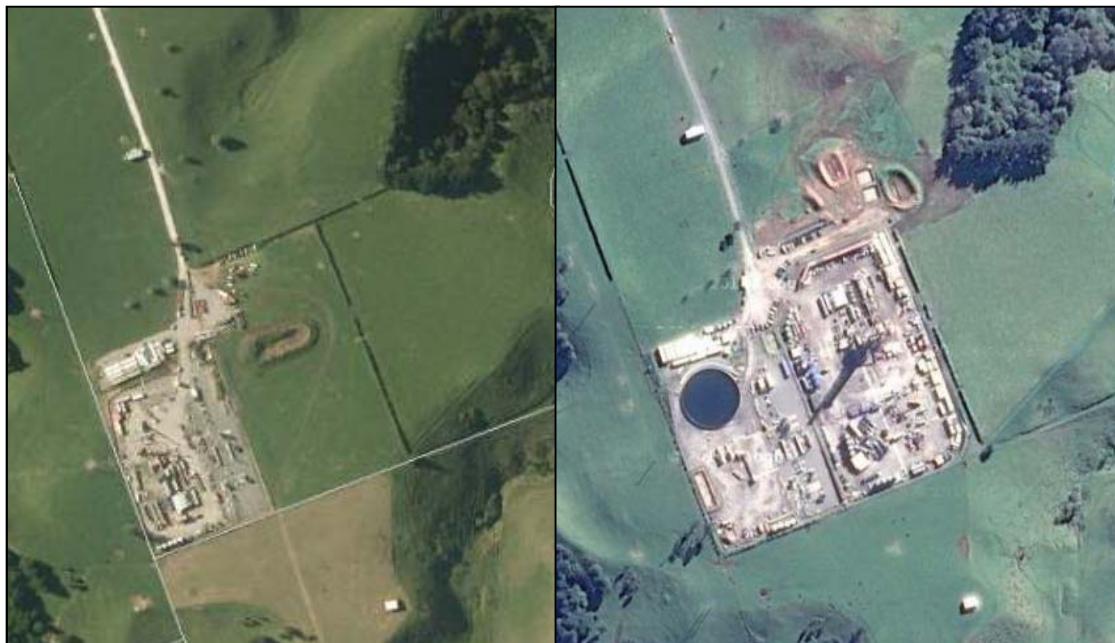
Figure 2 Aerial view of the original Mangahewa-C wellsite (left) and aerial view of the Mangahewa-C wellsite post boundary extension and facility upgrade as it operates at present (right)

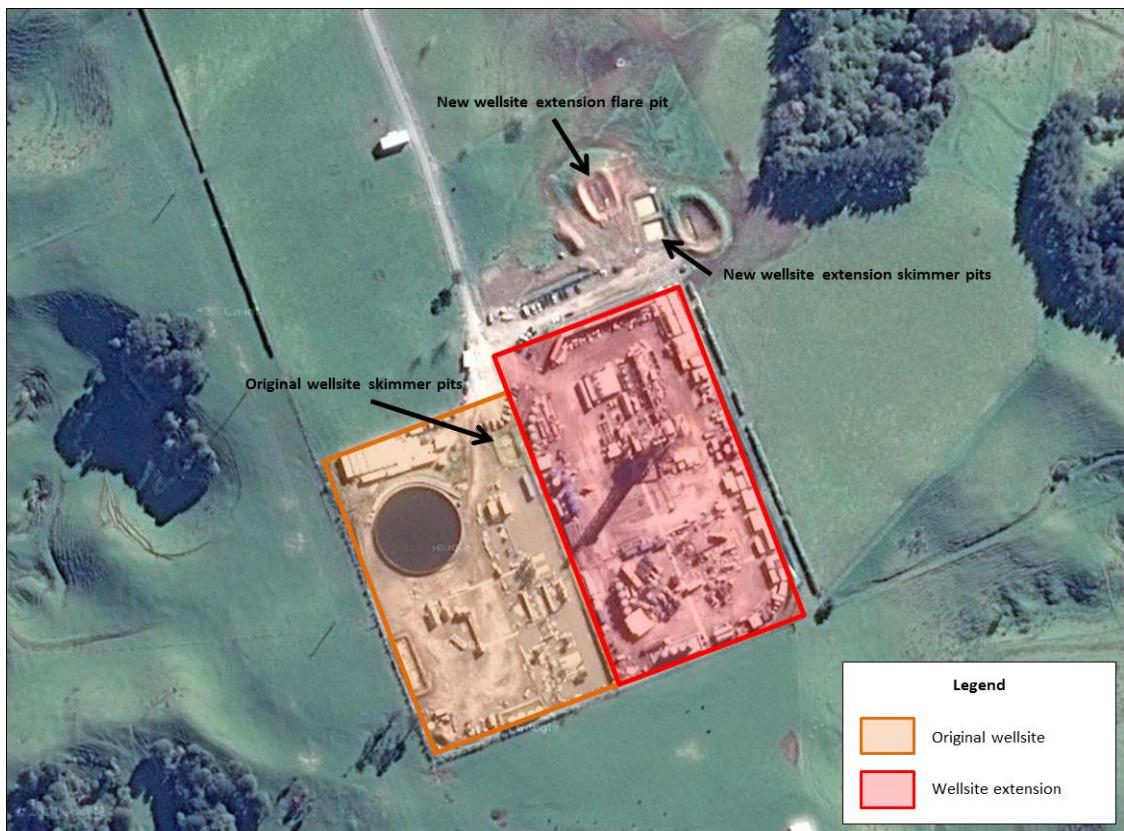
Figure 3 Aerial view of the Mangahewa-C wellsite highlighting the extent of the original and new sections of the wellsite in addition to the localities of the original and new skimmer and flare pits.

The site appeared clean and tidy with ring drains in good operational condition. Drilling had since been completed and the rig was in the initial stages of being relocated. Skimmer pits were inspected and found not to be discharging at the time of inspection. Samples were obtained from the second pit of both the original and the newly constructed skimmer pits (refer to Figure 3).

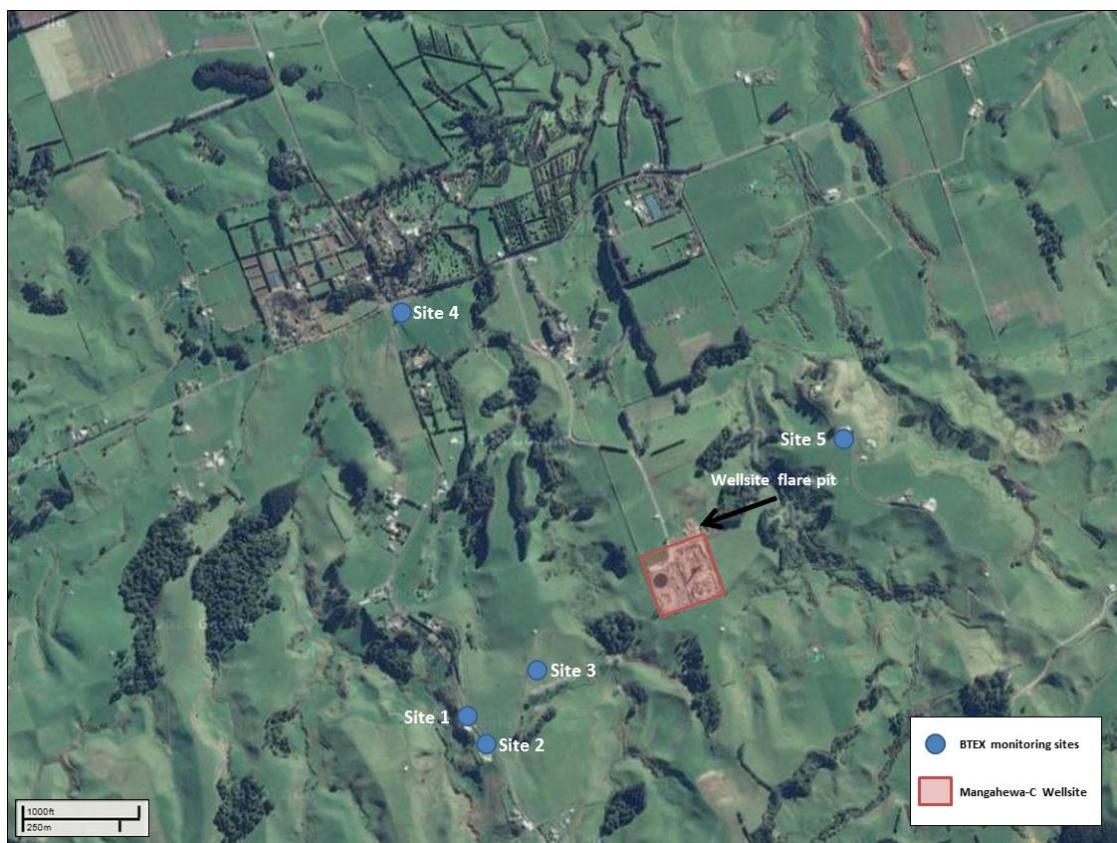
Figure 4 BTEX monitoring survey sites in relation to the Mangahewa-C wellsite and flare pit

However, due to concerns raised by members of the public regarding potential adverse effects from the black smoke emissions originating from the wellsite, Todd Energy Limited enlisted the Council's air quality officer to conduct an ambient Benzene, Toluene, Ethylbenzene and Xylene (BTEX) monitoring survey around the Mangahewa-C wellsite. Five sites were selected, as per Figure 4, for the survey with BTEX monitors deployed at each site from 24 September 2013 to 4 October 2013. Results are detailed in Table 3.

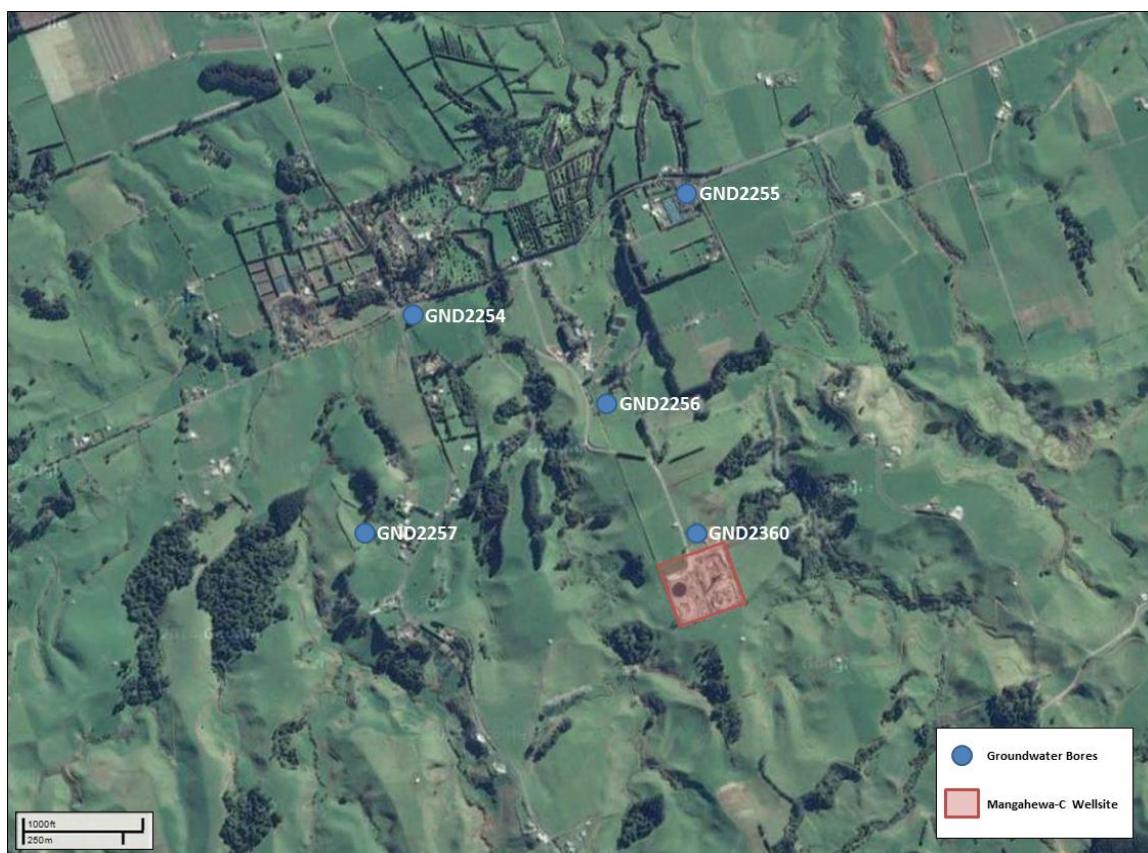
**Figure 5** Aerial photo depicting the locality of the Mangahewa-C wellsite and associated groundwater monitoring bores

Site No.	Easting (m)	Northing (m)
GND2254	1712606	5677572
GND2255	1713472	5677892
GND2256	1713212	5677276
GND2257	1712473	5676917
GND2360	1699694	5664377

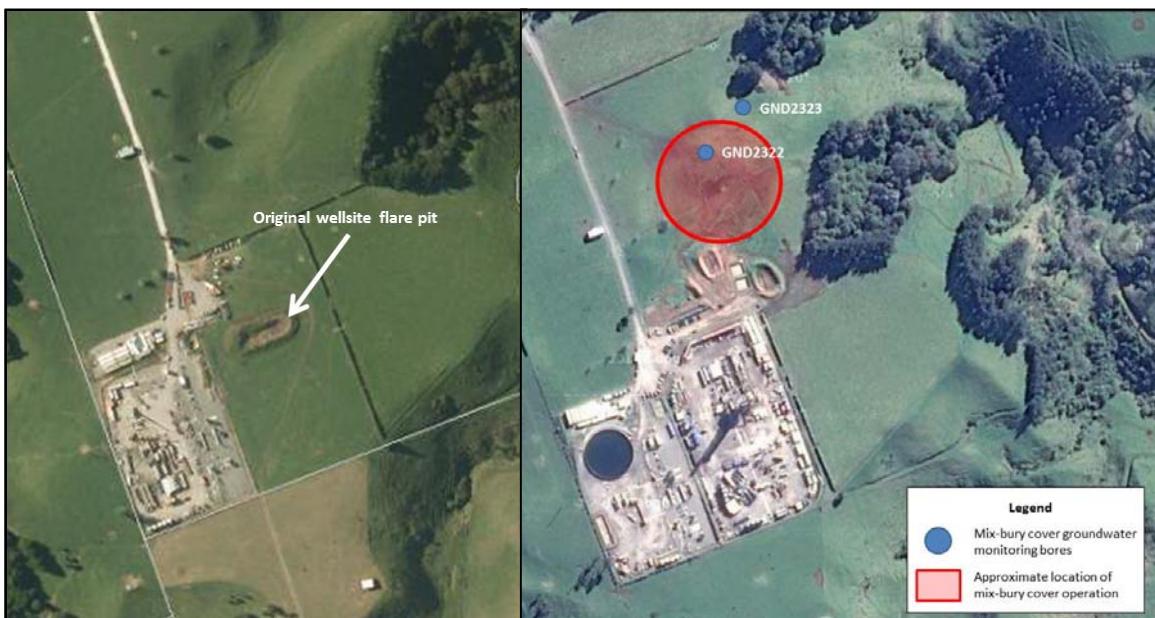
Figure 6 Aerial views of the Mangahewa-C wellsite featuring the original section of the wellsite and location of the remediated flare pit (left), and the Mangahewa-C wellsite at present identifying the approximate location of the mix-bury cover operation

This consent was exercised once during the period under review prior to the commencement of construction activities for the new section of the Mangahewa-C wellsite, where mix-bury-cover operations were utilized to dispose of lightly contaminated soil from the redundant flare pit from the original section of the wellsite (refer to Figure 6).
