BTW Company Limited
Brown Road-Wellington Landfarm
Monitoring Programme
Biennial Report
July 2011 – June 2013
Technical Report 2013–62

July 2014

Executive summary

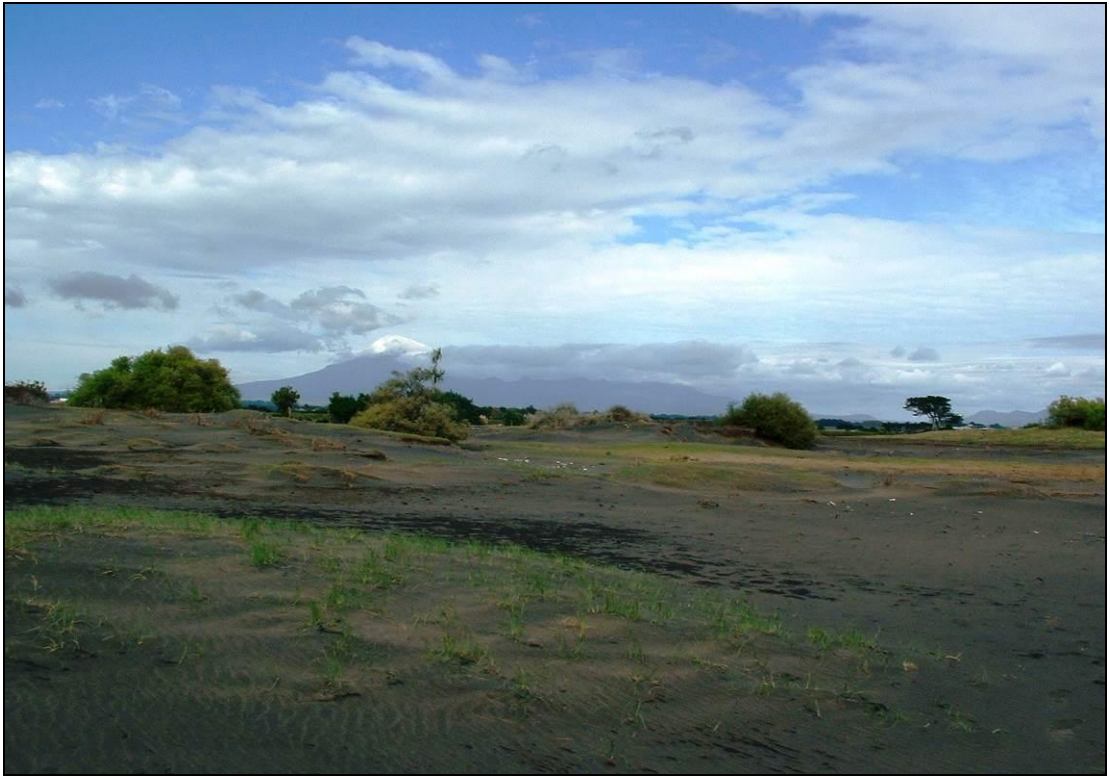
Photo 1 Property prior to landfarming, showing significant areas of exposed sand

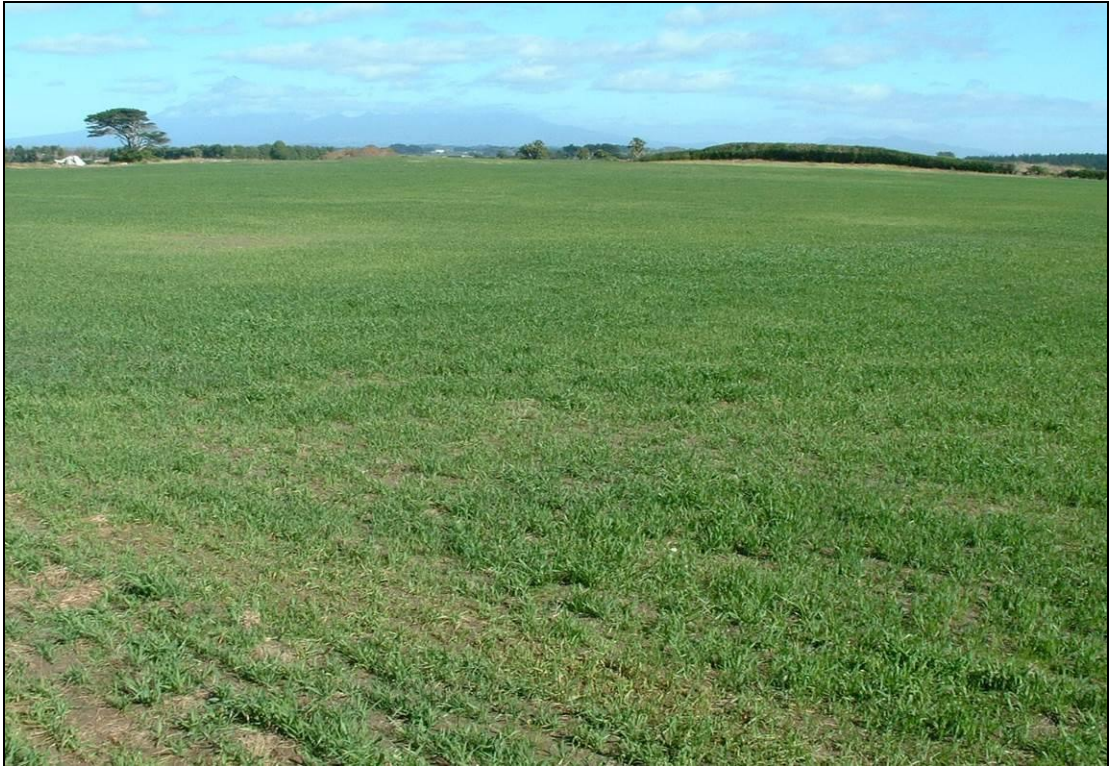
Photo 2 Spreading areas B10 and B4 post-spreading and sowing showing pasture establishment

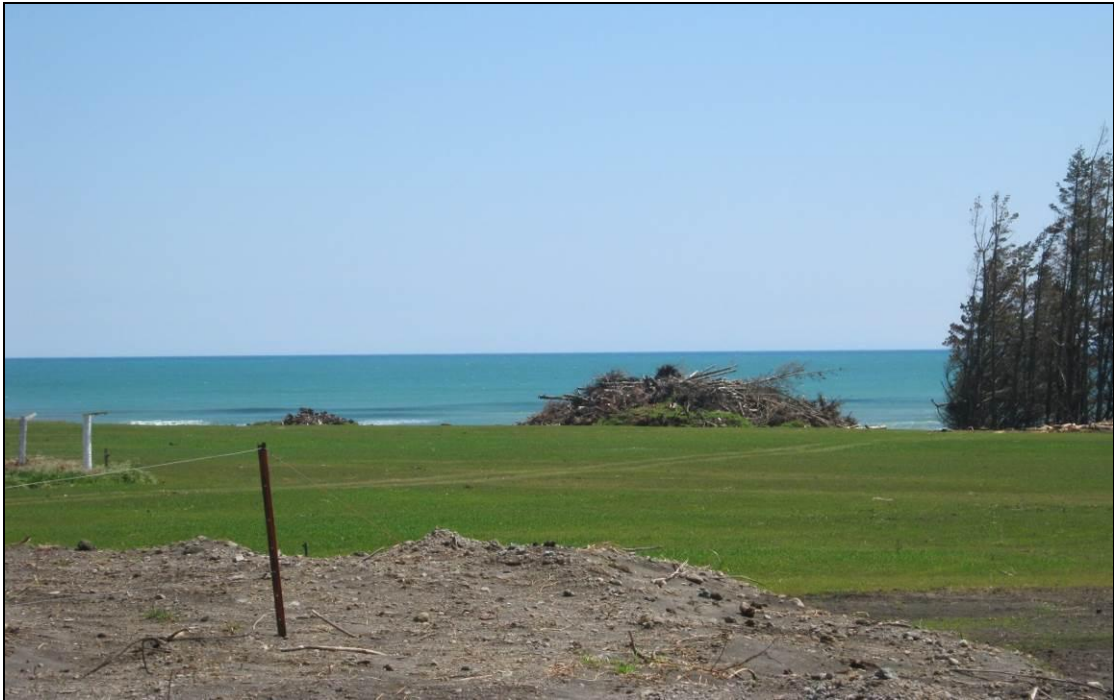
Photo 3 View seaward from storage area across spreading areas F7 and F5 showing pasture establishment

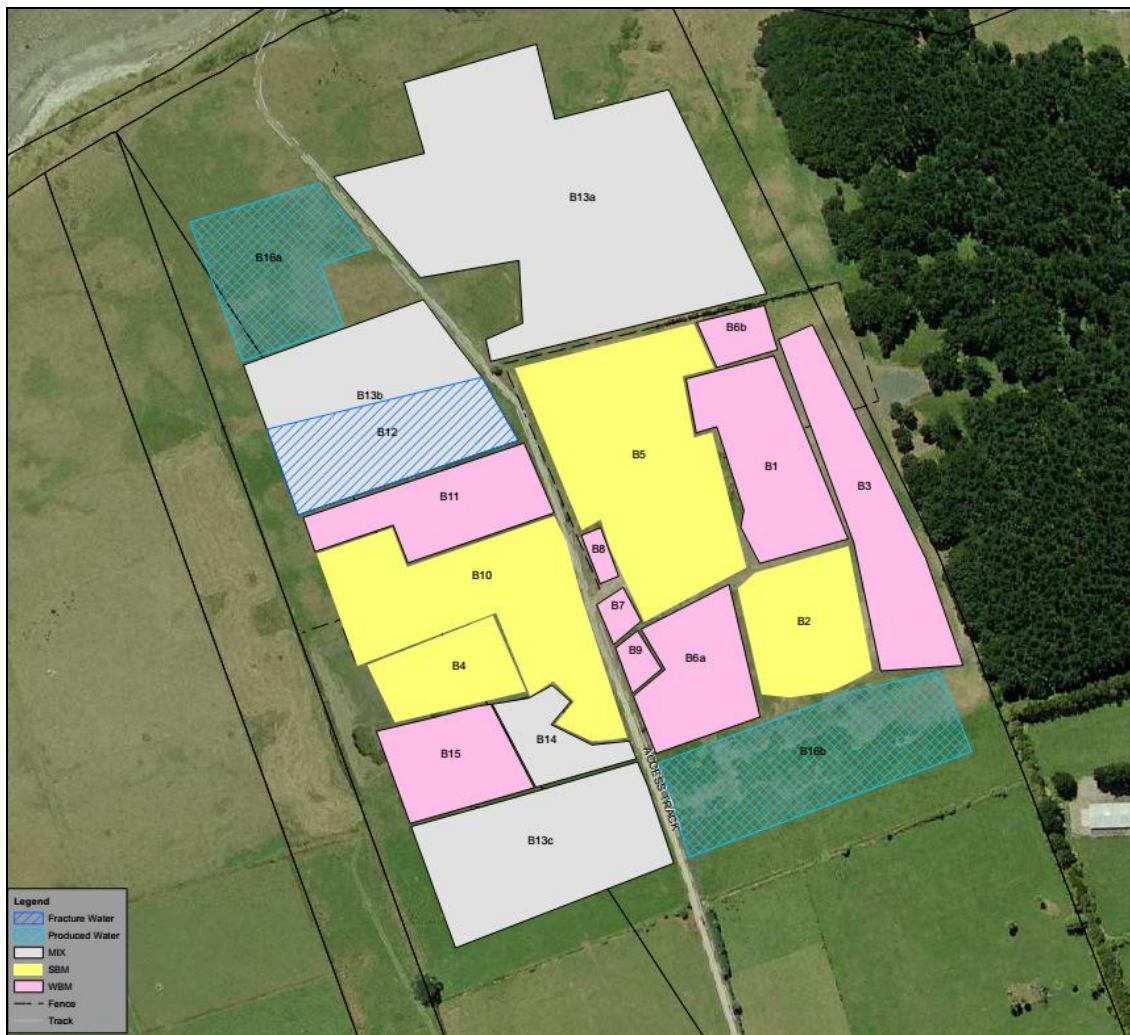
Figure 2 Usage of landfarm spreading areas B1-B16 (consent 6867-1)

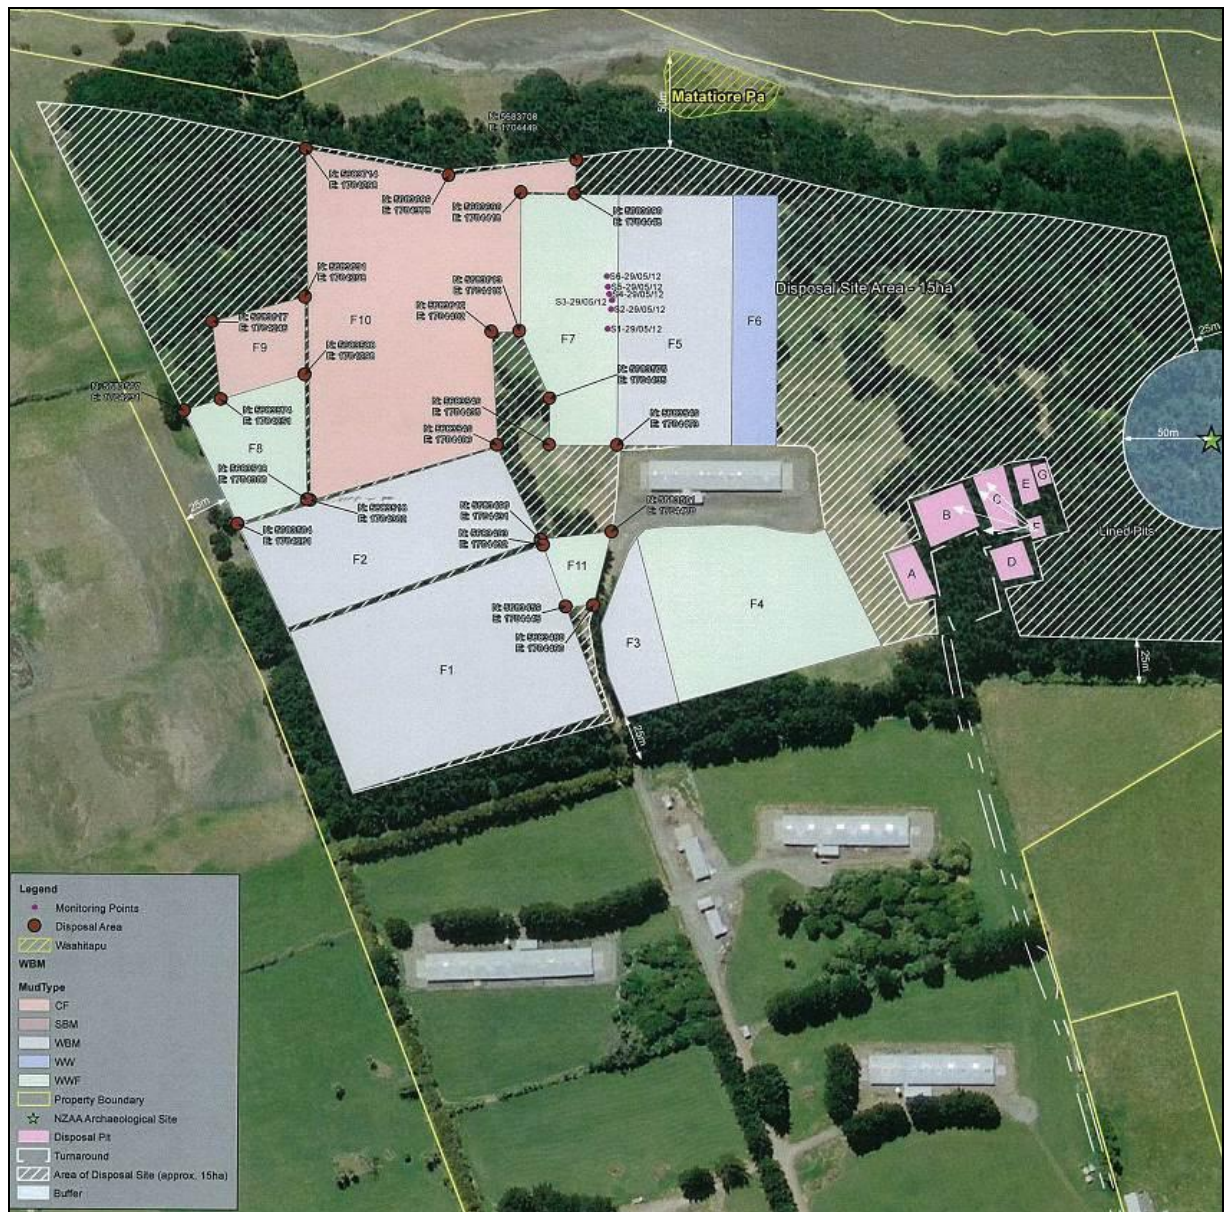
Figure 4 Active areas of landfarm as of June 2012 showing the location of pits and areas spread under consents 7670-1 (F1, F2), and 7884-1 (F3-11)

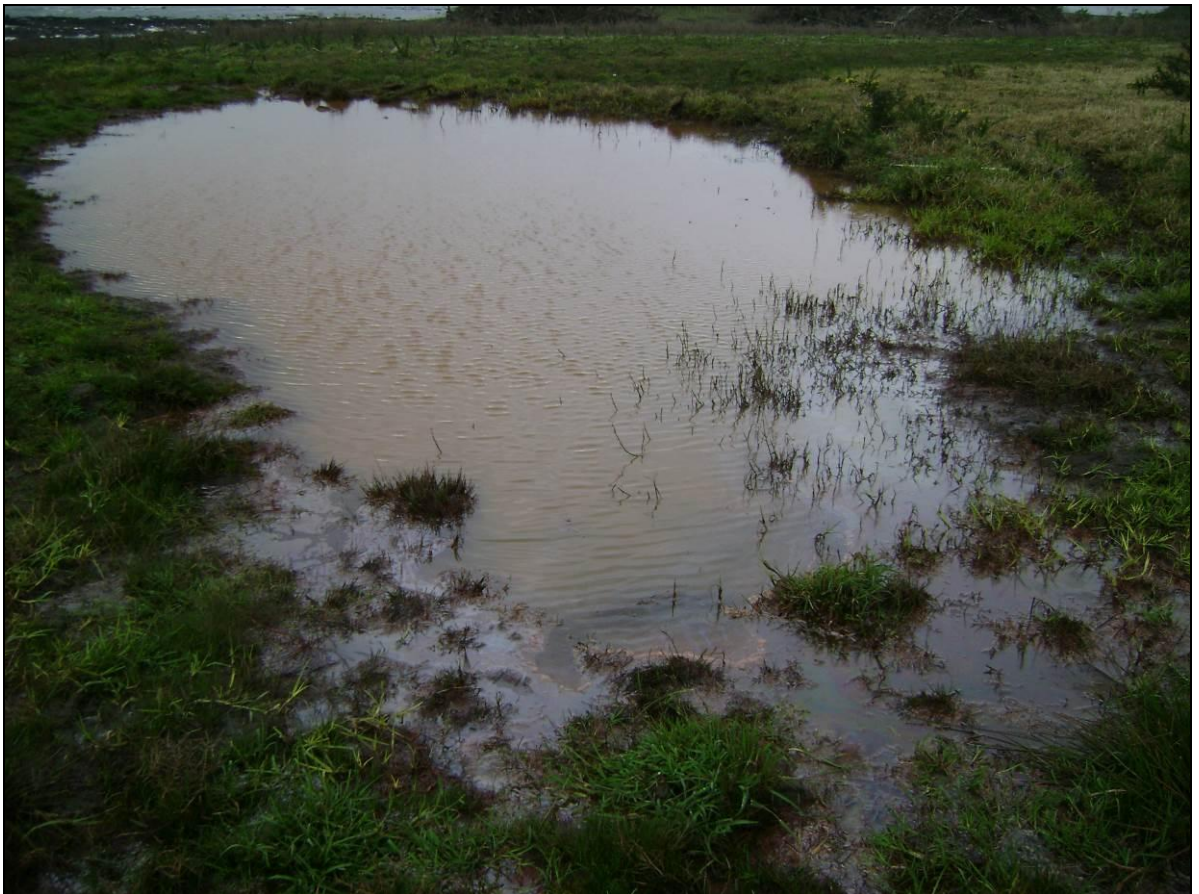
The results for the ponded surface water body from the 6 June 2012 sample show a significant increase in salinity, elevated nitrogen and the presence of benzene equal to the drinking water standard. (It should be noted that the pond has no discharge and is not used as a source for abstraction). The elevated salinity could potentially be a natural fluctuation given the proximity to the Tasman Sea, but the presence of benzene suggests the storage or spreading activities may also be having a detectable effect on this body of water. The Council determined that this required further attention. Additional sampling of this body of water was undertaken in the 2012-2013 monitoring year (see Section 3.4.4 below). The appearance of this ponded water raised concerns initially because of the presence of a sheen over part of the surface. On closer inspection this sheen was identified as being a naturally occurring iron oxide sheen, rather than hydrocarbon. No hydrocarbon odour was detected coming off this body of water.

Photo 3 Ponding water at landfarm showing iron oxide sheen

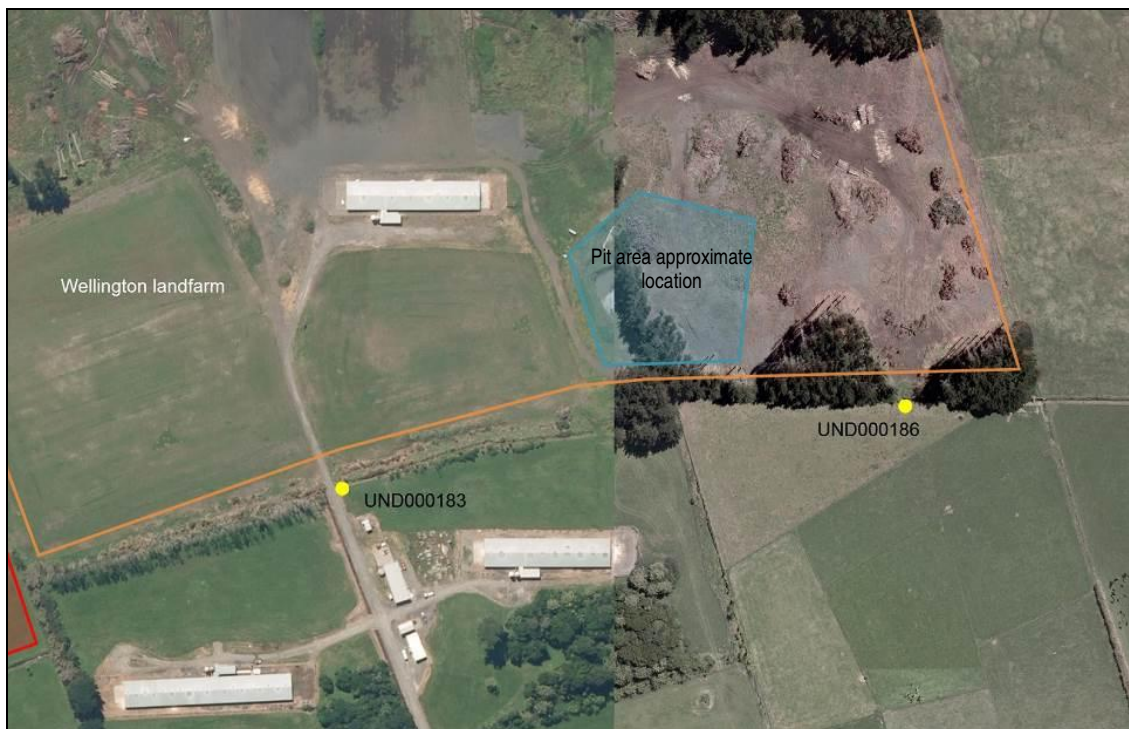
During the 2011-2012 monitoring period, samples were collected on two occasions from the farm drain upstream (UND000183) and downstream (UND000186) (Figure 5) to the south of the storage pits. The results are presented in Table 10 below.

Figure 5 Surface water sampling sites in relation to storage cells, consent 7884-1 site

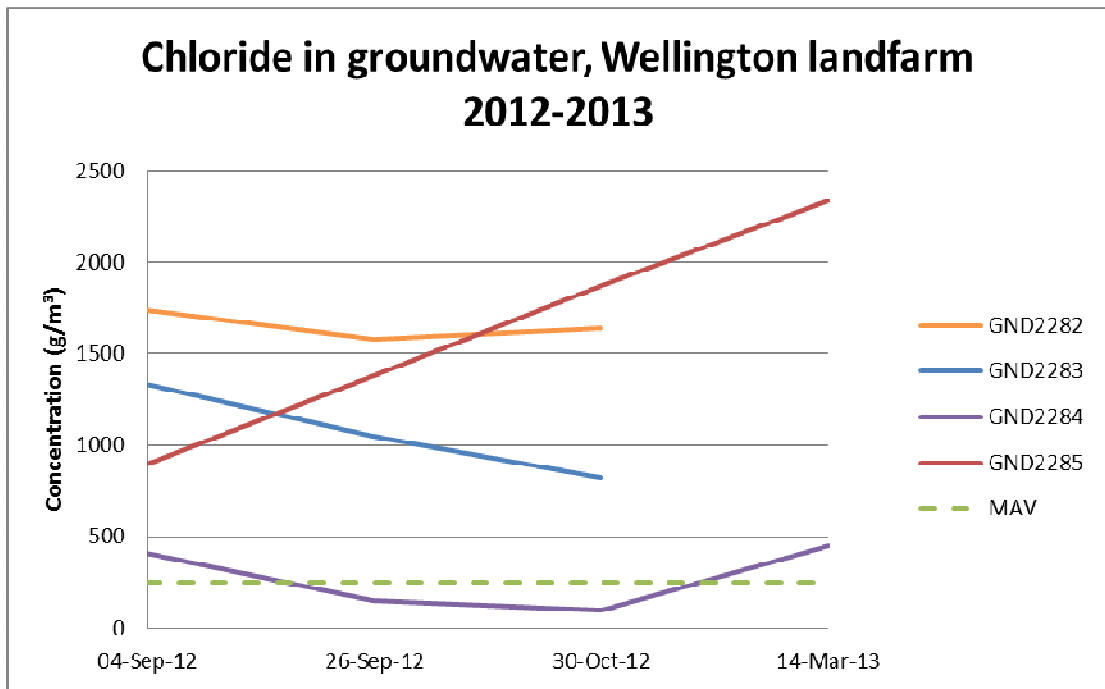
Figure 7 shows chloride concentrations in all bores over the monitoring year. Chloride is highly mobile and therefore works as an indicator contaminant, meaning elevations in chloride in ground or surface water can be used to track the movement of other contaminants potentially present.

Figure 7 Chloride concentrations in GW monitoring wells 2282-2285, 2012-2013 monitoring year

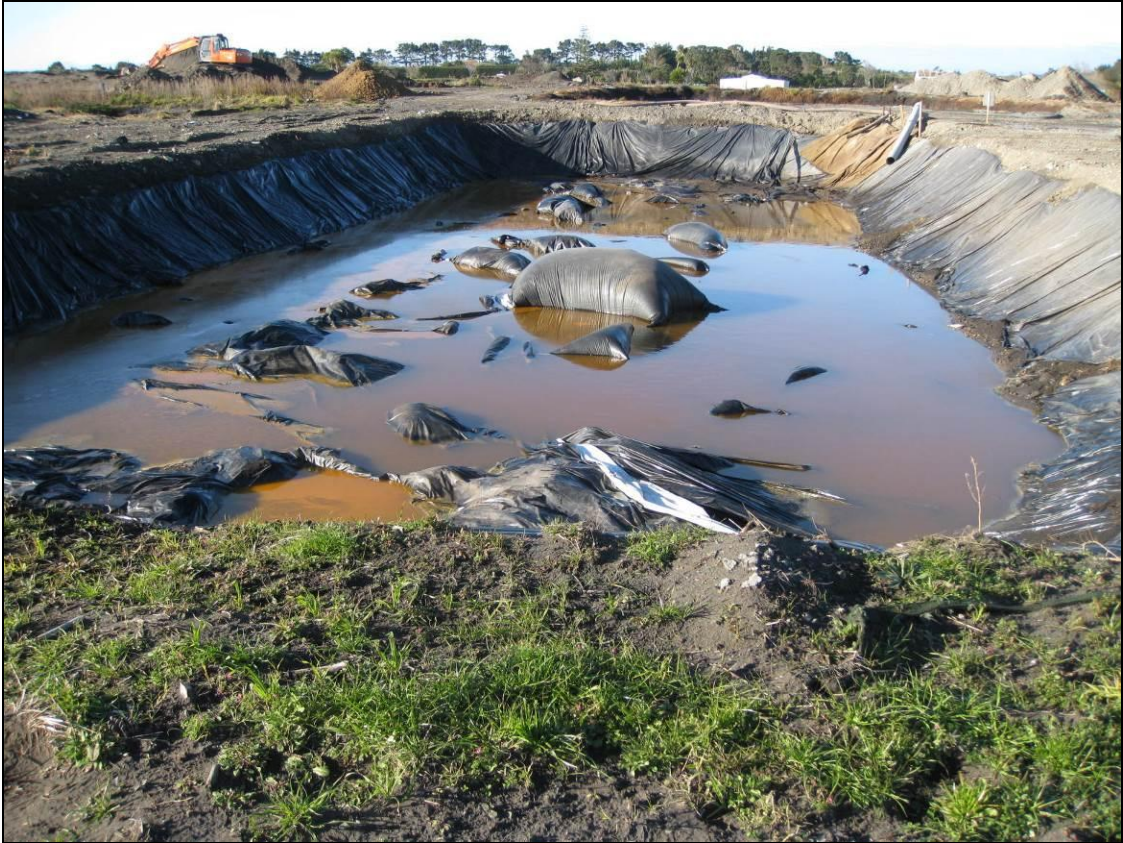
Photo 4 Return fluids pit showing initial sub-standard liner

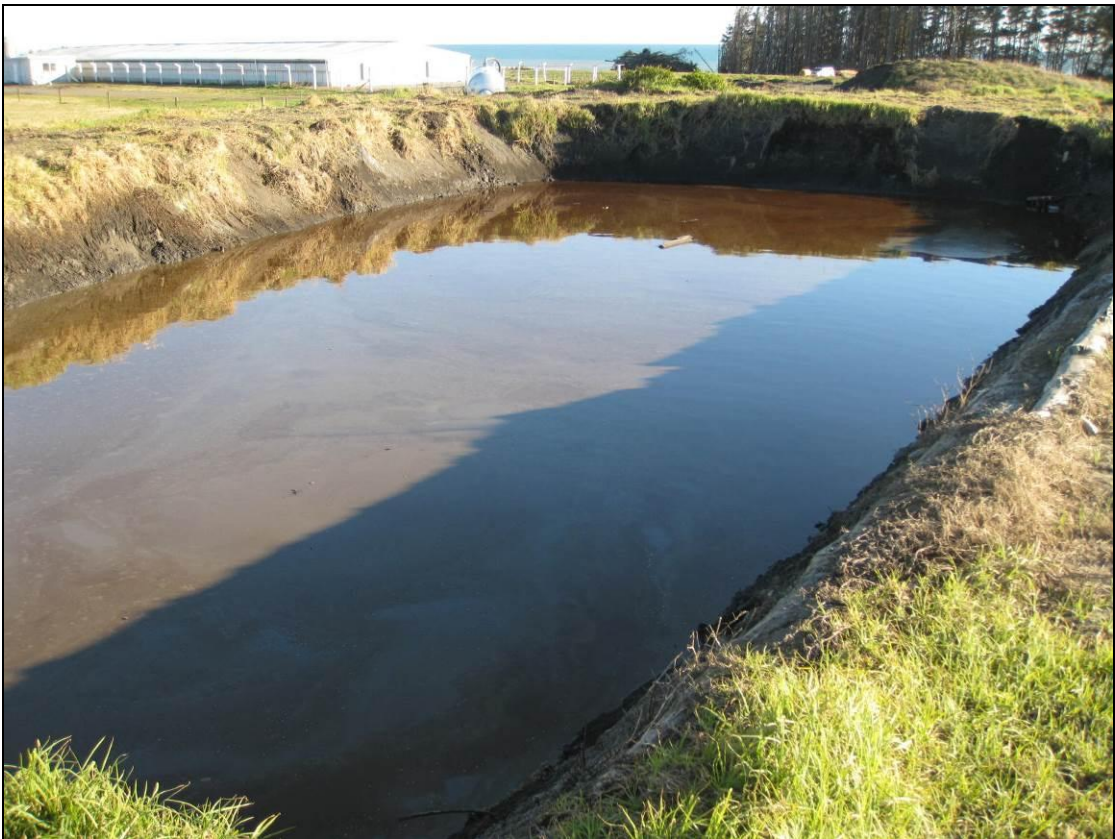
Furthermore, at the time of pit reinstatement and associated investigative sampling of the oily waste pit (pit F), material had been farmed from pit A, revealing the pit base to be roughly as deep as the groundwater table measured in bore GND2282. This suggested the possibility of direct throughflow through the pit base rather than infiltration and attenuation down from the unsaturated zone into the water table.

Photo 5 Pit A (initially unlined) containing produced water

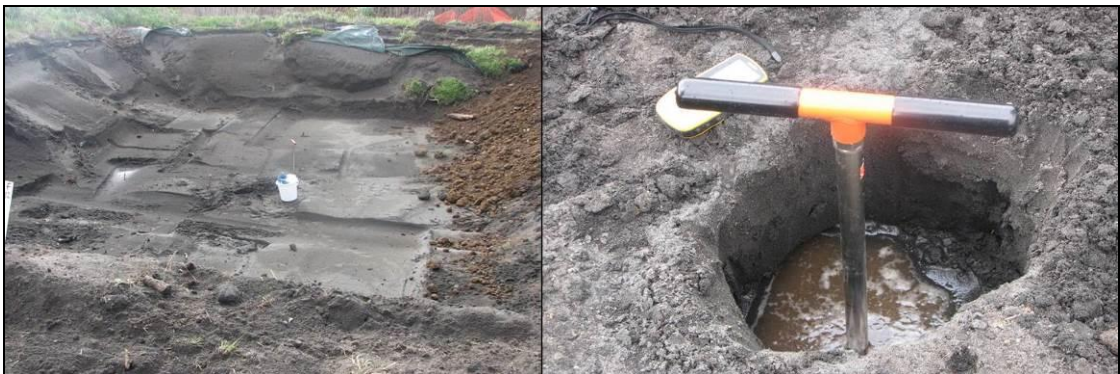
The three test pit sample results from the oily waste pit base showed very slightly elevated BTEX, but well within guideline values for sandy soils. The other parameters assessed for were all consent-compliant for these samples.

Figure 10 Investigative sampling of previous oily waste pit following partial reinstatement showing empty pit with test pits (left) and close up of test pit showing groundwater intrusion (right)

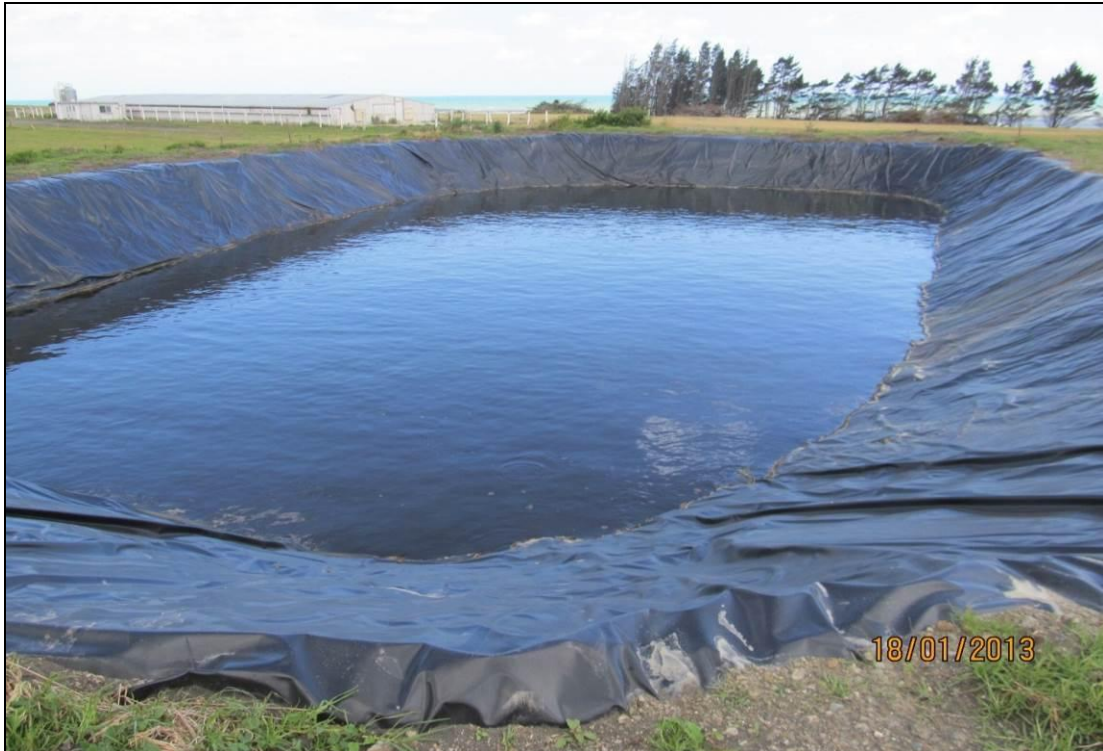
Photo 6 Pit A featuring new high grade HDPE liner

The stockpiling facilities were suspected to be the source of the change in groundwater quality, as liquid waste material was being held in concentrated form in storage pits with substandard lining. At the time of the initial non-compliance, effects were restricted to within the site boundaries, and levels of contaminants were shown to be reducing. On-going investigative monitoring continued to be conducted to determine whether environmental impacts from the site activities were reducing with the discontinuation of the use of the initial stockpiling facilities. This was shown to be the case.

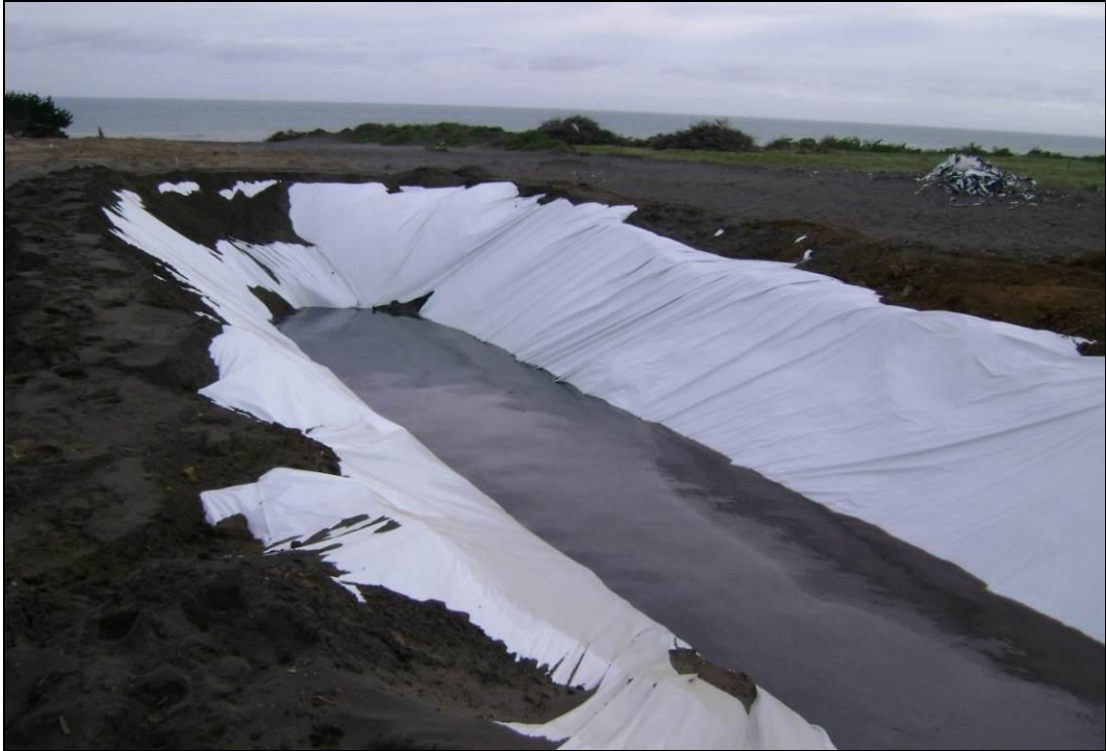
Photo 7 Produced water in makeshift pit

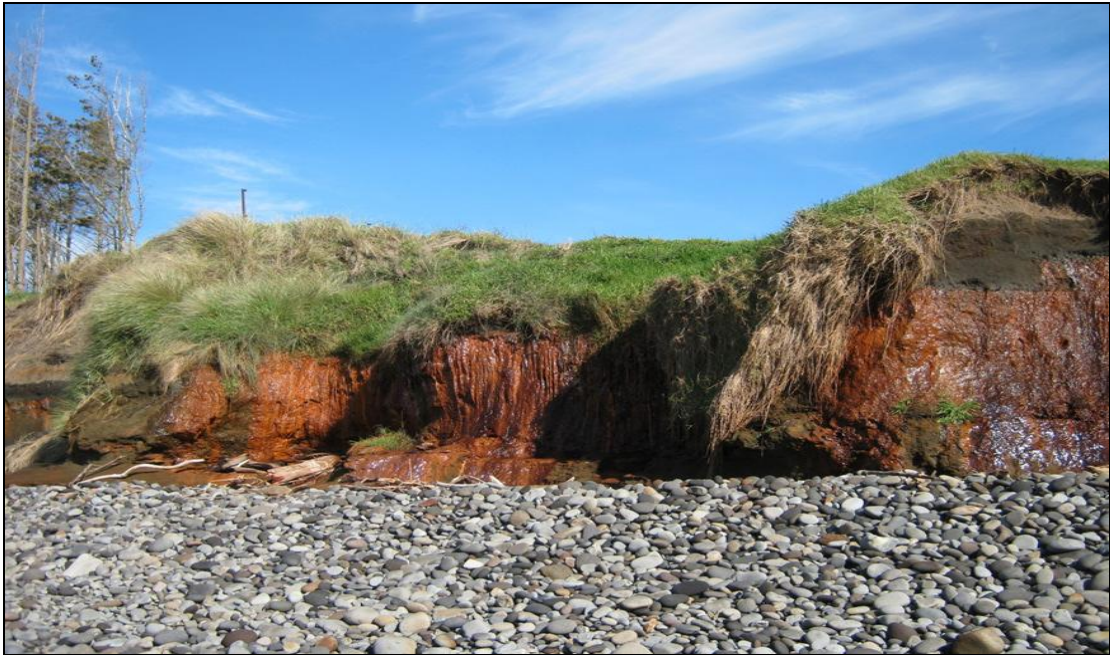
On 4 June 2013 the Company contacted the Council about photographs circulating on social media websites of a groundwater seep running from the site boundary onto the adjacent beachfront. The photographs showed orange staining of the escarpment, and an apparent sheen on the surface of the water flowing down the bank adjacent to the beach. Council staff had previously inspected this seep and found it to be the result of naturally occurring iron oxide bacteria (due to the lack of odour and the nature of the sheen). There are several groundwater seeps where groundwater flow converges by subsurface channelling into preferential flow paths. This is common for this area of coastline, with examples being found at regular intervals along the cliff/escarpment faces. An example is shown in Photo 8.

Photo 8 Groundwater seeps, north-eastern boundary of landfarm showing natural iron oxide staining and rainbow sheen

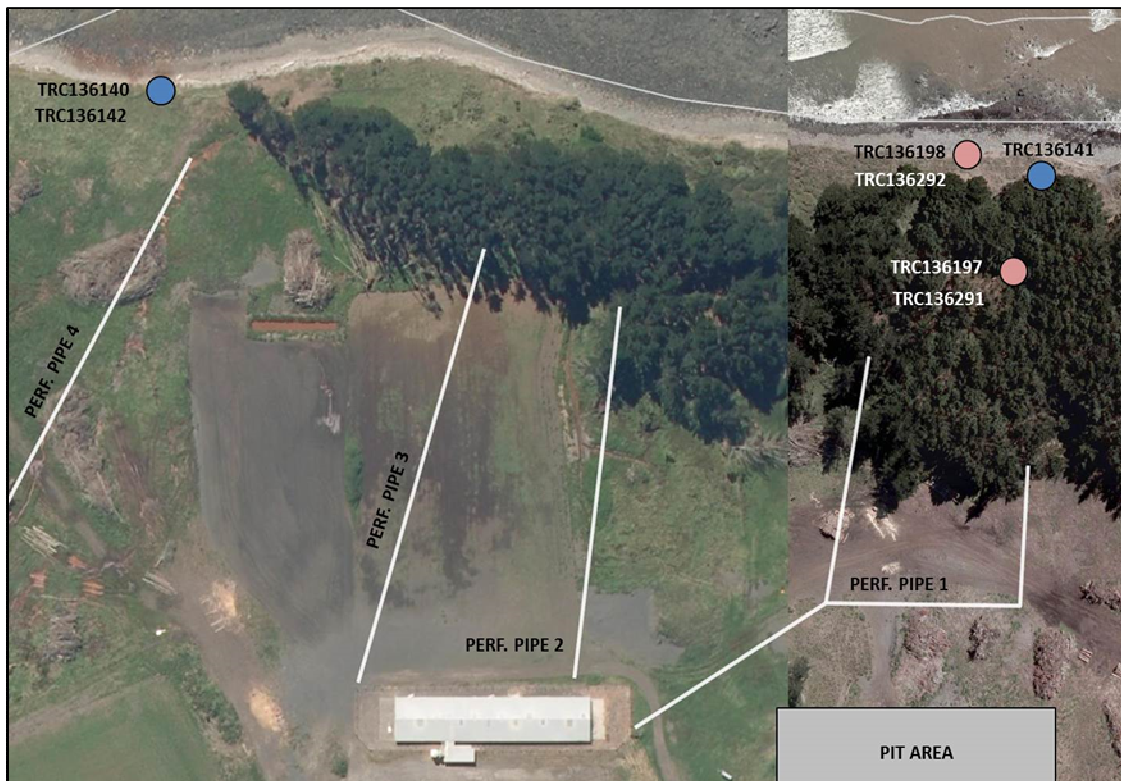
Separately, on 11 June 2013 at 10:00 am during a routine compliance monitoring inspection it was found that the site was not operating within resource consent conditions. A perimeter inspection revealed the end of a plastic perforated drainpipe which had been uncovered, originating from the area where drilling wastes had been spread (Photo 7). The discharge flowed overland and down the bank adjacent to the beach. Samples of the discharge from the pipe (TRC136291) and the discharge onto the beach (TRC136292) were taken and sent away for analysis. These sampling points are identified in pink in Figure 11. The results are presented in Table 20. Results of interest are highlighted in Tables 19 and 20.

Figure 11 Schematic depicting locations of investigative sampling sites in relation to perforated pipes at landfarming facilities (Consent 7884-1)

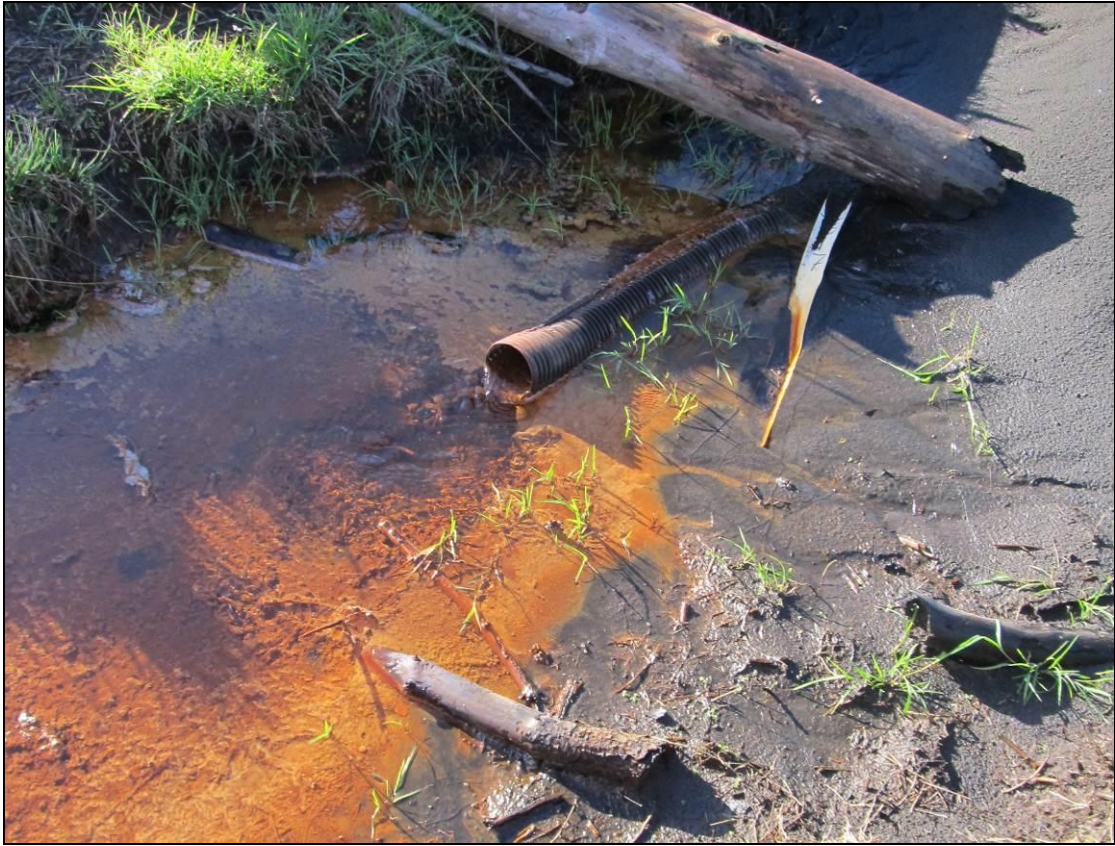
The results of the samples found that at the discharge point of the pipe (which was inside the landfarm boundary) there was benzene present at approximately four times the lifetime drinking water standard (0.039 g/m^3), but the discharge down the bank adjacent to the beach was significantly lower, at half the lifetime drinking water standard (0.0059 g/m^3).

Photo 9 Discharging perforated pipe showing iron oxide staining of substrate (Wellington property)

An abatement notice was issued requiring the discharge to be stopped. Another abatement notice was issued requiring the pipe to be removed to prevent any further 'fast tracking' of contaminants through the site to the coastal boundary. Discussions held with the Company revealed that the perforated pipe was one of four installed by the Company to drain excess soil moisture from the site to prevent excessive ponding following the removal of the original vegetation cover (pipe locations given in Figure 12, below).

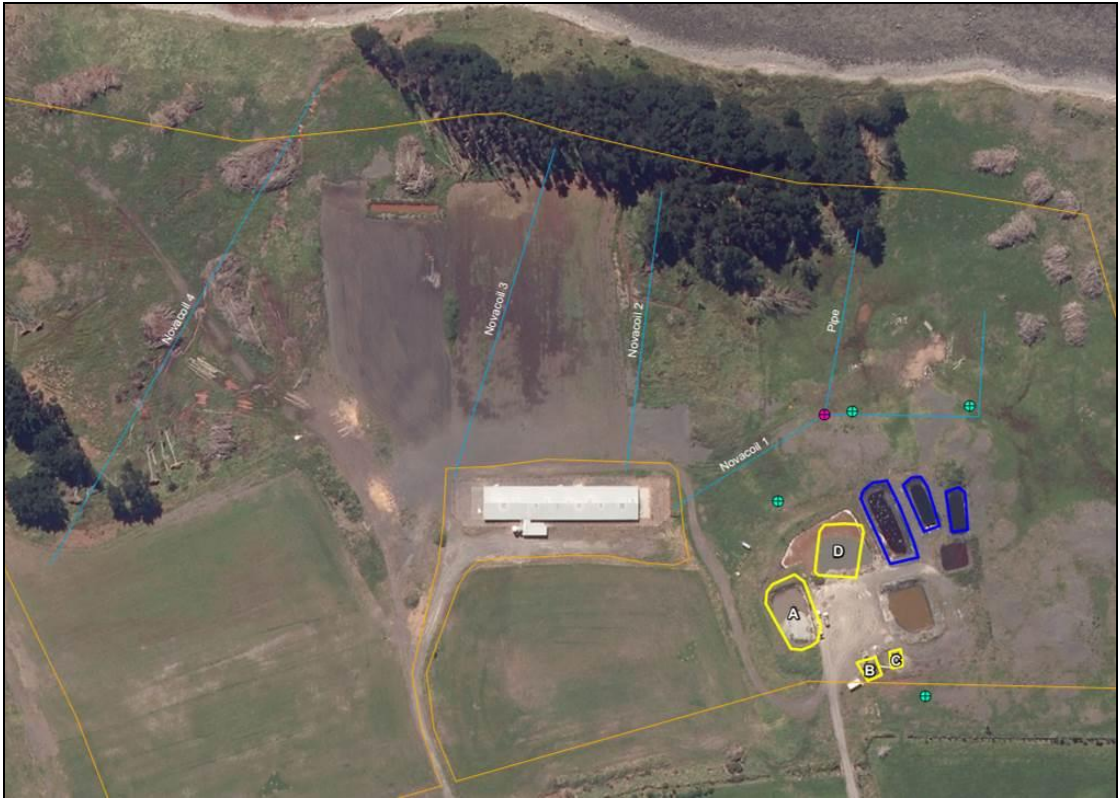
Figure 12 BTW supplied map showing perforated pipe locations in respect of storage pits

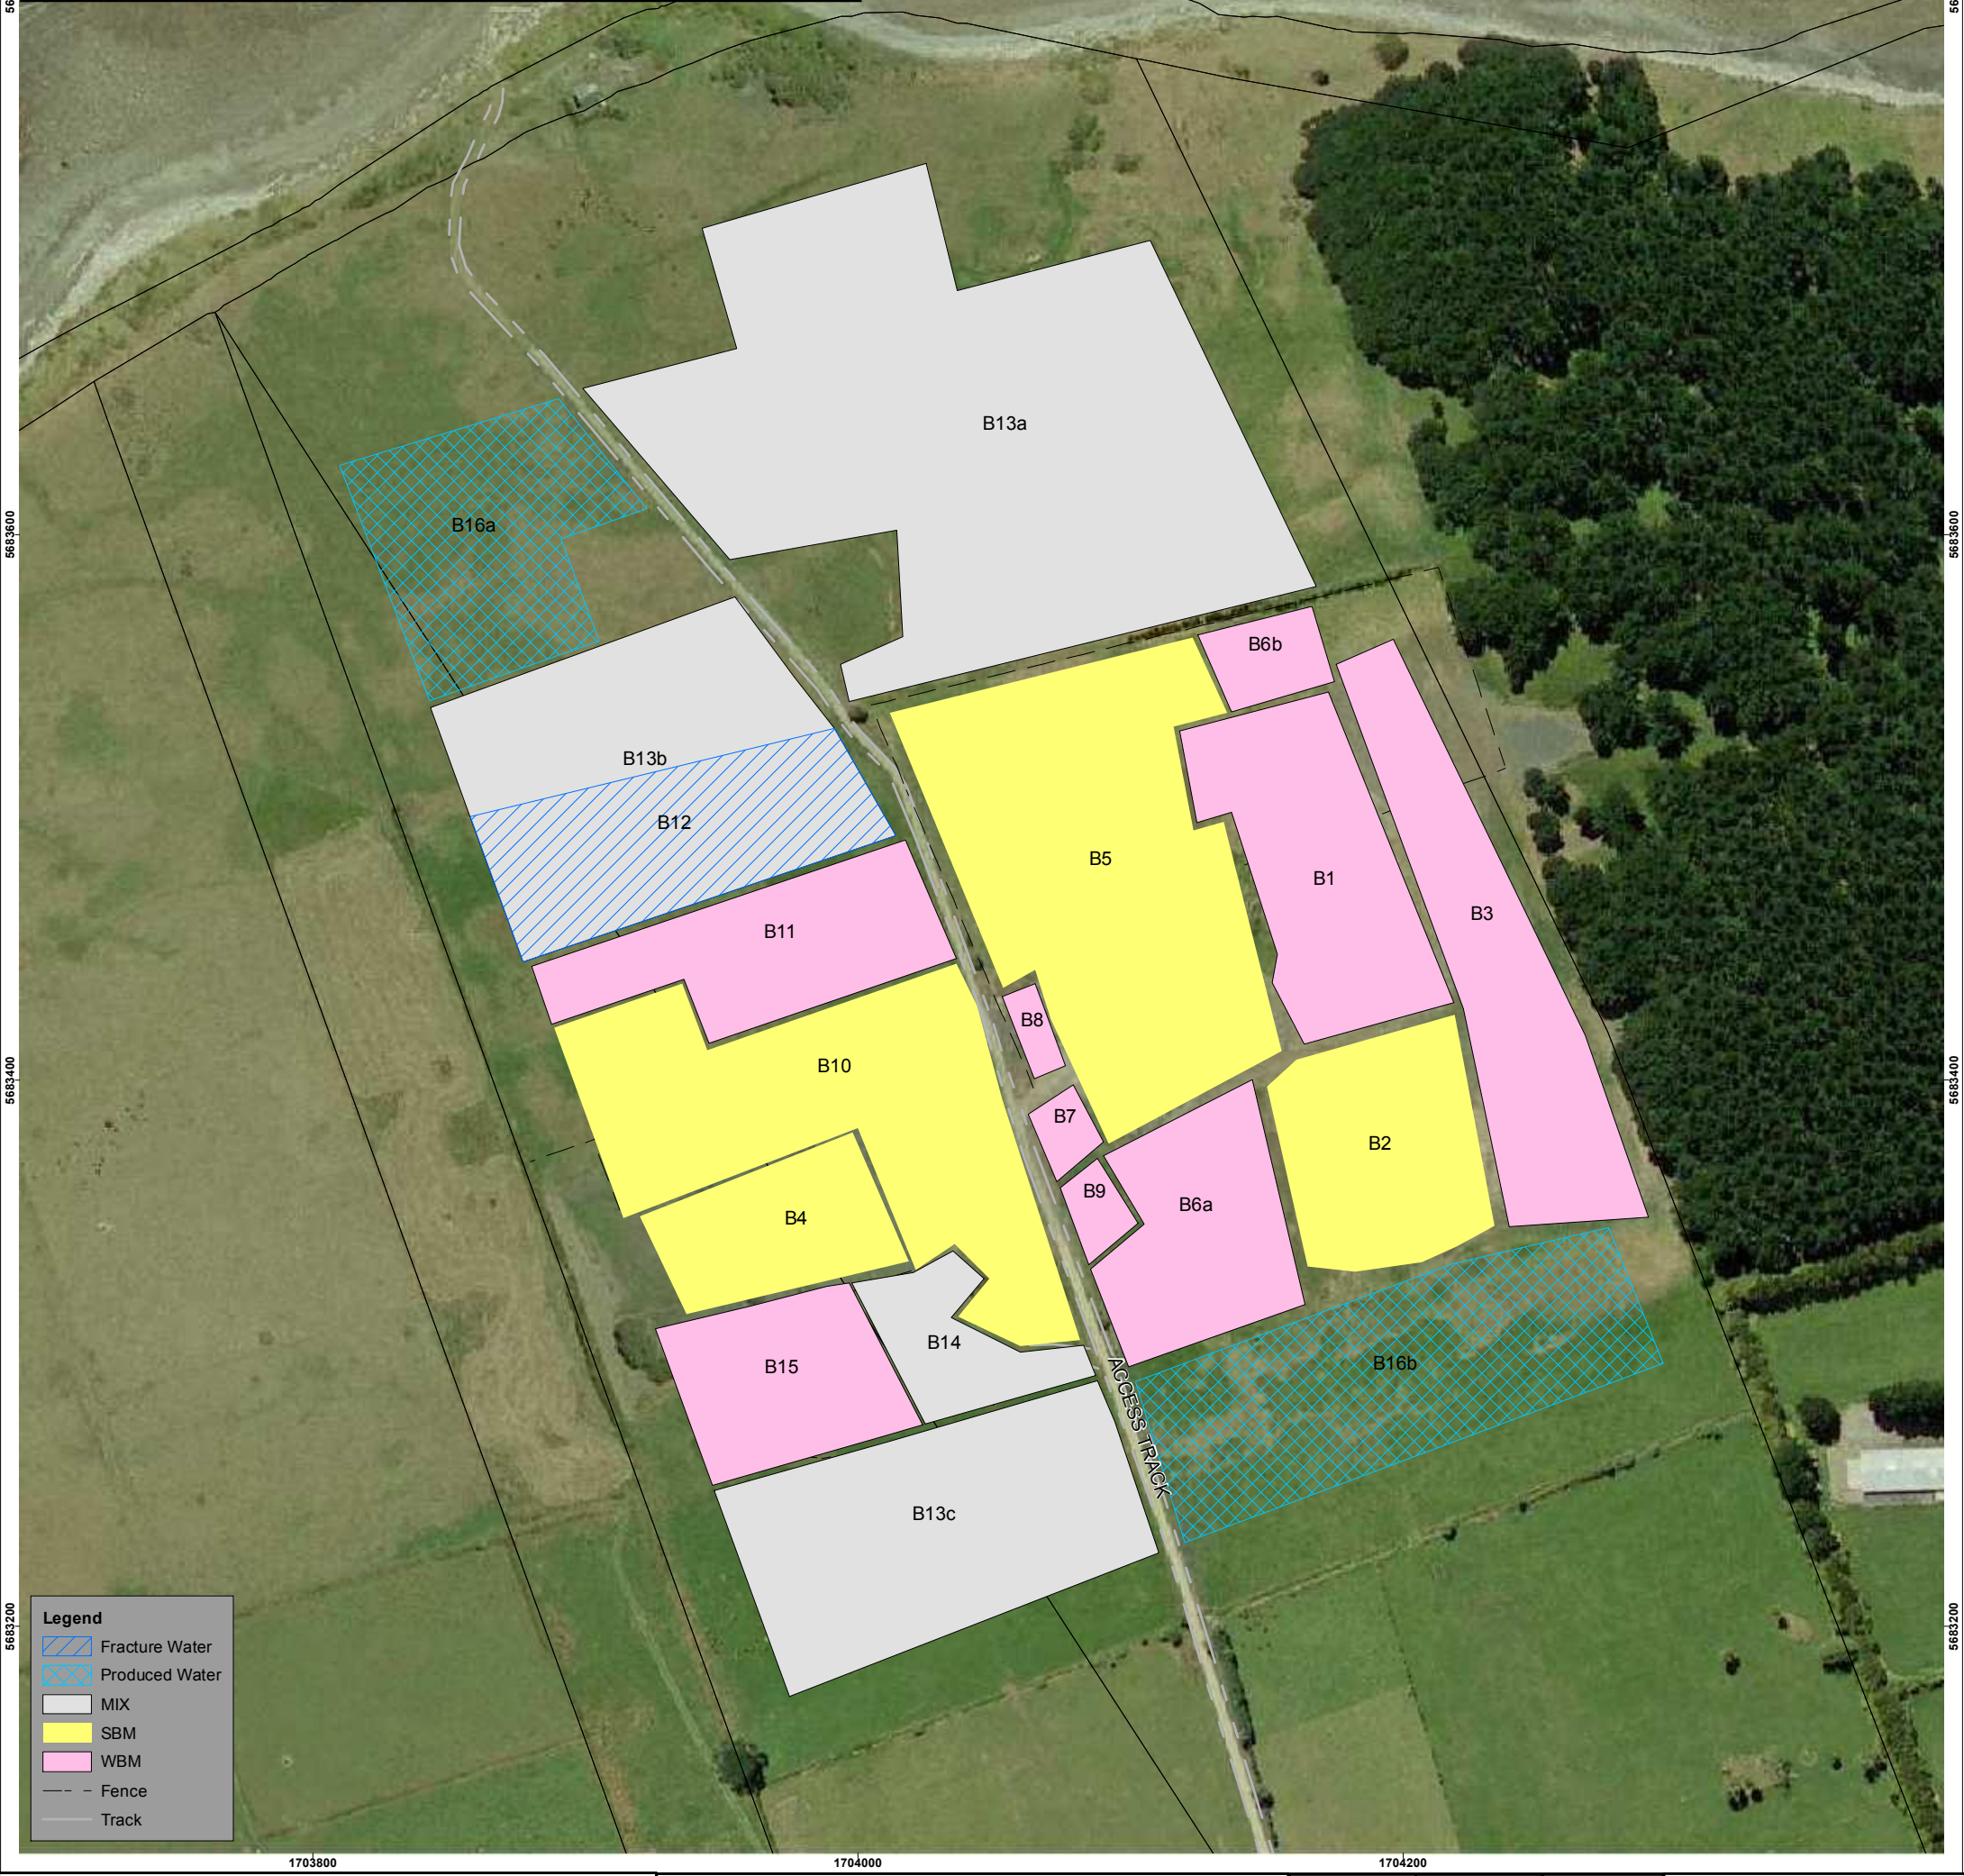
1703800			1704		
5684000	ID	MudType	Date Farmed	WellName	Easting	Northing	Area (m ²)
	B1	WBM	Oct 2006	Kowhai	1704171	5683469	6802
	B2	SBM	Oct 2006	Kowhai	1704192	5683371	5754
	B3	WBM	Jan 2007	Kowhai	1704229	5683456	7906
	B4	SBM	Jan 2007	Kowhai	1703978	5683345	3795
	B5	SBM	Nov 2009	Mangahewa D	1704089	5683476	15036
	B6a	WBM	Oct 2009	Mangahewa C	1704124	5683349	5151
	B6b	WBM	Oct 2009	Mangahewa C	1704150	5683554	1227
	B7	WBM	Oct 2009	KA 6/11	1704076	5683382	517
	B8	WBM	Oct 2009	Mystone / Waitui-1	1704064	5683417	409
	B9	WBM	Oct 2009	KA 8/12/15	1704087	5683354	577
	B10	SBM	Jan 2010	Mangahewa C	1704016	5683392	12211
	B11	WBM	Feb 2010	Waitui-1	1703991	5683418	5657
83300	B12	Fracture Water	09-07-2010	Mangahewa C	1703933	5683489	7098
	B13a	MIX	Dec 2010	McKee Production Station, Waitui-1 (SBM), Cheal B (WBM), Port Taranaki Contaminated Soil	1704054	5683635	28652
	B13b	MIX	Dec 2010	McKee Production Station, Waitui-1 (SBM), Cheal B (WBM), Port Taranaki Contaminated Soil	1703922	5683513	13422

B13c	MIX	Dec 2010	McKee Production Station, Waitui-1 (SBM), Cheal B (WBM), Port Taranaki Contaminated Soil	1704028	5683235	10758
	B14	MIX	Dec 2010	McKee Production Station, Cheal B	1704032	5683298	2513
	B15	WBM	Dec 2010	Broadside	1703972	5683289	4532
	B16a	Produced Water	Jan-May 2011	Tank Farms	1703859	5683600	7265
B16b	Produced Water	Jan-May 2011	Tank Farms	1704197	5683292	11121

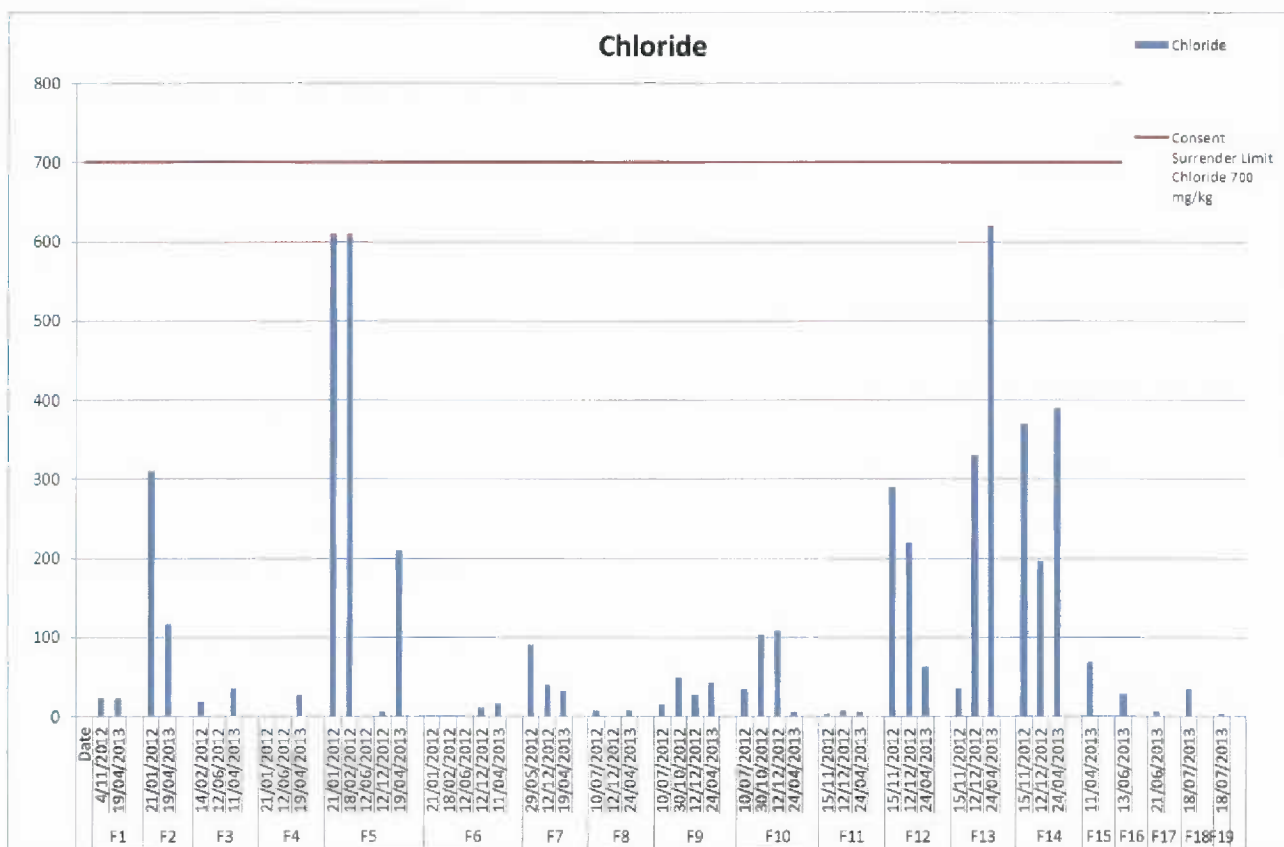
Figure 3 Chloride analysis – Wellington Disposal Site
