BTW Company Limited
Brown Road-Wellington Landfarm
Monitoring Programme
Biennial Report
July 2011 – June 2013
Technical Report 2013–62

July 2014

Executive summary

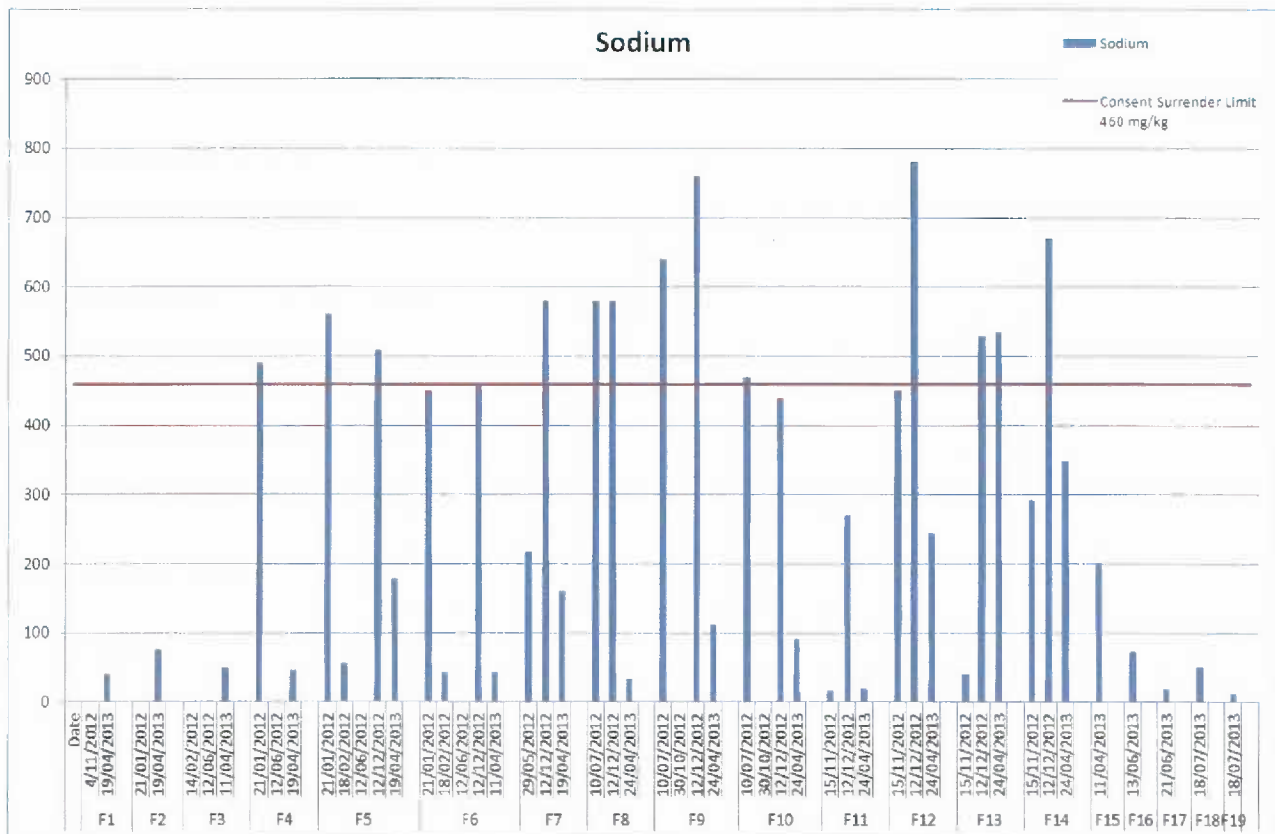
Figure 4 Sodium analysis – Wellington Disposal Site

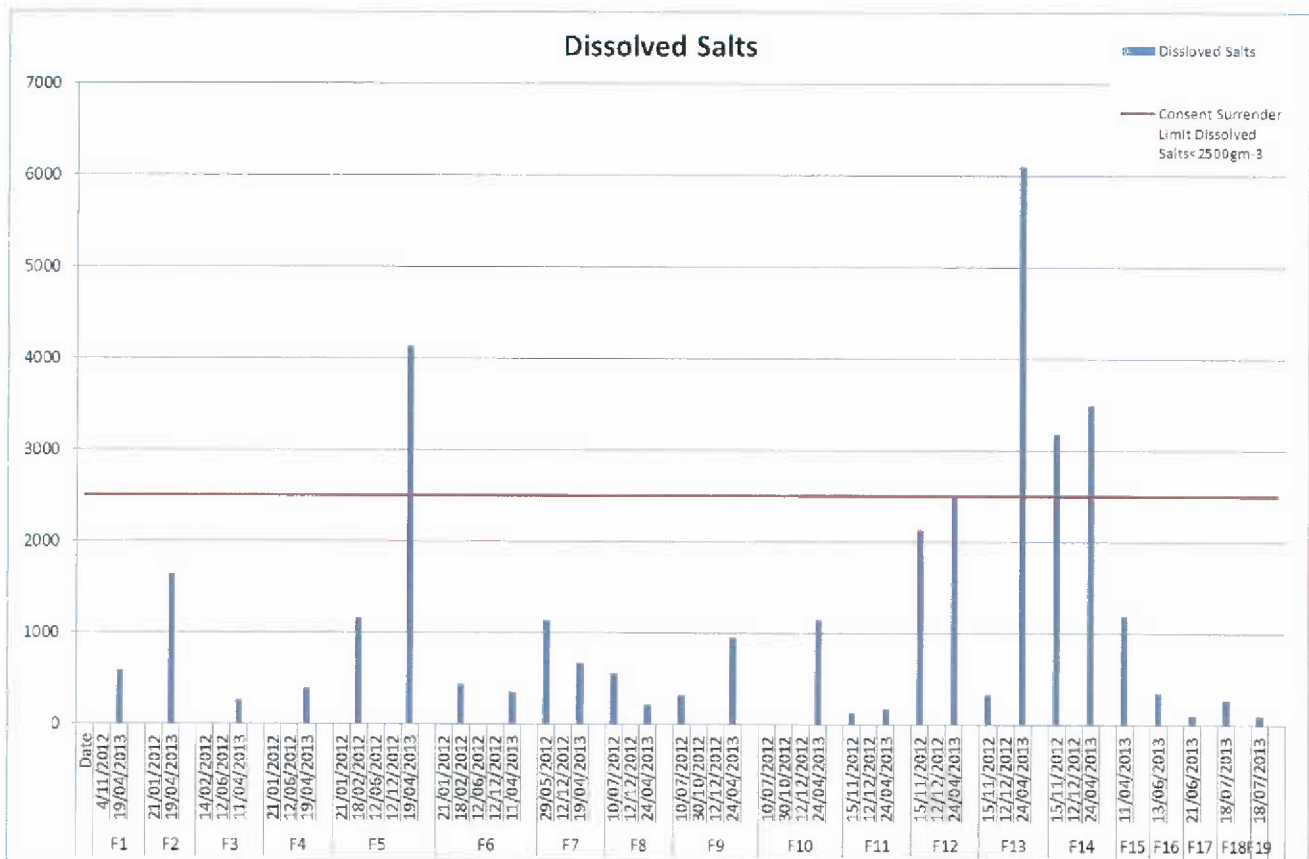
Figure 5 Dissolved Salts analysis – Wellington Disposal Site

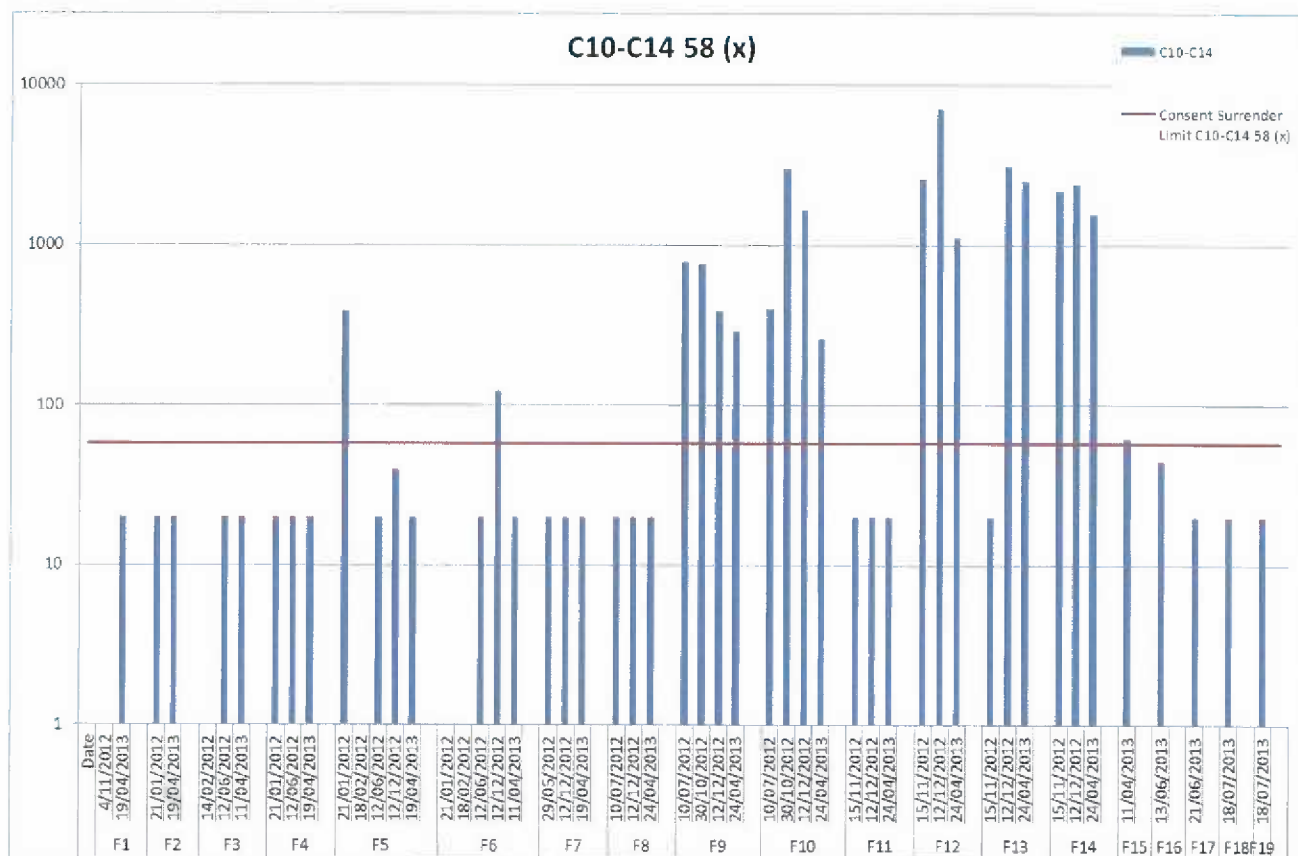
Figure 7 TPH C10-14 – Wellington Disposal Site

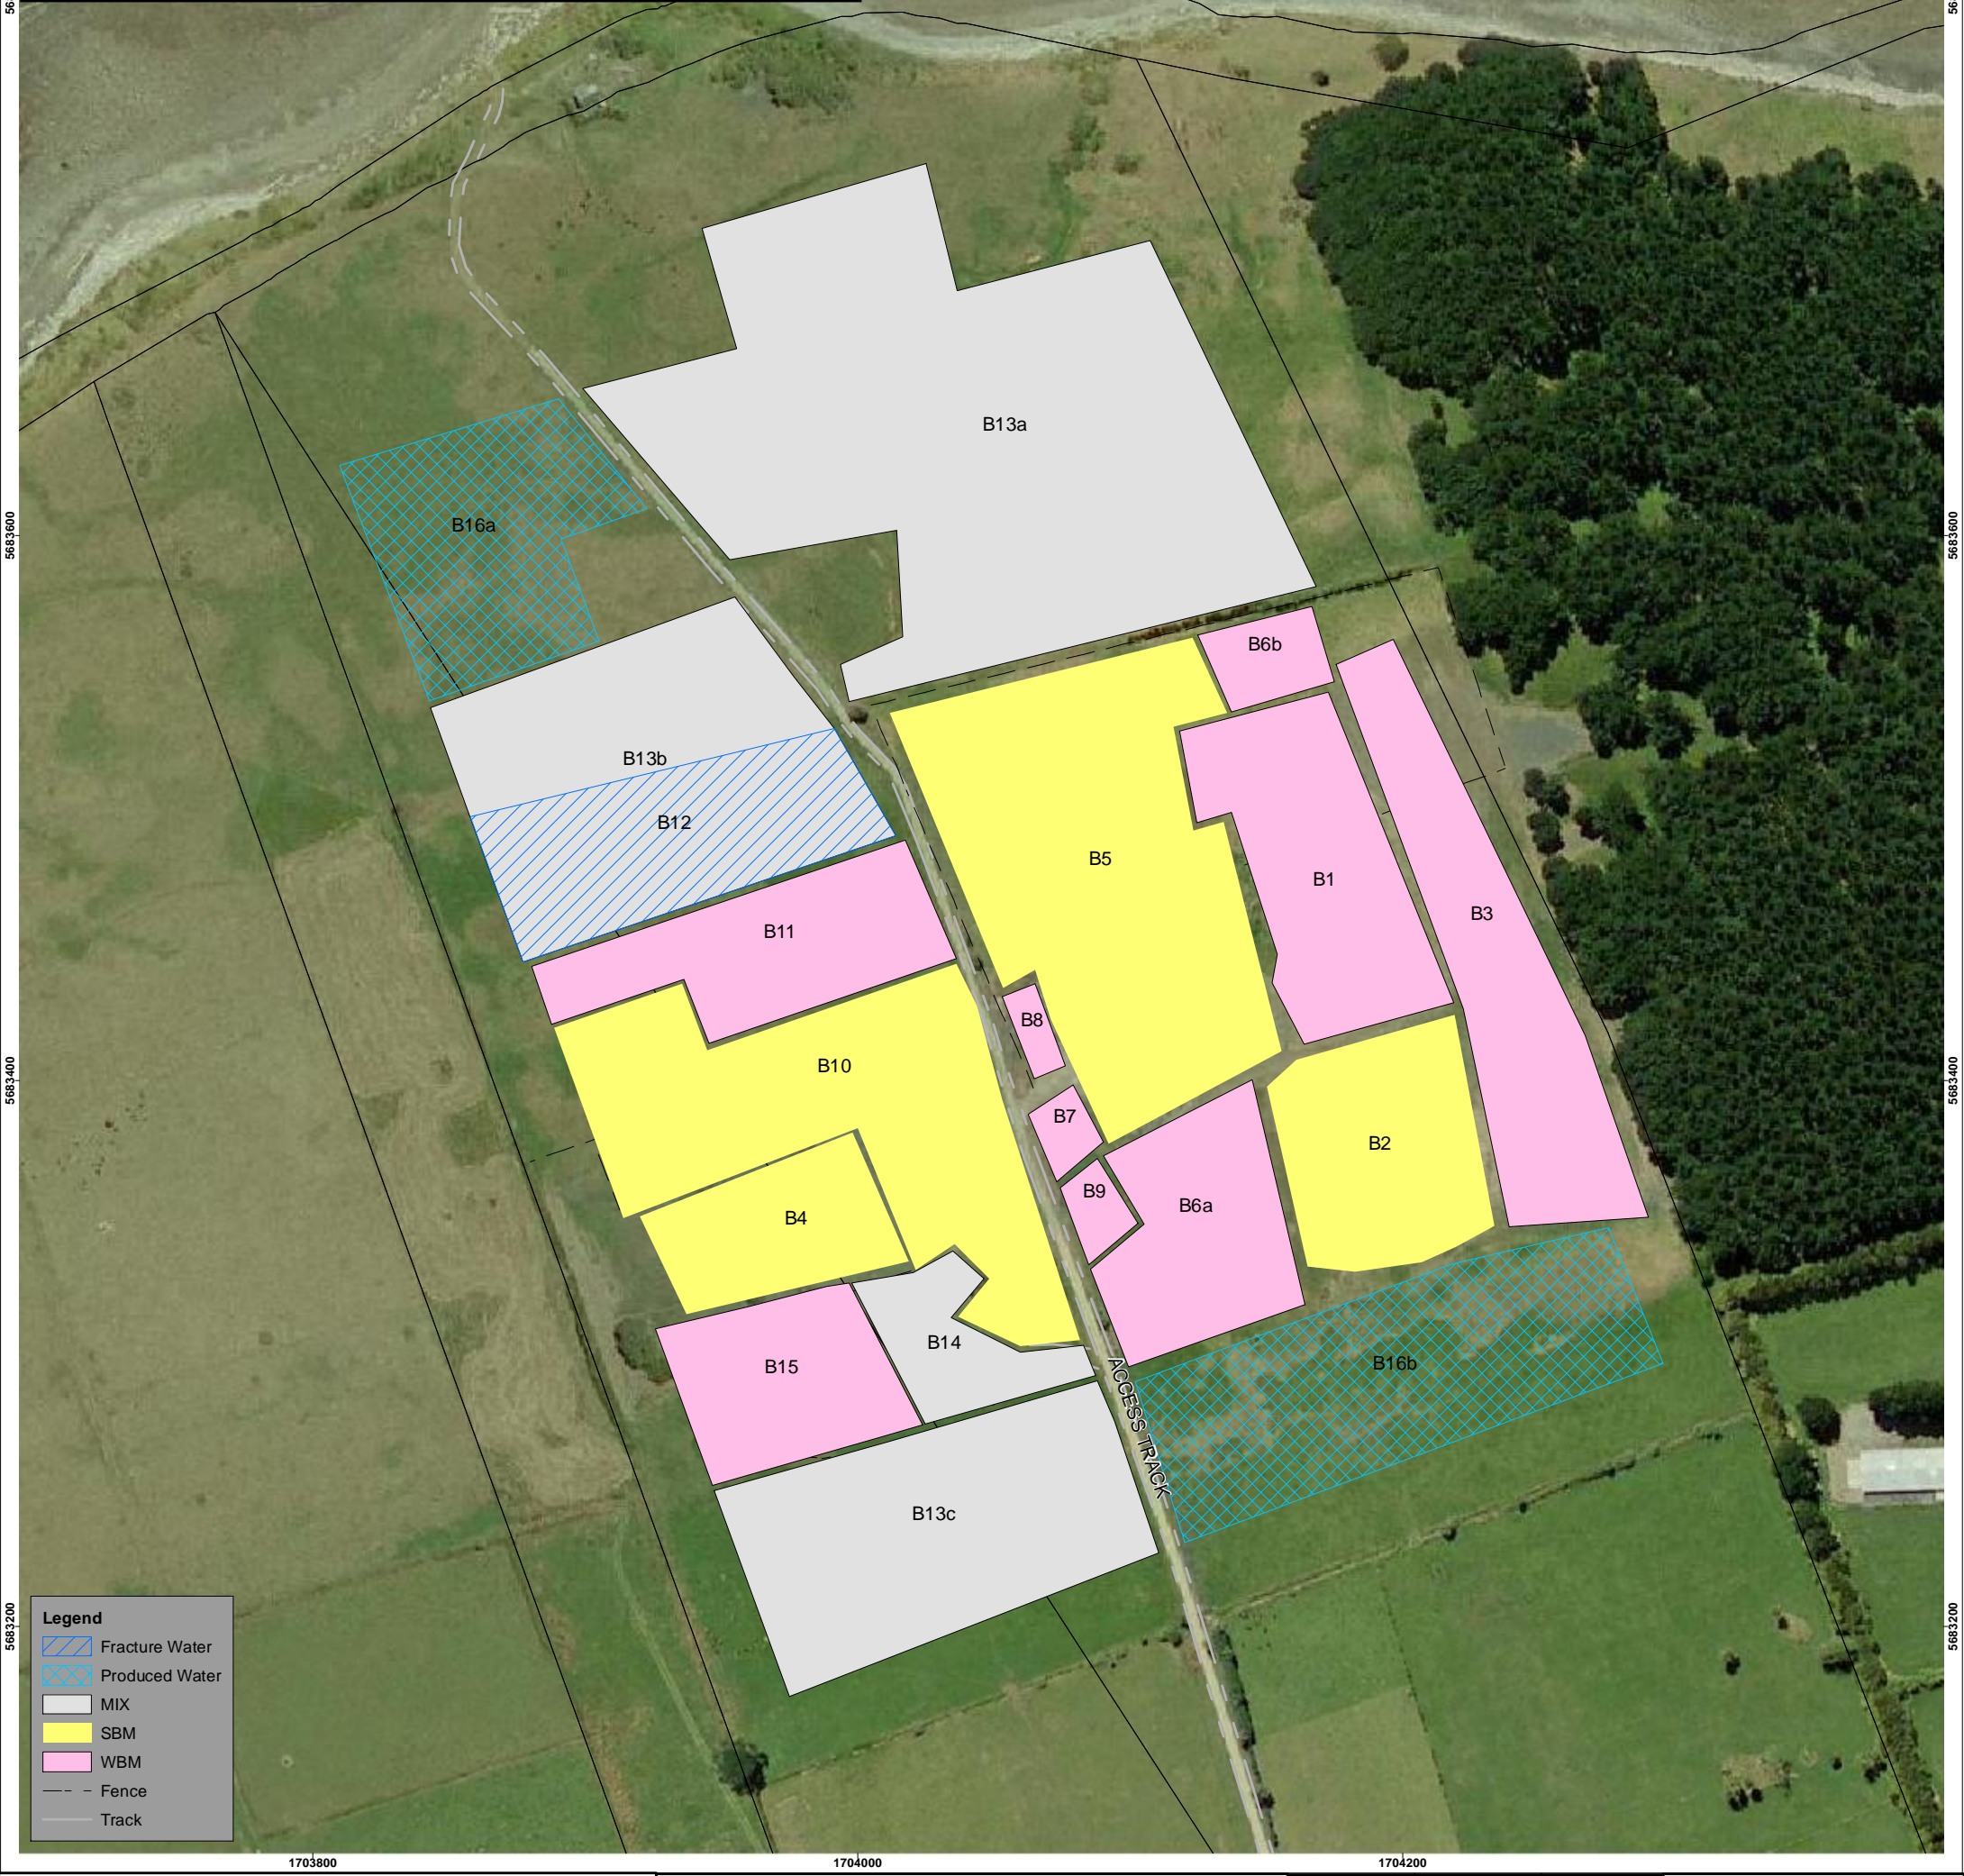
1703800					1704		
568-4000	ID	MudType	Date Farmed	WellName	Easting	Northing	Area (m²)
	B1	WBM	Oct 2006	Kowhai	1704171	5683469	6802
	B2	SBM	Oct 2006	Kowhai	1704192	5683371	5754
	B3	WBM	Jan 2007	Kowhai	1704229	5683456	7906
	B4	SBM	Jan 2007	Kowhai	1703978	5683345	3795
	B5	SBM	Nov 2009	Mangahewa D	1704089	5683476	15036
	B6a	WBM	Oct 2009	Mangahewa C	1704124	5683349	5151
	B6b	WBM	Oct 2009	Mangahewa C	1704150	5683554	1227
	B7	WBM	Oct 2009	KA 6/11	1704076	5683382	517
	B8	WBM	Oct 2009	Mystone / Waitui-1	1704064	5683417	409
	B9	WBM	Oct 2009	KA 8/12/15	1704087	5683354	577
	B10	SBM	Jan 2010	Mangahewa C	1704016	5683392	12211
	B11	WBM	Feb 2010	Waitui-1	1703991	5683418	5657
63800	B12	Fracture Water	09-07-2010	Mangahewa C	1703933	5683489	7098
	B13a	MIX	Dec 2010	McKee Production Station, Waitui-1 (SBM), Cheal B (WBM), Port Taranaki Contaminated Soil	1704054	5683635	28652
	B13b	MIX	Dec 2010	McKee Production Station, Waitui-1 (SBM), Cheal B (WBM), Port Taranaki Contaminated Soil	1703922	5683513	13422

B13c	MIX	Dec 2010	McKee Production Station, Waitui-1 (SBM), Cheal B (WBM), Port Taranaki Contaminated Soil	1704028	5683235	10758
	B14	MIX	Dec 2010	McKee Production Station, Cheal B	1704032	5683298	2513
	B15	WBM	Dec 2010	Broadside	1703972	5683289	4532
	B16a	Produced Water	Jan-May 2011	Tank Farms	1703859	5683600	7265
B16b	Produced Water	Jan-May 2011	Tank Farms	1704197	5683292	11121

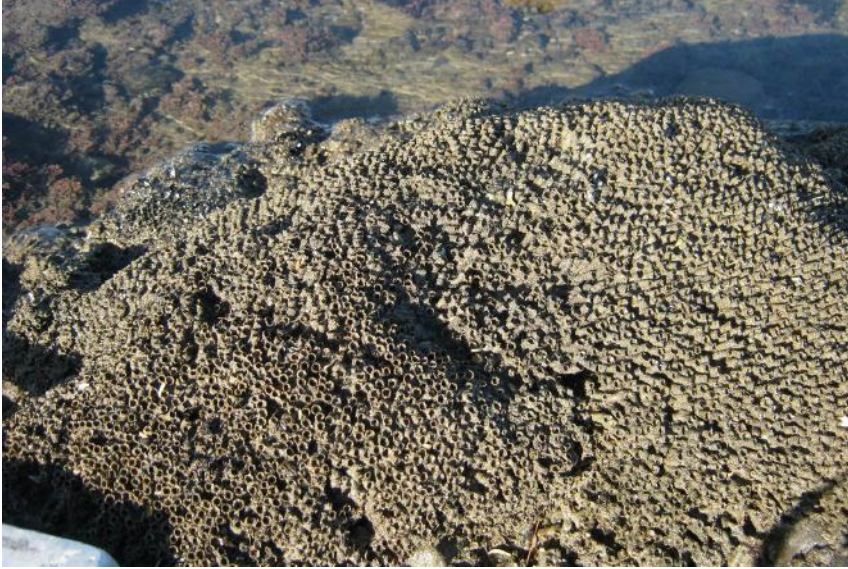
Both Turangi and 500m E had relatively low sand levels, which would not have adversely affected ecological diversity of the reefs. At Orapa B and Turanga, the mean sand cover per quadrat was 31% and 35% respectively. Although there appeared to be no noticeable effects of sand cover at Turanga, sand cover might have contributed to the significantly lower number of species recorded at Orapa B. At the Orapa B site, there was a high density of the colonial polychaete worm, *Neosabellaria kaiparaensis* (previously *Sabellaria kaiparaensis*). This species traps sand to build a worm case, preventing most other species from growing on either the substrate or the worm cases.

Photo 1 Polychaete worm *Neosabellaria kaiparaensis*

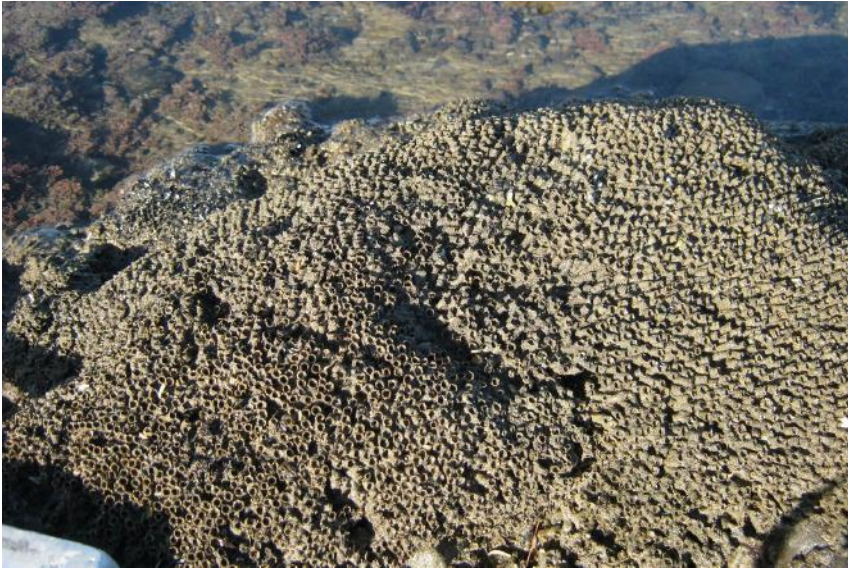
Both Turangi and Turanga had relatively low sand levels, which would not have adversely affected ecological diversity of the reefs. At Orapa B and 500m E, the mean sand cover per quadrat was 26% and 22% respectively. Although there appeared to be no noticeable effects of sand cover at 500m E, sand cover might have contributed to the significantly lower number of species recorded at Orapa B. At the Orapa B site, there was a high density of the colonial polychaete worm, *Neosabellaria kaiparaensis* (previously *Sabellaria kaiparaensis*). This species traps sand to build a worm case, preventing most other species from growing on either the substrate or the worm cases.

Photo 1 Polychaete worm *Neosabellaria kaiparaensis*

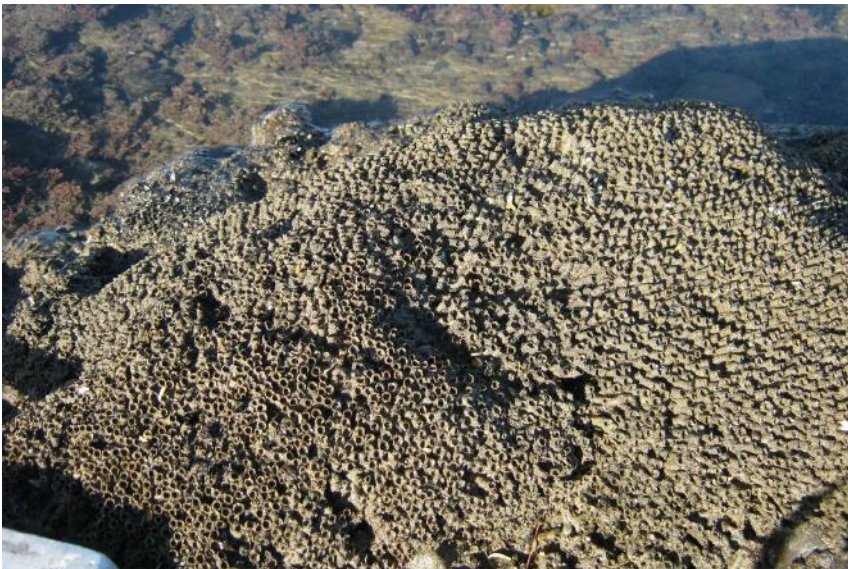
Both Turanga and 500m E had low sand levels, which would not have adversely affected ecological diversity of the reefs. At Orapa B and Turangi, the mean sand cover per quadrat was 23% and 16% respectively, which might have contributed to the significantly lower Shannon-Weiner index recorded at these two sites. At the Orapa B site, there was a high density of the colonial polychaete worm, *Neosabellaria kaiparaensis* (previously *Sabellaria kaiparaensis*). This species traps sand to build a worm case, preventing most other species from growing on either the substrate or the worm cases.

Photo 1 Polychaete worm *Neosabellaria kaiparaensis*
