BTW Company Limited
Oeo Landfarm
Monitoring Programme
Annual Report
2013-2014

Technical Report 2014-39

BTW Company Limited (BTW) operates a drilling waste disposal site located on South Road at Manaia. The site was primarily operational during the previous monitoring period, when synthetic and water-based muds and rock cuttings were disposed of to land via the process of landfarming. Activity at the site ceased at the beginning of the 2013-2014 monitoring period, as available spreading area capacity was reached in the main area of the site, and the decision was made not to farm the smaller area east of the Rawa Stream. This report for the period July 2013 – June 2014 describes the monitoring programme implemented by the Taranaki Regional Council to assess the Company's environmental performance during the period under review, and the results and environmental effects of the Company's activities.

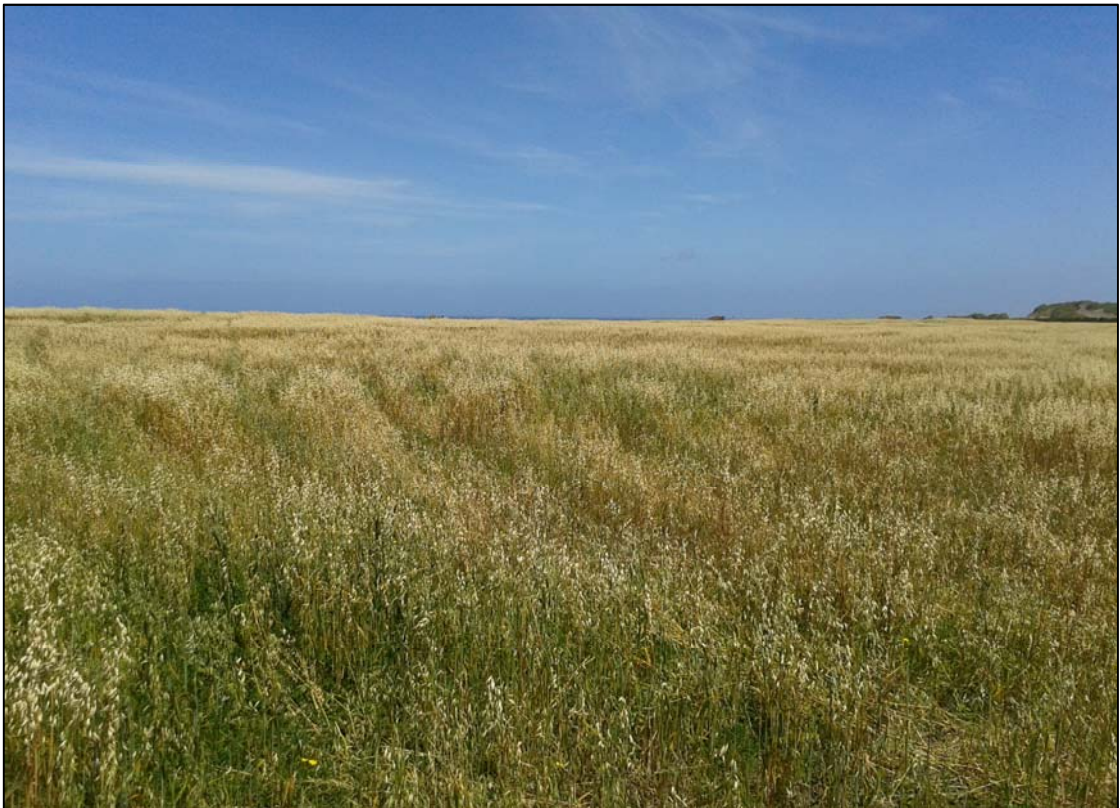
Photo 2 Spreading area F1 during 14 February sampling inspection showing good pasture establishment

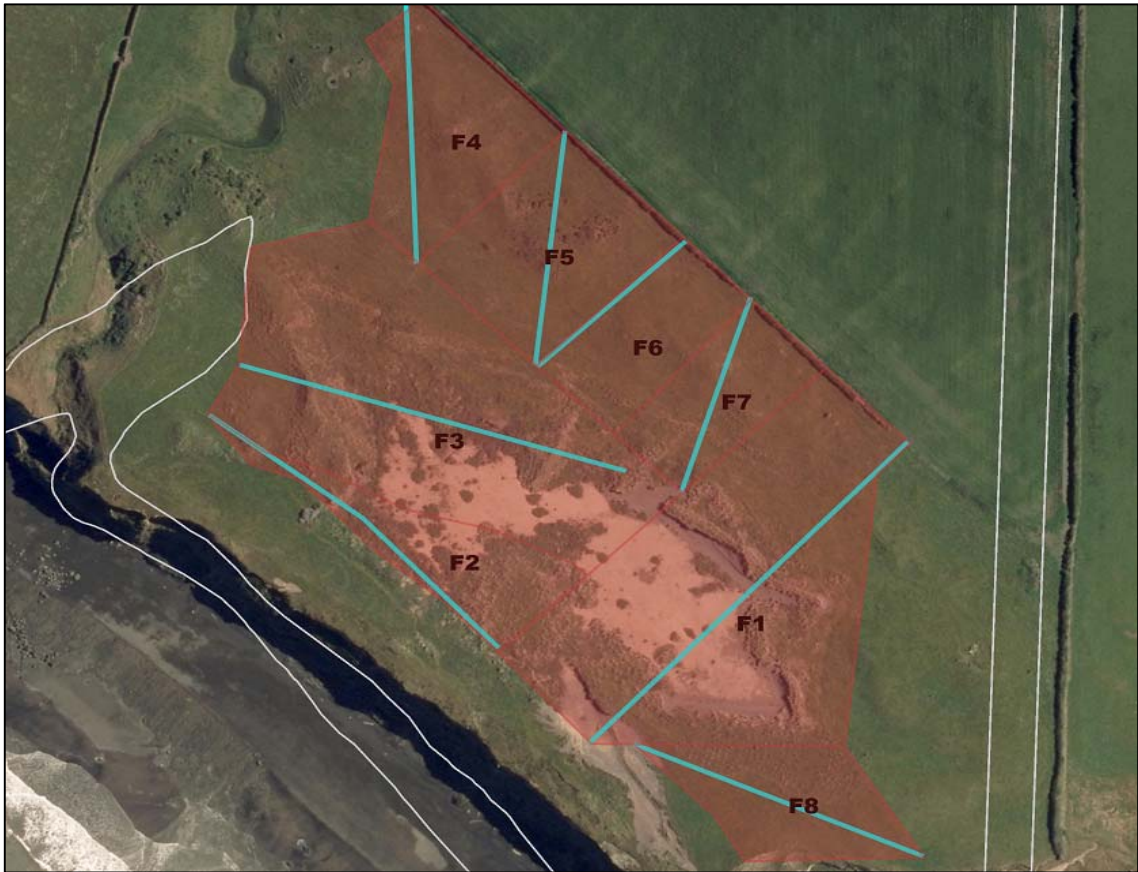
Figure 3 Council soil sampling transect locations, areas F1 to F8

During the monitoring year, six composite soil samples were collected by sub-sampling along transects at 10 m intervals to a depth of 250mm in completed spreading areas F2 to F8 (Figure 3) . The results are presented below in Table 2.

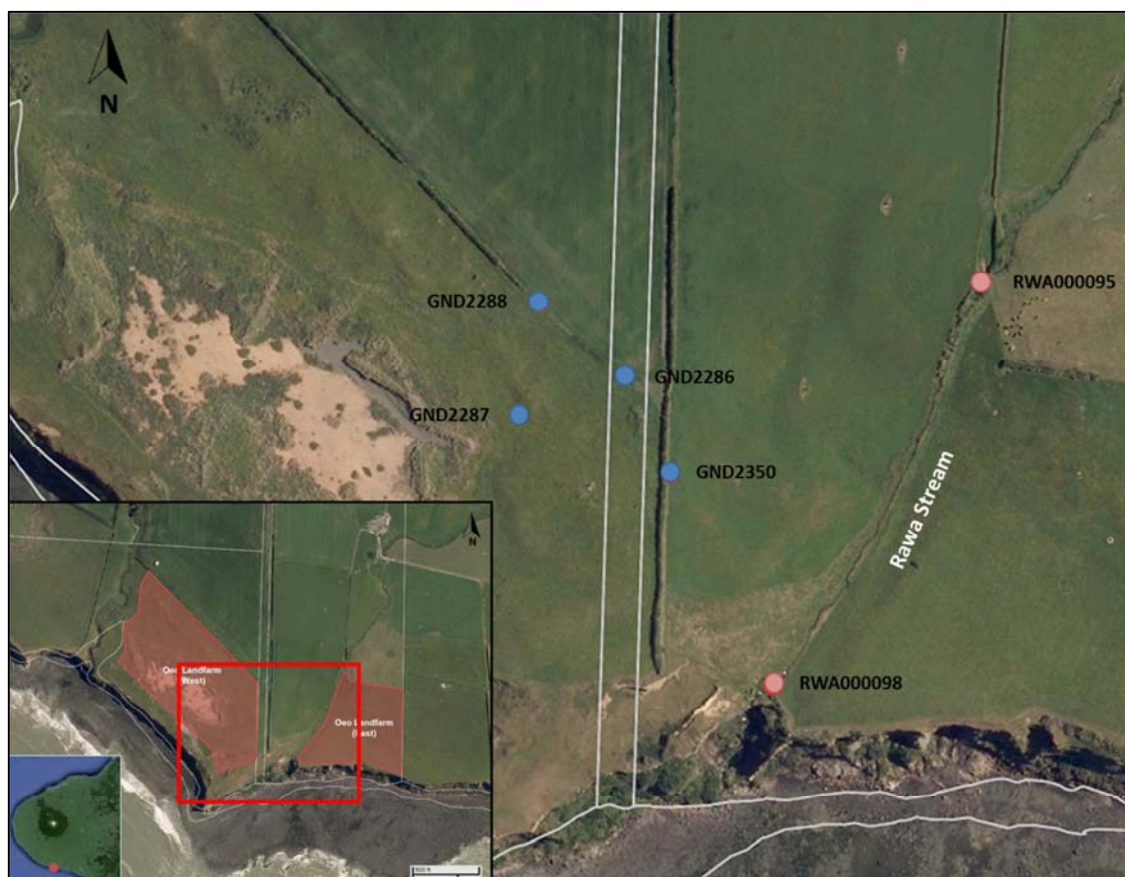
Figure 4 Groundwater and surface water sampling sites, Oeo landfarm

During the monitoring quarterly groundwater sampling was conducted from four monitoring bores at the Oeo site, located as shown in Figure 4, below. The results for each of the bores are presented in Tables 3 to 6 respectively.

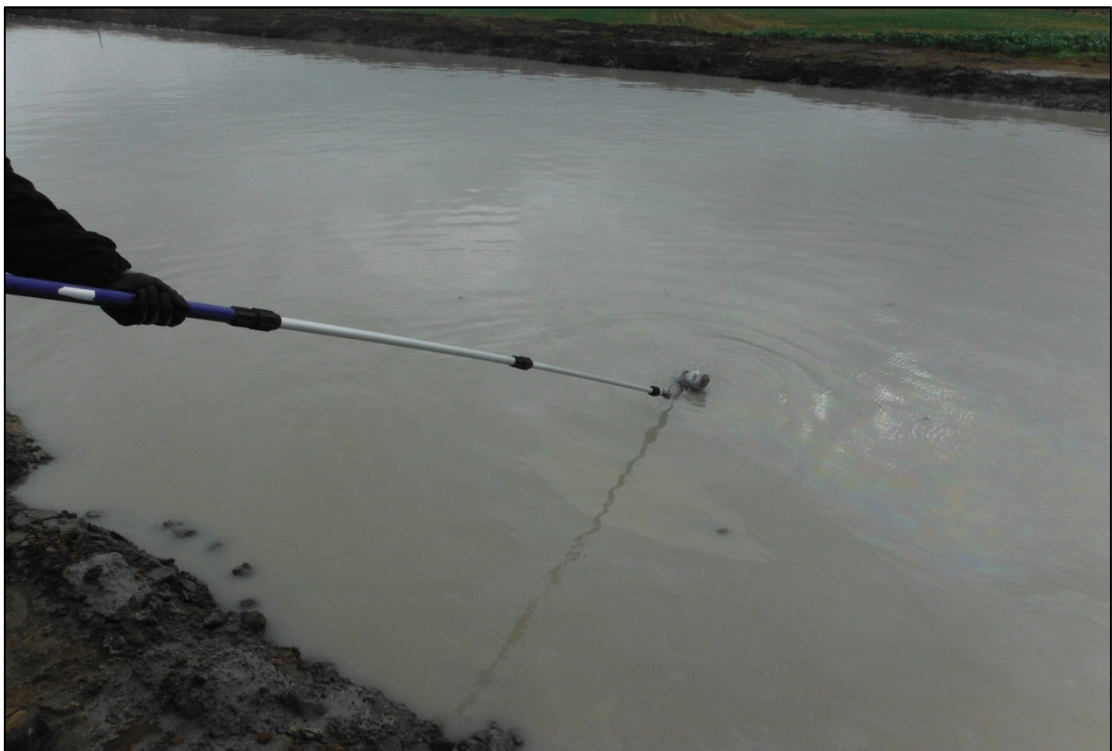
Photo 3 Sampling liquid portion of pit A mud/sludge

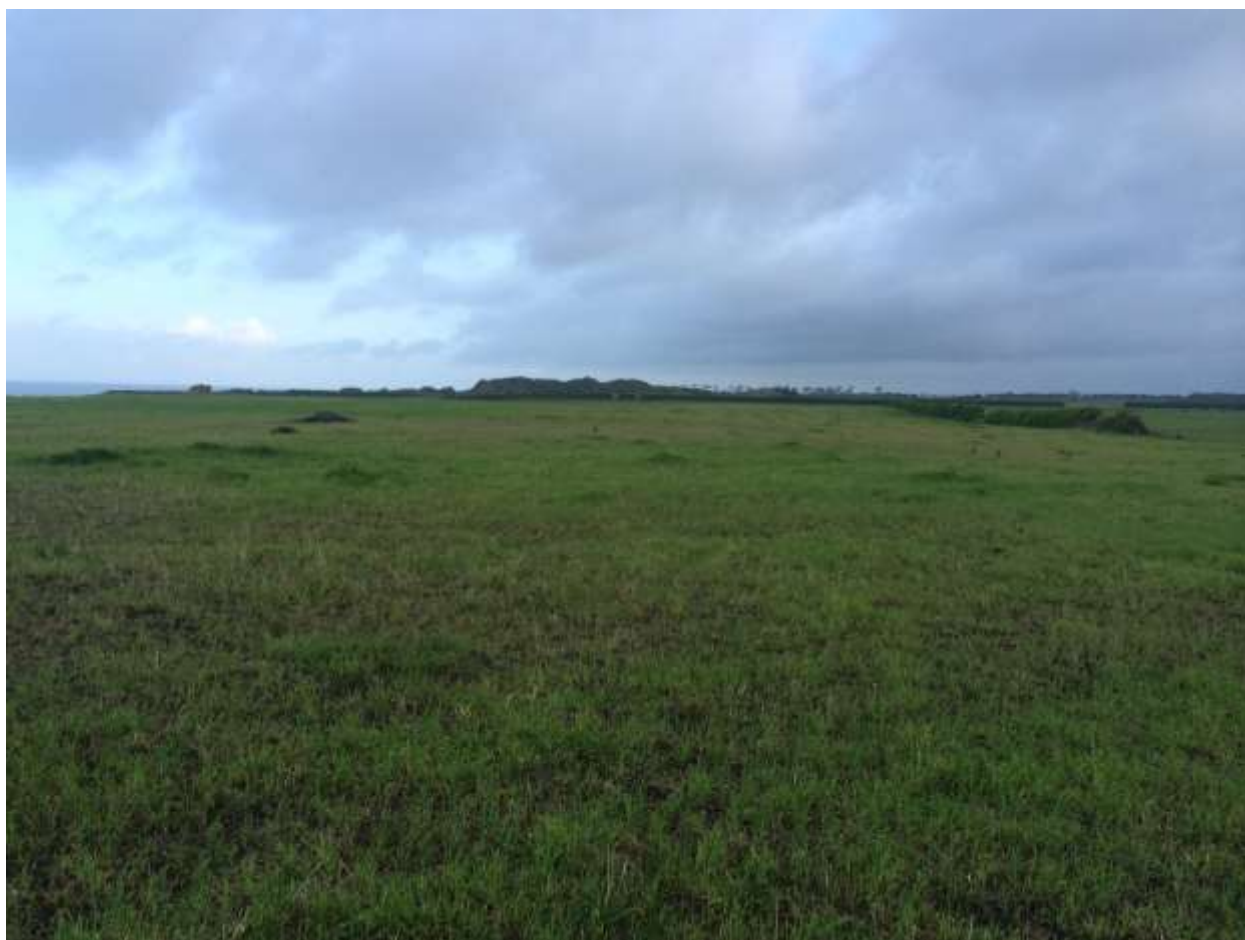
The whole site from F1 to F8 was re sown in oaks for initial vegetation establishment. The whole site has now been sown in permanent pasture. The F3 area still has a patchy pasture strike; however the rest of the site now has excellent pasture strike as shown in Figure 2.1 below

Figure 2.1: Pasture Establishment Oeo Landfarm 1-6-14
